# Mitch Fredericks Home Inspections

## Mitch Fredericks Home Inspections

**101 Heartwood Way  
Anaheim, CA**

Inspected on Wed, Feb 8 2023 at 2:49 PM

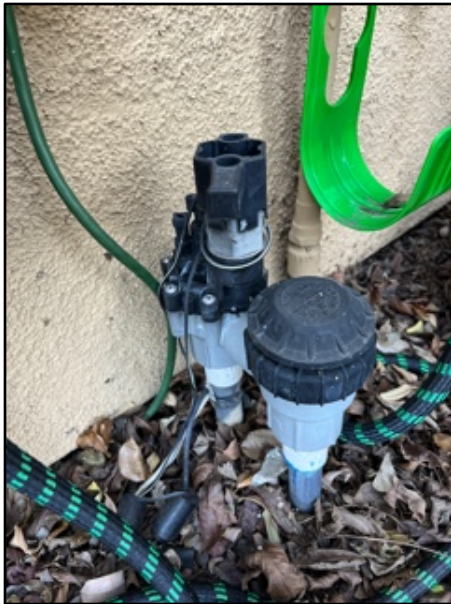
Figure 2-1

Right side sprinkler valve is free of leaks.

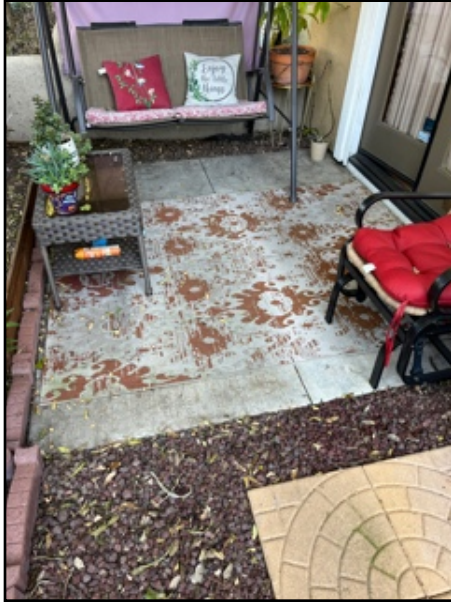
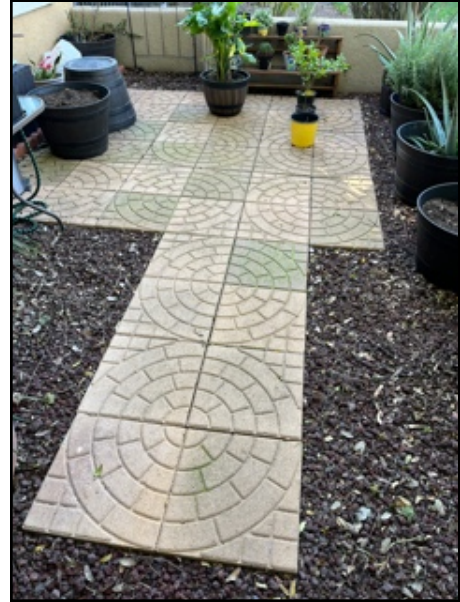
Figure 3-1

Left side, concrete patio slab appears solid and virtually crack free. Concrete tiles appear in overall good condition.

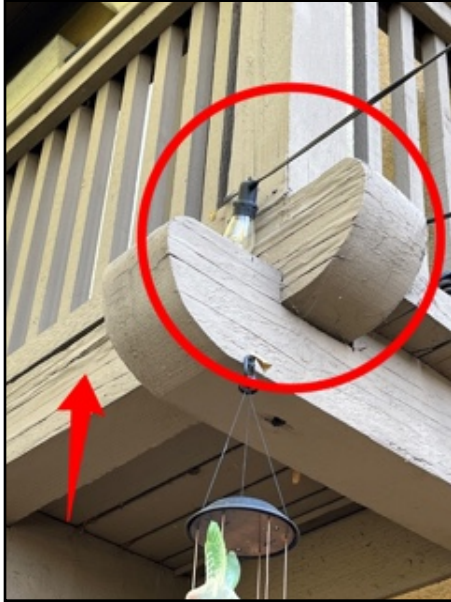
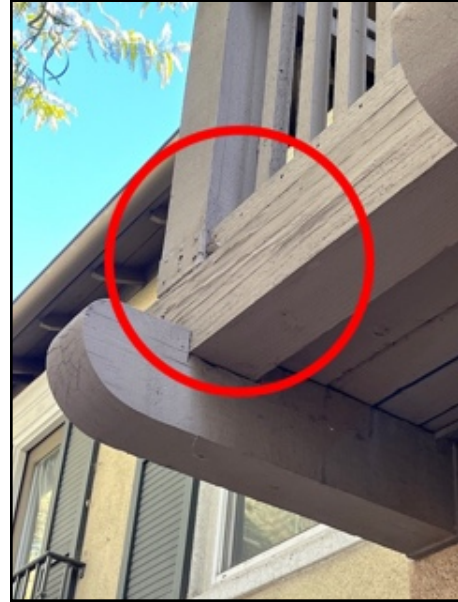
Figure 5-1

Master bedroom balcony wood beams, show paint blistering and possible wood damage. The exterior is maintained by the HOA.

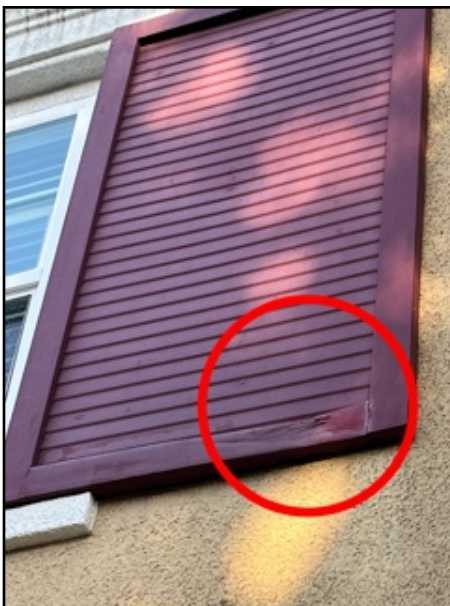
Figure 7-1

Comment 7:  
Master bathroom shutter shows wood damage.

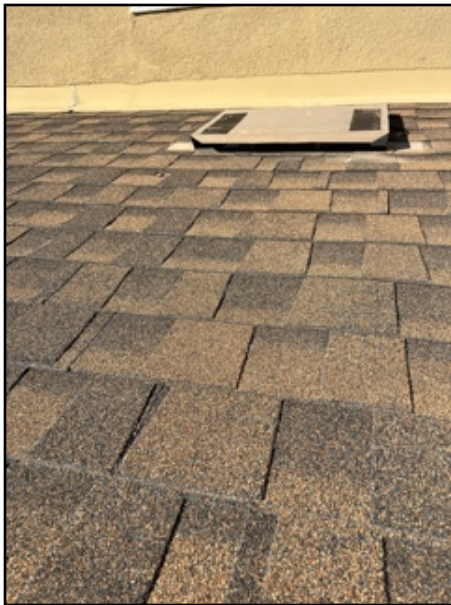
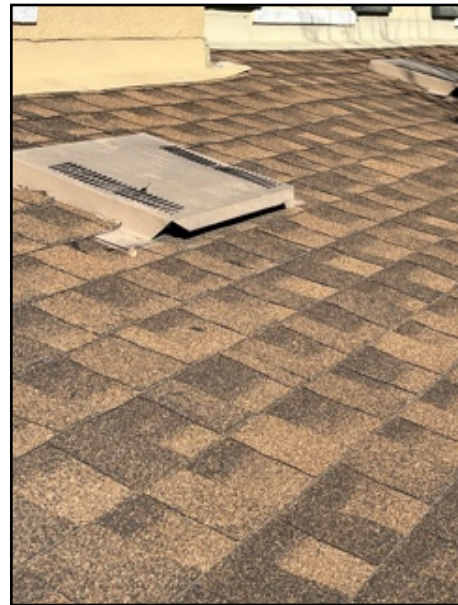
Figure 8-1

Asphalt shingles show medium weathering. Plumbing and exhaust vents appear well sealed.

Ridge cap asphalt shingles appear tight and sound. Attic vents are installed. We understand the roof is maintained by the HOA.

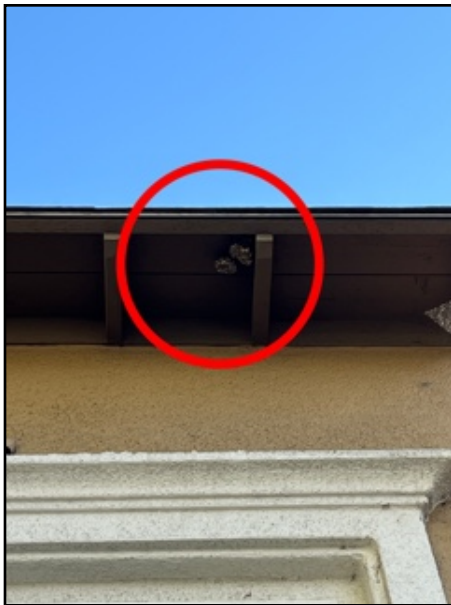
Figure 9-1

Difficult to see in this photo, however, wasp nests are noted in the eaves at the left side of the house.

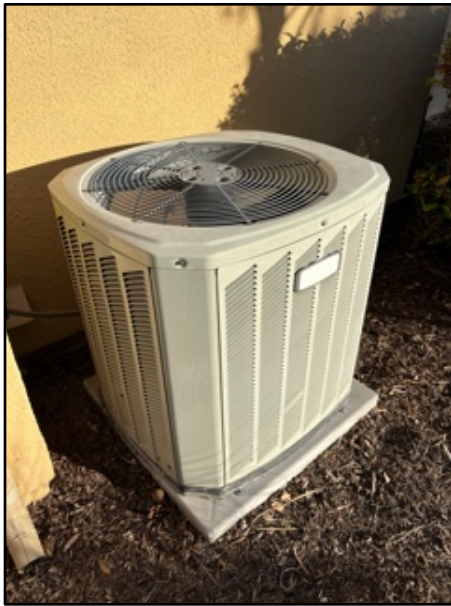
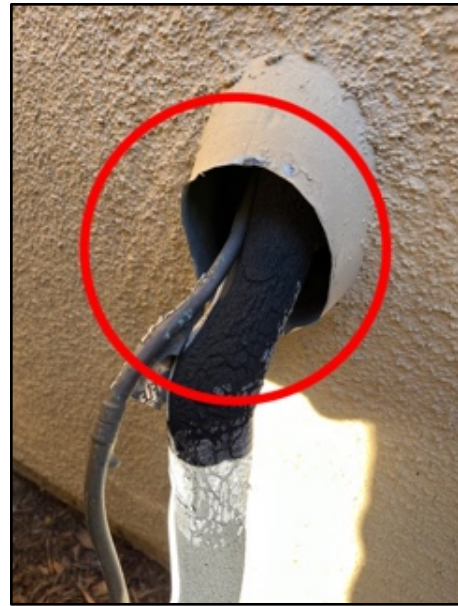
Figure 10-1

Outside compressor responds to thermostat controls.

This unit was installed in 2010 and uses the newer R 410 A freon.

Seal the opening from the outside air conditioning compressor to keep out rodents.

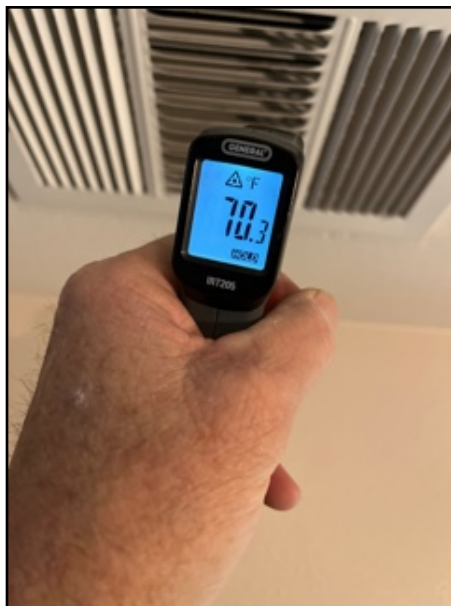
Figure 11-1

The air conditioning did not condense and cool down the house. Air was blowing out at 70°. Recommend a service call to an HVAC company.

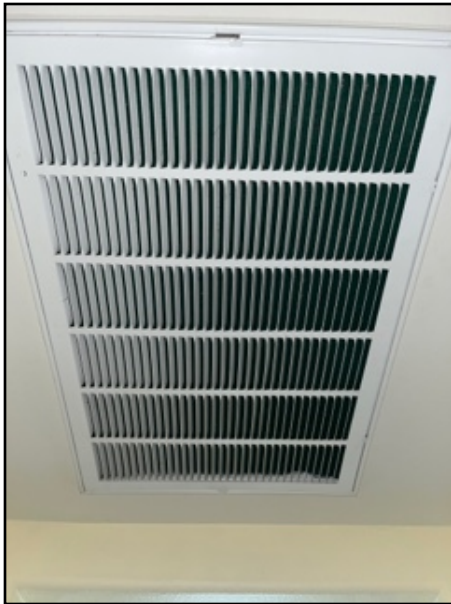
Figure 12-1

Air filter is dirty and should be replaced.

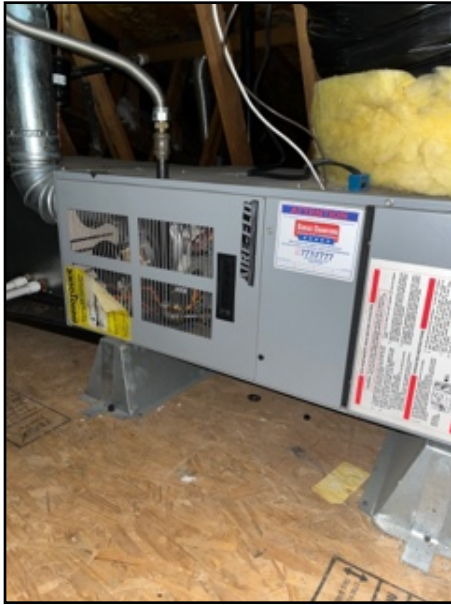
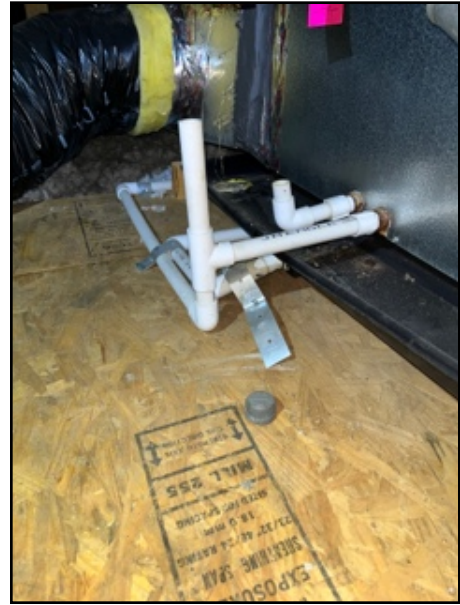
Figure 13-1

The furnace responds to the thermostat controls.

Blower motor is quiet at time of inspection.

No visible leaks from the condensation drain pipes in the attic.

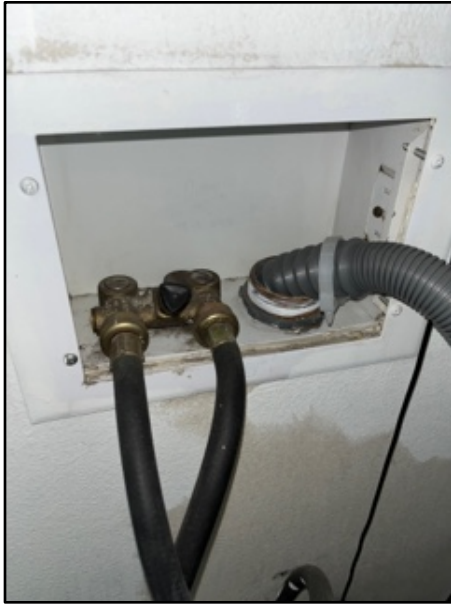
Figure 15-1

Washer hook up valves appear free of leaks. Recommend replacing rubber hoses with steel braided hoses.

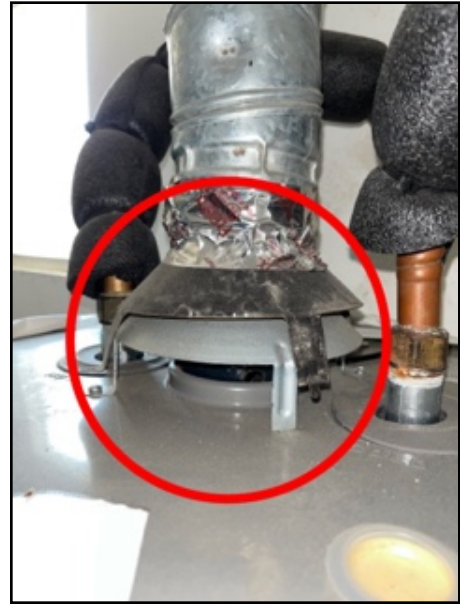
Figure 17-2

Water heater is free of leaks at time of the inspection. No visible corrosion buildup on the water supply valves.

The exhaust vent comes up slightly short of reaching the top of the tank. There are two draft hood vents to bring the vent closer to the top of the tank.

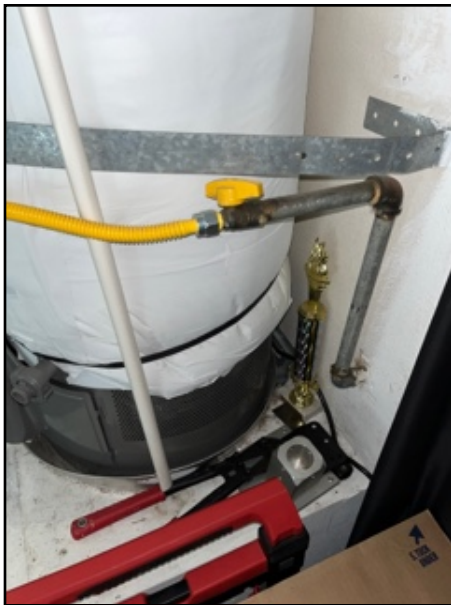
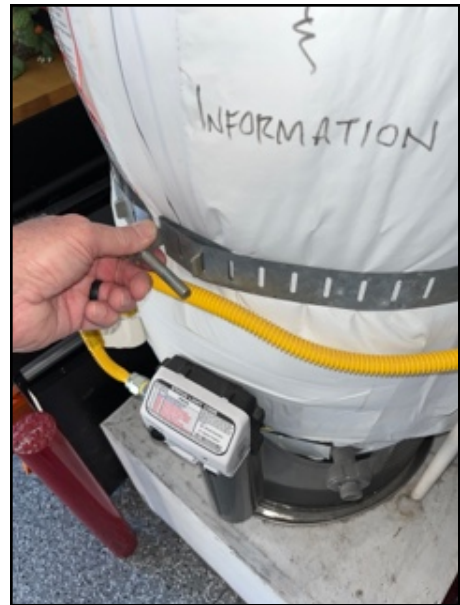
Figure 18-1

Water heater gas line does not have a sediment trap.

Lower earthquake strap is loose and should be tightened.

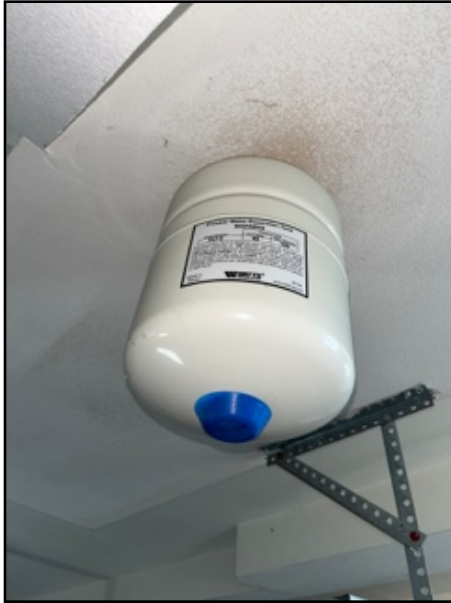
Figure 19-1

Absorption tank is free of leaks at time of the inspection.

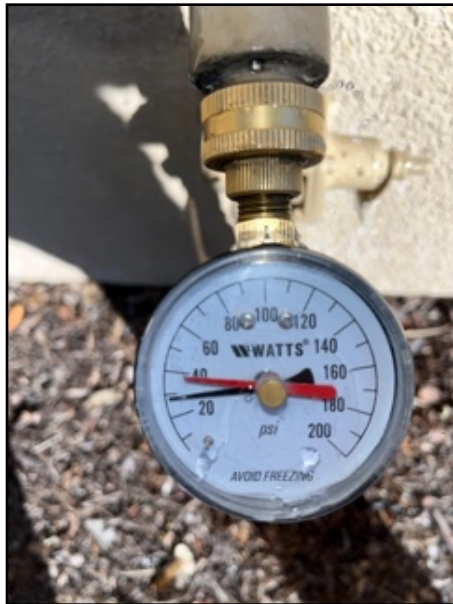
Figure 20-1

Water pressure is low at 30 psi. Water pressure should be between 65 and 75 psi. This home has a regulator that needs to be adjusted.

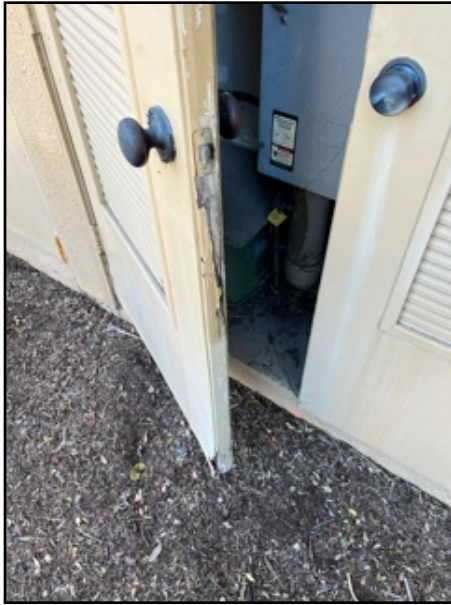
Figure 23-1

Electrical meter closet doors are damaged. This is maintained by the association.

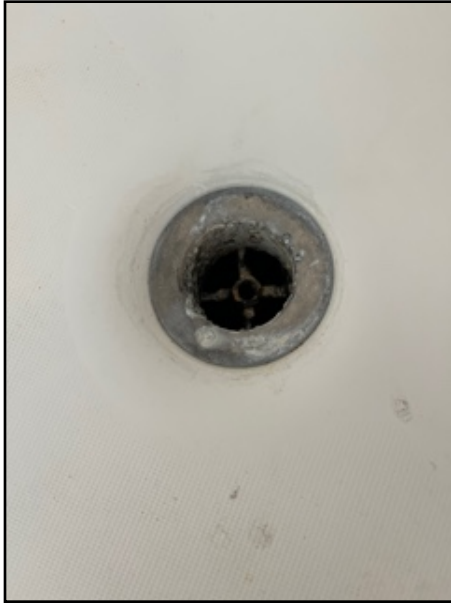
Figure 27-1

Hall bathroom tub collar is corroded and missing stopper.

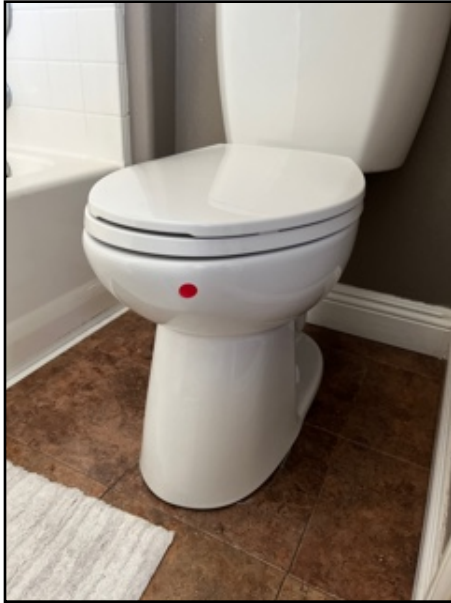
Figure 28-1

Upstairs hall bathroom toilet is loose. Toilet should be tightened.

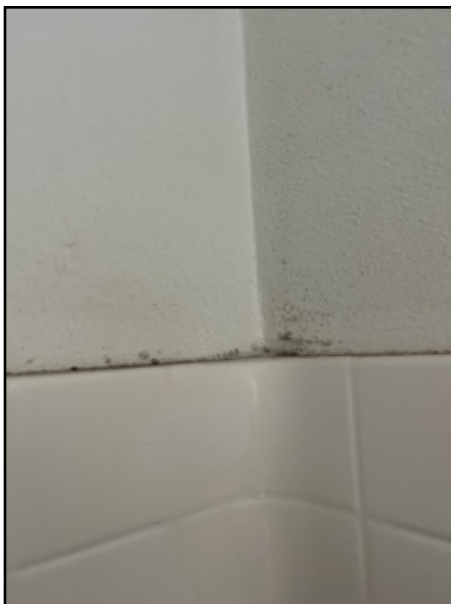
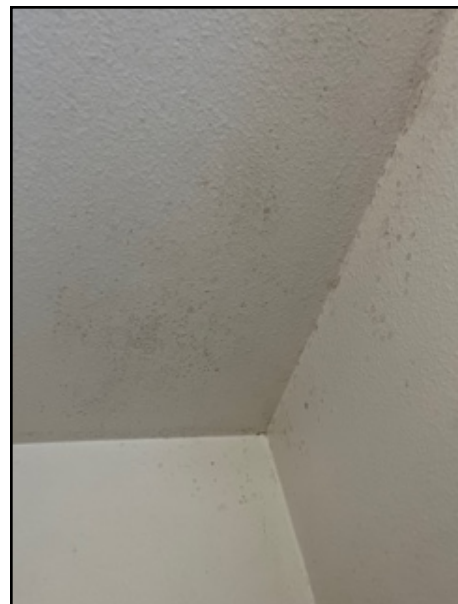
Figure 29-1

Master bathroom, walls and ceiling above the shower show mildew stains. This is caused from condensation of a hot steam shower.

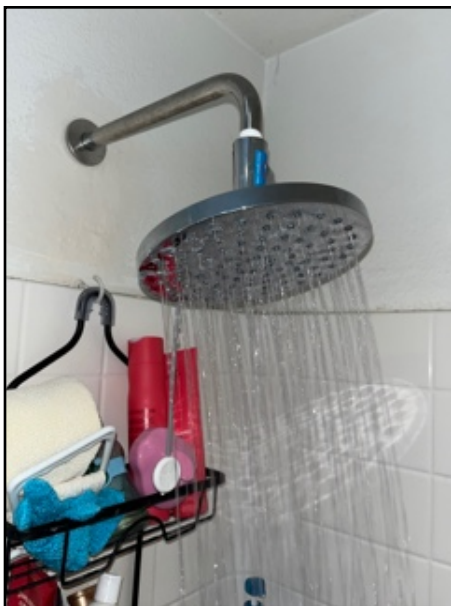
Figure 31-1

Comment 31:  
Master bathroom shower has low volume.

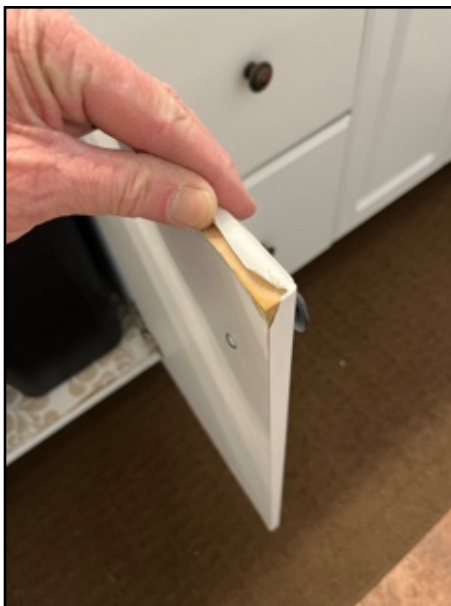
Figure 33-1

Comment 33:  
Master bathroom cabinet door shows finish peeling.

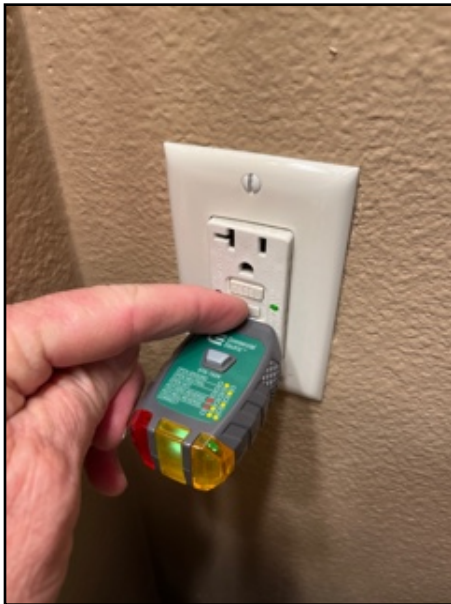
Figure 35-1

Half bathroom GFCI outlet does not trip. Outlet is faulty and should be replaced.

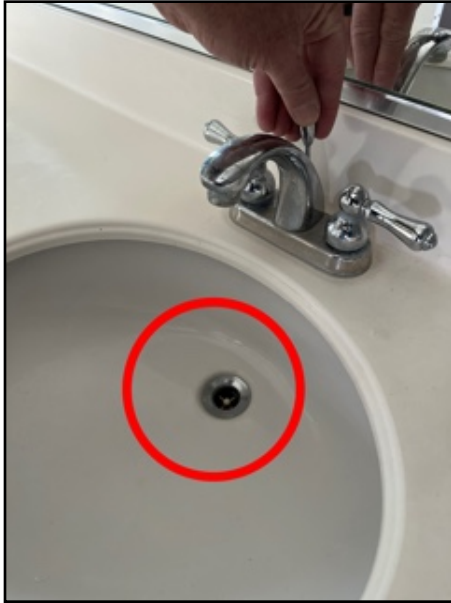
Figure 36-1

Comment 36:  
Hall bathroom is missing sink stopper.

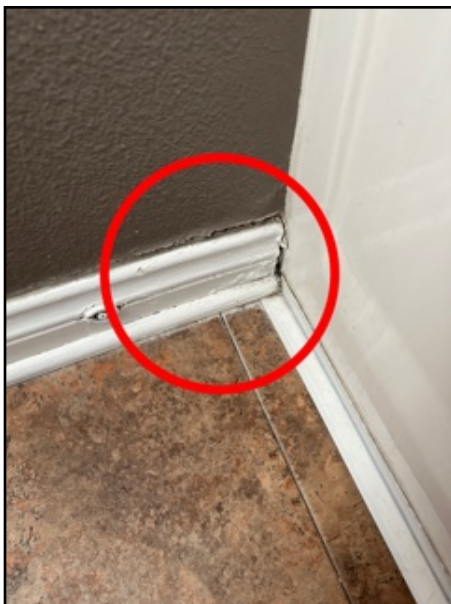
Figure 37-1

Comment 37:  
Hall bathroom shows water damage outside of the bath tub. Baseboard is soft at left side of the tub.

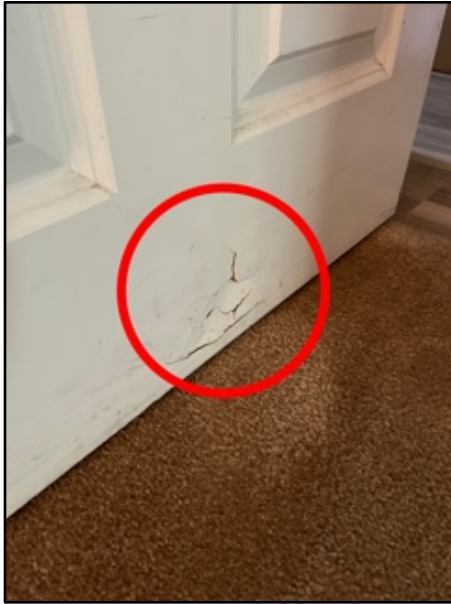
Figure 38-1

Master entry door shows damage.

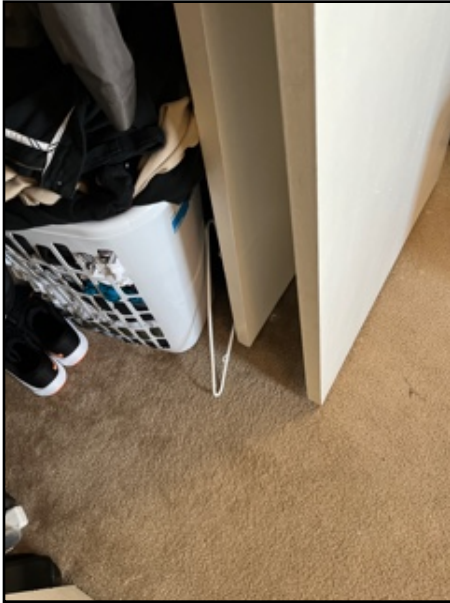
Figure 39-1

Comment 39:  
Front right bedroom closet door guide is missing.

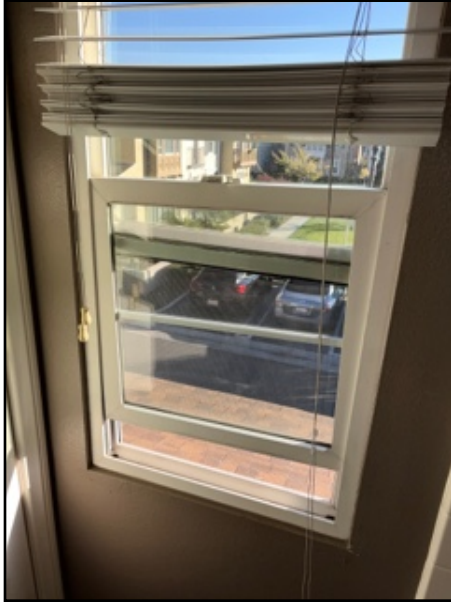
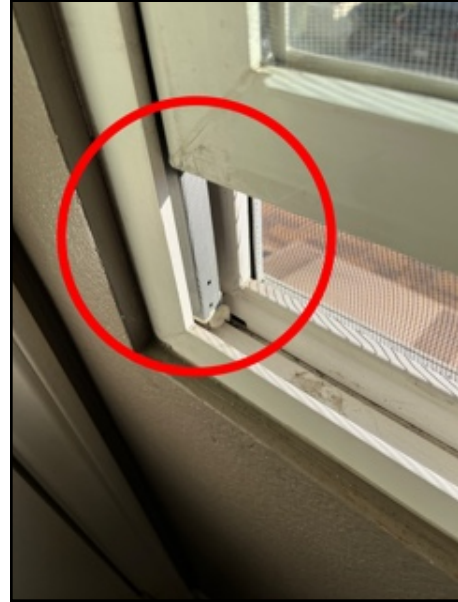
Figure 41-1

Upstairs hall bathroom window counter balance is falling out. Repairs are needed to the window at this time.

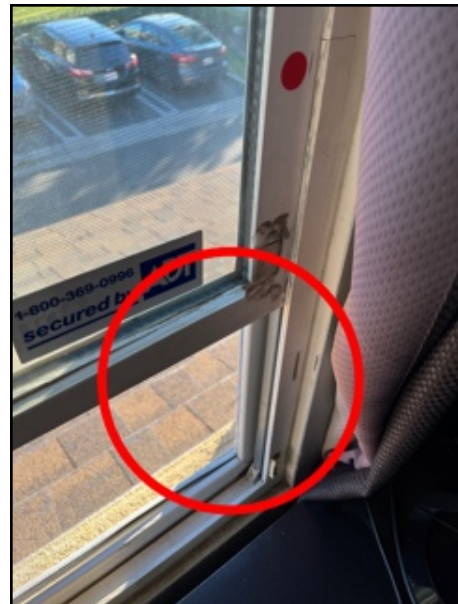
Figure 42-2

Front right bedroom window counterbalance has fallen out.

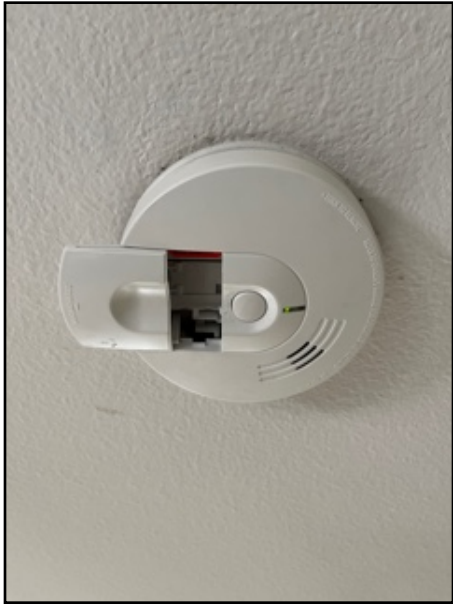
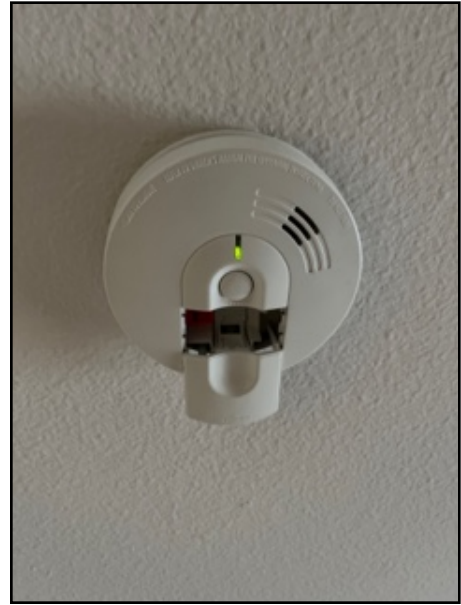
Figure 44-1

Comment 44:  
Smoke alarms are located downstairs hall and upstairs hall. Bedrooms have smoke detectors. Batteries are needed at several locations. No carbon monoxide detectors are noted.

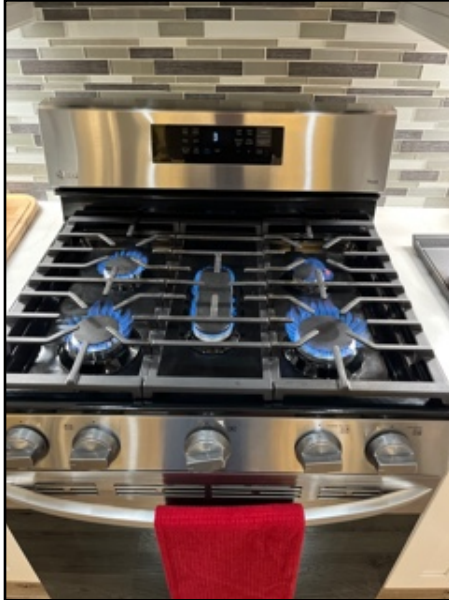
Figure 45-1

All cook top burners ignite.

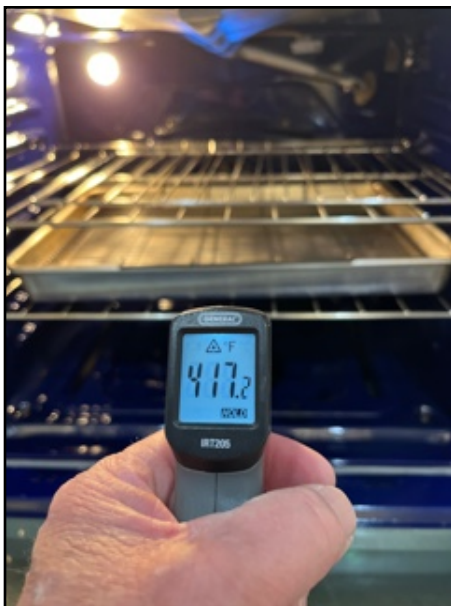
Figure 47-1

Comment 47:  
Oven bake and broil both heating to appropriate temperature.

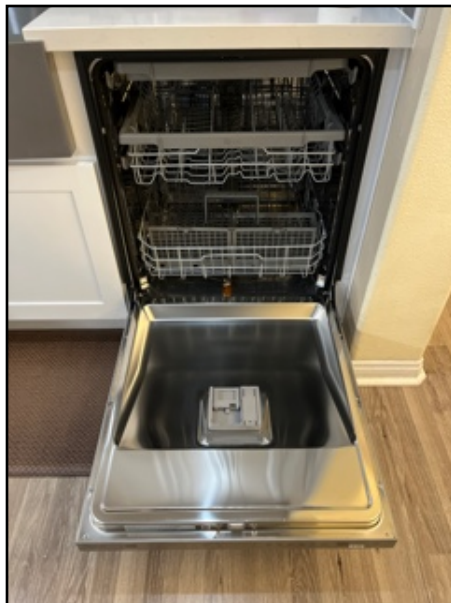
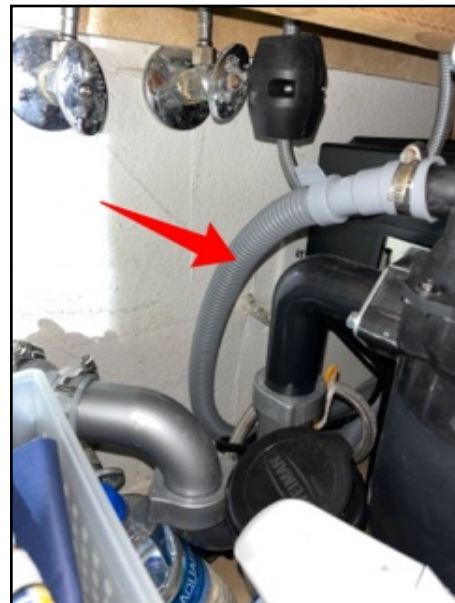
Figure 48-1

No water leaked out onto the floor during the wash cycle.

The dishwasher does not have an air gap so when the drain hose connects to the garbage disposal, it should be in a loop so dirty water will not go back into the dishwasher.

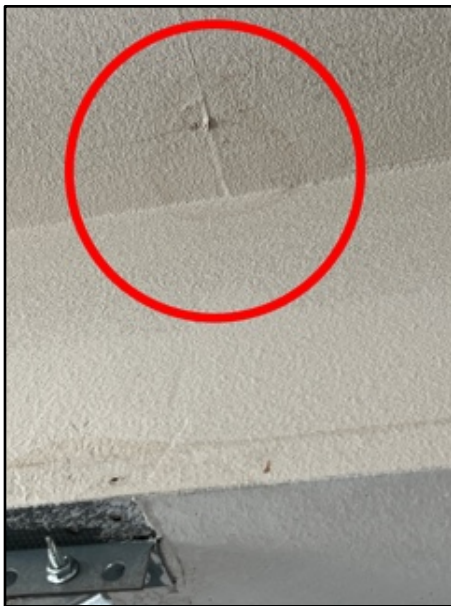
Figure 50-1

Garage ceiling shows a faint water stain near the mounting of the garage door track. The stain appears presently dry at the time of the inspection.

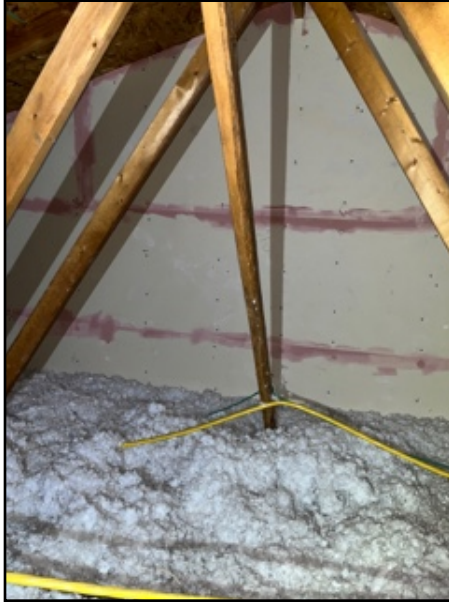
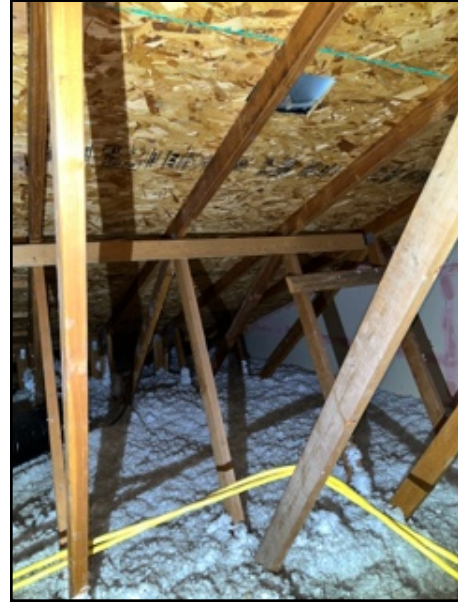
Figure 52-1

Attic has a firewall between the neighboring unit.

No visible water stains on the underside of the roof, located in the attic.

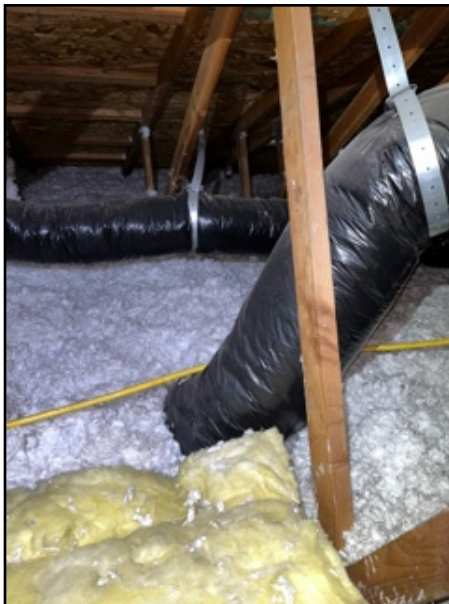
Figure 53-1

Heating ducts appear to be in overall good condition.

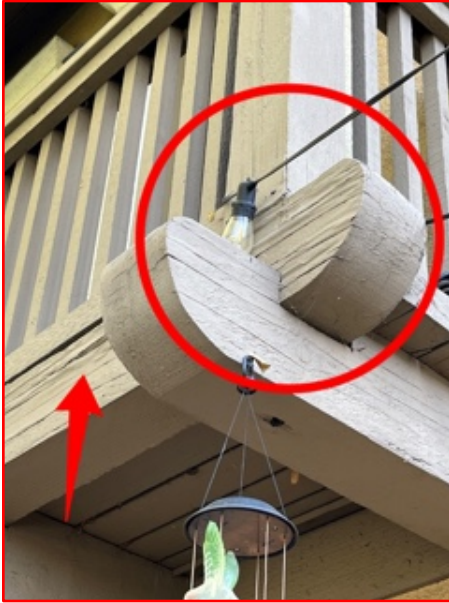
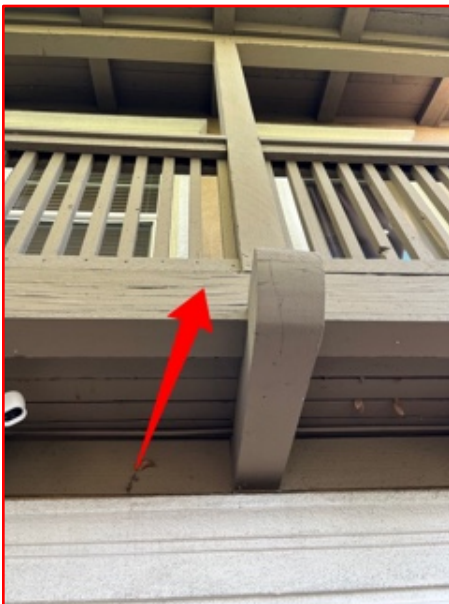
Figure 5-1

1) Master bedroom balcony wood beams, show paint blistering and possible wood damage. The exterior is maintained by the HOA.

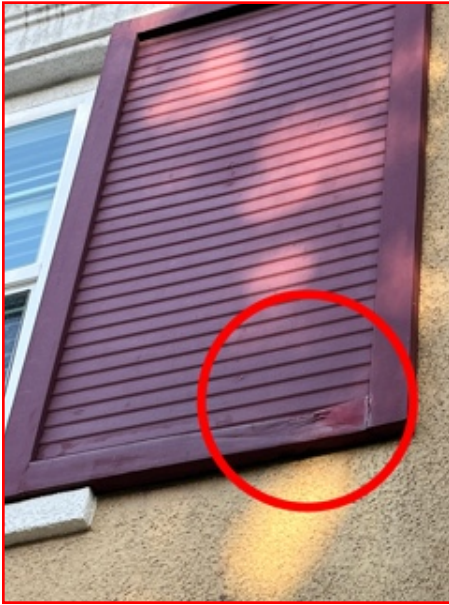
Figure 7-1

2) Master bathroom shutter shows wood damage.

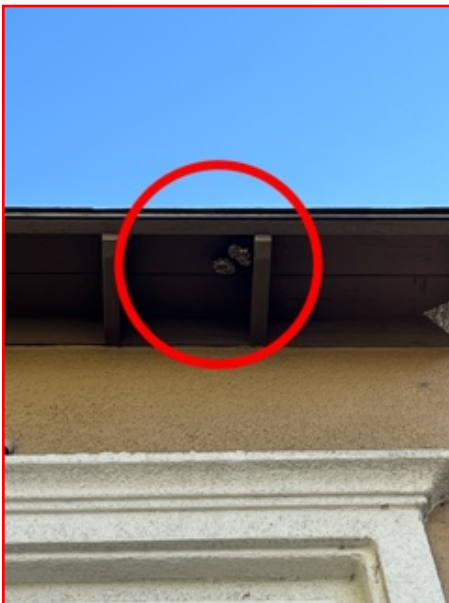
Figure 9-1

3) Difficult to see in this photo, however, wasp nests are noted in the eaves at the left side of the house.

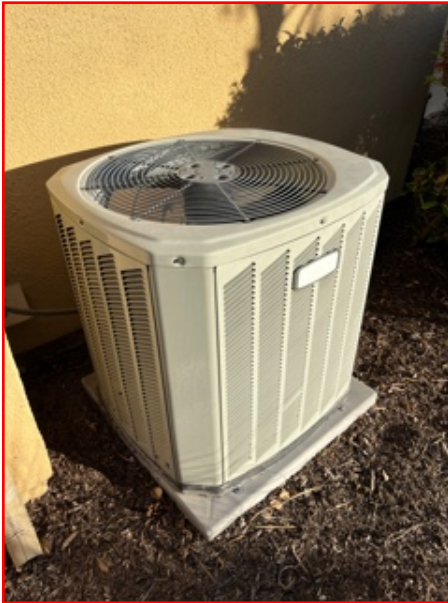
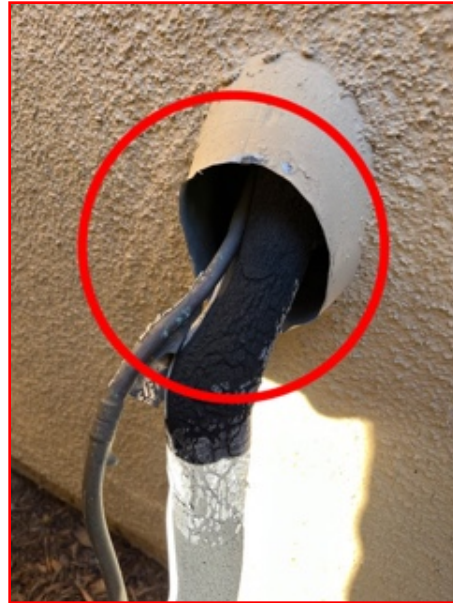
Figure 10-1

This unit was installed in 2010 and uses the newer R 410 A freon.

Seal the opening from the outside air conditioning compressor to keep out rodents.

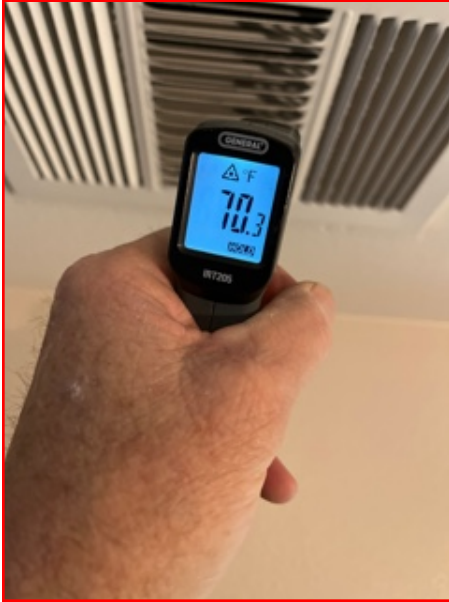
Figure 11-1

5) The air conditioning did not condense and cool down the house.  
Air was blowing out at 70°.  
Recommend a service call to an HVAC company.

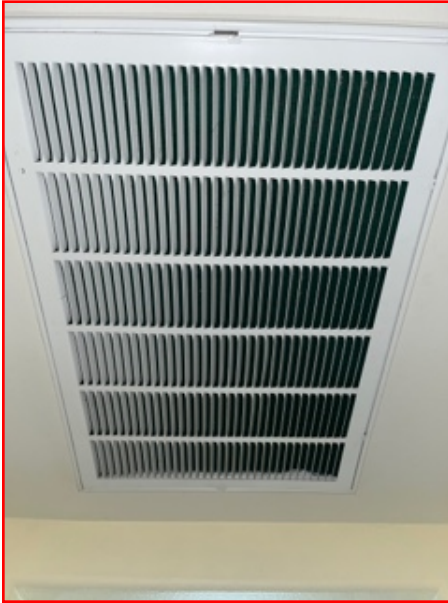
Figure 12-1

6) Air filter is dirty and should be replaced.

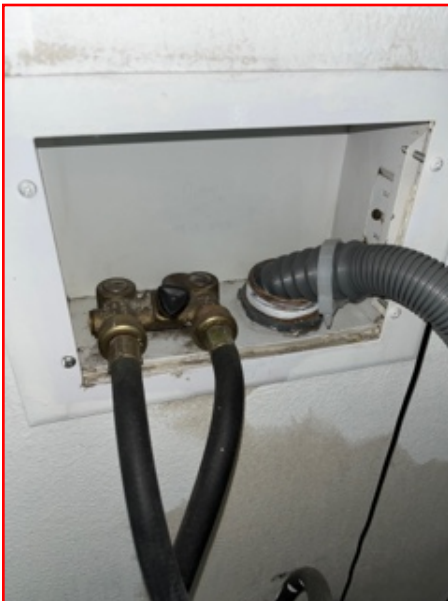
Figure 15-1

7) Washer hook up valves appear free of leaks. Recommend replacing rubber hoses with steel braided hoses.

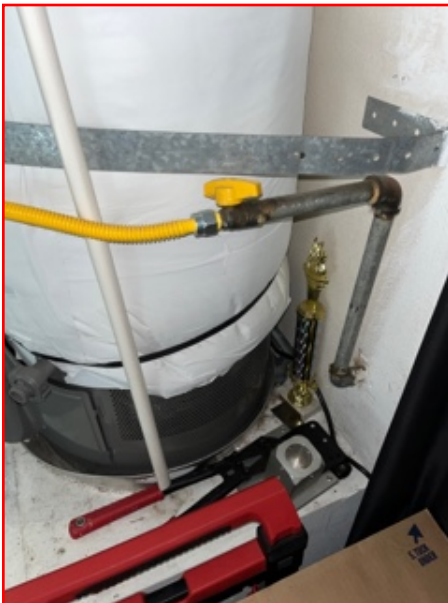
Figure 18-1

9) Water heater gas line does not have a sediment trap.

Lower earthquake strap is loose and should be tightened.

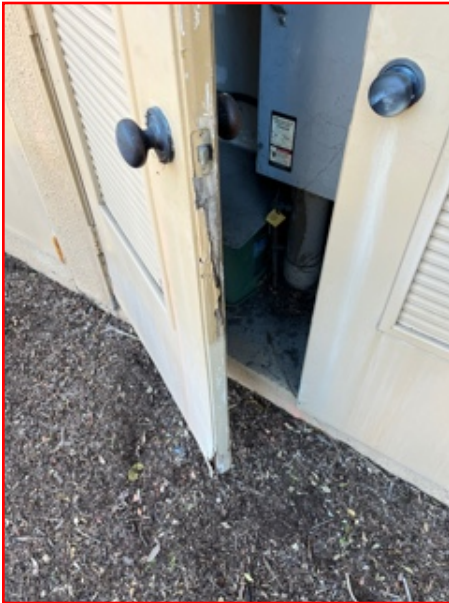
Figure 23-1

12) Electrical meter closet doors are damaged. This is maintained by the association.

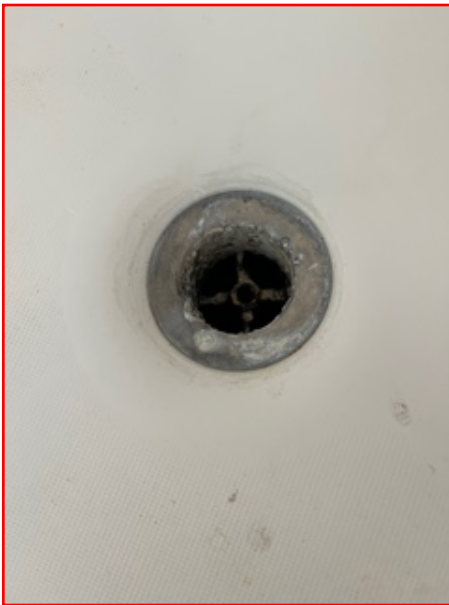
Figure 27-1

14) Hall bathroom tub collar is corroded and missing stopper.

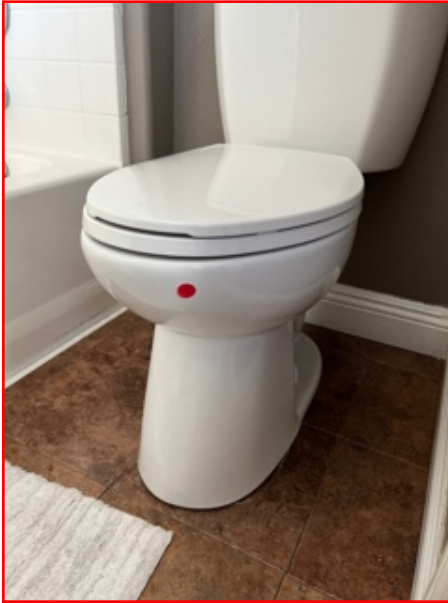
Figure 28-1

15) Upstairs hall bathroom toilet is loose. Toilet should be tightened.

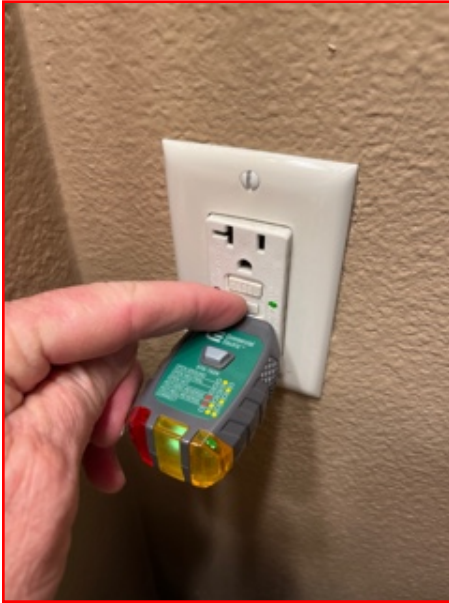
Figure 35-1

21) Half bathroom GFCI outlet does not trip. Outlet is faulty and should be replaced.

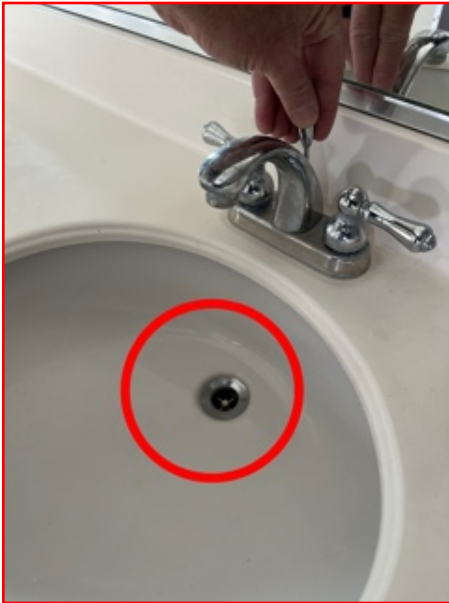
Figure 36-1

22) Hall bathroom is missing sink stopper.

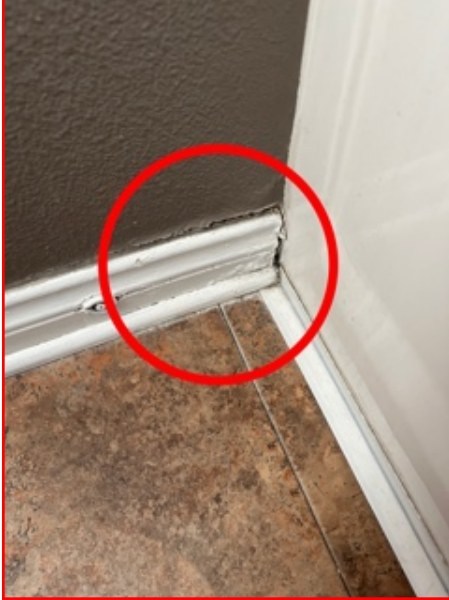
Figure 37-1

23) Hall bathroom shows water damage outside of the bath tub. Baseboard is soft at left side of the tub.

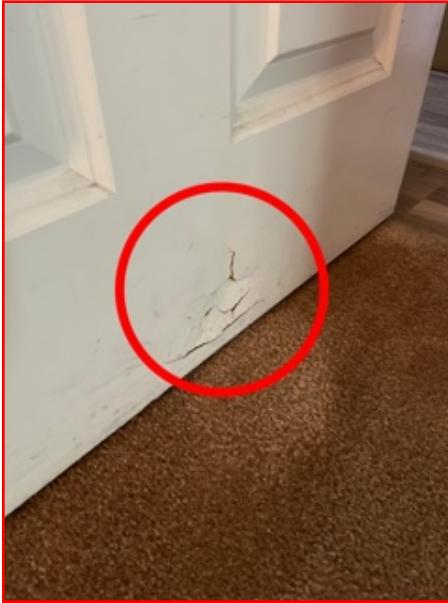
Figure 38-1

24) Master entry door shows damage.

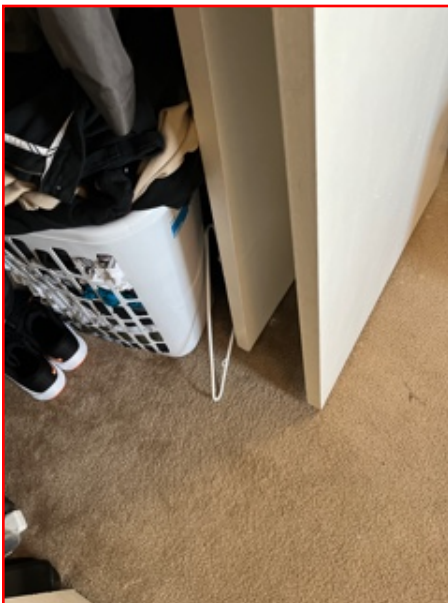
Figure 39-1

25) Front right bedroom closet door guide is missing.

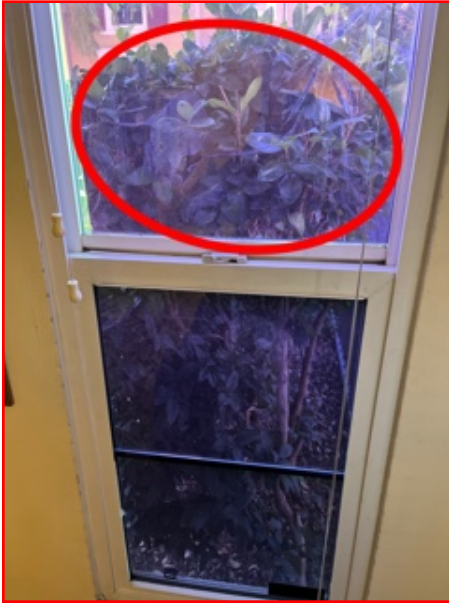
Figure 40-1

26) Living room left side window has tint that is wrinkled and difficult to view through.

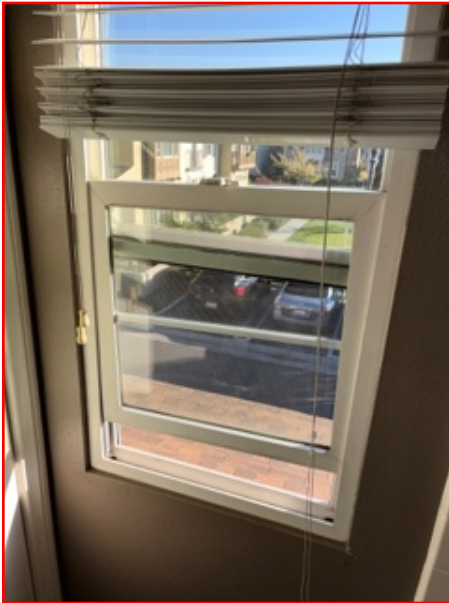
Figure 41-1

27) Upstairs hall bathroom window counter balance is falling out. Repairs are needed to the window at this time.

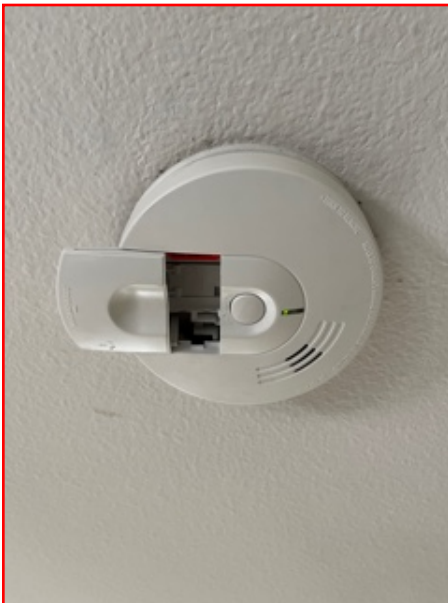
Figure 44-1

29) Smoke alarms are located downstairs hall and upstairs hall. Bedrooms have smoke detectors. Batteries are needed at several locations. No carbon monoxide detectors are noted.

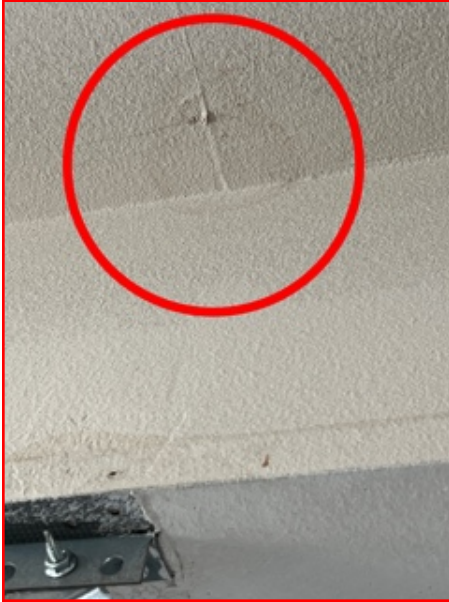
Figure 50-1

30) Garage ceiling shows a faint water stain near the mounting of the garage door track. The stain appears presently dry at the time of the inspection.
