Report Summary

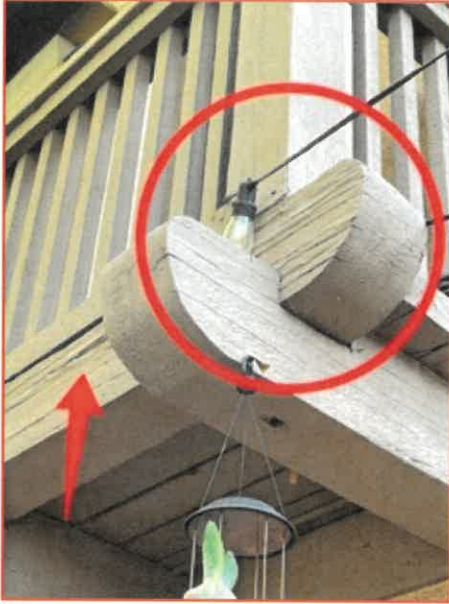
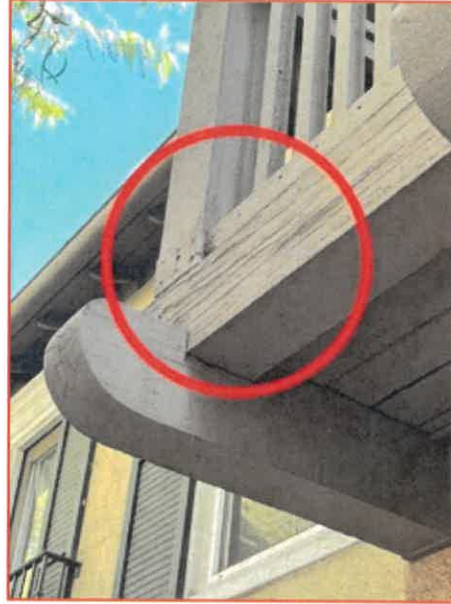
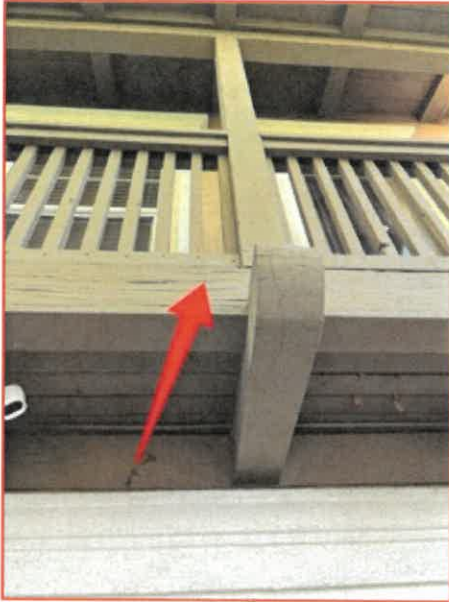
1) Master bedroom balcony wood beams, show paint blistering and possible wood damage. The exterior is maintained by the HOA.

HOA - Termite
Repaired

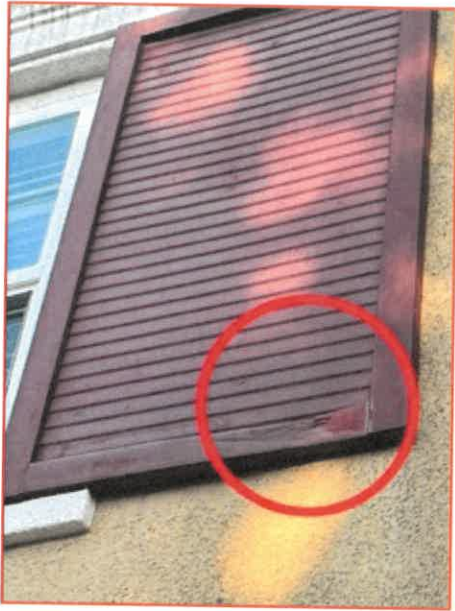
Figure 7-1

2) Master bathroom shutter shows wood damage.

HOA Repaired

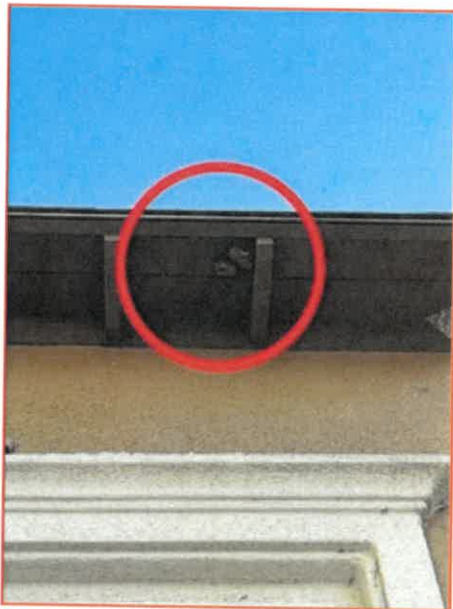
Figure 9-1

3) Difficult to see in this photo, however, wasp nests are noted in the eaves at the left side of the house.

removed

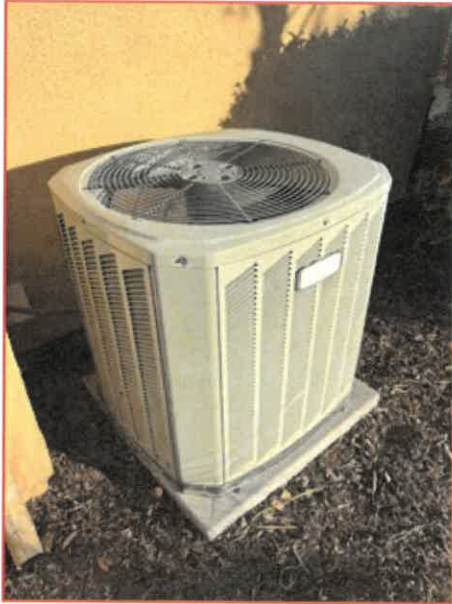
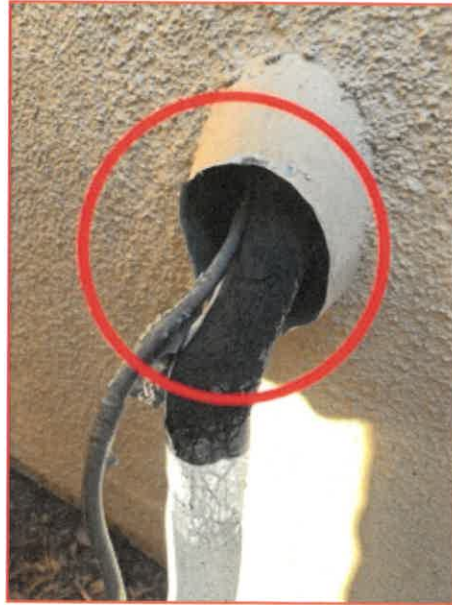
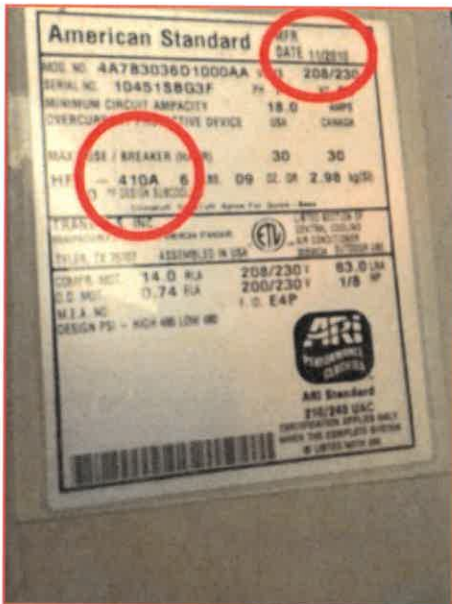
4) Outside compressor responds to thermostat controls.

This unit was installed in 2010 and uses the newer R 410 A freon.

Seal the opening from the outside air conditioning compressor to keep out rodents.

repaired

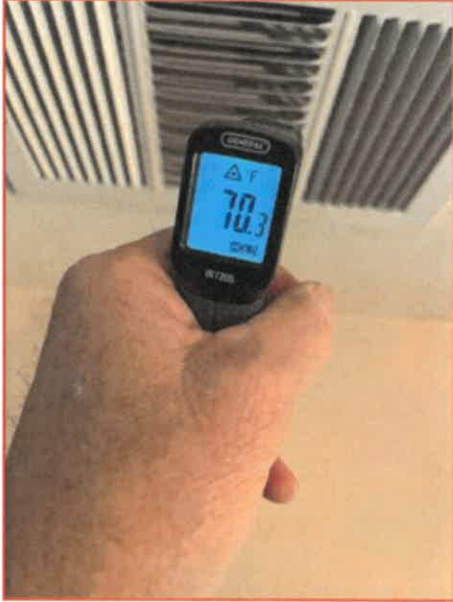
Figure 11-1

5) The air conditioning did not condense and cool down the house.
Air was blowing out at 70°.
Recommend a service call to an HVAC company.

repaired

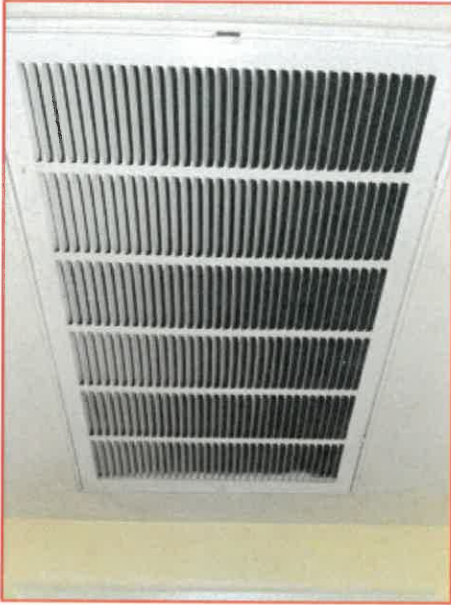
Figure 12-1

6) Air filter is dirty and should be replaced.

replaced

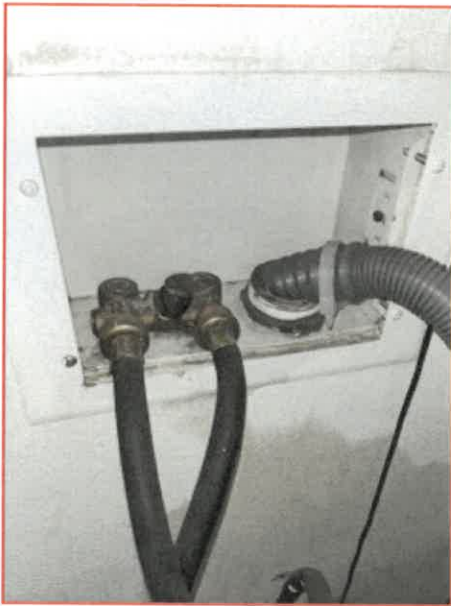
Figure 15-1

7) Washer hook up valves appear free of leaks. Recommend replacing rubber hoses with steel braided hoses.

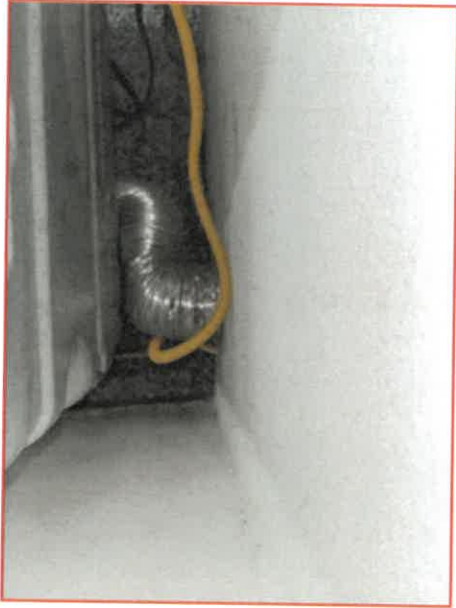
Figure 16-1

- 8)
Vacuum the dryer vent to clear lint and debris.

when seller moves out

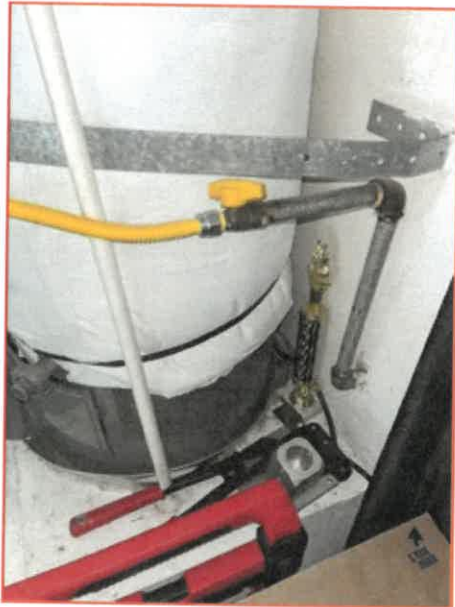
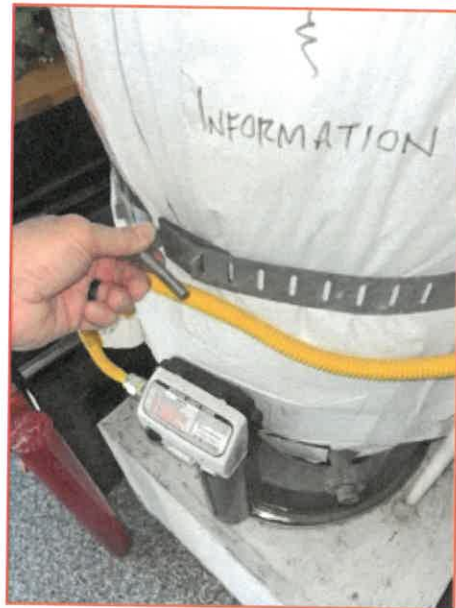
- 9) Water heater gas line does not have a sediment trap.
Lower earthquake strap is loose and should be tightened.

done

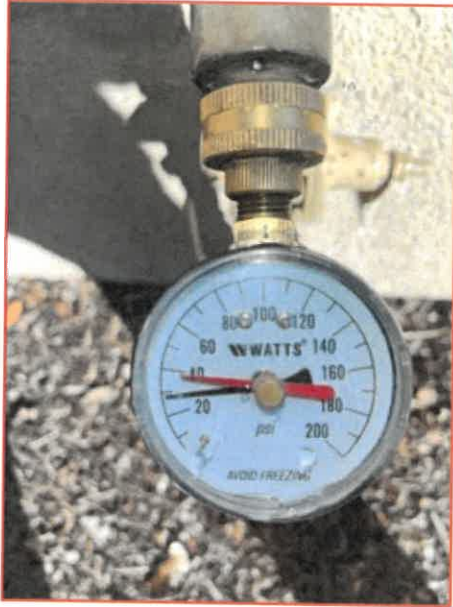
Figure 20-1

10) Water pressure is low at 30 psi. Water pressure should be between 65 and 75 psi. This home has a regulator that needs to be adjusted.

repaired

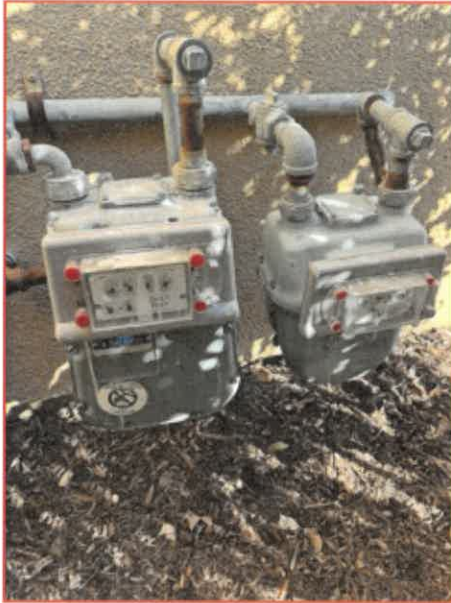
Figure 21-1

11) Gas meter is not clearly marked and labeled.

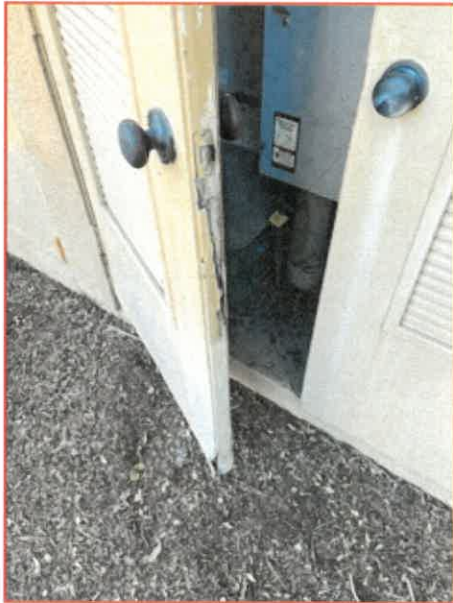
Figure 23-1

12) Electrical meter closet doors are damaged. This is maintained by the association.

HOA - has been notified

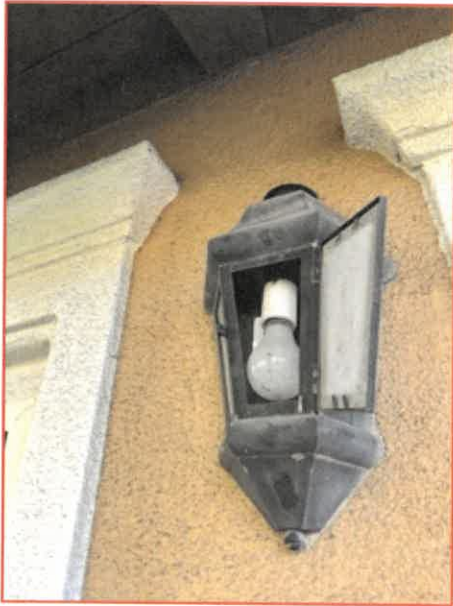
Figure 25-1

13) Master bedroom balcony porch light does not respond to switch.

repaired

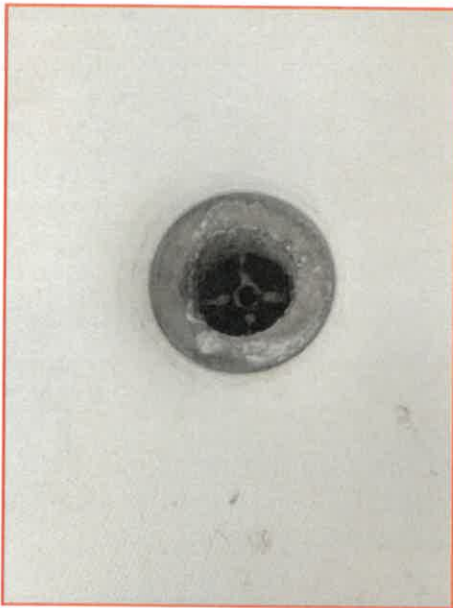
Figure 27-1

14) Hall bathroom tub collar is corroded and missing stopper.

repaired

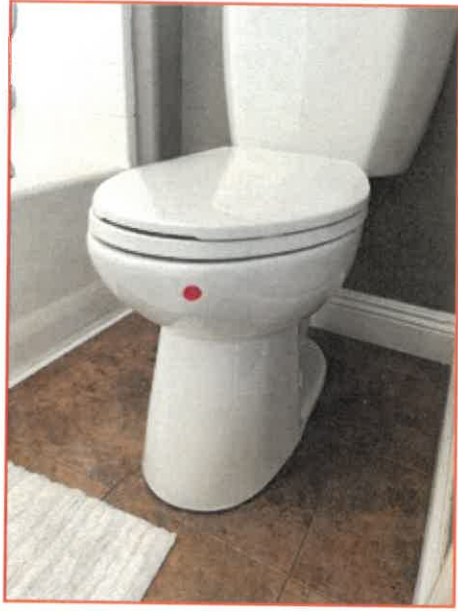
Figure 28-1

15) Upstairs hall bathroom toilet is loose. Toilet should be tightened.

done

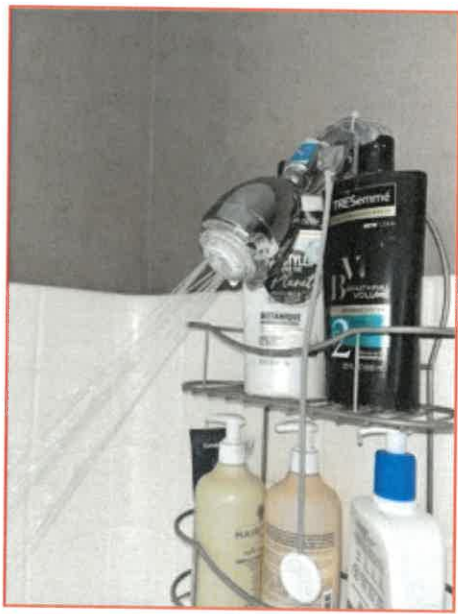
Figure 30-1

16) Hall bathroom shower volume is low.

done

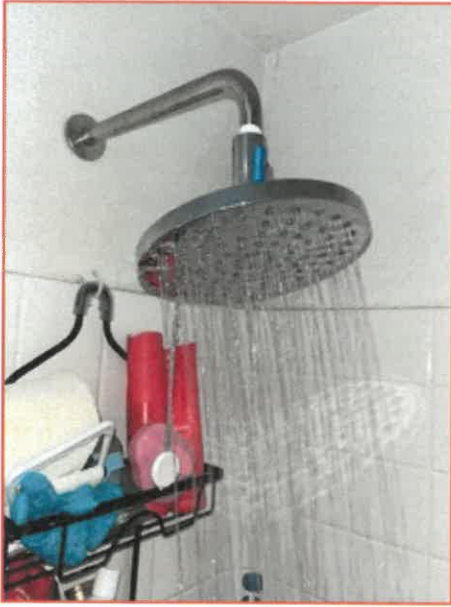
Figure 31-1

17) Master bathroom shower has low volume.

done

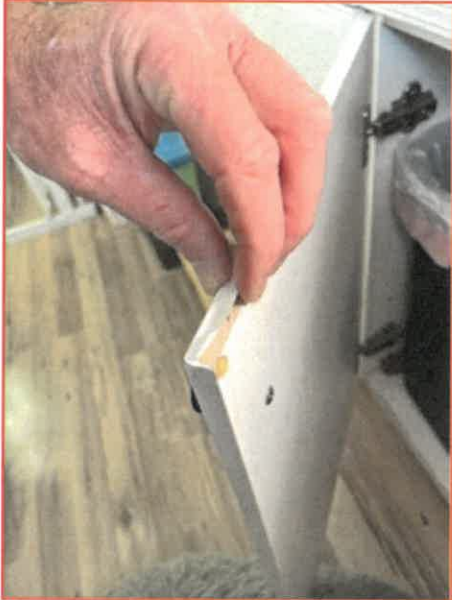
Figure 32-1

18) Hall cabinet doors have the finish peeling.

repaired

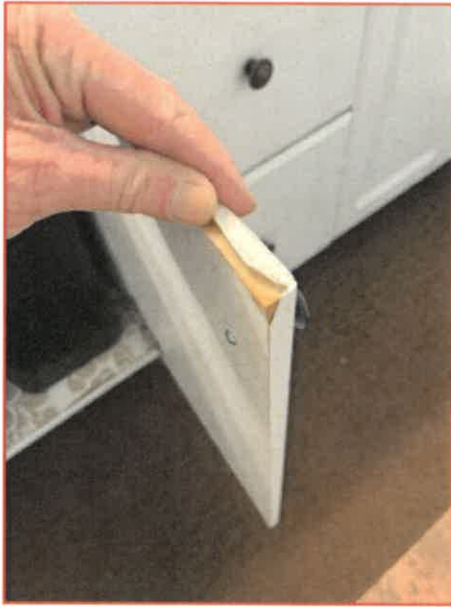
Figure 33-1

19) Master bathroom cabinet door shows finish peeling.

repaired

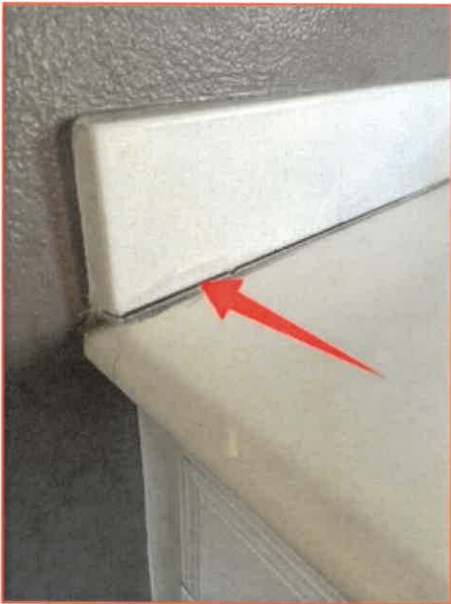
Figure 34-1

20) Hall bathroom countertop shows separation and needs caulking.

repaired

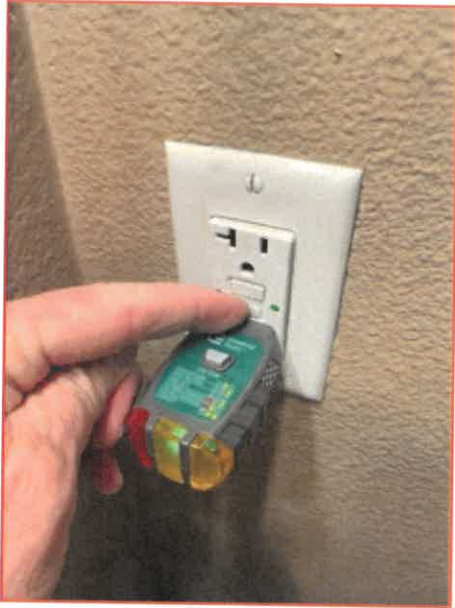
Figure 35-1

21) Half bathroom GFCI outlet does not trip. Outlet is faulty and should be replaced.

repaired

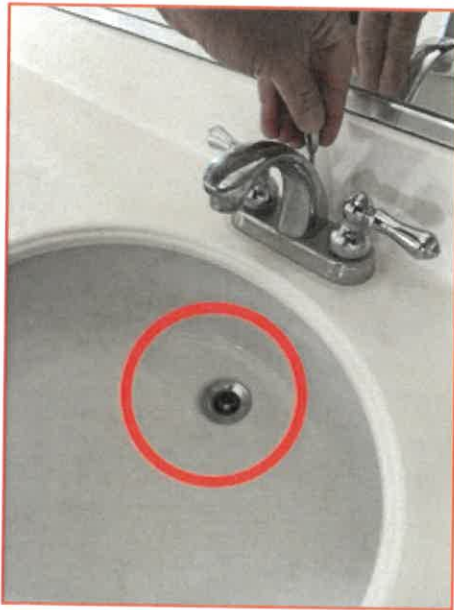
Figure 36-1

22) Hall bathroom is missing sink stopper.

repaired

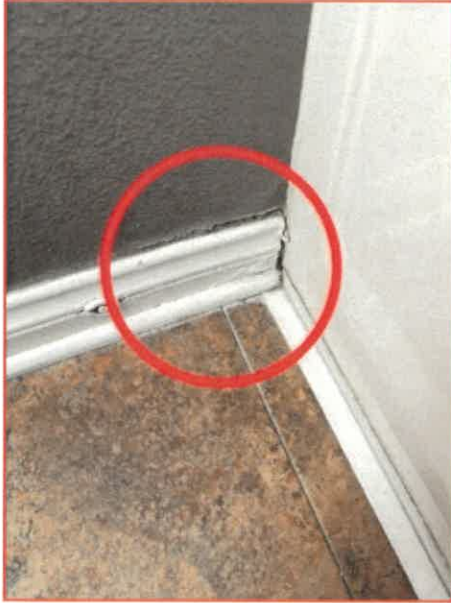
Figure 37-1

23) Hall bathroom shows water damage outside of the bath tub. Baseboard is soft at left side of the tub.

repaired

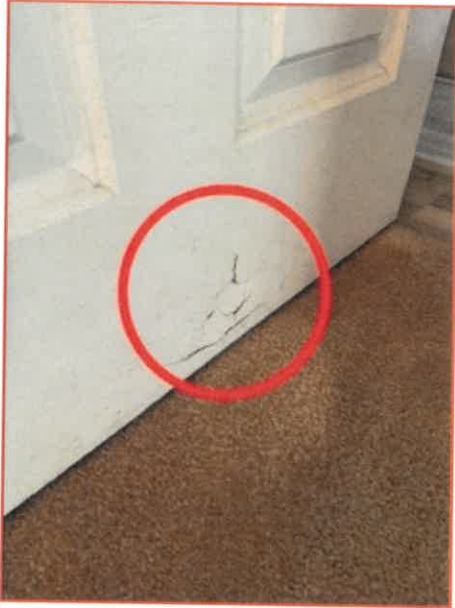
Figure 38-1

24) Master entry door shows damage.

repaired

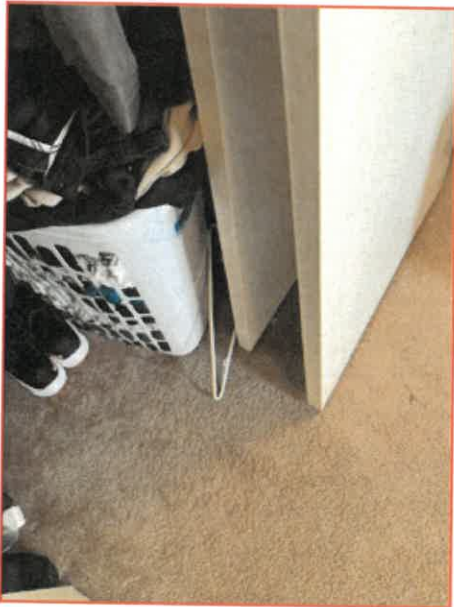
Figure 39-1

25) Front right bedroom closet door guide is missing.

repaired

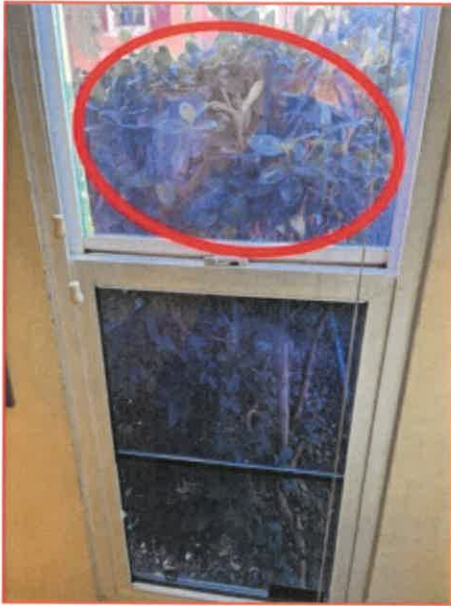
Figure 40-1

26) Living room left side window has tint that is wrinkled and difficult to view through.

removed

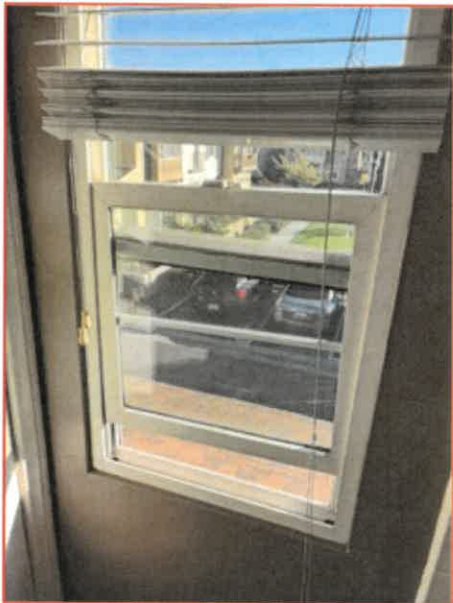
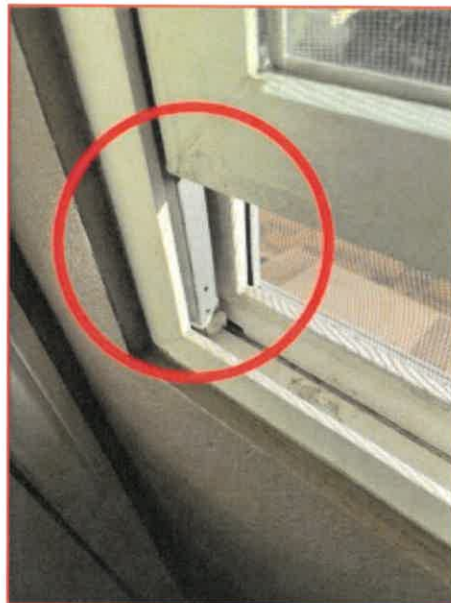
27) Upstairs hall bathroom window counter balance is falling out. Repairs are needed to the window at this time.

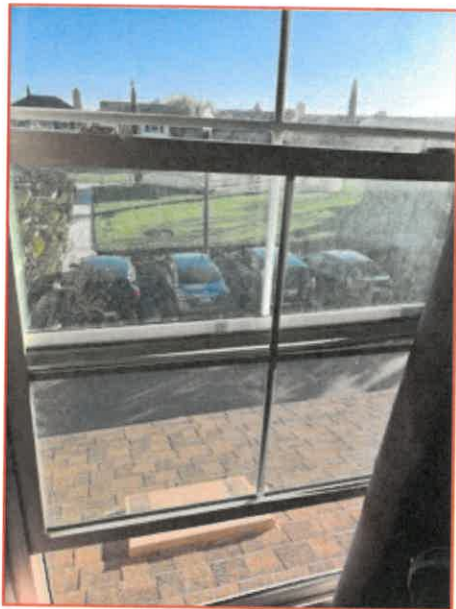
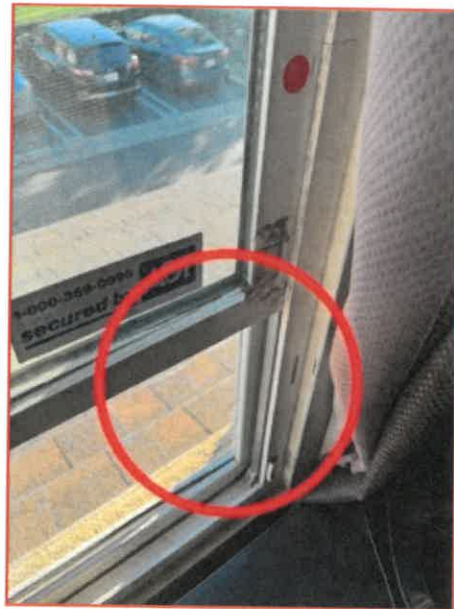
28) Front right bedroom window counterbalance has fallen out.

repaired

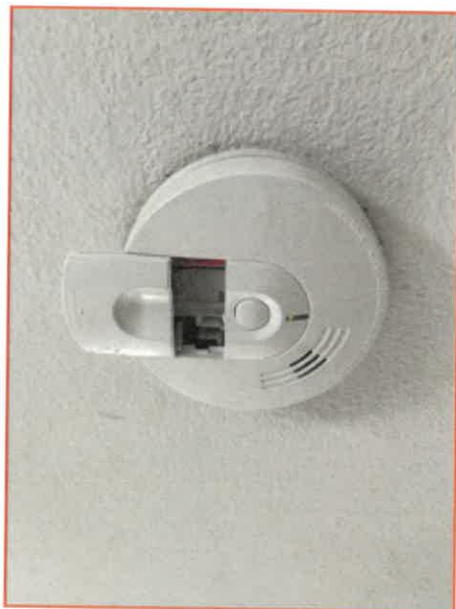
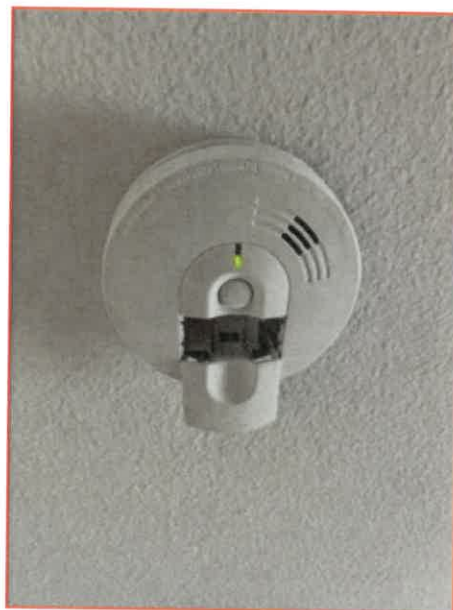
29) Smoke alarms are located downstairs hall and upstairs hall. Bedrooms have smoke detectors. Batteries are needed at several locations. No carbon monoxide detectors are noted.

replaced

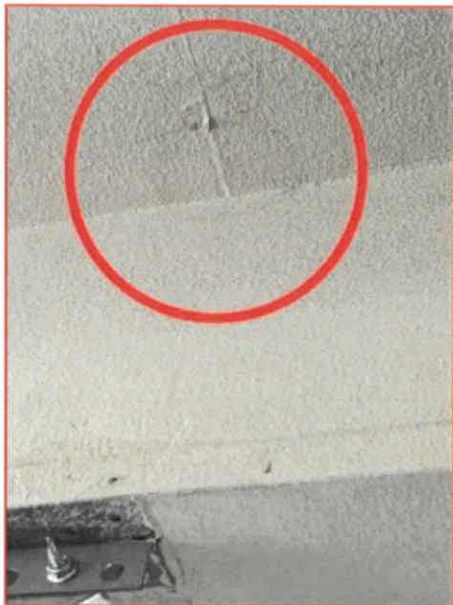
Figure 50-1

30) Garage ceiling shows a faint water stain near the mounting of the garage door track. The stain appears presently dry at the time of the inspection.
