# Inspection Report

**Ellen Nelson & Charlie Cote**  
**2249 Inyo Street**  
**Los Osos, CA 93402**

Report Date: 9/29/2025

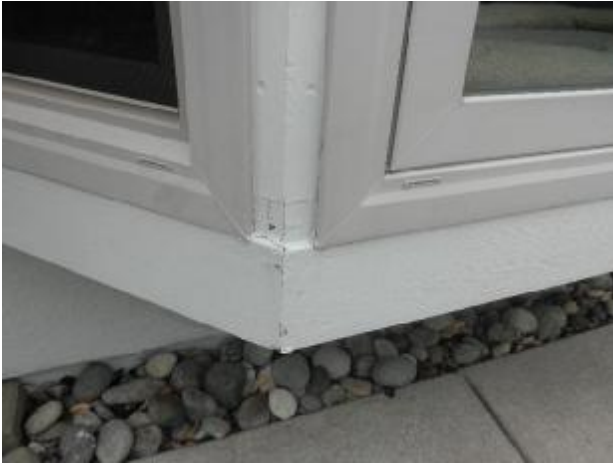
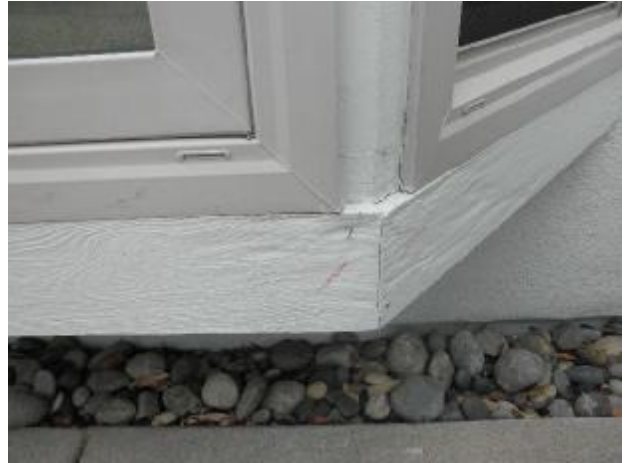
1.) There is some minor moisture damage to the wood trim below the bay window at the SE bedroom.

Moisture damage to the wood trim below the bay window.

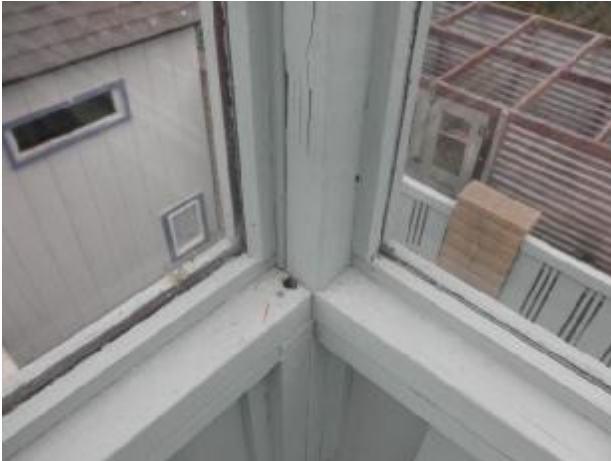
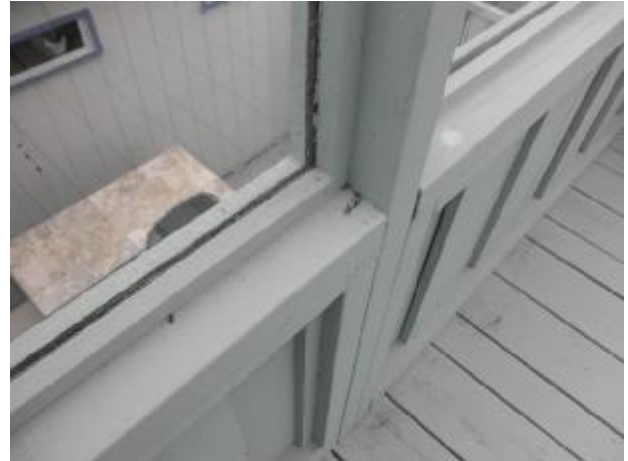
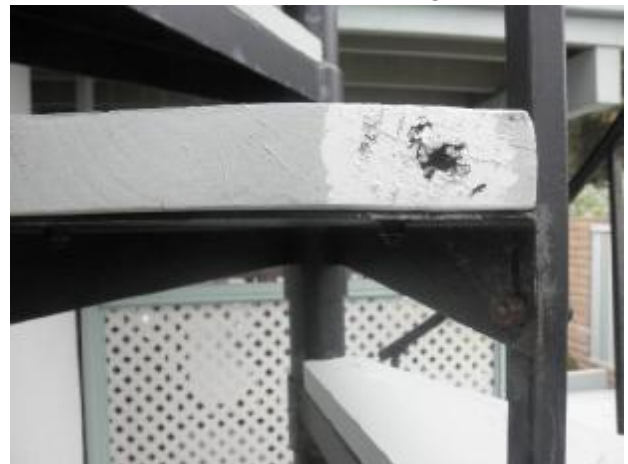
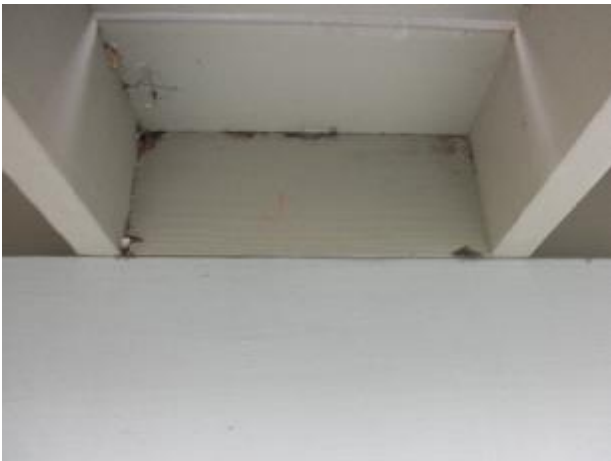
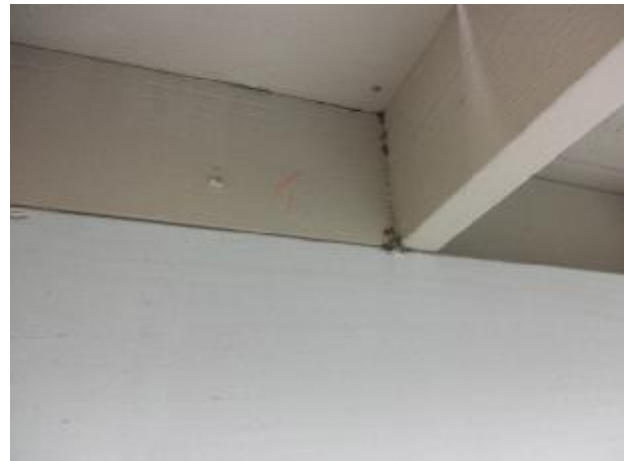
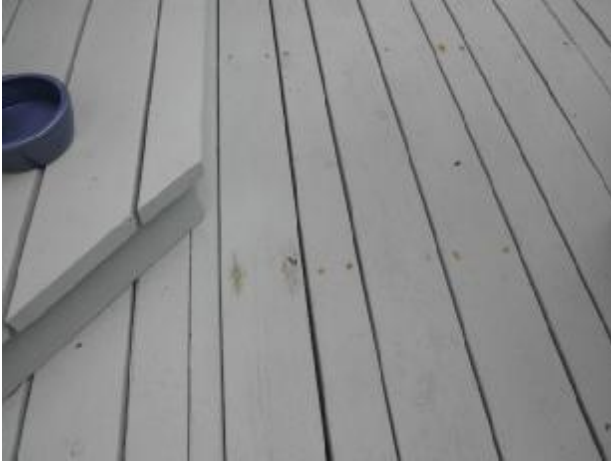
1.) There is moisture damage to parts of the wood deck planks, framing, wind wall and spiral stairs treads in the backyard. Refer to the Pest Control Report for a full accounting of this damage.

Example of the moisture damage at the backyard wood deck and stairs.

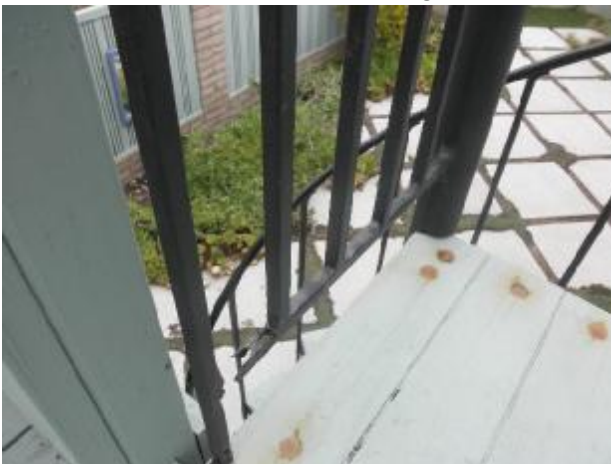
2.) There is some rust damage to the metal railing at the top of the backyard spiral stairs.

Rust damage to the railing at the top of the spiral stairs.

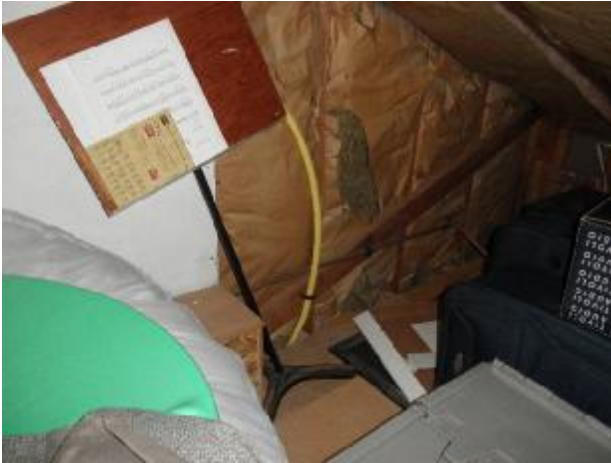
Yellow coated CSST piping in the attic.

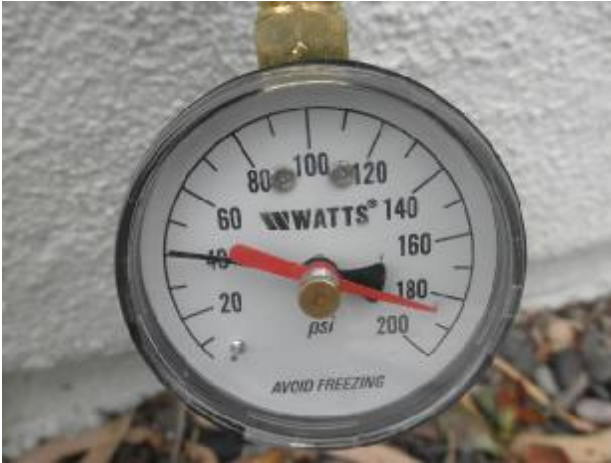
Information Note: The water pressure was measured at 40 psi at the time of inspection. This is within a normal and acceptable range.

The water pressure was measured at 40 psi.

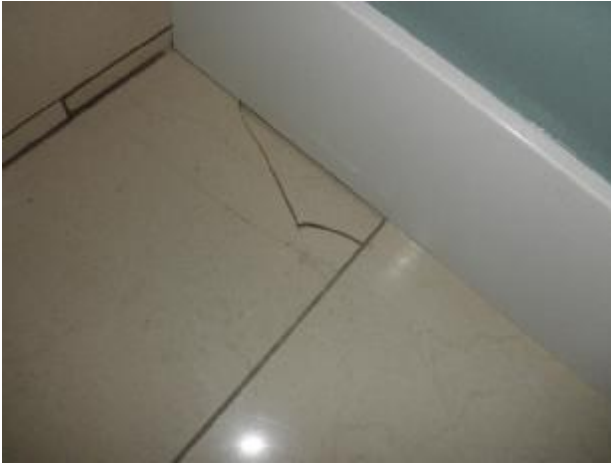
1.) There is on broken floor tile in the master bathroom.

Broken floor tile in the master bathroom.

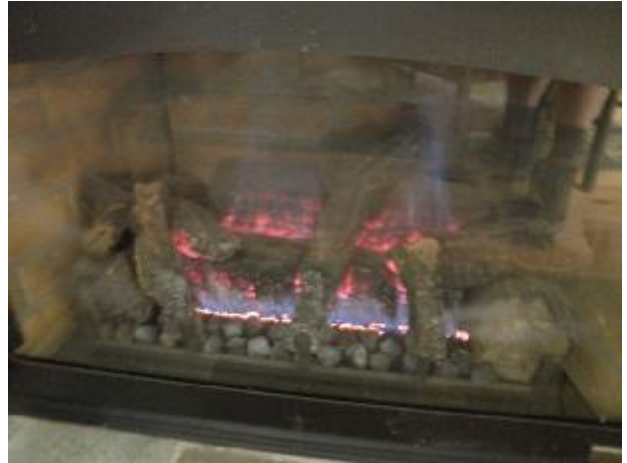
Fireplace was working during the time of inspection.

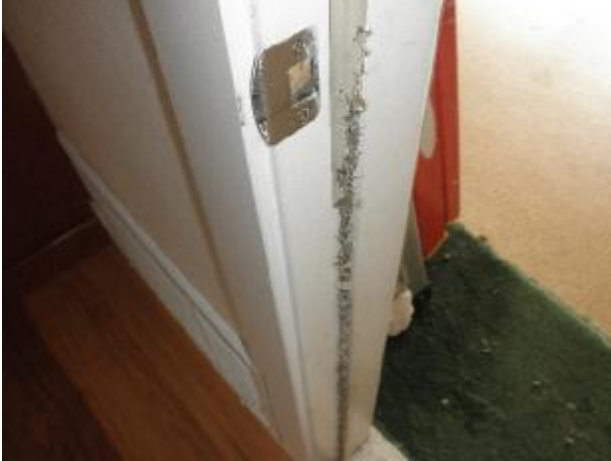
- 1.) There is damage to the weather stripping at the garage fire door.

Weather stripping damaged at the garage fire door.
