Inspection Report

Property Address:
1619 Armour Ln
Redondo Beach CA 90278

Ferguson Home Inspections

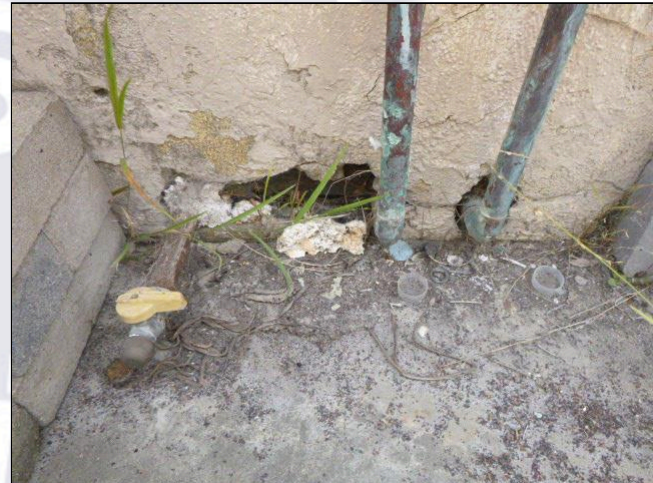
1.1 Item 1 (Picture)

1.1 (1) Settling and heaving noted at various areas, this is a potential trip hazard. Suggest review with a licensed contractor for repair/replacement costs as needed.

1.1 (2) Suggest lowering the exterior walkway/grade and/or installation of exterior sub-surface drains at the rear and left side as needed to prevent the excessive/ongoing water intrusion into the crawlspace. Re-grading where needed is recommended to assure all water drains away from the home's foundation.

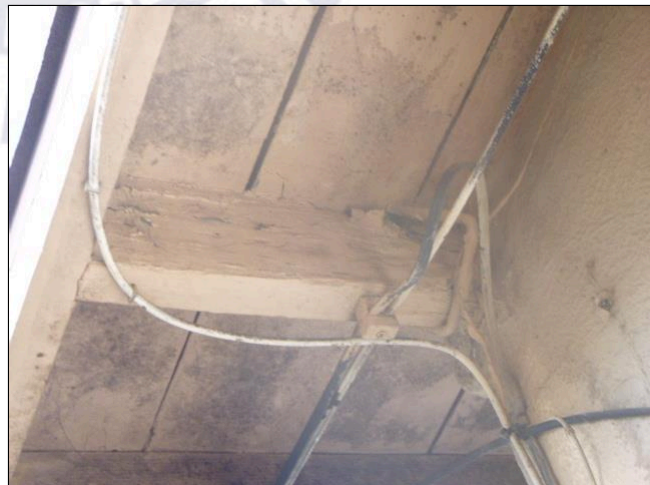
1.5 Item 2 (Picture)

1.5 (1) Paint blistering, peeling and wood deterioration noted at various trim areas. Suggest review with a termite company and/or a licensed contractor and repair/replace as needed.

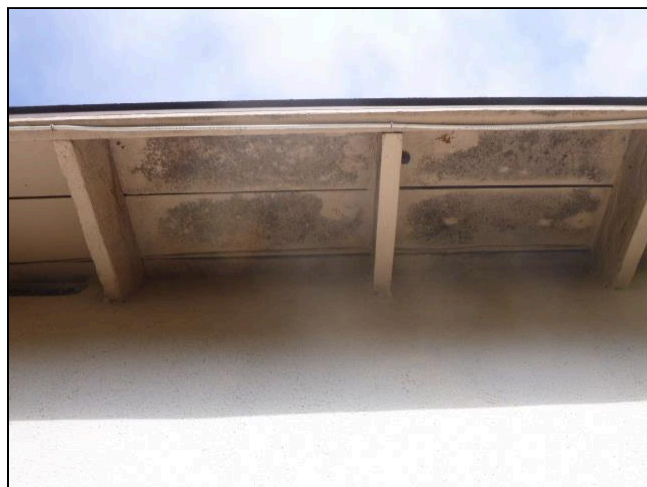
1.5 Item 3 (Picture)

1.5 (2) Excessive black staining noted at the roof line/eaves, suggest review with a licensed contractor for repairs as

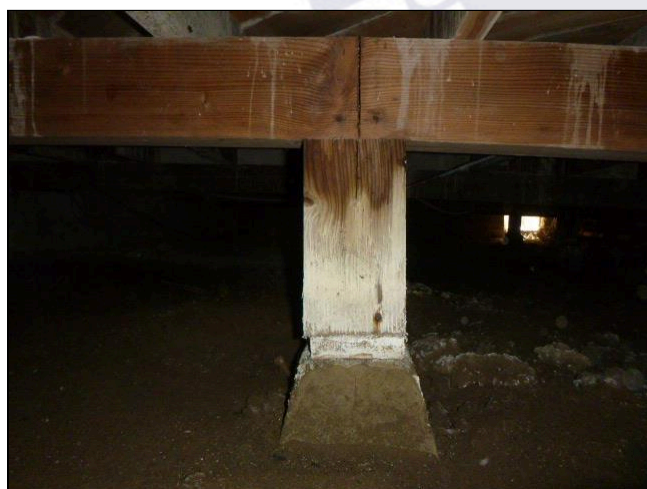
3.0 Item 10 (Picture)

3.0 (4) Excessive staining/saturation/deterioration of internal wood support members was noted due to excessive and ongoing water intrusion. Suggest review with a licensed foundation contractor for repair/replacement costs needed to prevent any future movement to the foundation and/or structure.

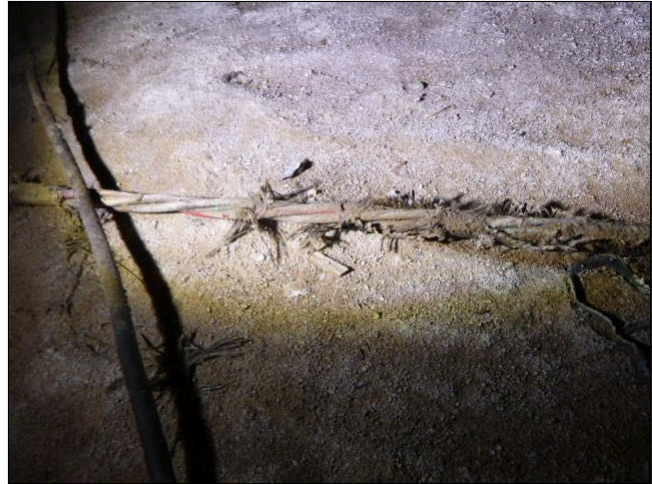
4.2 Item 2 (Picture)

4.2 The electrical wiring is frayed/deteriorated and in contact with the wet ground within areas of the crawl areas, this is potential safety hazard. Suggest review with a licensed electrician for repair/replacement costs as needed.

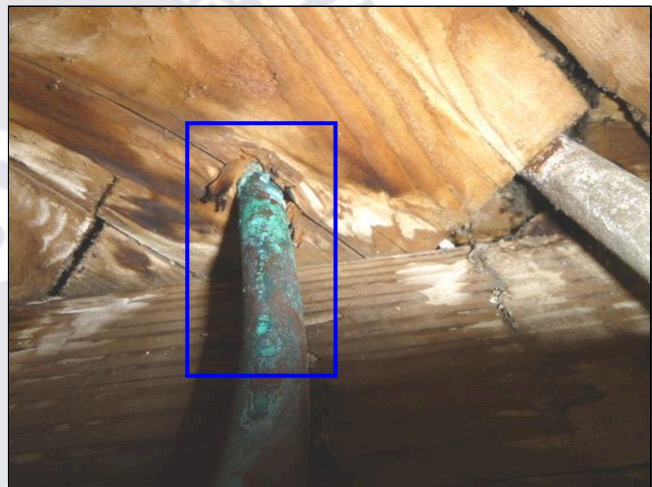
4.3 Item 2 (Picture)

4.3 (1) Corroded areas of the copper plumbing was noted throughout the crawl area, this can be a pre-cursor to 'pin hole' leaks. Suggest review with a licensed plumber for repair/replacement costs as needed.

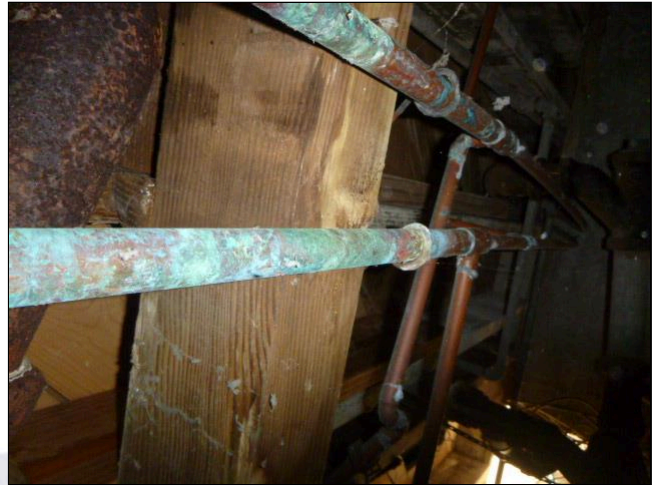
4.3 Item 4 (Picture)

4.3 (2) The copper plumbing lines are inadequately and improperly secured with straps that are causing excessive deterioration of the copper. Suggest replacing the deteriorated areas of the copper plumbing lines as well as replacing the straps with approved materials to prevent electrolysis and future leaks.

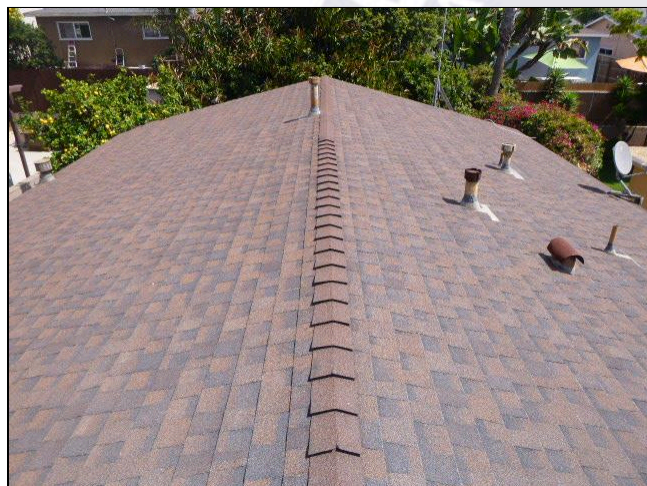
5.0 Item 1 (Picture)

5.0 (1) Worn areas and deterioration of the roofing was noted, suggest review with a licensed roofing contractor for repairs, periodic maintenance and to determine the remaining life expectancy of the roof.

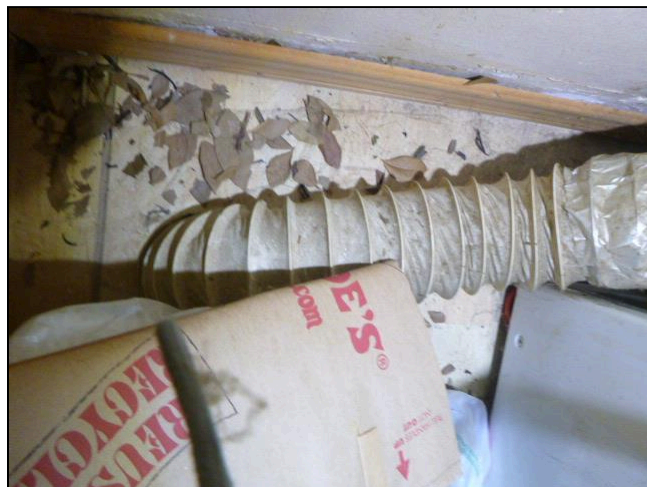
7.6 Item 1 (Picture)

7.6 (2) Improper vinyl flex vent installed to the crawl space (not installed to the exterior as required). Suggest removal of the existing material and install a rigid vent pipe to the exterior as required. Excessive lint noted was noted in the crawl area due to the incomplete installation, this is a potential fire hazard. Suggest review by licensed contractor for costs to remove the lint form the crawl area as required for safety.

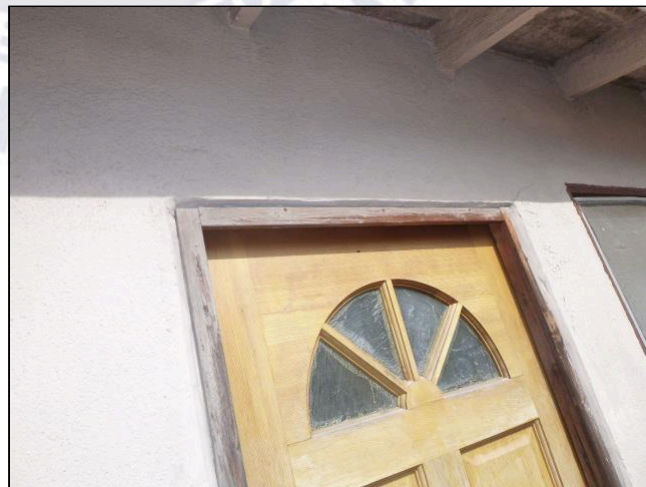
9.3 Item 1 (Picture)

9.3 No light fixture installed at this area as required, this is a possible safety hazard. Suggest review with a licensed electrician for installation costs for a light fixture to enhance safety.

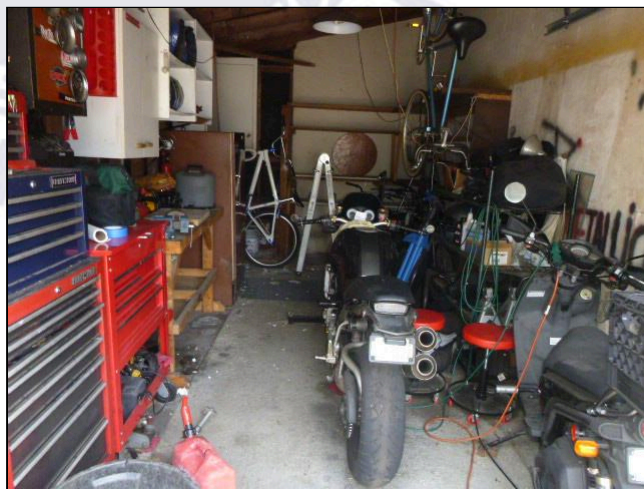
11.0 Item 1 (Picture)

11.0 (1) Access within this area was blocked or severely limited at the time of the inspection. An inspection of this area can be performed by appointment and at an additional cost when the area is made accessible.

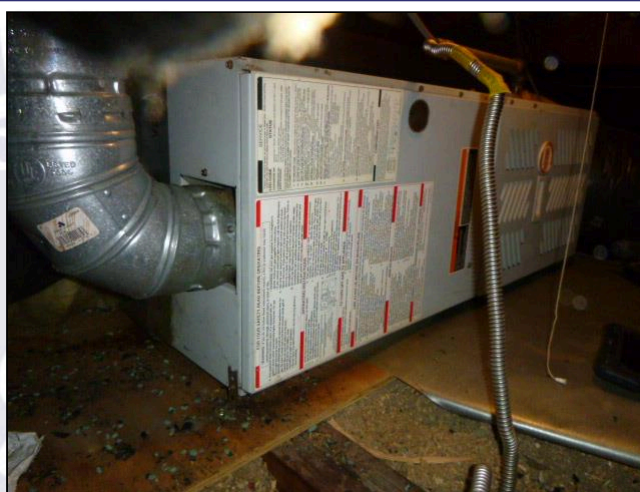
12.0 Item 4 (Picture)

12.0 (3) The heating unit has been installed on a plywood base, suggest review by a licensed heating contractor for installation on non-combustible stands as required.

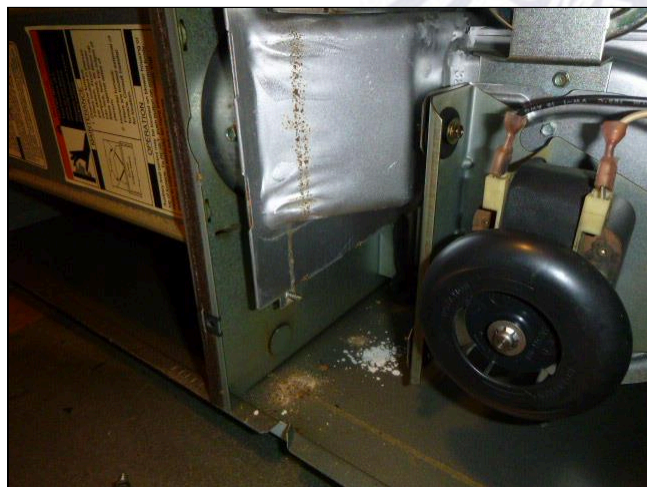
12.0 Item 5 (Picture)

12.0 (4) Deterioration/possible condensation debris/build-up was noted at the base of the exhaust vent manifold, suggest review with a licensed heating contractor for maintenance/repairs as needed.

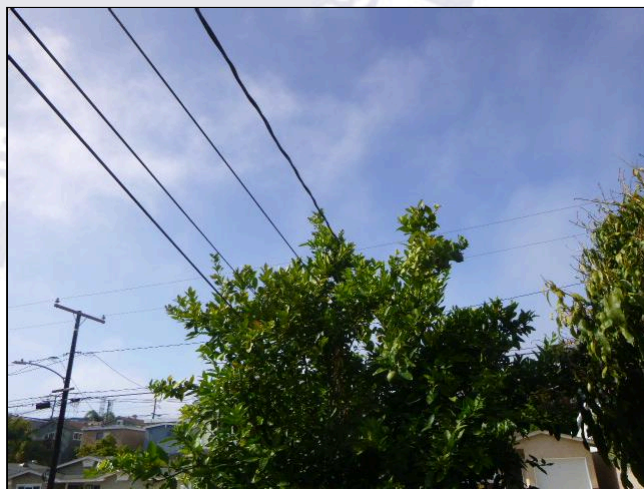
13.0 Item 1 (Picture)

13.0 (1) Utility wires are contacting foliage/tree limbs. When utility company wires coming into the service mast are sagging, frayed, strung through trees, they present a potential hazard, the utility company should be contacted to correct the condition.

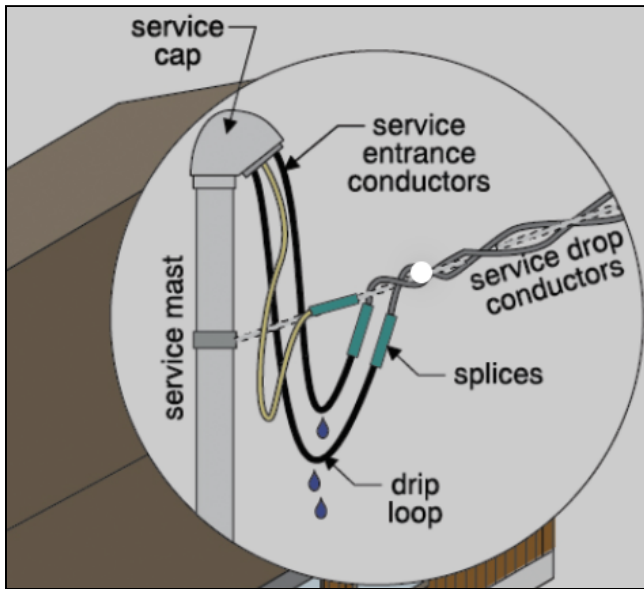
13.0 Item 2 (Picture)

13.0 (2) Inadequate drip loop was noted, suggest review with a licensed electrician for repairs as needed.

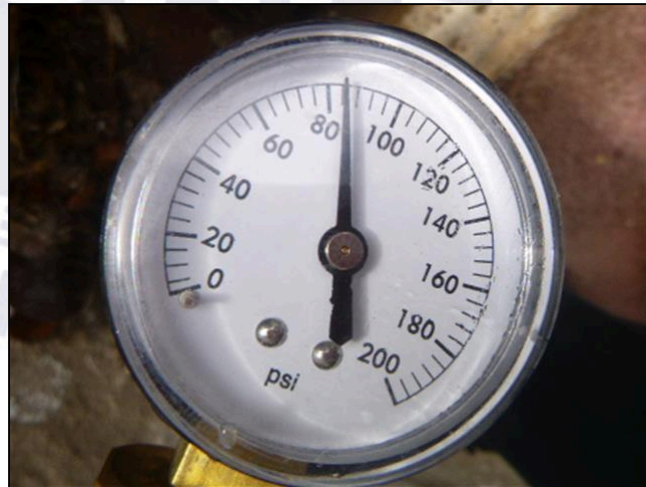
14.0 Item 1 (Picture)

14.0 (1) Suggest installation of a pressure regulator to reduce water pressure below 80 PSI to relieve stress on all plumbing joints and fittings.

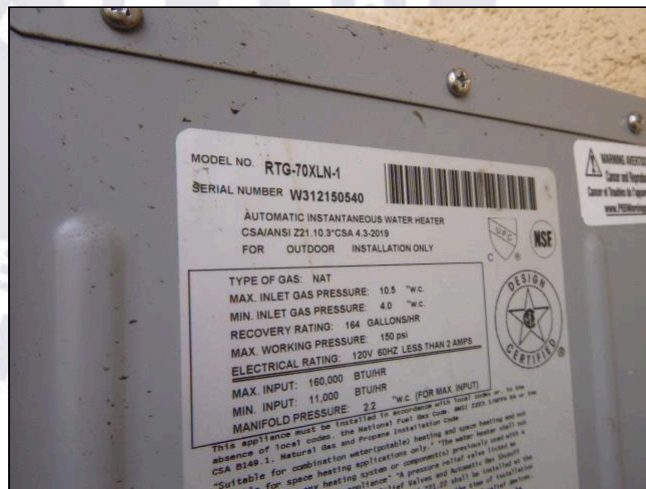
16.0 Item 1 (Picture)

16.0 (1) The water heater was operational at the time of the inspection.

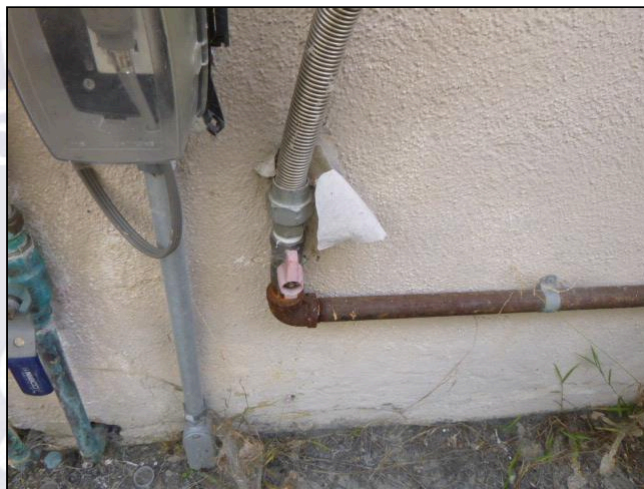
16.0 Item 3 (Picture)

16.0 (3) Currently no gas supply line drip leg/sediment trap is installed, please be aware that various cities do not enforce/require this installation. Suggest review with the local City Building Department and/or with a licensed plumbing contractor for installation costs as needed.

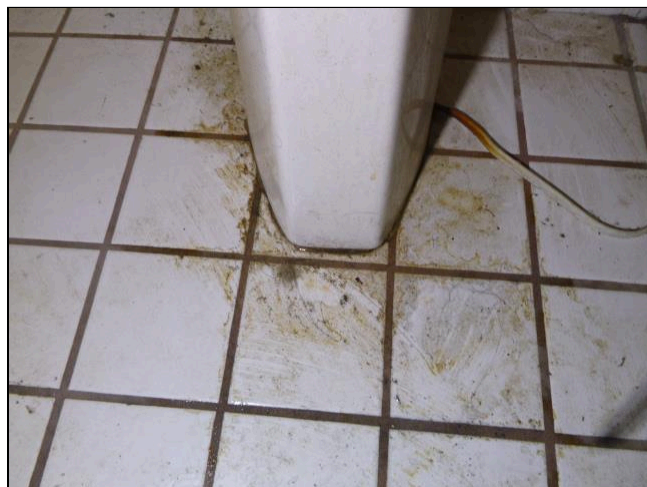
18.0 Item 1 (Picture)

18.0 Wet areas noted under the sink (likely due to the leaking drain), has caused sub floor damage. See the foundation comments and make repairs as needed.

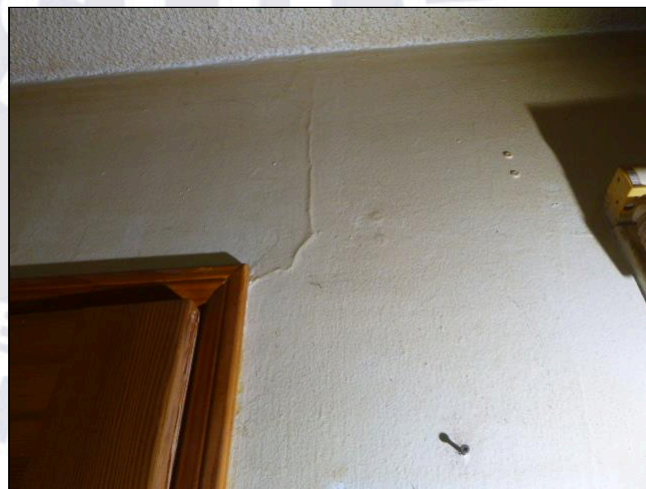
20.1 Item 1 (Picture)

20.1 (1) Settling cracks and patching was noted, suggest repair as needed.

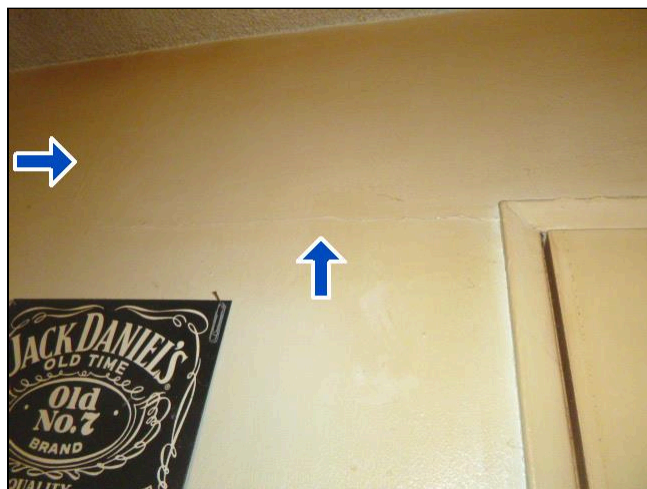
23.1 Item 1 (Picture)

23.1 (1) Excessive settling cracks noted, see the foundation and Lot/Drainage comments. Suggest review with a licensed contractor for repair/replacement costs as needed.

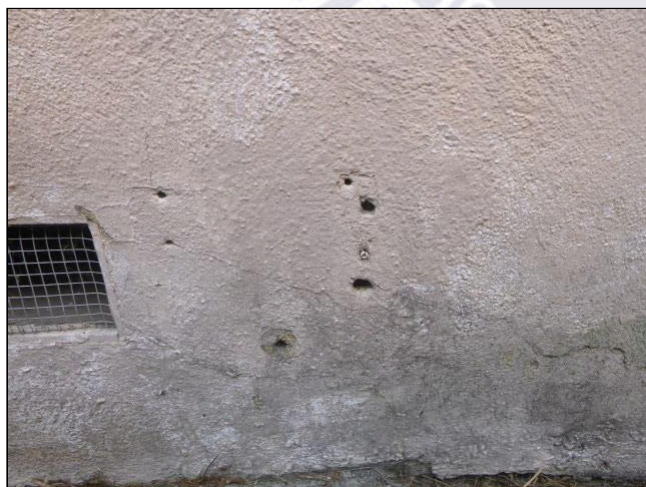
1.4 Item 5 (Picture)

(3) The holes in siding needs closing off with sealant, stucco or liquid foam at the right side.

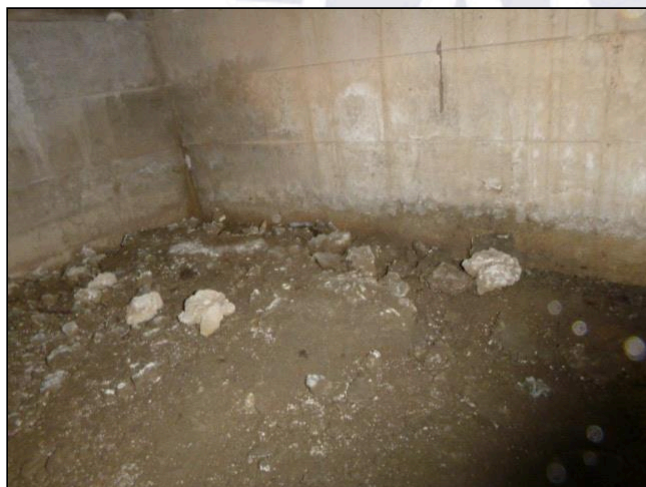
2.0 Item 1 (Picture)

(2) Re-grading where needed is recommended to assure all water drains away from the home's foundation. The inadequate drainage has caused the excessive moisture buildup at the foundation and intrusion into the crawl area, suggest review with a licensed contractor for foundation repairs and installation of rain gutters and an area drainage system to divert all the water away from the foundation.

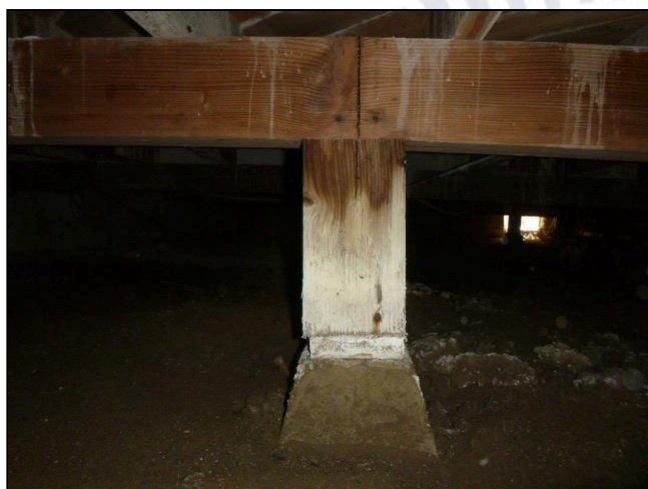
3.0 Item 10 (Picture)

(4) Excessive staining/saturation/deterioration of internal wood support members was noted due to excessive and ongoing water intrusion. Suggest review with a licensed foundation contractor for repair/replacement costs needed to prevent any future movement to the foundation and/or structure.

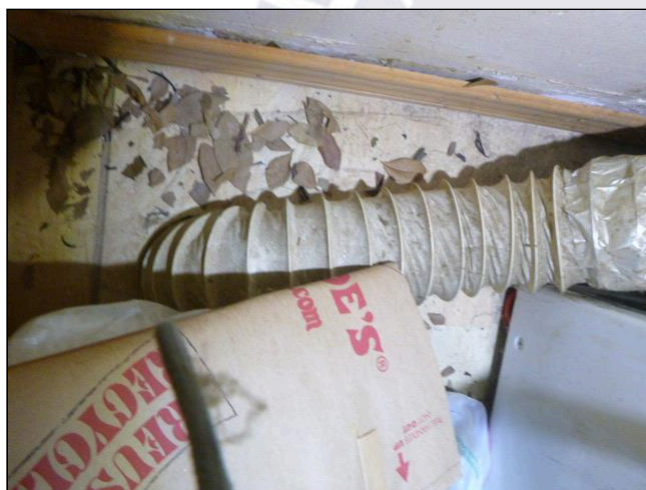
7.6 Item 1 (Picture)

(2) Improper vinyl flex vent installed to the crawl space (not installed to the exterior as required). Suggest removal of the existing material and install a rigid vent pipe to the exterior as required. Excessive lint noted was noted in the crawl area due to the incomplete installation, this is a potential fire hazard. Suggest review by licensed contractor for costs to remove the lint form the crawl area as required for safety.

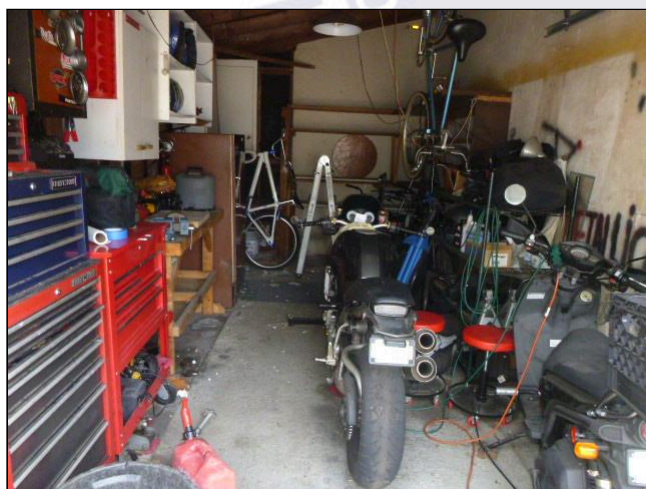
11.0 Item 1 (Picture)

(1) Access within this area was blocked or severely limited at the time of the inspection. An inspection of this area can be performed by appointment and at an additional cost when the area is made accessible.

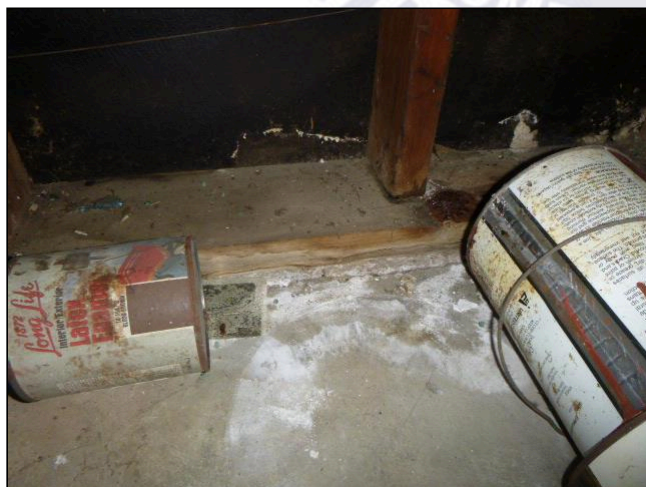
11.3 Item 3 (Picture)

(3) Water stains and deterioration noted at the lower section of the walls due to water intrusion. Suggest repair/replace as needed.

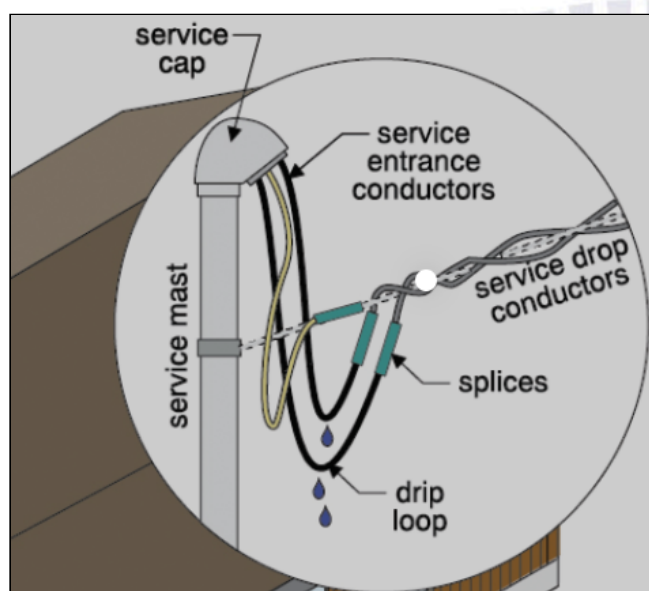
13.0 Item 2 (Picture)

(2) Inadequate drip loop was noted, suggest review with a licensed electrician for repairs as needed.

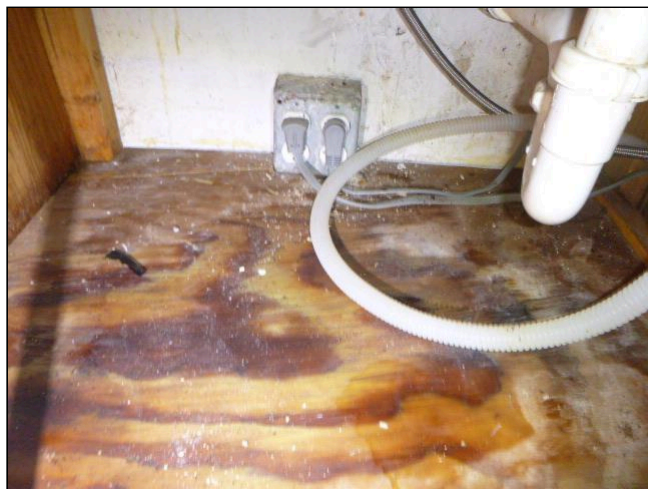
17.5 Item 1 (Picture)

- (1) The base cabinet under the sink is deteriorated/stained from previous leaks, suggest repair/replace as needed.

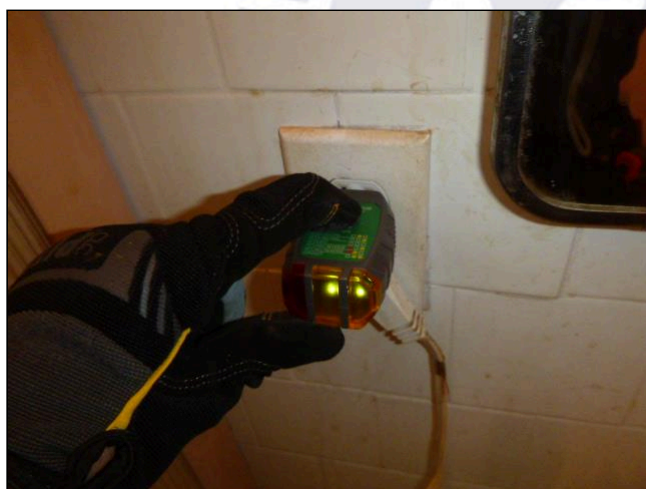
18.6 Item 1 (Picture)

No GFCI outlet or protection installed in this bathroom. GFCI protection has been required in bathrooms since 1975, suggest review by a licensed electrician for installation as required for safety.

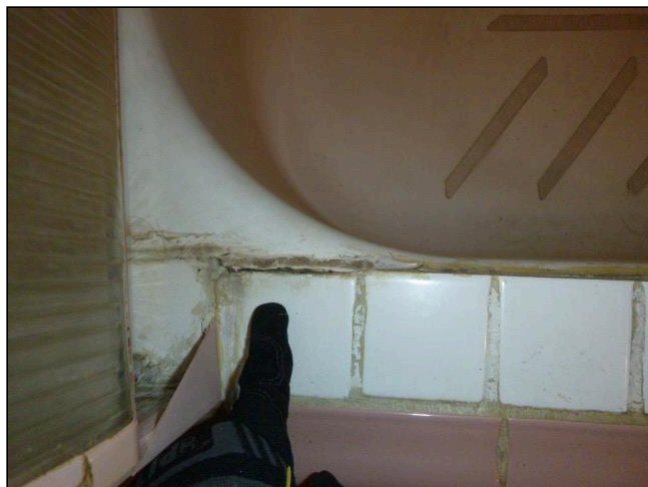
18.8 Item 1 (Picture)

Suggest caulking or re-grout as needed. The edges of the tub walls should be caulked to prevent moisture penetration. Failure to keep walls sealed can cause deterioration and extensive moisture damage to the interior walls, which is not always visible.

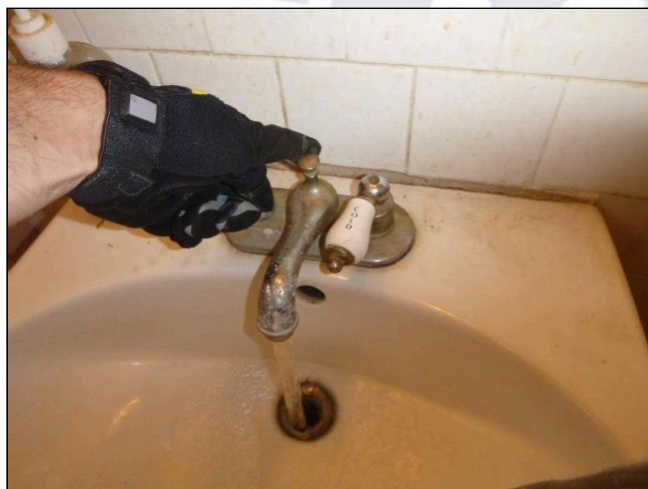
18.12 Item 1 (Picture)

The sink stopper is faulty/inoperable, suggest repair/replace as needed.

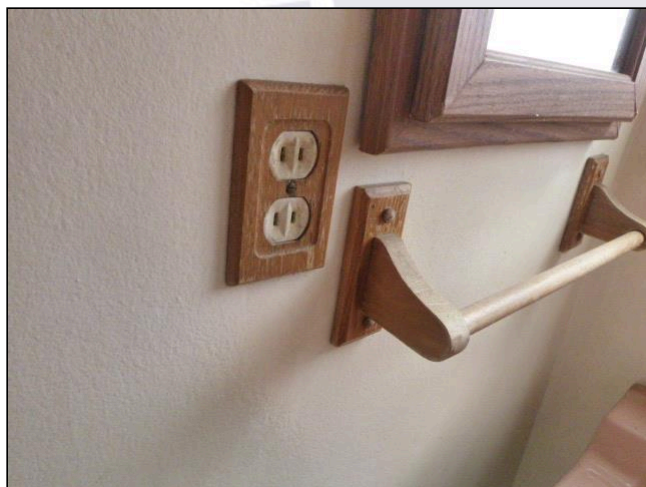
19.6 Item 1 (Picture)

(2) Two wire and two prong electrical receptacles noted. At the time of the original construction this type of system was the acceptable standard and appears to be intact. If three prong and GFCI receptacles are desired a ground source is required. Suggest review with a licensed electrician for costs to ground the outlets as needed as an upgrade and/or protected the outlet(s) on a GFCI circuit where recommended.

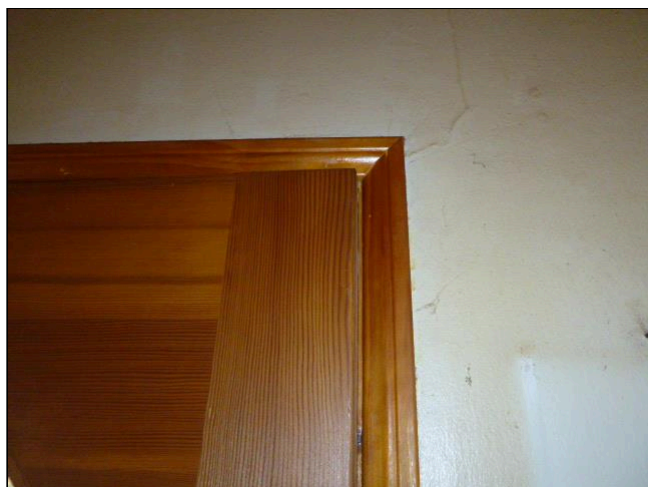
20.3 Item 2 (Picture)

(2) The door sticks/impacts on the jamb when operating due to settling, suggest repair as needed.

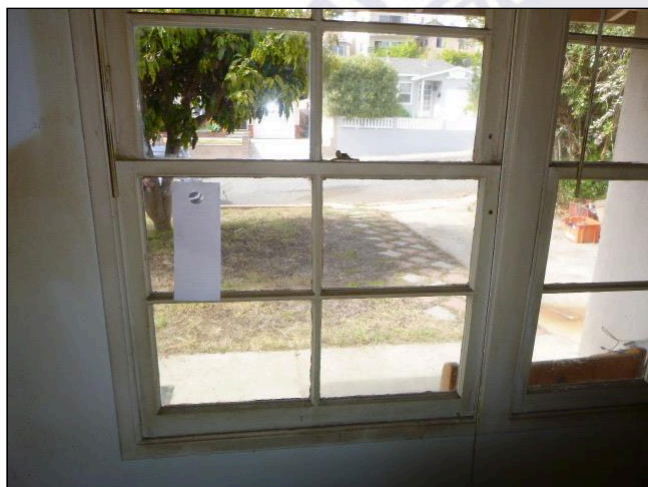
20.4 Item 1 (Picture)

(1) The window(s) are stuck/painted shut at the time of the inspection, maintenance or repair as needed is suggested to allow for emergency exit and ventilation.

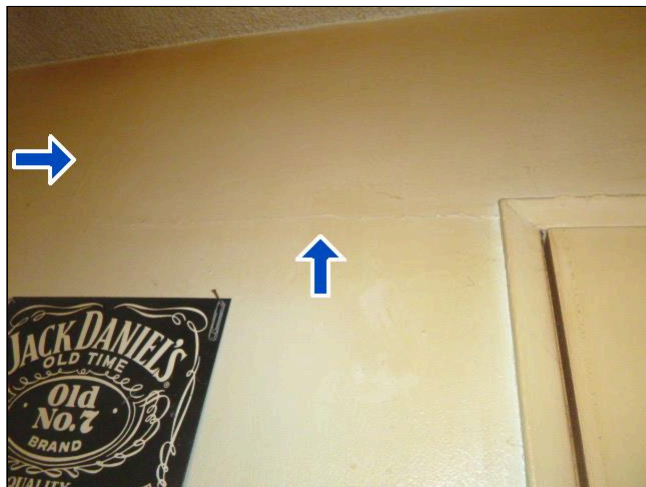
23.1 Item 1 (Picture)

(1) Excessive settling cracks noted, see the foundation and Lot/Drainage comments. Suggest review with a licensed contractor for repair/replacement costs as needed.

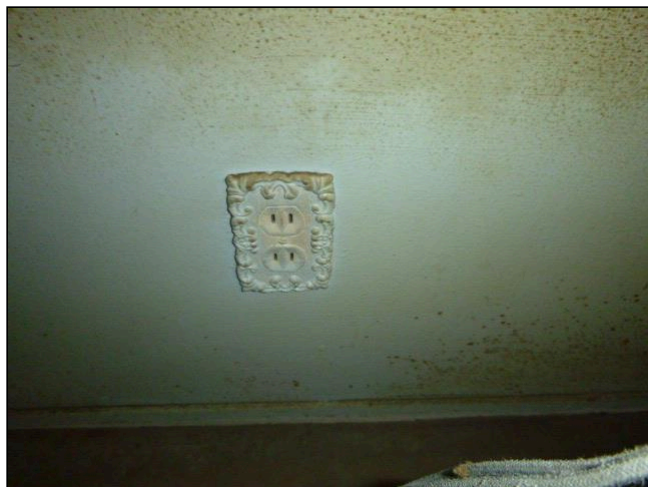
23.6 Item 1 (Picture)

(1) Two wire and two prong electrical receptacles noted. At the time of the original construction this type of system was the acceptable standard and appears to be intact. If three prong and GFCI receptacles are desired a ground source is required. Suggest review with a licensed electrician for costs to ground the outlets as needed as an upgrade and/or protected the outlet(s) on a GFCI circuit where recommended.

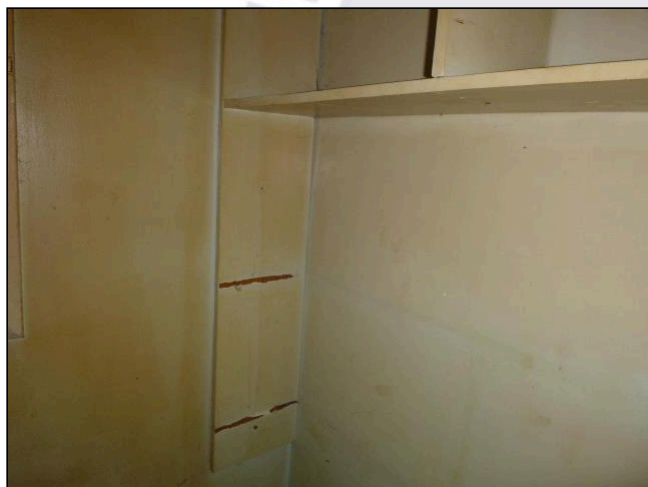
23.7 Item 1 (Picture)

Damaged/missing areas noted at the wall cabinetry, suggest repair/replace as needed.

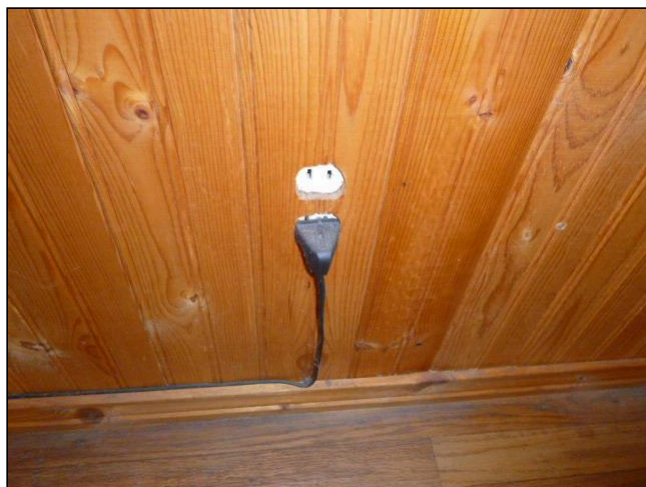
25.5 Item 1 (Picture)

(1) Two wire and two prong electrical receptacles noted. At the time of the original construction this type of system was the acceptable standard and appears to be intact. If three prong and GFCI receptacles are desired a ground source is required. Suggest review with a licensed electrician for costs to ground the outlets as needed as an upgrade and/or protected the outlet(s) on a GFCI circuit where recommended.

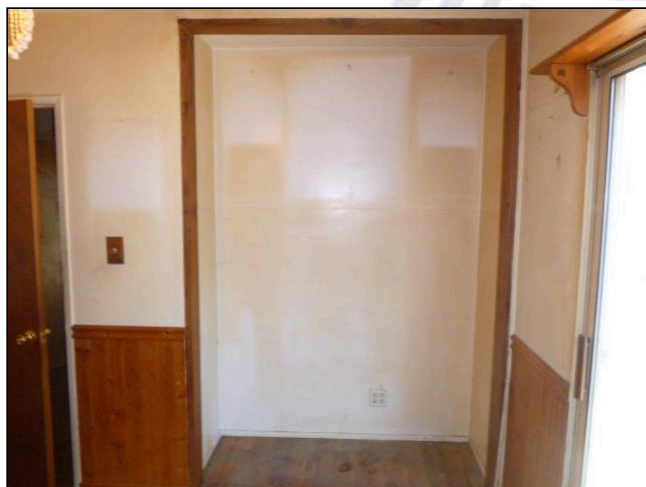
25.6 Item 1 (Picture)

(1) The closet doors were missing from this area at the time of the inspection, suggest replacing as needed.
