Key Findings Report

Property Address: 221 Tall Oak
Irvine CA 92603

Date of inspection: 2/11/2022 **Inspector:** Reid Anderson

Home Inspection Report

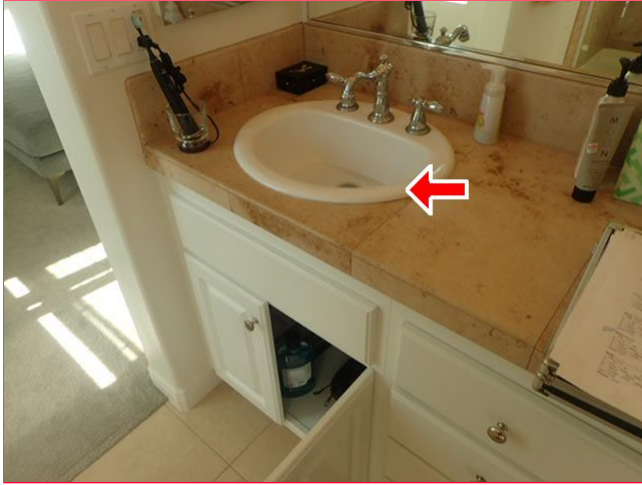
Item 1 - Item 1(Picture)

1. (1) A Master Bathroom sink drains slowly. It may be clogged with hair or other obstructions. - The drain should be cleared as needed by a qualified plumber.

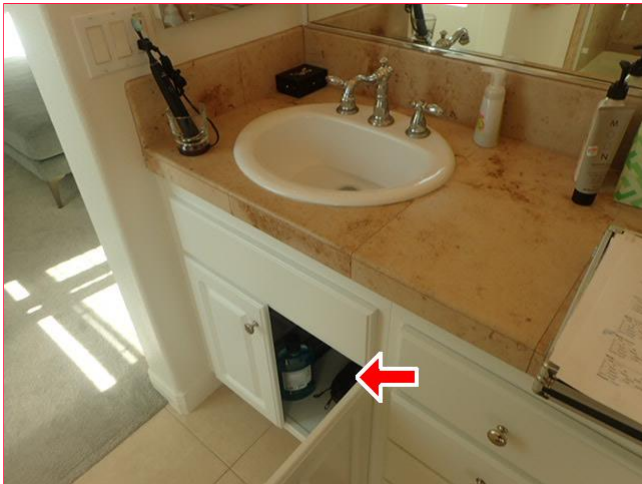
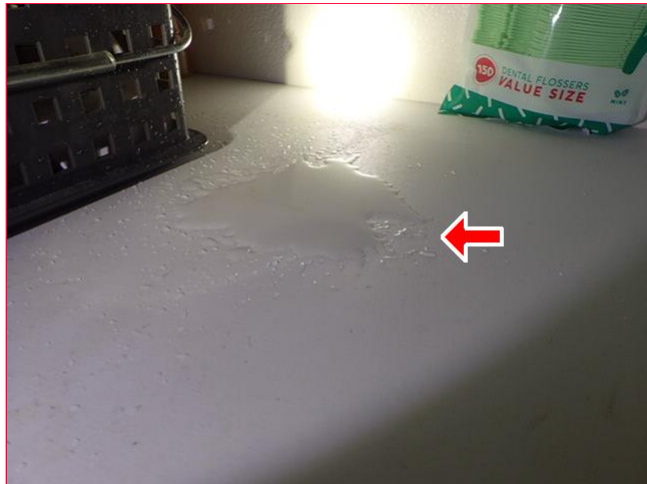
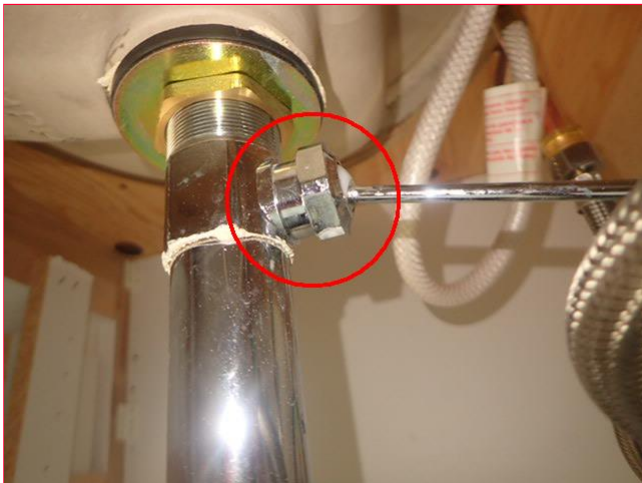
2. (2) The drain line is actively leaking under the Master Bathroom left wash basin. - All leaking piping should be repaired if possible or replaced as necessary. A qualified plumber should do the work.

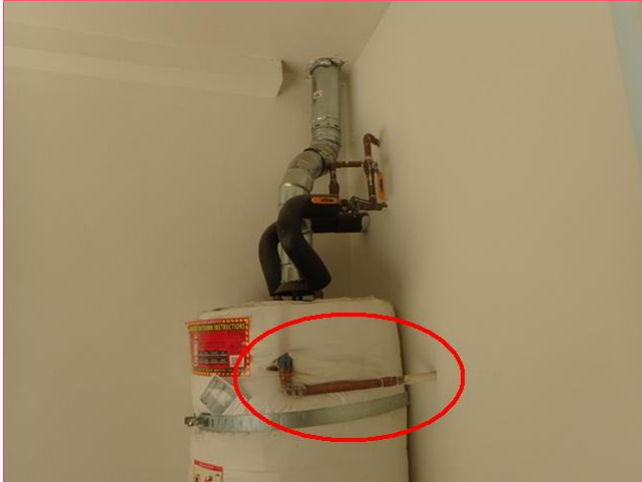
Item 3 - Item 1(Picture)

3. A section of the discharge pipe from the temperature-and-pressure (T&P) relief valve does not slope away from the valve. If the valve leaks, this could cause corrosion and/or a possible failure of the valve to perform in a situation where the

temperature or pressure would cause the valve to open.
- A qualified technician should adjust the discharge pipe.

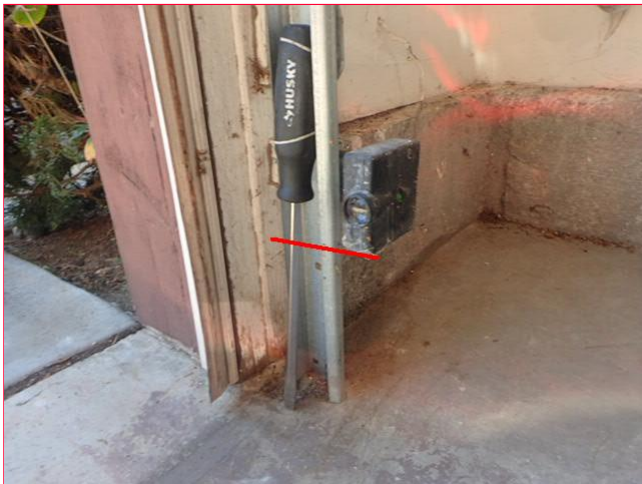
Item 4 - Item 1(Picture)

4. The optical sensor for the garage door opener(s) (which activates the safety reverse system) was installed too high. This is a child safety concern. - The optical sensors should be installed no more than six inches above the floor of the garage or in accordance with the manufacturer's specifications.

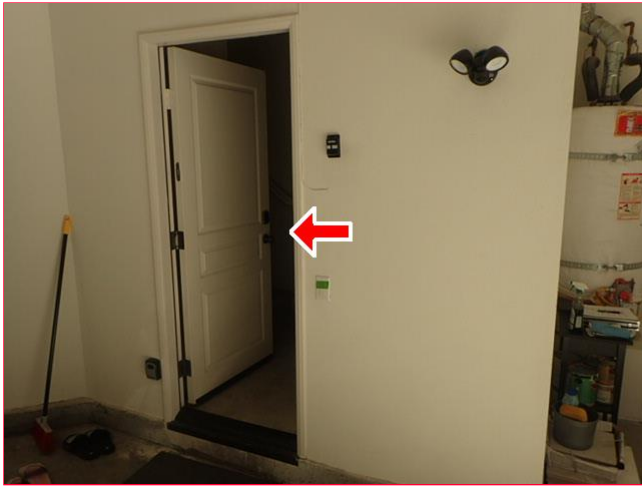
Item 5 - Item 1(Picture)

5. The passage door between the garage and the house is equipped with an automatic self closer. However, the door does not fully close and latch (the door should be able to overcome the air pressure caused when the vehicle door is closed). - The door and/or door hardware should be repaired, replaced or adjusted to ensure that the door closes and latches properly.

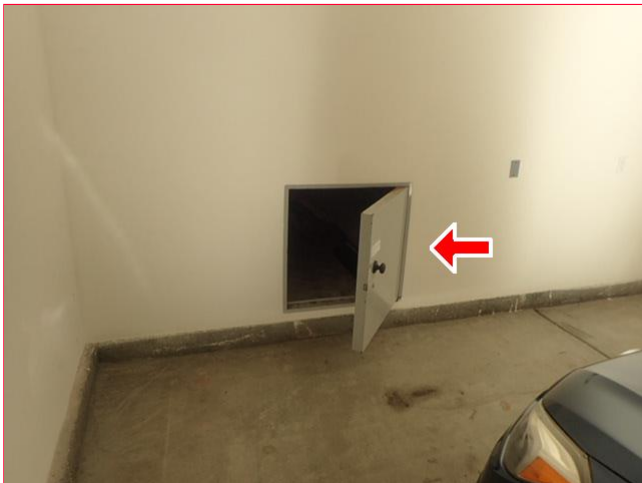
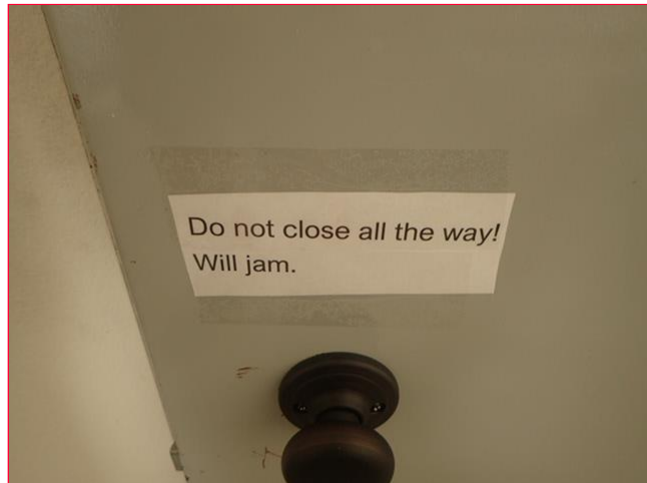
6. The fire-rated access door to the crawlspace should be adjusted to close properly. - A qualified technician should make repairs as needed.

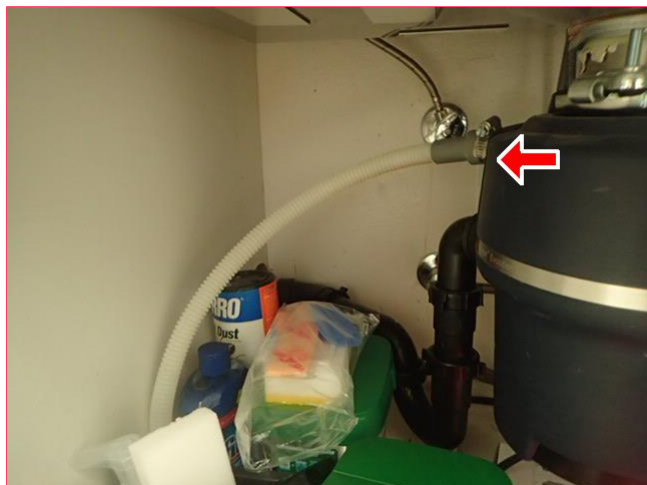
Item 7 - Item 1(Picture)

7. The dishwasher drain has no air gap. This can allow dirty sink water (from a clogged sink) to siphon back into the dishwasher.
- Consider having an air gap installed when the dishwasher is replaced, or when other plumbing work is done. In the meantime, the dishwasher drain hose should be secured as high as possible under the sink (in a "high loop" configuration), to prevent siphoning of the drain water back into the dishwasher.

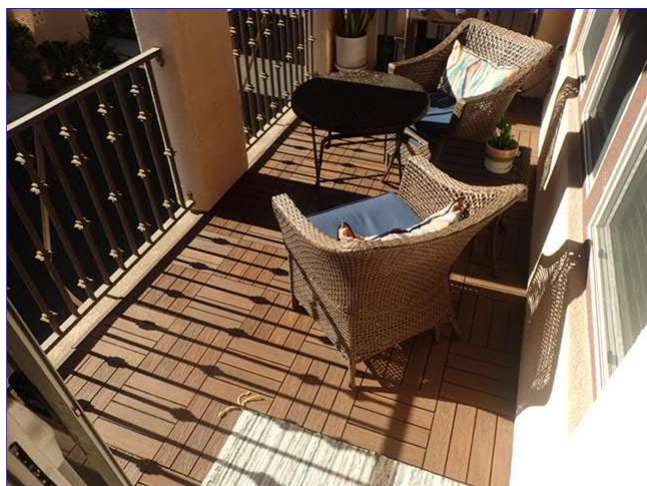
Item 9 - Item 1(Picture)

9. The deck surface is fully or partially covered by carpet or other materials, obscuring most of the underlying material. These coverings can trap moisture and may eventually lead to deterioration of the surface below. - The covering should be removed. The surfaces hidden by the carpet should be evaluated and repaired as necessary.

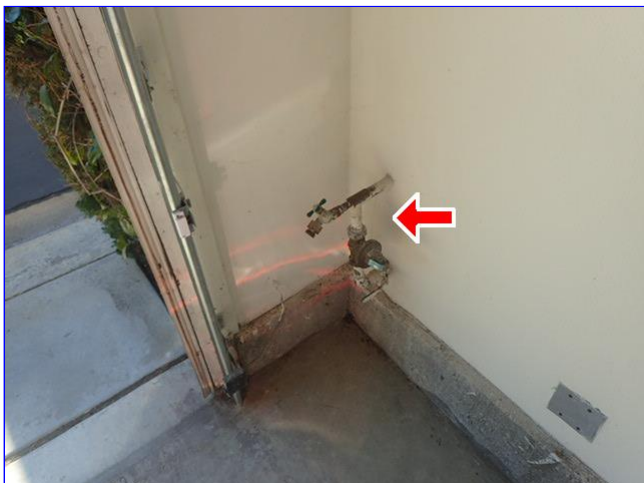
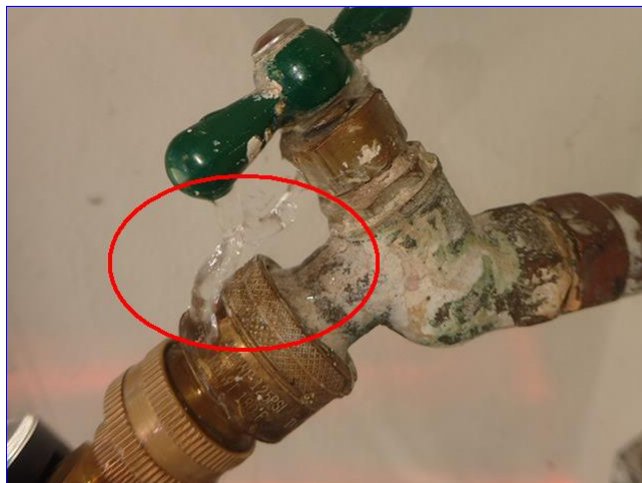
11. The hose bibb at the left front of the Garage leaks when the valve is opened. - A qualified plumber should make repairs or modifications as necessary.

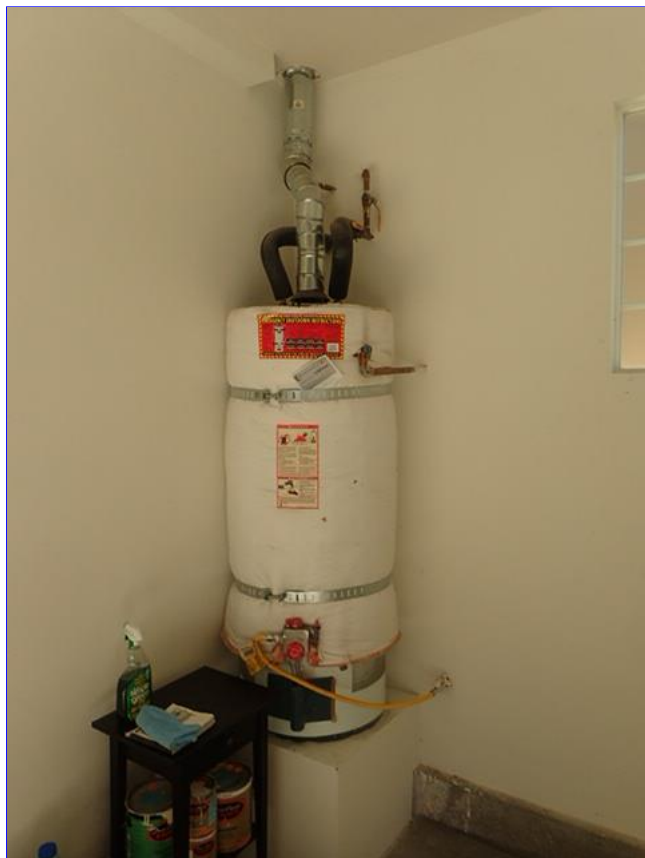
Item 13 - Item 1(Picture)

13. The water heater insulating blanket covered the data plate of the water heater. The size and age of the unit could not be verified. - It is recommended to verify the age of the water heater. The average useful lifespan for a water heater is 10-12 years.

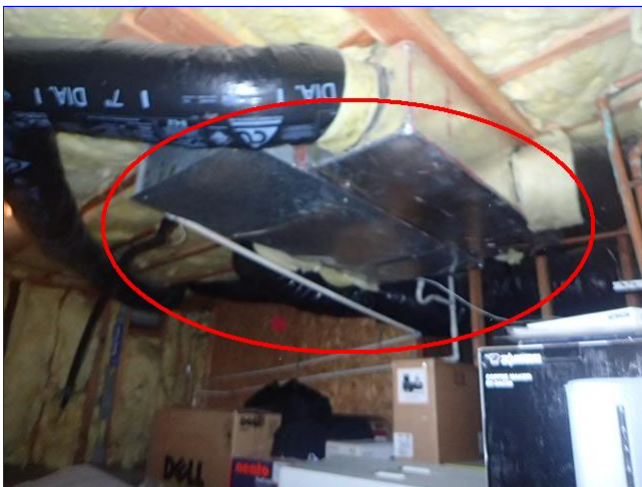
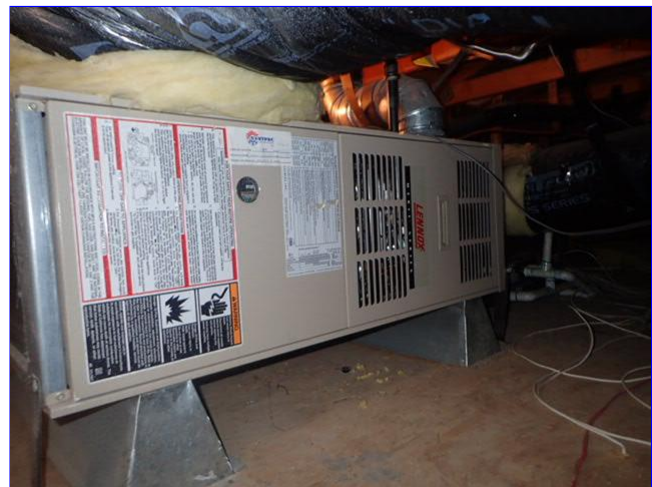
17. The furnace is / furnaces are the original installation. A qualified HVAC technician should clean, inspect and make any needed repairs to ensure that the system is in good and safe operating condition. (Posting a dated record on the furnace of the servicing is also recommended.)

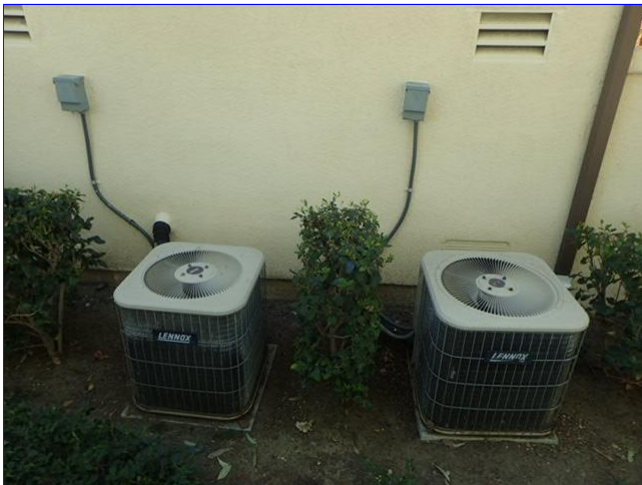
Item 19 - Item 1(Picture)

19. (1) The condensing unit(s) appears to be the original unit(s). Due to the age, we recommend asking the sellers when the unit(s) were last serviced. - A qualified HVAC technician should service as needed. They could also advise on the estimated remaining life of the unit(s).

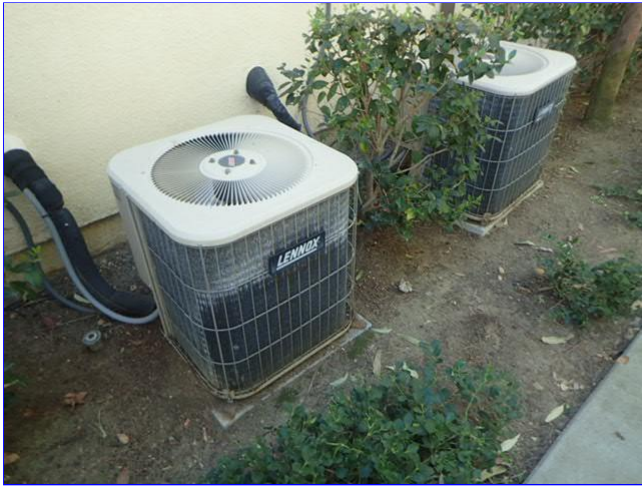
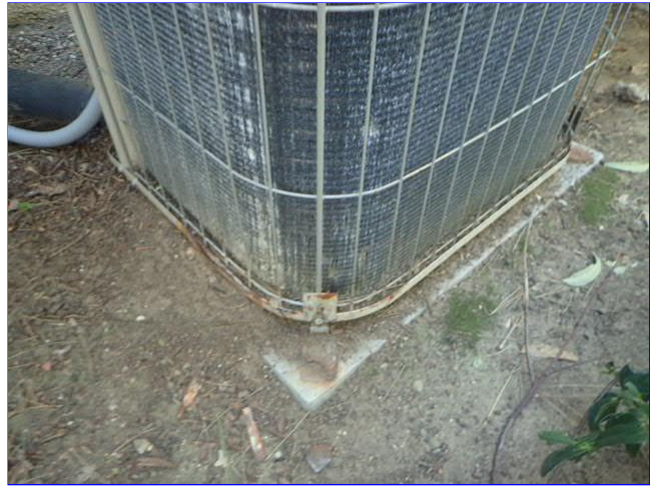
20. (2) The base of the condensing unit was directly in contact with soil. This can promote rust, deterioration, and early failure of the exterior casing, and possibly the internal components as well.
- Current standards require 3" of clearance between the condenser and the soil or soil coverings.

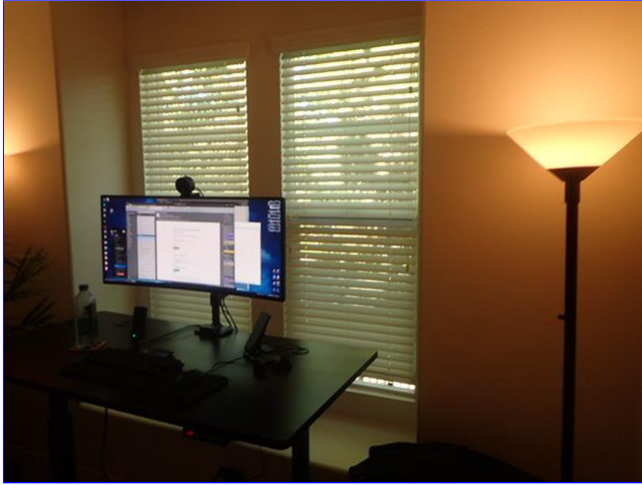
Item 22 - Item 1(Picture)

22. (2) One or more windows were blocked by furniture and/or shutters. The windows could not be operated. - We recommend testing the windows for proper operation no later than the final walkthrough.

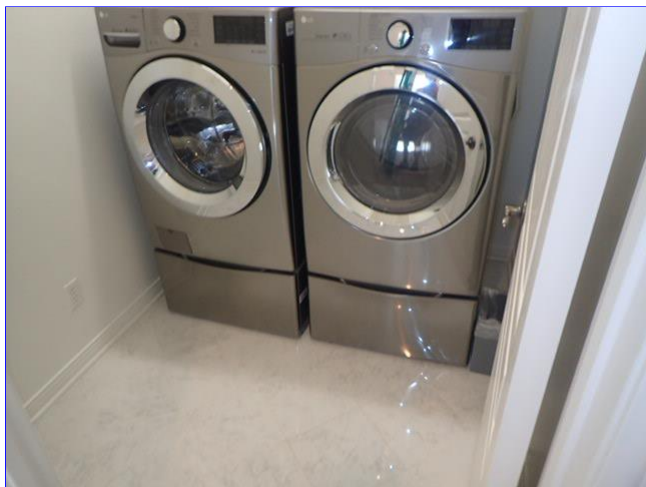
Item 25 - Item 1(Picture)

25. No floor drain is visible and no clothes washer overflow pan is present in the laundry. Because of the location of this laundry area over wood flooring or finished space on the floor below, a pan connected to a drain in good repair is advised. We recommend installation of a drained catch pan under the washing machine, as an upgrade and preventive measure.

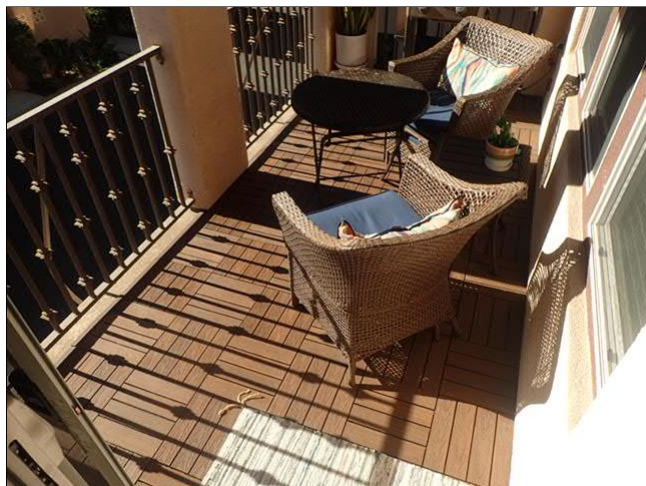
3.6 Item 1(Picture)

The deck surface is fully or partially covered by carpet or other materials, obscuring most of the underlying material. These coverings can trap moisture and may eventually lead to deterioration of the surface below. - The covering should be removed. The surfaces hidden by the carpet should be evaluated and repaired as necessary.

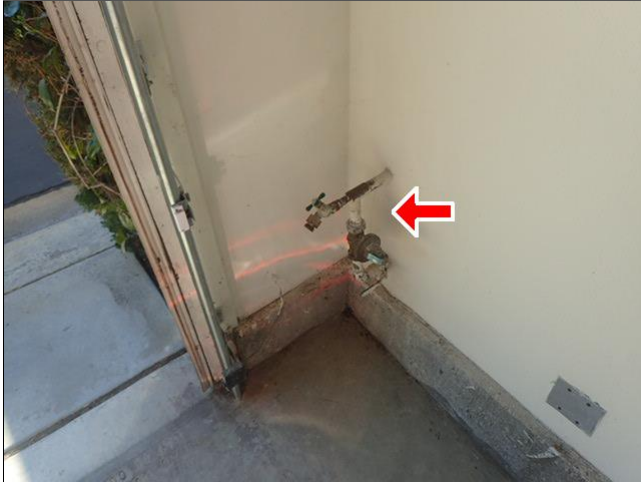
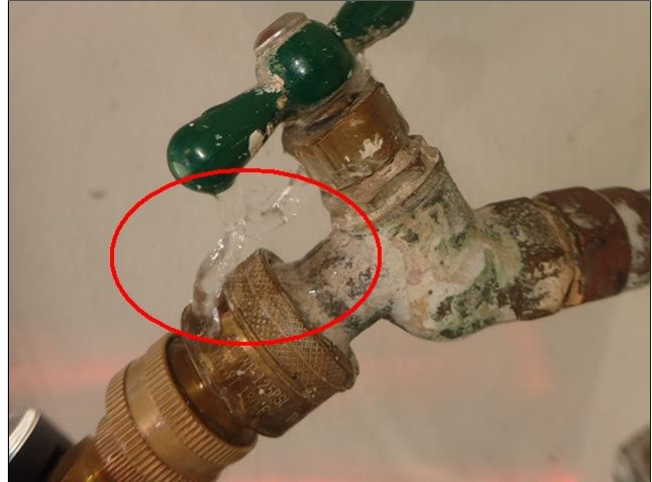
The hose bibb at the left front of the Garage leaks when the valve is opened. - A qualified plumber should make repairs or modifications as necessary.

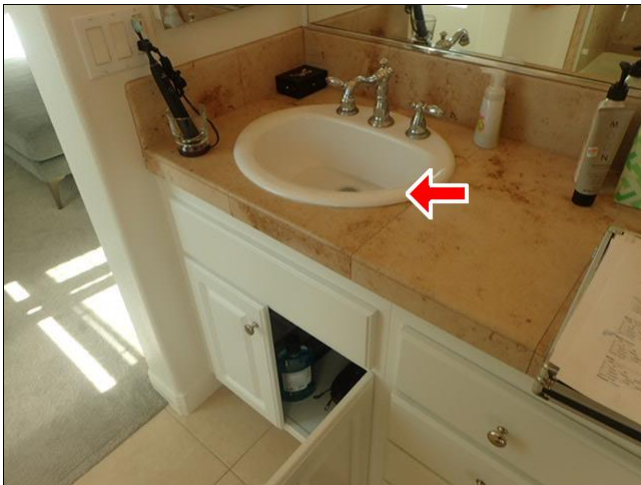
4.3 Item 1(Picture)

(1) A Master Bathroom sink drains slowly. It may be clogged with hair or other obstructions. - The drain should be cleared as needed by a qualified plumber.

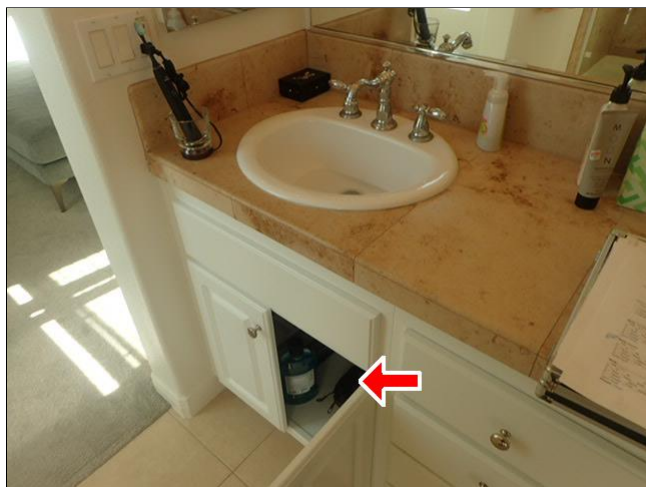
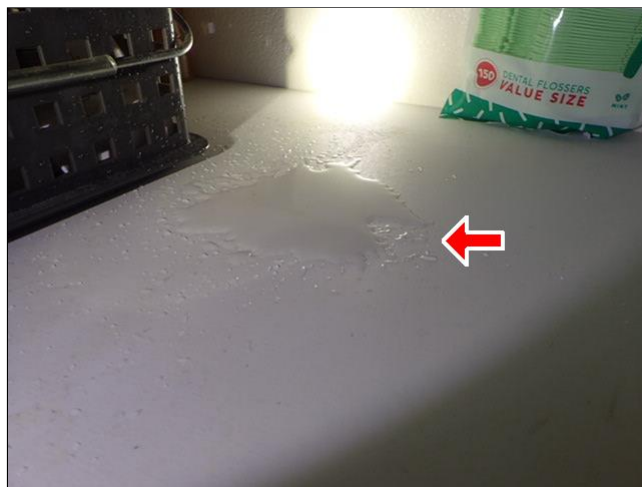
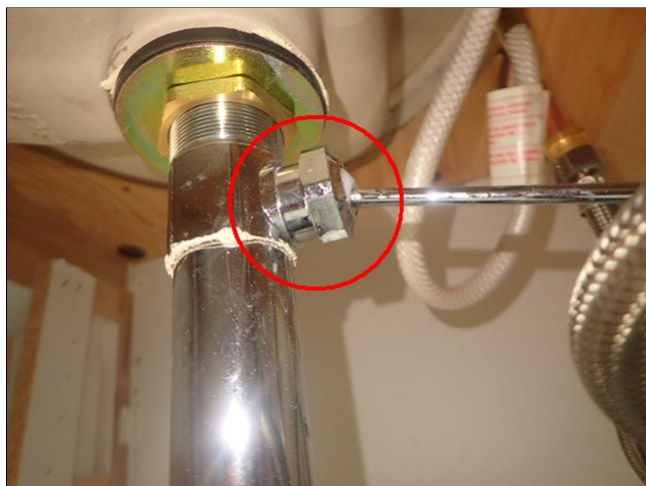
- ⛔ (2) The drain line is actively leaking under the Master Bathroom left wash basin. - All leaking piping should be repaired if possible or replaced as necessary. A qualified plumber should do the work.

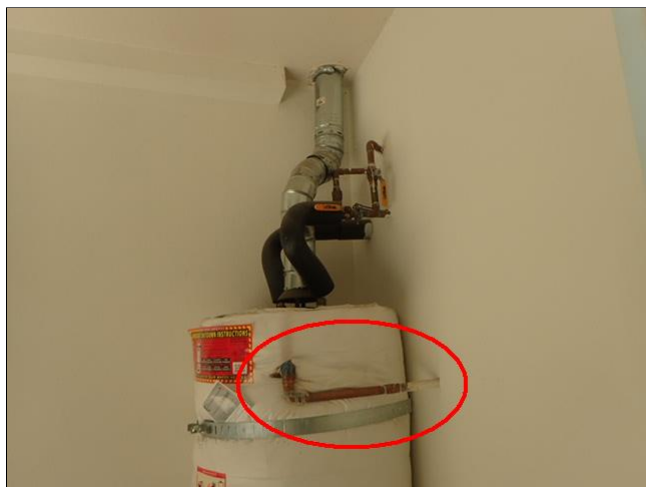
4.4 Item 1(Picture)

- ✚ A section of the discharge pipe from the temperature-and-pressure (T&P) relief valve does not slope away from the valve. If the valve leaks, this could cause corrosion and/or a possible failure of the valve to perform in a situation where the temperature or pressure would cause the valve to open.
- A qualified technician should adjust the discharge pipe.

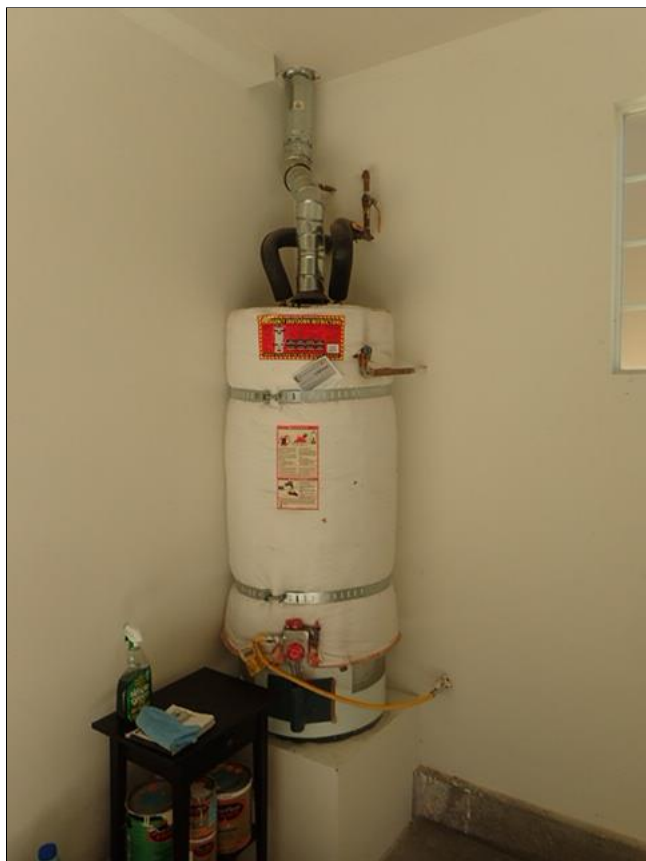
4.9 Item 1(Picture)

- ☞ The water heater insulating blanket covered the data plate of the water heater. The size and age of the unit could not be verified. - It is recommended to verify the age of the water heater. The average useful lifespan for a water heater is 10-12 years.

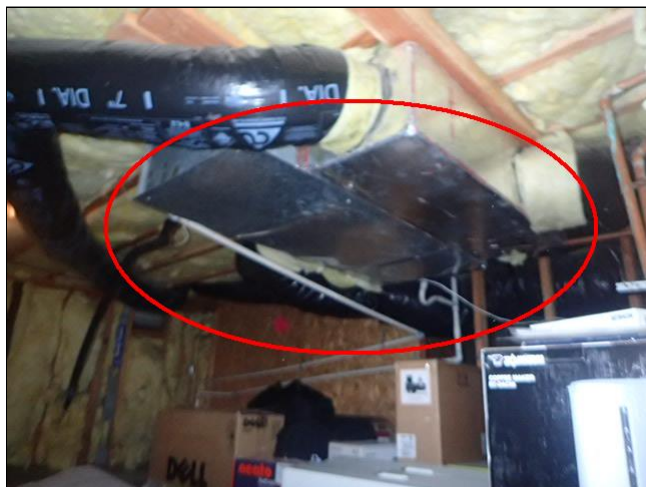
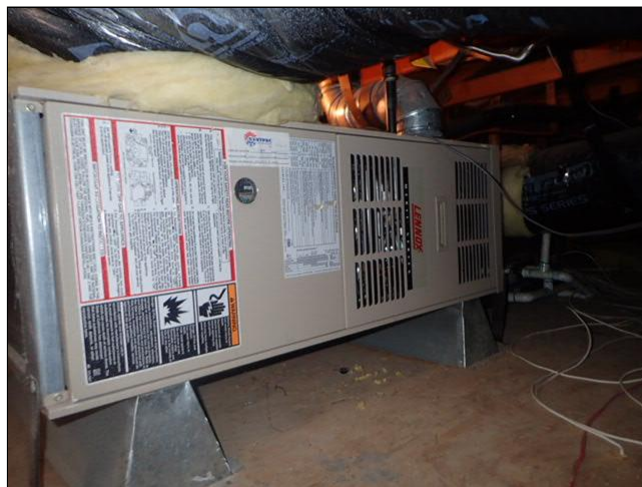
The furnace is / furnaces are the original installation. A qualified HVAC technician should clean, inspect and make any needed repairs to ensure that the system is in good and safe operating condition. (Posting a dated record on the furnace of the servicing is also recommended.)

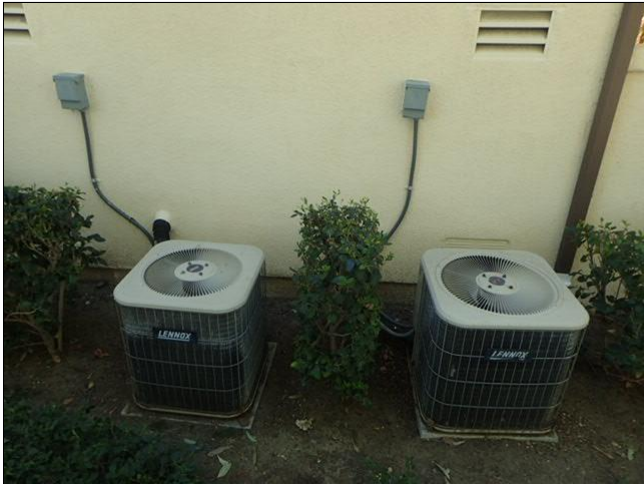
6.7 Item 1(Picture)

(1) The condensing unit(s) appears to be the original unit(s). Due to the age, we recommend asking the sellers when the unit(s) were last serviced. - A qualified HVAC technician should service as needed. They could also advise on the estimated remaining life of the unit(s).

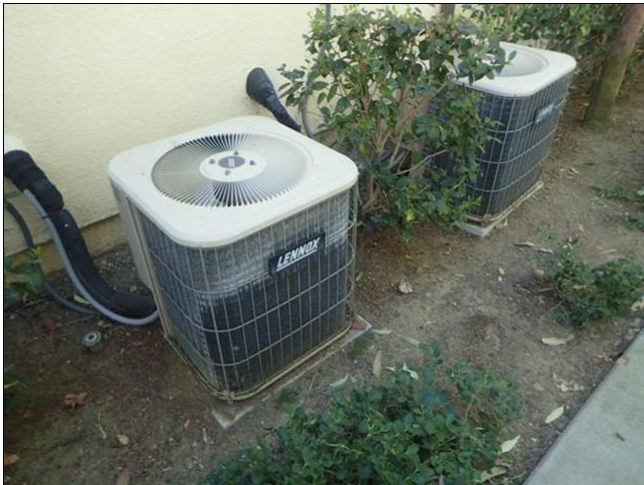
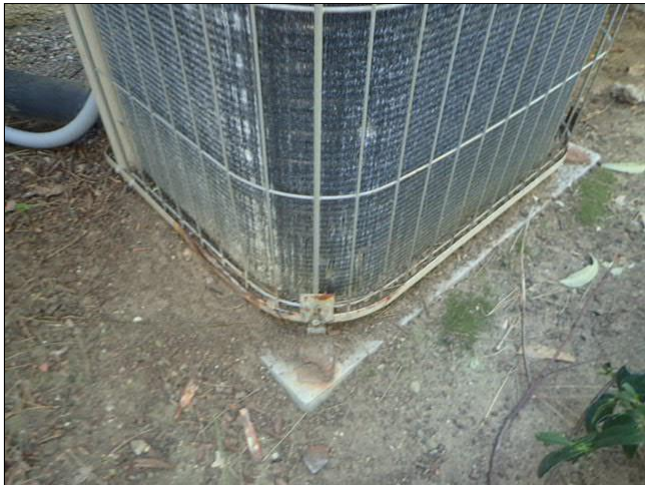
(2) The base of the condensing unit was directly in contact with soil. This can promote rust, deterioration, and early failure of the exterior casing, and possibly the internal components as well.
- Current standards require 3" of clearance between the condenser and the soil or soil coverings.

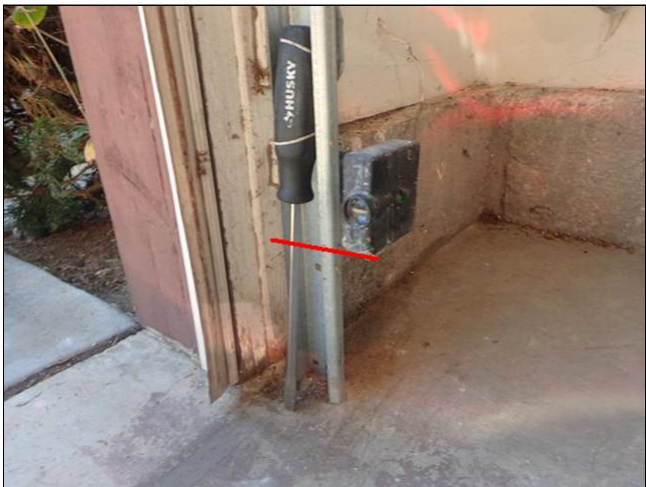
8.1 Item 1(Picture)

+ The optical sensor for the garage door opener(s) (which activates the safety reverse system) was installed too high. This is a child safety concern. - The optical sensors should be installed no more than six inches above the floor of the garage or in accordance with the manufacturer's specifications.

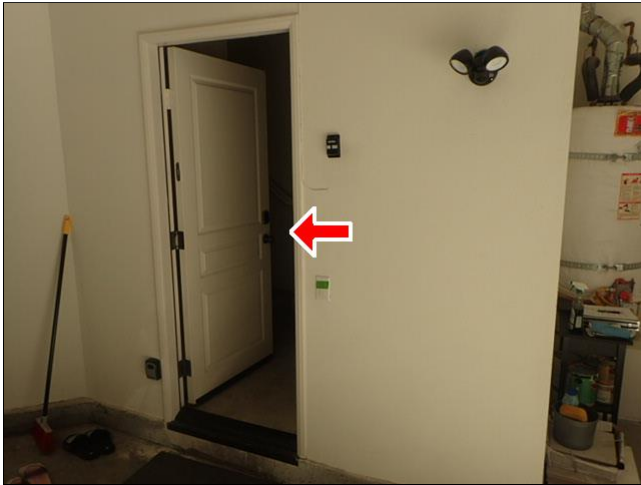
8.3 Item 1(Picture)

- ⊕ The passage door between the garage and the house is equipped with an automatic self closer. However, the door does not fully close and latch (the door should be able to overcome the air pressure caused when the vehicle door is closed). - The door and/or door hardware should be repaired, replaced or adjusted to ensure that the door closes and latches properly.

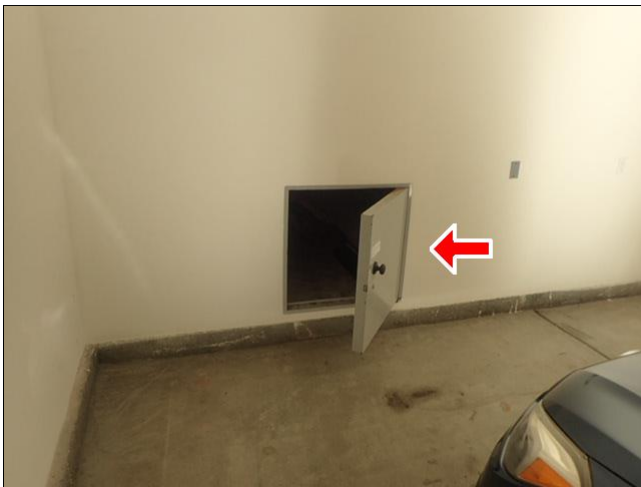
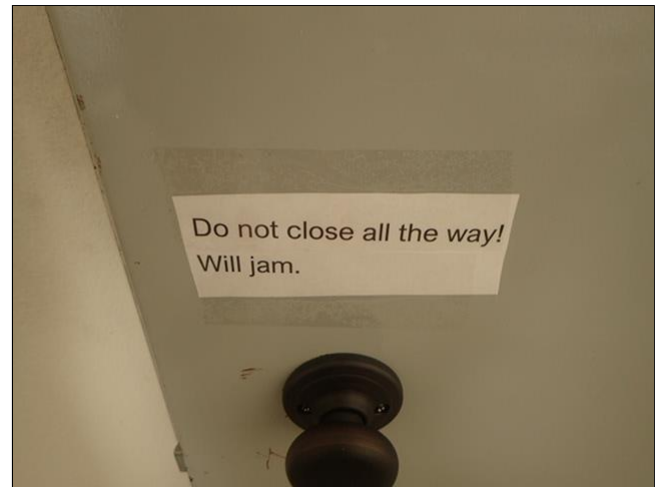
- ⊕ The fire-rated access door to the crawlspace should be adjusted to close properly. - A qualified technician should make repairs as needed.

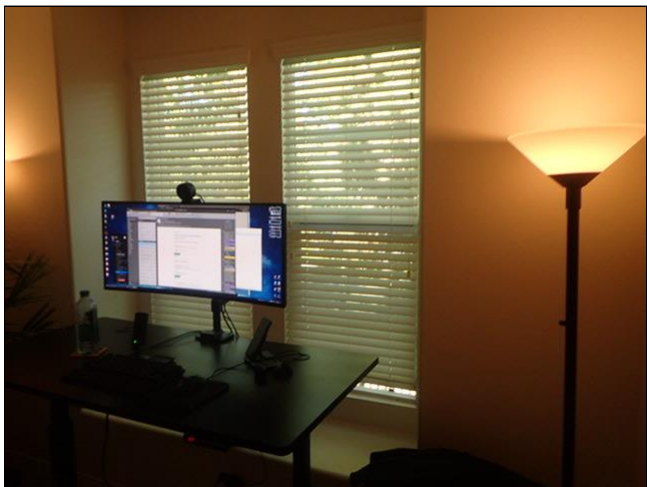
9.0 Item 2(Picture)

(2) One or more windows were blocked by furniture and/or shutters. The windows could not be operated. - We recommend testing the windows for proper operation no later than the final walkthrough.

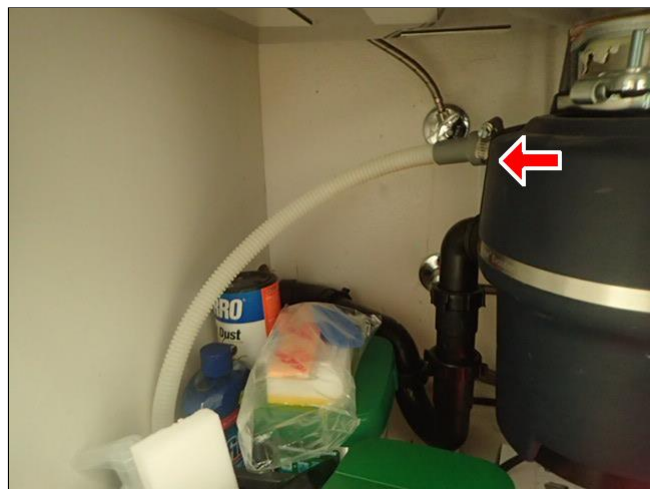
10.4 Item 1(Picture)

meantime, the dishwasher drain hose should be secured as high as possible under the sink (in a "high loop" configuration), to prevent siphoning of the drain water back into the dishwasher.

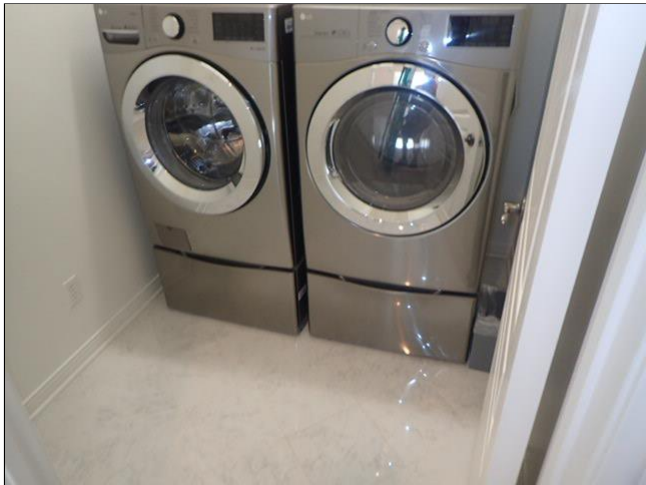
12.0 Item 1(Picture)

No floor drain is visible and no clothes washer overflow pan is present in the laundry. Because of the location of this laundry area over wood flooring or finished space on the floor below, a pan connected to a drain in good repair is advised. We recommend installation of a drained catch pan under the washing machine, as an upgrade and preventive measure.
