WOOD DESTROYING PESTS AND ORGANISMS INSPECTION REPORT

#: 20234418

BUILDING NO. 2640	STREET VIA RIVERA	CITY PALOS VERDES ESTATES	ZIP 90274	Date of Inspection 07/24/2023	NUMBER OF PAGES 1 of 7
-----------------------------	-----------------------------	-------------------------------------	---------------------	---	----------------------------------

GENERAL DESCRIPTION: Single story, stucco, residence. It has an attached garage. It has a tile roof and was vacant at the time of inspection.	Inspection Tag Posted: Garage.
	Other Tags Posted:

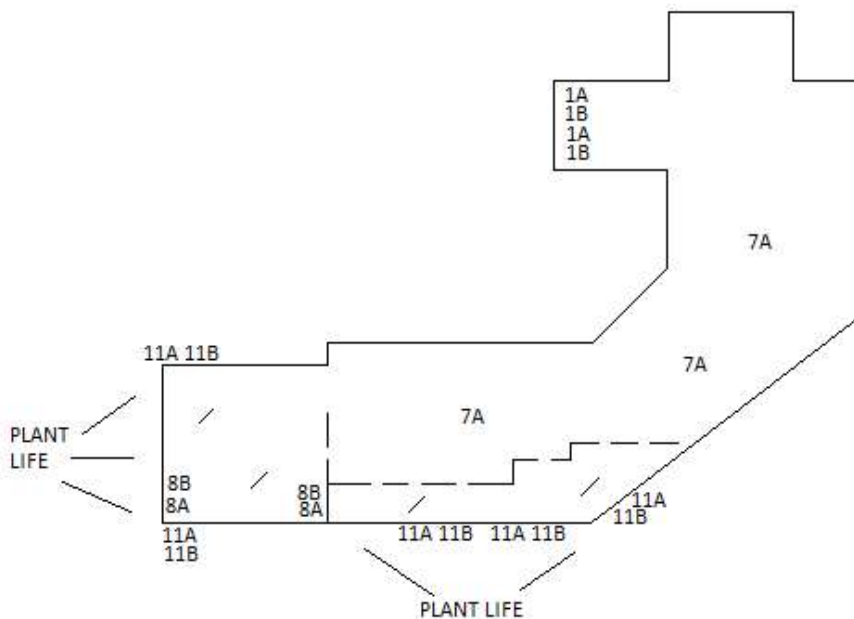
ITEM NO. 1A (Section 1)
FINDING: Evidence of DRYWOOD TERMITES as indicated by 1A on the diagram. Evidence noted in or near: SUBFLOOR.

ITEM NO. 1B (Section 1)
FINDING AND Drywood termite pellets as indicated by 1B on the diagram.
RECOMMENDATION: 1B

FINDING: Evidence of DRYWOOD TERMITES as indicated by 7A on the diagram. Evidence noted in or near: ATTIC FRAMING.

FINDING: Evidence of DRYWOOD TERMITES as indicated by 8A on the diagram. Evidence noted in or near: GARAGE FRAMING.

FINDING AND RECOMMENDATION: 8B Drywood termite pellets as indicated by 8B on the diagram.

- ITEM NO. 11A** (Section 1)
- FINDING:** Evidence of DRYWOOD TERMITES as indicated by 11A on the diagram. Evidence noted in or near: RAFTERS.
- RECOMMENDATION: 11A** Fumigate the structure with a fumigant lethal to DRYWOOD TERMITES (Sulfuryl Fluoride). See the occupants fumigation notice for further details. This company is not responsible for delays or schedule changes due to inclement weather or other agencies, nor is it responsible for damage to roof or plants as a result of the fumigation. Refer to the occupant's fumigation notice/preparation sheet (sent separately) for additional information.

- RECOMMENDATION: 11A** This item included in 1A.
- ITEM NO. 11B** (Section 1)
- FINDING:** DRYWOOD TERMITE DAMAGE as indicated by 11B on diagram. The damage was noted in or near: RAFTERS.

RECOMMENDATION: 1A Fumigate the structure with a fumigant lethal to DRYWOOD TERMITES (Sulfuryl Fluoride). See the occupants fumigation notice for further details. This company is not responsible for delays or schedule changes due to inclement weather or other agencies, nor is it responsible for damage to roof or plants as a result of the fumigation. Refer to the occupant's fumigation notice/preparation sheet (sent separately) for additional information.

Remove or cover pellets in visible and accessible areas. NOTE: It is common for additional pellets to sift down over a period of time due to normal household vibrations. This estimate is to cover the pellets one time only.

RECOMMENDATION: 7A This item included in 1A.

RECOMMENDATION: 8A This item included in 1A.

- RECOMMENDATION: 11B** Remove and replace damaged wood as necessary with today's available widths and grades.
- RECOMMENDATION: 11B** Cut off termite damage and repair with appropriate wood filler.
