## AmeriSpec Inspection Services

Doc #:	202305-92449	Inspector:	Alejandro Ortega
Date:	5/5/2023		
Address:	38 Fuchsia Aliso Viejo CA 92656		
Client Name:	Kim Mastel

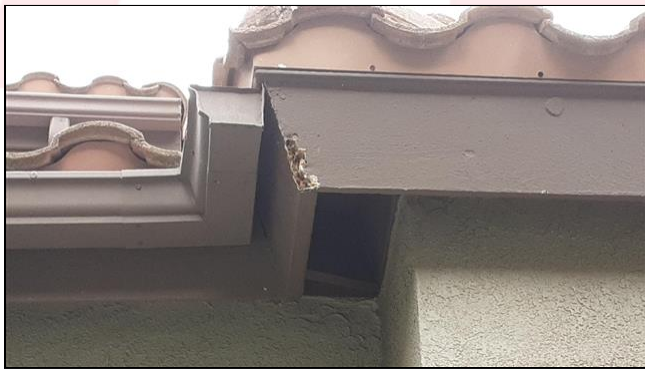
Step #	Component	Comment
1.0	Driveway	<b>Condition:. Cracked asphalt noted. Deteriorated asphalt noted.</b>
1.1	Walkways/Stairs	<b>S.</b>
1.2	Walls/Fence/ Gates	<b>N.</b>
1.3	Siding	<b>Serviceable. Common cracks noted.</b>
1.4	Trim	<b>Condition:. Deteriorated wood noted.</b>

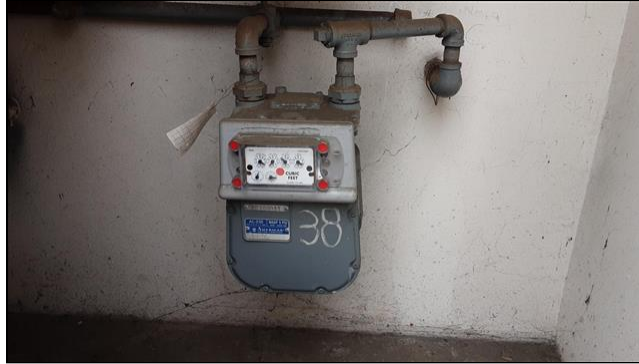
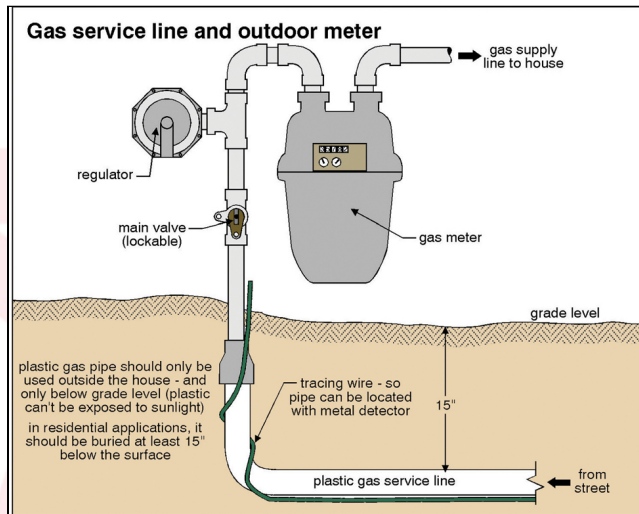
TRACER WIRE

- 1.9 Bell/Chime **Operable.**
- 1.10 Chimney **Serviceable. A spark arrester is installed as a safety feature.**
- 1.11 Lot Grade/Drainage **Home is built on a flat lot. Grade at the foundation appears to be adequate.**
- 1.12 Gas Meter **Gas meter is located in the right side exterior common closet.**

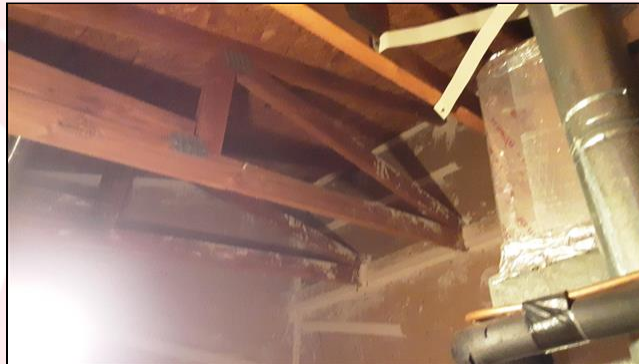
Step #	Component	Comment
3.0	Access	<b>Located in the rear bedroom.</b>

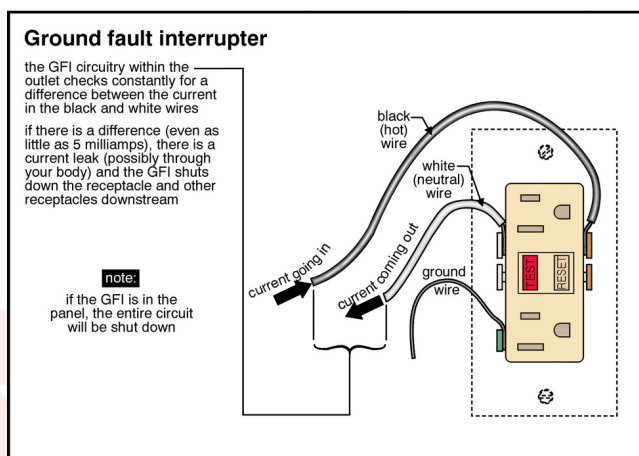
GFCI

Step #	Component	Comment
4.0	Cover	S.
4.1	Enclosure	S.
4.2	Electrical	<b>Serviceable. Ground fault circuit interrupter is provided for safety. We suggest periodic testing to ensure proper working order.</b>

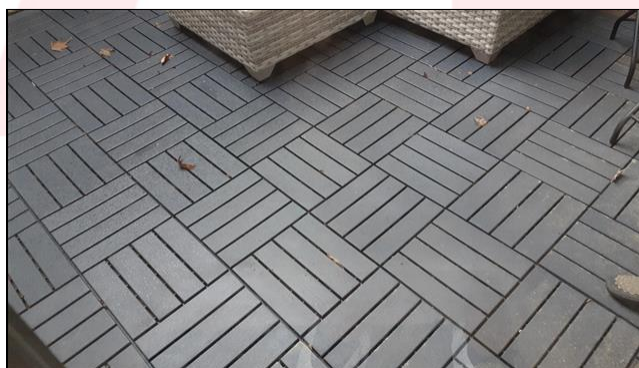
4.3	Deck/Slab	<b>Condition:. Unable to fully inspect due to covering,</b>
-----	-----------	---

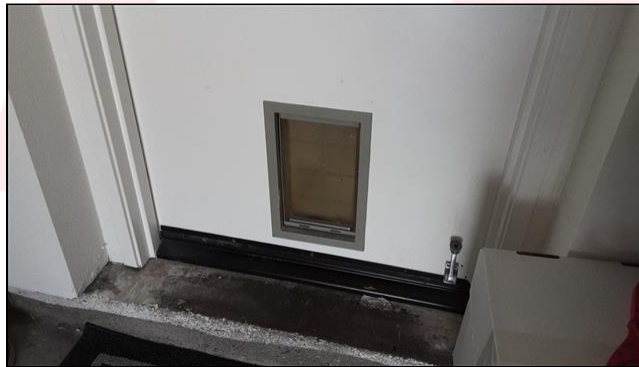
Step #	Component	Comment
5.0	Exterior	S.
5.1	Roof	<b>Condition:. Patching observed.</b>
5.2	Slab	<b>Serviceable. Common cracks noted.</b>
5.3	Garage Door	S.
5.4	Garage Door Hdwr	S.
5.5	Door Opener	<b>Serviceable. The garage door opener is equipped with a safety reverse device which operated when tested at the time of inspection. The U.S. product safety commission recommends these devices be checked monthly.</b>
5.6	Windows	N.
5.7	Screens	N.
5.8	Access Door	N.
5.9	Fire Door	<b>Condition:. Pet access is installed; no longer fire rated, noted as a possible safety hazard, suggest further review with a specialist.</b>

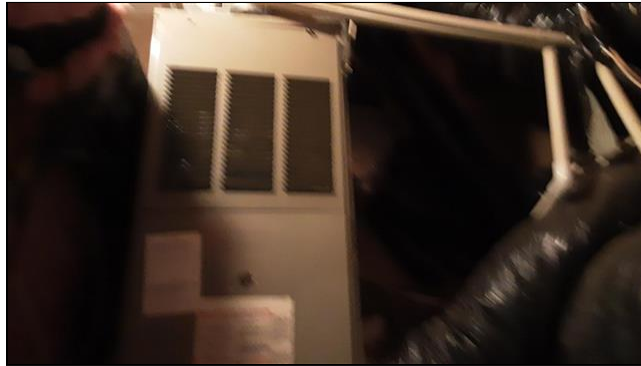
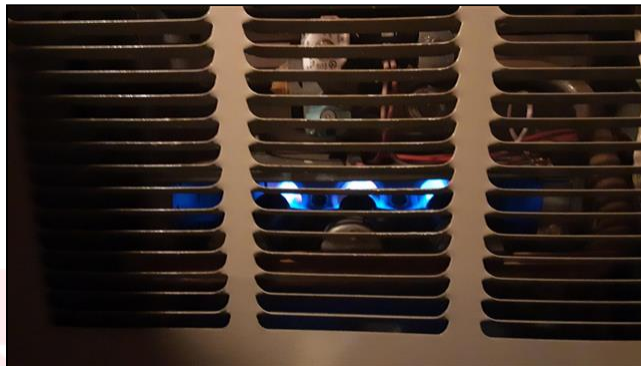
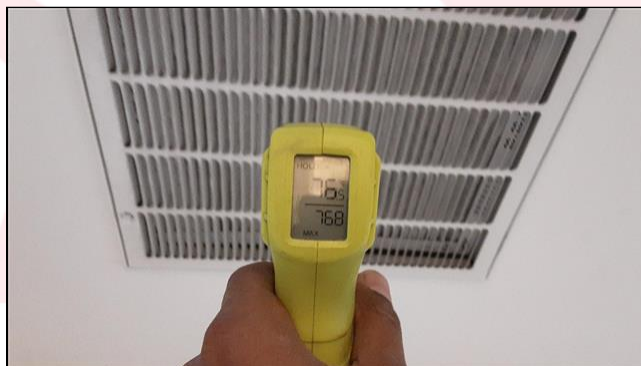
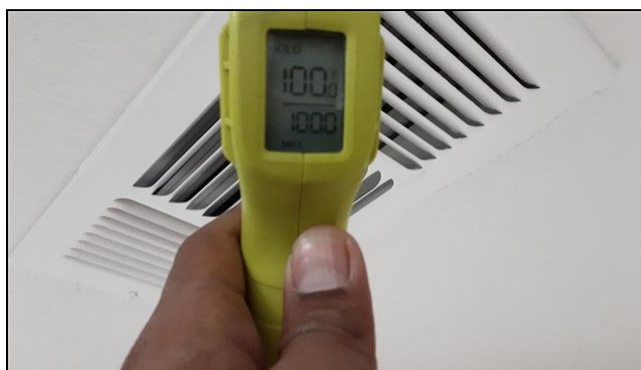
6.0 Heating

Unit is operable.

76 ° noted at the intake; 100 ° noted at the register, unit is heating within guidelines.

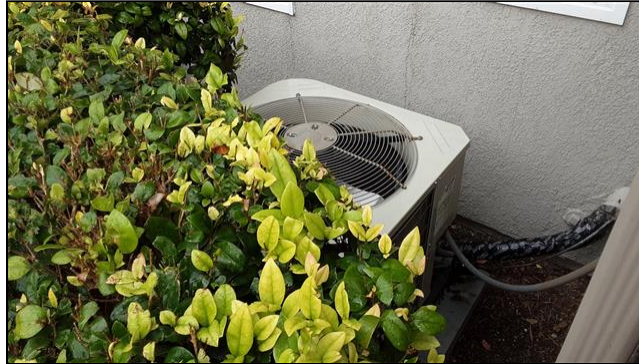
Condition:. Compressor is located in the front.

**Deteriorated fins noted.**

**Rusted fins noted.**

**Unable to fully inspect the compressor, blocked by vegetation.**

**As most manufacturers warn against operating air conditioning units when the outside temperature is less than 60 degrees, this unit was not tested. Client is advised to verify operation of the unit prior to close.**

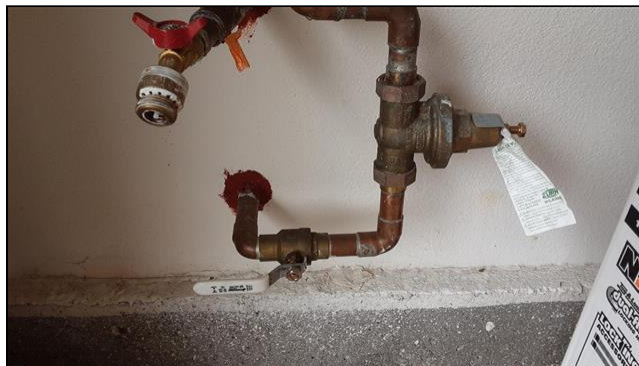
| 7.0 | Main Shut-off | <b>Main shut-off is located in the garage.</b> |

**The main water shut-off was not tested. These can fail at any time due to non-use and corrosion.**

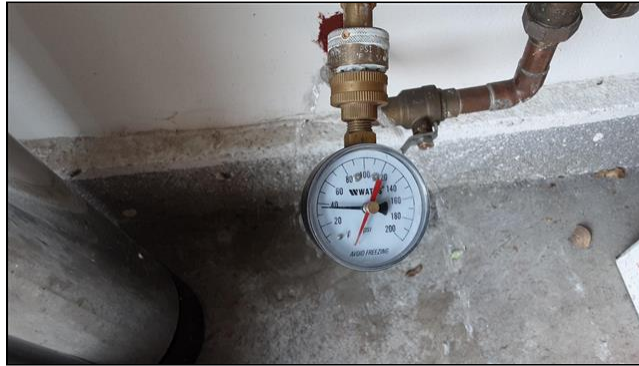
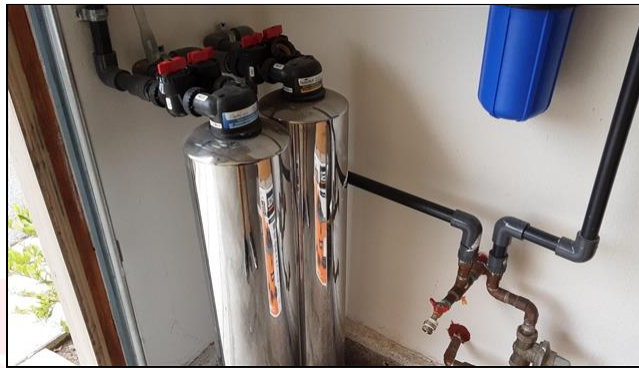
7.2 Other Comments **Pressure regulator and 40 psi noted. Water softener noted, not tested as it is beyond the scope of this inspection.**

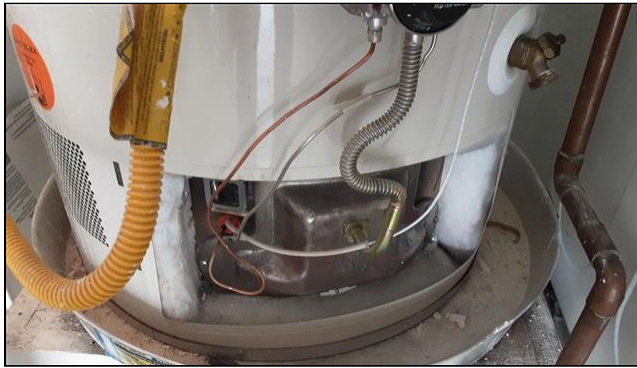
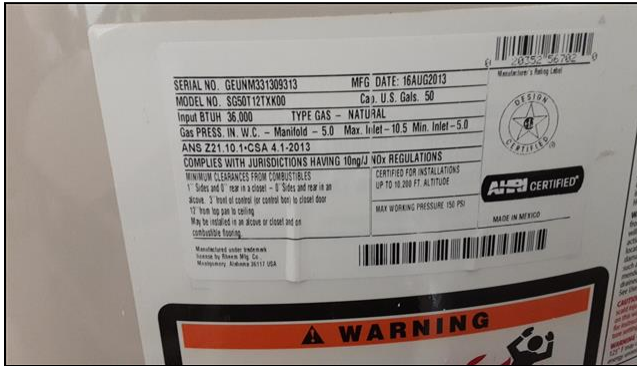
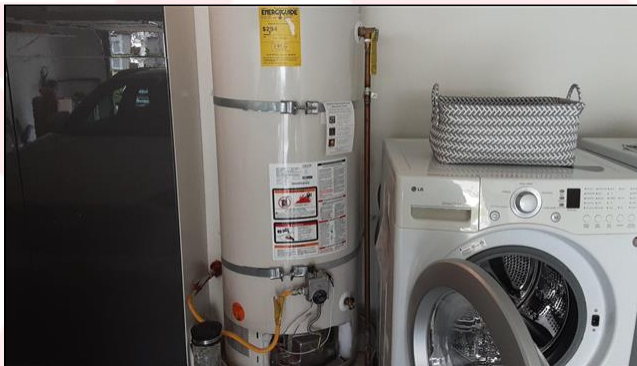
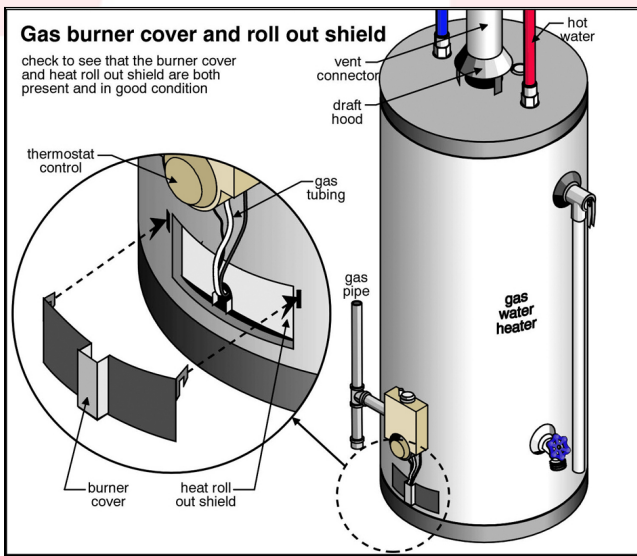
BURNER AREA

Outer burner door is not present. Manufactured August 2013.

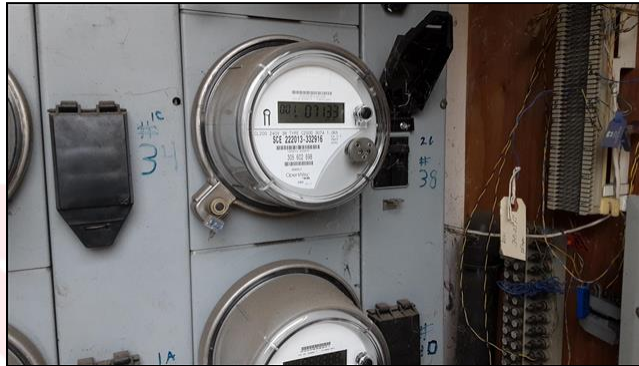
Step #	Component	Comment
9.0	Service Entrance	<b>Service entrance is underground.</b>

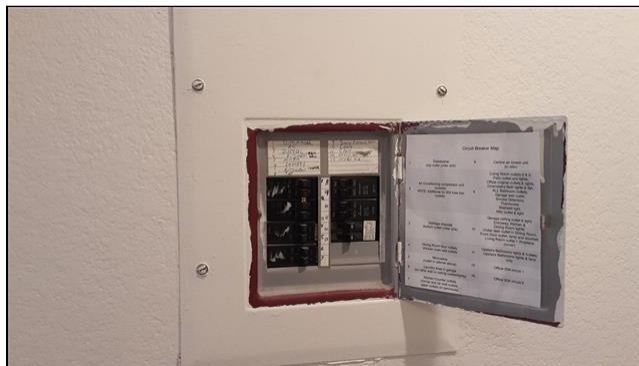
9.2	Sub Panel	<b>Sub panel is located in the hall.</b>
-----	-----------	--

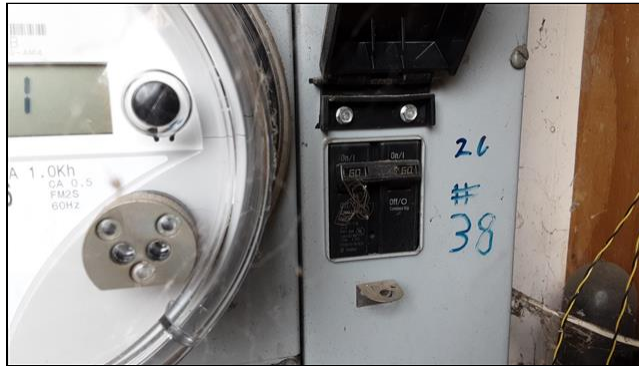
9.4 Main Disconnect

**Main disconnect noted.**

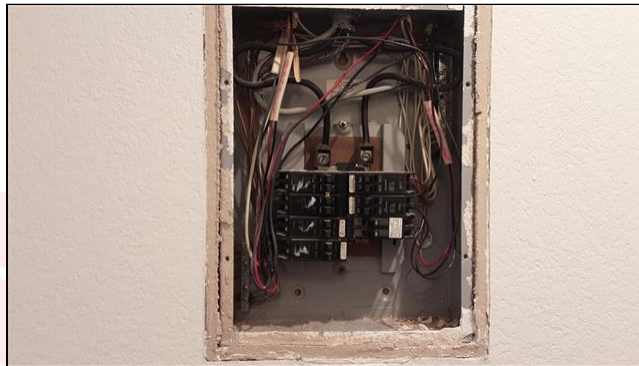
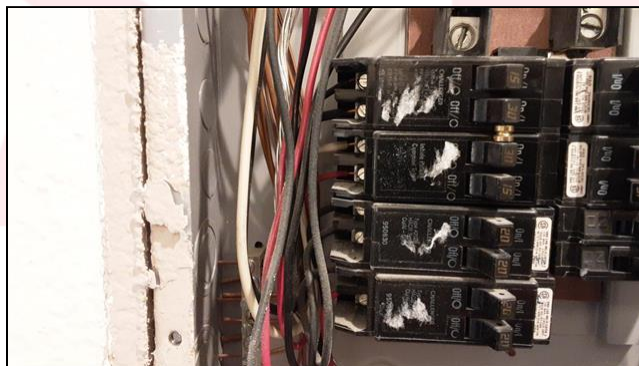
9.5 Wiring

**Condition: Low branch circuit wiring is copper.****A white wire is used as a positive wire to a breaker; unable to determine if permitted.**

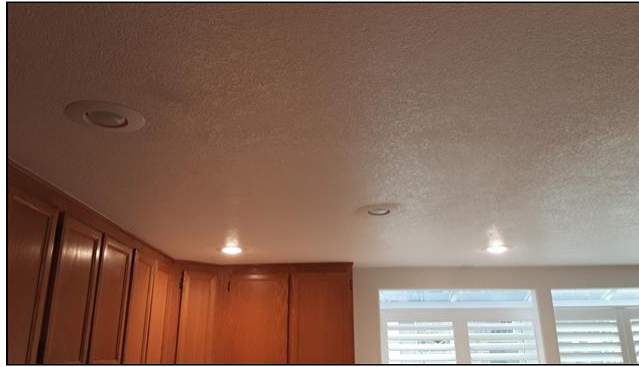
- 12.8 Electrical **Condition: Ground fault circuit interrupter is provided for safety. We suggest periodic testing to ensure proper working order. Inoperable lights noted.**
