### Inspection/Certification

Date of Inspection: **2/5/25** Property Owner: **Casa Medical Marketing LLC**  
Inspection Address: **390 San Marcos Rd, Paso Robles Ca 93446**  
Realtor/Finance Company: **Clint Kuhnle**  
Title Company: **N/A**

Date of Inspection: **2/5/25** Property Owner: **Casa Medical Marketing LLC**  
Inspection Address: **380 San Marcos Rd, Paso Robles Ca 93446**  
Realtor/Finance Company: **Clint Kuhnle**  
Title Company: **N/A**

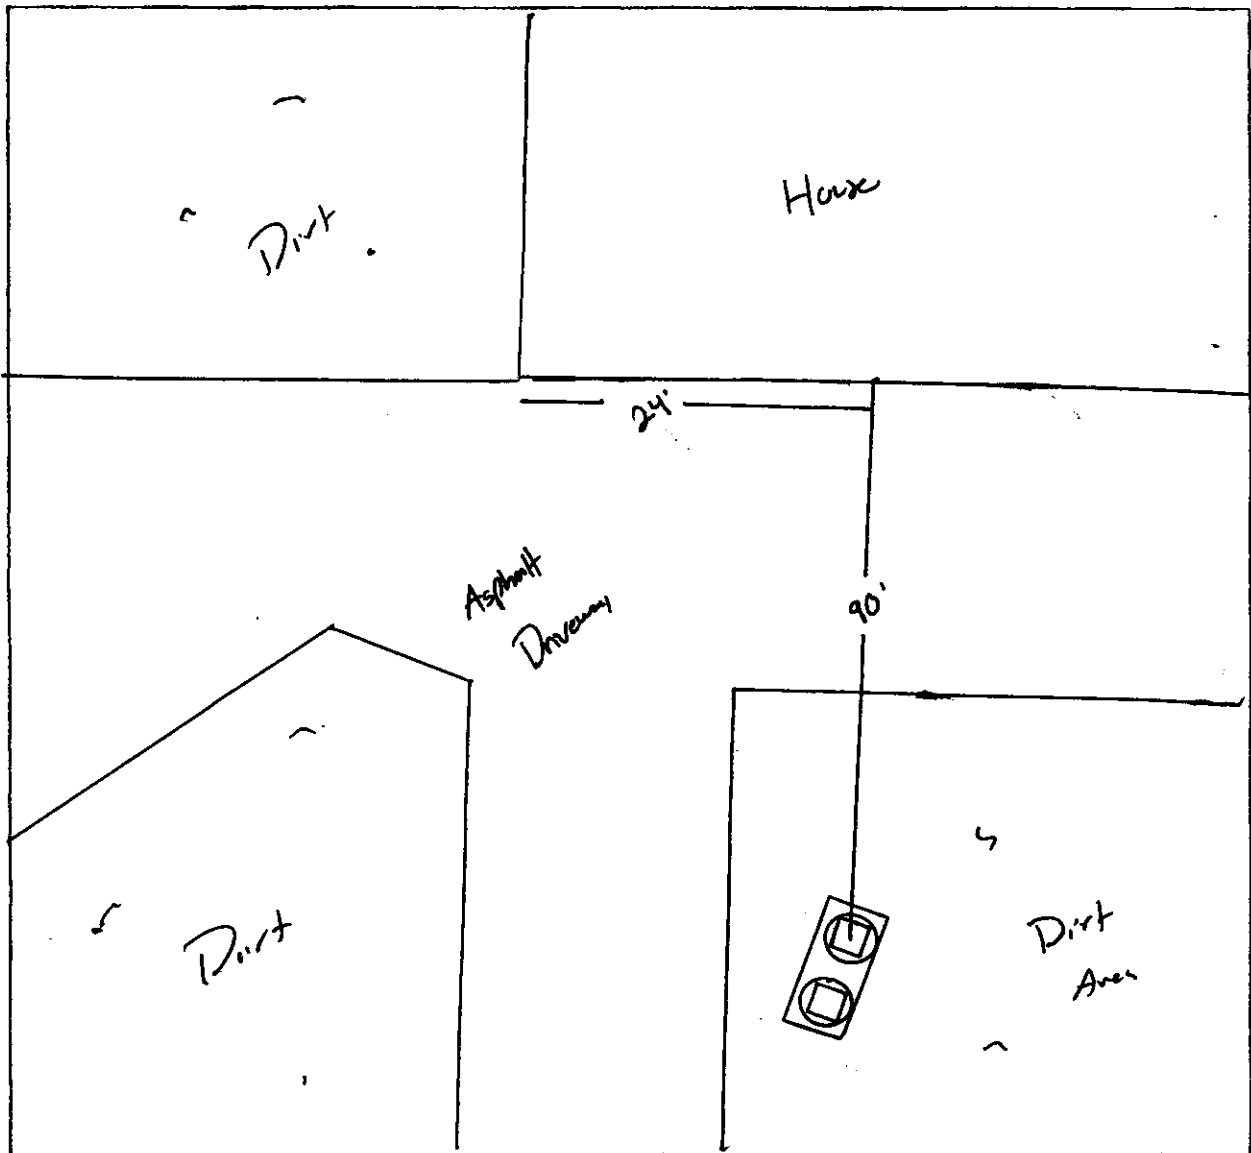
Comments: 1500 gal conc tank

☒ Full Diameter Access Risers to Grade

Depth From Top of Tank to Grade P:26 S:16

Distance to wellhead 100+

Clean Out Present ☒

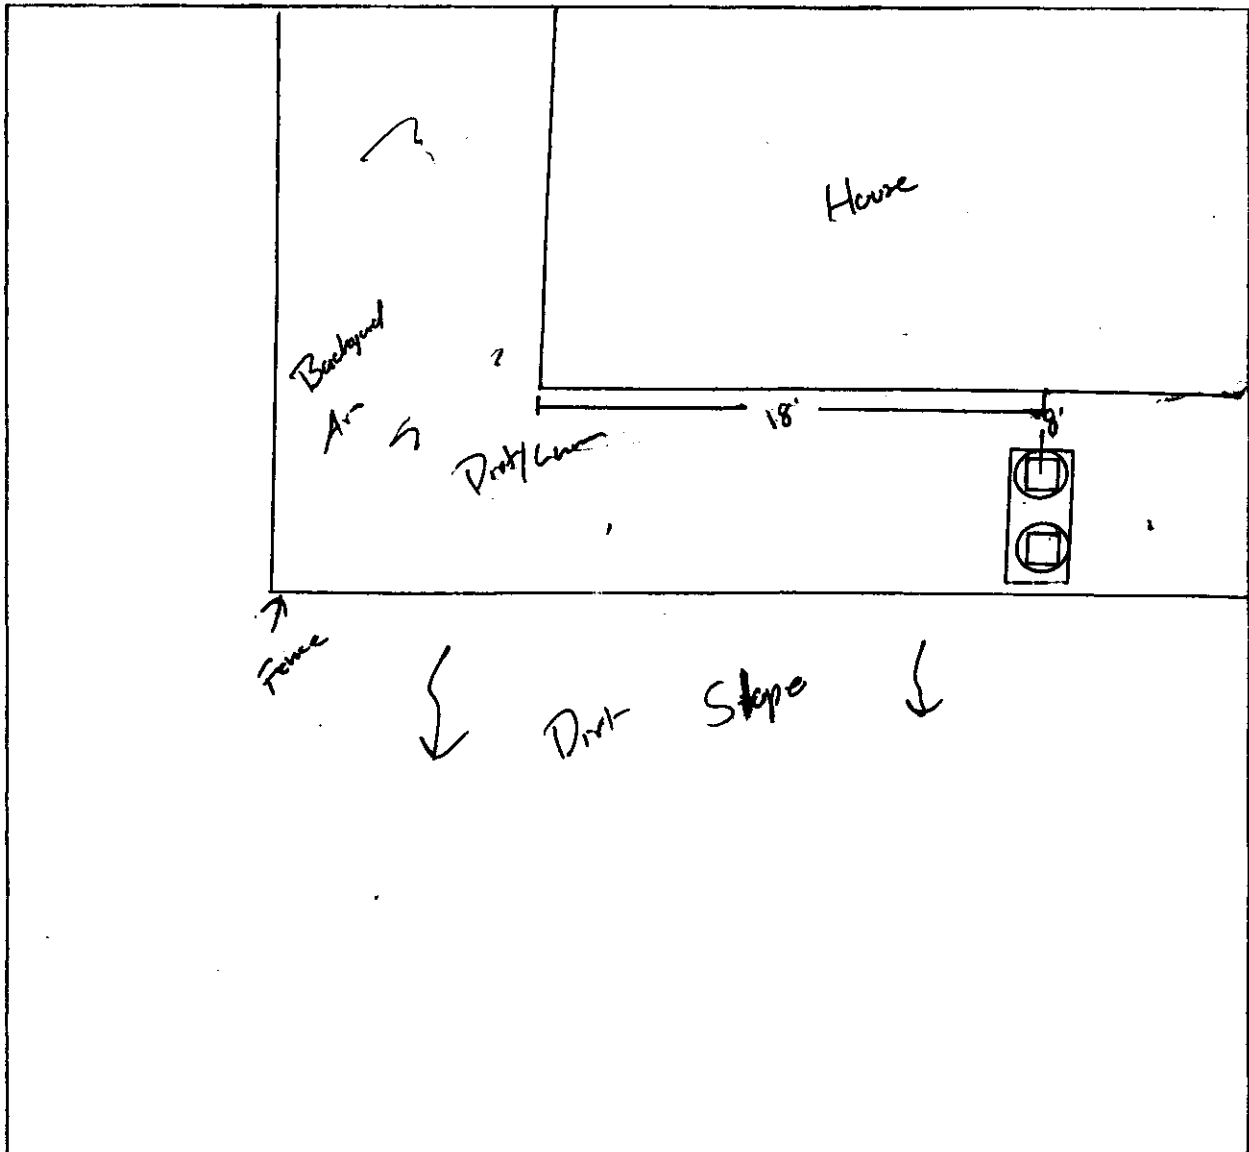
Comments: **The septic tank has a large number of roots in both the primary and secondary chambers. The septic tank sludge was unable to be cleaned out in its entirety due to the roots. Will need to pump the tank again to remove the roots and get the remaining sludge removed.**

Comments: 1200 gal Cess tank w/ Primary Lid 6" below  
grade

Depth From Top of Tank to Grade 18"

Distance to wellhead 100' +

Clean Out Present ✓

X: It is my opinion that, as of now, the septic system is NOT in good working order and will NOT function properly without the following repairs: **Remove roots and re-pump septic tank to remove the remaining sludge. (See attached proposal)**
