# Inspection Report

**Property Address:**  
3335 Broad St 12  
San Luis Obispo CA 93401

7/28/2025

**Harper Homes: Home Inspection Services**

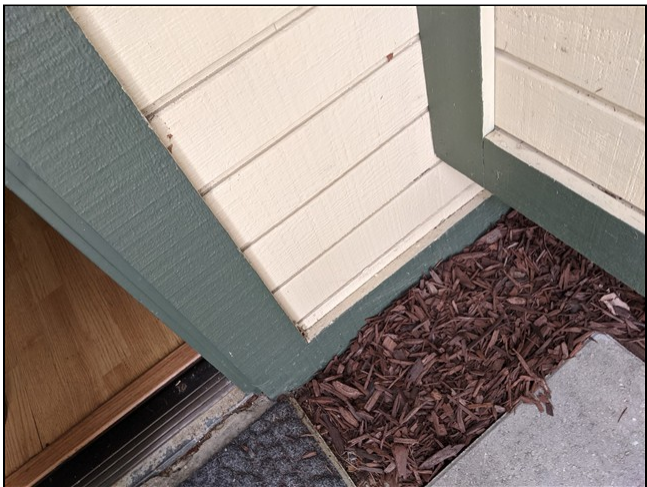
1.0 Item 1(Picture)

Soil or landscape materials pushed up against the wood siding at the front exterior. No moisture damage was noted. Refer to the pest report for more information on this condition and have material removed to prevent earth to wood contact while allowing drainage to remain effective.

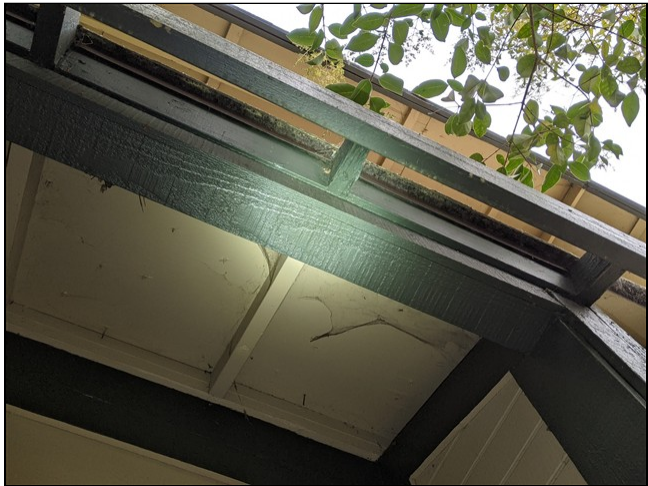
2.0 Item 1(Picture)

Moisture damage noted at the end of the rafters extending from the roofing at the left exterior. Refer to the pest report for further details and make repairs as prescribed.

(1) REPAIR NEEDED  
Moisture damage noted at the end of the rafters extending from the roofing at the left exterior. Refer to the pest report for further details and make repairs as prescribed.

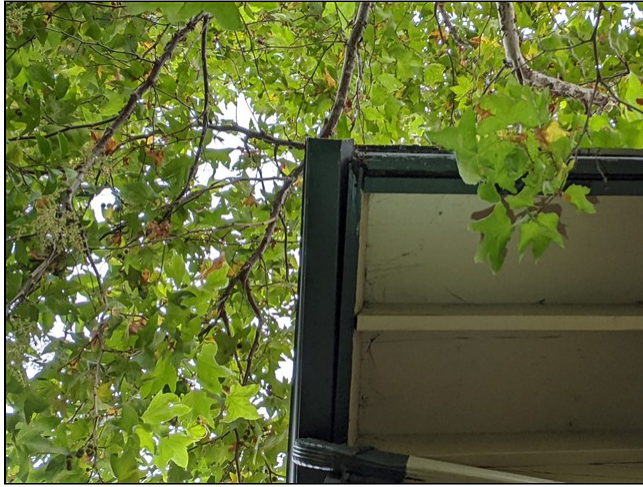
2.0 Item 2(Picture)

Leaves and debris need removed from the roof and an annual maintenance routine established. The trees need trimmed back to prevent contact with the roof and limit the amount of seasonal debris.

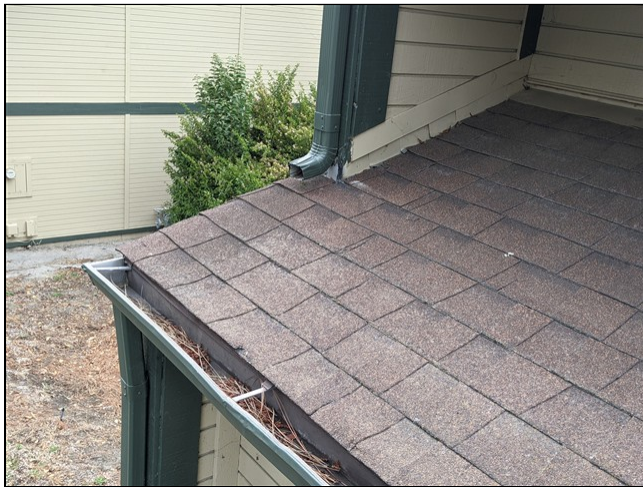
2.0 Item 3(Picture)

Damaged shingles noted at the front exterior and need repaired to prevent weather exposure to the roofing materials and further deterioration in this area.

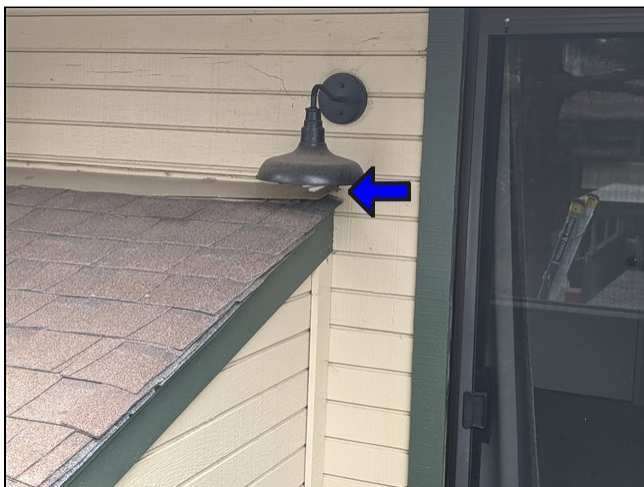
2.1 Item 1(Picture)

Metal roof flashing is lifting at the front exterior allowing possible moisture intrusion. Recommend all flashings be secured or altered as needed.

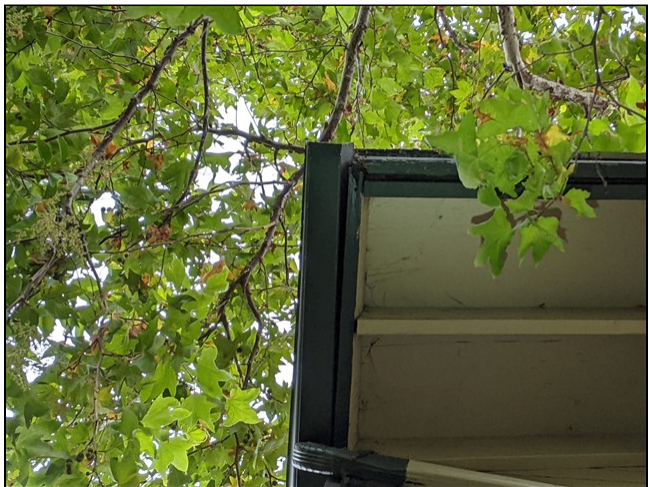
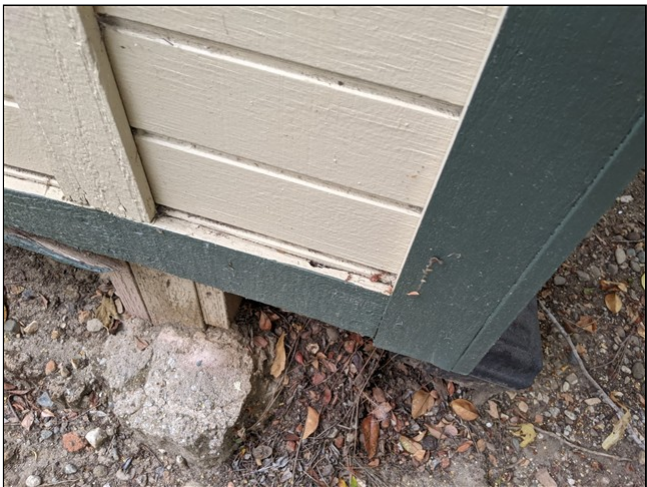
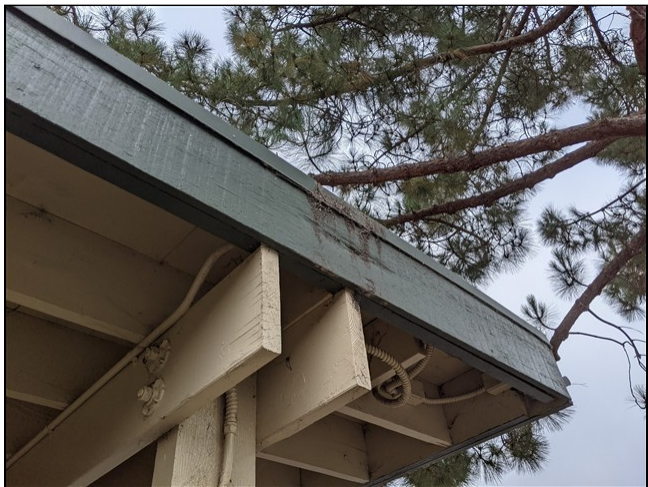
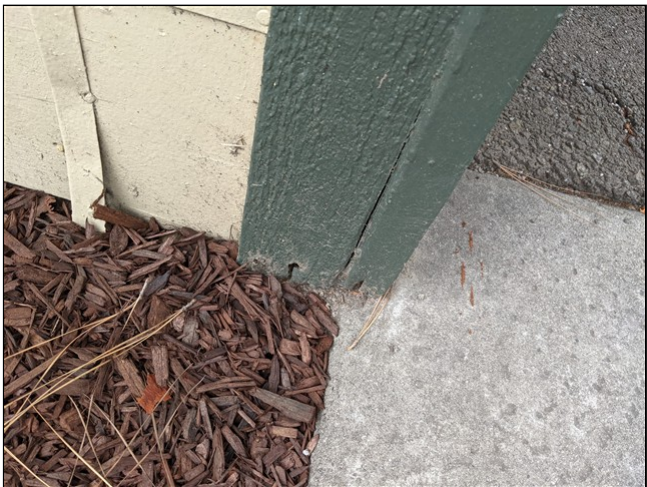
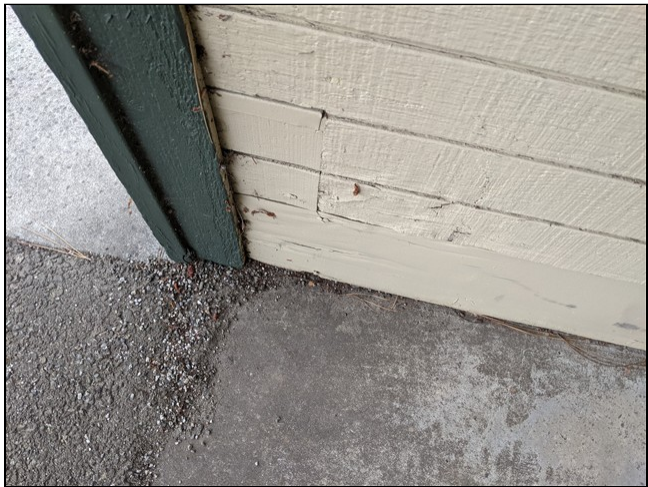
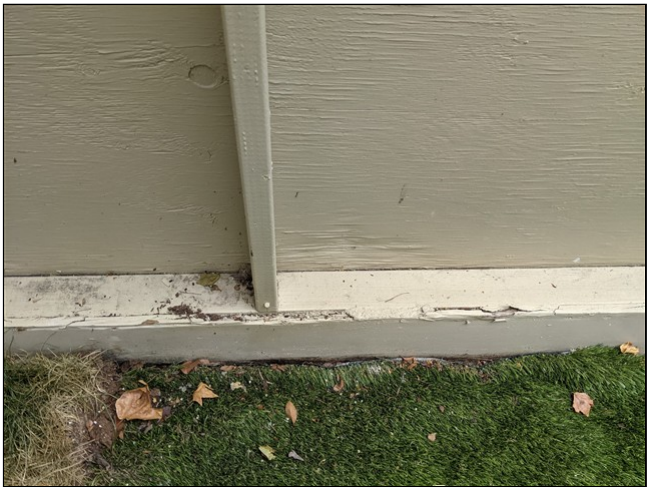
Moisture damage noted at the trim, fascia and siding. Recommend further evaluation by a structural pest control operator and make repairs as prescribed.

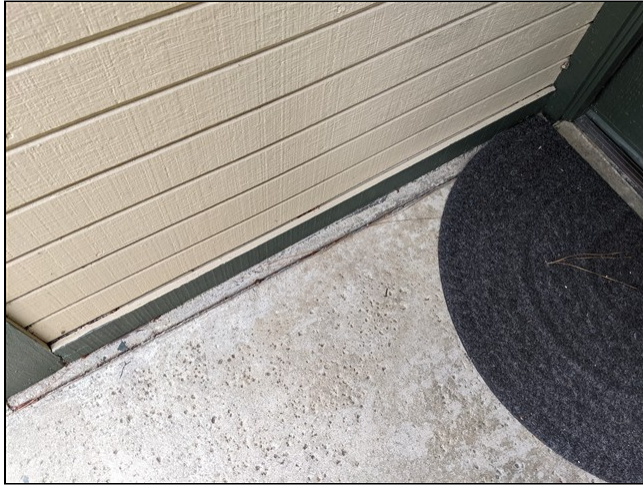
2.4 Item 7(Picture)

Siding and trim is in contact with concrete noted at the front exterior. Recommend wood materials be cut back from contacting the concrete to help prevent further moisture intrusion.

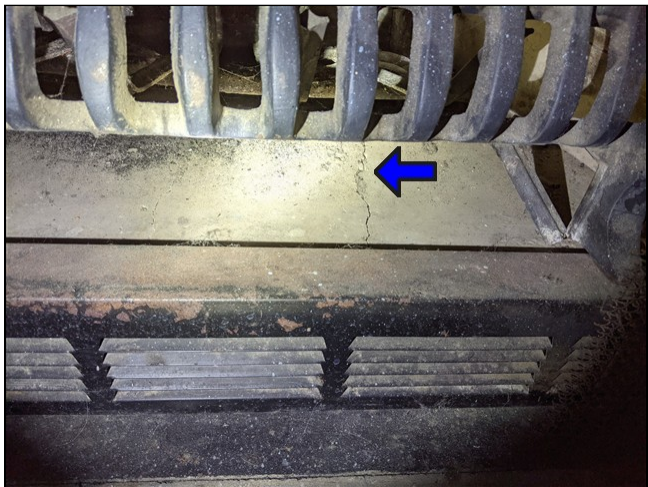
3.0 Item 1(Picture)

Fire-brick is cracked in the fireplace. Recommend further evaluation and repairs as needed by a qualified fireplace technician before further use.

(2) FURTHER EVALUATION  
Fire-brick is cracked in the fireplace. Recommend further evaluation and repairs as needed by a qualified fireplace technician before further use.

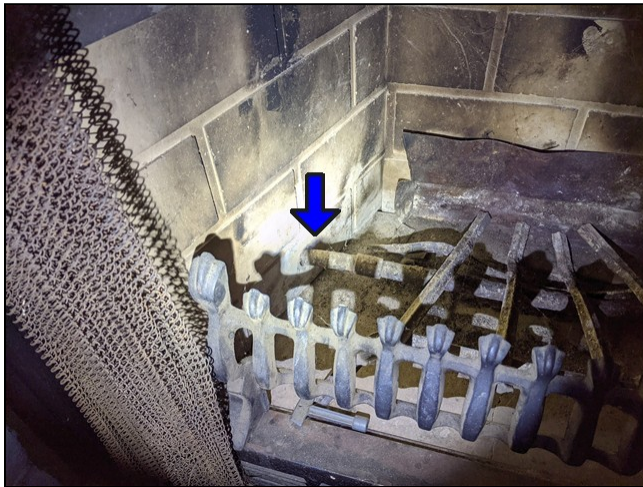
3.1 Item 1(Picture)

The penetration where the gas log lighter enters the fireplace needs to be sealed with fire rated sealant to ensure smoke and heat are properly contained to the fireplace.

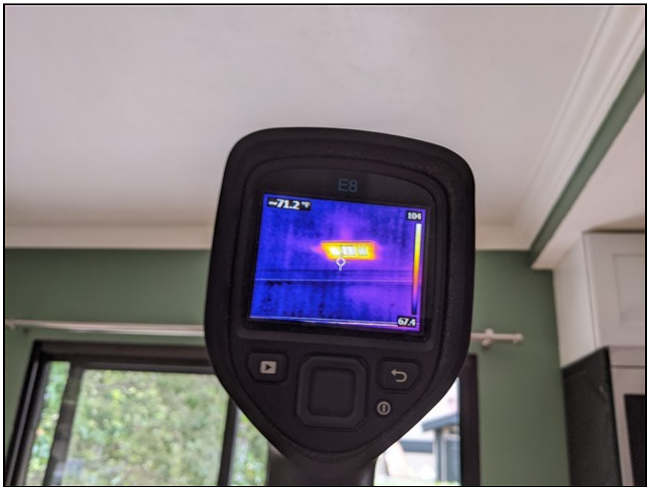
4.0 Item 1(Picture)

The furnace was tested and functional at the time of the inspection.

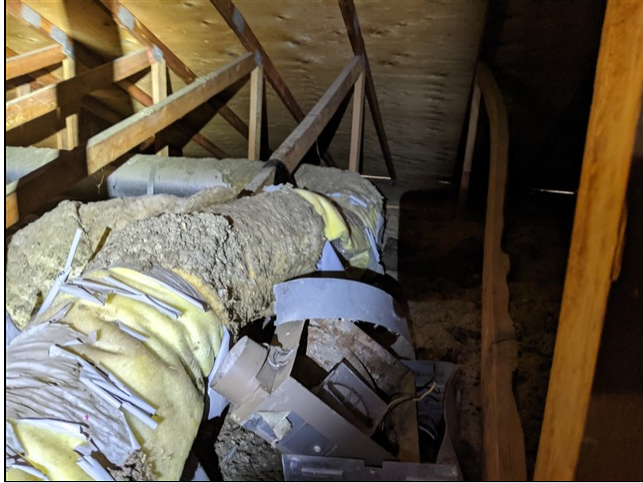
4.3 Item 1(Picture)

Ducting insulation damaged and missing at various areas in the attic. Recommend wrapping with new insulation where needed to help improve the efficiency of the HVAC system.

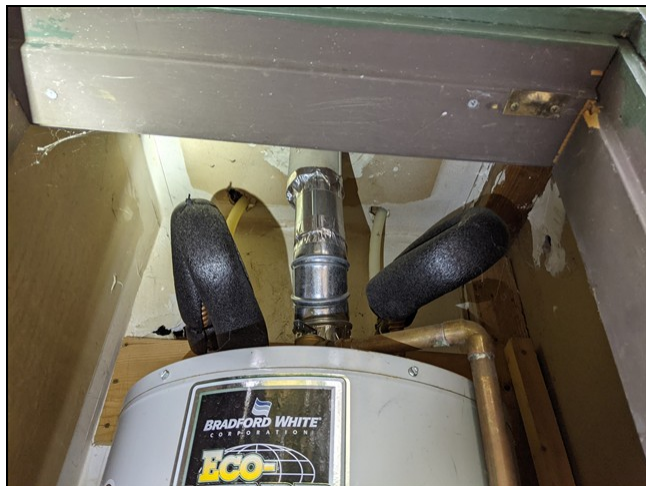
5.0 Item 1(Picture)

Foil tape was observed on the water heater vent, but it appears to have been improperly installed. Standard water heater venting typically requires mechanical fasteners and approved high-temperature sealants rather than foil tape alone. Evaluation and correction by a qualified plumbing or HVAC contractor is recommended to ensure safe and proper venting.

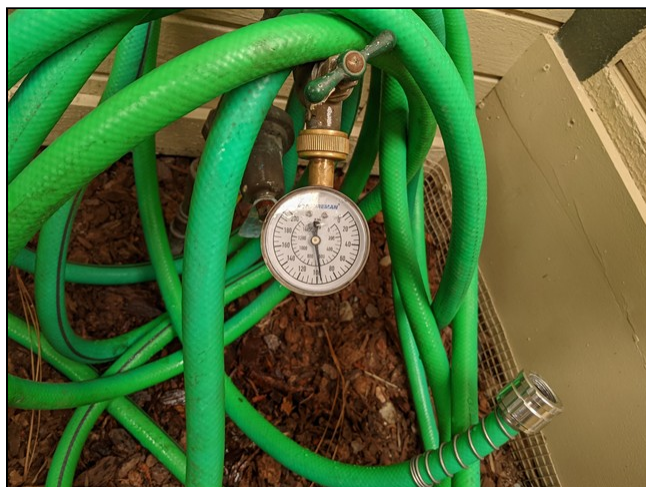
5.2 Item 1(Picture)

Water pressure noted at 95 PSI, higher than acceptable. Recommend adjustment or repair/replacement of the pressure regulator to prevent excessive wear on the plumbing valves, lines, and fixtures. Recommend 80 PSI max.

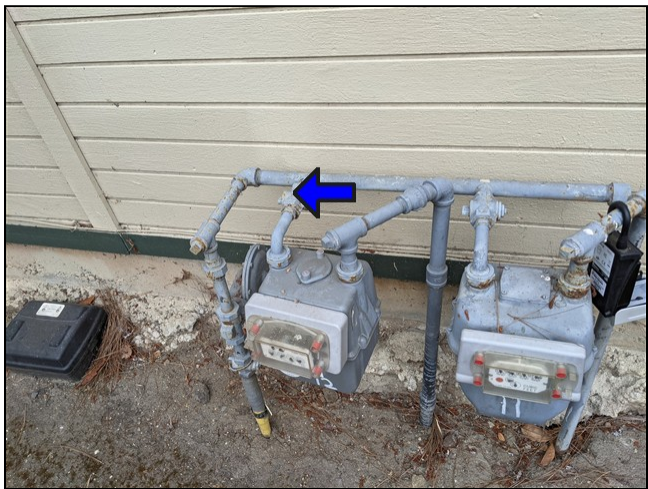
5.3 Item 1(Picture)

The gas shutoff is located at the left exterior of the home. To turn the gas off turn the valve perpendicular to the piping.

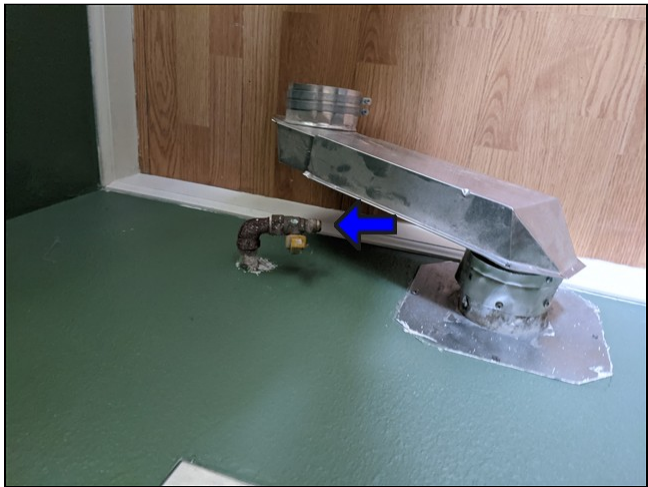
5.3 Item 2(Picture)

Cap needed on the gas valve at the laundry area and should remain in place until a gas appliance is connected in case of accidental opening of the valve.

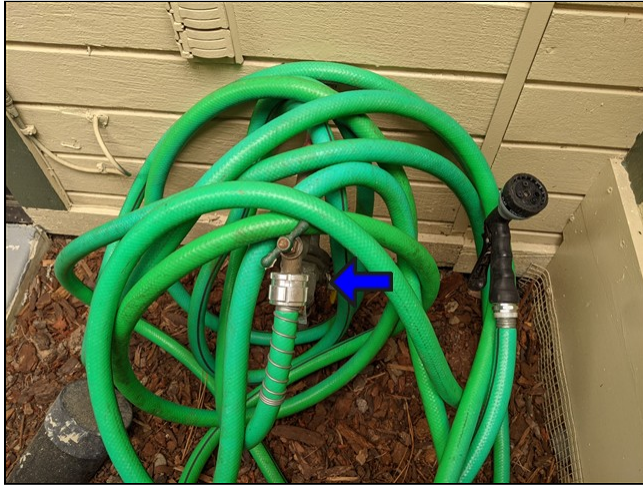
5.4 Item 1(Picture)

The water shutoff is located at the front exterior of the home. To turn the water off turn the handle perpendicular to the piping.

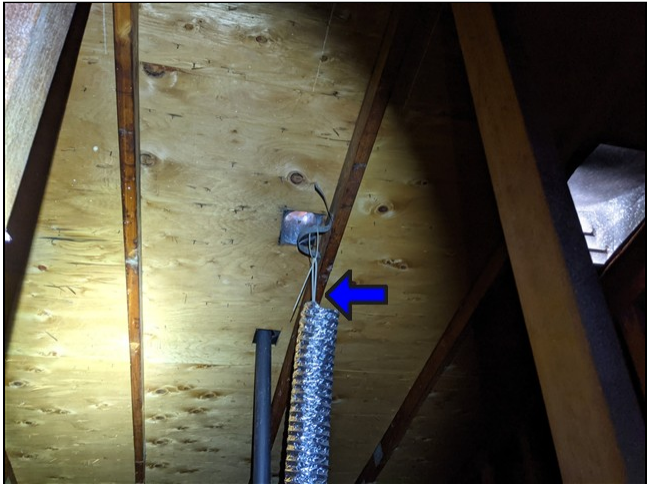
7.4.A Item 1(Picture)

Exhaust fan terminates in the attic space and should be extended out to a proper screen covered vent terminal location. This will prevent moist air exposure in the attic.

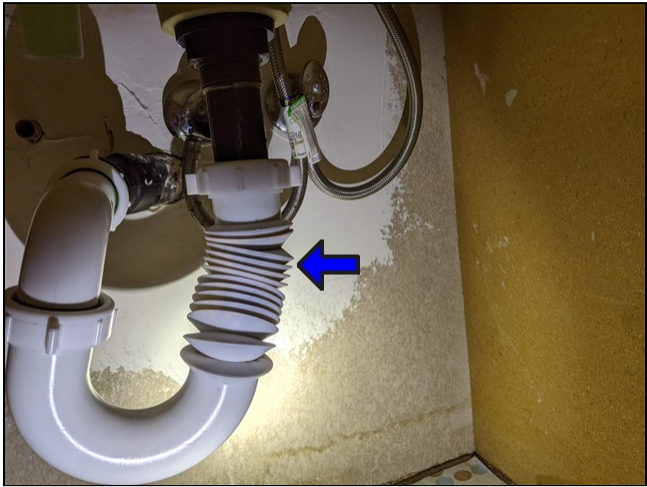
7.1.B Item 1(Picture)

REPAIR NEEDED  
Flex drain line utilized in the drain system under the sink. Recommend proper drain parts and methods utilized to prevent unnecessary clogging or displacement and leaks in the drain line.

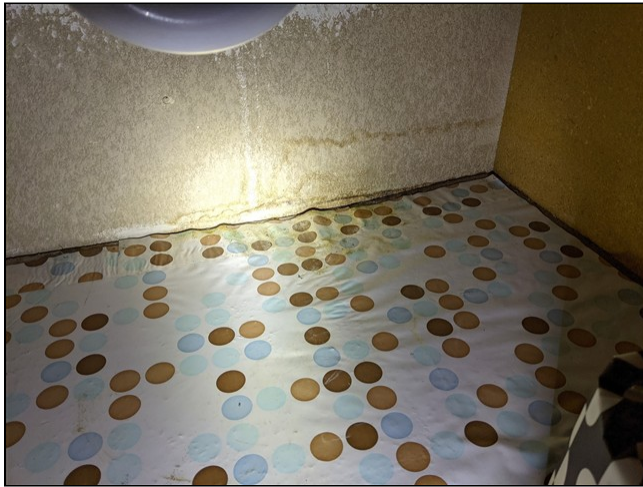
7.2.B Item 1(Picture)

Slight moisture damage noted to the cabinet under the sink. No leaks noted at the time of inspection. Cosmetic repairs can be made as needed.

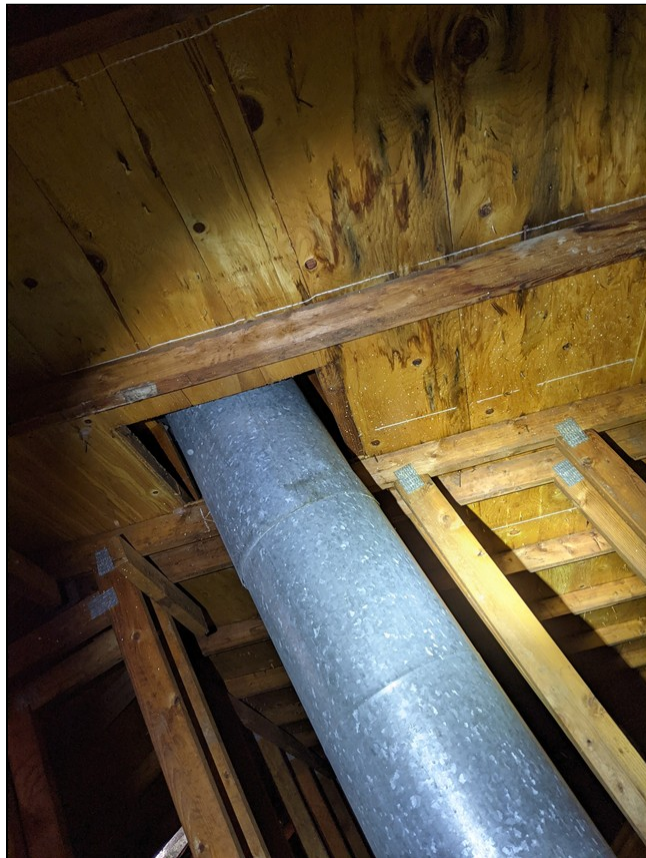
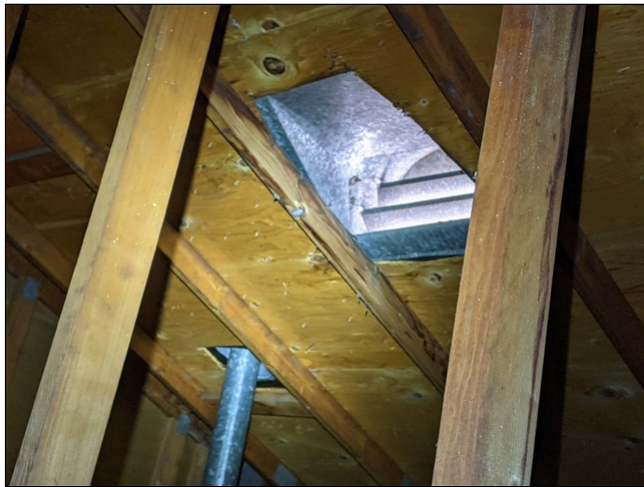
Moisture stains noted on the roof sheathing and framing. No current moisture was present. Recommend further evaluation as needed.

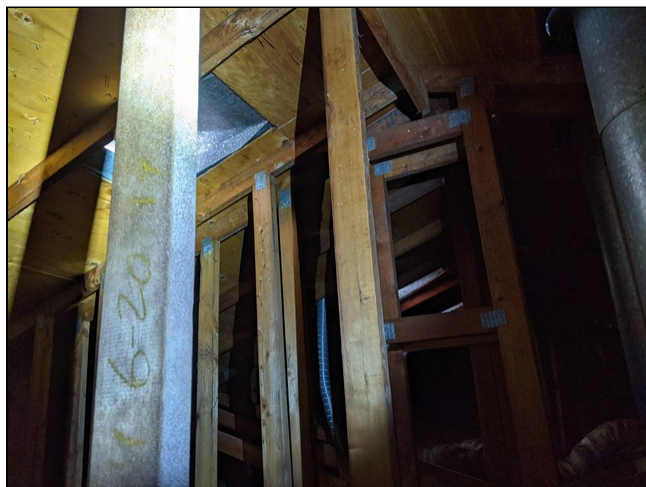
10.2 Item 3(Picture)

Firewall separation is not installed in the attic between units. While this may not have been required at the time of construction, installation of a proper firewall would significantly improve the safety of the building.
