Superior Home Inspections

Inspection reference: 2885

Confidential Inspection Report

201 E Platt St

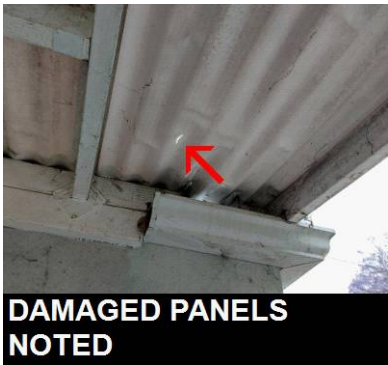
P1

Attention Needed - The patio cover needs repair to function properly. Damaged patio cover panels noted. Please see additional pictures.

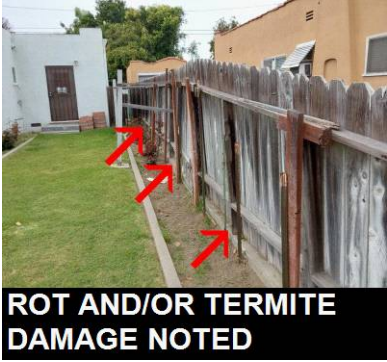
P4

Action Necessary - The fencing is not performing its intended function. Repair or replacement is suggested. The wood fence located on the East and North sides of the house is in a condition that warrants replacement. Please note that this is a common wall and typically the repairs expenses can be split between the two neighbors. See additional pictures.

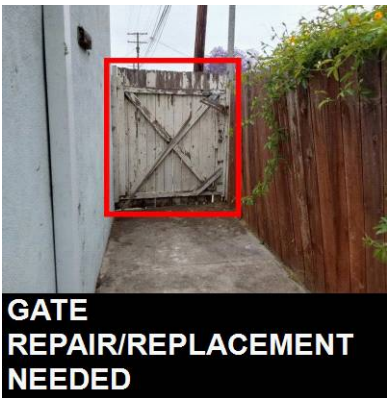
P9

Action Necessary - The gate is not functional or is deteriorated to the degree that replacement is indicated.

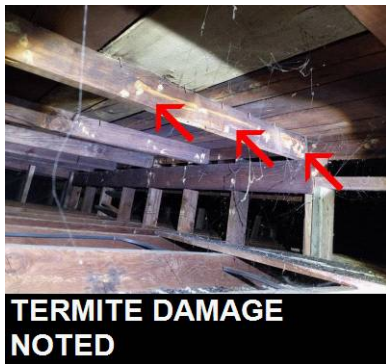
P11

Action Necessary - A condition exists that calls for repairs. Termite damage noted on one of the roof rafters.

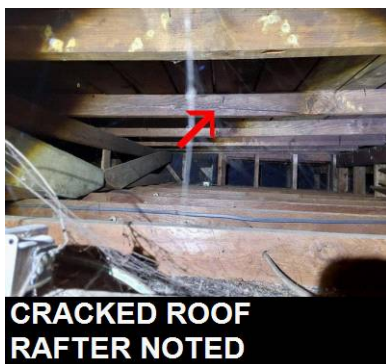
P12

A cracked roof rafter was noted, we are suggesting to have the roof rafter repaired/reinforced to prevent from further damage.

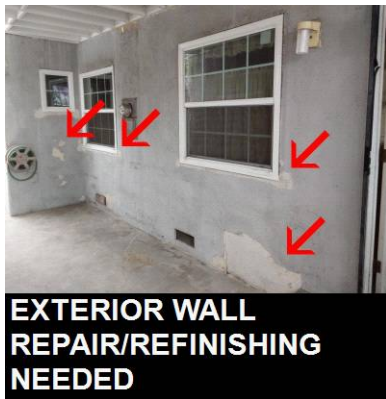
P13

Action Necessary - Some portion of the exterior siding material or finish is in a deteriorated condition that requires repair or replacement.

Flaking off stucco noted on several areas of the house, we are suggesting to have the noted areas

repaired/refinished to prevent from further deterioration.
Please note: These are cosmetic repairs and not a safety concern.
See additional pictures.

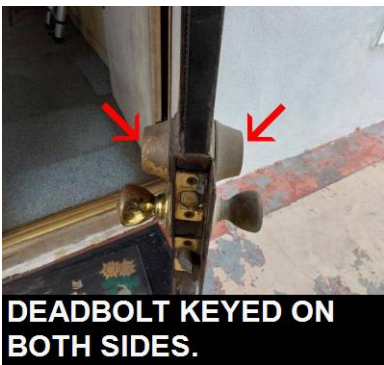
P20

Action Necessary - The outside entry door is in need of repair or replacement.

The deadbolt is keyed on both sides. This is a potential safety hazard if you need to exit the house quickly and there is no key readily available.

This conditions were noted on all of the exterior doors
See additional pictures.

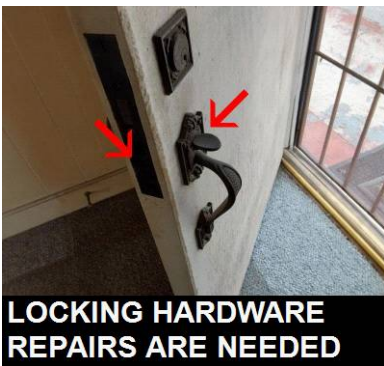
P21

The door locking hardware needs to be repaired/replaced.

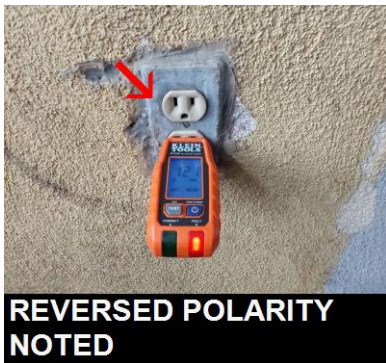
P28

Reverse polarity is noted,
This is the electrical outlet located on the exterior wall of the garage.

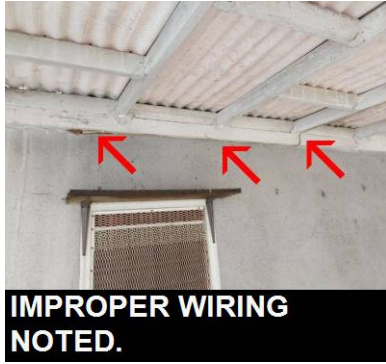
P29

Please note: The electrical wiring used for the patio cover is the wrong type wiring, Romex type wiring shouldn't be exposed or used outdoors.

The services of a qualified electrician may be needed to make the necessary repairs.

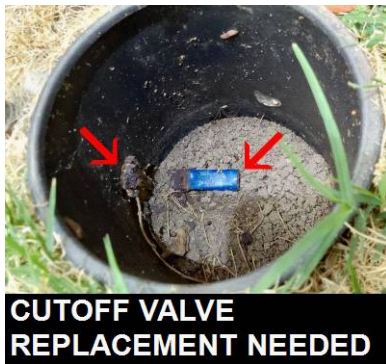
P30

Please note: The water shutoff valve handle is broken and needs to be replaced.

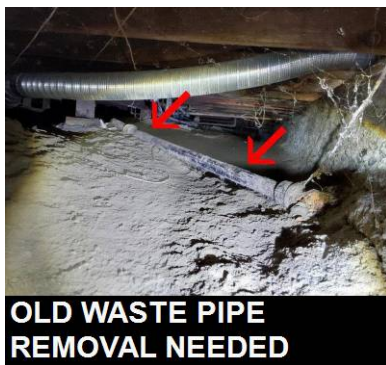
P31

Please note: The inspector noted that the old cast iron sewer pipes were replaced with plastic pipes and the old pipes were left behind in the crawlspace, the inspector is strongly suggesting to have the old pipes removed and properly dispose off.

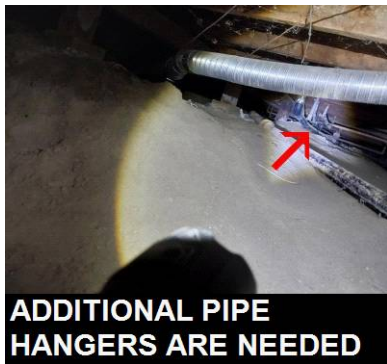
P34

Attention Needed - Of the existing support straps and hangers, at least one loose or broken support exists and needs to be repaired or replaced.

The sewer pipes need to have additional hangers needed, the inspector noted sagging on the pipes and is strongly suggesting to have additional hangers installed.

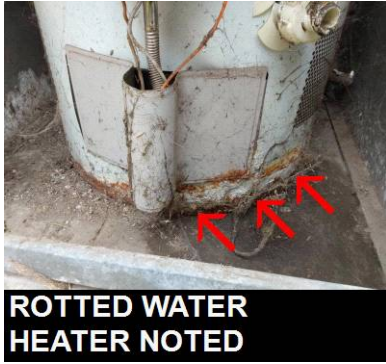
P35

Action Necessary - There is evidence of deterioration due to rust or leakage. Replacement is recommended.

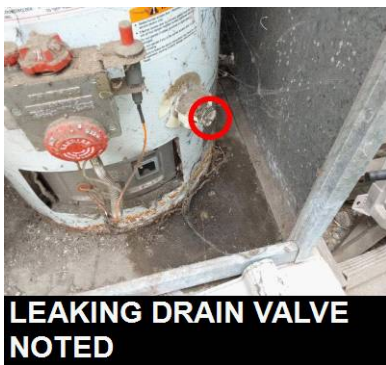
P37

Yes - There is a drain valve installed on the lower side of the water heater. Please note: The drain valve is leaking.

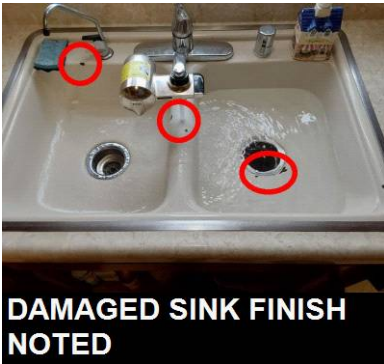
P39

Damaged sink finish noted.

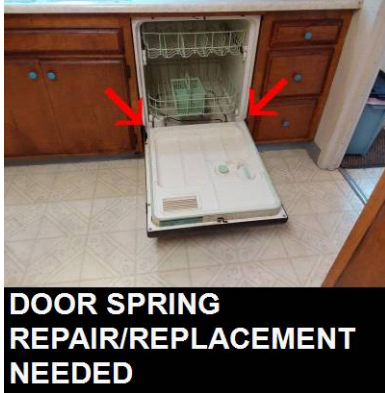
P41

The door springs need to be replaced.

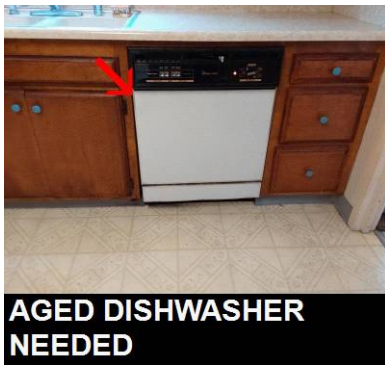
P42

Attention Needed - Although this unit was operational during the inspection, the age and/or condition is such that you may need to replace it in the near future.

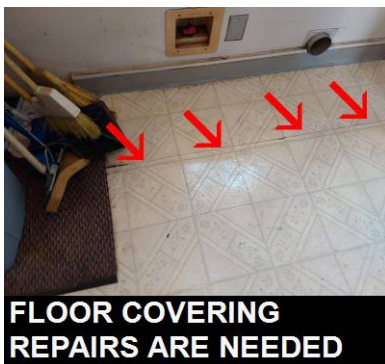
P43

Action Necessary - The floor in the laundry room needs some repair or replacement. The floor covering material is vinyl.

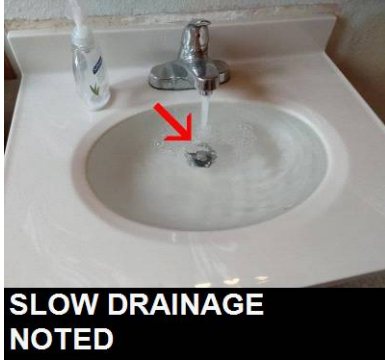
P44

Attention Needed - The basin or drainage fixture needs attention. The lavatory drains slowly. There may be some blockage either in the fixture or the drain line.

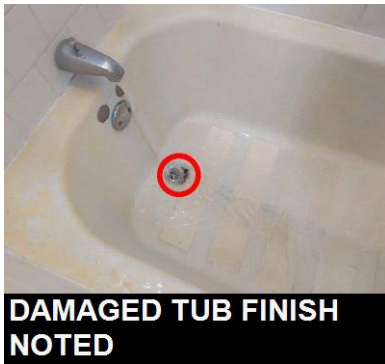
P46

Action Necessary - The finish on the bathtub is damaged. It is not a leak now. However, when the finish on a steel tub is damaged, it will eventually rust causing a leak. Repair of the damaged area can delay further deterioration.

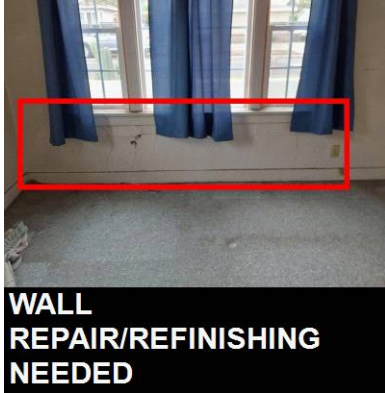
P47

Action Necessary - There is a condition in the wall sheeting that needs to be repaired.

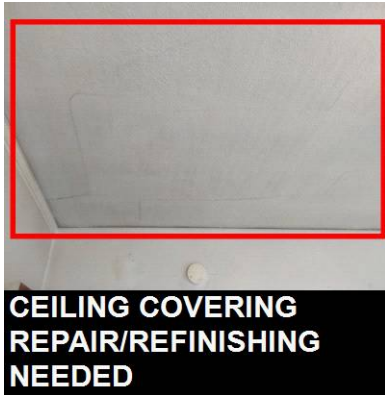
P48

Action Necessary - There is deterioration in the ceiling of this room that needs to be repaired.

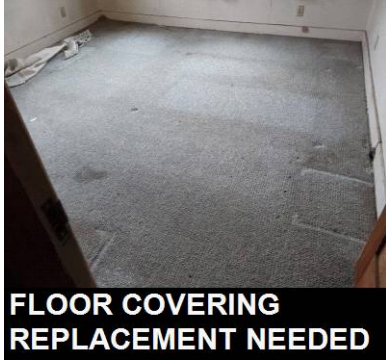
P50

The floors are in functional condition.
The floor covering is in a condition that warrants replacement.

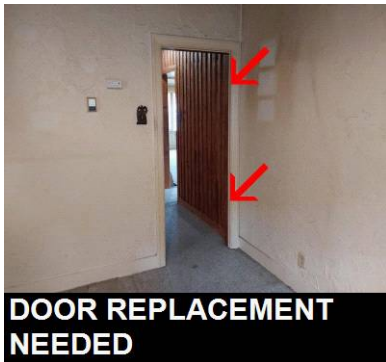
P51

Entry Door:
The door needs to be replaced.

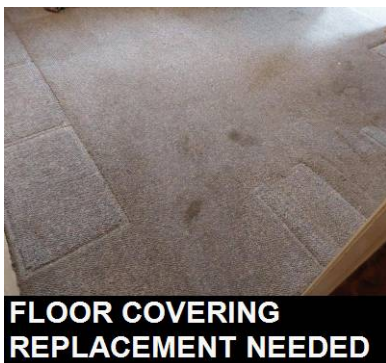
P52

Floor:
The floors are in functional condition.
The floor covering is in a condition that warrants replacement.

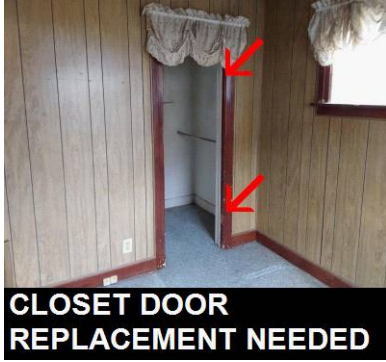
P53

Closet:
The closet door needs to be replaced.

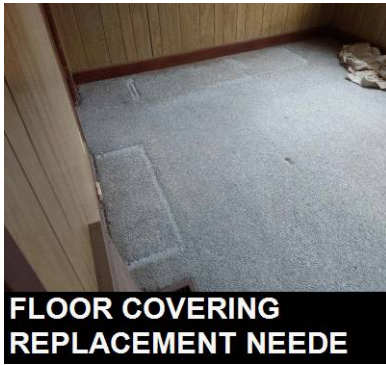
P54

The floors are in functional condition.
The floor covering is in a condition that warrants replacement.

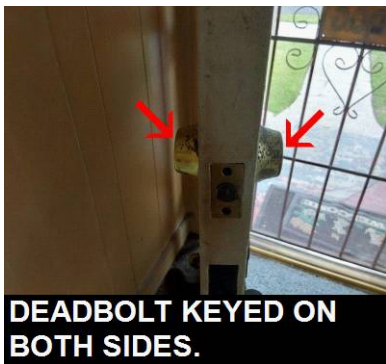
P55

There is a deadbolt installed on the main entry door, and it is operational. This is a recommended safety feature. The deadbolt is keyed on both sides. This is a potential safety hazard if you need to exit the house quickly and there is no key readily available.

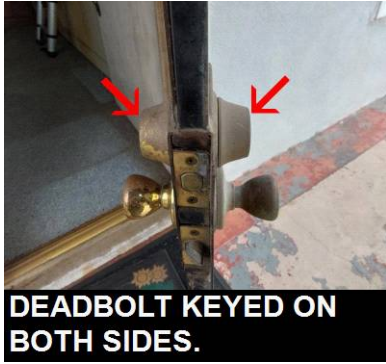
P56

The deadbolt is keyed on both sides. This is a potential safety hazard if you need to exit the house quickly and there is no key readily available.

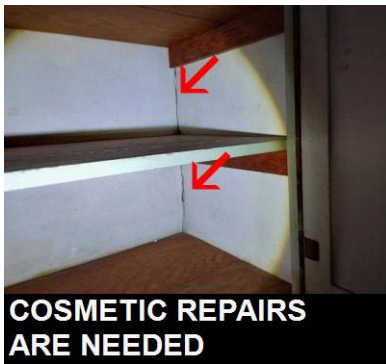
P57

Attention Needed - The linen closet walls need minor repair/refinishing.

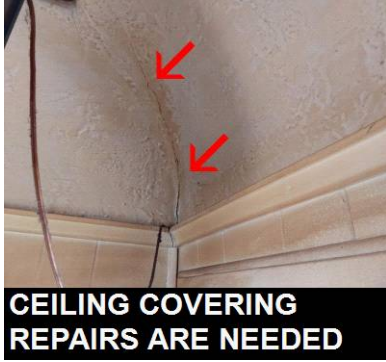
P59

Action Necessary - There is deterioration in the ceiling of this room that needs to be repaired.

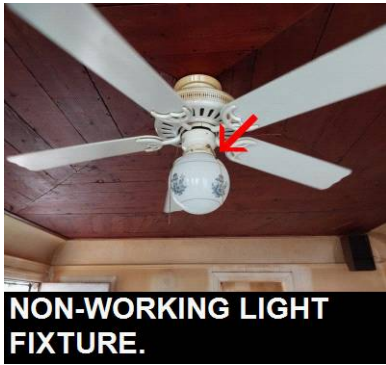
P60

The ceiling fan light was not functional at the time of the inspection. Repairs may be as simple as replacing the light bulb.

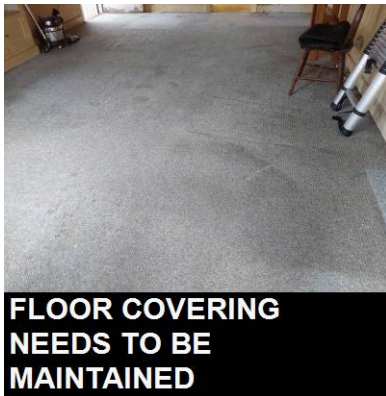
P61

The floors are in functional condition. The floor covering needs to be maintained.

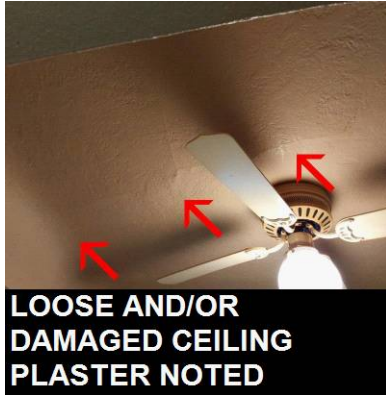
P62

Action Necessary - There is deterioration in the ceiling of this room that needs to be repaired.

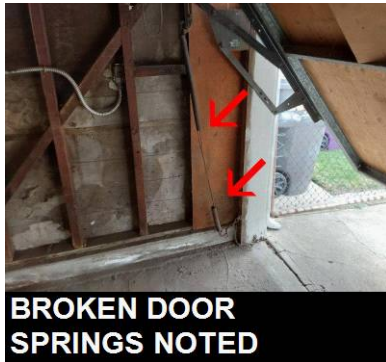
P63

Action Necessary - The overhead door needs repair or replacement. The overhead door springs or hardware needs some repair or replacement parts.

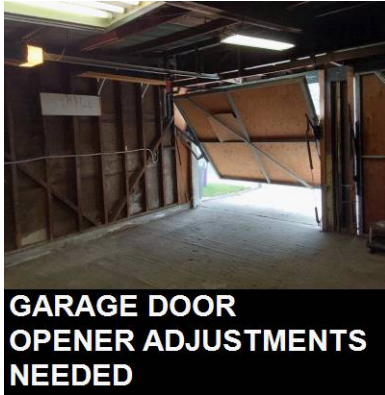
P65

The garage door opener needs to be properly adjusted, currently the door opener does not fully open as it is supposed to.

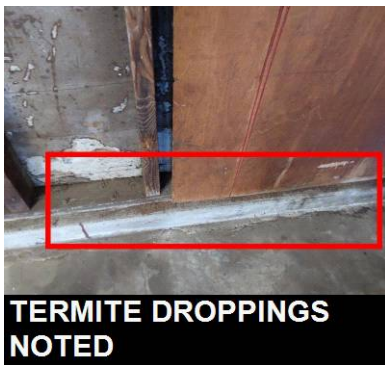
P66

The inspector noted evidence of termite damage and termite droppings on the garage walls. We are strongly suggesting to have the house inspected by a qualified termite inspection company. See additional picture.

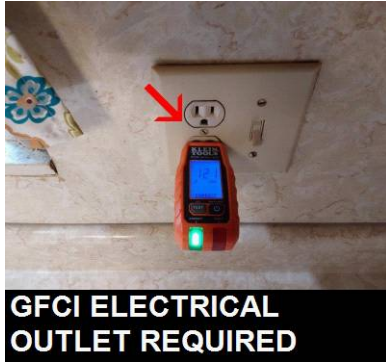
P68

The outlets tested in the kitchen are correctly wired and grounded. As a whole, outlets throughout the room are in serviceable condition. This kitchen does not have Ground Fault Circuit Interrupt outlets installed within 6 feet of water sources. The age of the structure may pre-date the required installation; however, for safety considerations, it is strongly suggested that one be installed at any location within 6 feet of a water source.

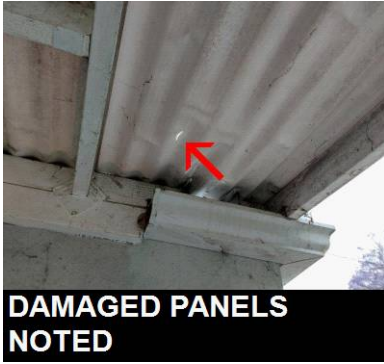
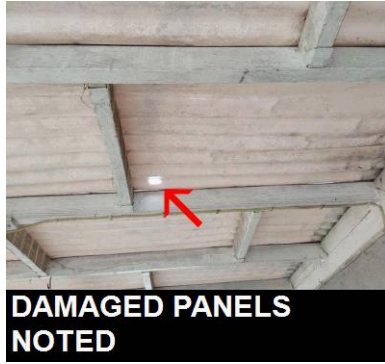
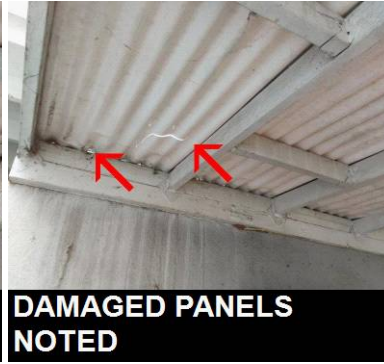
Attention Needed - The patio cover needs repair to function properly. Damaged patio cover panels noted. Please see additional pictures.

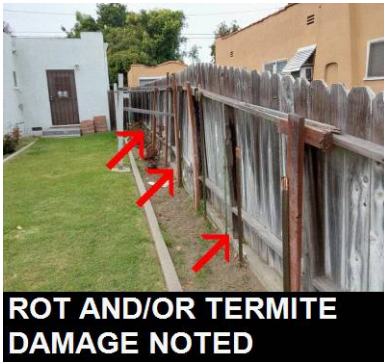
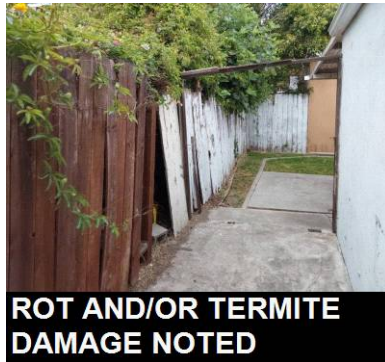
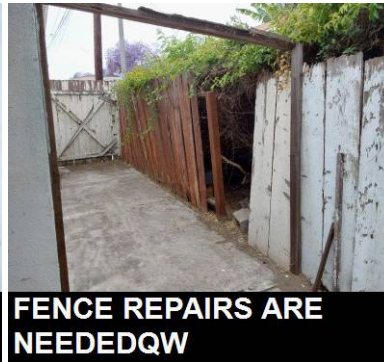
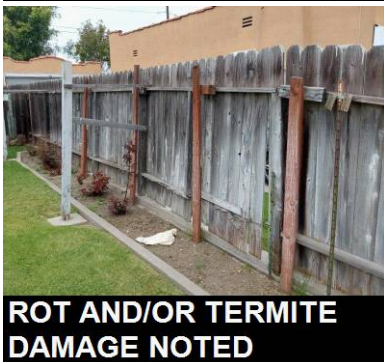
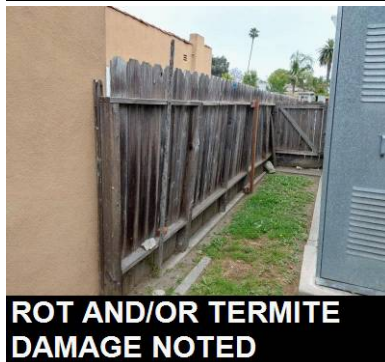
Action Necessary - The fencing is not performing its intended function. Repair or replacement is suggested. The wood fence located on the East and North sides of the house is in a condition that warrants replacement. Please note that this is a common wall and typically the repairs expenses can be split between the two neighbors. See additional pictures.

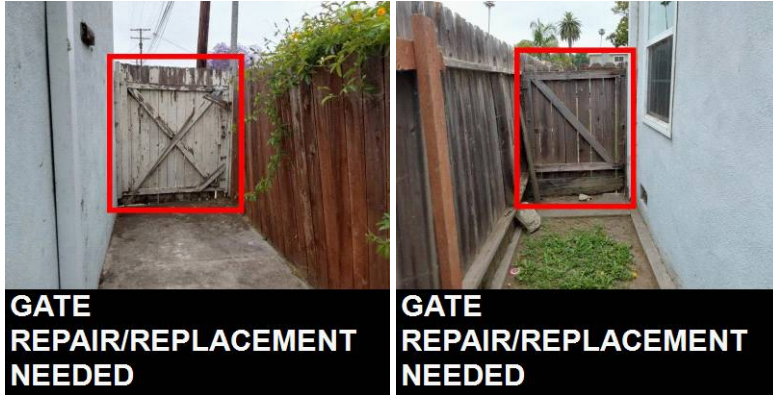
Action Necessary - The gate is not functional or is deteriorated to the degree that replacement is indicated.

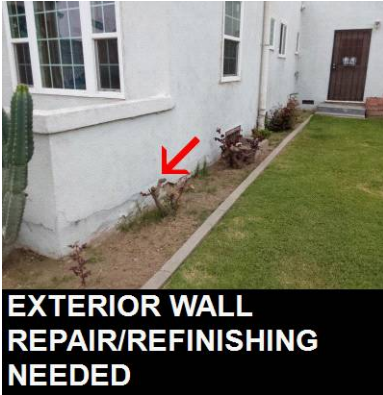
Action Necessary - Some portion of the exterior siding material or finish is in a deteriorated condition that requires repair or replacement.

Flaking off stucco noted on several areas of the house, we are suggesting to have the noted areas repaired/refinished to prevent from further deterioration.

Please note: These are cosmetic repairs and not a safety concern.

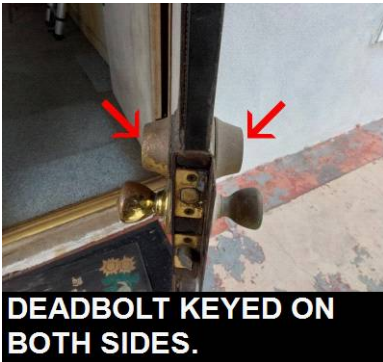
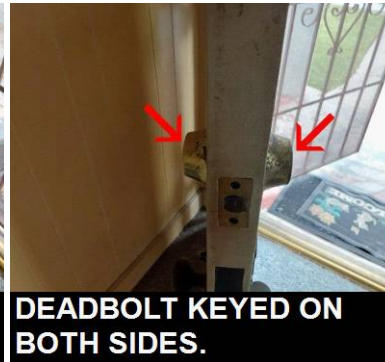
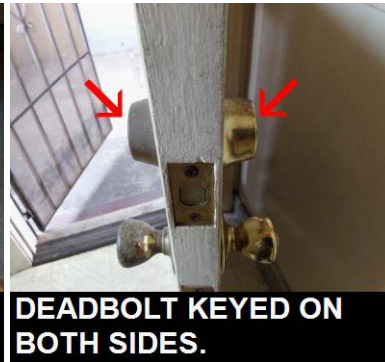
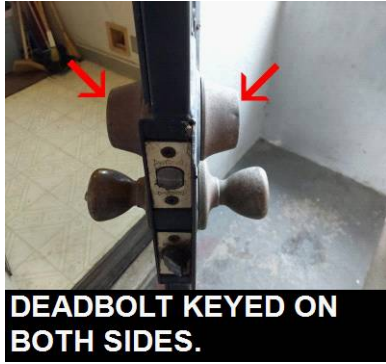
Action Necessary - The outside entry door is in need of repair or replacement.

The deadbolt is keyed on both sides. This is a potential safety hazard if you need to exit the house quickly and there is no key readily available.

This conditions were noted on all of the exterior doors
See additional pictures.

The door locking hardware needs to be repaired/replaced.

Rotted door noted, this is the exterior door located on the bedroom located on the Northeast corner of the house.

DEADBOLT KEYED ON BOTH SIDES.

ROTTED DOOR NOTED

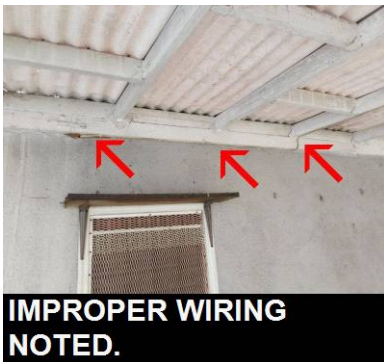
Please note: The electrical wiring used for the patio cover is the wrong type wiring, Romex type wiring shouldn't be exposed or used outdoors.

The services of a qualified electrician may be needed to make the necessary repairs.

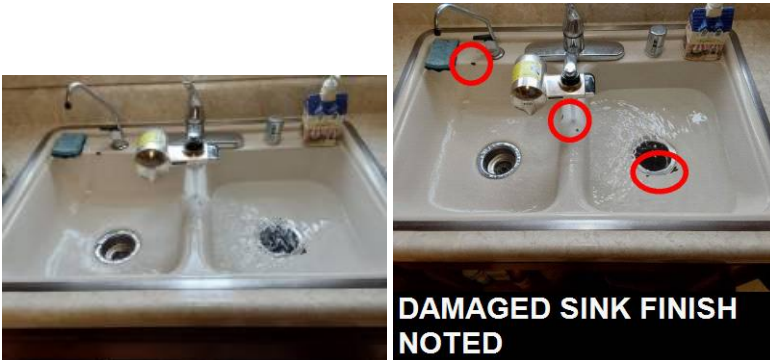
Damaged sink finish noted.

DAMAGED SINK FINISH NOTED

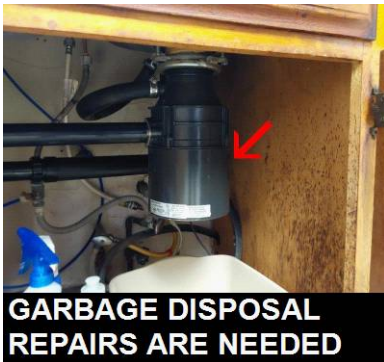
System is Badger.
The food waste disposal is stuck.

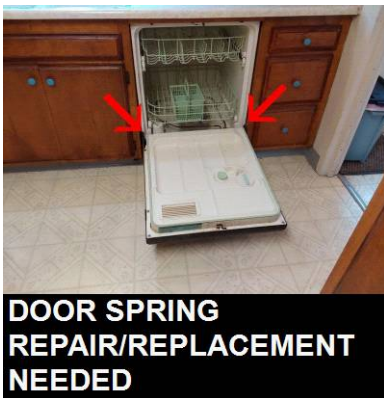
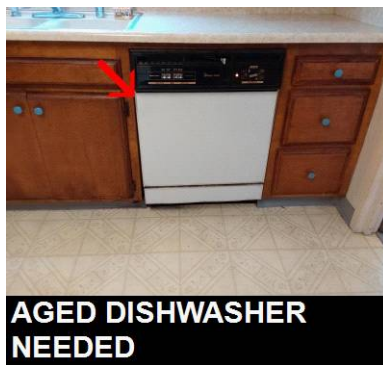
System is Majic Chef.
The door springs need to be replaced.

Attention Needed - Although this unit was operational during the inspection, the age and/or condition is such that you may need to replace it in the near future.

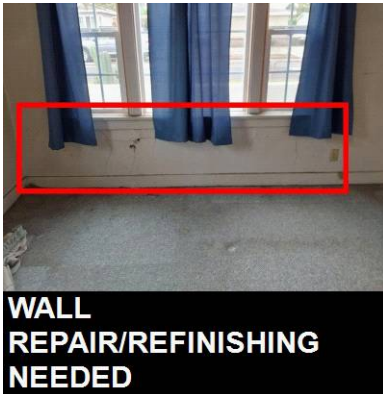
Action Necessary - There is a condition in the wall sheeting that needs to be repaired.

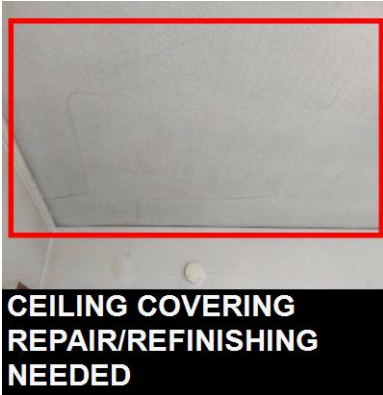
Action Necessary - There is deterioration in the ceiling of this room that needs to be repaired.

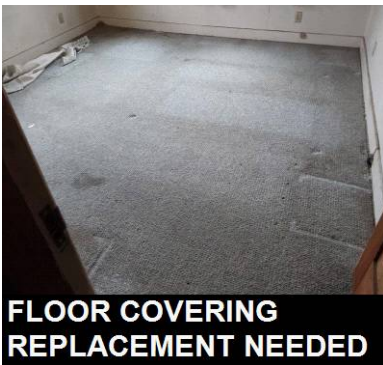
The floors are in functional condition.

The floor covering is in a condition that warrants replacement.

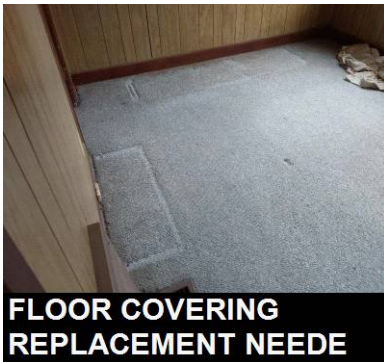
The floors are in functional condition.

The floor covering is in a condition that warrants replacement.

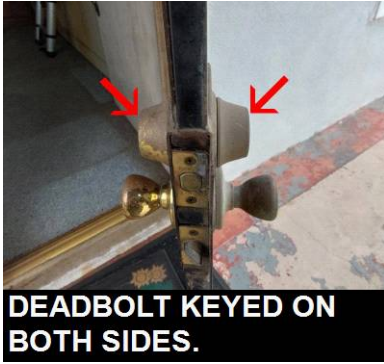
The deadbolt is keyed on both sides. This is a potential safety hazard if you need to exit the house quickly and there is no key readily available.

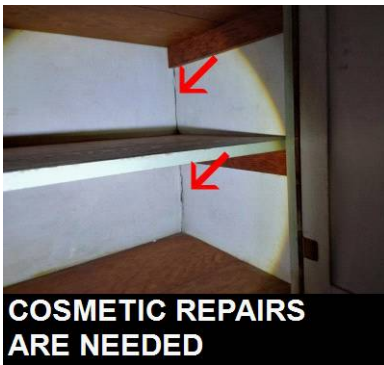
Attention Needed - The linen closet walls need minor repair/refinishing.

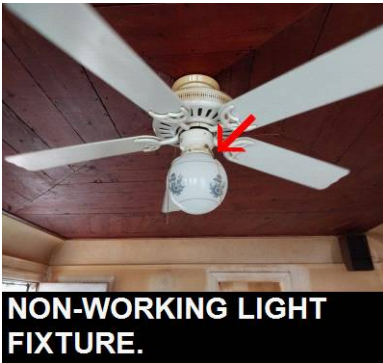
The ceiling fan light was not functional at the time of the inspection. Repairs may be as simple as replacing the light bulb.

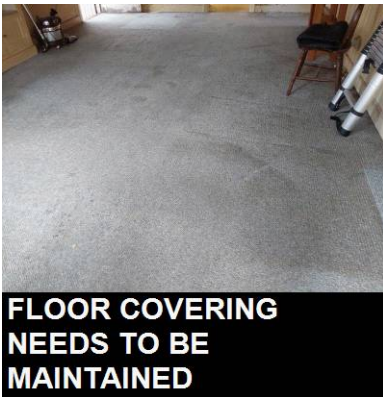
The floors are in functional condition. The floor covering needs to be maintained.

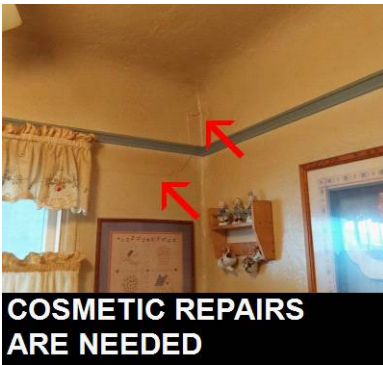
Attention Needed - The walls in the room show some condition that does not appear to be a serious structural concern at this time.

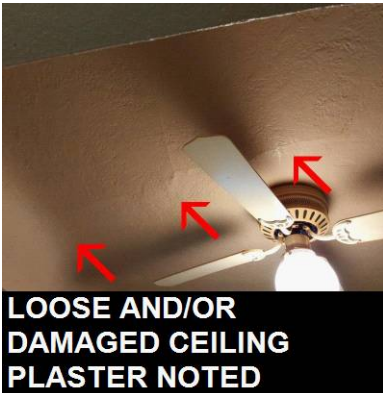
Action Necessary - There is deterioration in the ceiling of this room that needs to be repaired.

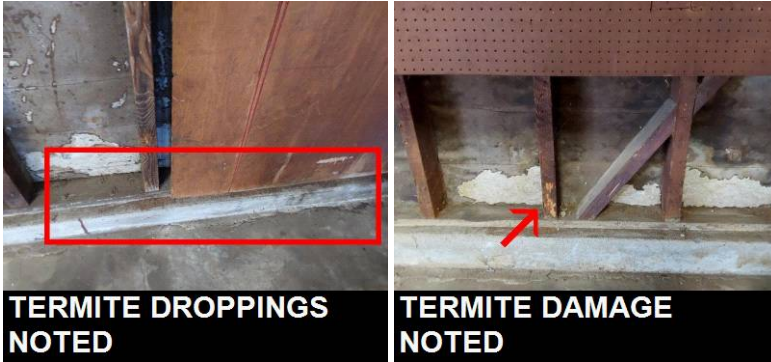
The inspector noted evidence of termite damage and termite droppings on the garage walls. We are strongly suggesting to have the house inspected by a qualified termite inspection company. See additional picture.
