WOOD DESTROYING PESTS AND ORGANISMS INSPECTION REPORT

BUILDING NO. 3566	STREET, CITY, STATE, ZIP Mount Vernon Avenue, Riverside CA 92507	Date of Inspection 3/24/2023	No. of Pages 6
-----------------------------	--	--	--------------------------

General Description: One story, stucco framed, residence, concrete slab, composition roof, occupied	Inspection Tag Posted: Garage
	Other Tags Posted: None Noted

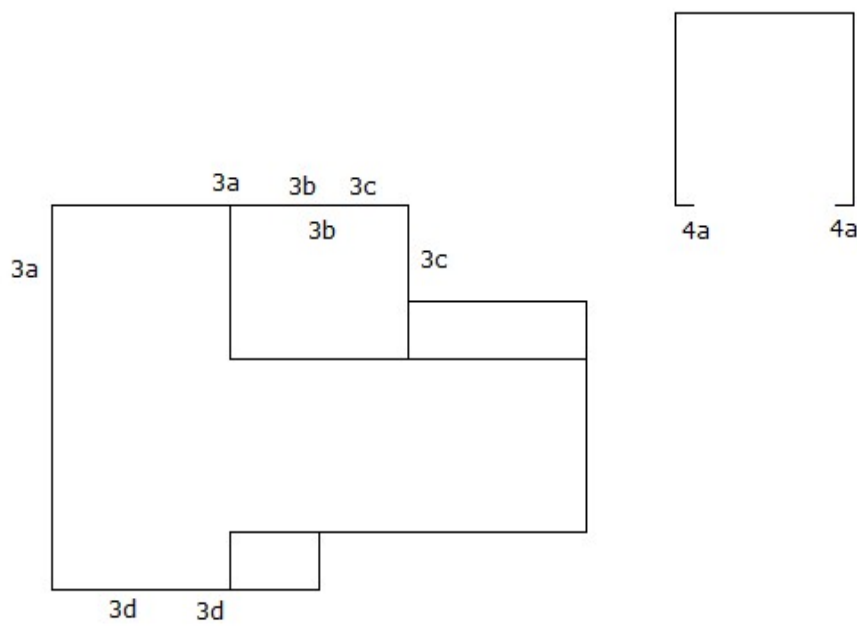
Fungus Damage noted at left and rear fascia and trim. Marked 3a on diagram.

Fungus Damage noted at rear room/patio header and joist. Marked 3b on diagram.

Fungus Damage noted at rear siding. Marked 3c on diagram.

Fungus Damage noted at front roof sheathing. Marked 3d on diagram.

Water Damage noted at garage trims. Marked 4a on diagram.

Remove and replace approximately 2', 6', & 8' of 2" x 6" and 8' of 1" x 2". **Paint tan primer-see note. NOTE: Wood not guaranteed to match due to milling changes and availability. NOTE: Wood used will be Douglas Fir and/or Spruce unless otherwise noted.

Others to remove and replace damaged wood.

Remove and replace approximately (4) 10' of 1" x 8" shiplap. **Paint tan primer-see note. NOTE: Wood not guaranteed to match due to milling changes and availability. NOTE: Wood used will be Douglas Fir and/or Spruce unless otherwise noted.

Remove and replace approximately (2) 4' of 1" x 8" shiplap. **Paint tan primer-see note. This company guarantees roofing materials over replaced wood only. NOTE: Wood not guaranteed to match due to milling changes.

Others to remove and replace damage.
