### Inspection/Certification

Date of Inspection: **9/11/25**

Inspection Address: **2995 Atascadero Rd, Morro Bay Ca 93442**

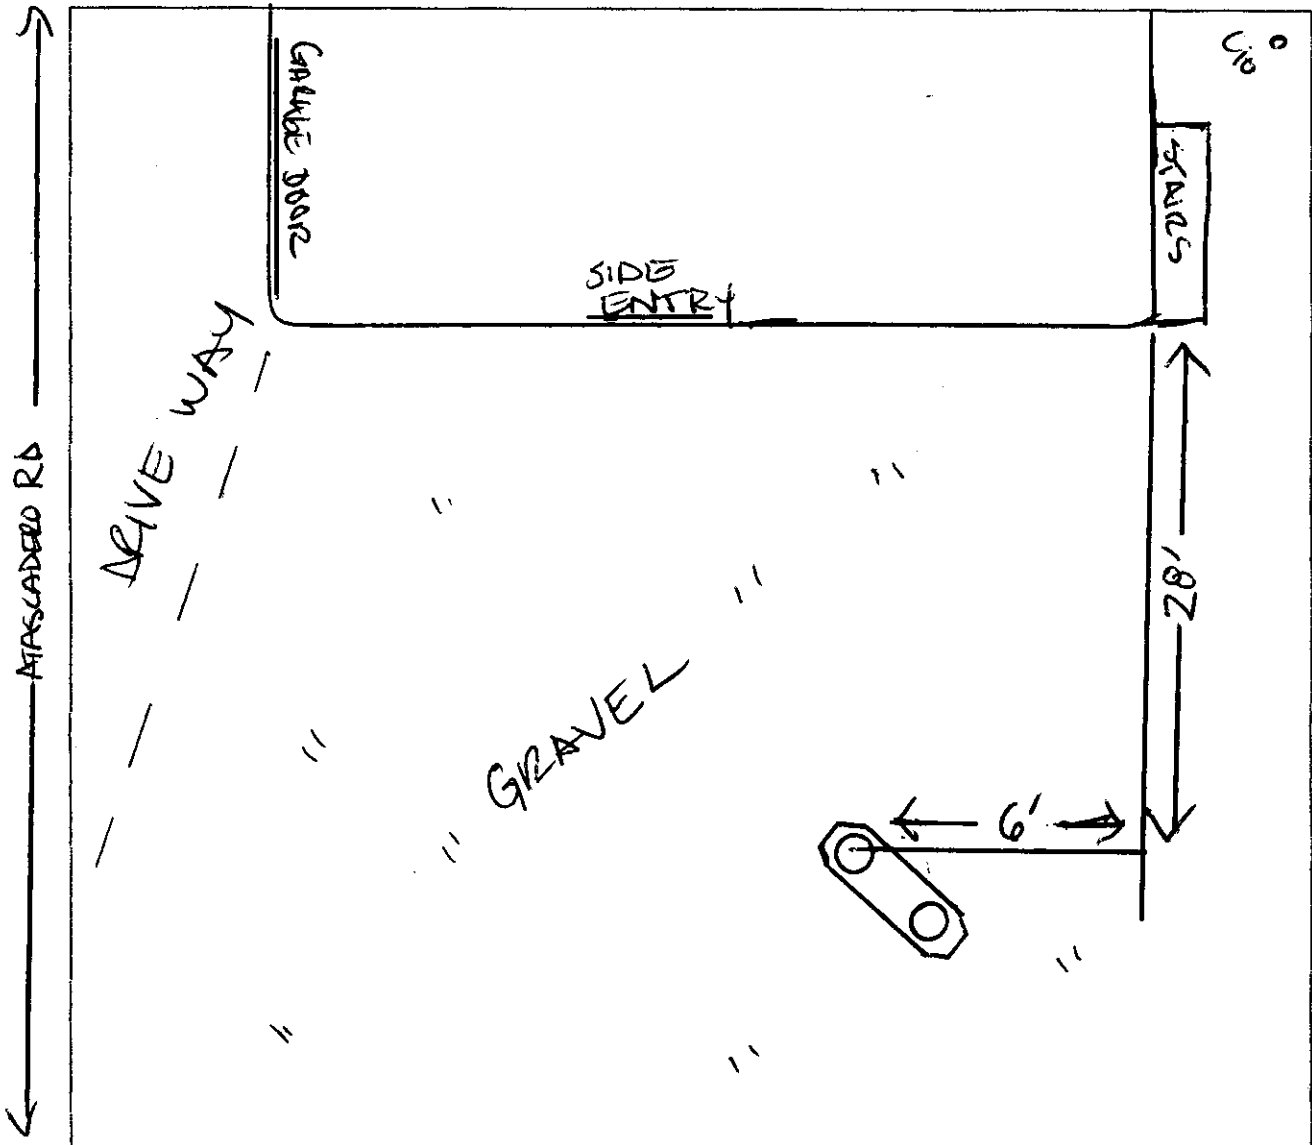
Comments: 1200 Gallon Fiberglass tank

NO Full Diameter Access Risers to Grade

Depth From Top of Tank to Grade 24'

Distance to wellhead NATURAL SPRING Clean Out Present
