## WOOD DESTROYING PESTS AND ORGANISMS INSPECTION REPORT

| Building No.<br><b>8383</b> | Street<br><b>Paso Robles Ave.</b> | City<br><b>Northridge</b> | Zip<br><b>91325</b> | Date of Inspection<br><b>8-28-25</b> | Number of Pages<br><b>5</b> |
| General Description: <u>One story wood framed residence with attached garage</u> | | | Inspection Tag Posted: <u>attic</u> | | |

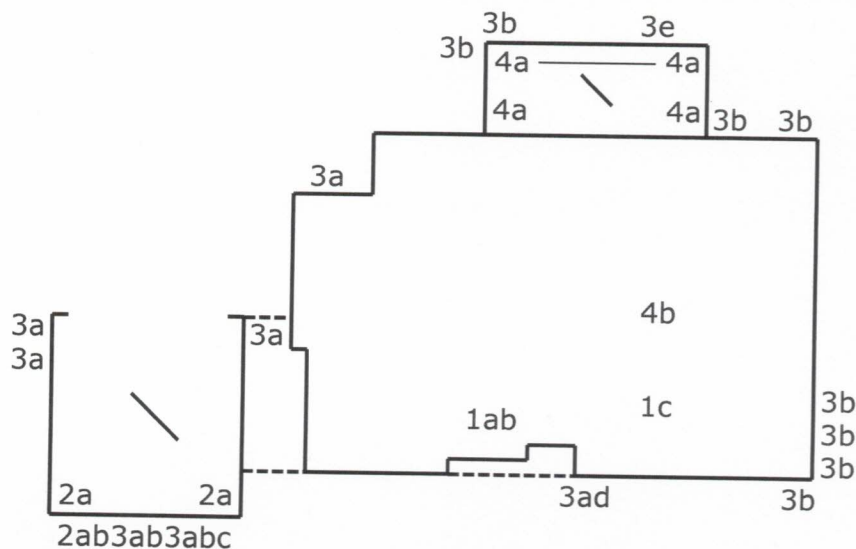
1a **FINDING:** Evidence of old Subterranean termites in the substructure area.

1b **FINDING:** Subterranean termite damage was noted at the subfloor.

1c **FINDING:** Evidence of Subterranean termites in cellulose debris in the substructure area.

2a **FINDING:** Evidence of drywood termites noted in the rafter tail(s) and garage framing.

2b **FINDING:** Drywood termite damage was noted at the rafter tail(s).

3a **FINDING:** Dryrot was noted to the roof sheathing as indicated.

3b **FINDING:** Dryrot was noted to the fascia as indicated.

3c **FINDING:** Dryrot was noted to the rafter tails as indicated.

3d **FINDING:** Dryrot was noted to the siding as indicated.

3e **FINDING:** Dryrot was noted to the window & trim as indicated.

**RECOMMENDATION:** Repair/replace/reinforce damaged wood members, as necessary.

**RECOMMENDATION:** Remove cellulose debris and treat soil with a state registered toxicant.

**PRIMARY RECOMMENDATION:** Is to completely tarp entire structure including all attached units.

**RECOMMENDATION:** Call proper contractor. (Metal roof tiles over wood shake roof).

**RECOMMENDATION:** Repair and or replace damaged wood members, as necessary.
