Inspection Report

Address: 246 16th St Paso Robles, CA 93446

3/20/23

Inspector: Keith Vreeken, MCI, FCI
P.O. Box 415 Templeton, CA 93465 O: 805.462.1978 C: 805.440.5050

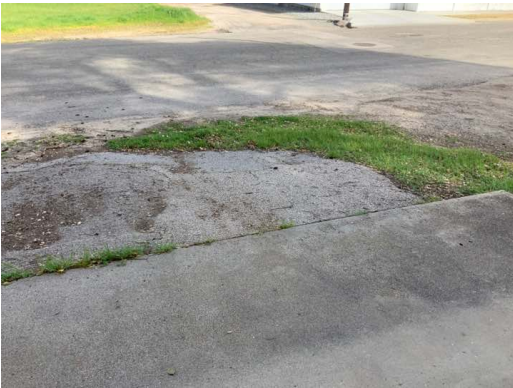
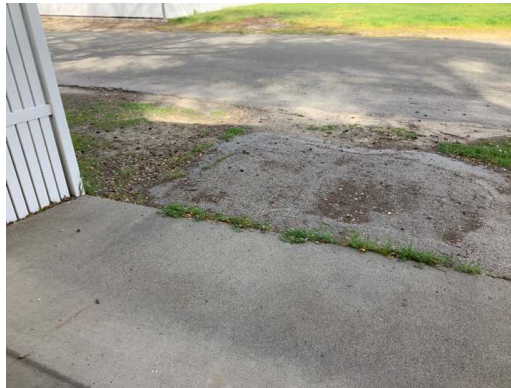
15: Asphalt driveway found damaged in need of replacement

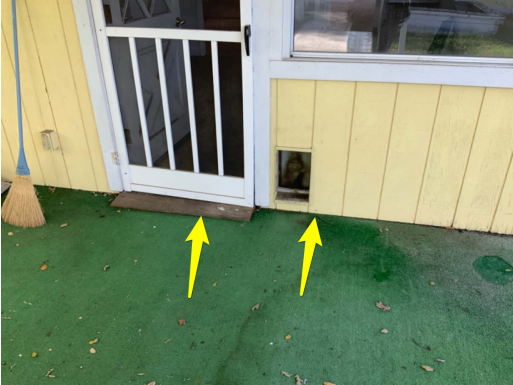
DS 20: Areas of the BACKYARD PATIO were installed at or above exterior siding and exterior door threshold. Recommend monitoring, maintenance and upgrades to help ensure water tightness and integrity of the walls and door thresholds. Refer to the Termite Report for additional comments and recommendations.

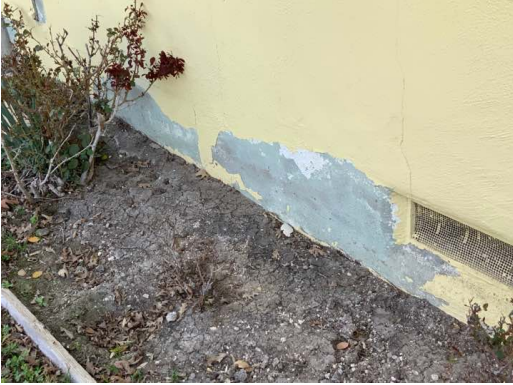
MR 27: Some typical moisture damage, peeling of painted stucco color coat. (Ongoing maintenance recommended).

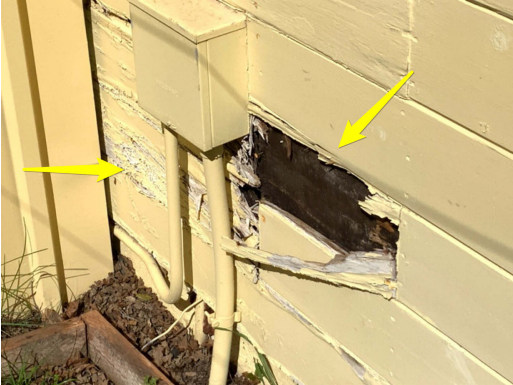
E&C 28: Some moisture and/or bug type damage and deterioration found at areas of the exterior wood siding and trim. Refer termite report for additional comments, recommendations, locations and extent.

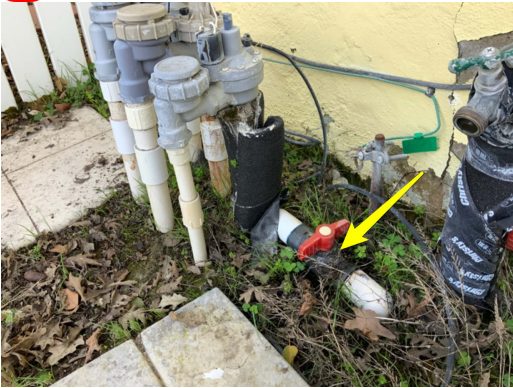
E&C 32: Active water leak found at sprinkler valve and/or piping: ON THE SOUTHEAST CORNER

Active leaking

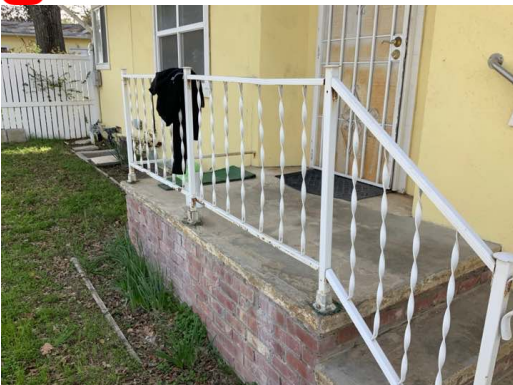
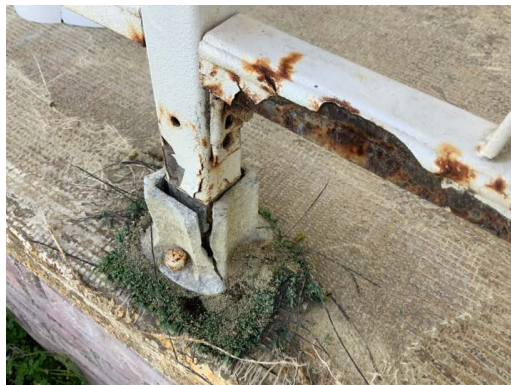
SC 34: Loose and damaged stairway railings at the OFF THE FRONT ENTRY. Corrections needed for safety.

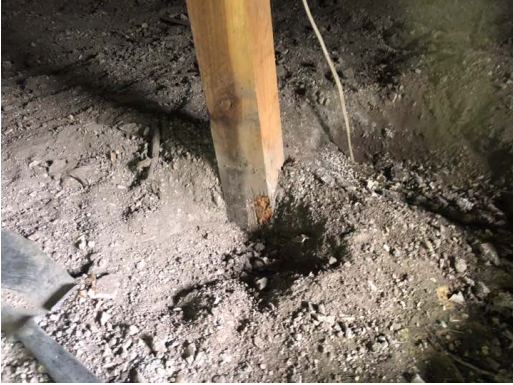
MR 43: Earth-to-wood contact found in areas of the crawlspace. Upgrades recommended. Refer to termite report for locations.

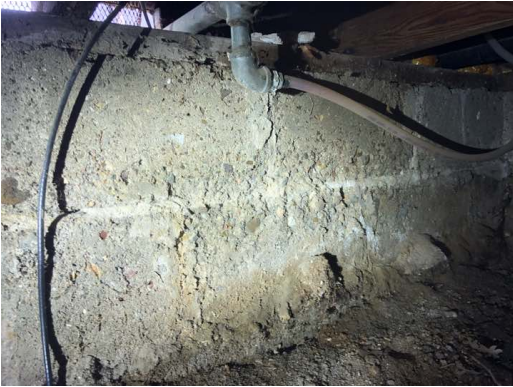
MR 44: Some deterioration / spalling of the concrete foundation noted. This appears typical of the age. However, upgrades are recommended to help prevent additional deterioration, damage or compromise of the concrete. Contact a licensed concrete foundation specialist to evaluate and make recommendations.

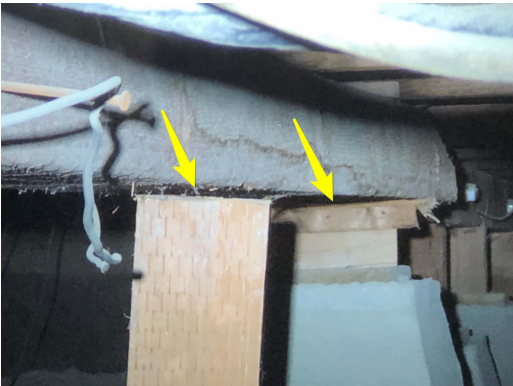
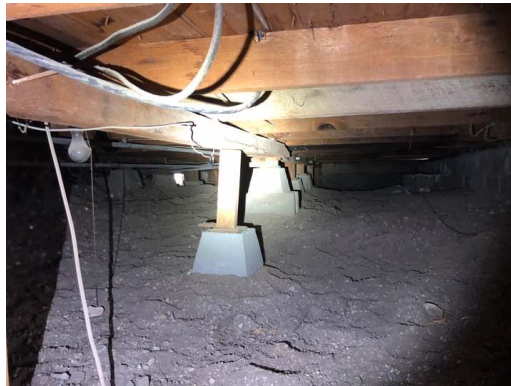
E&C FI 46: A few structural support posts in the crawlspace found leaning and some are not making contact with the girder. Evaluation and repairs are needed.

Piers are not making contact with the girder

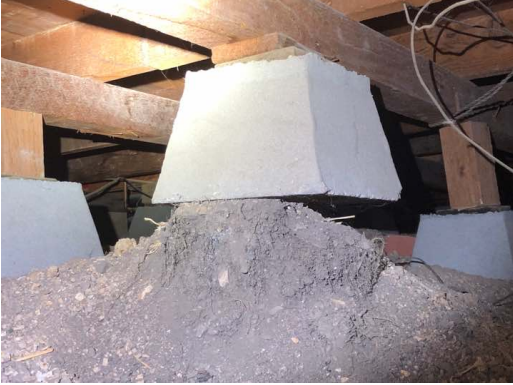
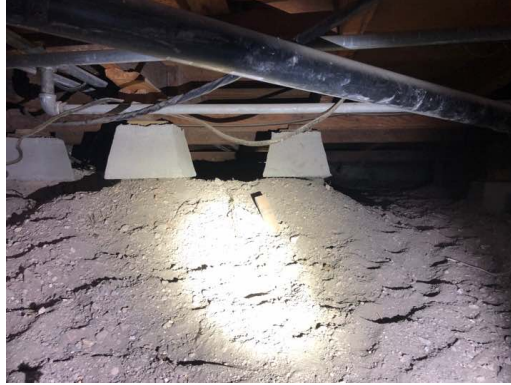
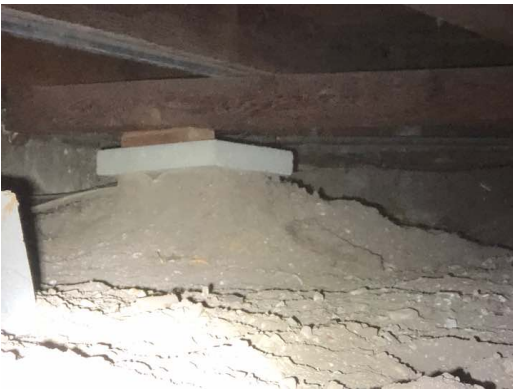
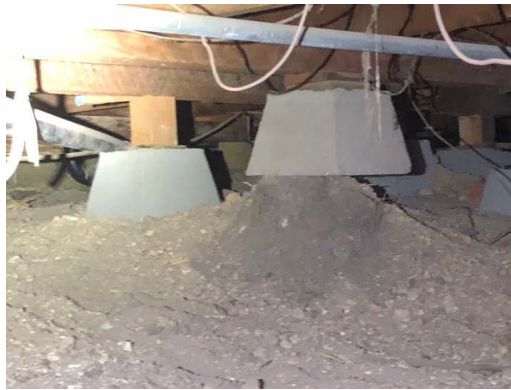
E&C 47: Areas where the soil was removed from along the sides of some structural piers the in the crawlspace. This has and can continue to negatively affect the integrity of the house foundation.

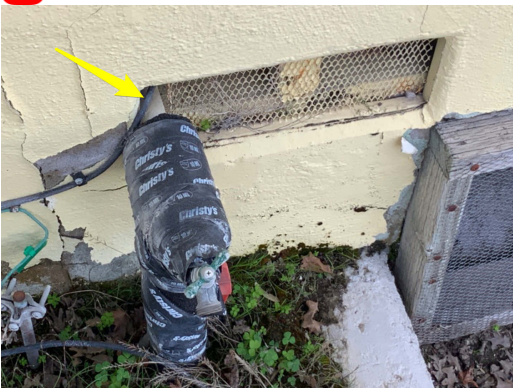
E&C 48: Damaged exterior crawlspace ventilation screens found in need of repair to help prevent critter intrusion.

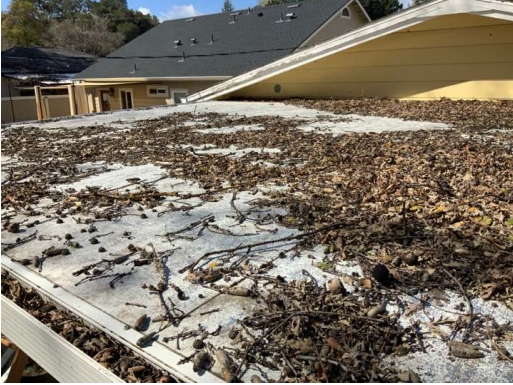
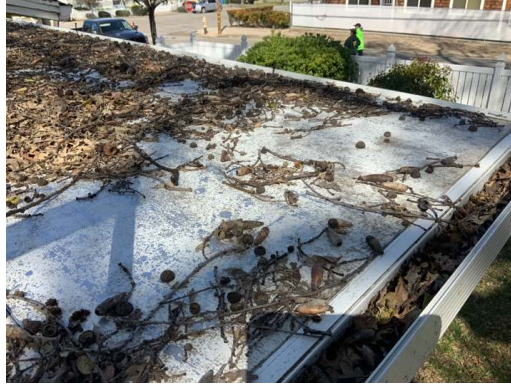
MR 52: Insulated aluminum awning panels at the back patio cover appears to be in good condition. However, recommend servicing, caulking and sealing joints at the awning roof to help prevent leakage.

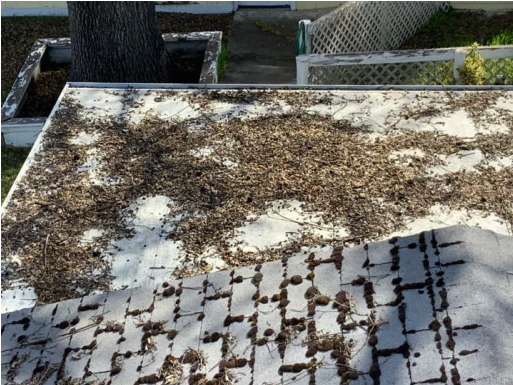
MR 55: Debris covers portions of roof and/or roof flashings. This may cause deterioration and/or a roof leak. Areas of the roof are not fully visible. Recommend removal of the debris and inspect areas to determine current conditions. Continuous cleaning and inspections is warranted to help prevent roof leakage.

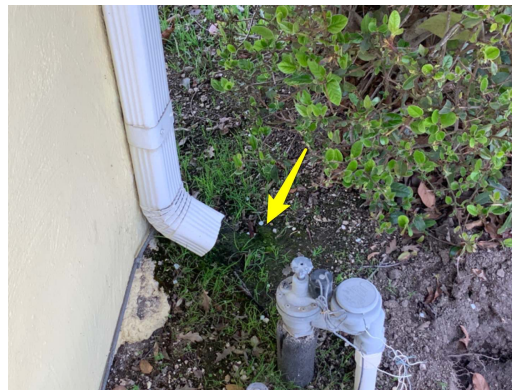
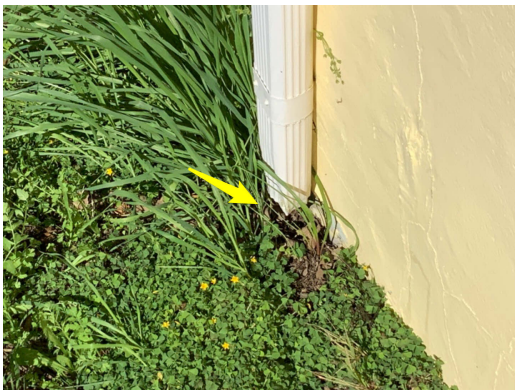
MR 62: Recommend splash blocks and diverting the rain gutter downspouts at the bottom to assist in proper flow of roof water away from the house and to help prevent soil erosion where not installed.

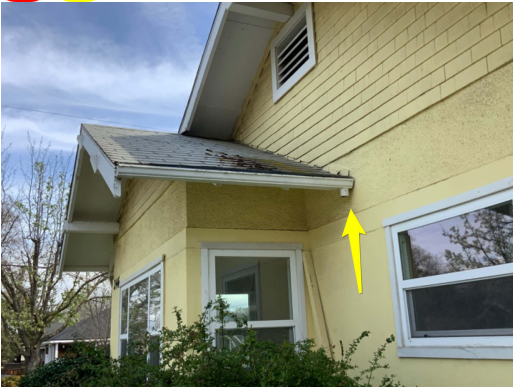
E&C MR 63: Some Loose and/or disconnected rain gutter downspouts.

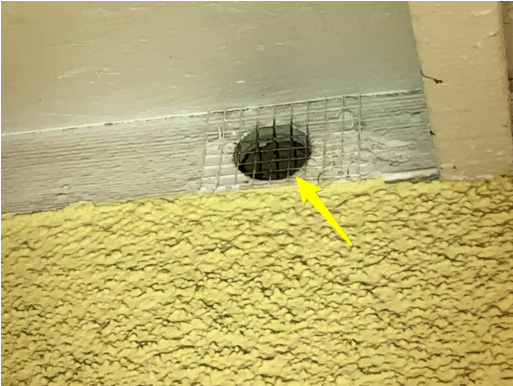
SU 69: Some Ventilation screens for the attic are found to be oversized or unscreened. A 1/4 inch screen recommended to avoid critter intrusion into the attic.

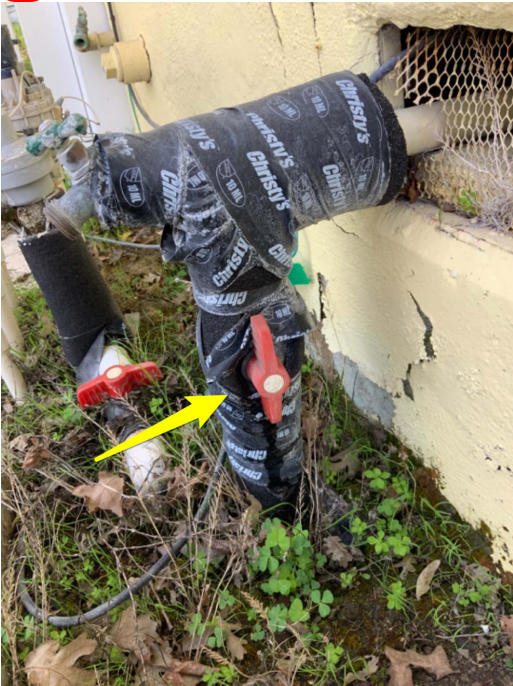
E&C 73: Active water leak noted at the MAIN WATER SUPPLY pipe or valve.

Active leaking

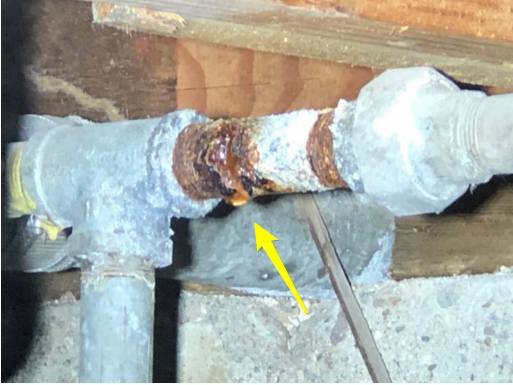
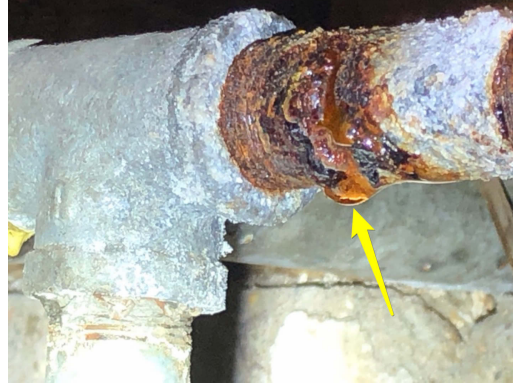
E&C 78: Active water leak found in the crawlspace under the hall bathroom. Have a plumber check all pipes and fittings to ensure there are no other areas at warranty repairs or upgrades.

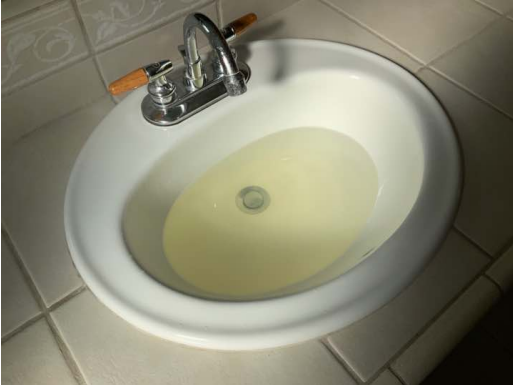
FI DS 79: Be advised that the galvanized water supply piping, like areas of the piping installed in this building, has an average life expectancy of approximately 50 years. +/- and can fail without warning. Discoloration or sediment in the water may be a sign of deteriorated galvanized water supply piping. Recommend further evaluation and opinion by a licensed plumbing professional.

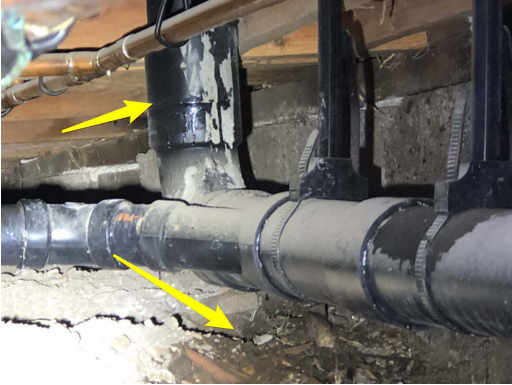
E&C FI 87: Active water leak(s) found in the waste pipe in the crawlspace: UNDER THE HALL BATHROOM. Have plumber check all waste piping throughout the crawlspace for any additional leakage.

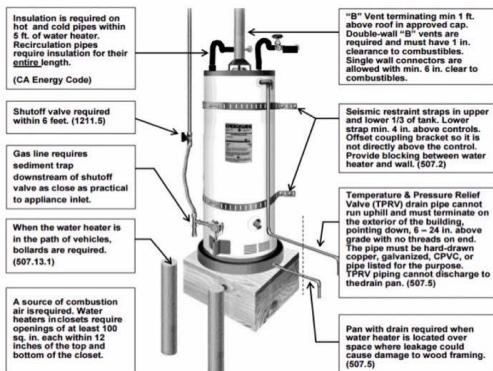
SC 91: The Water heater operated but found to be improperly installed or not installed well. Recommend further review and repairs by a licensed plumbing professional familiar with minimum installation requirements. See details in the report for specific comments as to the defective installation. Refer to the water heater, section for specific comments and defects.

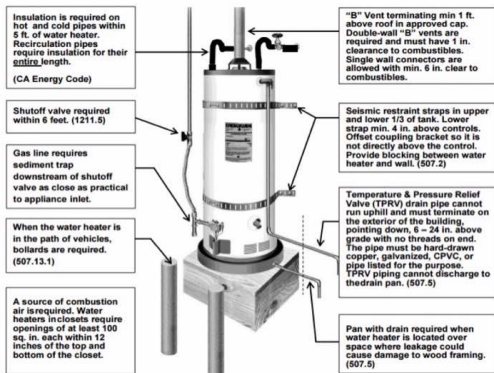
E&C 93: The Water Heater is NOT strapped per standards. Recommend adding proper STRAPPING & BRACING or BLOCKING to the wall to properly secure the tank per Uniform Plumbing Code and State Architect Requirements.

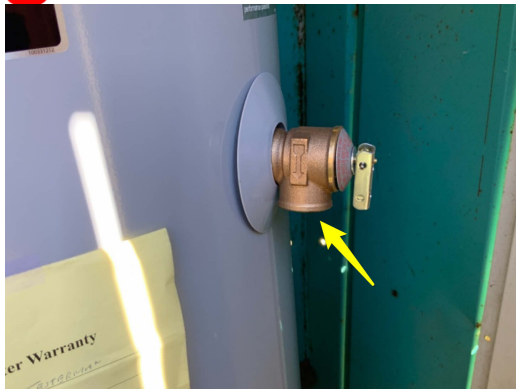
SC 94: Water heater TPR (temperature pressure relief) pipe is missing / not installed.

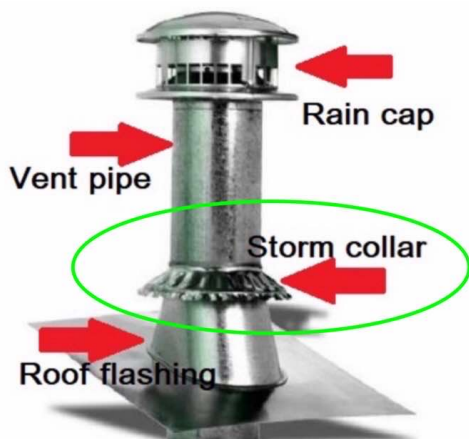
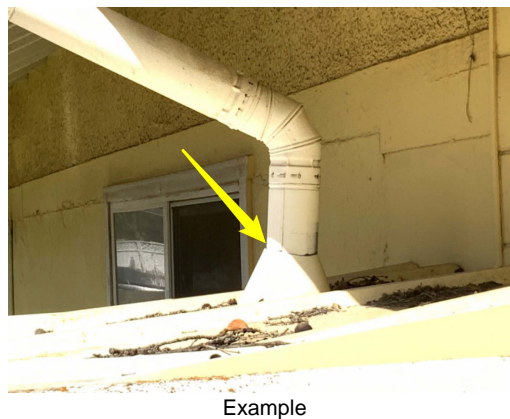
E&C 95: Missing / Recommend a proper storm collar per standards at the water heater vent pipe at the roof termination.

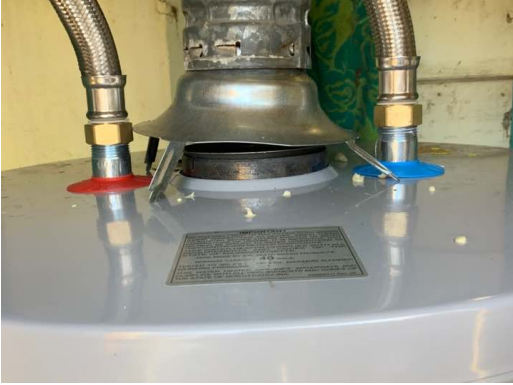
SC 96: The draft hood at the top of the new water heater found crashed. Proper repairs are needed to help ensure that the water heater draft the exhaust properly.

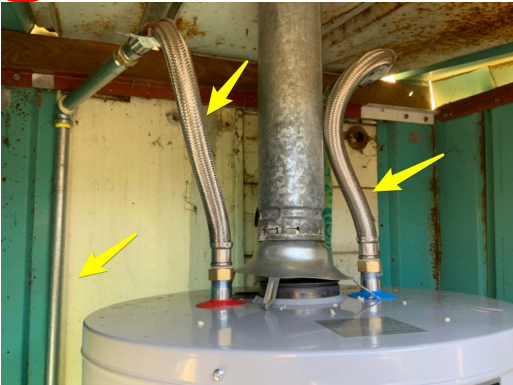
E&C 98: Missing the insulation on the Hot and Cold water supply piping at the water heater.

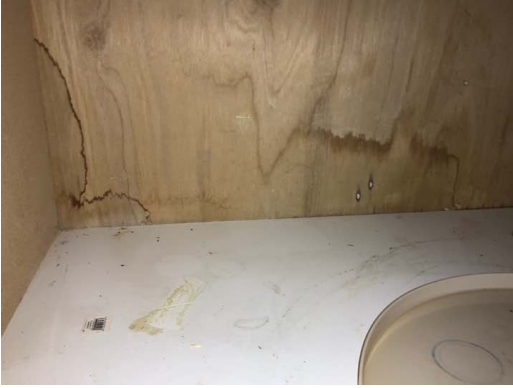
FI 101: Some past / dry moisture stains and damage in the cabinetry below the kitchen sink.

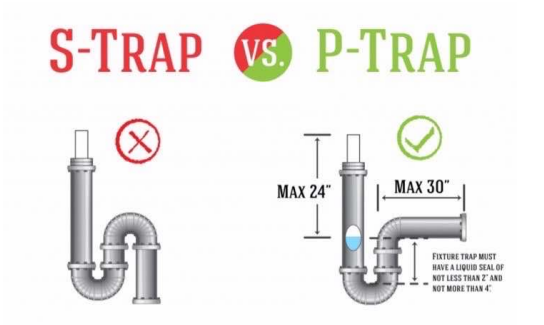
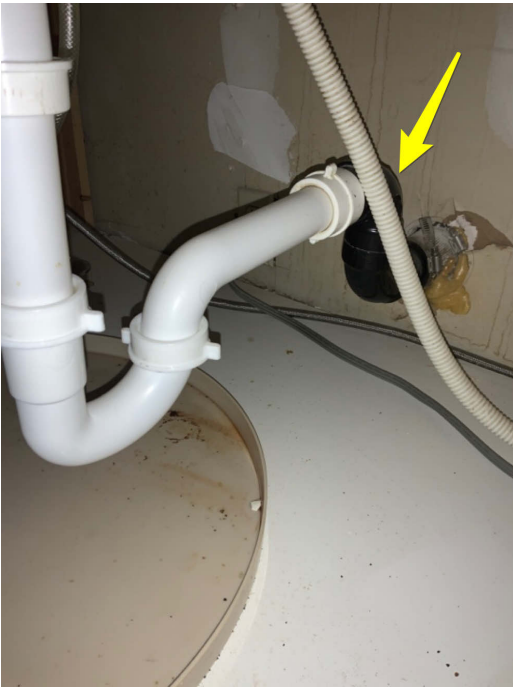
E&C 102: Improper drain piping, improper S-type trap system installed under Kitchen sink. Simple corrections are needed for safety.

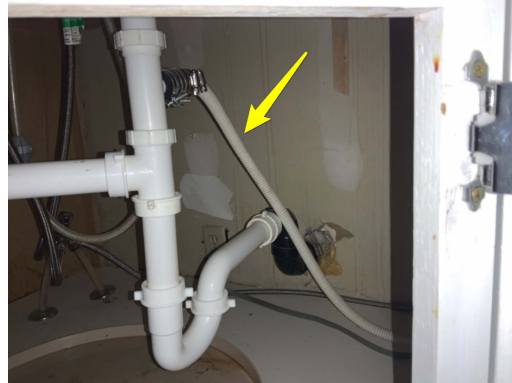
E&C 104: Improper installation of the dishwasher drain hose. Missing the Air Gap Device at the dishwasher drain per minimum codes and standards (California does not allow for high-loop methods or direct waste connections). {CPC 801.2}

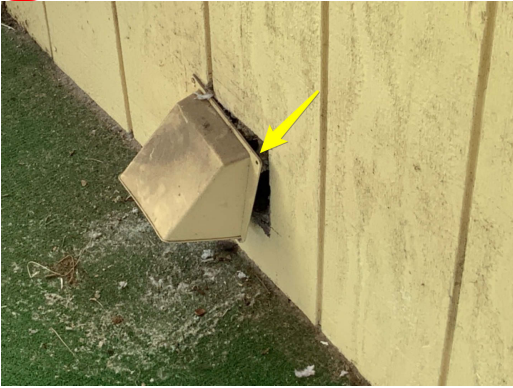
E&C 115: Damaged laundry dryer vent cap. Repairs recommended.

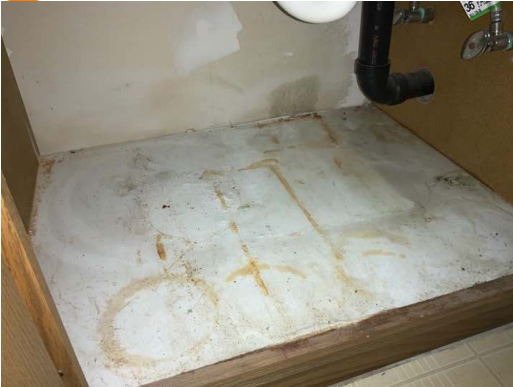
FI 117: Some past / dry moisture stains and damage in the cabinetry below the Laundry sink.

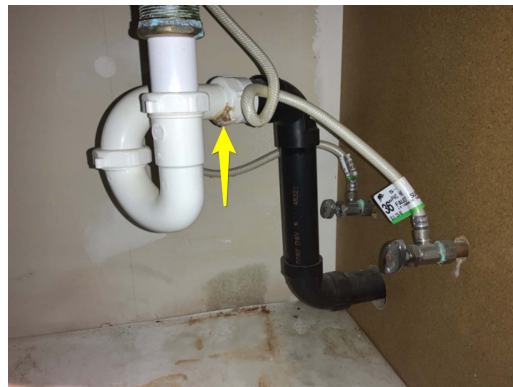
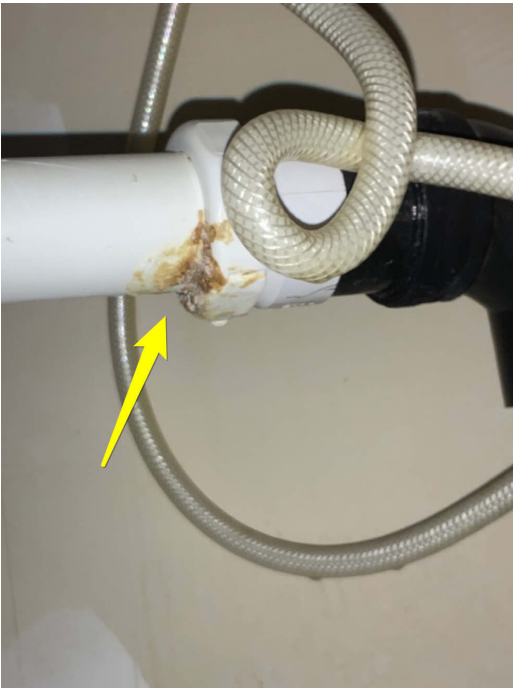
E&C 118: Improper drain piping / S-type trap system installed and some corrosion with evidence of a past leak under bathroom sink: LAUNDRY SINK

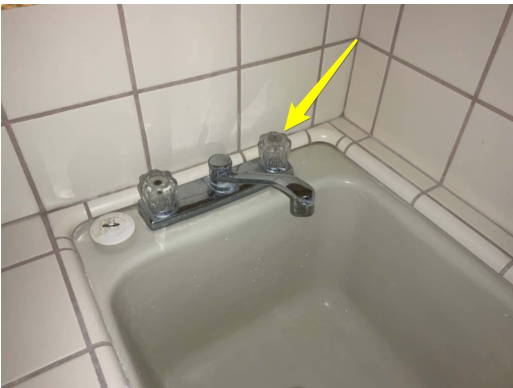
E&C 119: Cold water from non operational and the sink faucet is loose at the sink connection at the laundry room utility sink.

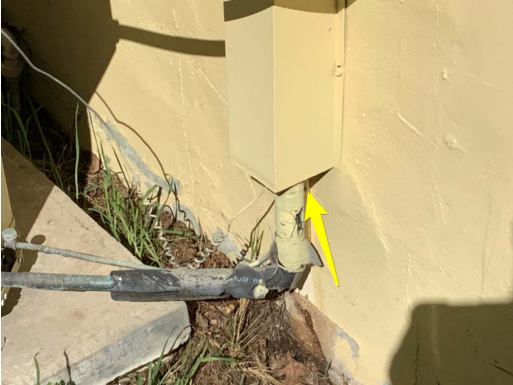
SU 161: Recommend sealing the hole or opening through the exterior wall where the Air Conditioner's refrigeration pipes enter the building. This will help prevent rodent, bug and /or water intrusion through this area as need per standards.

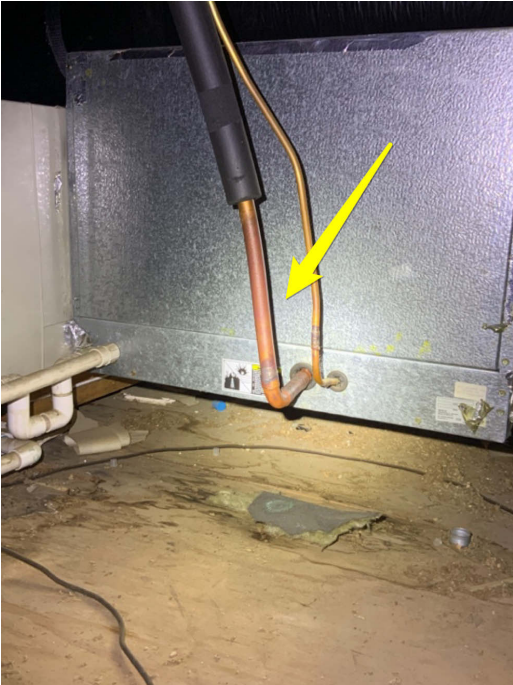
E&C 162: Insulation damaged or missing at areas of the Air Conditioner refrigerant piping near the coil in the attic. This allows water to condensate and drip causing water stains and/or damage. Repairs or additional insulation needed.

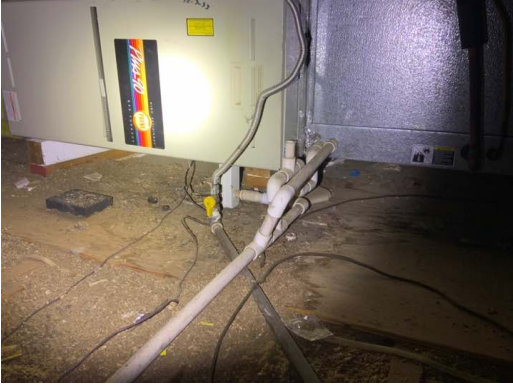
E&C 164: Improper connection of the Air conditioner secondary condensate drip piping into the primary drain piping at coil in ATTIC.

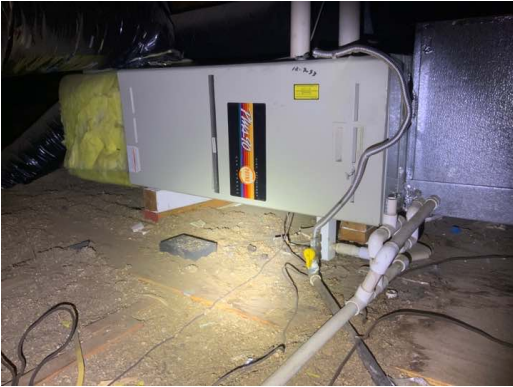
E&C 165: Missing the required catch pan under the condensing furnace in the attic to help prevent water damage to the ceiling below if a leak were to occur per standards. Recommended repairs by a certified or licensed HVAC professional familiar with the minimum installation requirements.

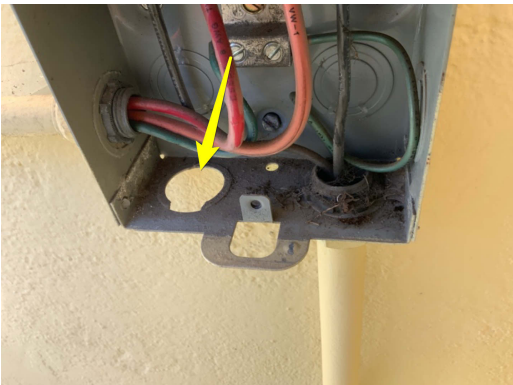
SC 166: An unprotected open hole found at the bottom of the air conditioner electrical service disconnect box. The opening needs to be properly sealed to help prevent critter and water intrusion

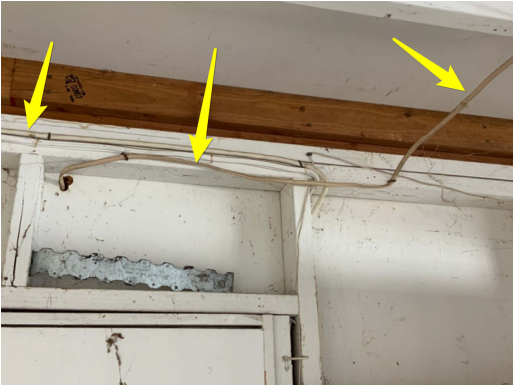
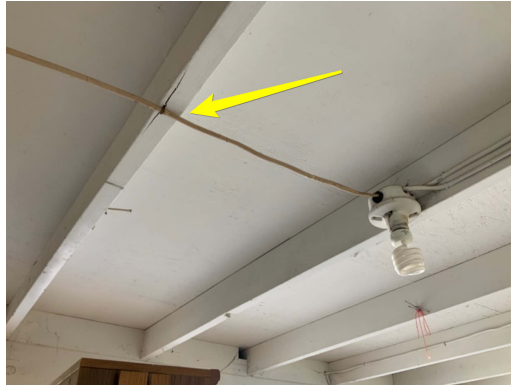
SC 173: Improper and unsafe electrical wiring. Exposed electrical wiring, "Romex" improperly installed subject to physical damage, not in a conduit or raceway per standards: in the garage

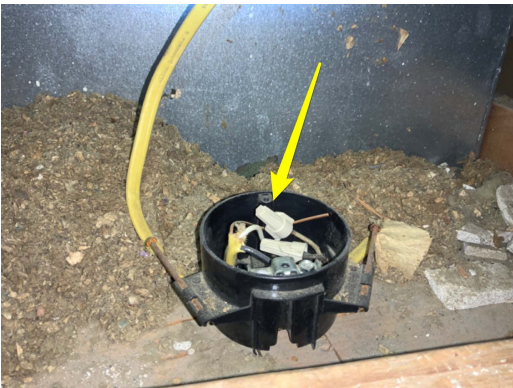
SC 176: Missing cover plate(s) at some electrical junction boxes IN THE ATTIC. Have electrician re-evaluate the entire ATTIC to confirm all boxes have cover plates.

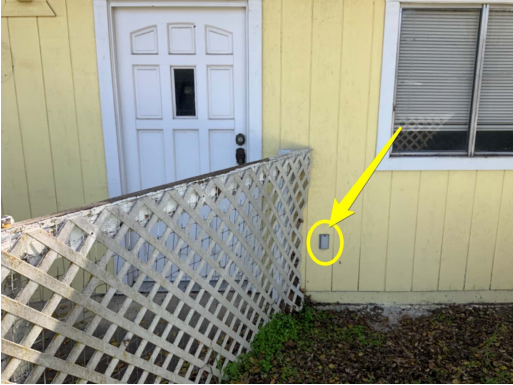
SC 179: GFCI protection at GFCI outlet found non-operational. Recommend replacement of the defective outlet:
AT THE DETACHED GARAGE.

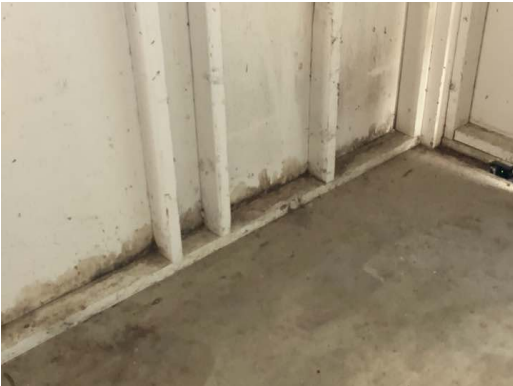
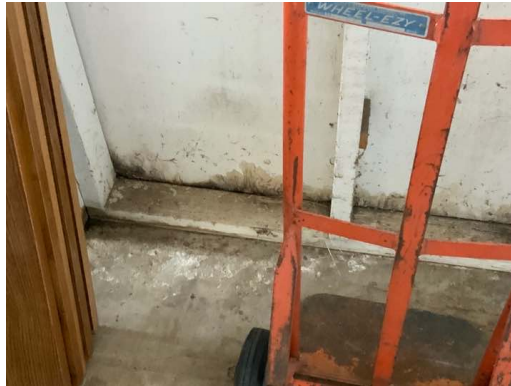
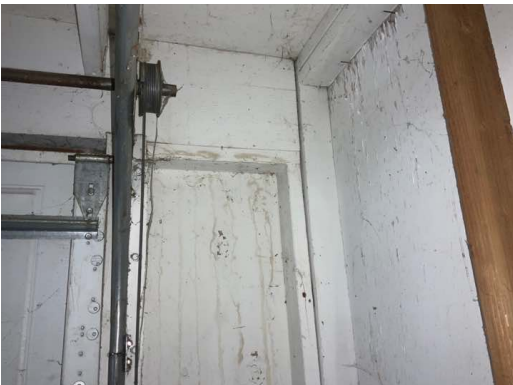
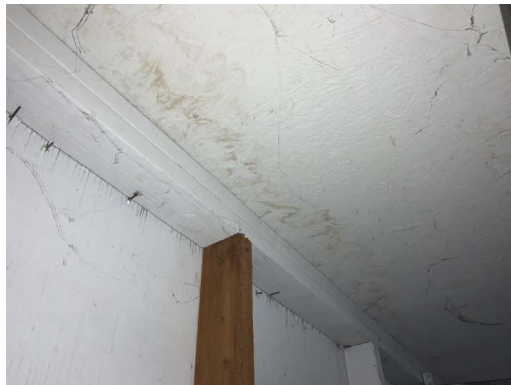
FI 187: Moisture stains and/or damage found on areas of the garage walls and ceiling. Recommend further review to determine cause, current condition and if repairs are needed. Areas found dry today.
