# WOOD DESTROYING PESTS AND ORGANISMS INSPECTION REPORT

| BUILDING NO.<br><b>304</b> | STREET, CITY, STATE, ZIP<br><b>VIA COLUSA, REDONDO BEACH CA 90277</b> | Date of Inspection<br><b>3/17/2025</b> | No. of Pages<br><b>10</b> |

| General Description:<br><b>ONE STORY, FRAMED, STUCCO, RESIDENCE, UNOCCUPIED,<br/><br/>WITH DETACHED TWO CAR GARAGE.</b> | Inspection Tag Posted:<br><b>GARAGE</b><br><br>Other Tags Posted:<br><b>NONE NOTED</b> |

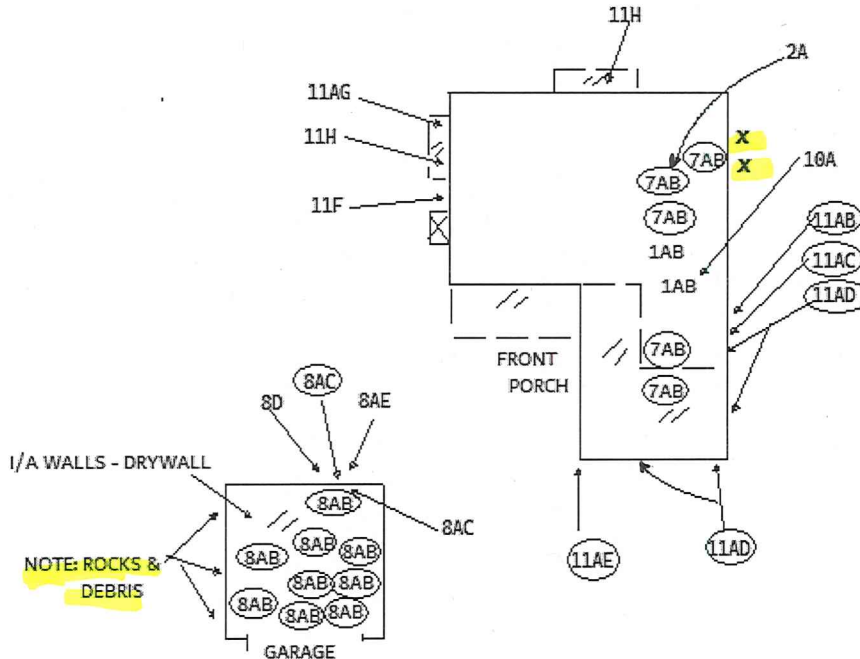
Key: 1=Substructure 2=Stall Shower 3=Foundation 4=Porches 5=Ventilation 6=Abutment 7=Attic 8=Garage 9=Patio 10=Interior 11=Exterior X=Plants

NOTE: PARTS OF SUBAREA HAS INACCESSIBLE AREAS DUE TO CONSTRUCTION (AIR DUCTS & PLUMBING) AS MARKED ON DIAGRAM. IT IS NOT PRACTICAL TO MAKE ACCESSIBLE.

ITEM 7B EVIDENCE OF DRYWOOD TERMITE PELLETS NOTED, AS MARKED ON DIAGRAM.

ITEM 8B EVIDENCE OF DRYWOOD TERMITE PELLETS NOTED, AS MARKED ON DIAGRAM.

ITEM 8C DRYWOOD TERMITES HAVE DAMAGED DOOR JAMB, AS MARKED ON DIAGRAM.

ITEM 8D MINOR SURFACE FUNGUS DAMAGE WAS NOTED TO DOOR JAMB, AS MARKED ON DIAGRAM. APPEARS TO BE CAUSED BY UNCONTROLLABLE EXTERIOR MOISTURE SOURCES.

ITEM 8E DRYWOOD TERMITES HAVE DAMAGED DOOR TO THE GARAGE, AS MARKED ON DIAGRAM.

ITEM 8F DRYWOOD TERMITES HAVE DAMAGED SILL TO THE GARAGE, AS MARKED ON DIAGRAM.

ITEM 11B DRYWOOD TERMITES HAVE DAMAGED RAFTER, AS MARKED ON DIAGRAM.

ITEM 11C DRYWOOD TERMITES HAVE DAMAGED RAFTER, AS MARKED ON DIAGRAM.

ITEM 11D DRYWOOD TERMITES HAVE DAMAGED FACIABOARD, AS MARKED ON DIAGRAM.

ITEM 11E DRYWOOD TERMITES HAVE DAMAGED FACIABOARD, AS MARKED ON DIAGRAM.

ITEM 11F DRYROT DAMAGE WAS NOTED TO WINDOW TRIM, AS MARKED ON DIAGRAM. APPEARS TO BE CAUSED BY UNCONTROLLABLE EXTERIOR MOISTURE SOURCES.

ITEM 11G DRYWOOD TERMITES HAVE DAMAGED DOOR TRIM, AS MARKED ON DIAGRAM.

ITEM 11H DRYROT DAMAGE WAS NOTED TO DOOR ASSEMBLY, AS MARKED ON DIAGRAM. APPEARS TO BE CAUSED BY UNCONTROLLABLE EXTERIOR MOISTURE SOURCES.

**NOTE: PLANTS AS NOTED "X" ON DIAGRAM - SHOULD BE TRIMMED/CUT BACK FROM STRUCTURE PRIOR TO FUMIGATION.**
