WOOD DESTROYING PESTS AND ORGANISMS INSPECTION REPORT

BUILDING NO. 27608	STREET SADDLE RD.	CITY ROLLING HILLS ESTATES	ZIP 90274	Date of Inspection 05/24/2023	NUMBER OF PAGES 1 of 6
------------------------------	-----------------------------	--------------------------------------	---------------------	---	----------------------------------

GENERAL DESCRIPTION: This is a two story, stucco, residence. It has a detached garage. It has a tile roof and was occupied and furnished at the time of inspection.	Inspection Tag Posted: Attic.
	Other Tags Posted:

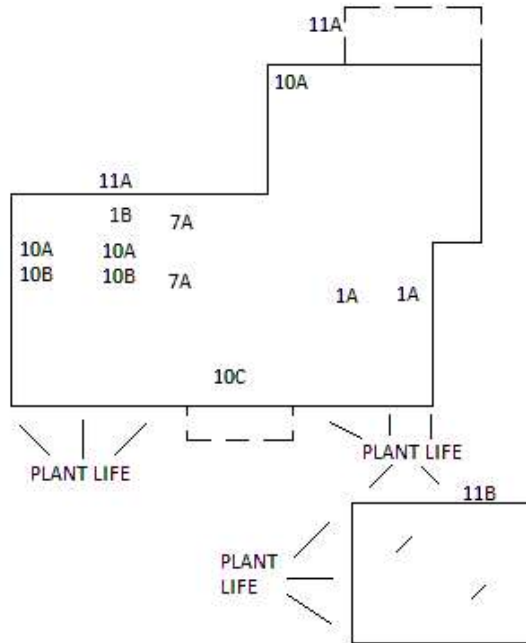
ITEM NO. 1A (Section 2)
FINDING AND RECOMMENDATION: 1A CELLULOSE DEBRIS noted as 1A on the diagram.
We recommend removing CELLULOSE DEBRIS of rake size or larger.

ITEM NO. 1B (Section 1)
FINDING: FUNGUS DAMAGE indicated by 1B on diagram. The FUNGUS DAMAGE was noted in or near: SUBFLOOR.
RECOMMENDATION: 1B We recommend scraping or brushing area and treating with a registered fungicide.

FINDING: Evidence of DRYWOOD TERMITES as indicated by 7A on the diagram. Evidence noted in or near: ATTIC FRAMING.

FINDING: Evidence of DRYWOOD TERMITES as indicated by 10A on the diagram. Evidence noted in or near: EAVES.

FINDING: DRYWOOD TERMITE DAMAGE as indicated by 10B on diagram. The damage was noted in or near: EAVES.

FINDING: Water stains noted as 10C on the diagram. No moisture was noted. The stains were in or near: CEILING.

FINDING: FUNGUS DAMAGE indicated by 11A on diagram. The FUNGUS DAMAGE was noted in or near: FASCIA.

FINDING: FUNGUS DAMAGE indicated by 11B on diagram. The FUNGUS DAMAGE was noted in or near: GARAGE DOOR.

RECOMMENDATION: 7A Fumigate the structure with a fumigant lethal to DRYWOOD TERMITES (Sulfuryl Fluoride). See the occupants fumigation notice for further details. This company is not responsible for delays or schedule changes due to inclement weather or other agencies, nor is it responsible for damage to roof or plants as a result of the fumigation. Refer to the occupant's fumigation notice/preparation sheet (sent separately) for additional information.

RECOMMENDATION: 10A Fumigate the structure with a fumigant lethal to DRYWOOD TERMITES (Sulfuryl Fluoride). See the occupants fumigation notice for further details. This company is not responsible for delays or schedule changes due to inclement weather or other agencies, nor is it responsible for damage to roof or plants as a result of the fumigation. Refer to the occupant's fumigation notice/preparation sheet (sent separately) for additional information.

RECOMMENDATION: 10B Cut off termite damage and repair with appropriate wood filler.

RECOMMENDATION: 10C It is recommended that owner contact a state licensed contractor to determine source of water stains and correct.

RECOMMENDATION: 11A Cut out FUNGUS treat with a wood preservative and repair as necessary.

RECOMMENDATION: 11B Remove and replace damaged wood as necessary with today's available widths and grades.
