# HOME INSPECTION REPORT

8534 Bothwell Road, Northridge

679847

June 30, 2026

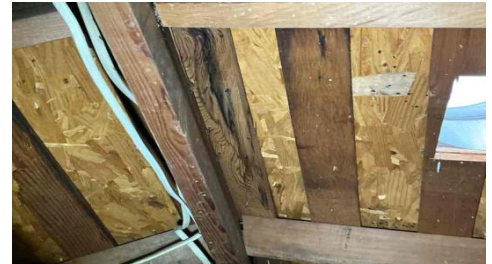
Photo 49

1. Water stains were evident in the attic and/or garage at the time of inspection. It is unknown whether these stains are from a past or present leak. We recommend consulting the home owner for further information in regards to past or present repairs to the roof.

- ! 1. Water stains were evident in the attic and/or garage at the time of inspection. It is unknown whether these stains are from a past or present leak. We recommend consulting the home owner for further information in regards to past or present repairs to the roof.  
[\(See Photo 49\)](#)

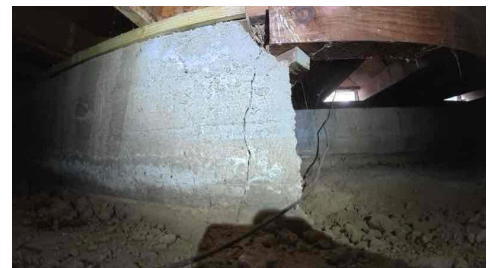
Photo 57

2. Vertical cracking was observed in the foundation walls of the structure indicating movement and/or settlement of the structure may have occurred. The rate of movement cannot be predicted during a one-time inspection. A thorough evaluation of this condition is beyond our qualifications. For additional information we recommend contacting a licensed foundation contractor for further evaluation.

- ! 2. Vertical cracking was observed in the foundation walls of the structure indicating movement and/or settlement of the structure may have occurred. The rate of movement cannot be predicted during a one-time inspection. A thorough evaluation of this condition is beyond our qualifications. For additional information we recommend contacting a licensed foundation contractor for further evaluation.  
[\(See Photo 57\)](#)

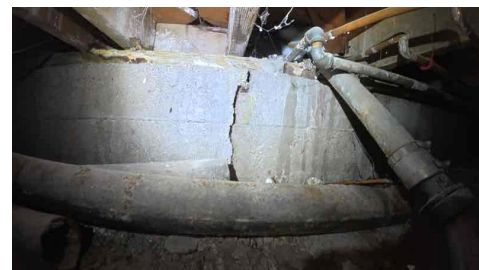
Photo 52

3. Large cracks and/or movement was observed in the foundation of the structure at the front left side. This implies that structural movement and/or settlement of the building has occurred. The rate of movement cannot be predicted during a one-time inspection. A thorough evaluation of this condition is beyond our qualifications. For additional information we recommend contacting a licensed foundation contractor for further evaluation.

- ! 3. Large cracks and/or movement was observed in the foundation of the structure at the front left side. This implies that structural movement and/or settlement of the building has occurred. The rate of movement cannot be predicted during a one-time inspection. A thorough evaluation of this condition is beyond our qualifications. For additional information we recommend contacting a licensed foundation contractor for further evaluation.  
[\(See Photo 52\)](#)

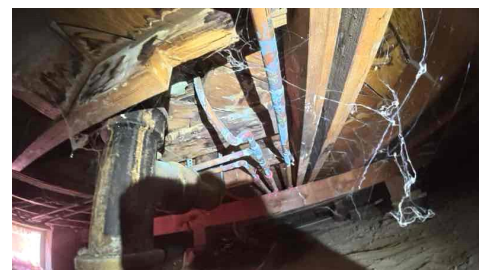
Photo 58

4. The wood members under the primary bathroom show evidence of water damage. We recommend the services of a licensed structural pest control operator for investigation of this condition.

- ! 4. The wood members under the primary bathroom show evidence of water damage. We recommend the services of a licensed structural pest control operator for investigation of this condition.  
[\(See Photo 58\)](#)

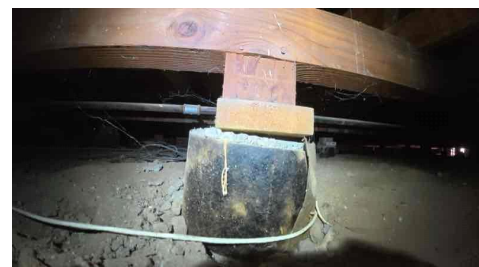
Photo 53

5. Various piers and post at the crawlspace are marginally connected and/or shimmed. We recommend repair or replacement, in accordance with present standards. It is recommended that a qualified licensed contractor be consulted for further advice on structural improvements.

- ! 5. Various piers and post at the crawlspace are marginally connected and/or shimmed. We recommend repair or replacement, in accordance with present standards. It is recommended that a qualified licensed contractor be consulted for further advice on structural improvements.  
[\(See Photo 53\)](#) [\(See Photo 55\)](#)

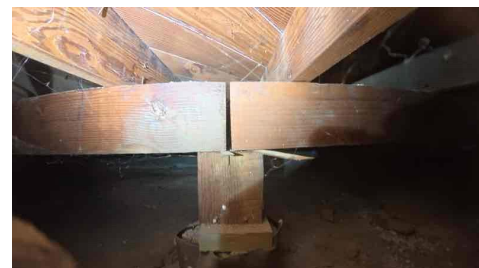
Photo 56

6. The beams at the center of the crawlspace are disconnected/separating. Recommend further evaluation by a licensed foundation contractor.

- ! 6. The beams at the center of the crawlspace are disconnected/separating. Recommend further evaluation by a licensed foundation contractor.  
[\(See Photo 56\)](#)

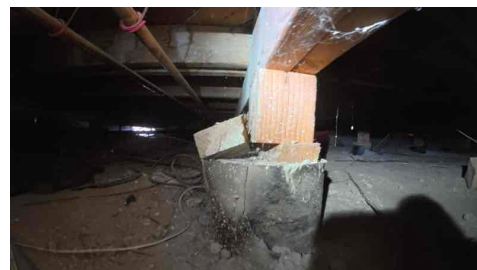
Photo 54

7. Various piers and post are damaged and cracked at the crawl space. We recommend repair or replacement, in accordance with present standards. It is recommended that a qualified licensed contractor be consulted for these repairs  
([See Photo 54](#))

- ! 7. Various piers and post are damaged and cracked at the crawl space. We recommend repair or replacement, in accordance with present standards. It is recommended that a qualified licensed contractor be consulted for these repairs  
[\(See Photo 54\)](#)

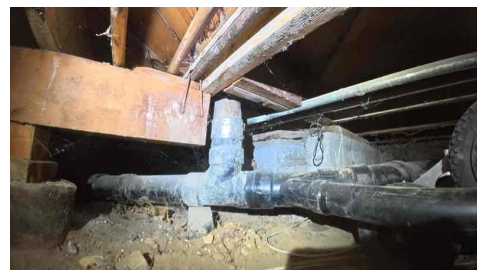
Photo 51

8. The framing at the left side has been notched excessively in the crawl space. We recommend the services of a licensed general contractor.  
([See Photo 51](#))

- ! 8. The framing at the left side has been notched excessively in the crawl space. We recommend the services of a licensed general contractor.  
[\(See Photo 51\)](#)

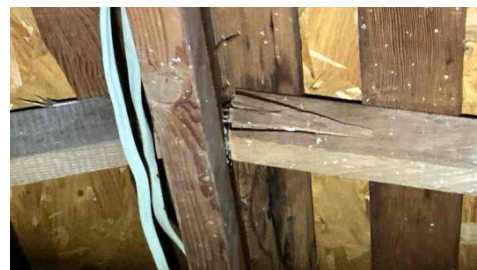
Photo 50

9. One or more roof supports, rafters or joists over the of the attic are disconnected, cracked and/or damaged. This can may affect the integrity of the roof. This area should be investigated and improved by a qualified licensed professional.  
([See Photo 50](#))

- ! 9. One or more roof supports, rafters or joists over the of the attic are disconnected, cracked and/or damaged. This can may affect the integrity of the roof. This area should be investigated and improved by a qualified licensed professional.  
[\(See Photo 50\)](#)

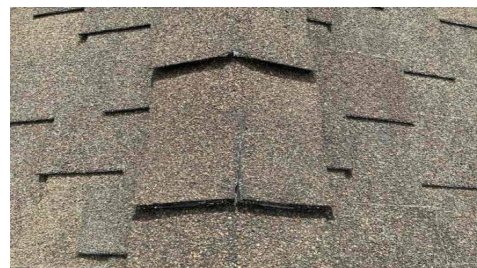
Photo 01

10. Repairs to the roof covering are recommended. Damaged, loose or missing roofing material at the rooftop should be repaired or replaced. All roof penetrations should be examined and sealed as necessary. For further evaluation of the condition of the roof we recommend you consult a licensed roofing contractor.  
([See Photo 1](#)) ([See Photo 5](#)) ([See Photo 6](#))

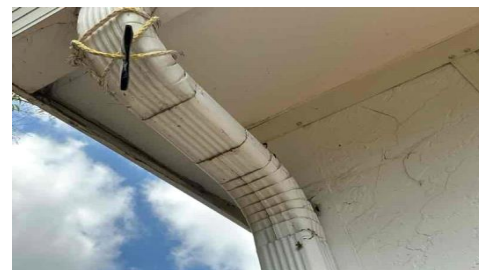
Photo 22

11. Leaks were noted in the downspouts and/or gutters at the rear. During wet weather conditions these areas are more obvious and during dry weather conditions they are noted from the stains at the areas where the leaks have occurred. We recommend all leaks be repaired.

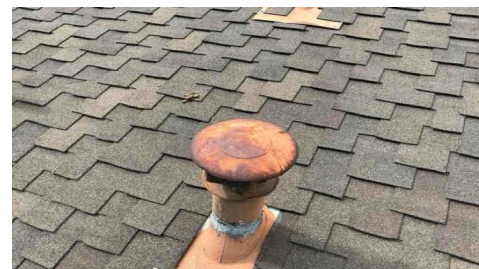
Photo 02

12. All deteriorated or rusted out roof plumbing or appliance vent caps should be replaced.

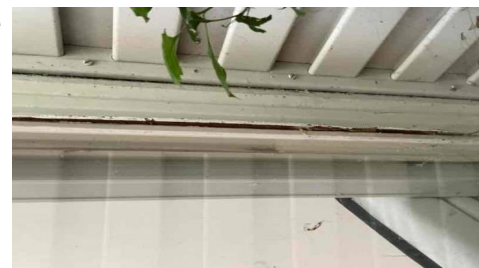
Photo 11

14. Damaged or non-functional exterior window hardware at the right side should be repaired as necessary.

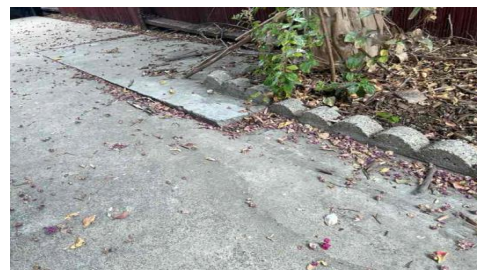
Photo 17

15. The cracked, heaved, or uneven walkway sections at the exterior pose a potential trip hazard. We recommend corrective action to improve safety and reduce the risk of injury. A qualified contractor should assess the affected areas and perform necessary repairs to ensure a level walking surface.

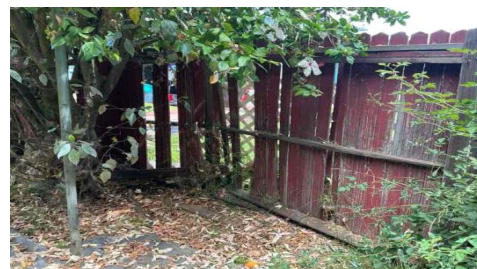
Photo 19

16. The wood fencing at the rear of the property is in need of repairs.

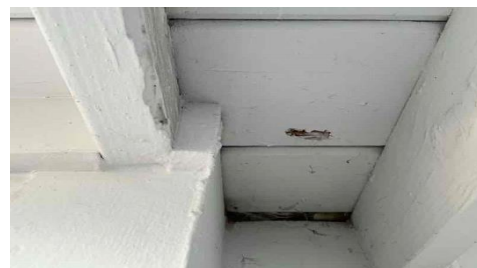
Photo 13

17. Water damage was observed to the roof eaves/sheathing at the front and rear. We recommend the services of a licensed general contractor and/or structural pest control company.

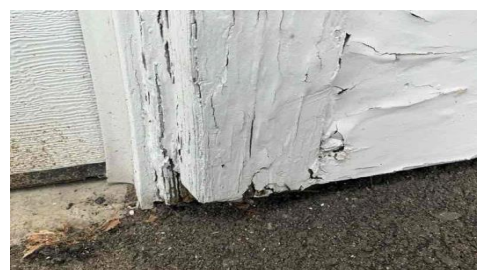
Photo 14

18. Water damage was observed to the exterior trim at the front. We recommend the services of a licensed general contractor and/or structural pest control company.

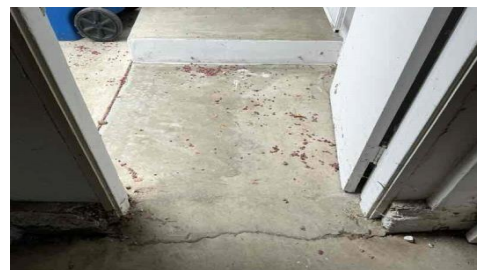
Photo 34

19. A missing or improper threshold was noted at the garage door. We recommend the installation of a threshold that conforms to present building standards. This will also help to avoid possible trip hazards and limit moisture intrusion.

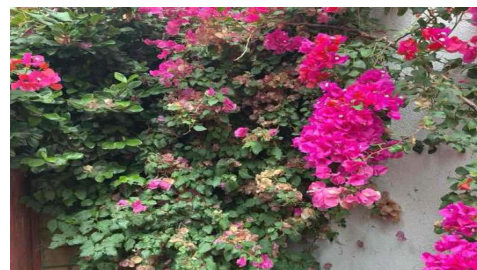
Photo 25

20. Heavy foliage/vegetation was noted at the right side of the structure or property, making this area inaccessible. Reportable conditions may be hidden from inspection. We recommend this area be cleared to allow for further inspection.

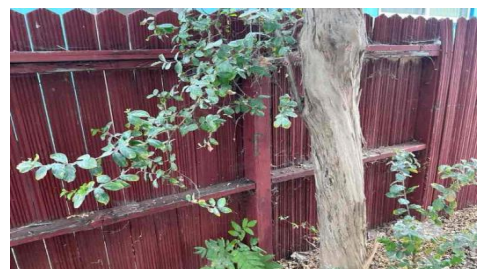
Photo 16

21. Various fence posts are loose. We recommend all loose, damaged or deteriorated posts be reinforced or replaced as necessary.

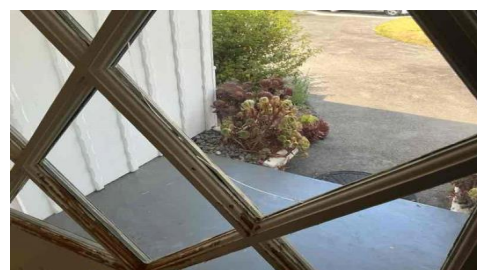
Photo 40

22. Cracked or broken exterior window glass in the door should be replaced.

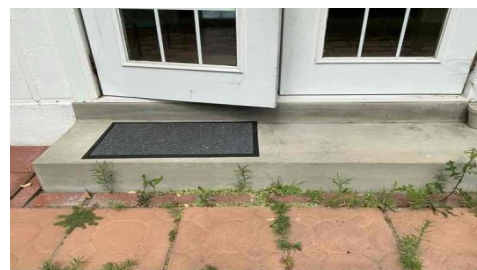
Photo 21

23. The steps at the rear appear to be non-conforming. This could create a potential fall hazard. We recommend the services of a licensed general contractor.

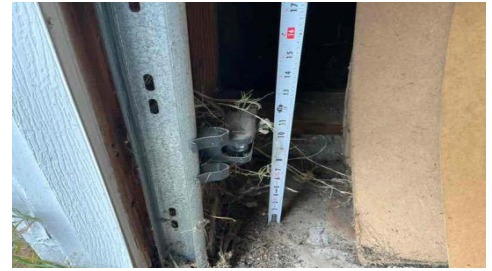
Photo 32

24. The garage door did reverse properly when the infrared detection system for the auto reverse was tested; however, we did note that the detection system for the auto reverse was installed too high from the ground. We recommend proper mounting of the devices on the base of the garage jambs between 4" to 8" inches from the ground as per manufacturers recommendations. Information on the garage door openers is available from the consumer product safety commission at [www.cpsc.gov](http://www.cpsc.gov).

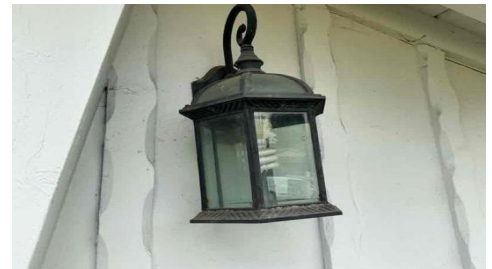
Photo 15

25. The loose light fixtures in the exterior front and hallway should be repaired or replaced.

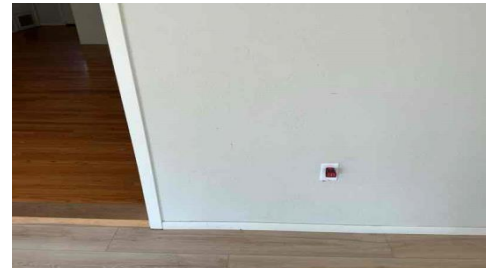
Photo 44

26. Ungrounded "3-prong" outlets at the addition should be improved. A grounded cable or ground wire could be installed at these outlets, the outlet labeled as ungrounded or the original "2-prong" receptacle could be installed. Based upon our inspection of a representative number of outlets, we recommend testing of every outlet. Repairs or rewiring are recommended at all deficient locations. For additional information we recommend a licensed electrician be consulted.

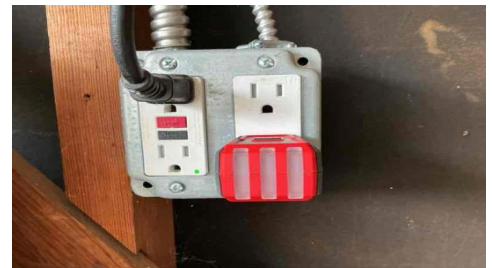
Photo 31

27. One or more outlets at the garage were inoperative at the time of our inspection. Possibly due to turned off switches which were not located during our inspection. These outlets and circuits should be investigated and corrected as necessary. Based upon our inspection of a representative number of outlets, we recommend testing of every outlet at a later date. Repairs or rewiring are recommended at all deficient locations.

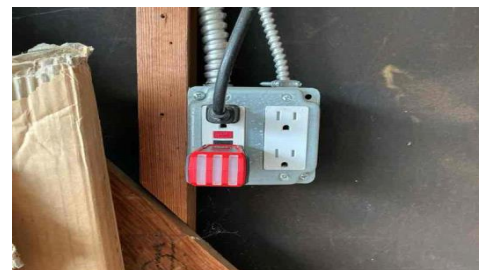
Photo 30

28. A ground fault circuit interrupter (GFCI) outlet at the garage did not function or did not trip when tested with an outside source and/or the test button. This outlet and circuit should be investigated and repaired.

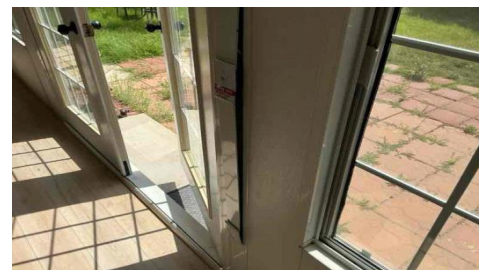
Photo 42

29. The conduit installed at the addition is damaged. We recommend that this conduit be repaired or replaced.

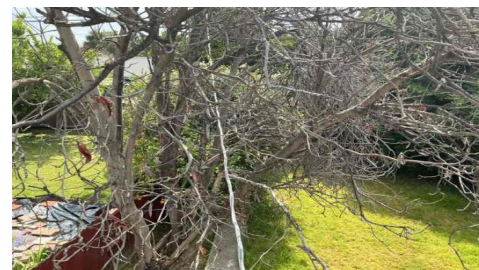
Photo 04

30. Tree limbs should be cut back from the electrical service entrance wires. This work should be done by or coordinated with the utility provider.

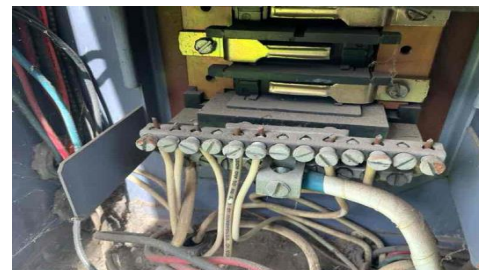
Photo 18

31. Evidence of periodic moisture entry/rust were noted in the interior of the main electrical panel. We recommend further evaluation and improvement of the panel by a licensed electrical contractor.

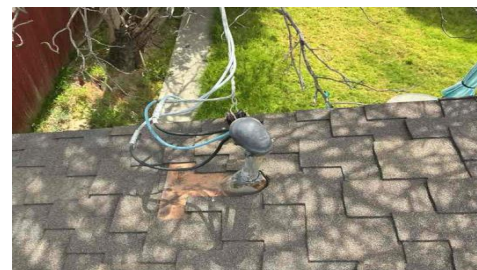
Photo 03

32. The overhead electrical service wires do not have adequate clearance from the driveway (12 feet), walkway (10 feet) and/or building (3 feet). We recommend modification in accordance with present standards. This work should be done by, or coordinated with the local utility service provider.

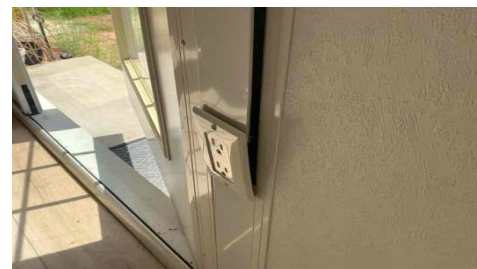
Photo 43

33. The outlet at the addition was noted to be loose and pulling out of the receptacle box. We recommend it be repaired.

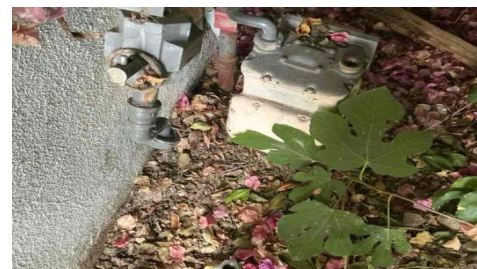
Photo 12

34. There was no gas service at the time of our inspection. We cannot offer opinions about gas appliances, service performance or general state or repair. We recommend inspection by the appropriate trades when service has been restored.

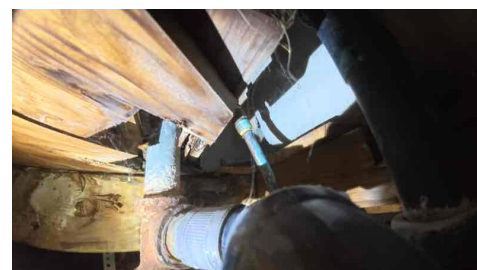
Photo 59

35. The metallic/plastic supply piping is leaking at the crawlspace under the primary bathroom. We recommend all leaks be repaired.

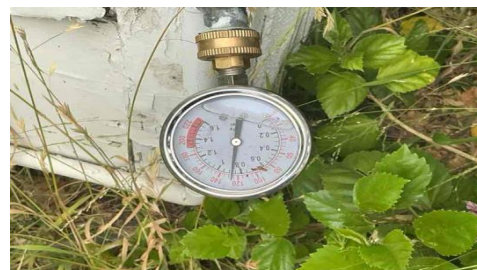
Photo 09

36. The water pressure of the home was tested and found to be 100+ psi. The current pressure is higher than the typical range of 45-75 psi. We recommend contacting a licensed plumber for further evaluation of this condition.

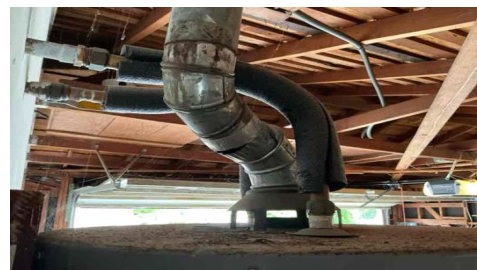
Photo 26

37. For enhanced safety, it is recommended that the loose or damaged connections of the water heater venting system be improved. A minimum of 3 screws at each section of the duct is recommended.

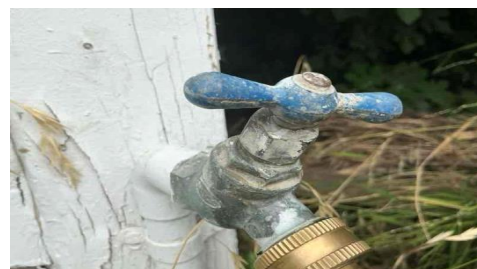
Photo 10

38. The exterior hose bib at the front and left side is leaking. We recommend all leaks be repaired.

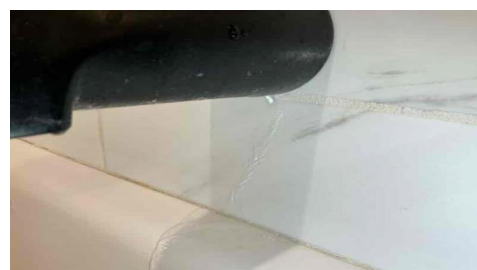
Photo 38

39. The tub spout is leaking at the hall bathroom. We recommend all leaks be repaired.

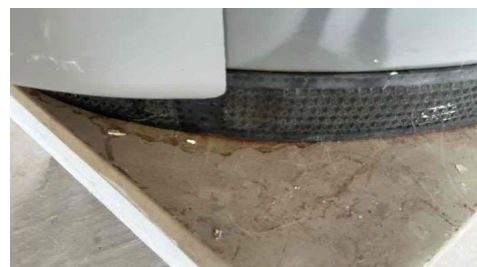
Photo 28

40. Evidence of water stains to the hot water heater stand was observed. We recommend the services of a licensed contractor and/or structural pest control operator.

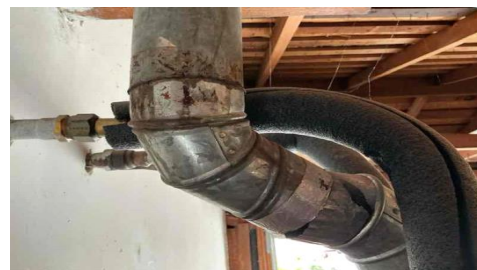
Photo 27

41. The water heater vent was noted to be corroded and leaking. This is a potential hazardous condition and we recommend repair.

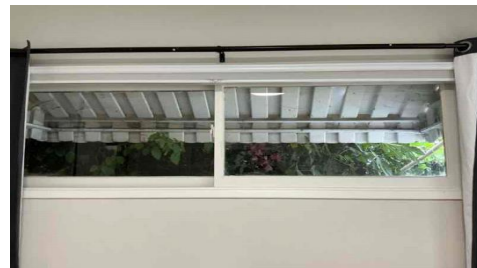
Photo 35

42. The interior windows at the front right bedroom, rear right bedroom, and laundry room are inoperable, stuck, or painted shut. We recommend repair or replacement to restore functional use of these areas.

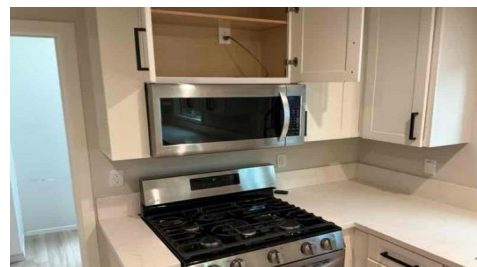
Photo 48

43. There is no "exterior vented" exhaust fan for the gas appliances installed in the kitchen. It is recommended that all gas appliances be vented to the exterior.

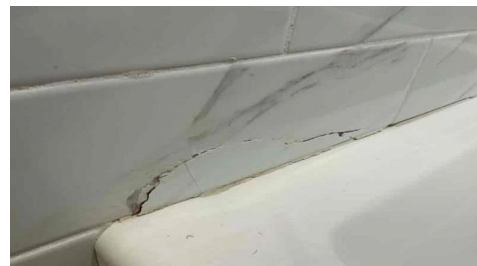
Photo 36

44. The tub walls at the hall bathroom are cracked or damaged and should be replaced. Water leaking through non-sealed areas can cause damage. Damage caused by water seepage cannot be determined by this visual observation.

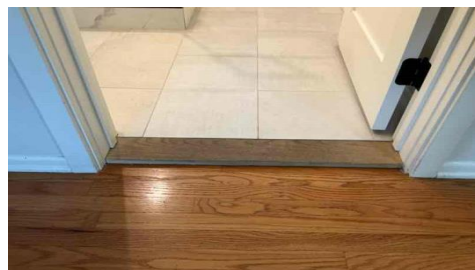
Photo 45

45. A floor threshold at the primary bathroom and rear left bedroom floor is improper. This difference in floor height creates a trip hazard. We recommend a threshold be installed at this floor transition to eliminate this condition.

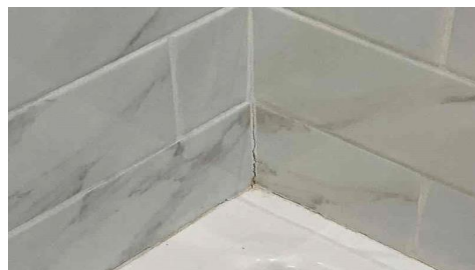
Photo 37

46. Cracked, deteriorated and/or missing grout and caulk should be replaced. Water leaking through non-sealed areas can cause damage. Damage caused by water seepage cannot be determined by this visual observation. A flexible caulking material is recommended rather than rigid cementitious grout.

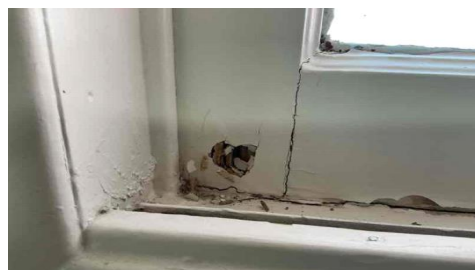
Photo 39

47. The window frame at the rear right bedroom is water damaged. We recommend it be repaired or replaced.

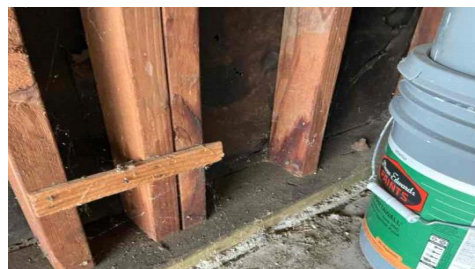
Photo 33

48. The wall at the garage and primary bathroom shows evidence of water stains. It is recommended that the source of the moisture be identified and corrected and the surface be repaired and refinished to restore its appearance.
