WOOD DESTROYING PESTS AND ORGANISMS INSPECTION REPORT

Building Address:		Date of Inspection	Number of Pages
7202 E. La Cumbre Dr., Orange, CA 92869		10/15/2025	6
<div> <div>

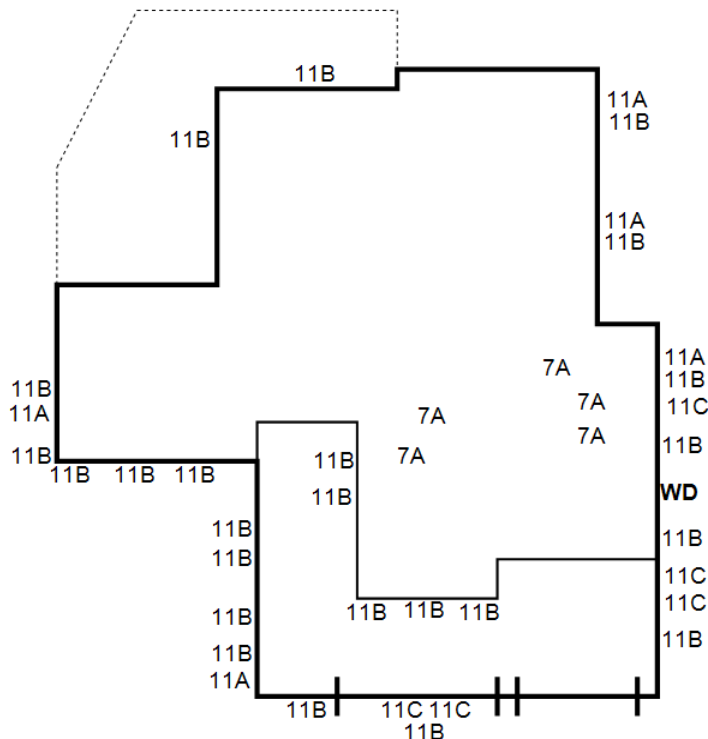
This Diagram is not to scale

7A PRICE: \$2,690.00 (Section I)
FINDINGS: Evidence of drywood termite infestation noted at time of inspection.
RECOMMENDATION: Vacate the premises and seal the structure for fumigation. Remove or cover accessible evidence of infestation. Fumigation awareness notice must be signed prior to fumigation. See fumigation notice for terms and liabilities. Fumigation warranty three years.

11A PRICE: See 7A (Section I)
FINDINGS: Evidence of drywood termite infestation noted at time of inspection.
RECOMMENDATION: Vacate the premises and seal the structure for fumigation. Remove or cover accessible evidence of infestation. Fumigation awareness notice must be signed prior to fumigation. See fumigation notice for terms and liabilities. Fumigation warranty three years.

- 11B PRICE: \$4,340.00 (Section I)
FINDINGS: Evidence of termite damaged wood members noted at time of inspection.
RECOMMENDATION: Repair or replace termite damaged wood members as required. Bugmasters is not responsible for any damage to roofing materials that may occur during repairs made to roof members.
- 11C PRICE: \$760.00 (Section I)
FINDINGS: Dry-rot wood members found at time of inspection.
RECOMMENDATION: Replace dry-rot damaged wood members, as necessary. Bugmasters is not responsible for any damage to roofing materials that may occur during repairs made to roof eve members. If additional adverse conditions are uncovered during repairs, further inspection will be recommended, and a supplemental report will be issued indicating any additional costs.

NOTE: Weathered door noted, could have possible cosmetic damage. Contact proper tradesman to inspect and repair if deemed necessary by parties involved. See "WD" on diagram.
