WOOD DESTROYING PESTS AND ORGANISMS INSPECTION REPORT

Building Address: 6403 Paramount Blvd., Pico Rivera, CA 90660		Date of Inspection 02/14/2024	Number of Pages 6
West Coast Termite Inc. 1408 ANAHEIM STREET Harbor City CA 90710 Phone: (424) 249-2013 Fax: (424) 263-5470		Report # W10908	Lic. Registration # PR 7103
		Escrow #	
Ordered by: Steve Sanchez 6403 Paramount Blvd. Pico Rivera, CA 90660	Property Owner and/or Party of Interest: Steve Sanchez 6403 Paramount Blvd. Pico Rivera, CA 90660	Report Sent to: Steve Sanchez 6403 Paramount Blvd. Pico Rivera, CA 90660	
COMPLETE REPORT <input checked="" type="checkbox"/> LIMITED REPORT <input type="checkbox"/> SUPPLEMENTAL REPORT <input type="checkbox"/> REINSPECTION REPORT <input type="checkbox"/>			
General Description:		Inspection Tag Posted: Attic	
		Other Tags Posted: None	
An inspection has been made of the structure(s) shown on the diagram in accordance with the Structural Pest Control Act. Detached porches, detached steps, detached decks and any other structures not on the diagram were not inspected.

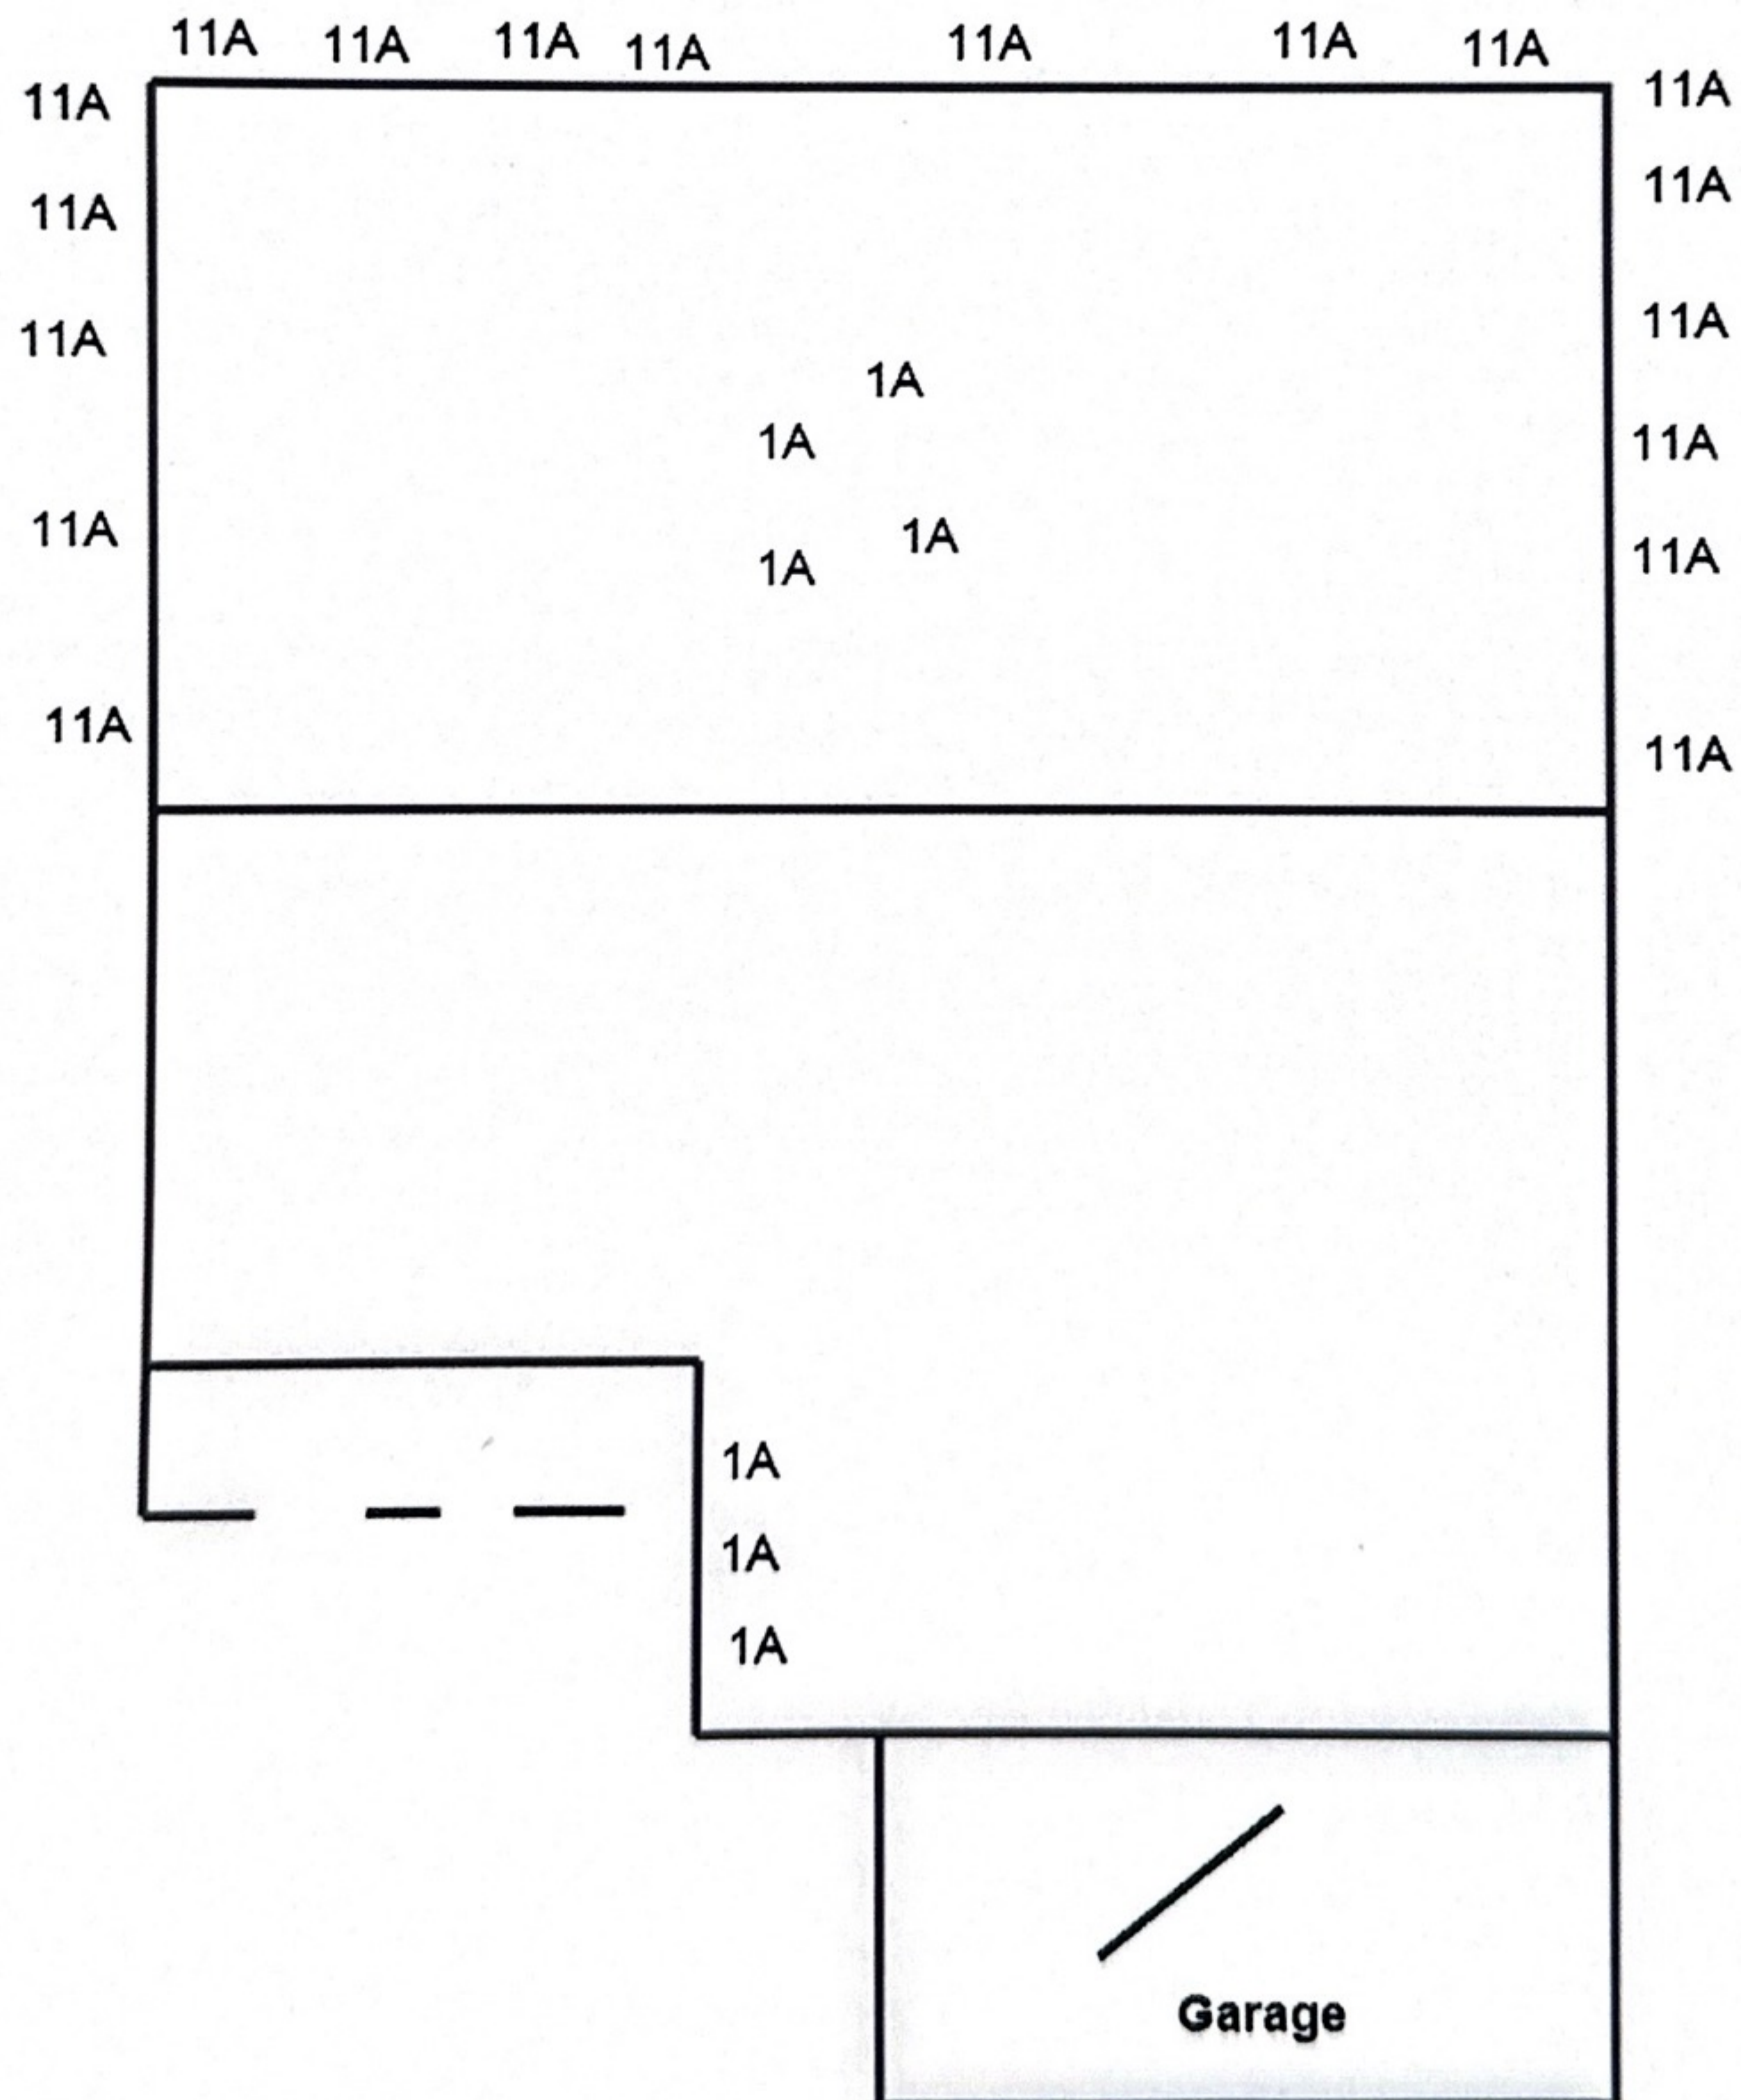
Front of House

Substructure: drywood termites found at sub flooring / joist, WEST COAST WILL TREAT ALL SOIL UNDER HOME TO HELP PREVENT SUB TERMITES

1A PRICE: \$2,200.00 (Section I)
FINDINGS: Evidence of drywood termite infestations at ? as indicated on the diagram.
RECOMMENDATION: Vacate the premises and seal the structure for fumigation with Vikane Gas. Remove or cover accessible evidence of infestation. Fumigation warranted for 2 years Fumigation awareness notice must be signed prior to fumigation. See fumigation notice for terms and liabilities.

Other Exterior: drywood termites found at siding, rafter tails, rim joists

11A PRICE: \$.00 (Section I)
FINDINGS: Evidence of drywood termite infestations at ? as indicated on the diagram.
RECOMMENDATION: Vacate the premises and seal the structure for fumigation with Vikane Gas. Remove or cover accessible evidence of infestation. Fumigation warranted for 2 years Fumigation awareness notice must be signed prior to fumigation. See fumigation notice for terms and liabilities.
