WOOD DESTROYING PESTS AND ORGANISMS INSPECTION REPORT

Building Address: 530-532 Almond Ave, Long Beach, CA 90802		Date of Inspection 03/18/2024	Number of Pages 12
 	Impressive Exterminating 1030 N. Mountain Ave. #319 Ontario, CA 91762 Office: (951) 279-3100 Fax: (800) 380-2780 www.impressiveexterminating.com EPA#: NAT-F117372-1		Report # W29489
			Lic. Registration # PR 5080
			Escrow #
Ordered by: Synergy One Real Estate Services Christian Hernandez 3811 bedford Canyon Rd. 101 Corona, CA 92883	Property Owner and/or Party of Interest: Synergy One Real Estate Services Christian Hernandez 3811 bedford Canyon Rd. 101 Corona, CA 92883	Report Sent to: Synergy One Real Estate Services Christian Hernandez 3811 bedford Canyon Rd. 101 Corona, CA 92883	
COMPLETE REPORT <input checked="" type="checkbox"/> LIMITED REPORT <input type="checkbox"/> SUPPLEMENTAL REPORT <input type="checkbox"/> REINSPECTION REPORT <input type="checkbox"/>			
General Description: One story (front unit), two story (back unit above Garage), gabled composition roof, wood (front unit) and stucco (back unit), occupied/furnished, raised foundation (front unit) and slab foundation (back unit) with attached to back unit, o

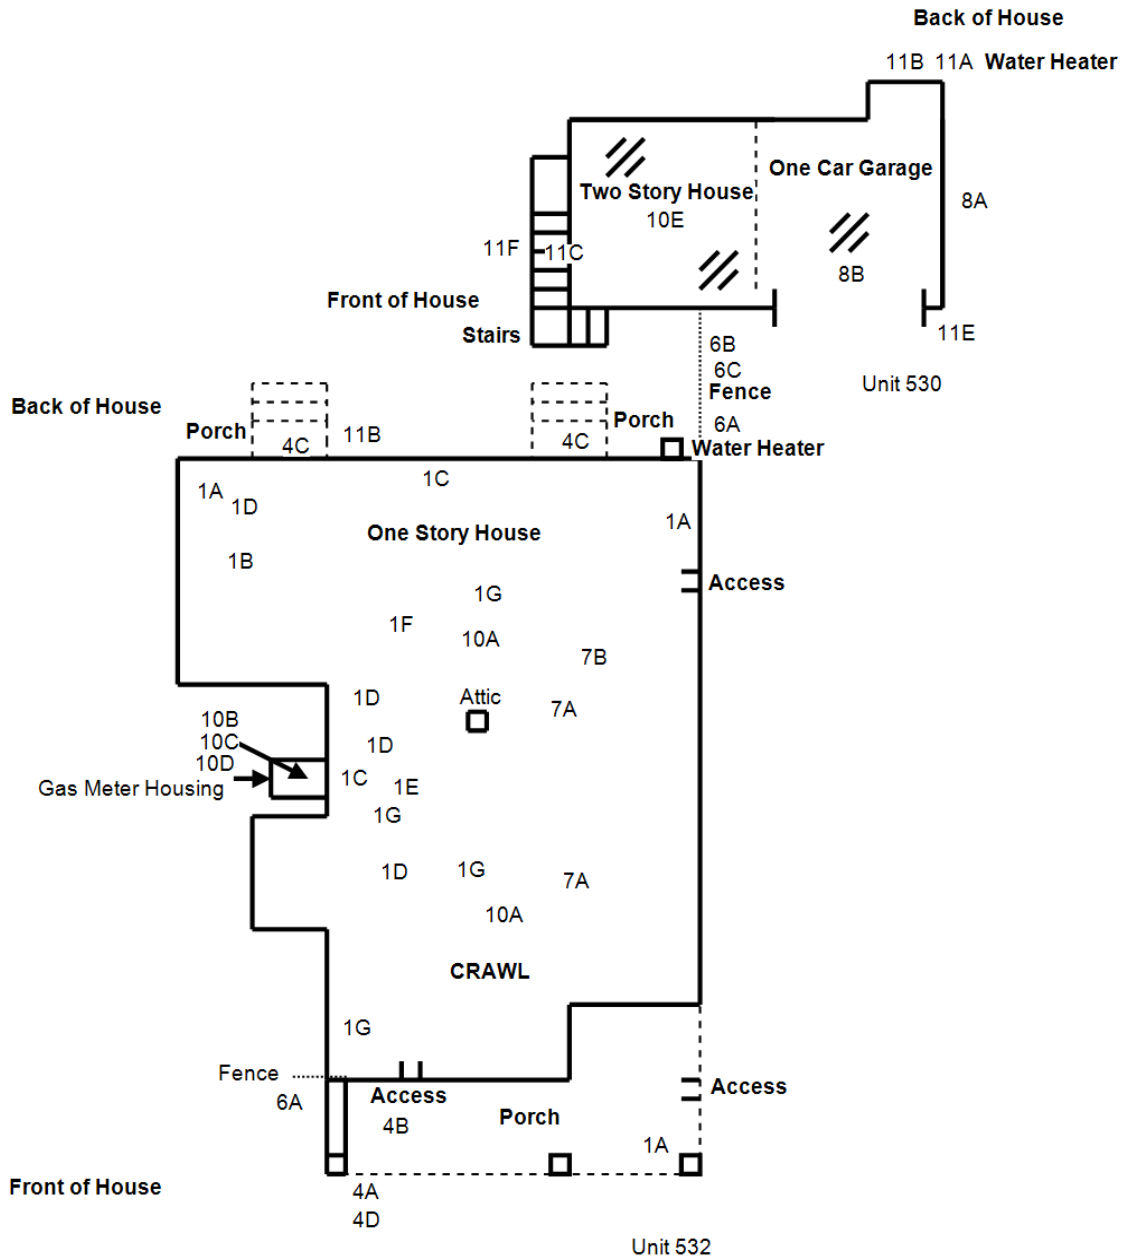
This Diagram is not to scale

- 1A PRICE: \$2,155.00 (Section I)
FINDINGS: Evidence of dry-wood termite infestations at Subarea Subflooring as indicated on the diagram.
RECOMMENDATION: Vacate the premises and seal the structure for fumigation with Vikane Gas. Remove or cover accessible evidence of infestation. Fumigation warranted for two years. Fumigation awareness notice must be signed prior to fumigation. See fumigation notice for terms and liabilities.
We are not responsible for Roof Damage Initials: owner/agent _____

- 1B PRICE: \$250.00 (Section I)
FINDINGS: Evidence of subterranean termite infestation at Foundation Wall as indicated on the diagram.
RECOMMENDATION: Pressure "ROD" treat, foam, trench application or low pressure spot spray as necessary. Break accessible sub tubes.

- 1D PRICE: Informational (Section II)
FINDINGS: Earth-wood contacts visible at time of inspection at Subarea Supports/bracking as indicated on the diagram.
RECOMMENDATION: Break earth-wood contact and or heavily treat wood members where conditions are deemed likely to lead to infestation.

- 4A PRICE: See 1A (Section I)
FINDINGS: Evidence of dry-wood termite infestations at Porch Flooring, Supports & Railing as indicated on the diagram.
RECOMMENDATION: Vacate the premises and seal the structure for fumigation with Vikane Gas. Remove or cover accessible evidence of infestation. Fumigation warranted for two years. Fumigation awareness notice must be signed prior to fumigation. See fumigation notice for terms and liabilities.
We are not responsible for Roof Damage Initials: owner/agent _____

- 4B PRICE: Unknown (Further Inspection)
FINDINGS: Dry-rot wood members found at time of inspection at Porch at Porch as indicated on the diagram. Caused by normal weather conditions/elements and or lack of rain gutters.
RECOMMENDATION: Recommend that Flooring be opened for further inspection.

- 4D PRICE: See 6C (Section I)
FINDINGS: Evidence of drywood termite damaged wood members noted at time of inspection at Porch Supports and Railing as indicated on the diagram.
RECOMMENDATION: Repair/Patch/Reinforce termite damaged wood members as necessary. No painting or primer is included in this estimate. When replacing damaged wood, we will only use standard regular soft pine wood. If additional adverse conditions are uncovered during repairs, further inspection will be recommended and a supplemental report will be issued indicating any infection, or additional repairs.

- 6A PRICE: Informational (Section II)
FINDINGS: Earth-wood contacts visible at time of inspection at Fence as indicated on the diagram.
RECOMMENDATION: Break earth-wood contact and or heavily treat wood members where conditions are deemed likely to lead to infestation.
- 6B PRICE: See 1A (Section I)
FINDINGS: Evidence of dry-wood termite infestations at Fence Posts as indicated on the diagram.
RECOMMENDATION: Vacate the premises and seal the structure for fumigation with Vikane Gas. Remove or cover accessible evidence of infestation. Fumigation warranted for two years. Fumigation awareness notice must be signed prior to fumigation. See fumigation notice for terms and liabilities.
We are not responsible for Roof Damage Initials: owner/agent _____

- 6C PRICE: \$1,690.00 (Section I)
FINDINGS: Evidence of drywood termite damaged wood members noted at time of inspection at Fence Post as indicated on the diagram.
RECOMMENDATION: Repair/Patch/Reinforce termite damaged wood members as necessary. No painting or primer is included in this estimate. When replacing damaged wood, we will only use standard regular soft pine wood. If additional adverse conditions are uncovered during repairs, further inspection will be recommended and a supplemental report will be issued indicating any infection, or additional repairs.

- 7A PRICE: See 1A (Section I)
FINDINGS: Evidence of dry-wood termite infestations at Attic Framing as indicated on the diagram.
RECOMMENDATION: Vacate the premises and seal the structure for fumigation with Vikane Gas. Remove or cover accessible evidence of infestation. Fumigation warranted for two years. Fumigation awareness notice must be signed prior to fumigation. See fumigation notice for terms and liabilities.
We are not responsible for Roof Damage Initials: owner/agent _____
- 7B PRICE: Unknown (Further Inspection)
FINDINGS: Few dry water stains noted at time of inspection at Attic Roof Sheathing. Cosmetic only and no signs of a leak, at time of the inspection. <Impressive Exterminating> does not guarantee the presence or non-presence of any leaks or hidden damage from same.
RECOMMENDATION: Recommend a proper tradesman be called to correct, if deemed necessary.

- 10C PRICE: See 1A (Section I)
FINDINGS: Evidence of dry-wood termite infestations at Interior Gas Meter Housing as indicated on the diagram.
RECOMMENDATION: Vacate the premises and seal the structure for fumigation with Vikane Gas. Remove or cover accessible evidence of infestation. Fumigation warranted for two years. Fumigation awareness notice must be signed prior to fumigation. See fumigation notice for terms and liabilities.
We are not responsible for Roof Damage Initials: owner/agent _____

- 10D PRICE: Unknown (Section I)
FINDINGS: Evidence of drywood termite damaged wood members noted at time of inspection at Interior Door as indicated on the diagram.
RECOMMENDATION: Recommend a proper licensed tradesman be called to correct as necessary

- 11A PRICE: See 1A (Section I)
FINDINGS: Evidence of dry-wood termite infestations at exterior Back Unit Water Heater Framing as indicated on the diagram.
RECOMMENDATION: Vacate the premises and seal the structure for fumigation with Vikane Gas. Remove or cover accessible evidence of infestation. Fumigation warranted for two years. Fumigation awareness notice must be signed prior to fumigation. See fumigation notice for terms and liabilities.
We are not responsible for Roof Damage Initials: owner/agent _____

- 11B PRICE: See 6C (Section I)
FINDINGS: Dry-rot wood members found at time of inspection at exterior Back Unit Water Heater Dooras indicated on the diagram. Caused by normal weather conditions/elements and or lack of rain gutters.
RECOMMENDATION: Replace/Reinforce/Repair/Patch/Cut Ends dry-rot damaged wood members as necessary. No painting or Primer is included in this estimate. When replacing damaged wood, we will only use standard regular soft pine wood.
