# Confidential Inspection Report

522 Ave. F  
Redondo Beach CA 90277

July 24, 2025

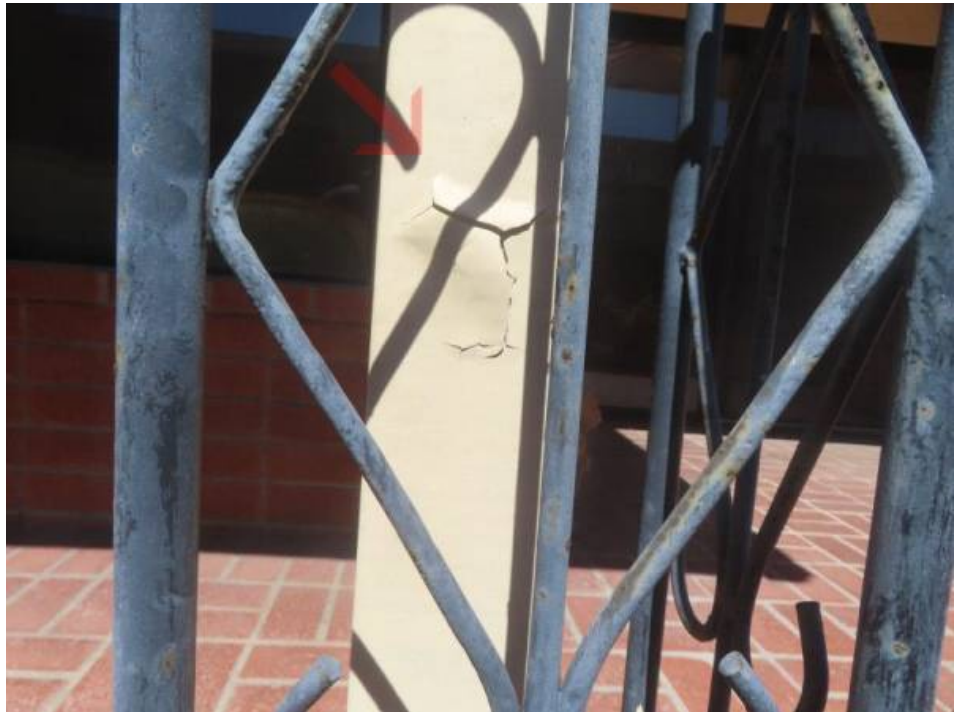
MAINTENANCE: Paint is deteriorated, loose or peeling. We recommend painting at this time to protect the wood from further deterioration and to enhance its appearance.

Electrical doors are bowed and don't close properly.

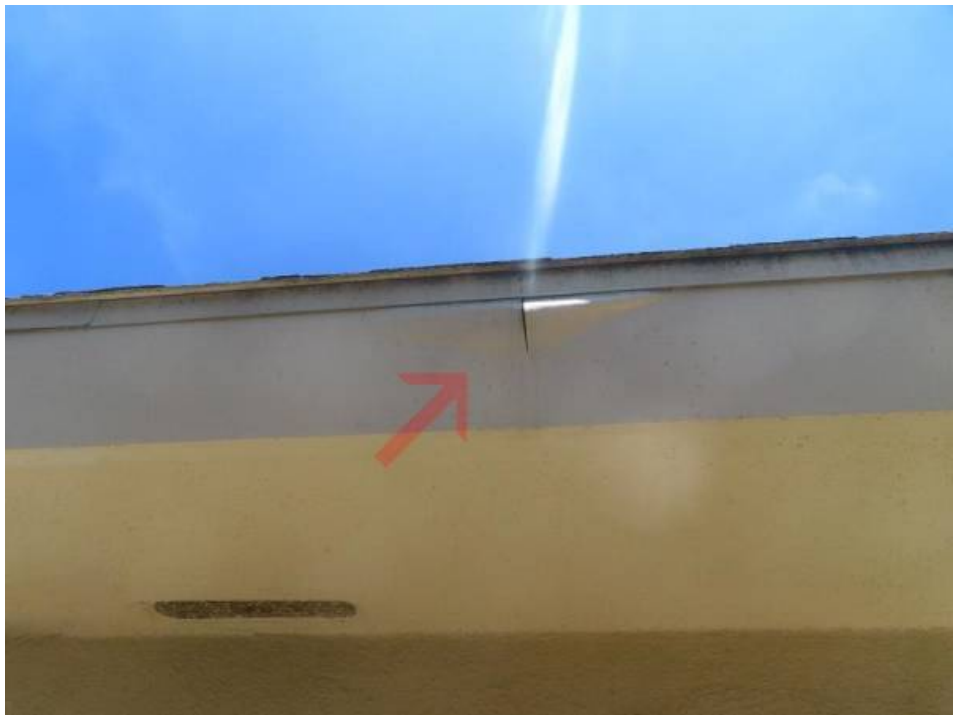
MAINTENANCE: Paint is deteriorated, loose or peeling. We recommend painting at this time to protect the wood from further deterioration and to enhance its appearance.

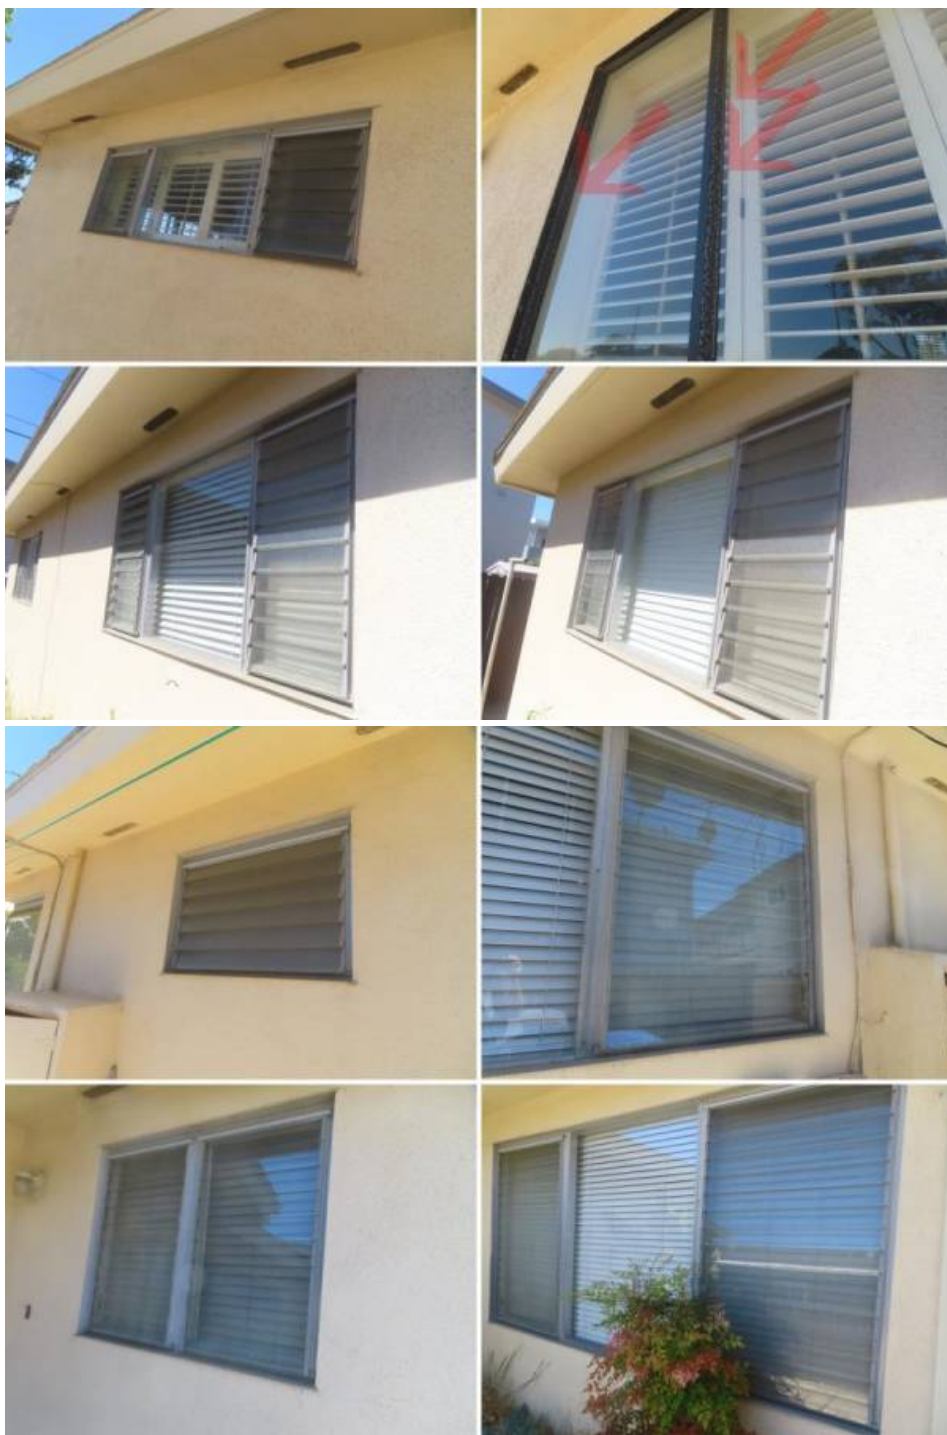
MAINTENANCE: Screen was damaged at one or more windows sampled.

MAINTENANCE: Metal frame is corroded at one or more windows sampled. We recommend further evaluation by a licensed window installer.

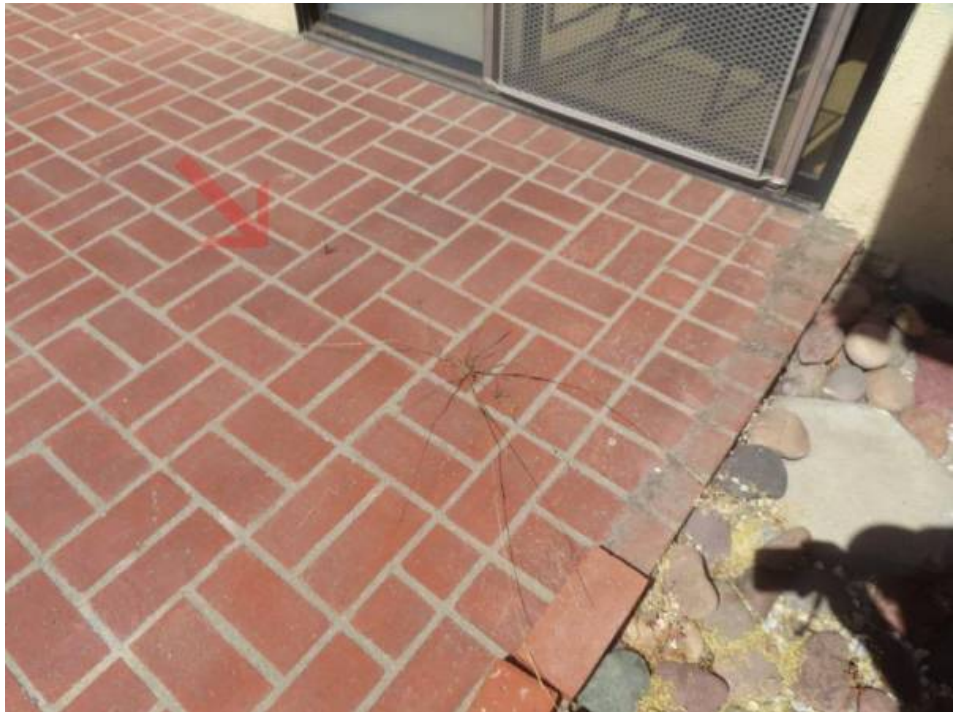
522 entry.

MONITOR: Small cracks viewed in the paving appear to be typical of settlement or shrinkage. We recommend monitoring cracks from time to time. Change in the size or number of cracks may be symptomatic of other conditions such as defective drainage, settlement or soil movement and should be further evaluated by a licensed concrete contractor.

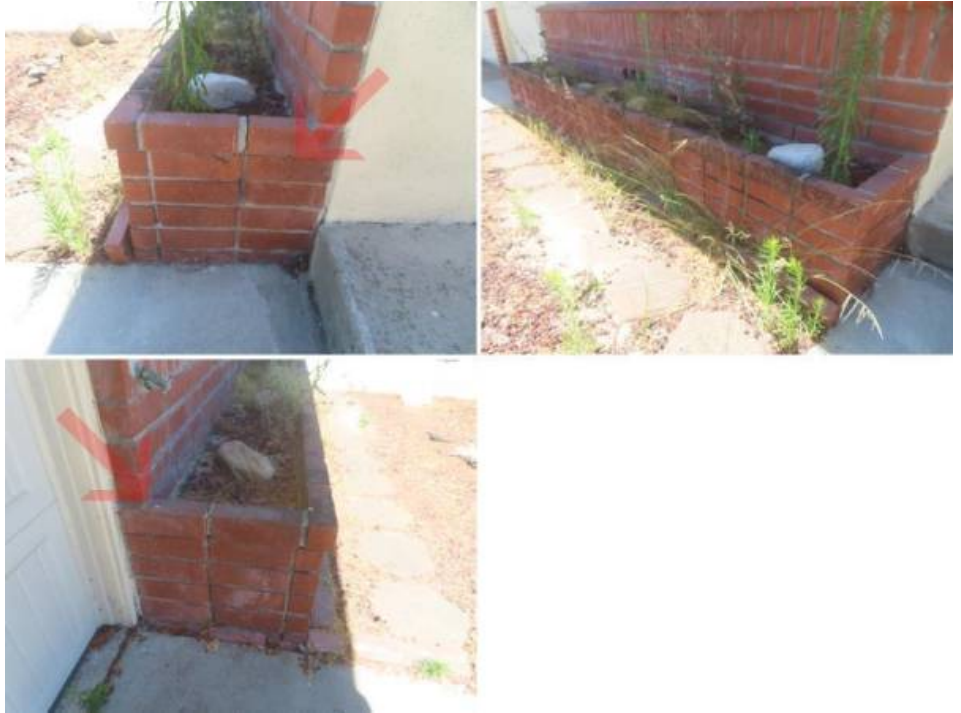
DEFECTIVE: Large cracks. We recommend further evaluation by a licensed masonry contractor. Where displacement is caused by tree roots we recommend consulting with a licensed landscaping contractor or arborist for remedial advice.

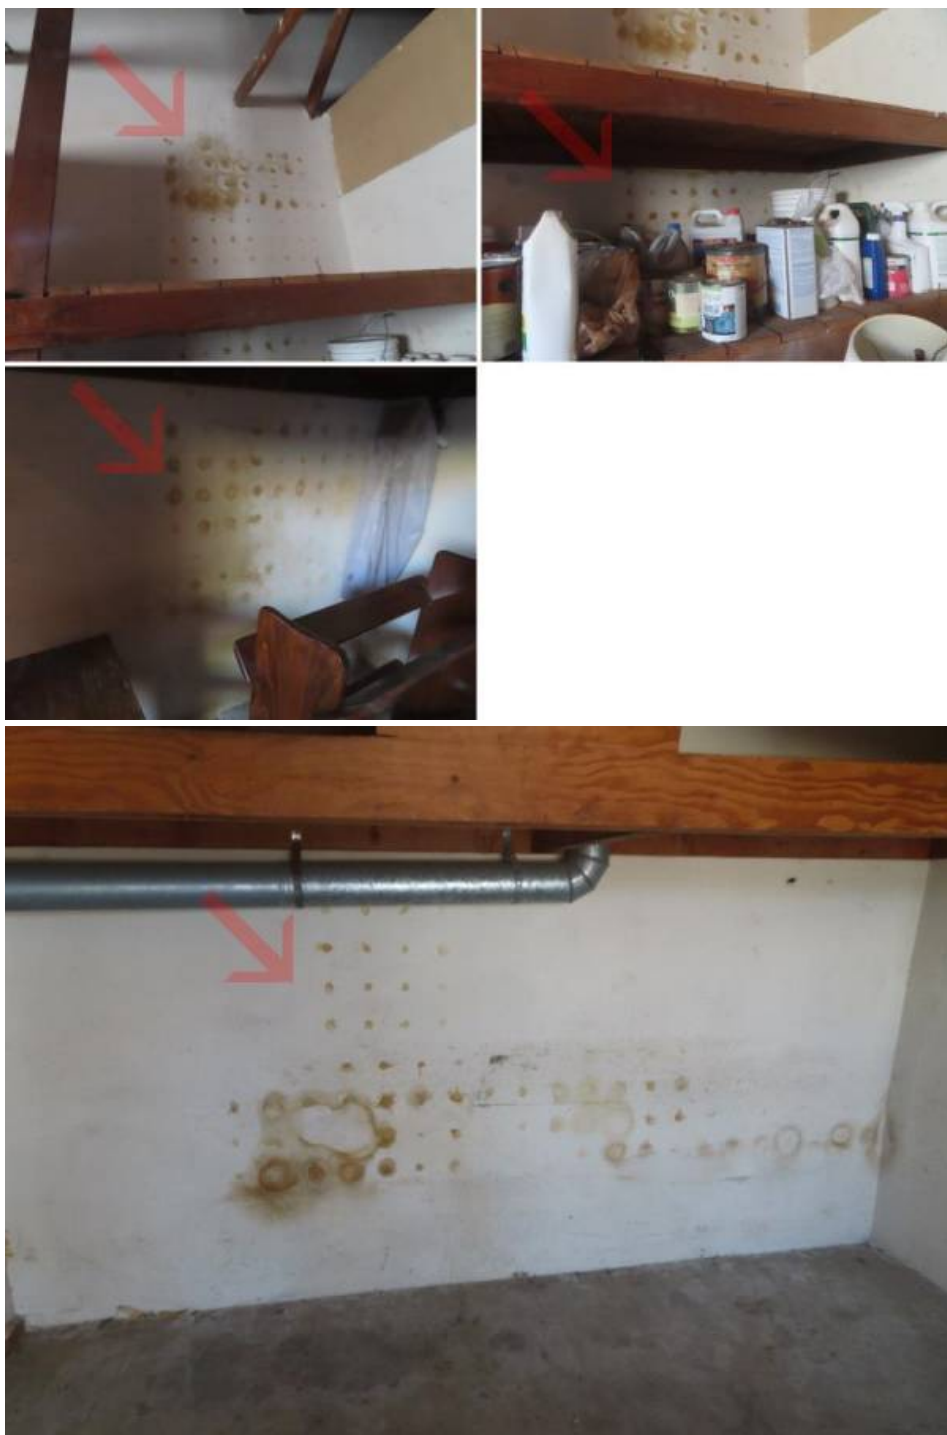
DEFERRED: Moisture stains noted at the ceiling/walls were dry at the time of our inspection. We could not determine if the stains are from an intermittent or repaired leak.

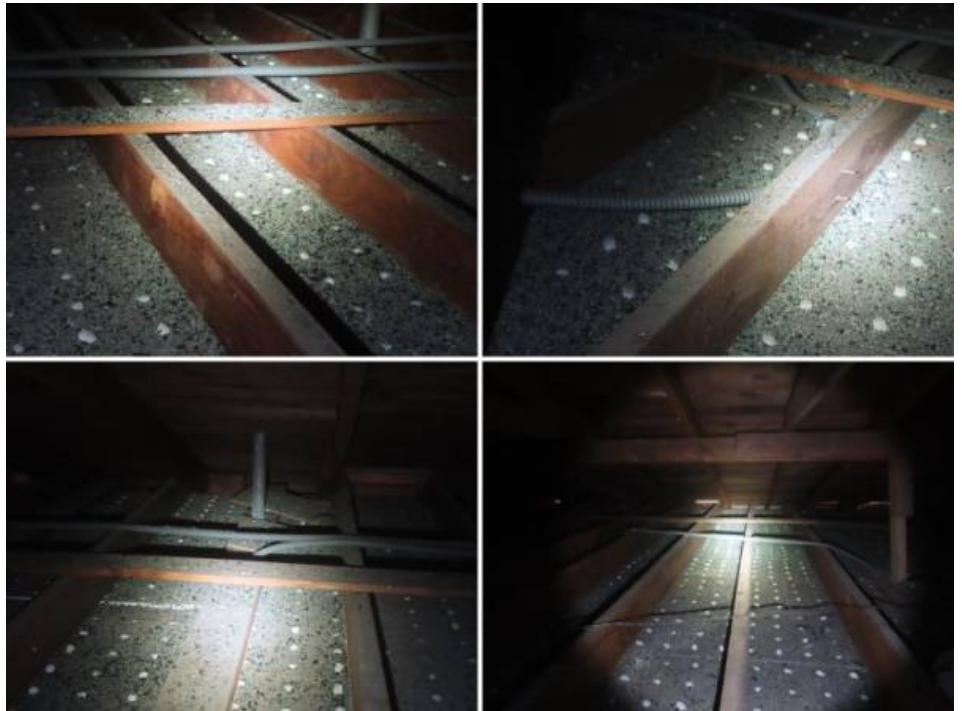
None installed. We recommend installing insulation for energy conservation reasons.

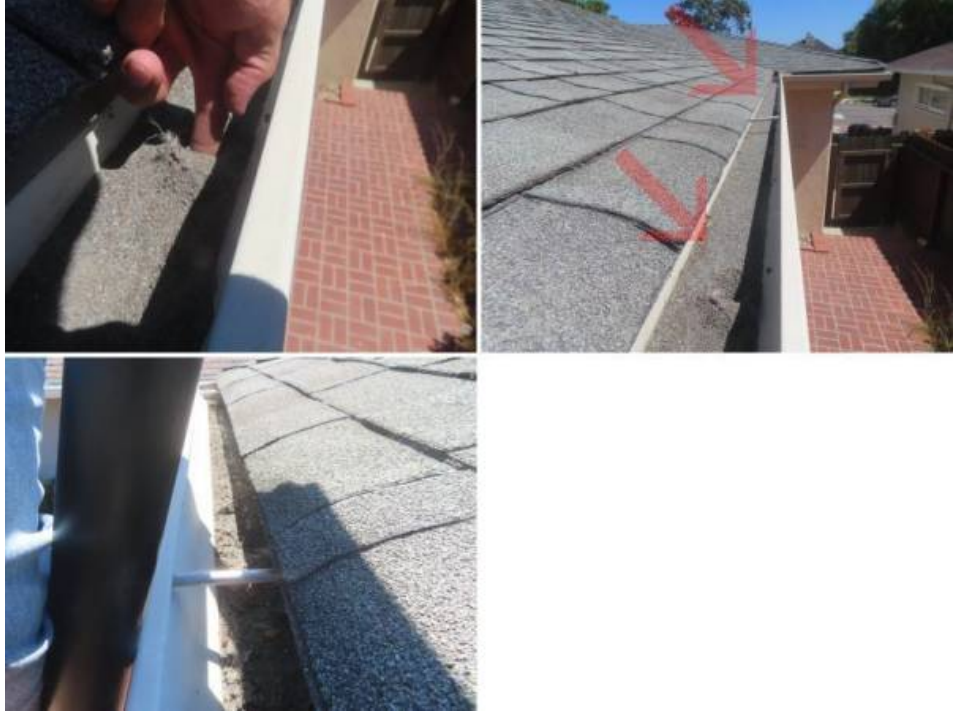
MAINTENANCE: Debris noted in the gutters. We recommend cleaning the gutters now and prior to each rainy season and periodically as needed.

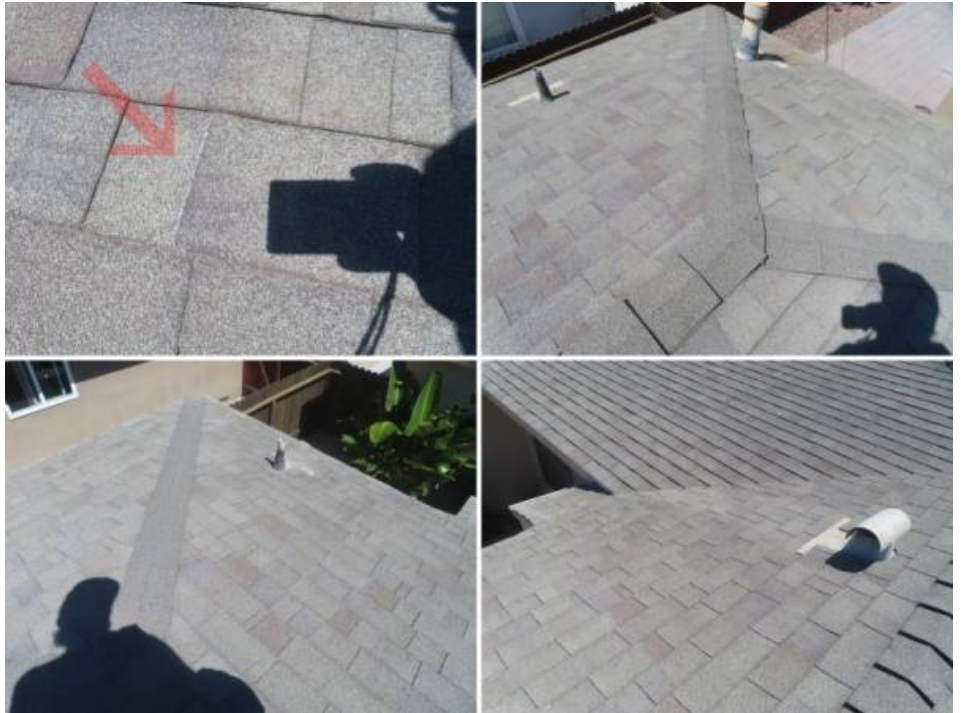
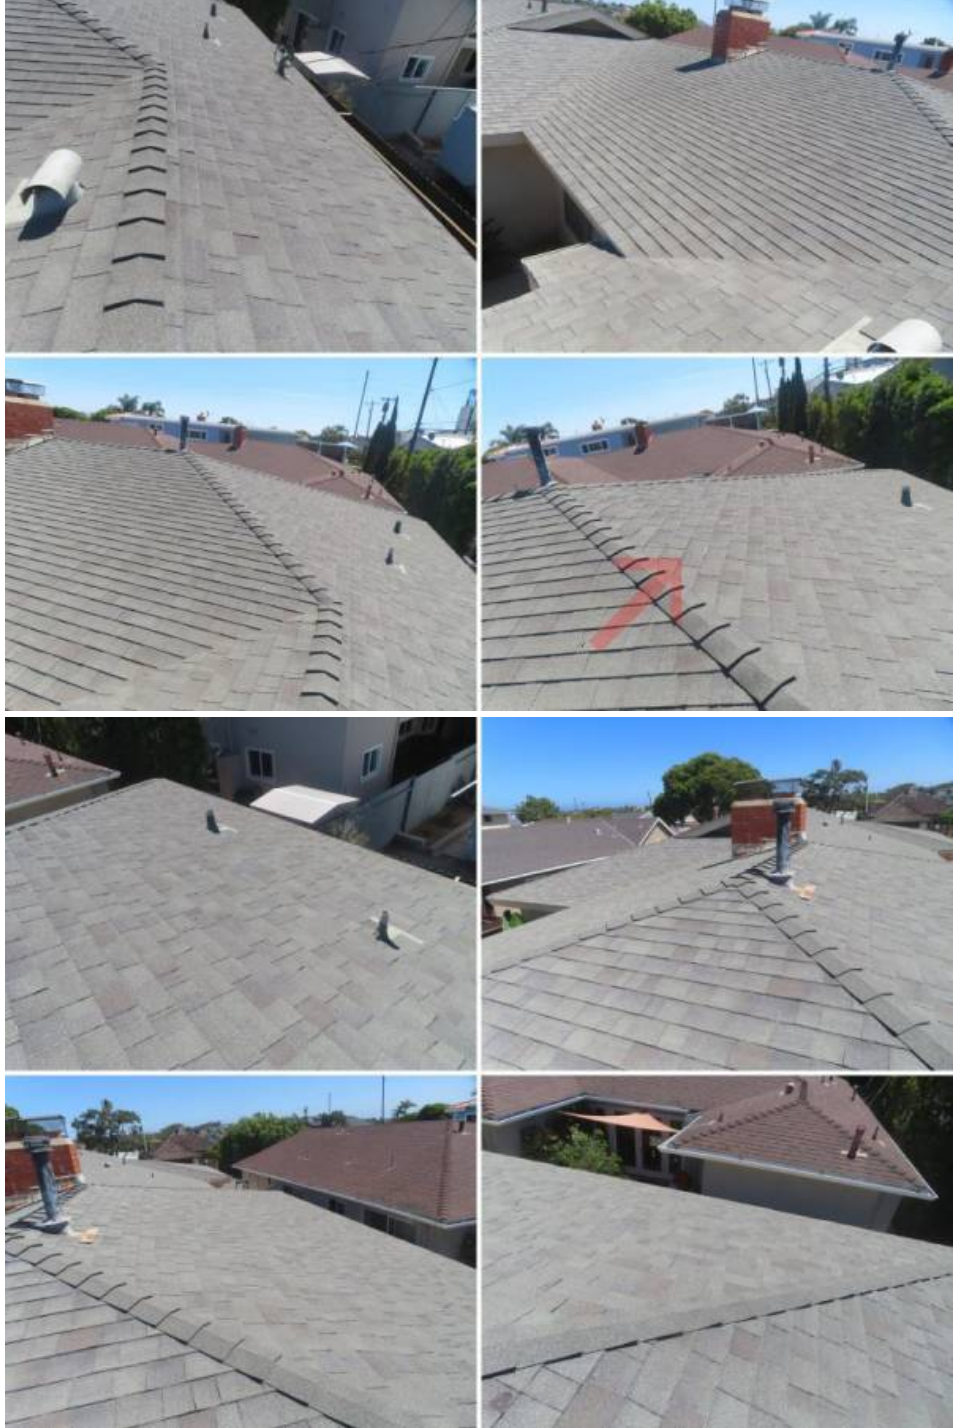
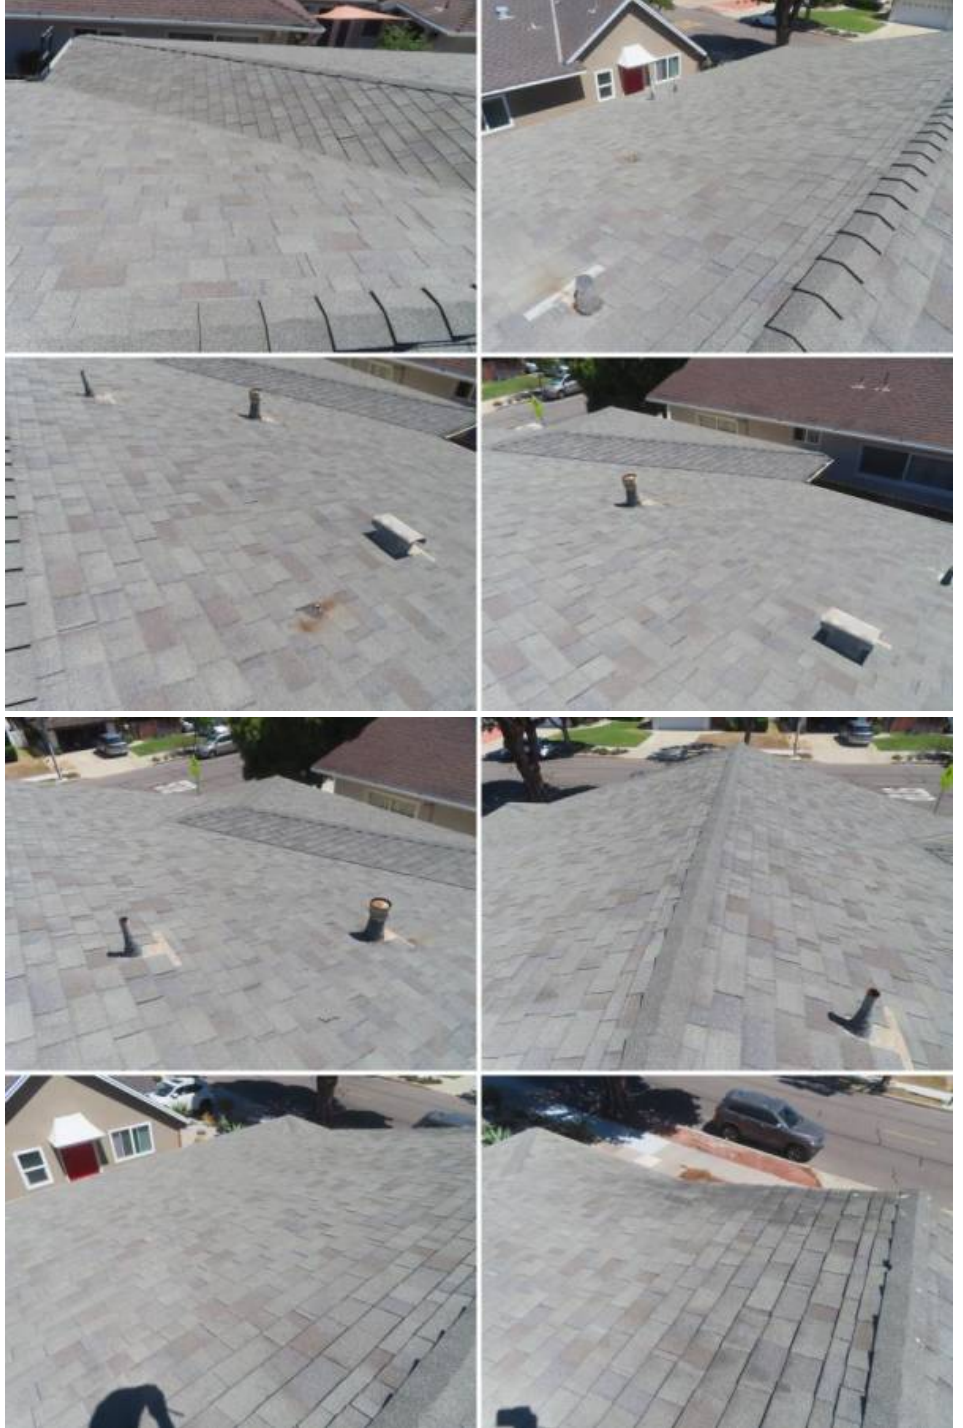
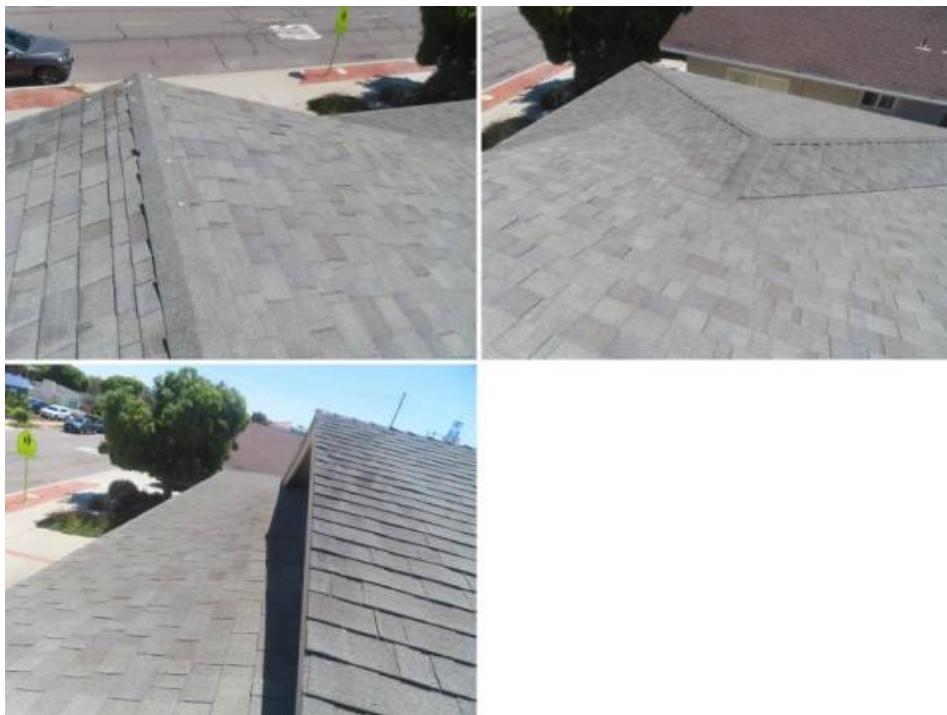
Roof is beginning to wear, roofing materials are washing into the gutters.

MONITOR: Older roof, appears to be at or near the end of its design life. We recommend further evaluation by a licensed roofer and suggest budgeting for a new roof in the near future.

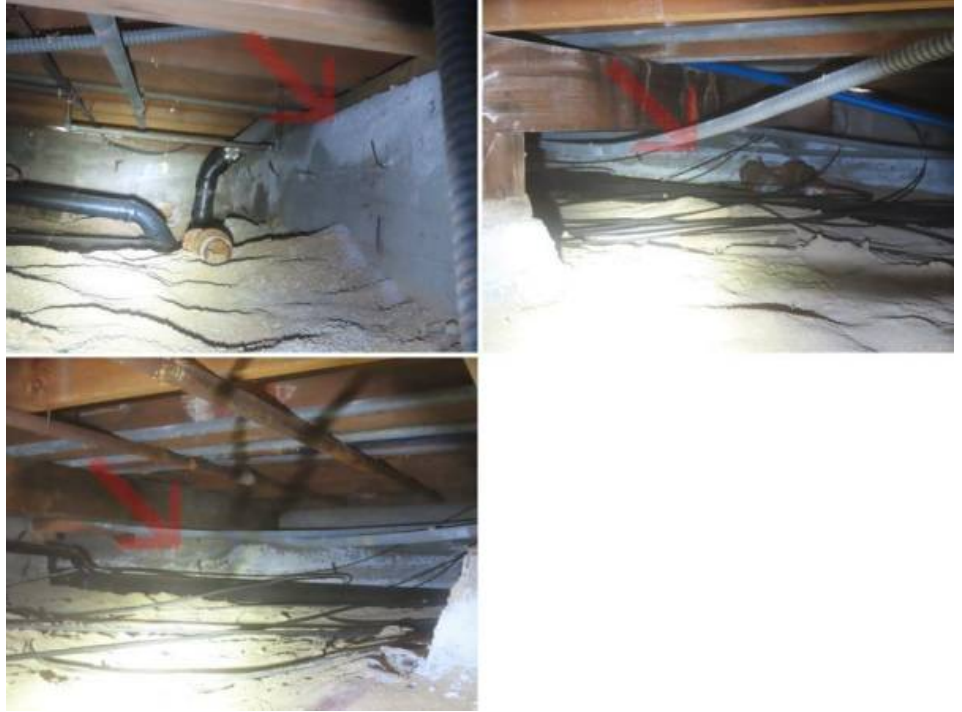
Likely from past plumbing issue.

DEFERRED: Efflorescence noted in the sub area. Efflorescence is a powdery crystalline substance caused by excessive moisture. In severe cases deterioration of the concrete and embedded structural steel products can result.

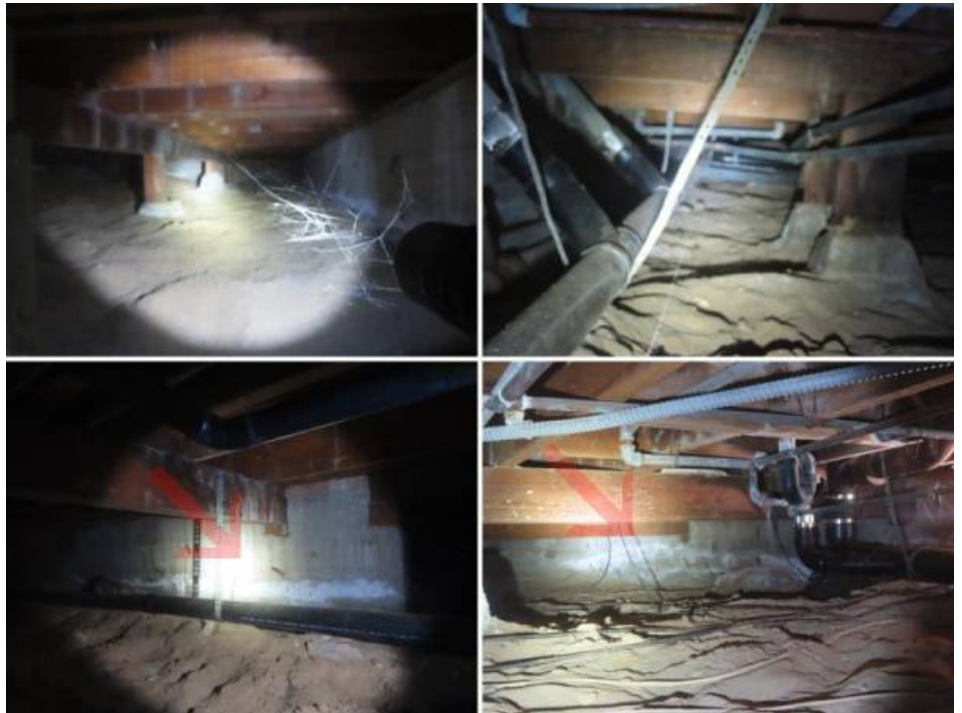
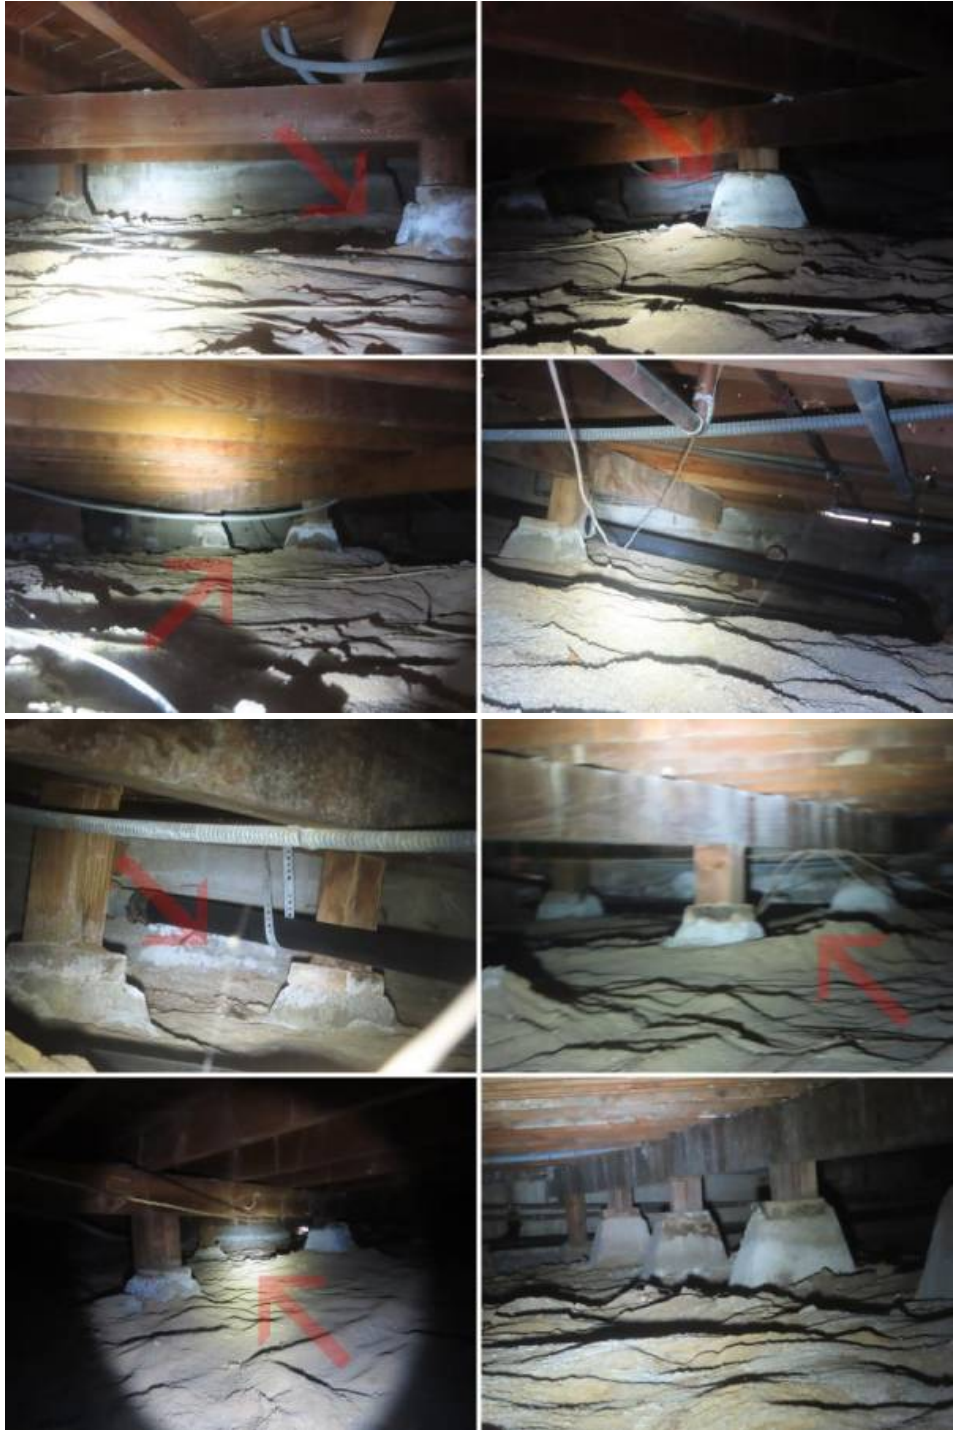
The piers are deteriorating from the moisture from drain line or past leaks.

DEFERRED: Light to moderate efflorescence noted in the sub area. Efflorescence is a powdery crystalline substance caused by excessive moisture. In severe cases deterioration of the concrete and embedded structural steel products can result.

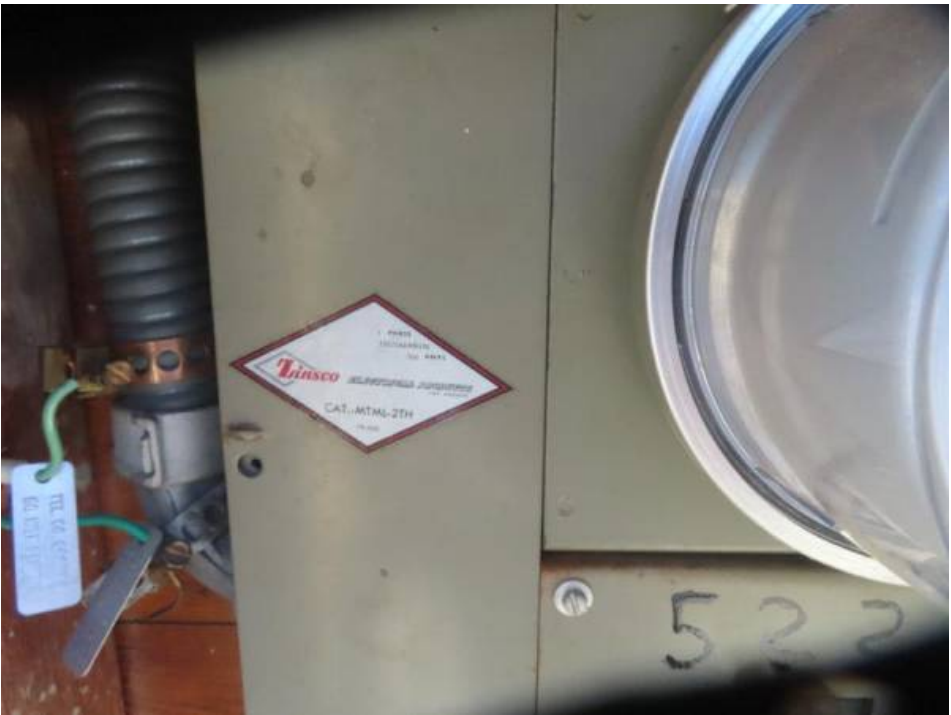
| <i>Panel observations, exterior</i> | SAFETY: Federal Pacific or Zinsco brand panel present. Electrical panels and circuit breakers are known to deteriorate with age. Many older panels have aluminum bus bars that are susceptible to oxidization, which can compromise the electrical connections. Also, older breakers have a higher failure rate than do modern breakers. Both of these conditions can lead to arcing and overheating, sometimes resulting in an electrical fire. |

A visual inspection cannot determine if these panels and breakers are performing to their original design specifications. Federal Pacific and Zinsco brands in particular are problematic and we routinely recommend replacing these panels as a safety upgrade.

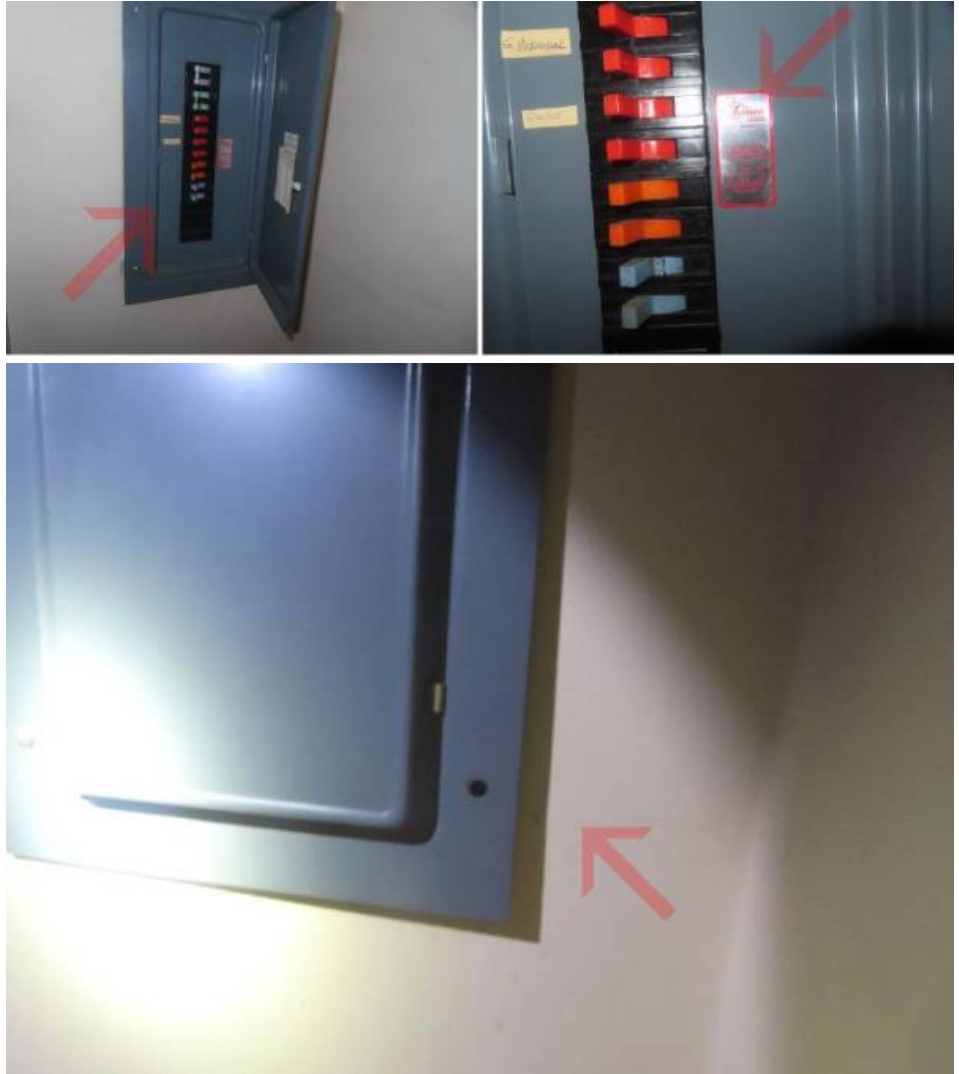
SAFETY: Federal Pacific or Zinsco brand panel present. Electrical panels and circuit breakers are known to deteriorate with age. Many older panels have aluminum bus bars that are susceptible to oxidization, which can compromise the electrical connections. Also, older breakers have a higher failure rate than do modern breakers. Both of these conditions can lead to arcing and overheating, sometimes resulting in an electrical fire. A visual inspection cannot determine if these panels and breakers are performing to their original design specifications. Federal Pacific and Zinsco brands in particular are problematic and we routinely recommend replacing these panels as a safety upgrade. SAFETY: Circuit breakers are not adequately labeled for area/items served. We recommend permanently labeling each breaker for emergency needs. DEFECTIVE: Panel cover is not adequately attached; missing, stripped or improper screws.

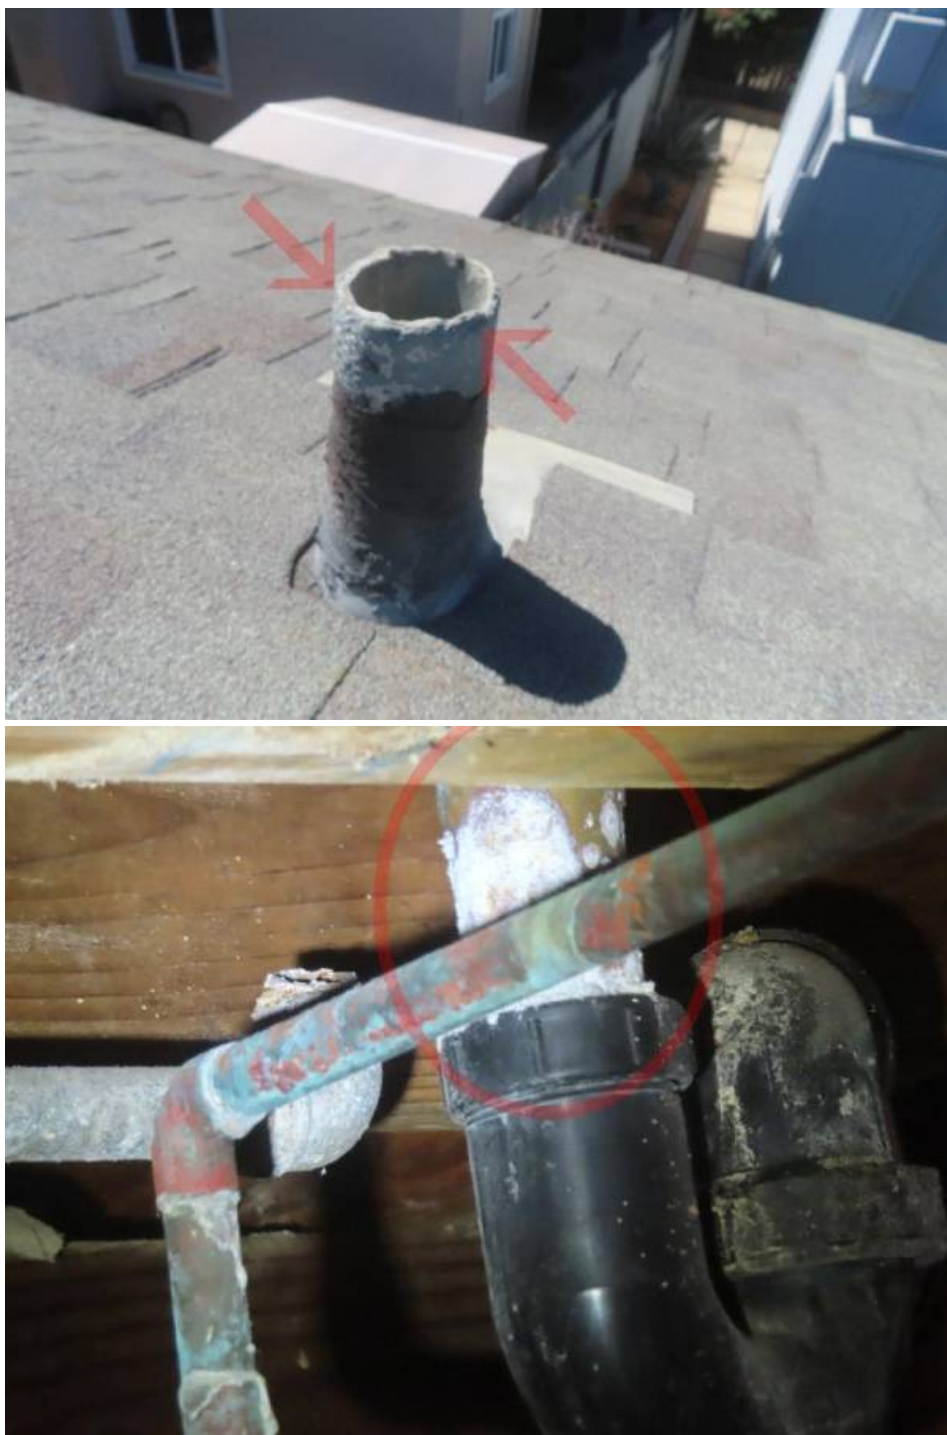
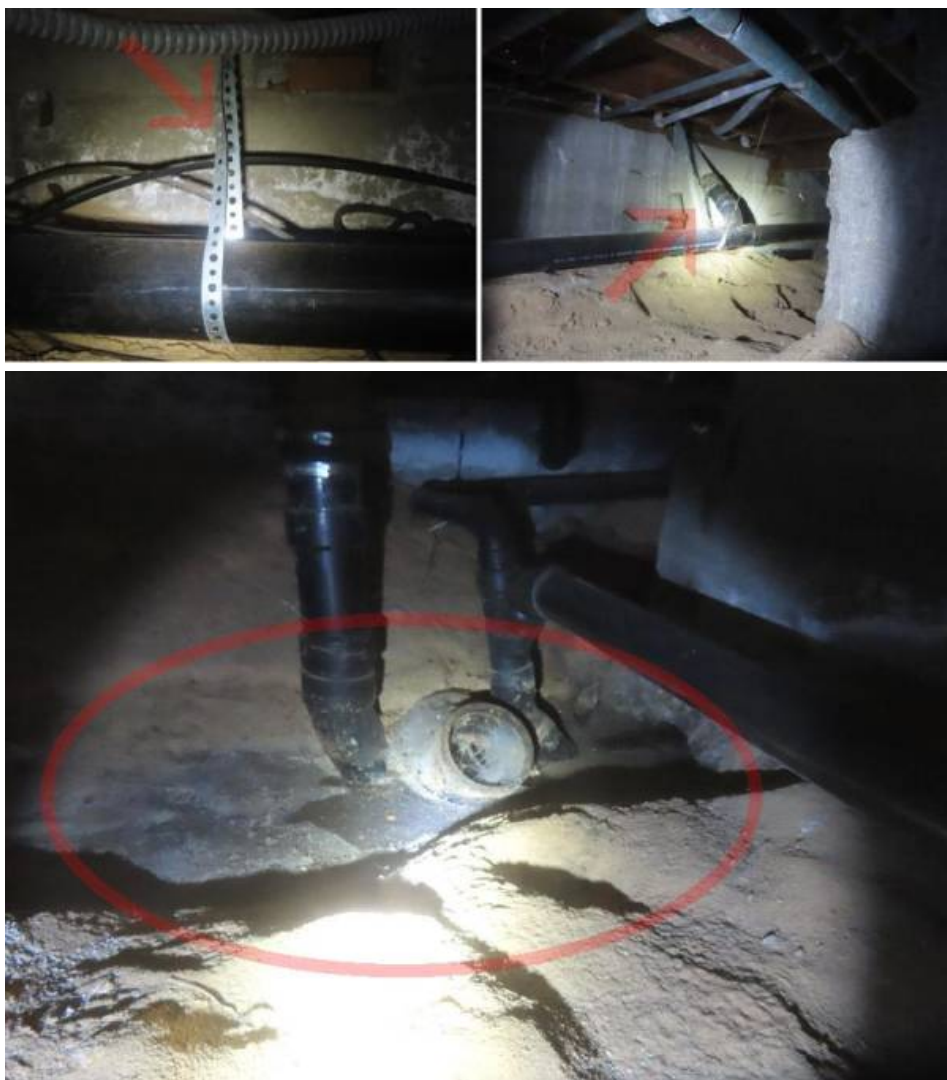
Plumbing fixtures drained well at the time of our inspection with limited use. We recommend asking the current owner for any history of drain blockage or repair.  
DEFECTIVE: Under 522 primary bedroom. Clean out is open and water is draining into the sub area when draining. Recommend a proper sized cap.  
DEFERRED: Metal straps on ABS, Plastic straps are to be used to prevent corrosion and sagging.  
522 Tub drain.  
MONITOR: Excessive corrosion observed on tub drain. Preventive maintenance repairs may be desirable at this time.

MAINTENANCE: While on the roof we noticed a groove in the transite vent pipe that was probably caused by a drain cleaning snake. This may indicate past or recurring blockage in the sewer line. We recommend asking the current owner if there is a history of sewer blockage. You may also wish to obtain a video scan to determine the interior condition of the sewer line (service provided by others).  
Clean out at foundation access.

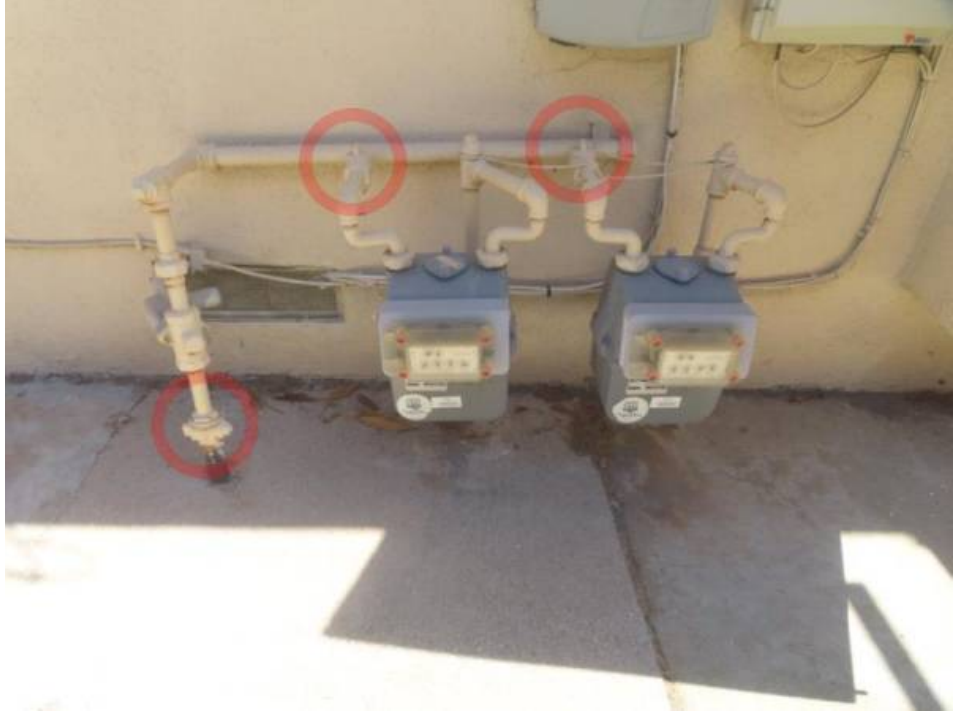
**SAFETY:** No seismic shutoff valve. We recommend installing a seismic shutoff valve on the gas meter for protection against fire loss in the event of a damaging earthquake. (A seismic shutoff valve is required to be installed on the gas system of residences in the City of Los Angeles prior to the transfer of title.)

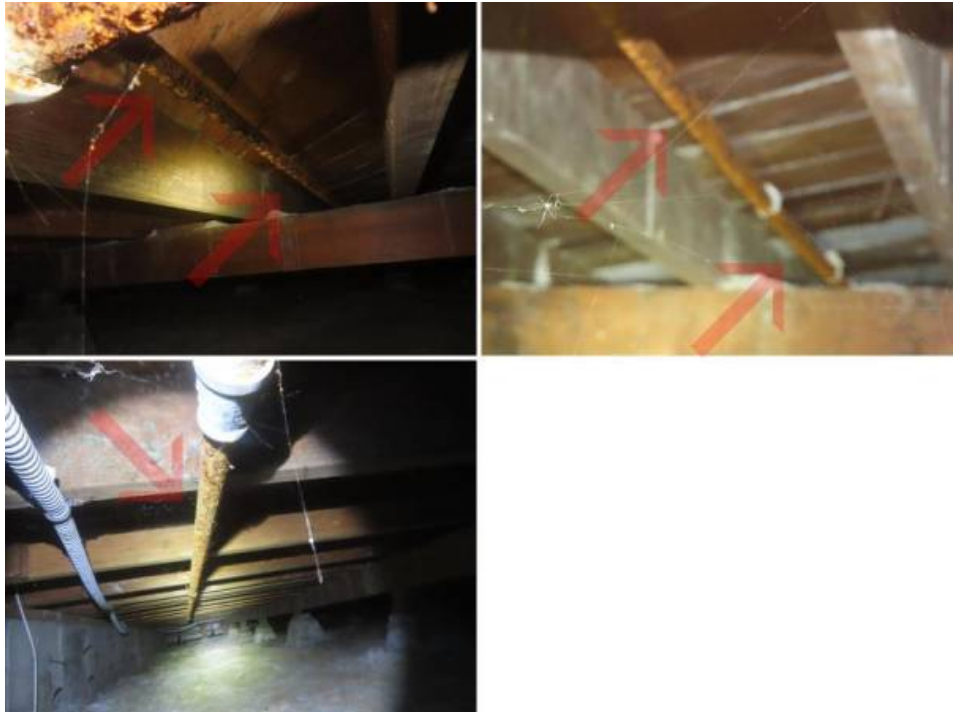
DEFERRED: Gas lines in sub area are rusting\corroding from past or present leaks. Recommend further inspection and repairs as needed by a licensed plumber.

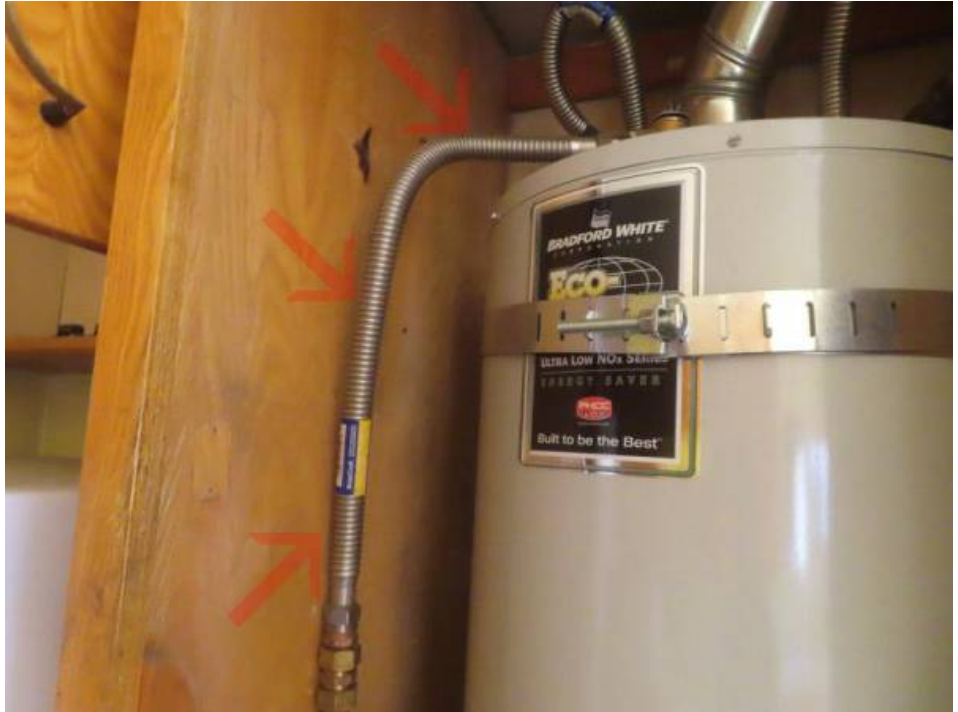
DEFECTIVE: Improper or no discharge line. The discharge piping should be of hard drawn copper or steel or other type approved for hot water distribution. It should be no smaller than the outlet of the valve and must pitch downward to allow complete drainage of the safety relief valve and discharge line. The end of the discharge line should not be threaded and should terminate below the controls at the exterior of the building and within 6" of the ground or other approved location. Valves, reducer couplings, or flexible connectors should not be installed on the discharge line.

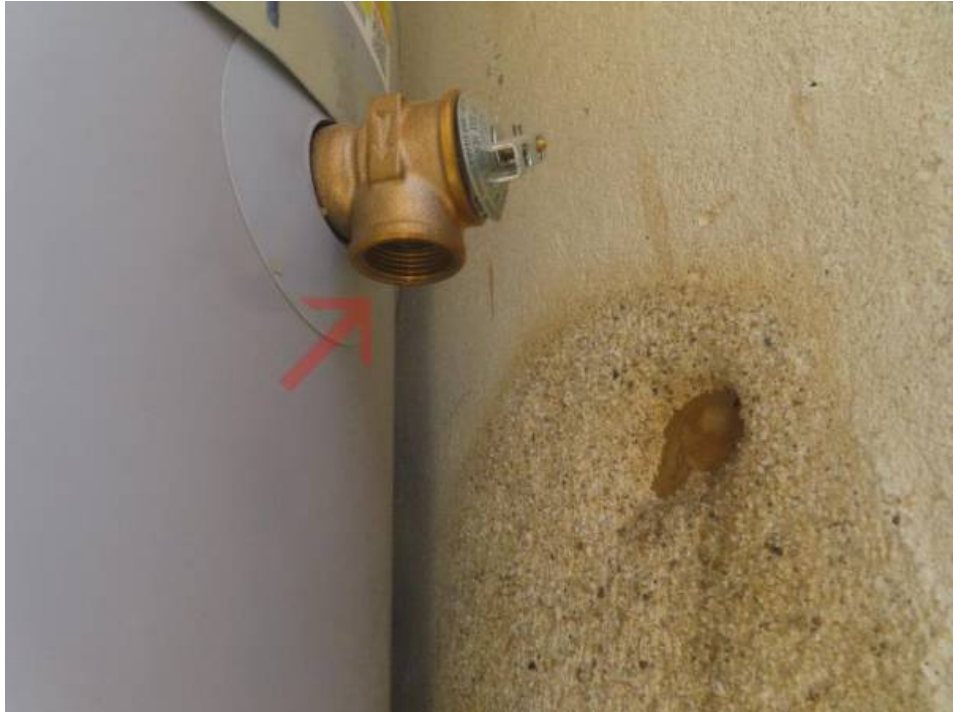
DEFECTIVE: Improper or no discharge line. The discharge piping should be of hard drawn copper or steel or other type approved for hot water distribution. It should be no smaller than the outlet of the valve and must pitch downward to allow complete drainage of the safety relief valve and discharge line. The end of the discharge line should not be threaded and should terminate below the controls at the exterior of the building and within 6" of the ground or other approved location. Valves, reducer couplings, or flexible connectors should not be installed on the discharge line.

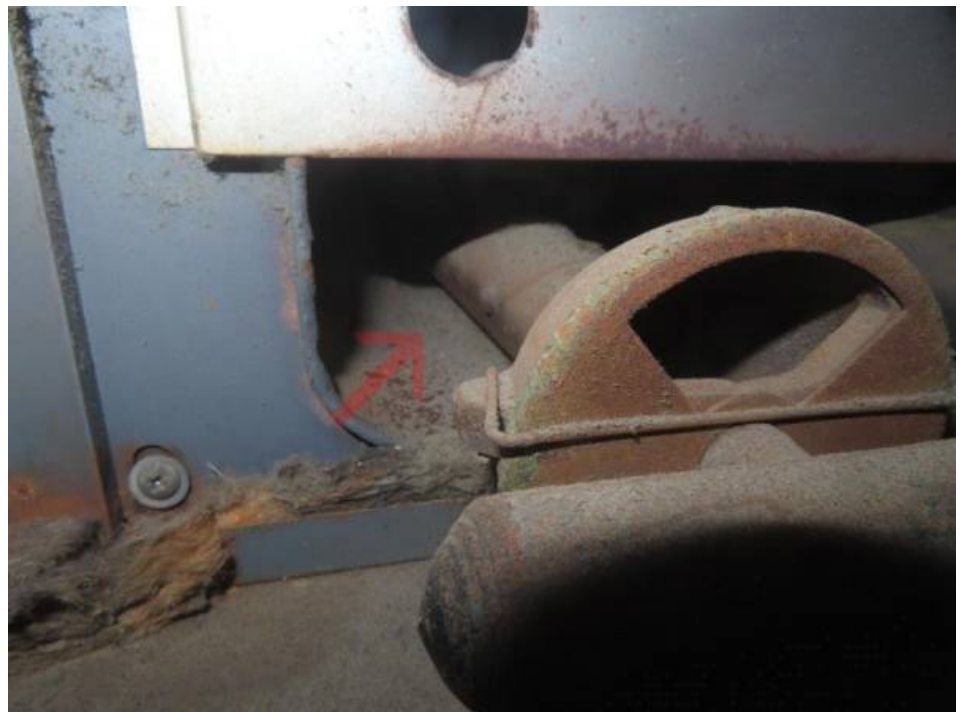
DEFERRED: Excessive rust flakes in the burner chamber may indicate a venting or other defect. We recommend further evaluation by a licensed heating contractor.
