# Confidential Inspection Report

522 Ave. F  
Redondo Beach CA 90277

July 24, 2025

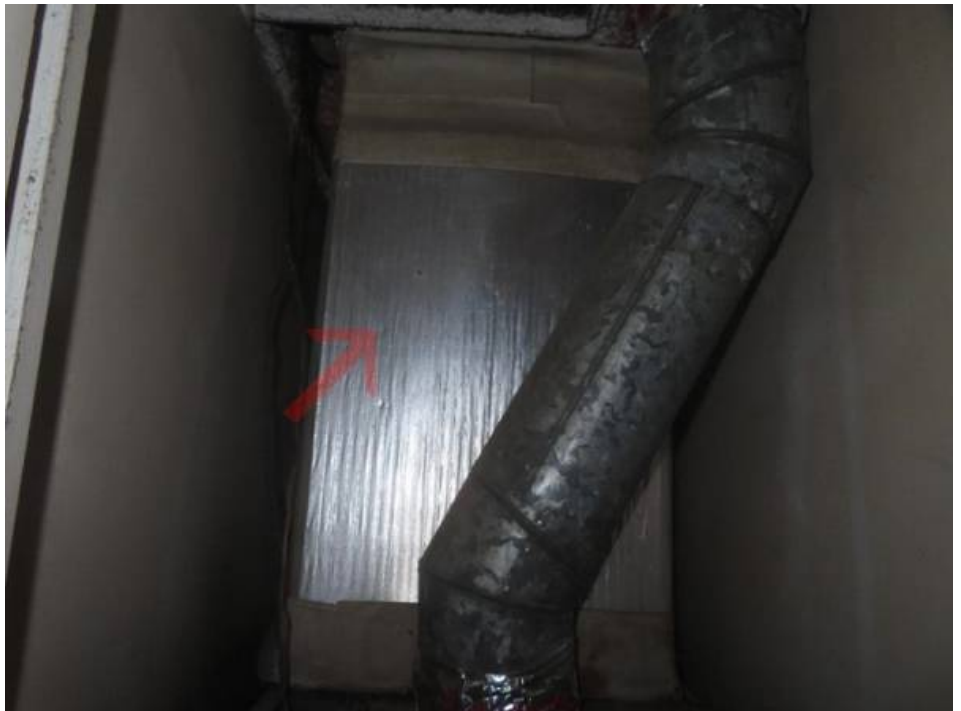
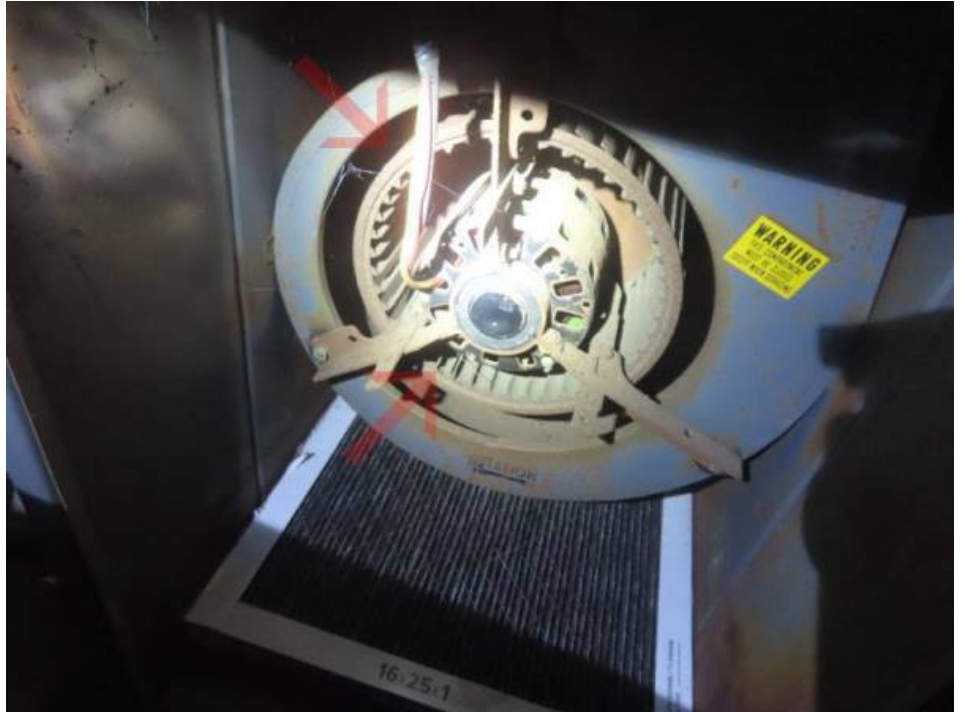
MAINTENANCE: Accumulated dust viewed on the motor is an indication that the furnace has not been serviced recently. We recommend annual maintenance servicing be done at this time.

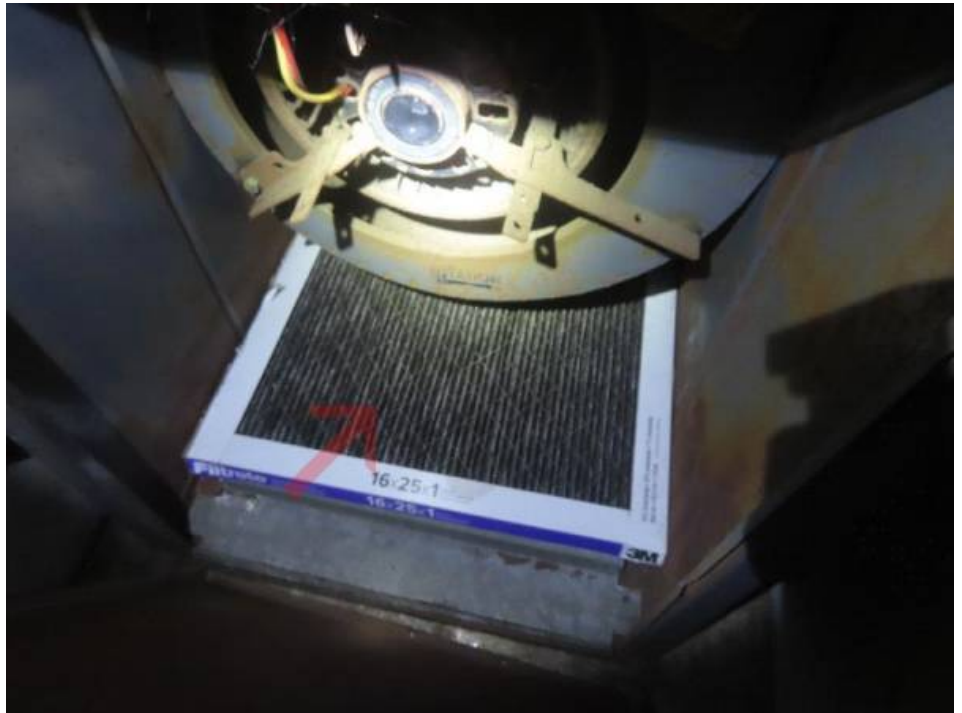
MAINTENANCE: Filter is dirty. Filters should be checked every two to three months and cleaned or changed as needed. We recommend cleaning or replacing filters when any dust can be observed for increased efficiency and energy conservation.

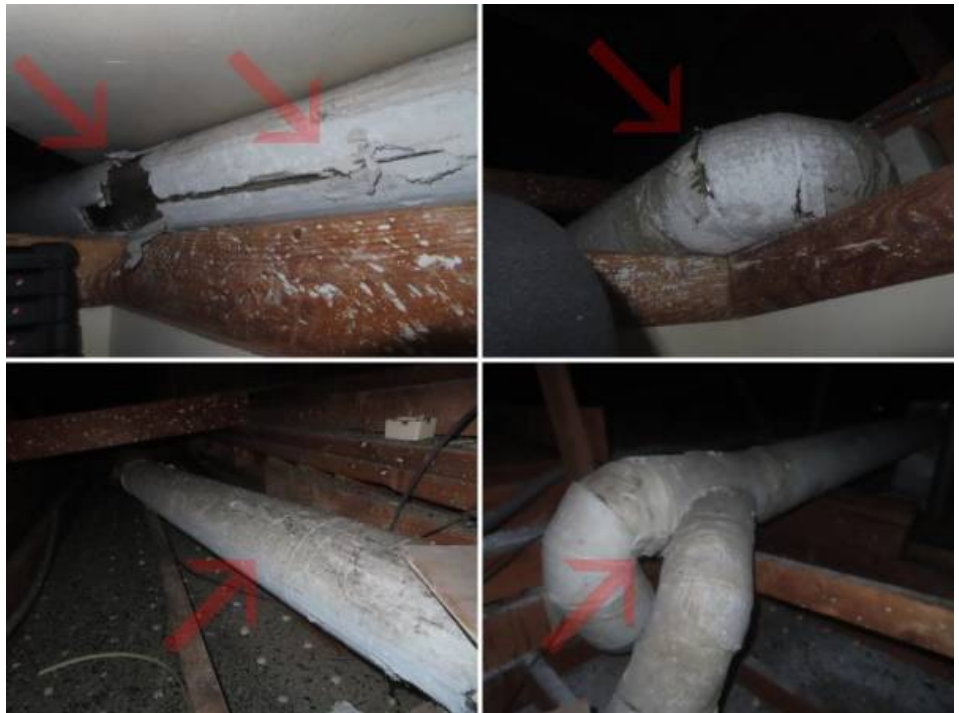
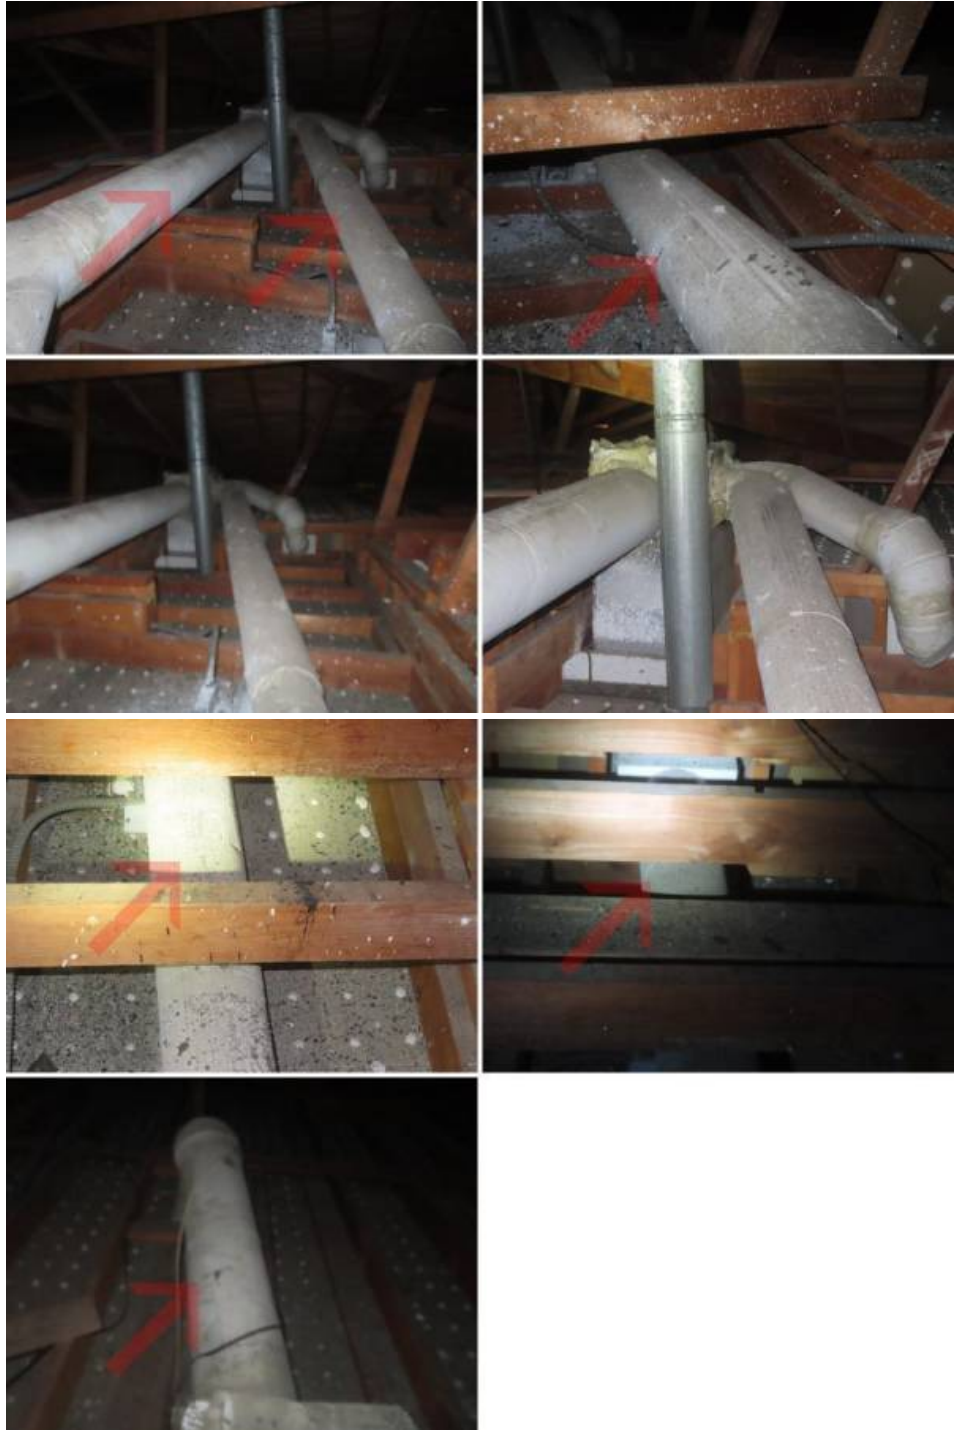
SAFETY: Suspect asbestos insulating material visible on the plenum is in damaged condition. Removal or encapsulation is generally recommended when material is damaged and/or in friable condition. Positive identification of asbestos can only be made from samples sent to a certified laboratory. If you have any concerns we recommend further evaluation by a licensed asbestos assessor .

SAFETY: Suspect asbestos material damaged, loose or in friable condition. We recommend further evaluation by a licensed asbestos assessor.

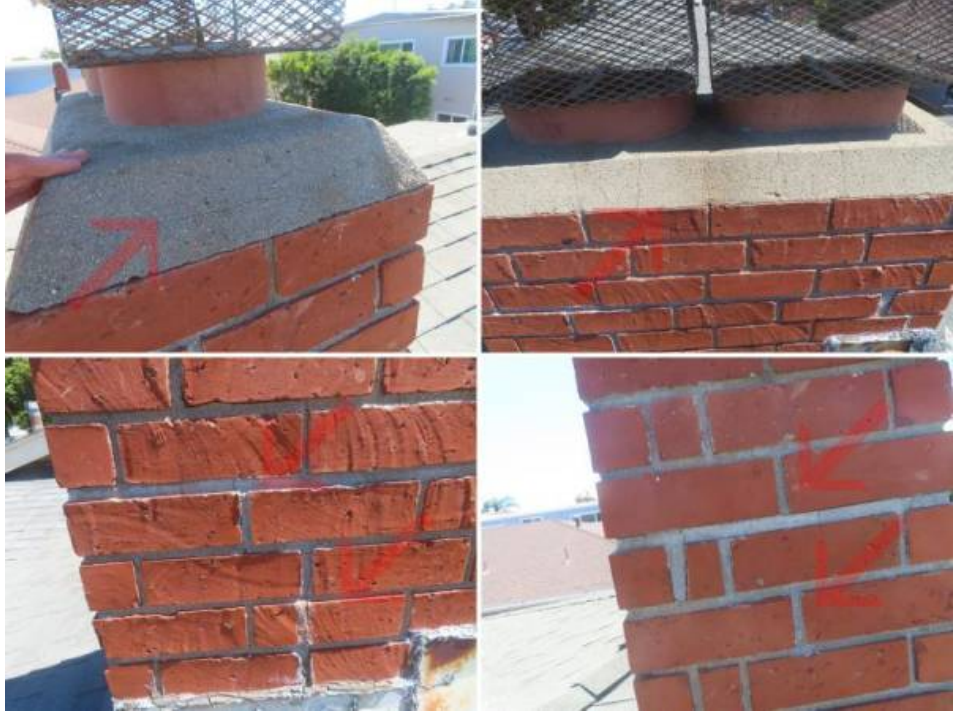
MAINTENANCE: Crown is cracked or otherwise deteriorated. The crown protects the masonry from the effects of weather and needs maintenance/repair at this time. We recommend further evaluation and repair as needed by a qualified fireplace professional.  
DEFECTIVE: Small cracks observed. We recommend further evaluation by a qualified fireplace professional prior to use.

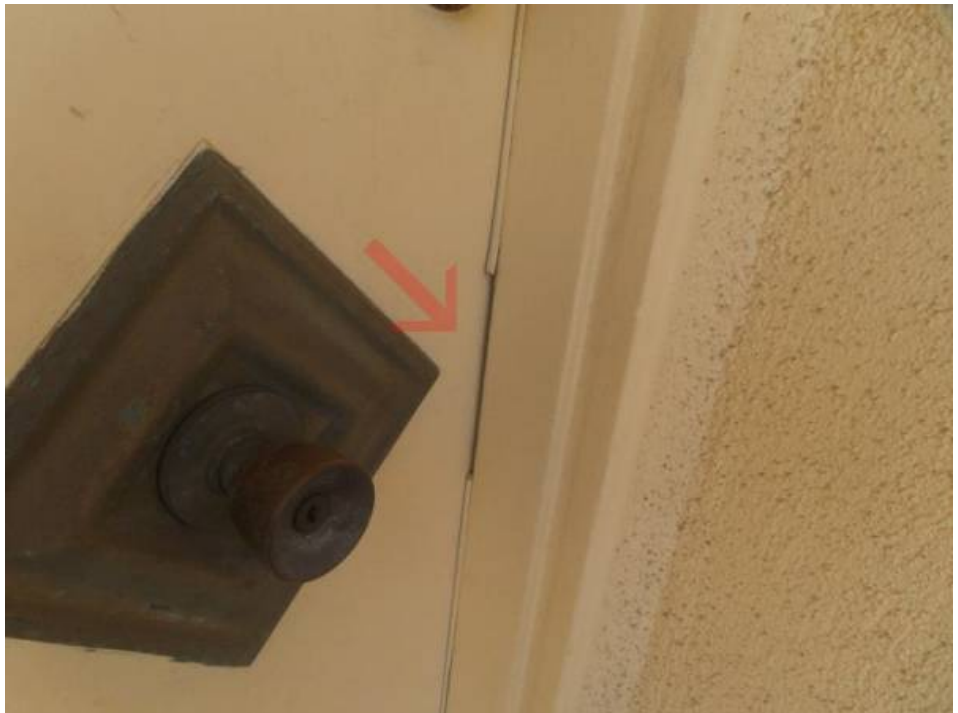
SAFETY: Door is a hollow core type. We recommend installing solid core doors at all exterior locations for enhanced security.

MAINTENANCE: Weather-stripping or threshold not installed or in disrepair. We recommend installing/maintaining thresholds and weather-stripping on exterior doors to guard against air infiltration and water intrusion.

MAINTENANCE: Dragging on carpet.

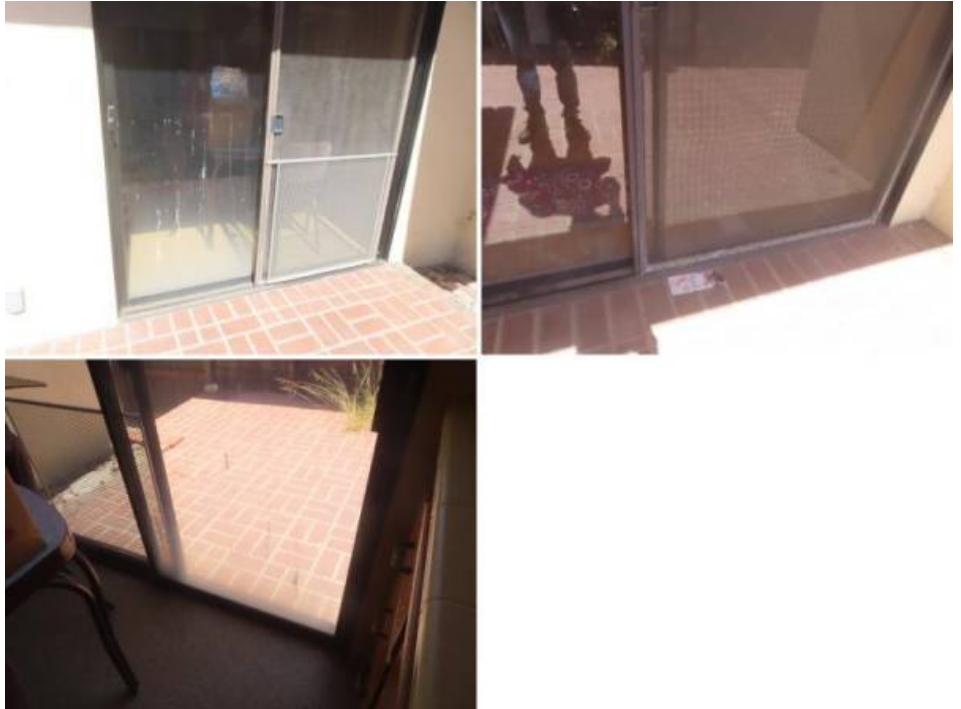
522.  
Kitchen, glass is dirty or faded.

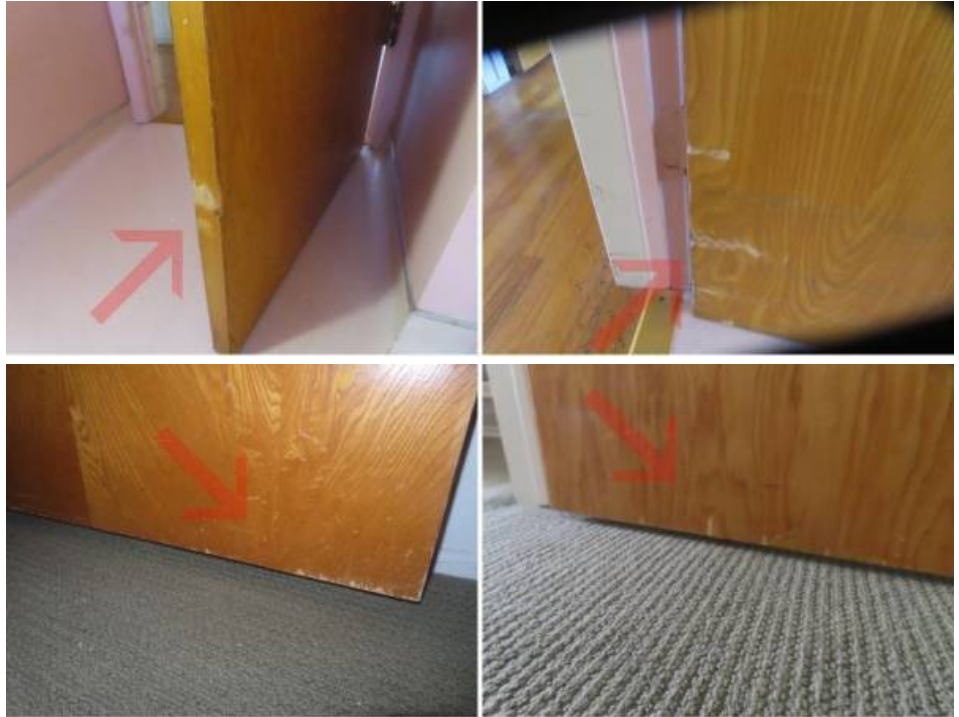
522 Main bath door, damaged.  
522A.  
MAINTENANCE: Doors delaminating at base.

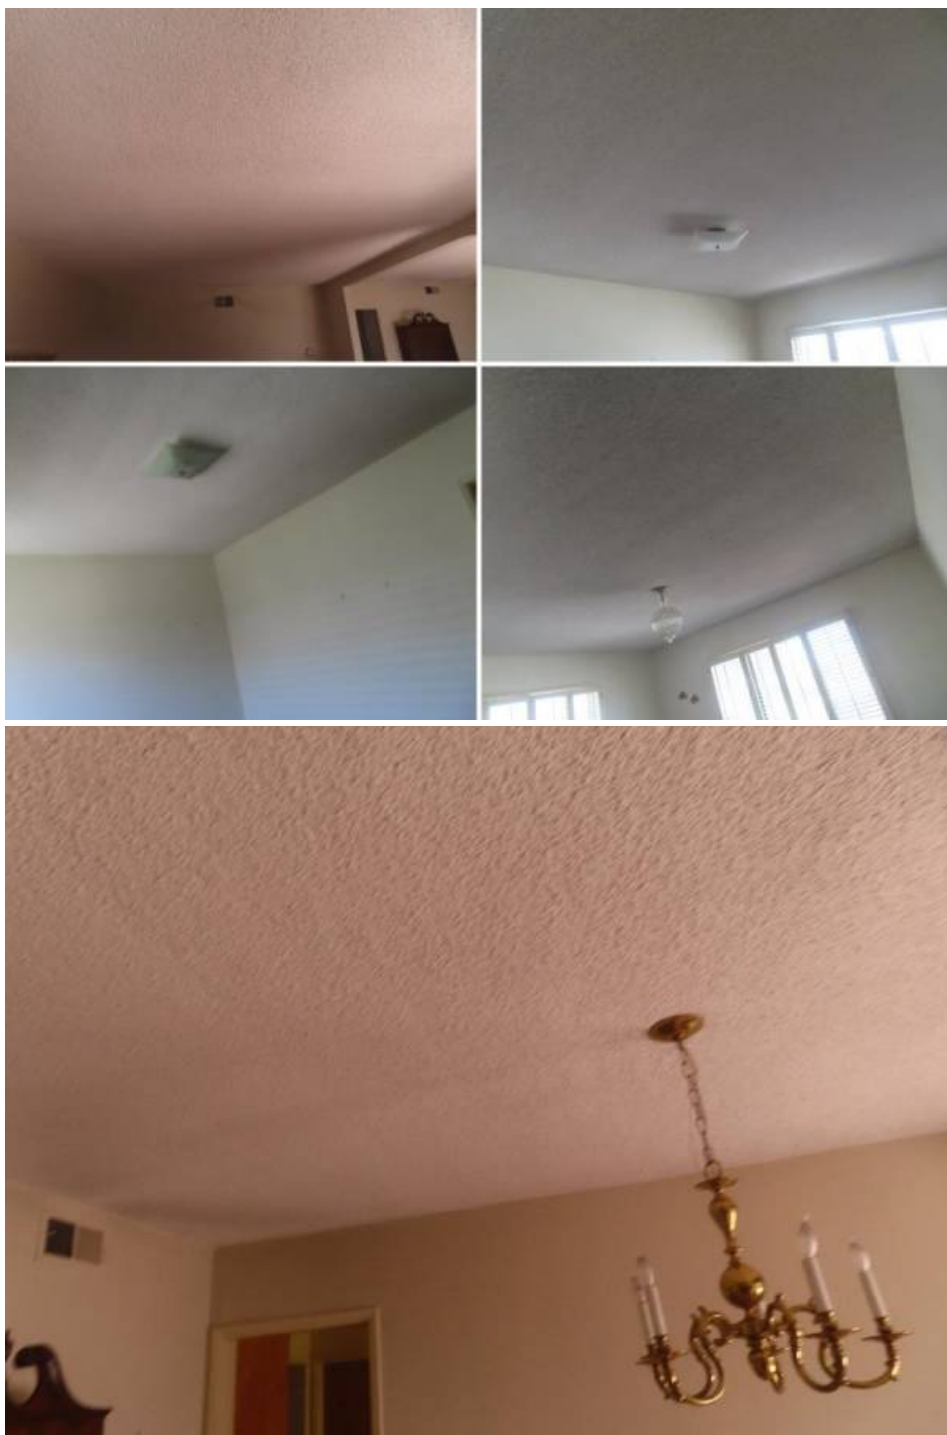
SAFETY: Acoustic ceilings viewed may contain asbestos. Positive identification of asbestos can only be made by a certified laboratory. The acoustic ceilings appear to be in good condition. Removal or encapsulation is not generally recommended unless the material is damaged and/or in friable condition. Asbestos was widely used in building materials prior to 1983. This material if present can pose health risks and will require special handling if disturbed. Your real estate agent may be able to provide you with the pamphlet "Asbestos In The Home" (CPSC Document #453) or you may obtain one yourself from the Consumer Products Safety Commission by calling them at (800) 638-CPSC, or it can be found at their web site: [www.cpsc.gov](http://www.cpsc.gov). We also have that document available as a .pdf file, which we will e-mailed to you upon request.

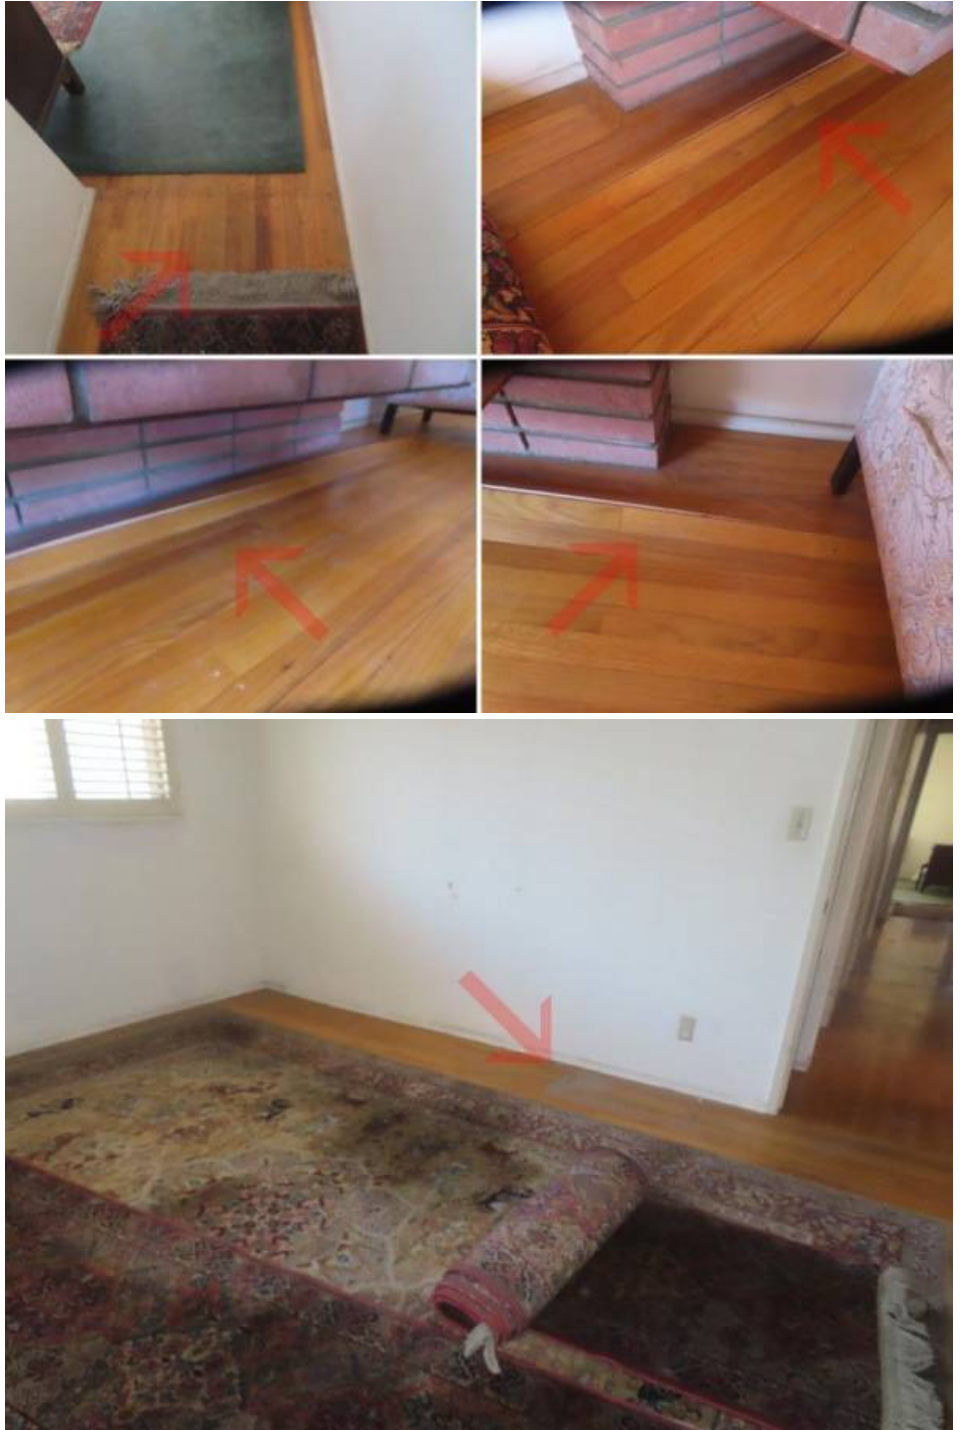
DEFERRED: Insect damage viewed.

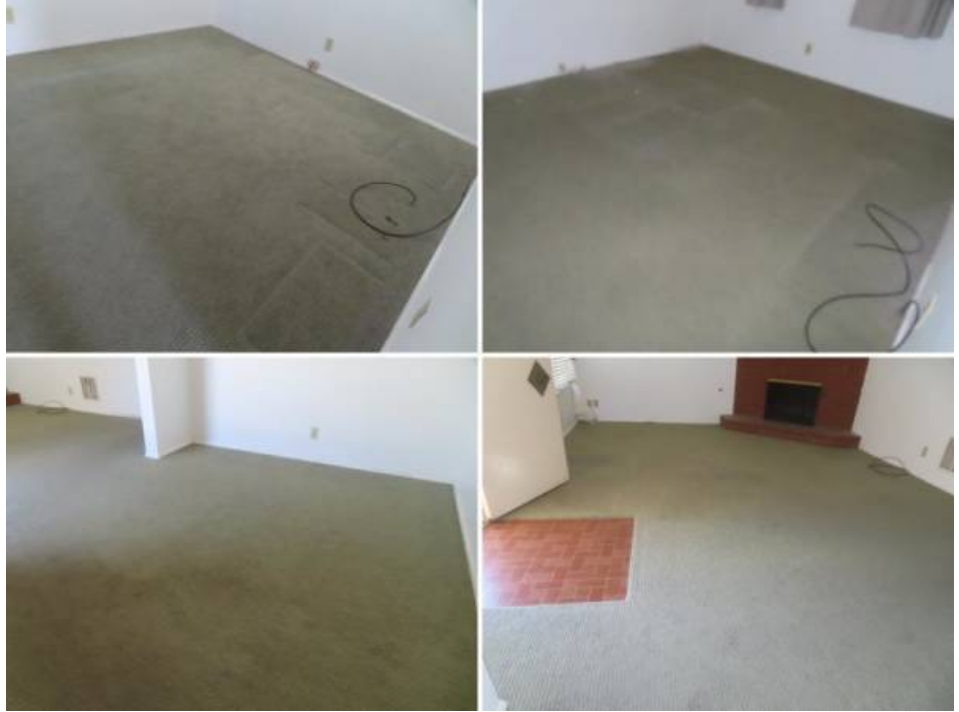
522A.  
MAINTENANCE: Carpet is worn with some possible fading.

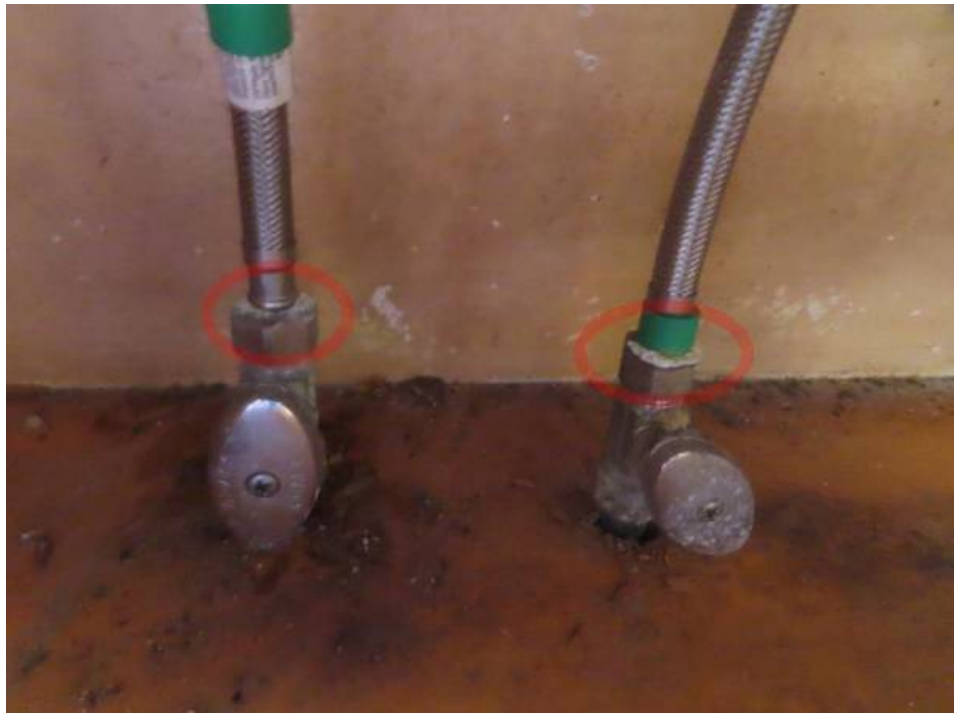
MAINTENANCE: Shutoff valve or connector is corroded. Corroded components will eventually fail; we recommend replacing corroded components when observed.

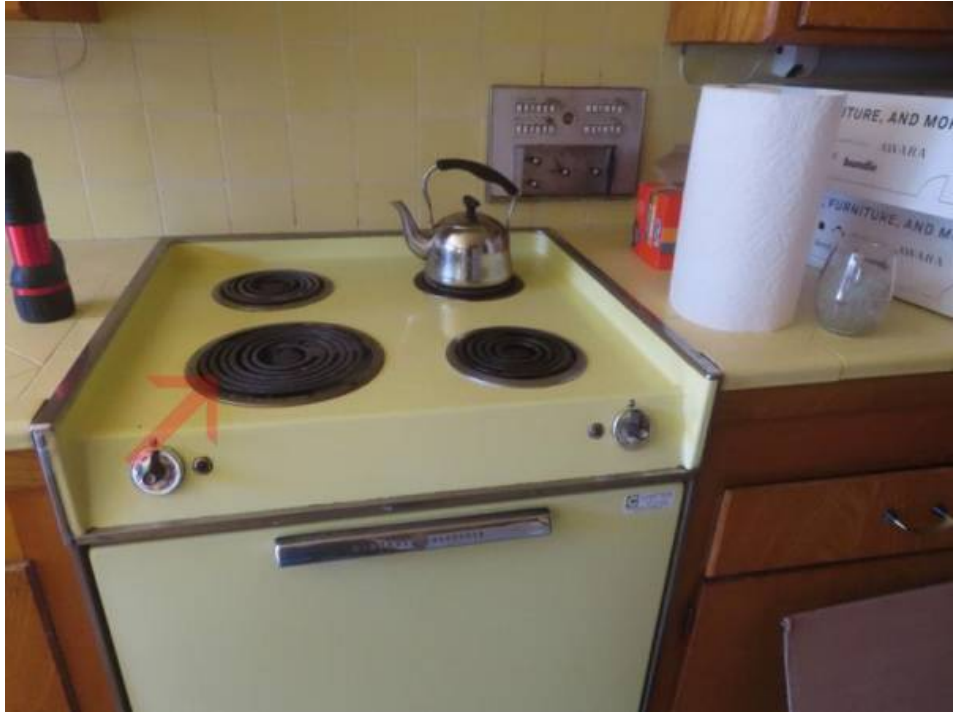
Electric range.  
Right front burner.  
DEFECTIVE: One or more burners did not respond to user controls.

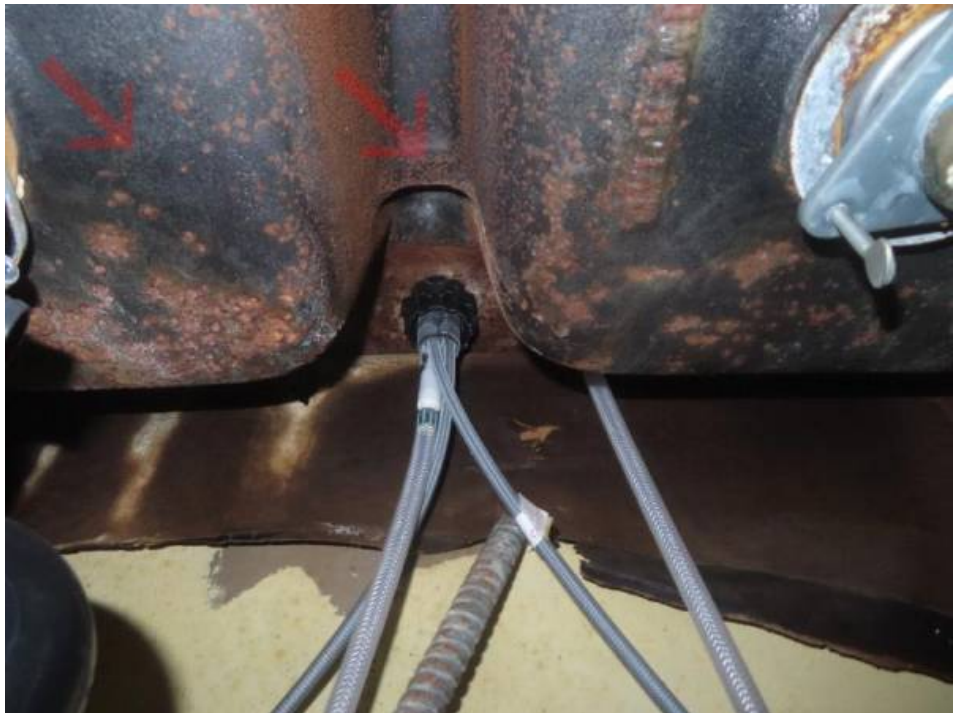
MAINTENANCE: Stained, heavy wear noted.

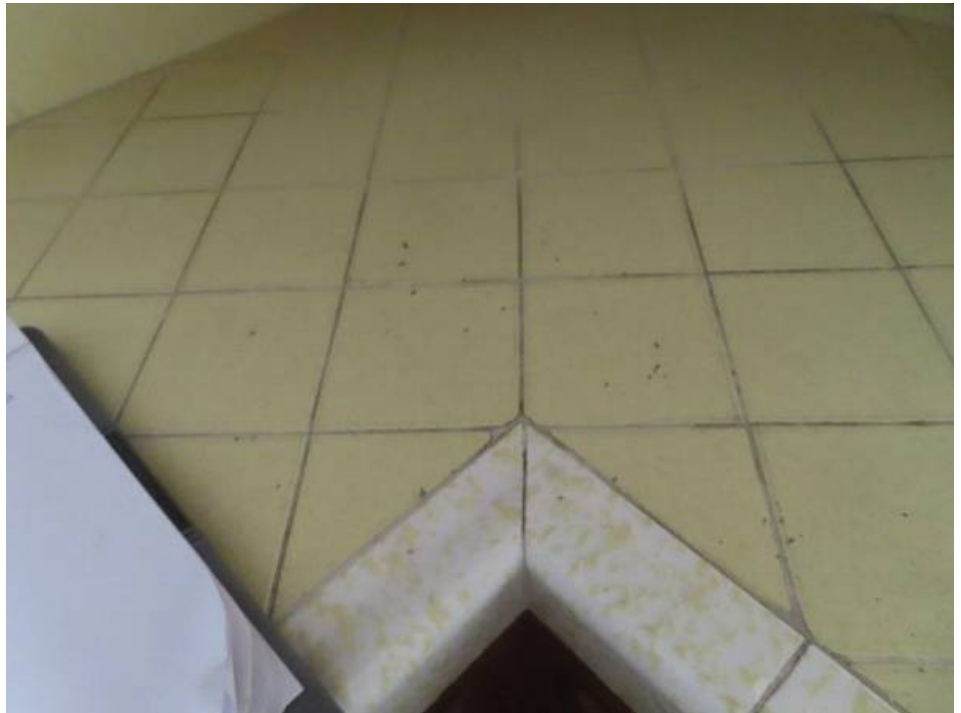
Tile. Chipped or cracked tiles or heavy wear noted.

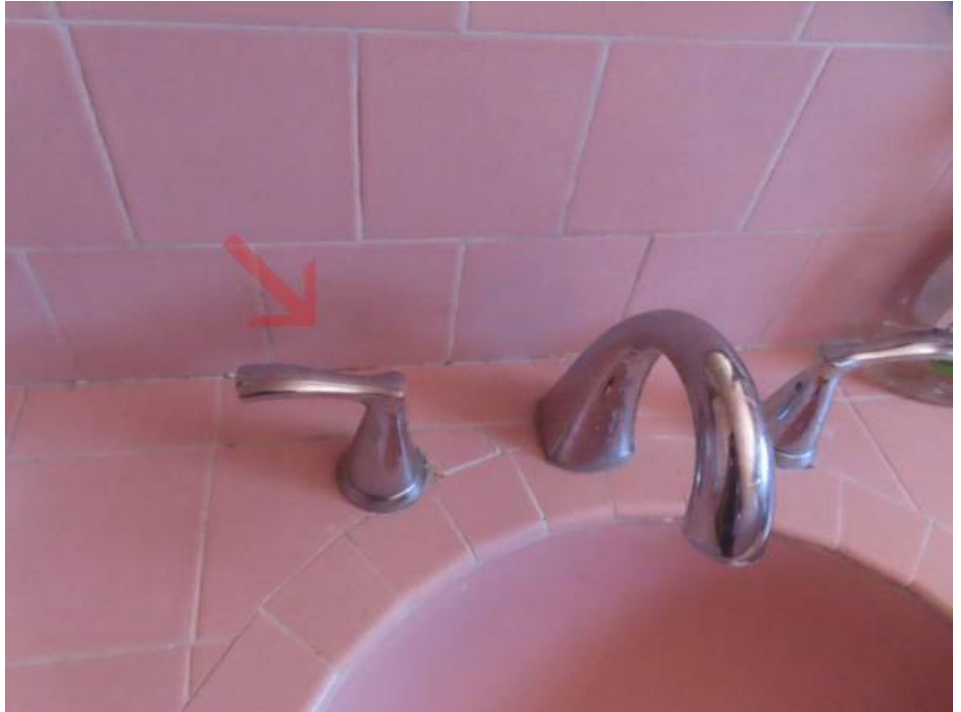
Tile. Chipped or cracked tiles or heavy wear noted.

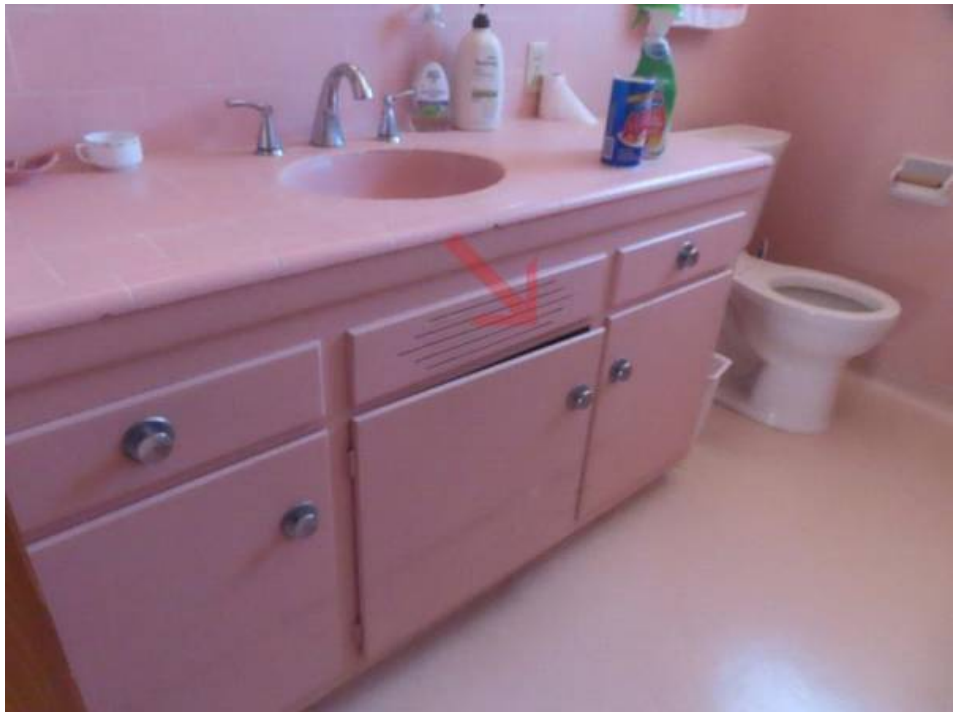
MAINTENANCE: Moderate to heavy wear. Some hinges or doors may be damaged, or do not latch securely, or drawer guides/slides are worn or in disrepair.

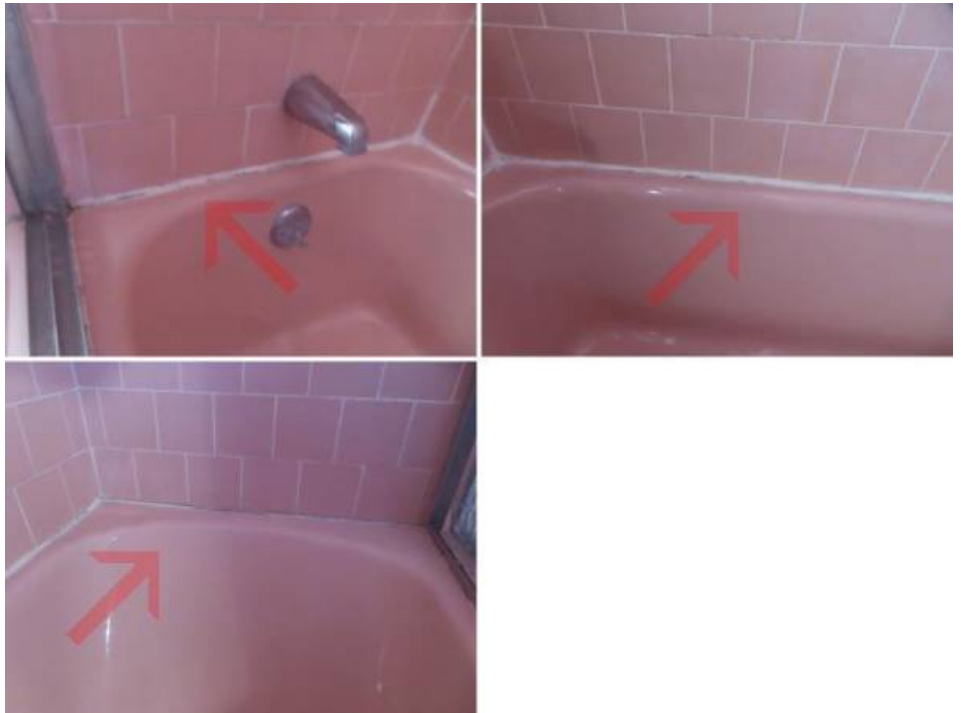
**MAINTENANCE:** Deteriorated or missing caulking at the bathtub rim, floor, or at the base of the fixtures. We recommend maintaining caulking as needed at this time to prevent water intrusion and subsequent damage.

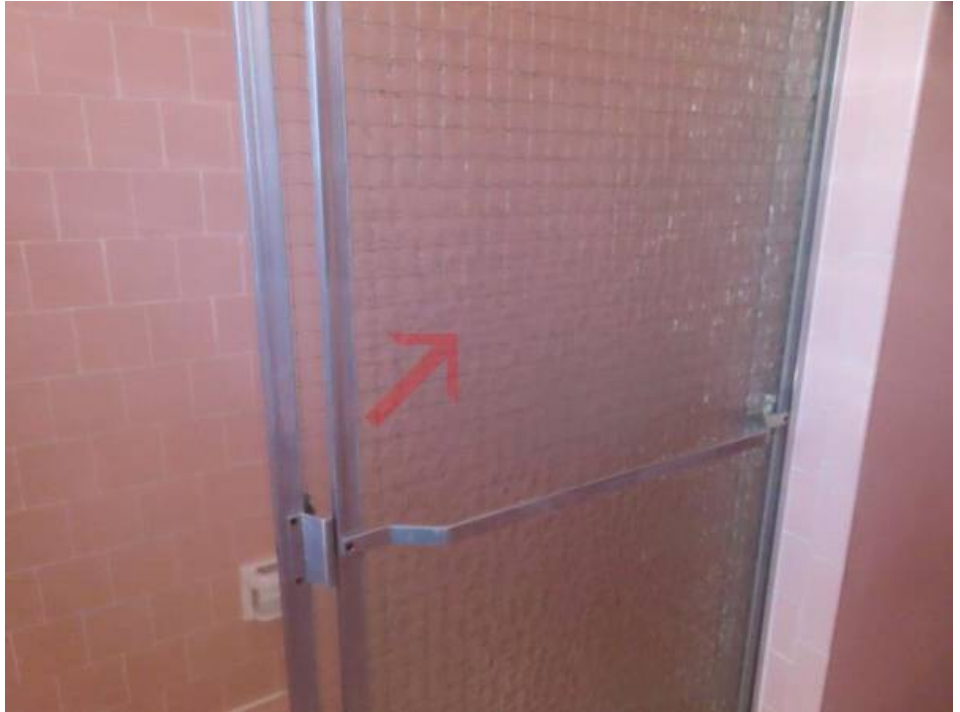
**SAFETY:** Wire glass is not an approved type of safety glass by today's standards. We recommend replacing with safety glass (may require replacing the entire enclosure).

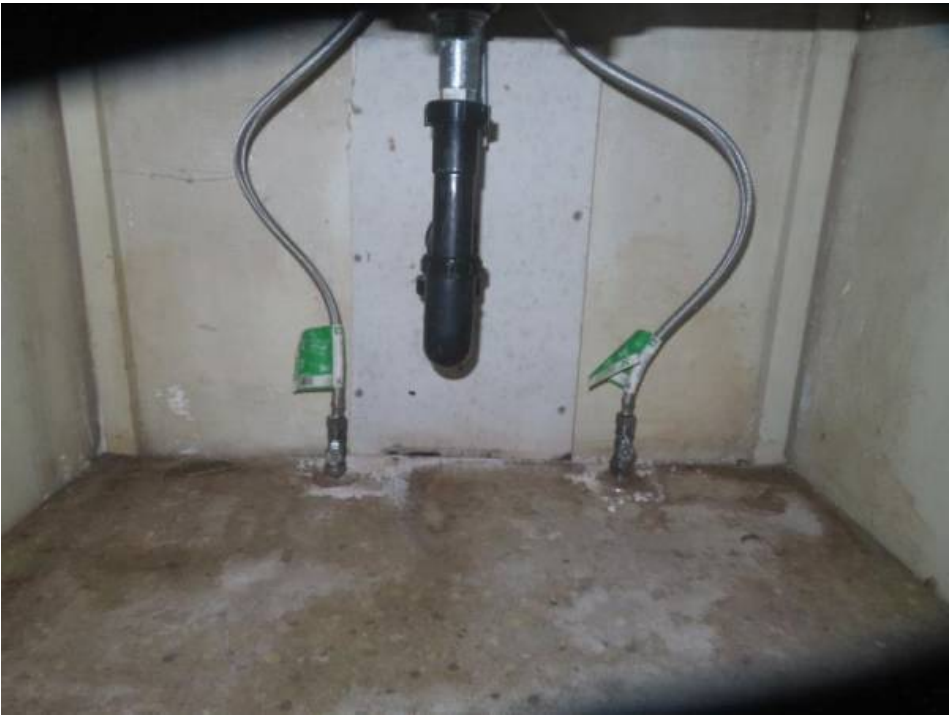
MAINTENANCE: Moderate to heavy wear. Some hinges or doors may be damaged, or do not latch securely, or drawer guides/slides are worn or in disrepair.

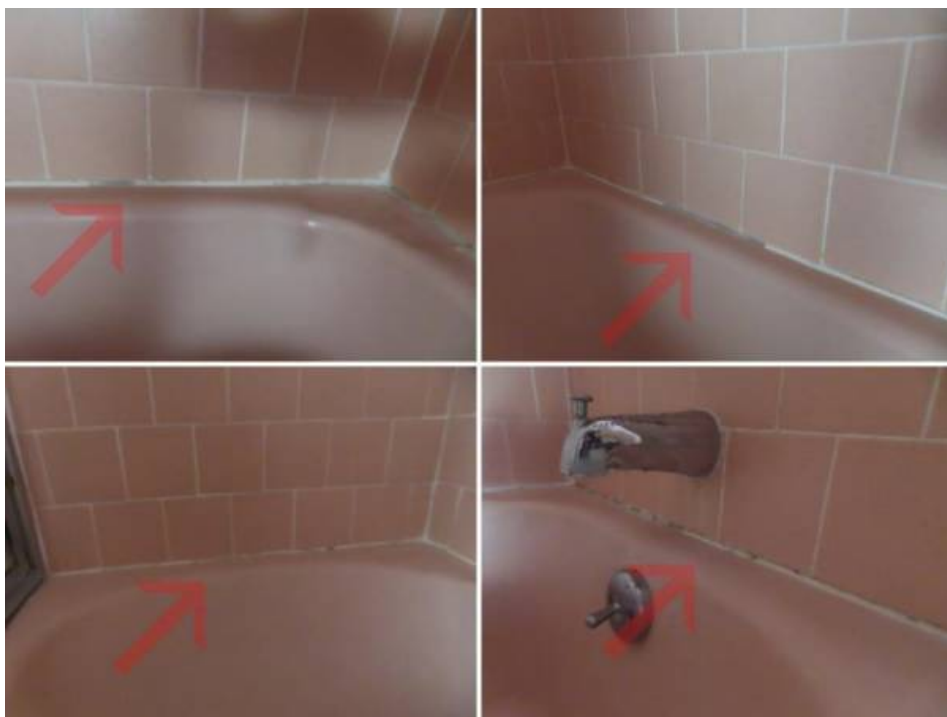
MAINTENANCE: Deteriorated or missing caulking at the bathtub rim, floor, or at the base of the fixtures. We recommend maintaining caulking as needed at this time to prevent water intrusion and subsequent damage.

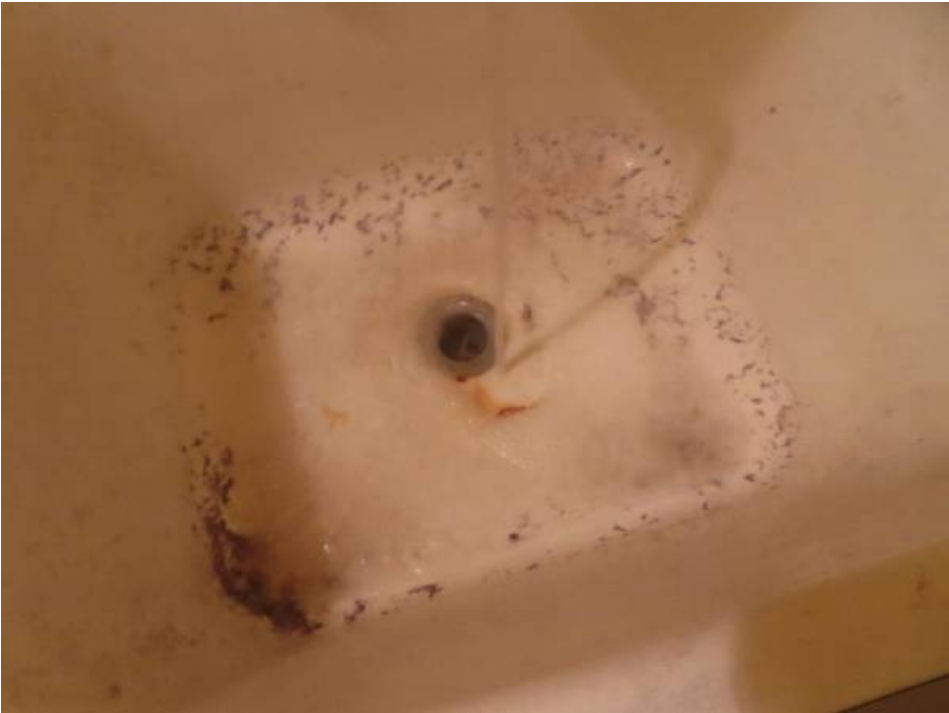
MAINTENANCE: Not adequately attached to the wall. Movement may cause the plumbing to leak.  
MAINTENANCE: Stained, heavy wear noted.

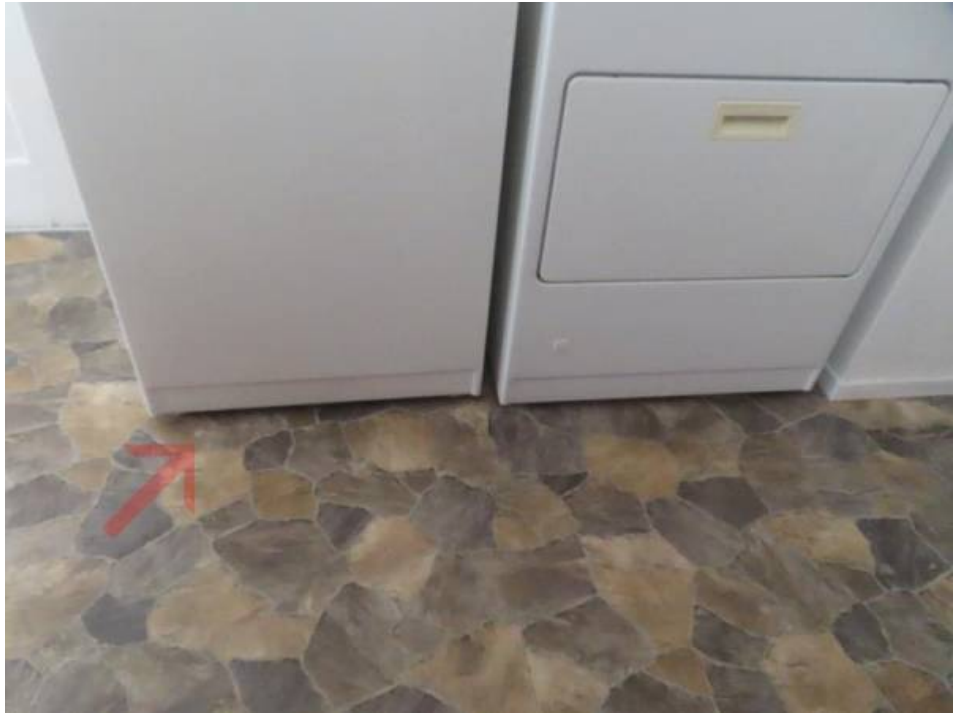
SAFETY: We suggest installing a catch pan with a drain to the exterior to prevent water damage in the event of a leak in the washing machine.
