Jul 9th, 2024

25321 Terreno Dr., Mission Viejo, CA, 92691

# Home Inspection Report

Joseph Kennison / Loyalty Inspections

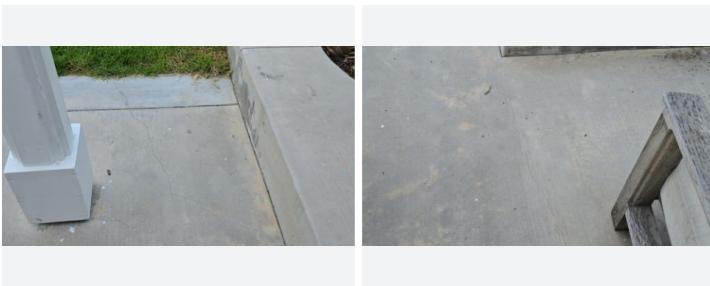
### 1.5 PATIO

Typical cracks/pits in cement - recommend having filled and sealed.

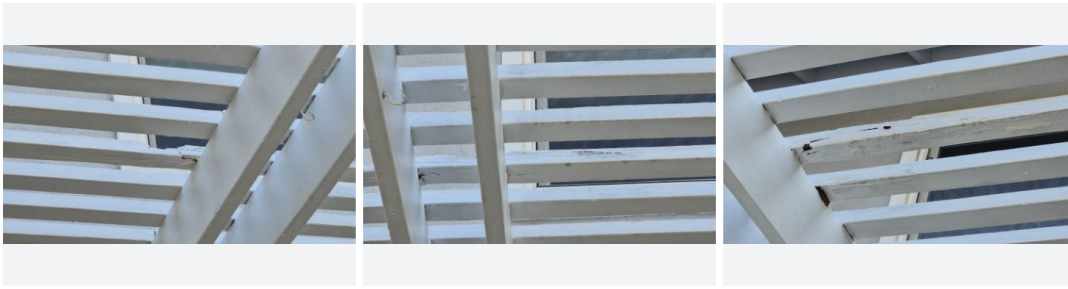
Visible damage to patio cover - recommend having repaired/repainted.

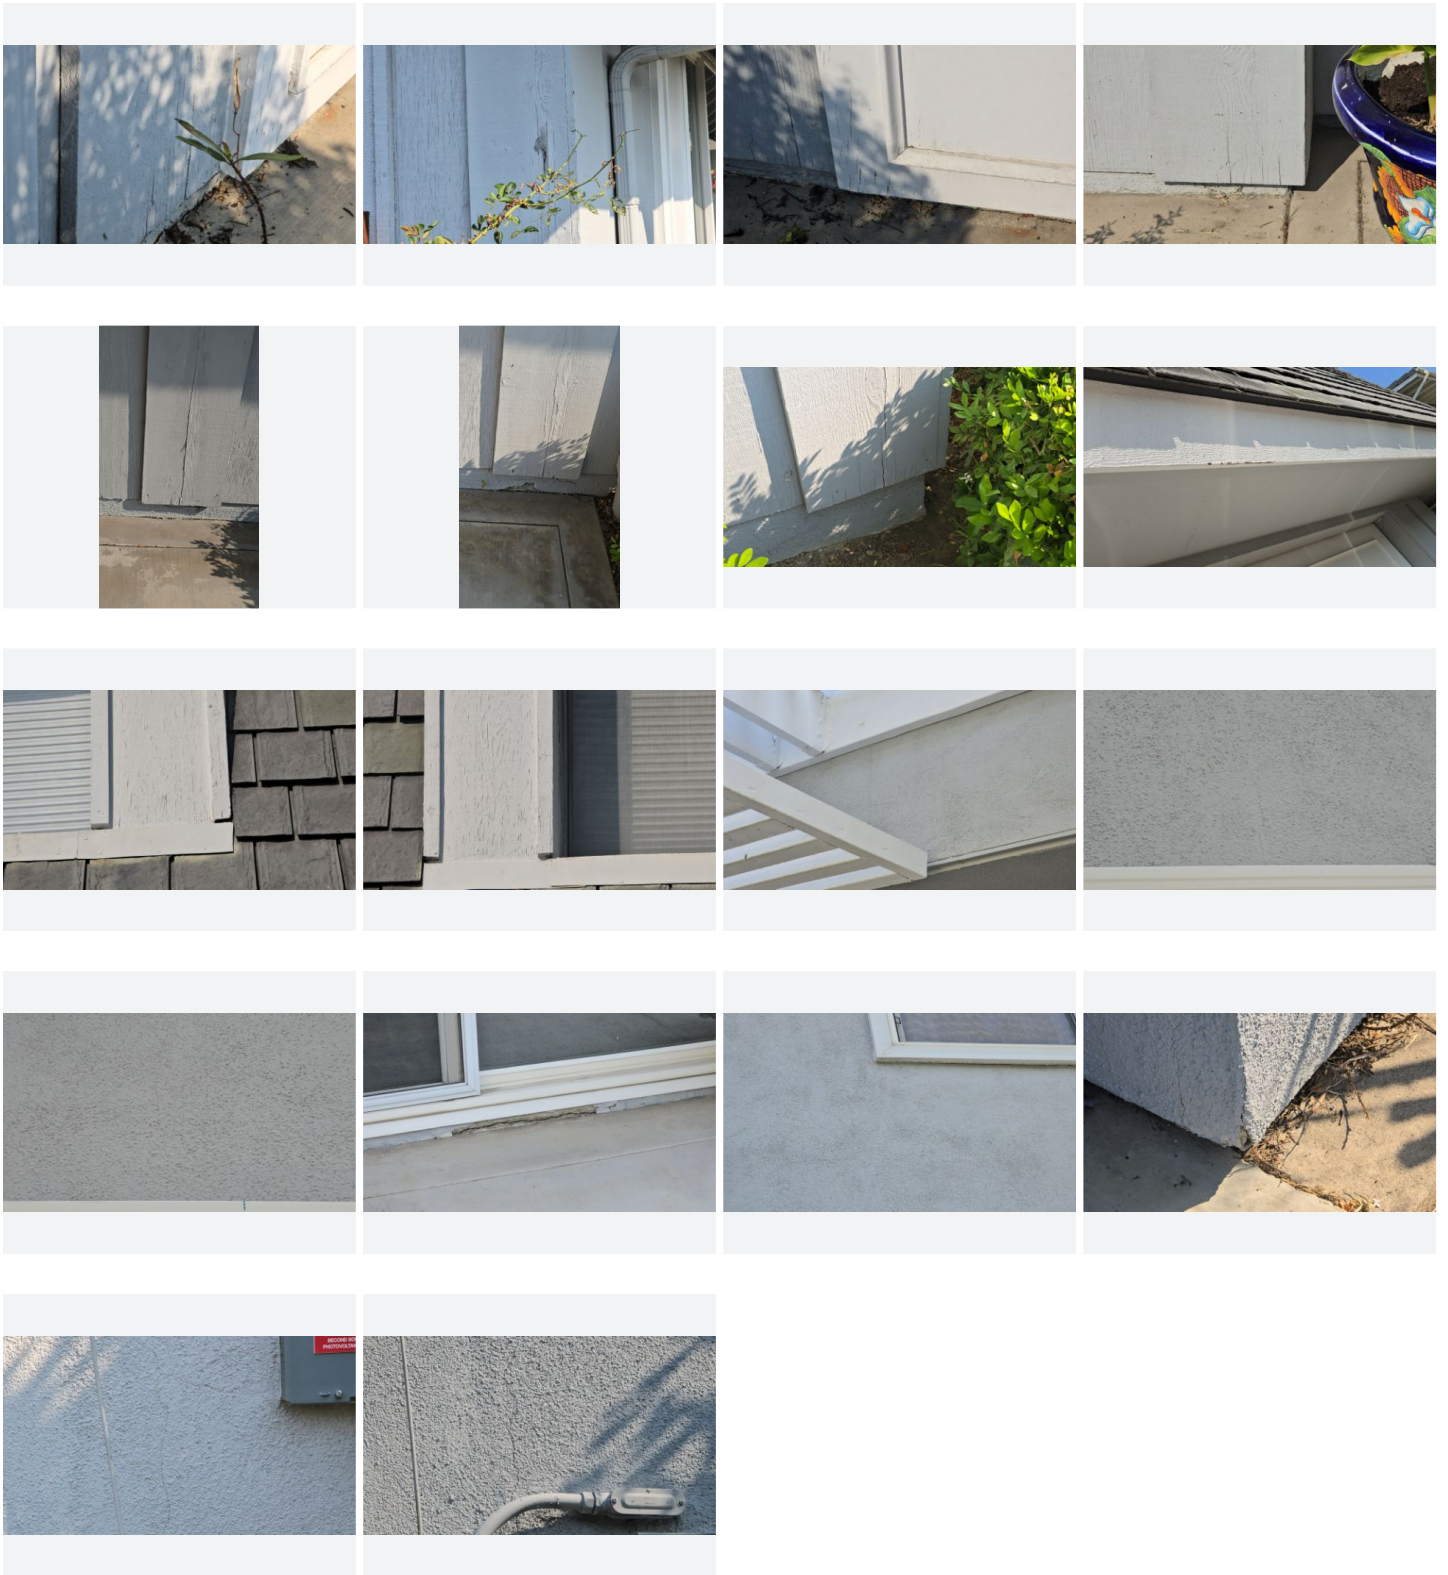
## 2.1 TYPE

Visible signs of cracks/peeling paint on siding - recommend having repaired/repainted.

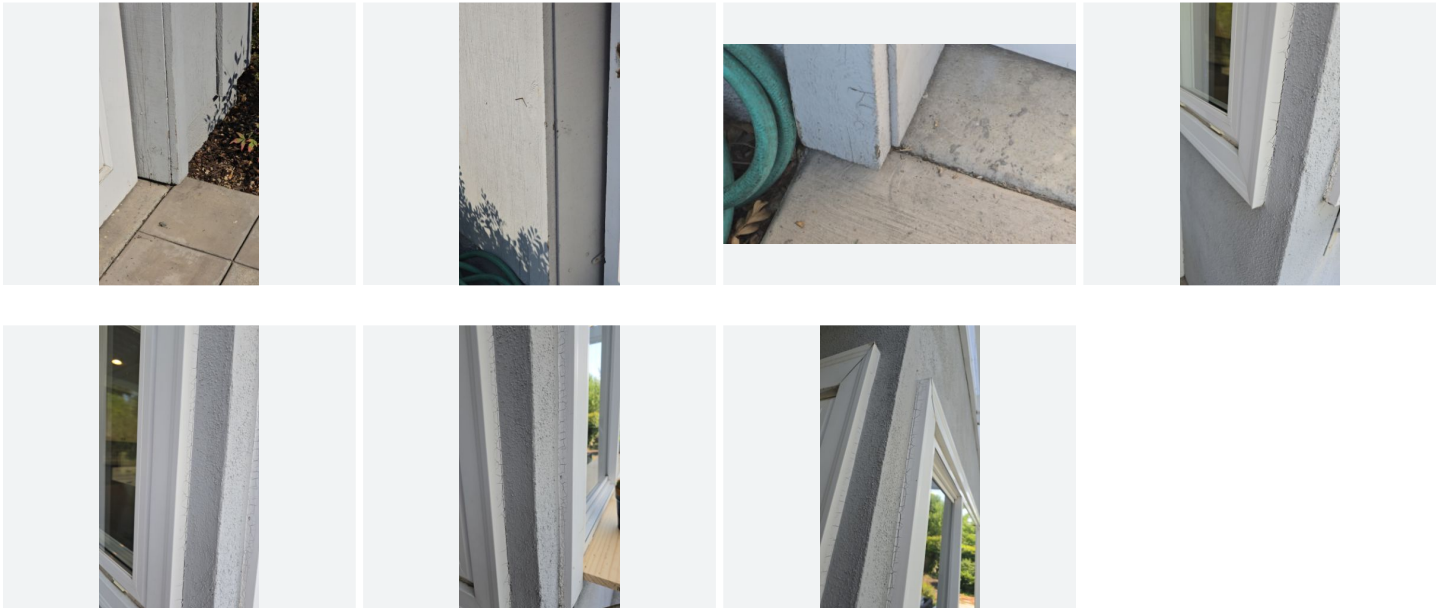
## 2.2 TRIM

Visible signs of cracks/peeling paint on siding - recommend having repaired/repainted.

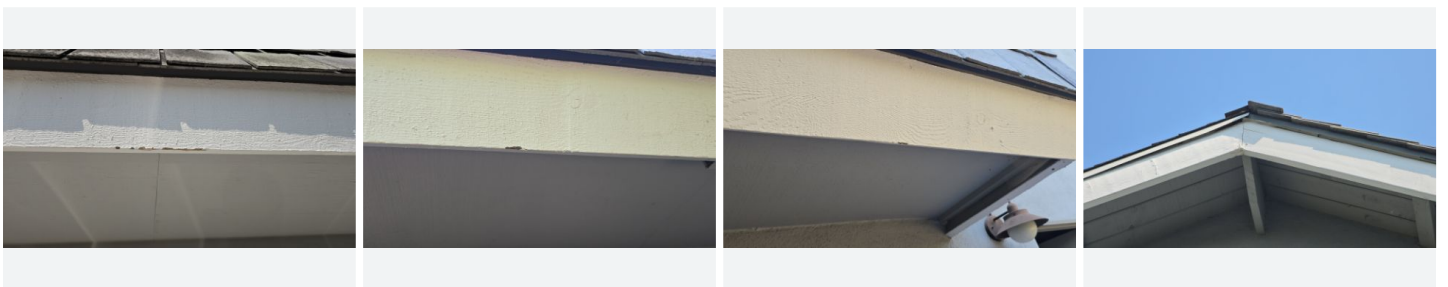
## 2.3 FASCIA

Visible damage/separation - recommend having repaired/repainted.

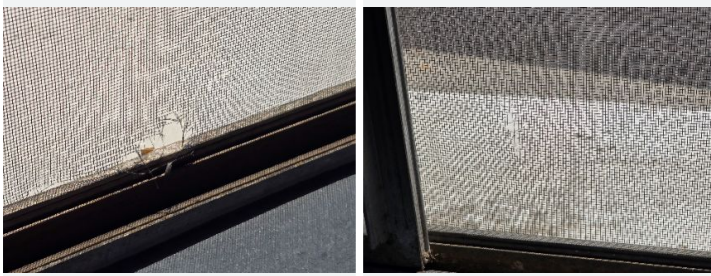
## 2.9 WINDOW SCREENS

Window screen torn/bent - recommend having repaired/replaced.

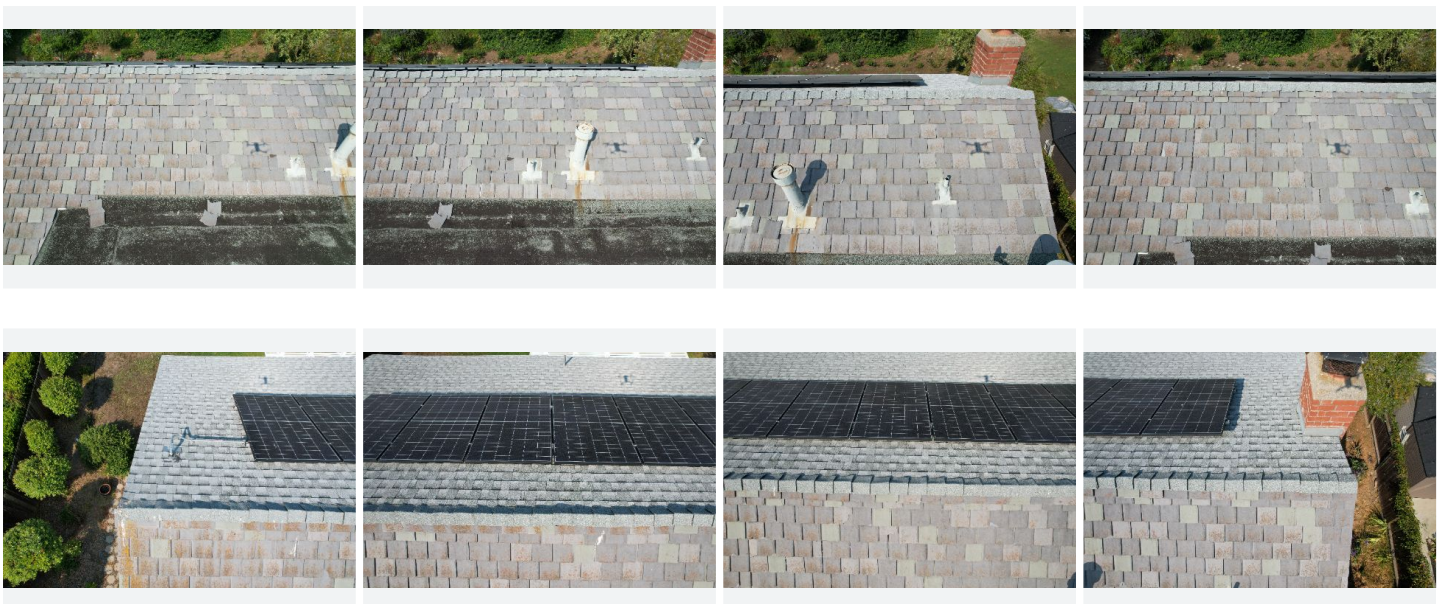
## 3.2 MATERIAL

Loose/damaged roof coverings - recommend having roofer evaluate and repair.

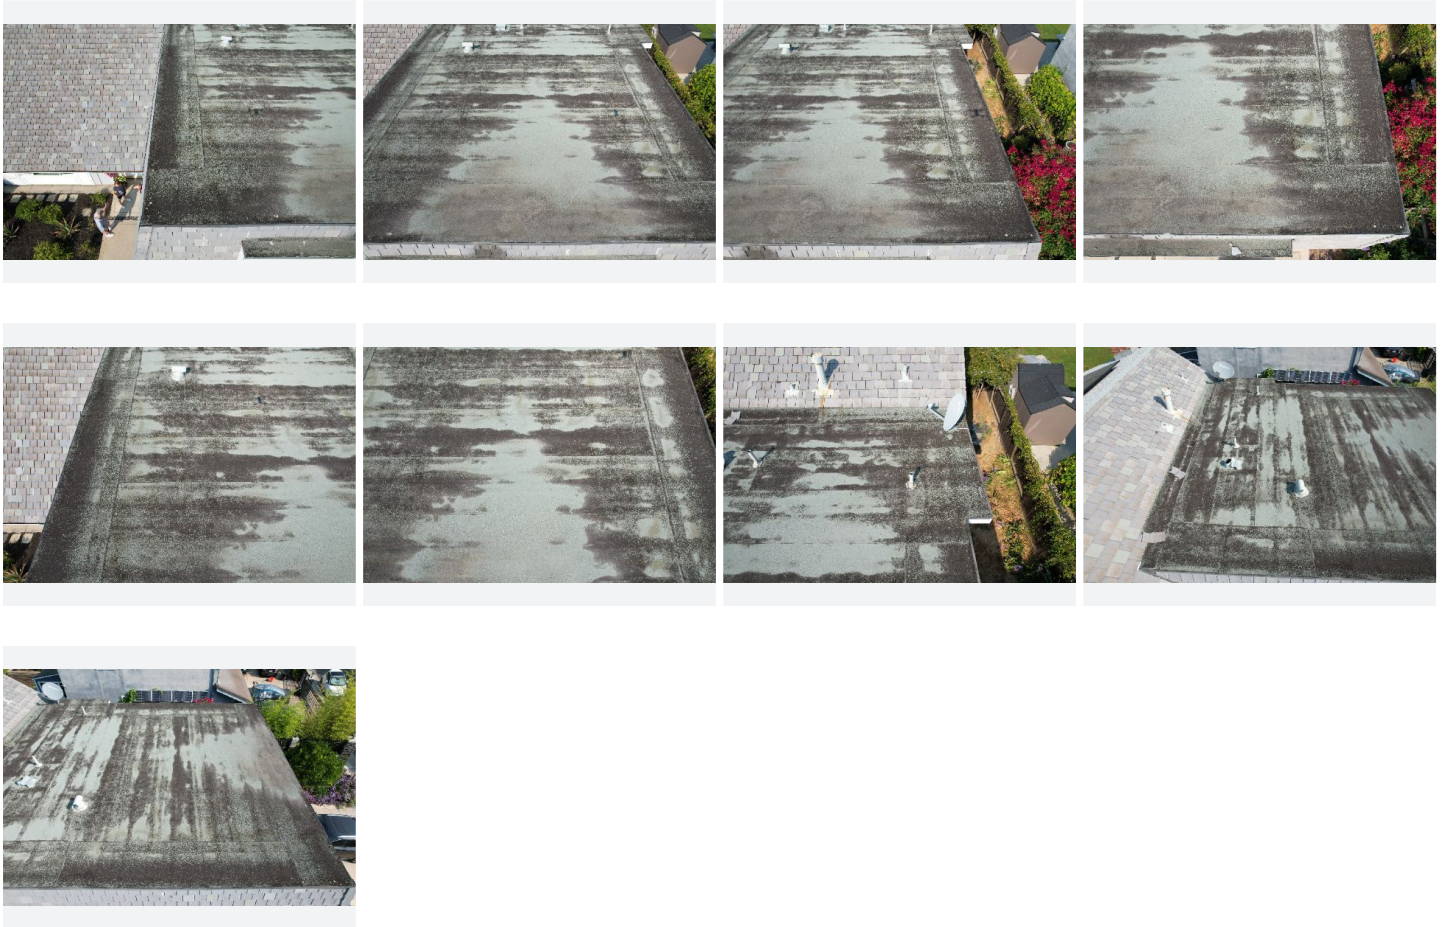
Visible signs of ponding - recommend having roofer evaluate and repair/replace.

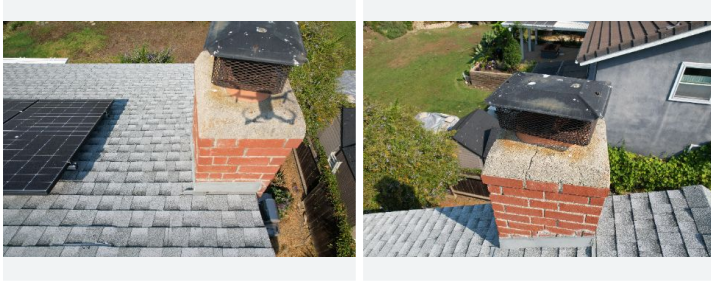
### 3.14 FLUE/FLUE CAP

Visible cracks - recommend having filled and sealed.

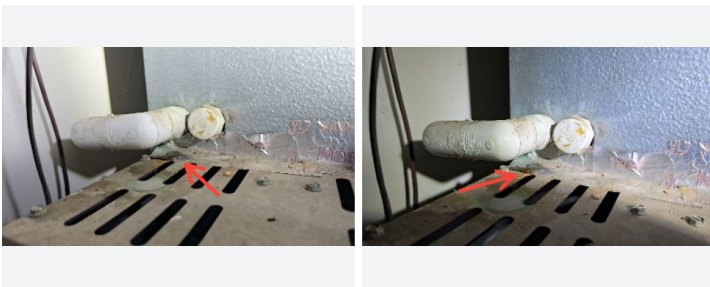
### 4.2 CONDENSATE REMOVAL

Visible leak detected - recommend having HVAC technician evaluate and repair.

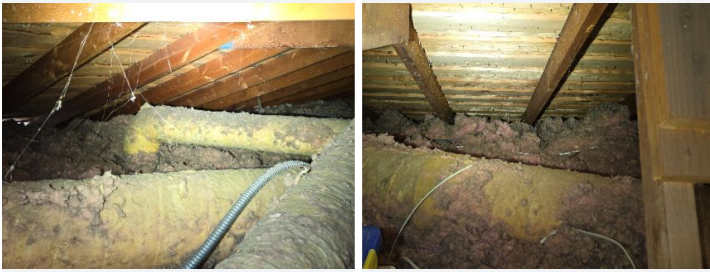
## 5.15 SUSPECTED ASBESTOS

In satisfactory condition at the time of inspection

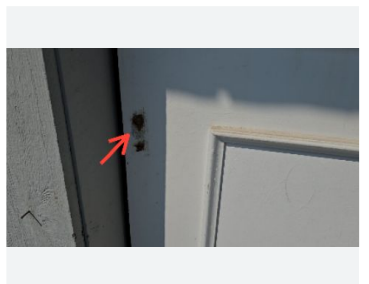
### 7.2 GARAGE DOORS

Door damaged

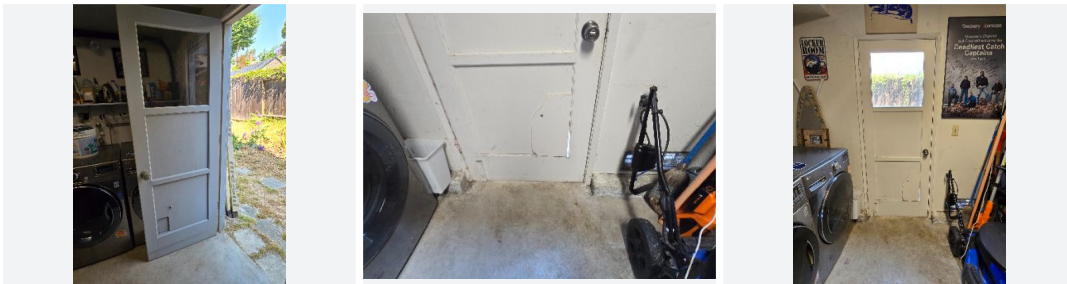
### 7.8 SERVICE DOORS

Visible damage to door/frame - recommend having repaired/repainted.

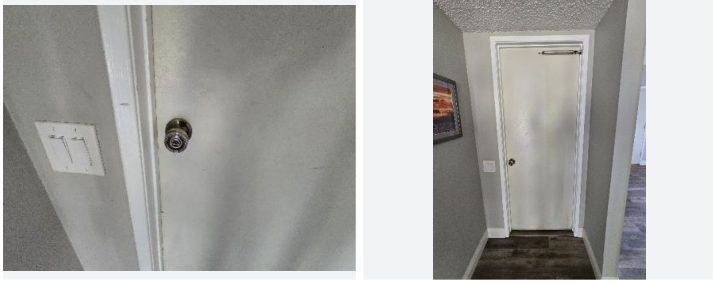
Hardware loose - recommend having secured.

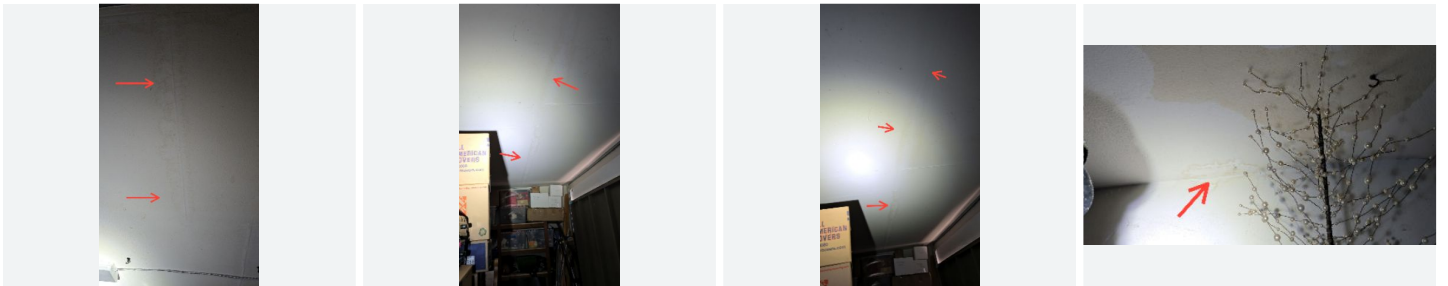
## 7.9 CEILING

Moisture stain present - no moisture detected at time of inspection.

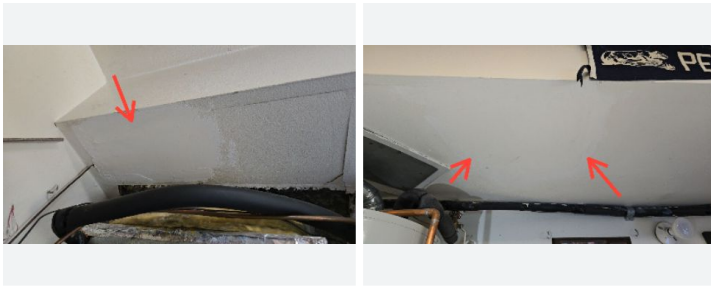
Visible hole - recommend having repaired/repainted.

Visible sign of repair - recommend to monitor.

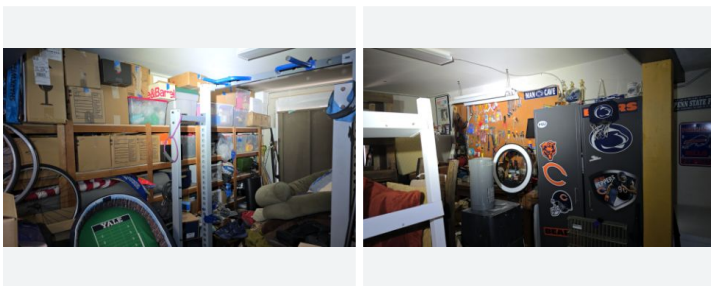
## 7.10 WALLS

Unable to evaluate entire wall surface due to clutter.

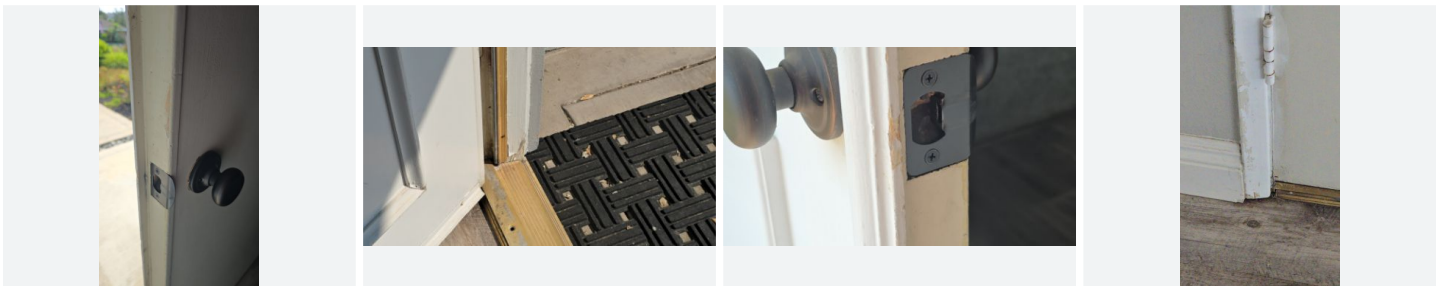
Visible door/frame damage - recommend having repaired/repainted.

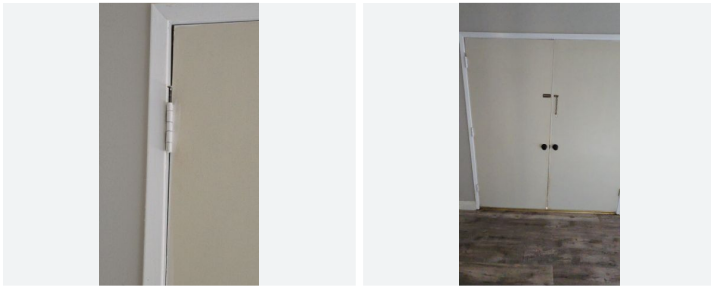
Door hardware loose causing door to rub - recommend having secured/adjusted.

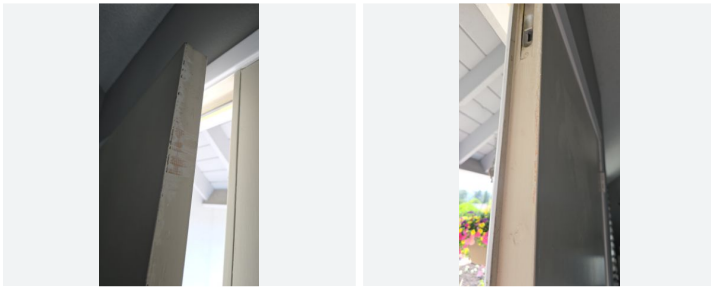
Door rubs on side - recommend having repaired/repainted.

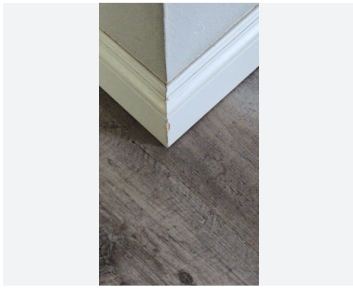
Visible damage - recommend having repaired/repainted.

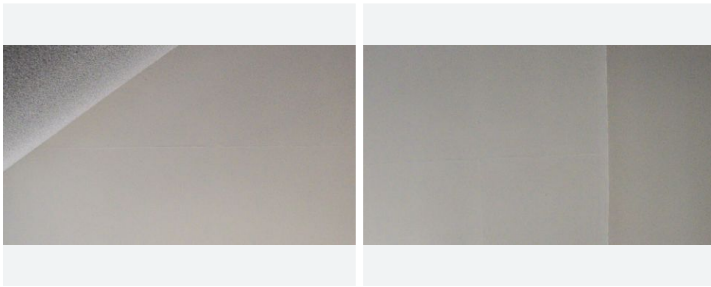
Visible cracks/peeling - recommend having repaired/repainted.

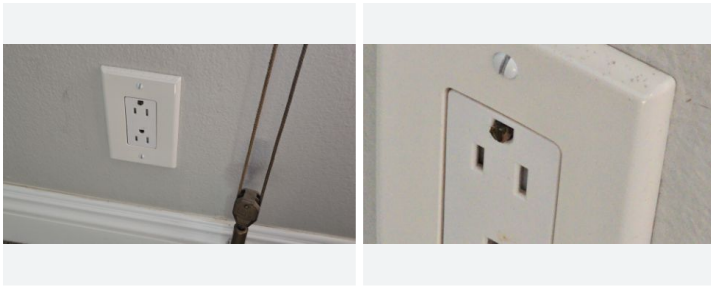
Metal piece broken into ground portion of receptacle - recommend having replaced.

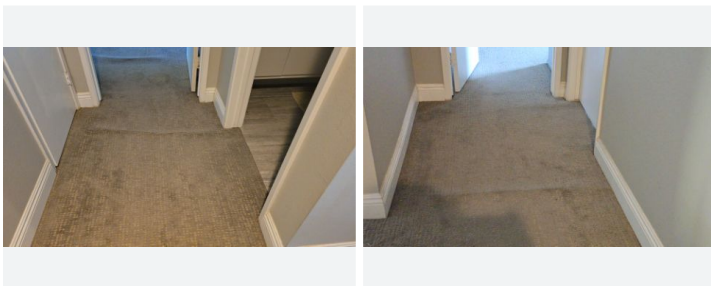
Loose carpet causing trip hazard - recommend having corrected.

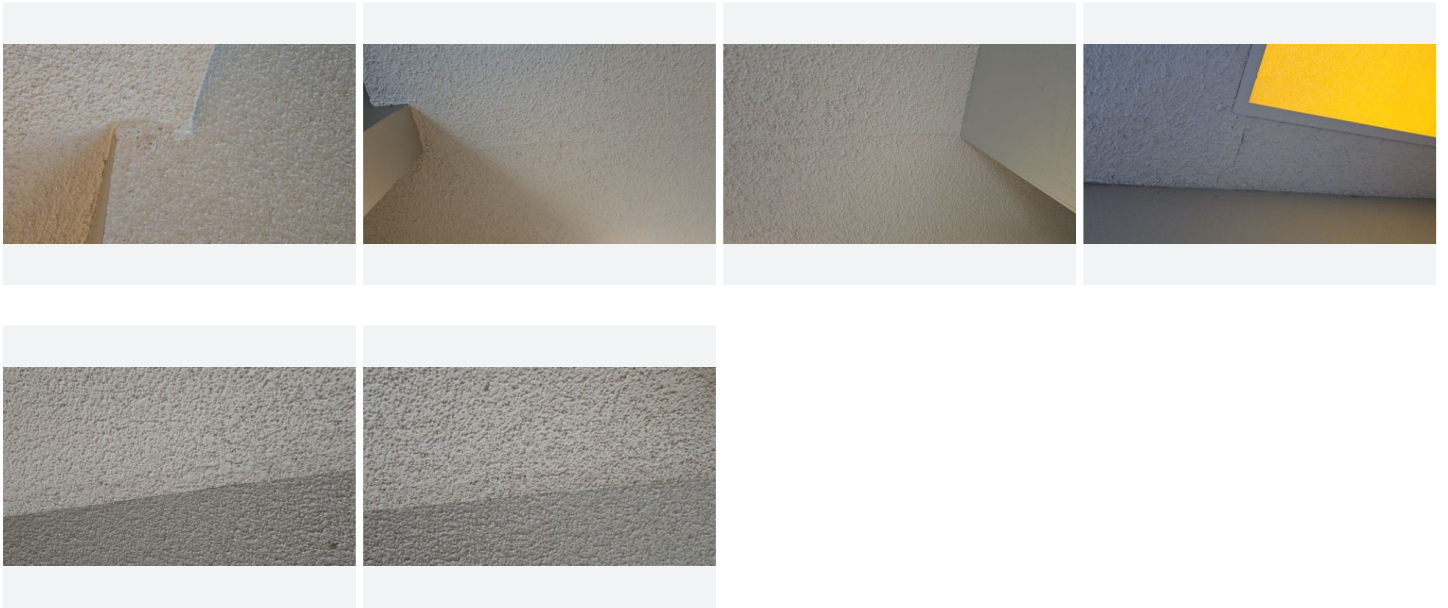
Typical cracking/flaws were observed in ceiling finish

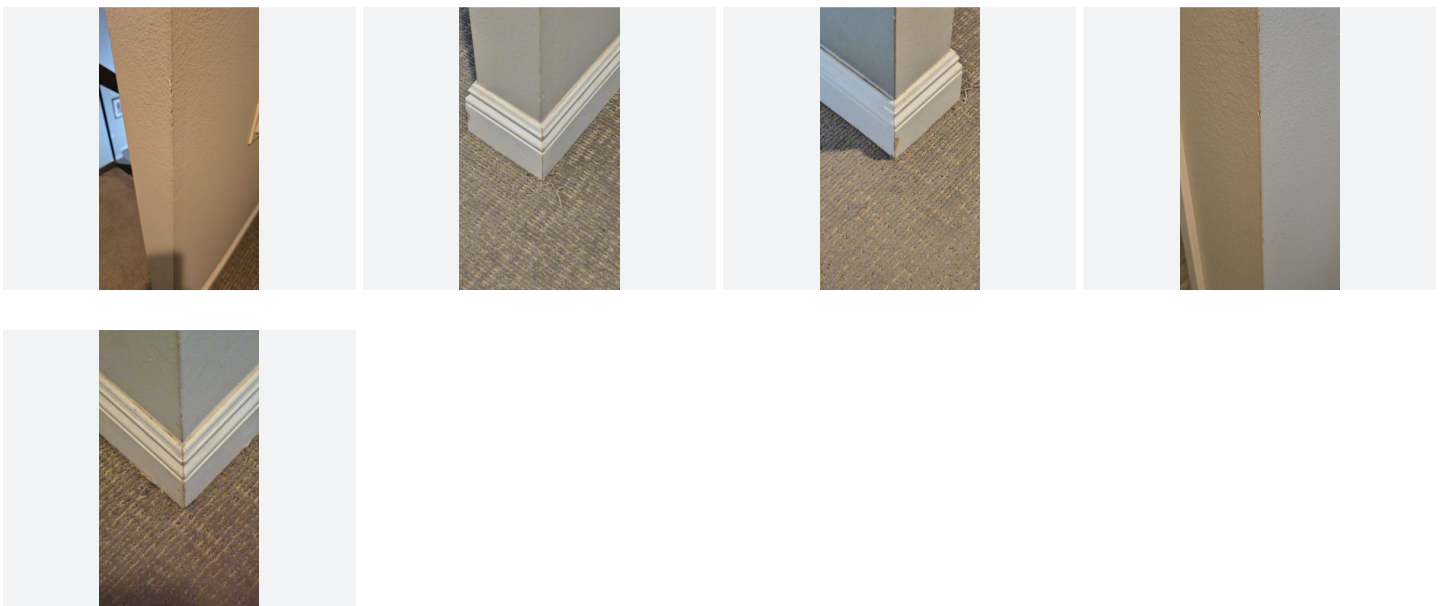
Typical cracking/flaws were observed in wall finish

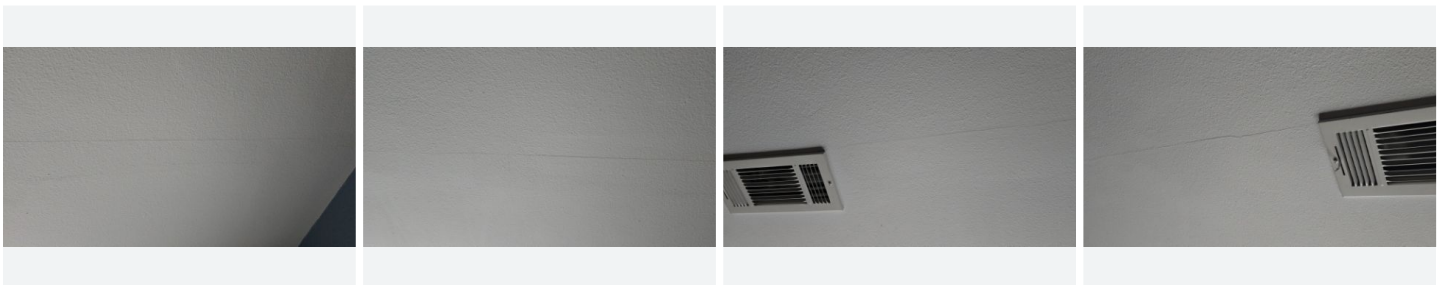
Visible cracks/peeling - recommend having repaired/repainted.

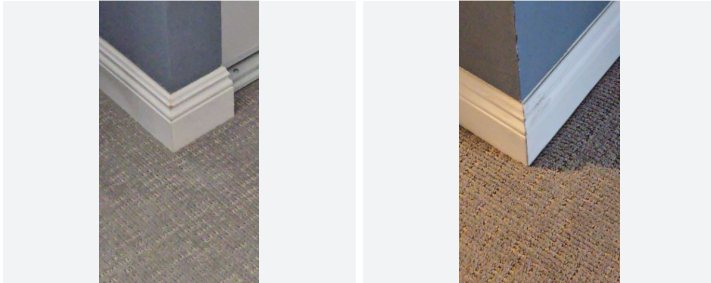
Visible damage - recommend having repaired/repainted.

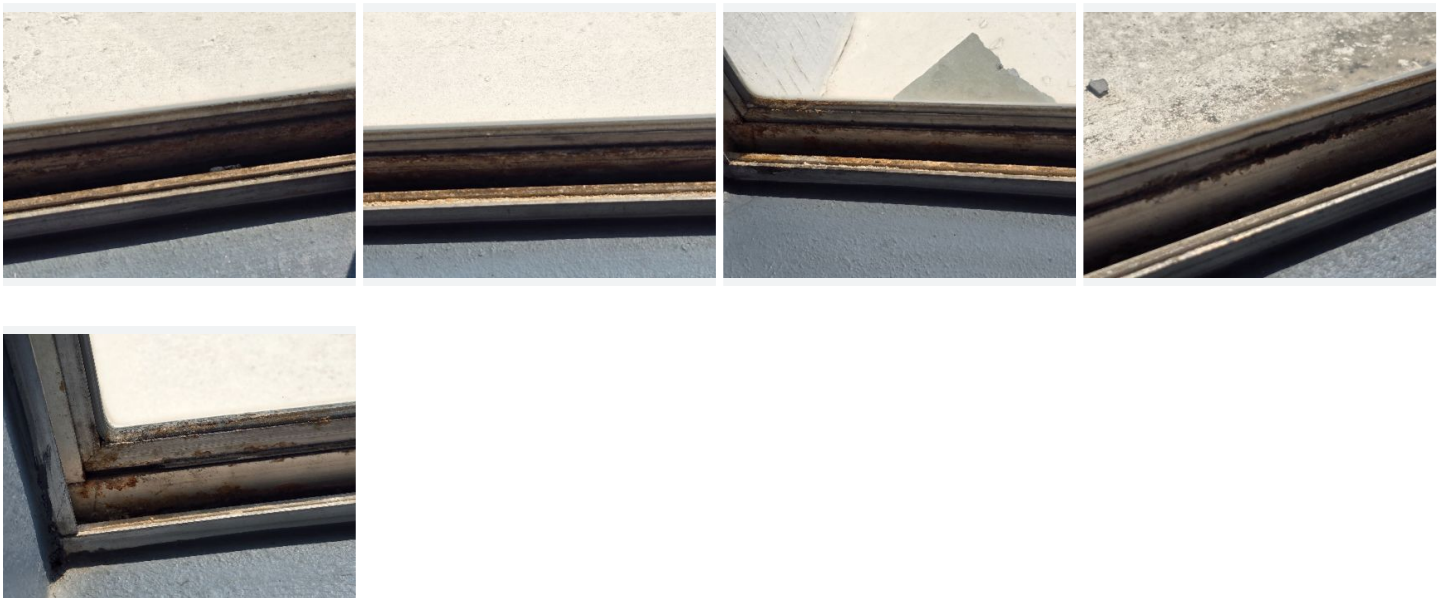
Visible rust inside windowpanes - recommend having sealed or replaced.

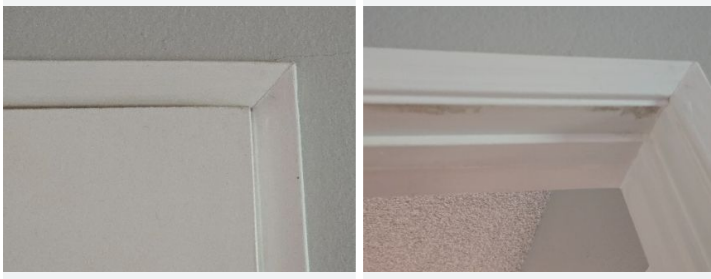
Visible door/frame damage - recommend having repaired/repainted.

The door is sticking

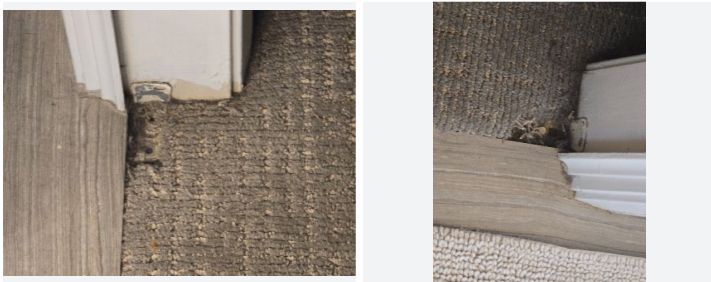
Carpet is damaged - recommend having repaired/replaced.

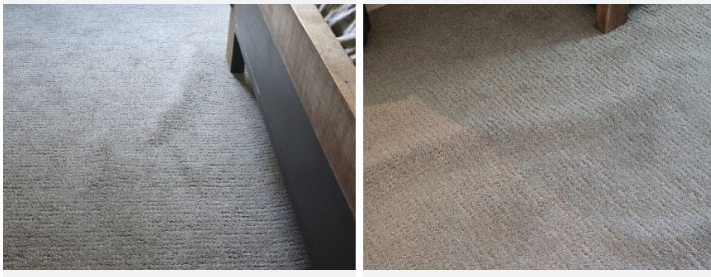
Loose flooring causing trip hazard - recommend having corrected.

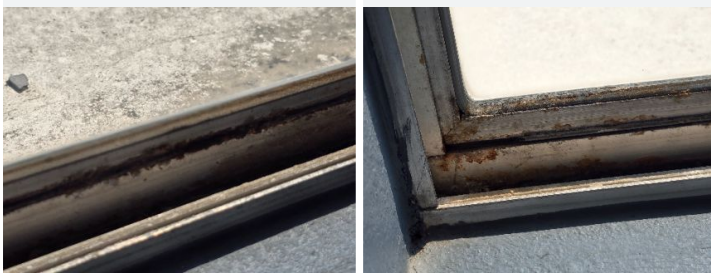
Visible rust in between windowpanes - the possible cause is moisture - recommend having sealed.

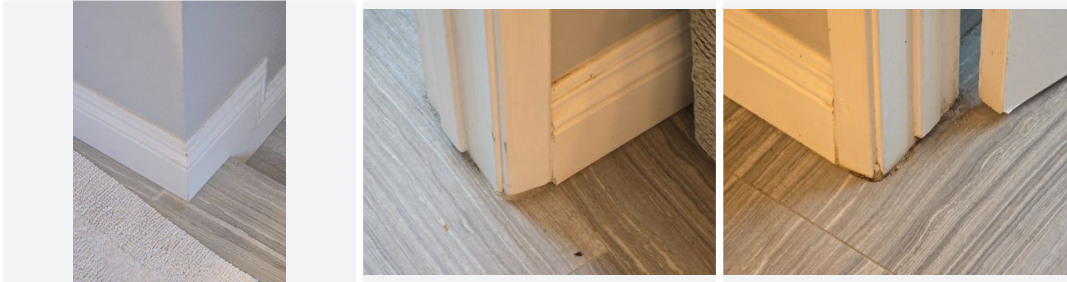
Visible damage - recommend having repaired/repainted.

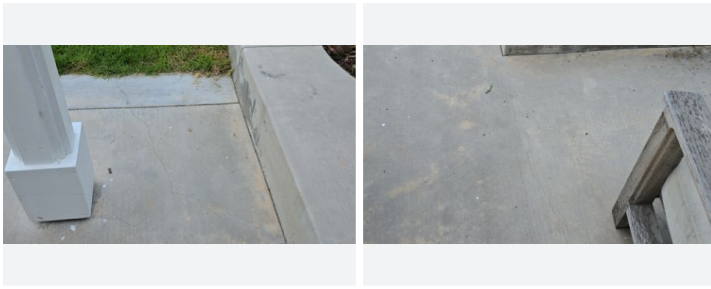
Typical cracks/pits in cement - recommend having filled and sealed.

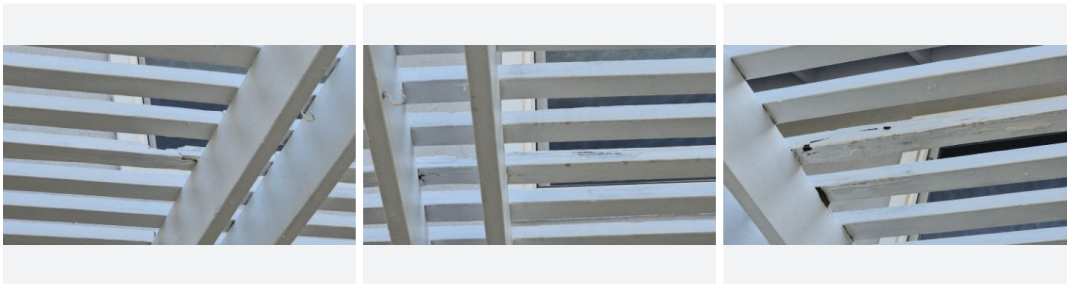
Visible damage to patio cover - recommend having repaired/repainted.

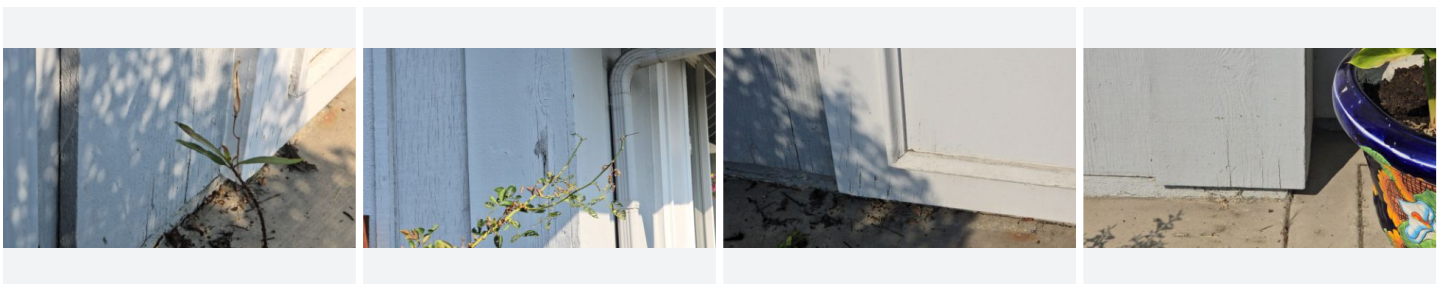
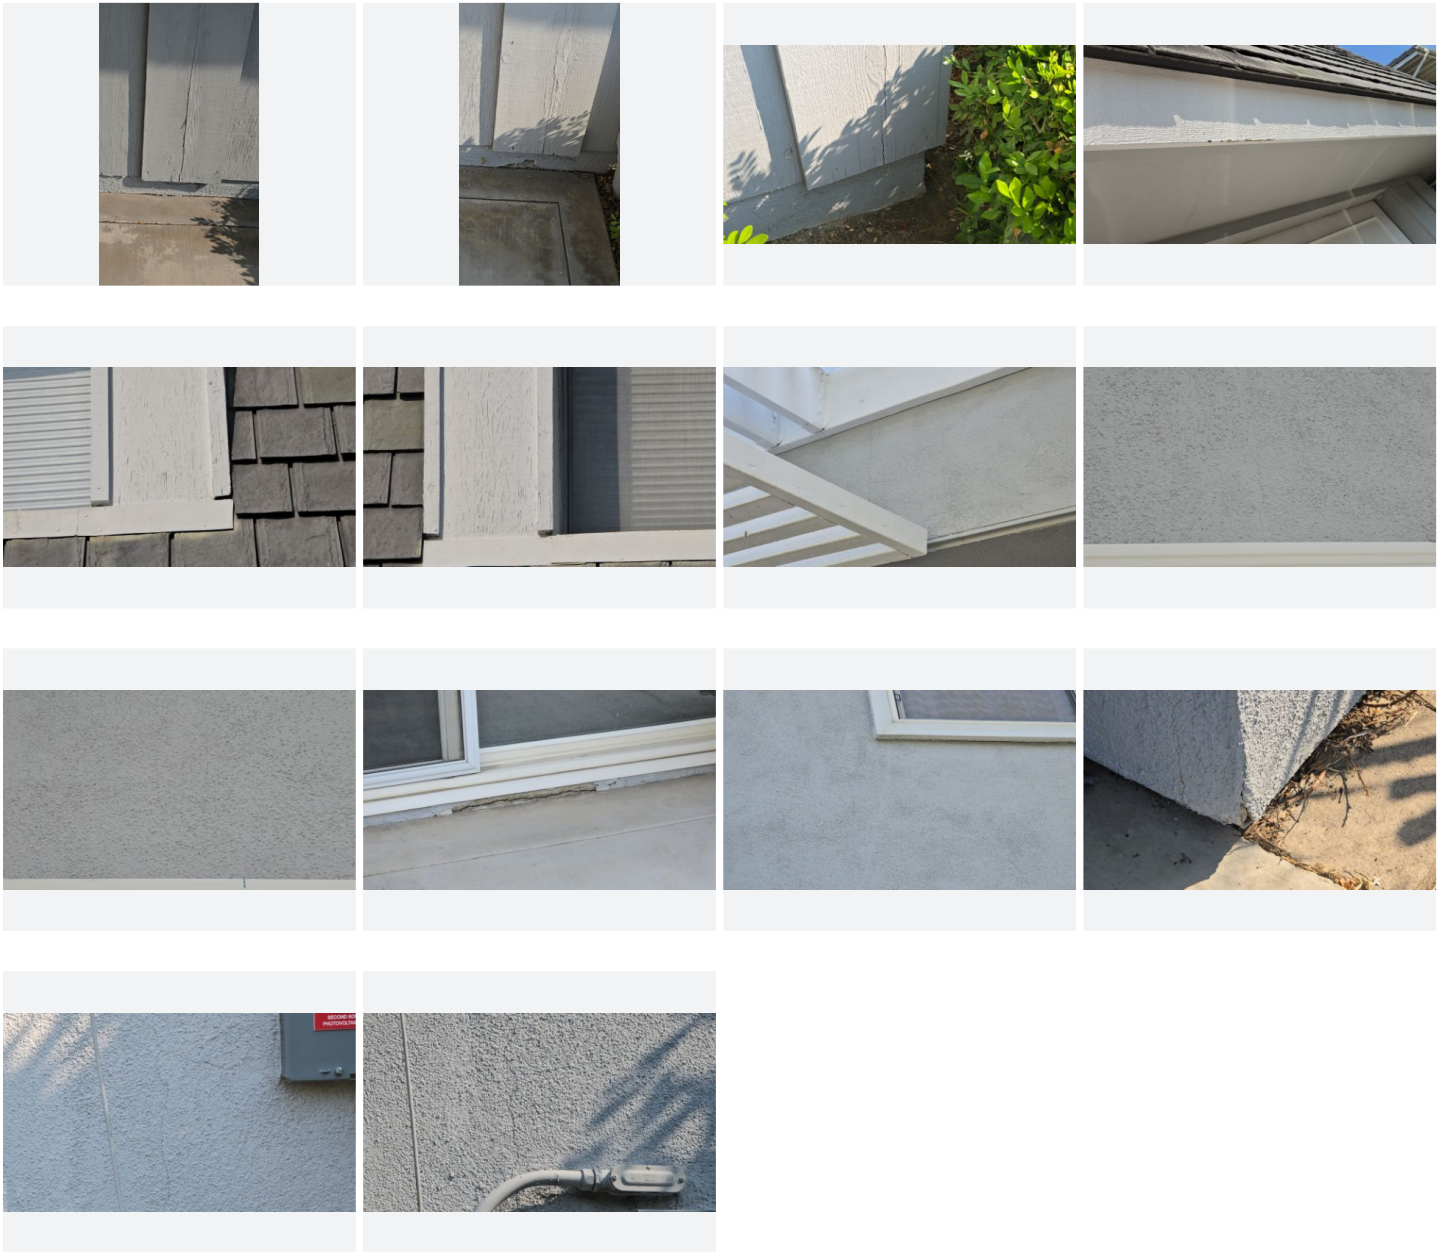
### 2.1 TYPE

Visible signs of cracks/peeling paint on siding - recommend having repaired/repainted.

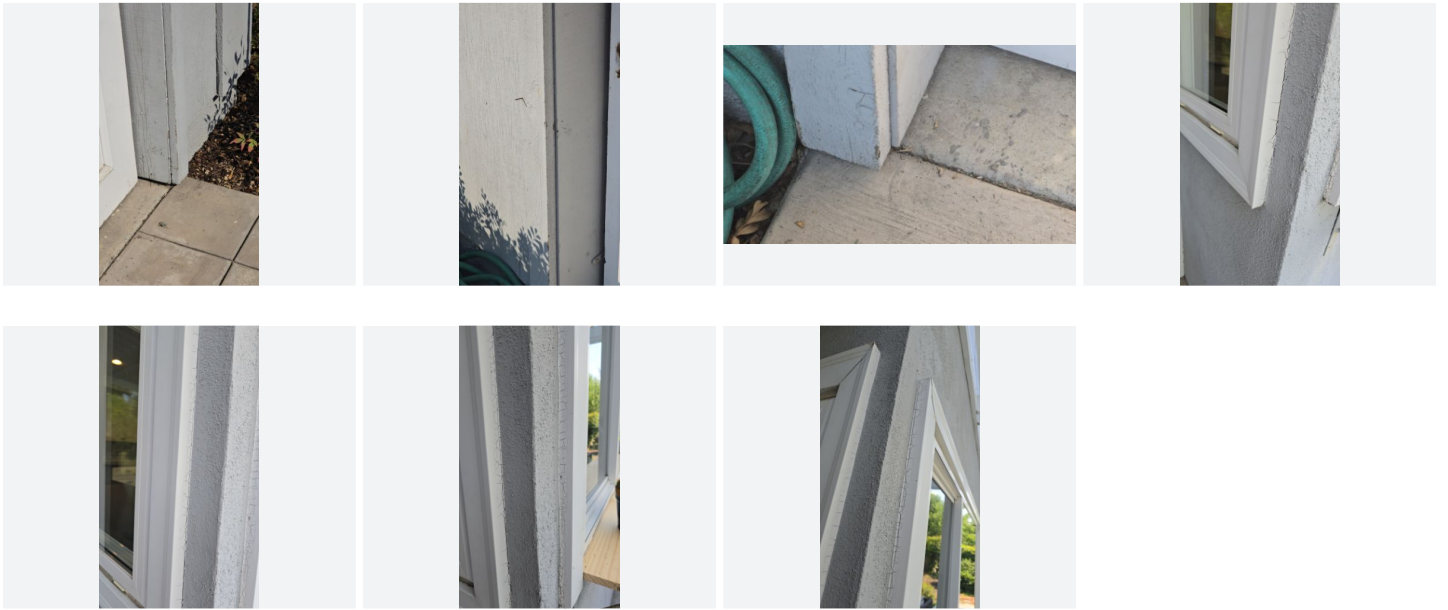
## 2.2 TRIM

Visible signs of cracks/peeling paint on siding - recommend having repaired/repainted.

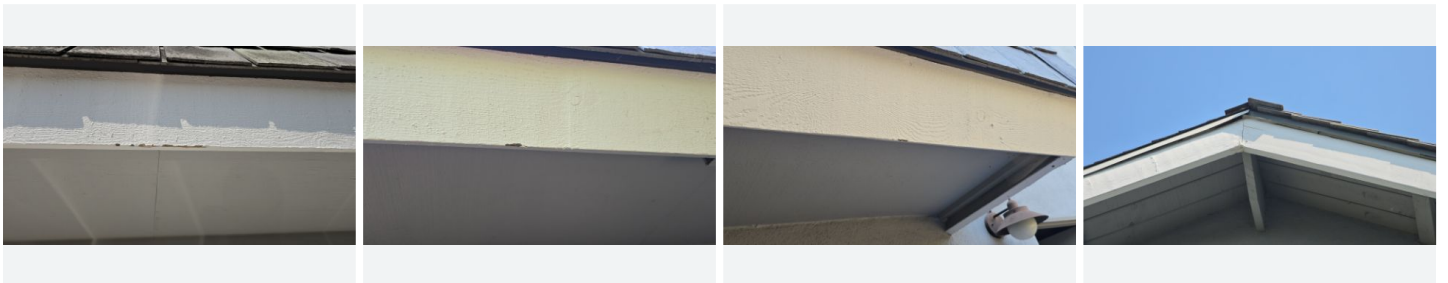
### 2.3 FASCIA

Visible damage/separation - recommend having repaired/repainted.

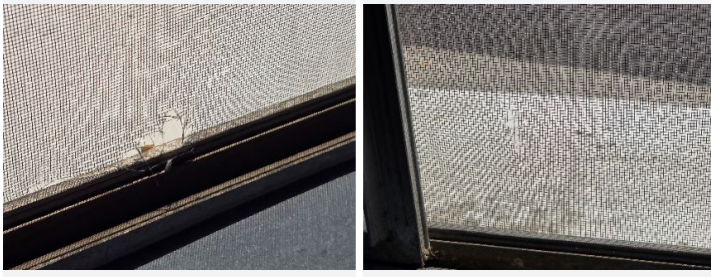
### 2.9 WINDOW SCREENS

Window screen torn/bent - recommend having repaired/replaced.

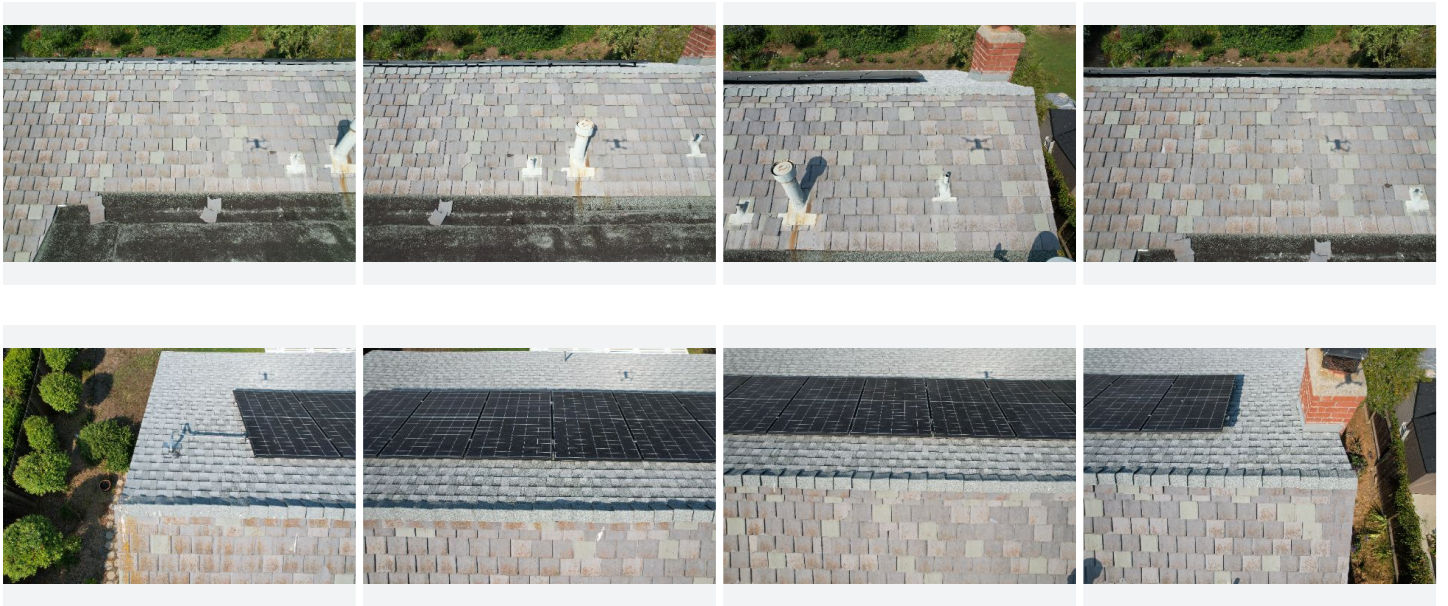
### 3.2 MATERIAL

Loose/damaged roof coverings - recommend having roofer evaluate and repair.

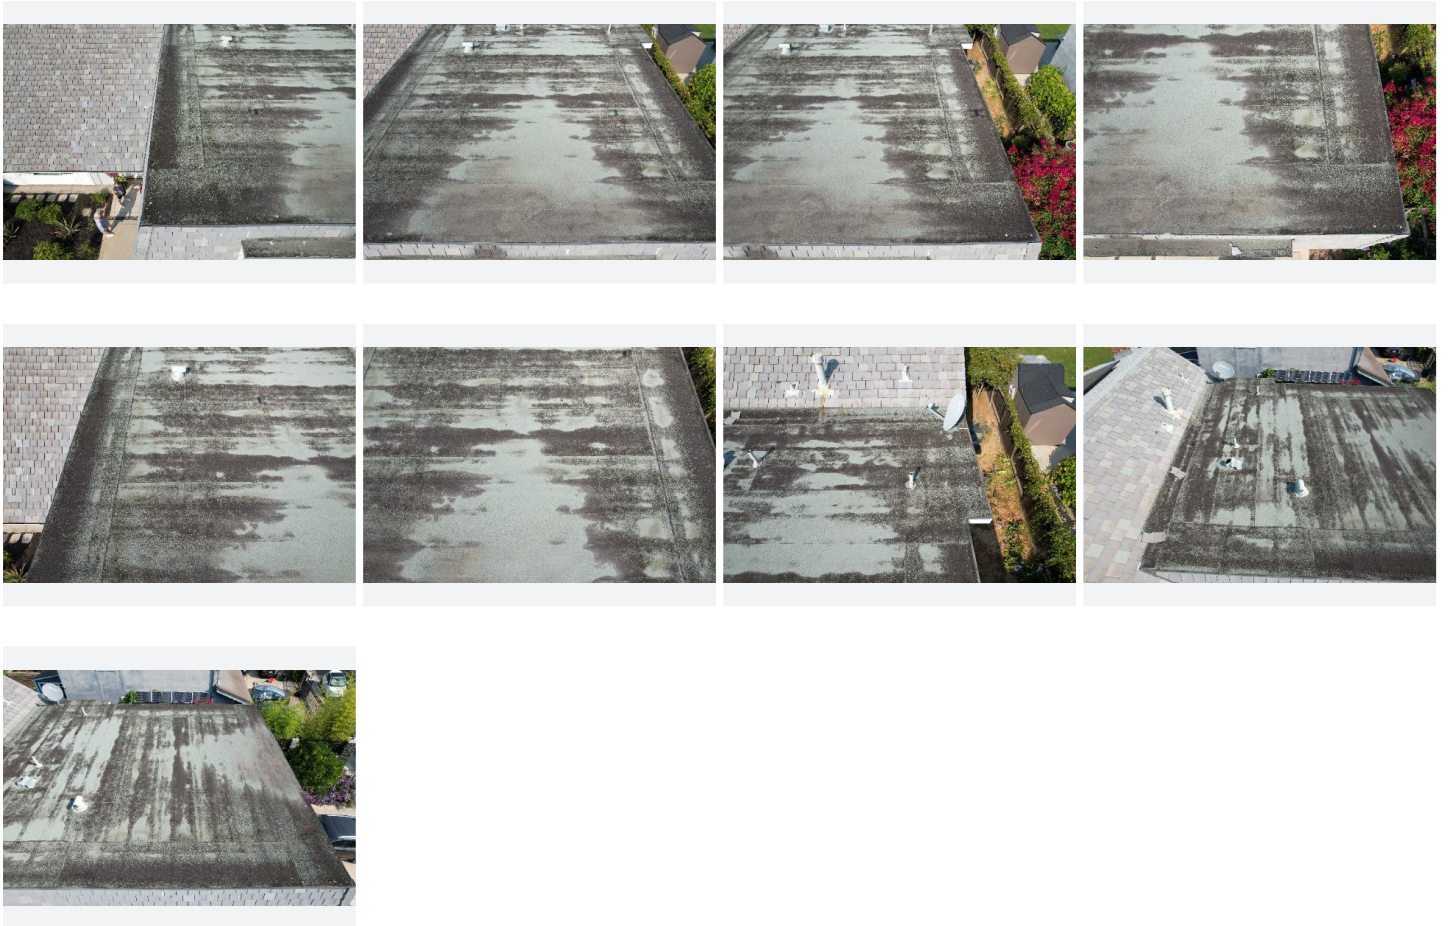
Visible signs of ponding - recommend having roofer evaluate and repair/replace.

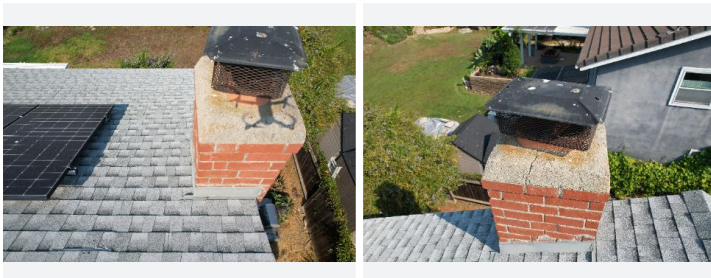
### 3.14 FLUE/FLUE CAP

Visible cracks - recommend having filled and sealed.

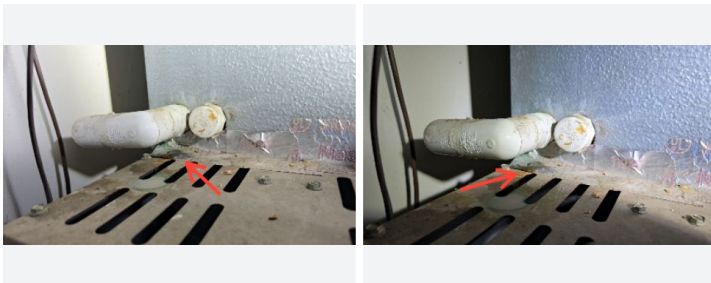
Visible leak detected - recommend having HVAC technician evaluate and repair.

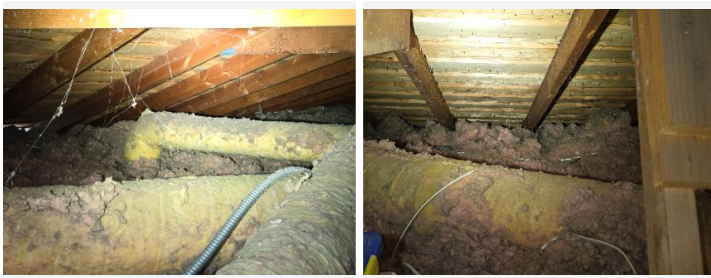
### 5.15 SUSPECTED ASBESTOS

In satisfactory condition at the time of inspection

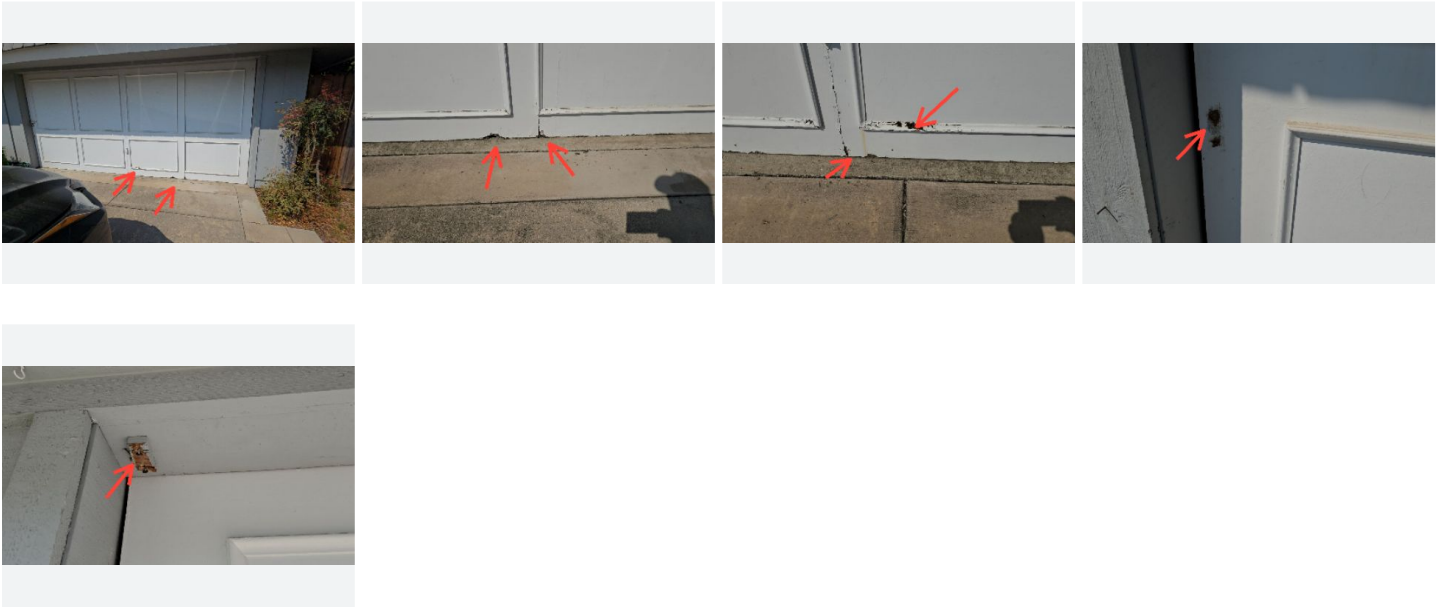
## 7.2 GARAGE DOORS

Door damaged
