Jul 9th, 2024

25321 Terreno Dr., Mission Viejo, CA, 92691

# Home Inspection Report

Joseph Kennison / Loyalty Inspections

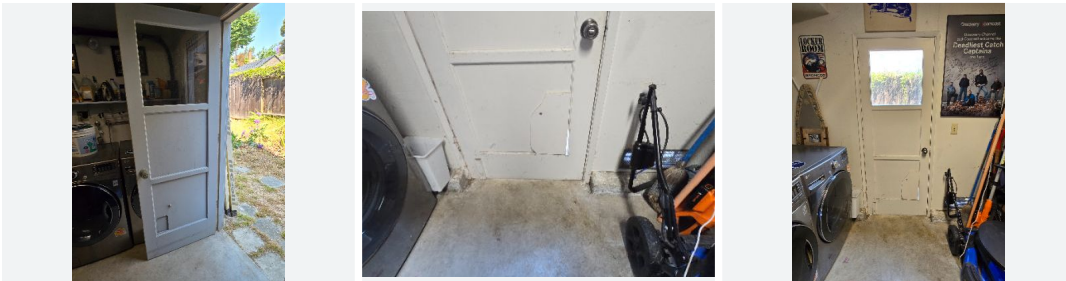
## 7.8 SERVICE DOORS

Visible damage to door/frame - recommend having repaired/repainted.

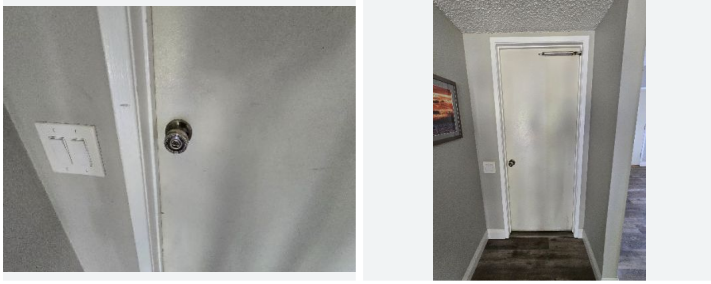
Hardware loose - recommend having secured.

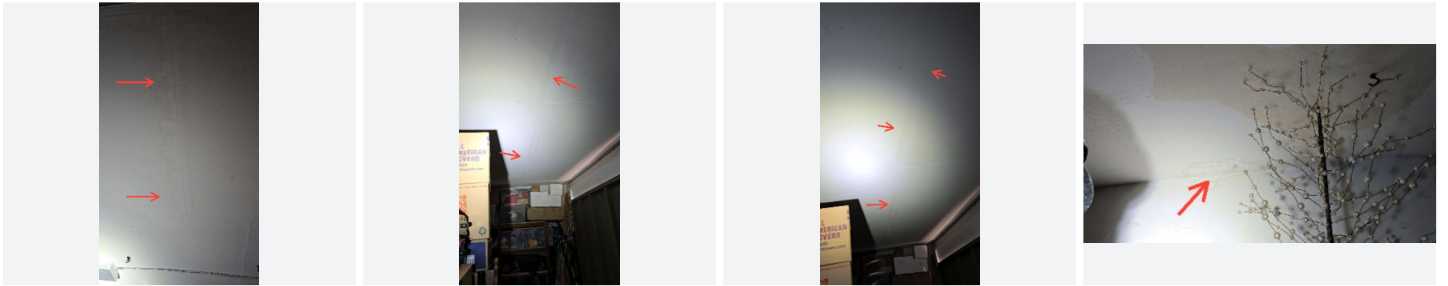
## 7.9 CEILING

Moisture stain present - no moisture detected at time of inspection.

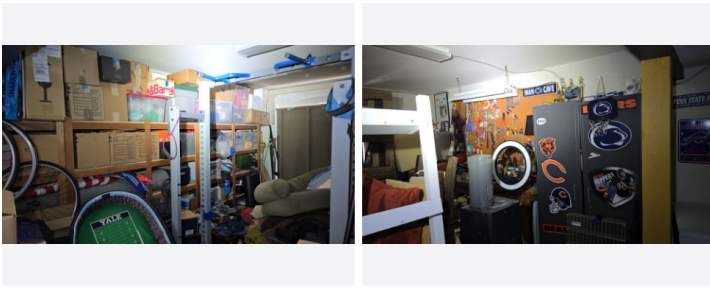
Unable to evaluate entire wall surface due to clutter.

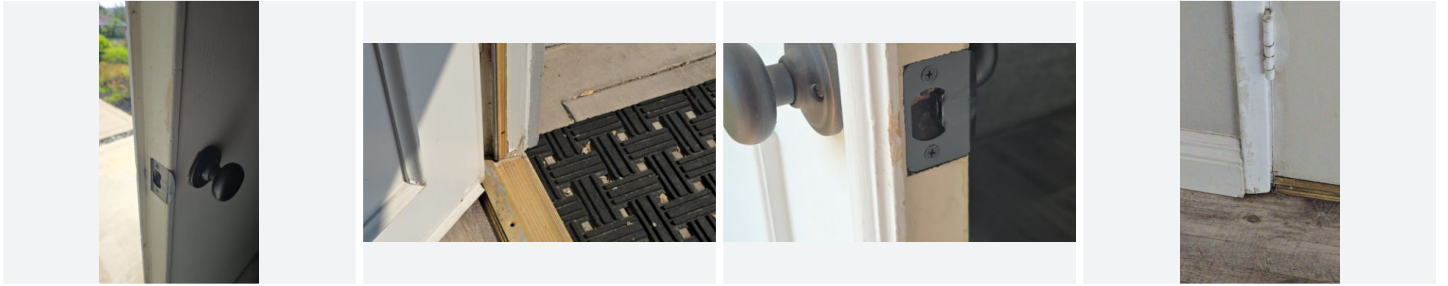
Visible door/frame damage - recommend having repaired/repainted.

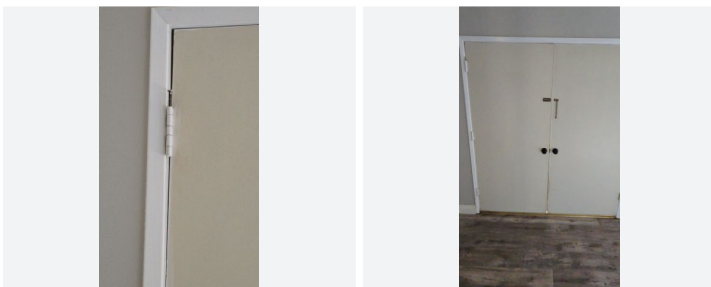
Door hardware loose causing door to rub - recommend having secured/adjusted.

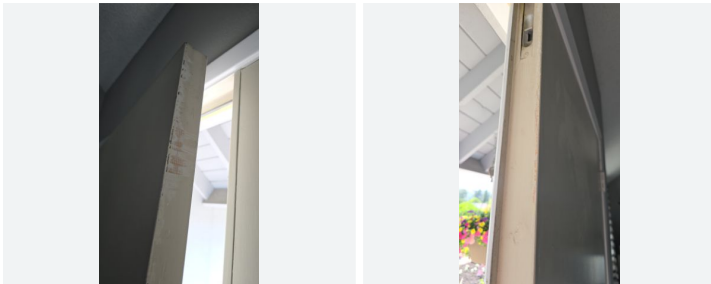
Door rubs on side - recommend having repaired/repainted.

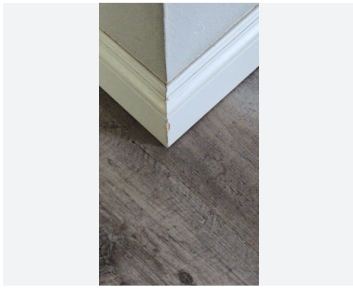
## 12.4 WALLS

Visible damage - recommend having repaired/repainted.

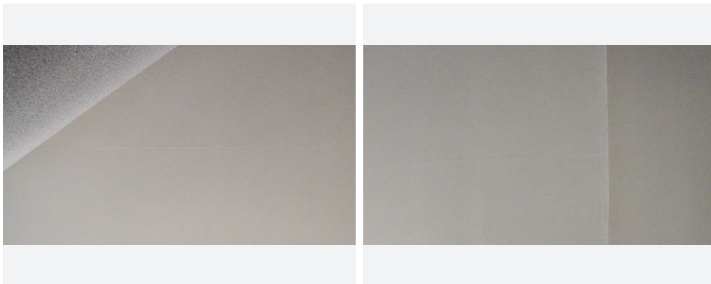
Visible cracks/peeling - recommend having repaired/repainted.

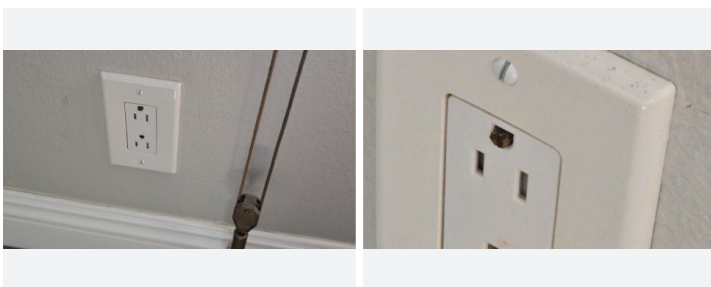
## 12.7 ELECTRICAL

Metal piece broken into ground portion of receptacle - recommend having replaced.

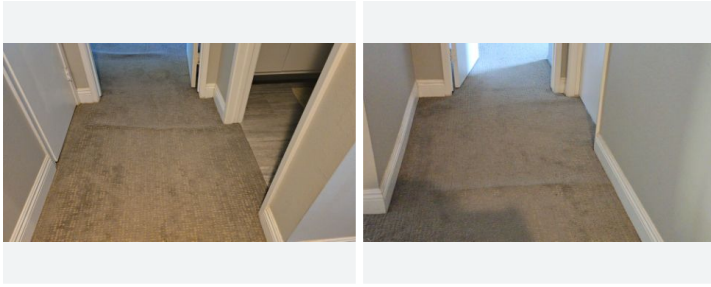
### 14.2 FLOOR

Loose carpet causing trip hazard - recommend having corrected.

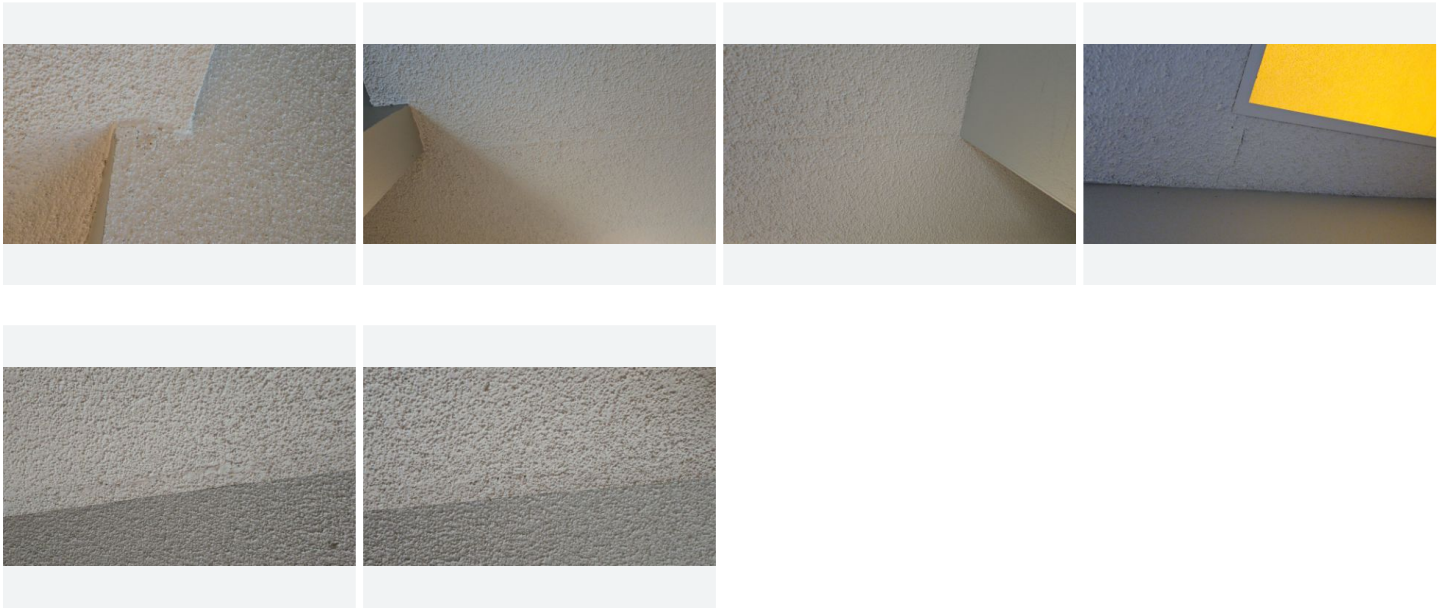
### 14.3 CEILING

Typical cracking/flaws were observed in ceiling finish

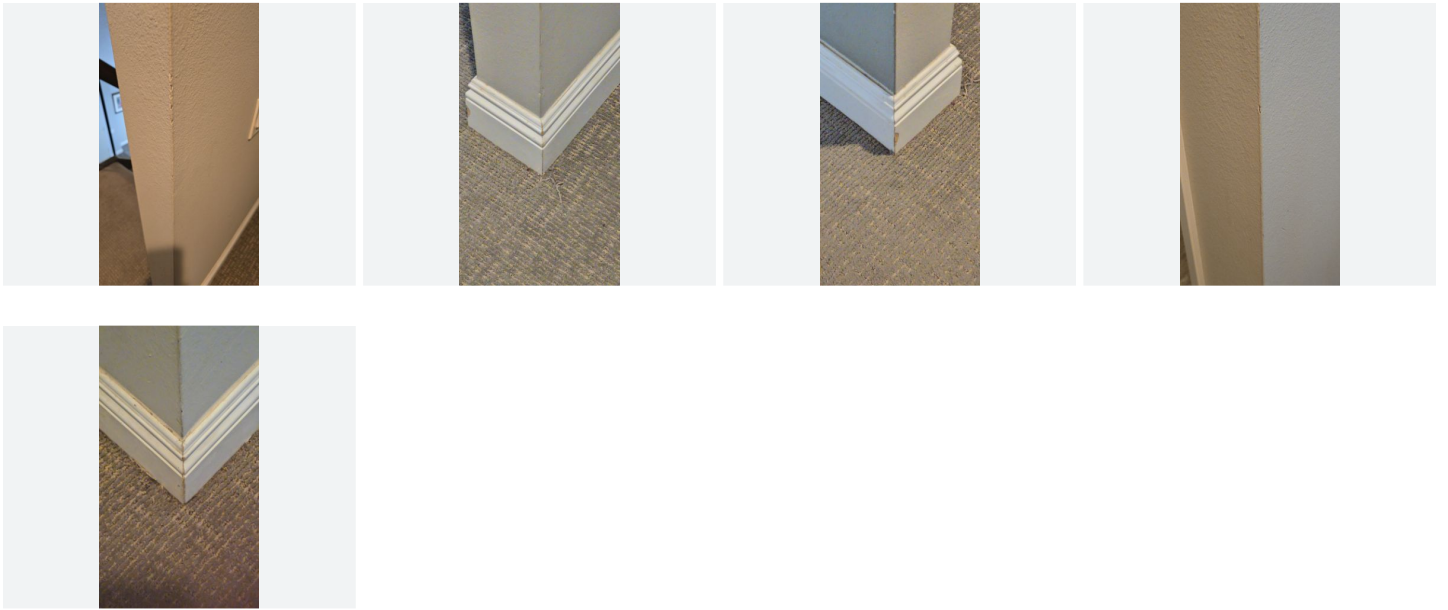
### 14.4 WALLS

Typical cracking/flaws were observed in wall finish

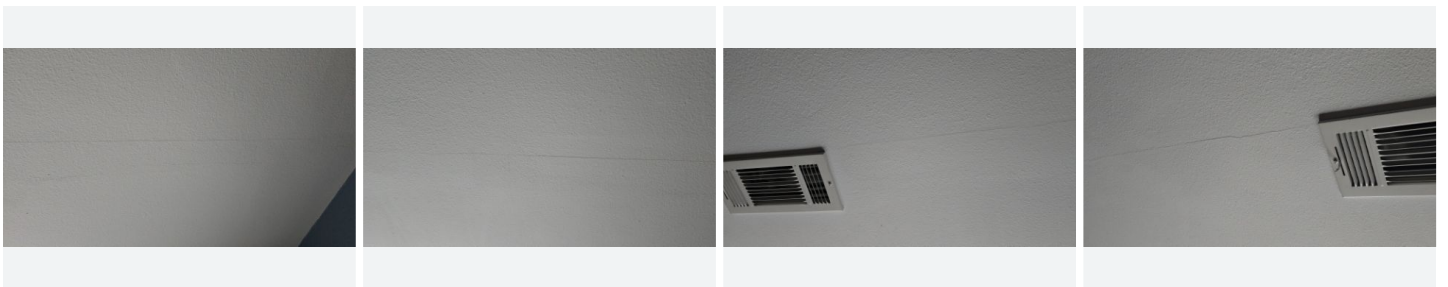
### 16.3 CEILING

Visible cracks/peeling - recommend having repaired/repainted.

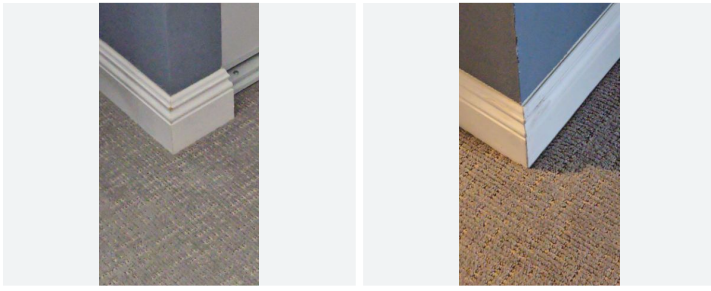
### 16.4 WALLS

Visible damage - recommend having repaired/repainted.

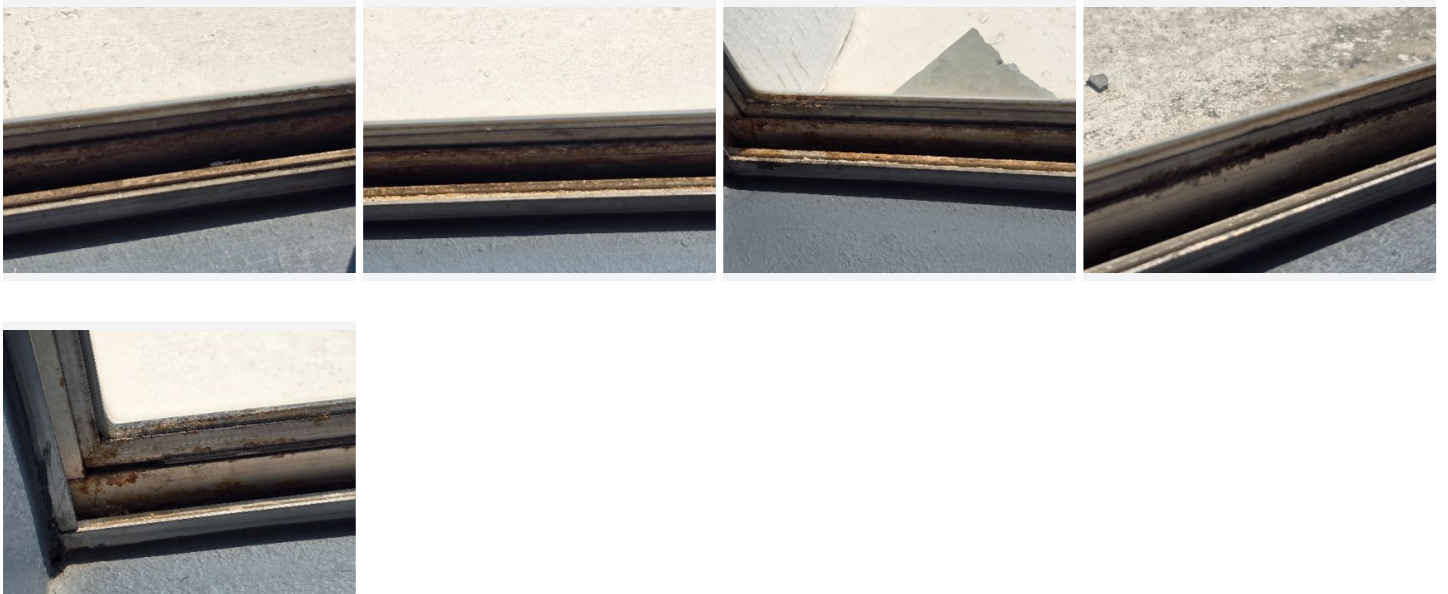
## 16.6 WINDOWS

Visible rust inside windowpanes - recommend having sealed or replaced.

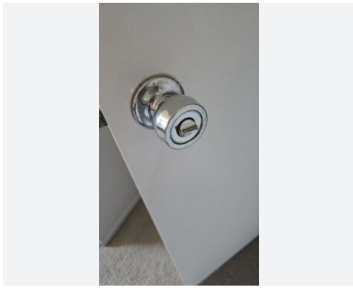
### 17.1 DOORS

Hardware does not lock - recommend having repaired/replaced.

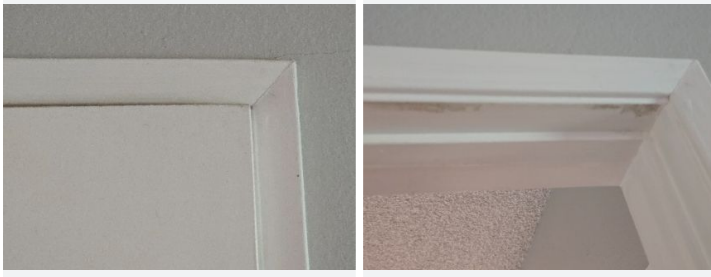
Visible door/frame damage - recommend having repaired/repainted.

The door is sticking

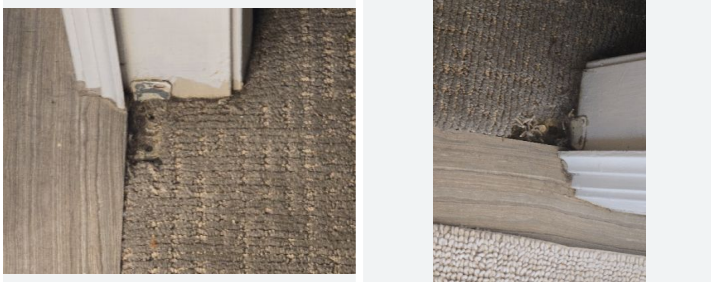
## 19.2 CLOSET

Carpet is damaged - recommend having repaired/replaced.

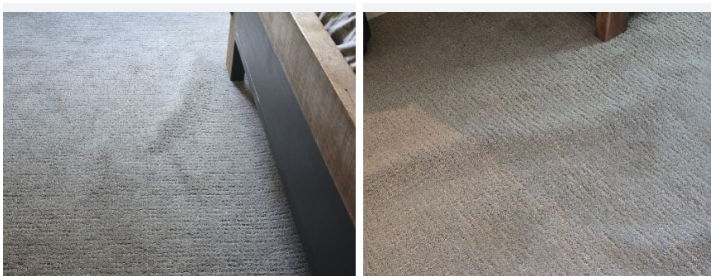
## 19.5 FLOOR

Loose flooring causing trip hazard - recommend having corrected.

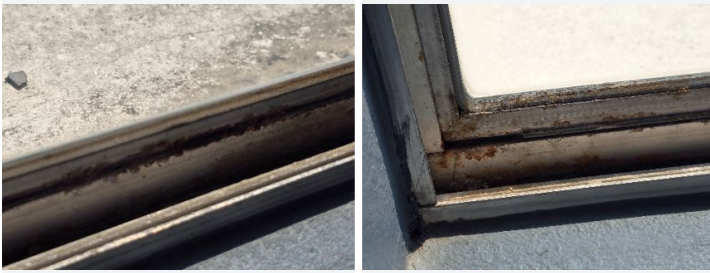
## 19.7 WINDOWS

Visible rust in between windowpanes - the possible cause is moisture - recommend having sealed.

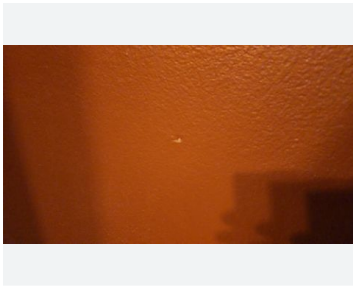
Visible damage - recommend having repaired/repainted.

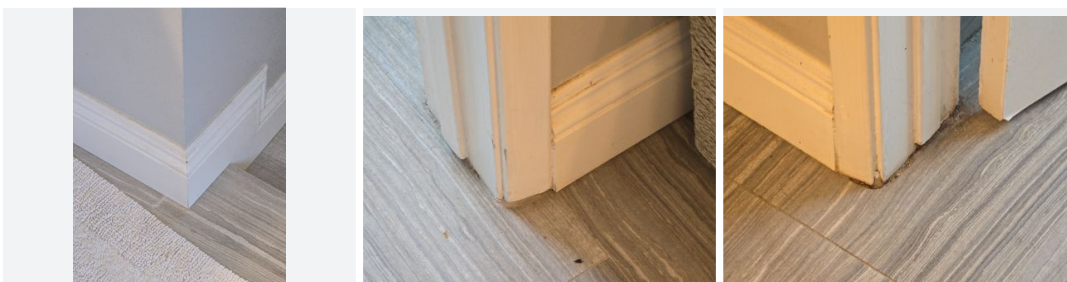
Visible damage - recommend having repaired/repainted.
