# WOOD DESTROYING PESTS AND ORGANISMS INSPECTION REPORT

Building No. 1289	Street Palmetto Ave	City Chico	ZIP 95926	Date of Inspection 11/23/2022	Number of Pages 5
----------------------	------------------------	---------------	--------------	----------------------------------	----------------------

Report # : 40492  
 Registration # : PR3779  
 Escrow # :  
 CORRECTED REPORT

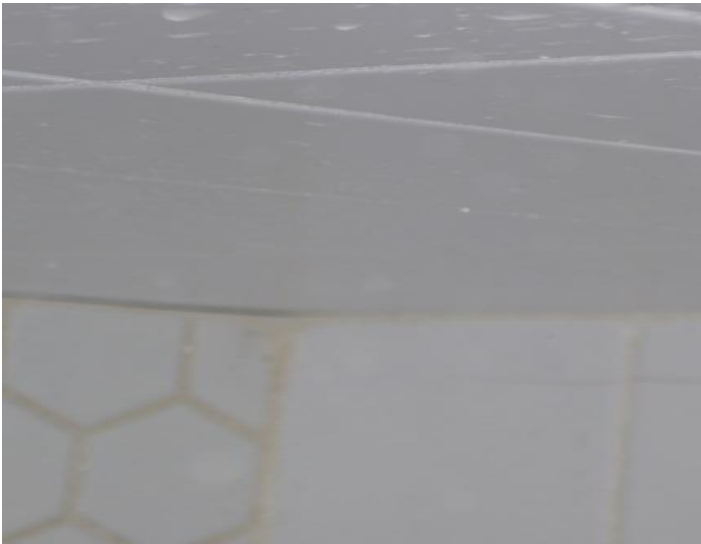
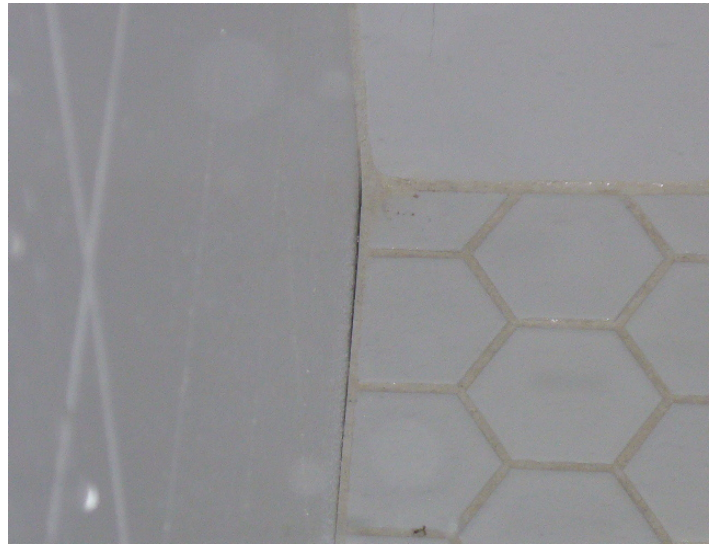
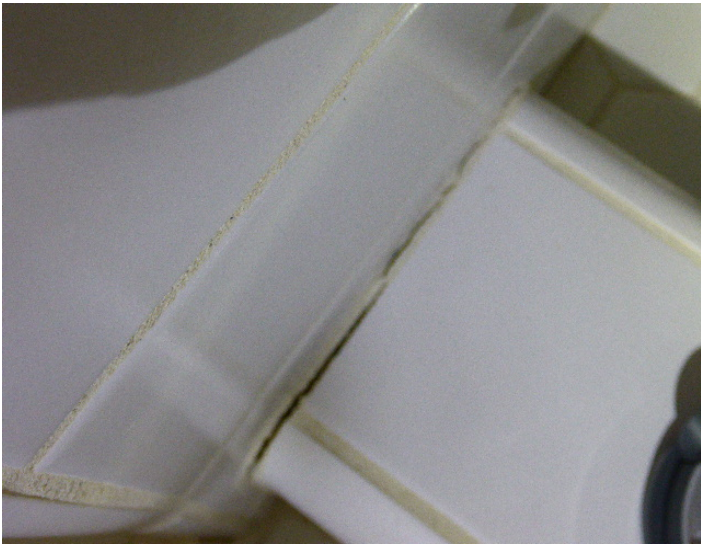
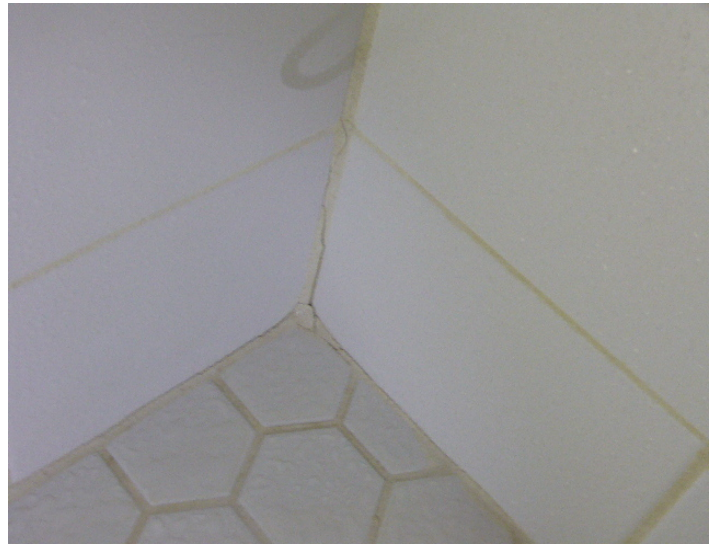
FINDING: Cracked tile grout was noted at both bathroom stall shower enclosures.

RECOMMENDATION: Seal the stall shower tile grout as needed to help prevent moisture related problems in this area.

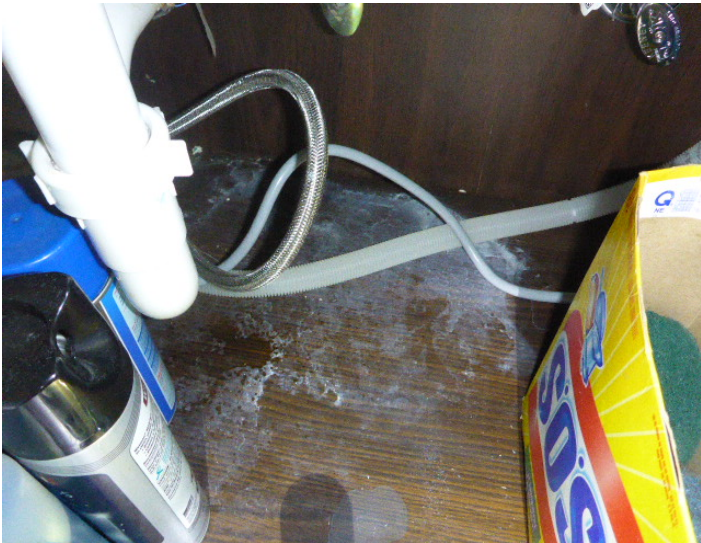
10A

FINDING: Stains (dry) were noted at the kitchen sink cabinet bottom.

RECOMMENDATION: Interested parties should engage the services of a licensed plumber to check for leaks and make repairs as needed.

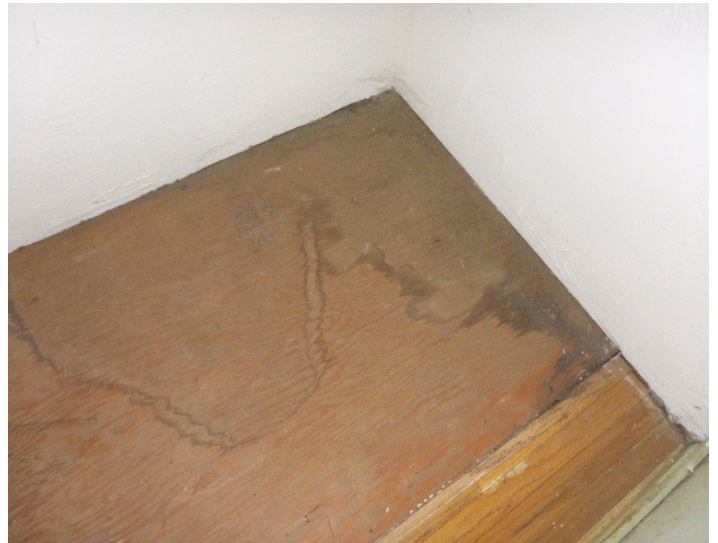
10B

FINDING: Stains were noted at the base of the entryway closet walls and floor. Unable to determine if stains are active or passive.

RECOMMENDATION: Interested parties should engage the services of a licensed contractor to check for leaks and to perform any corrective work needed.

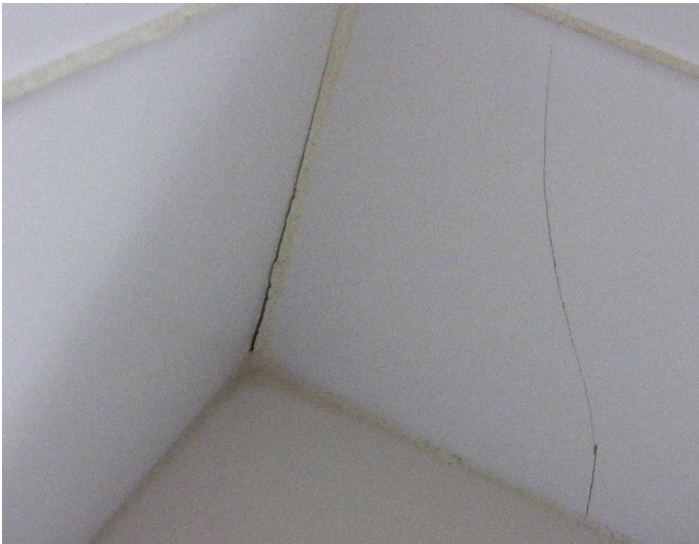
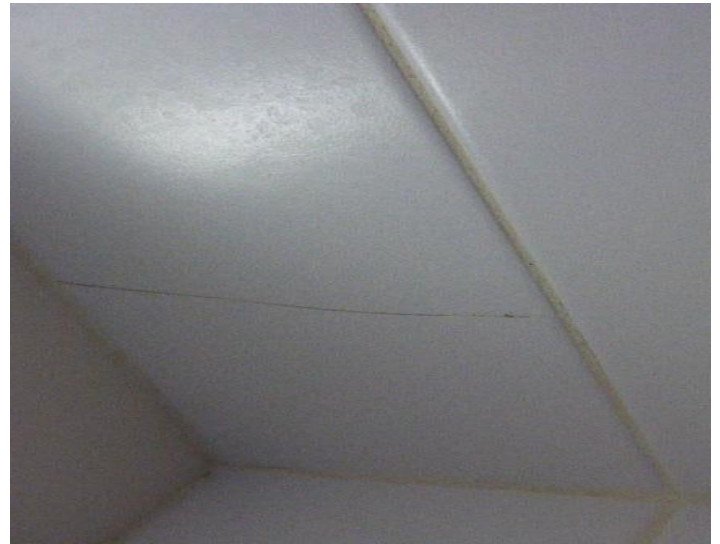
FINDING: Cracked tiles and grout was noted at the hall bathroom bathtub/shower enclosure walls.

RECOMMENDATION: Seal/repair the bathtub surround tiles and grout as needed to help prevent moisture related problems in this area.

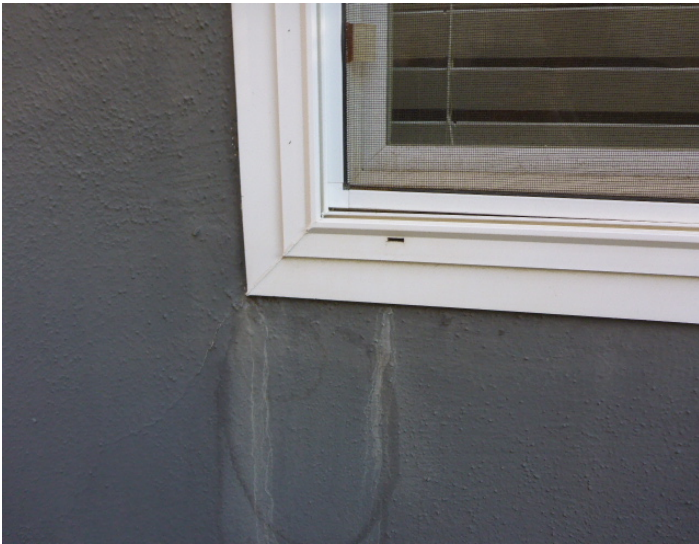
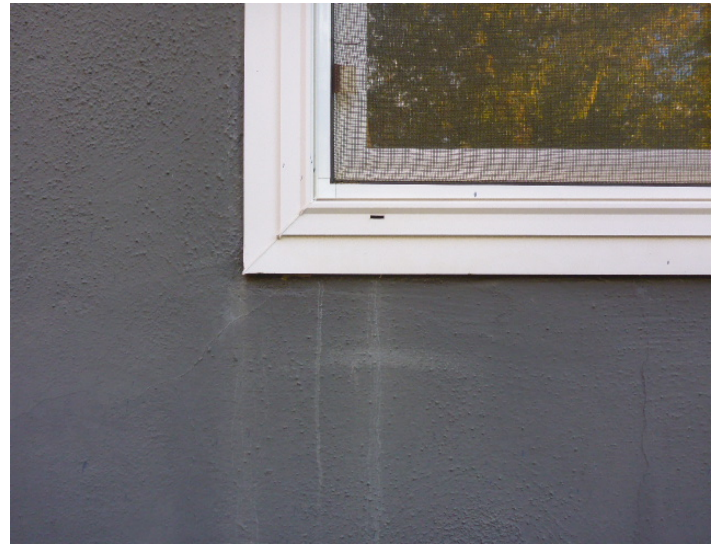
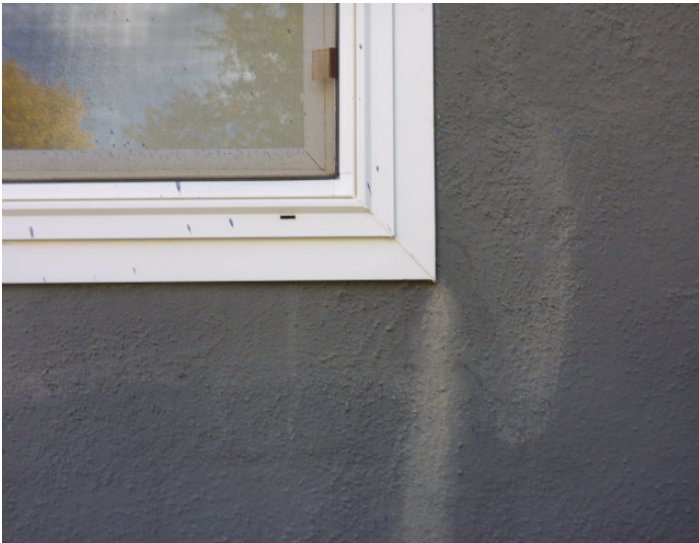
FINDING: Stains were noted at the stucco walls beneath the windows. Unable to determine if stains are active or passive.

RECOMMENDATION: Interested parties should engage the services of a licensed contractor to check for leaks and to perform any corrective work needed.

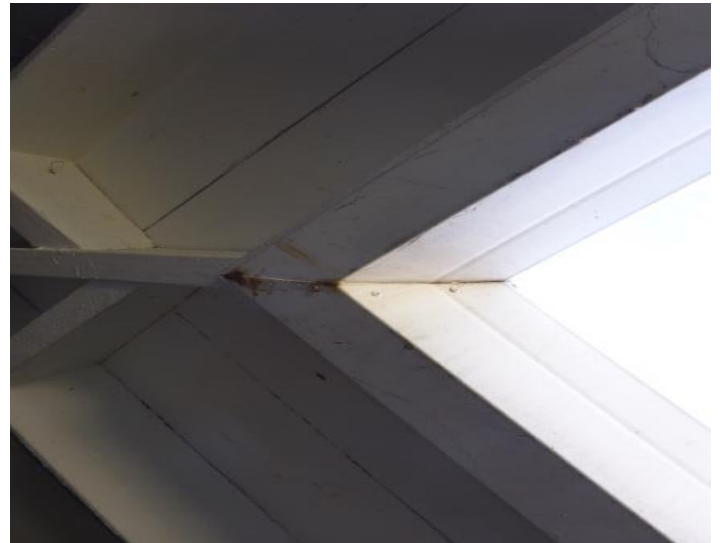
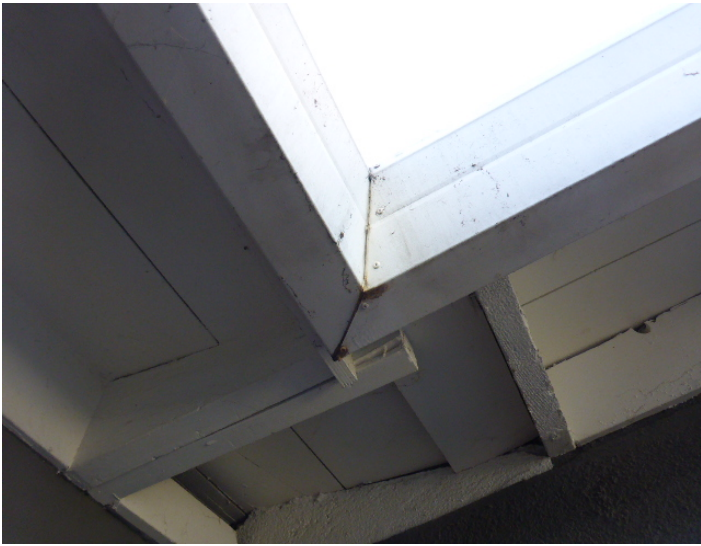
FINDING: Stains were noted at the gutter and downspout seams.

RECOMMENDATION: Seal the gutter and downspout seams as needed to help prevent moisture-related problems in this area.

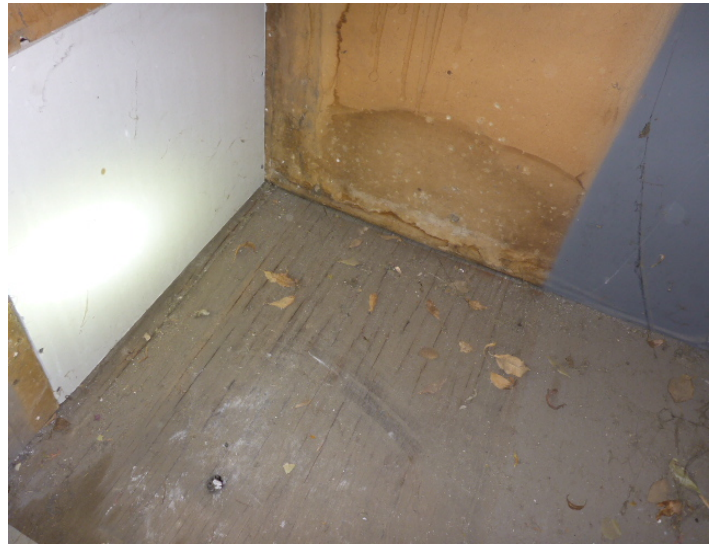
11C

FINDING: Stains were noted at the water heater closet walls and floor.

RECOMMENDATION: Interested parties should engage the services of a licensed contractor to check for leaks and to perform any corrective work needed.
