General Summary

Ferguson Home Inspections

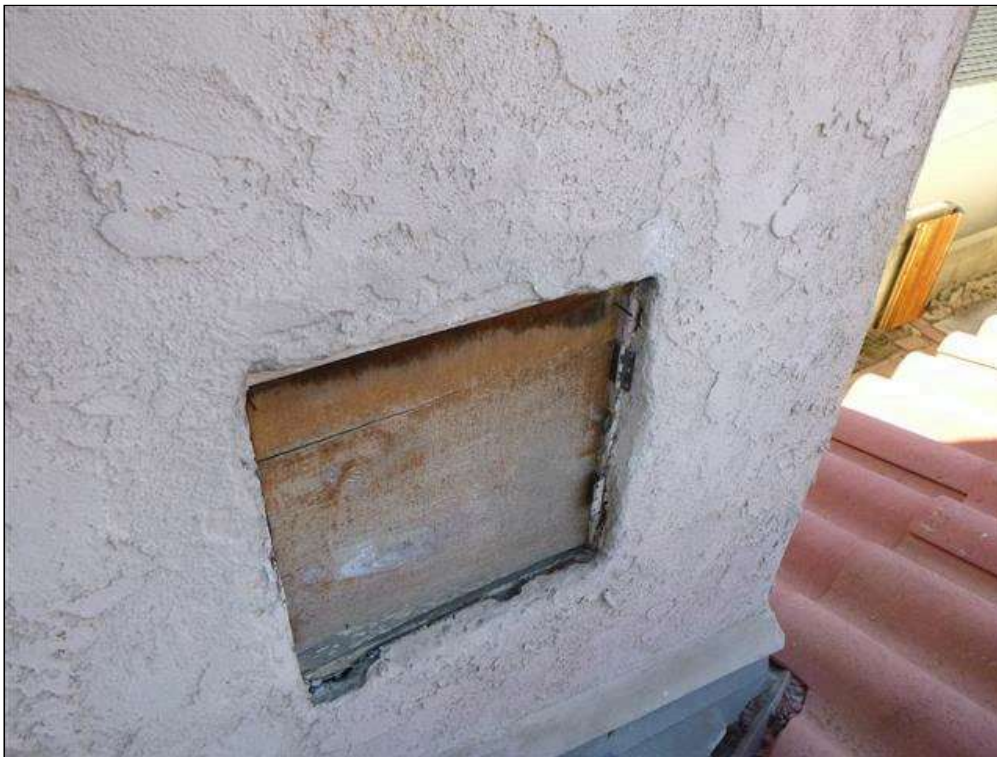
1.4 Item 2(Picture)

- (1) Deteriorated and blistering stucco noted at various areas. See the Lot/Drainage comments and review with a licensed contractor to repair as needed and divert water away from the foundation areas.
- (2) Multiple trees and bushes are in contact with the siding. Suggest trimming them away from the siding to prevent any future damage.
- (3) Various areas of the siding have been patched, suggest review with the seller on the cause and any repairs needed.

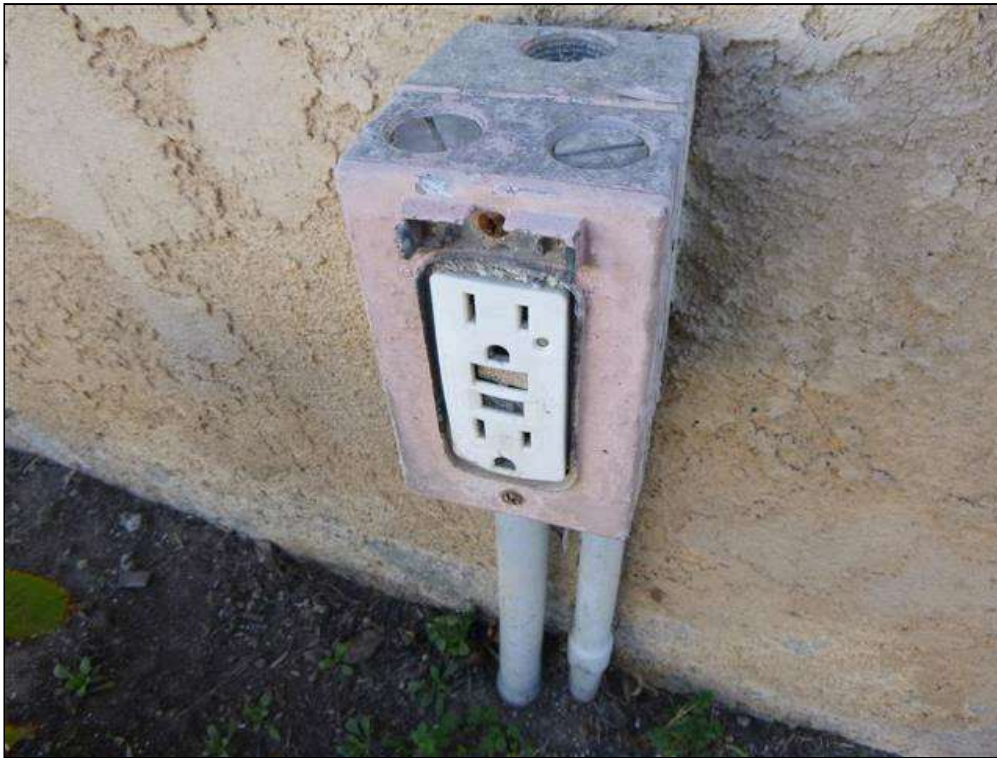
1.8 Item 1(Picture)

(1) Various exterior outlet(s) are missing the weather cover(s). Suggest installation for safety and as required.

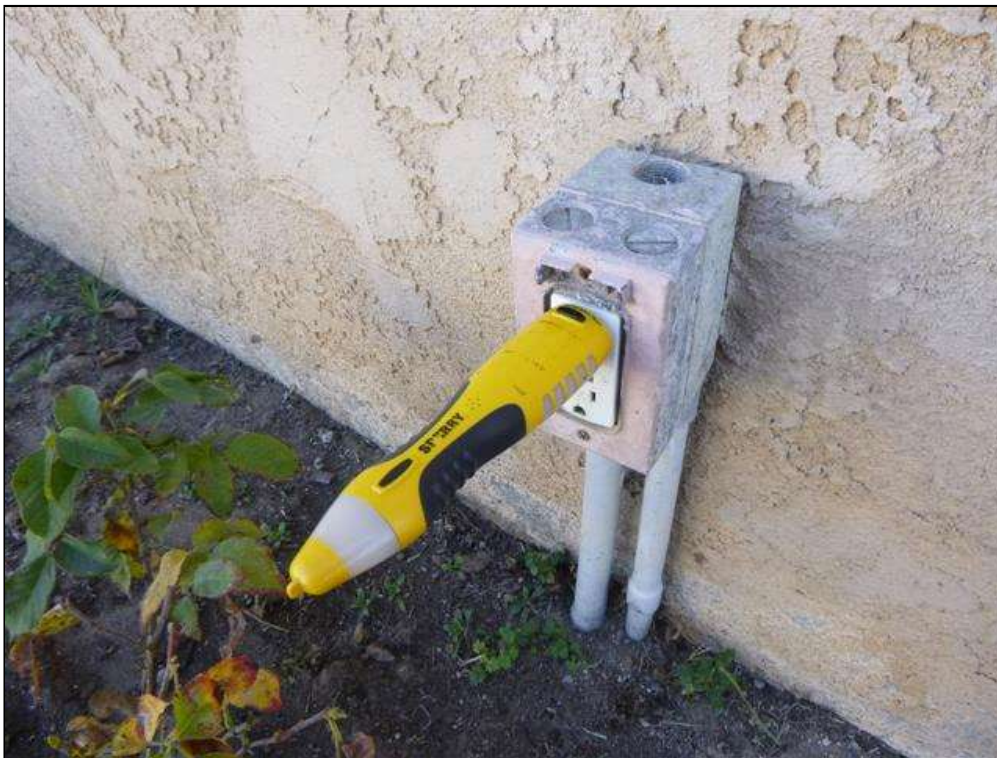
1.8 Item 2(Picture)

(2) The inspector was unable to test the GFCI outlet(s) at the front yard as there was no power to the outlet(s). Suggest review with a licensed electrician for repair/replacement cost and confirm correct operation as needed.

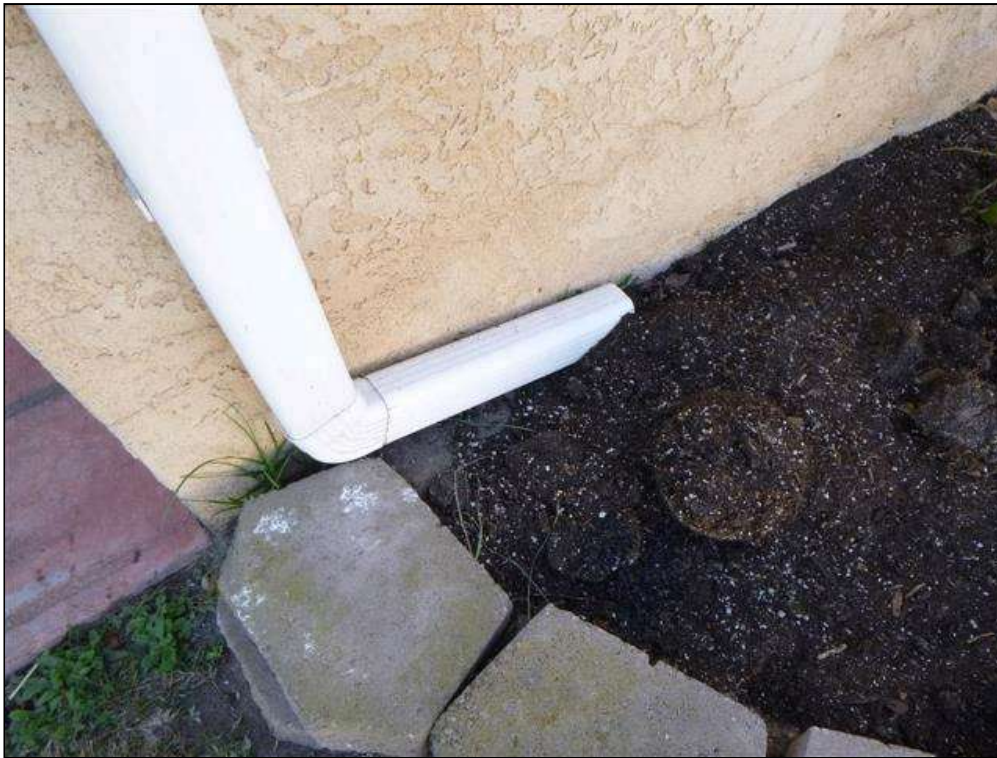
1.9 Item 1(Picture)

(1) Suggest installation of gutters throughout all eave areas and installation of an area drainage system to divert the water away from the foundation to the street as an upgrade.

(2) Suggest redirecting the downspouts out of the planters to reduce ponding during the rainy season.

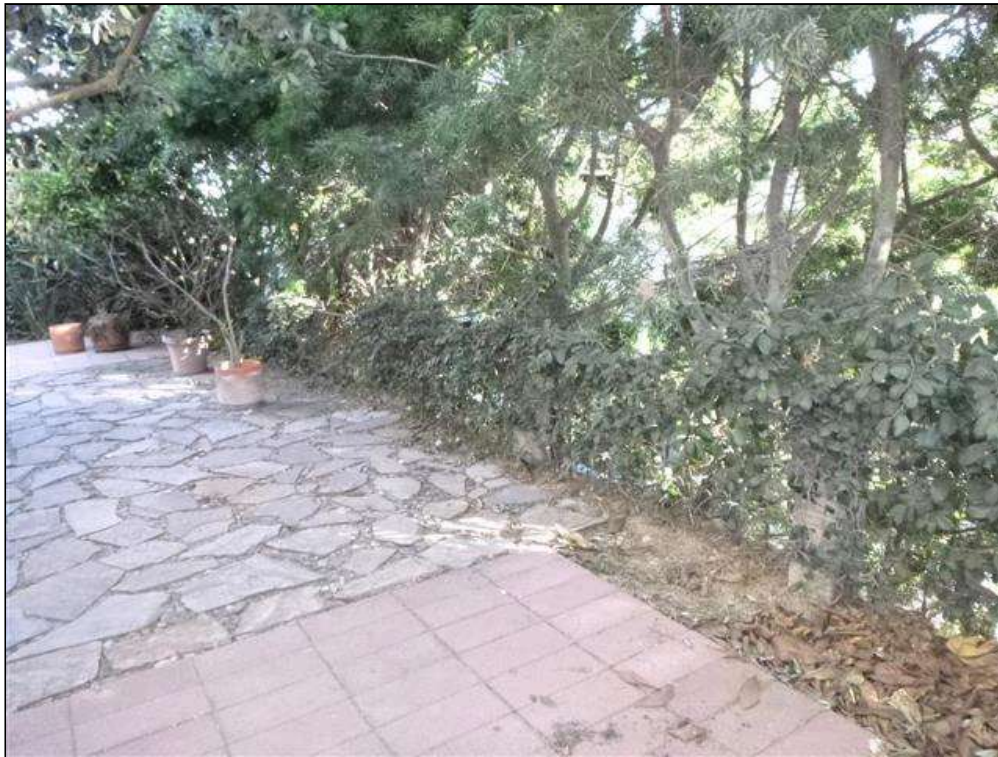
1.10 Item 1(Picture)

The rear retaining wall not visible/accessible at the time of the inspection. Suggest review with a licensed contractor on this item as needed.

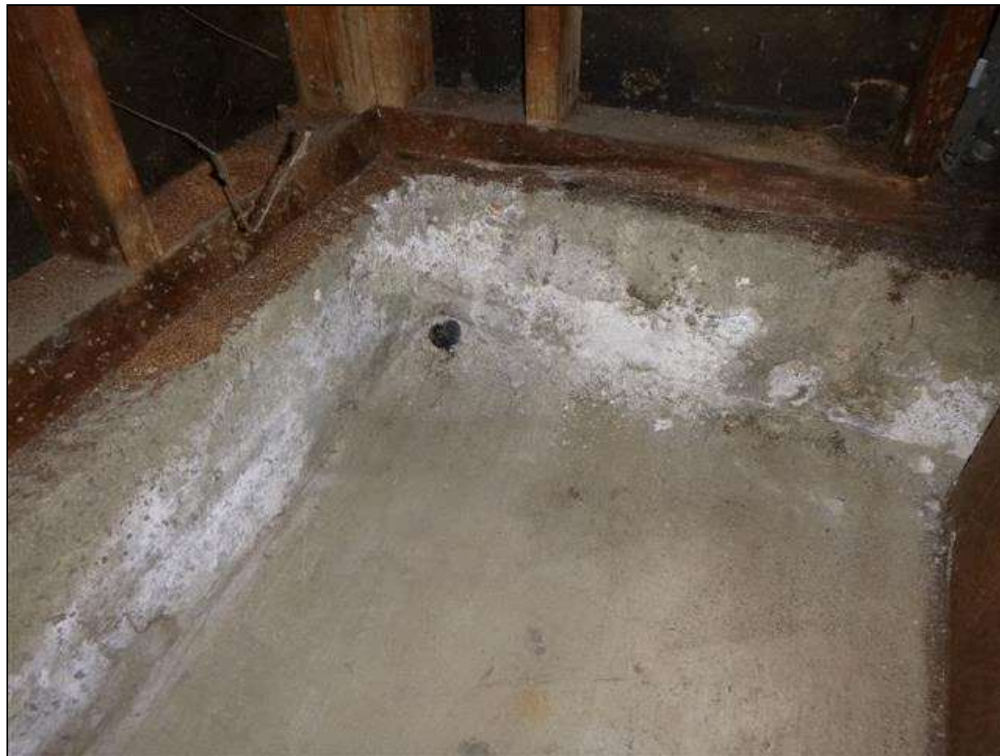
3.0 Item 1(Picture)

(2) White efflorescence (powder substance) on foundation footings indicates prior, and possibly ongoing, excessive moisture build up at the exterior of the foundation. Ongoing water intrusion at the foundations can, in some cases, cause the steel in the foundations to rust, called spawling, which can lead to horizontal cracking of the foundation (currently there are no major cracks visible at the foundation). Any future cracking/damaged can be an expensive repair as the foundation is now structurally weak and susceptible to horizontal movement. Suggest review of the Lot/Grade/ drainage and sewer drainage systems, including rain gutters, to reduce and prevent further and future water buildup at the exterior of the dwellings foundations.

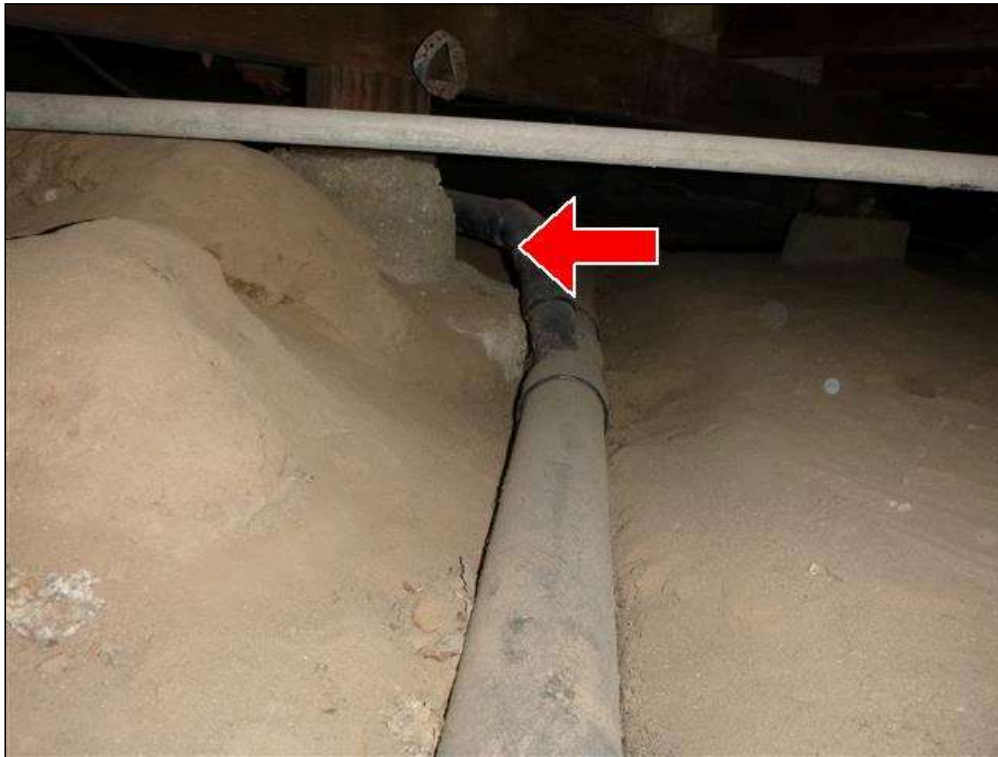
3.0 Item 2(Picture)

(3) Undermining of the foundation was noted due to the new sewer drain installation. Suggest review by a licensed contractor for costs to re-install/compact the removed dirt from this area to prevent possible future movement of the foundation.

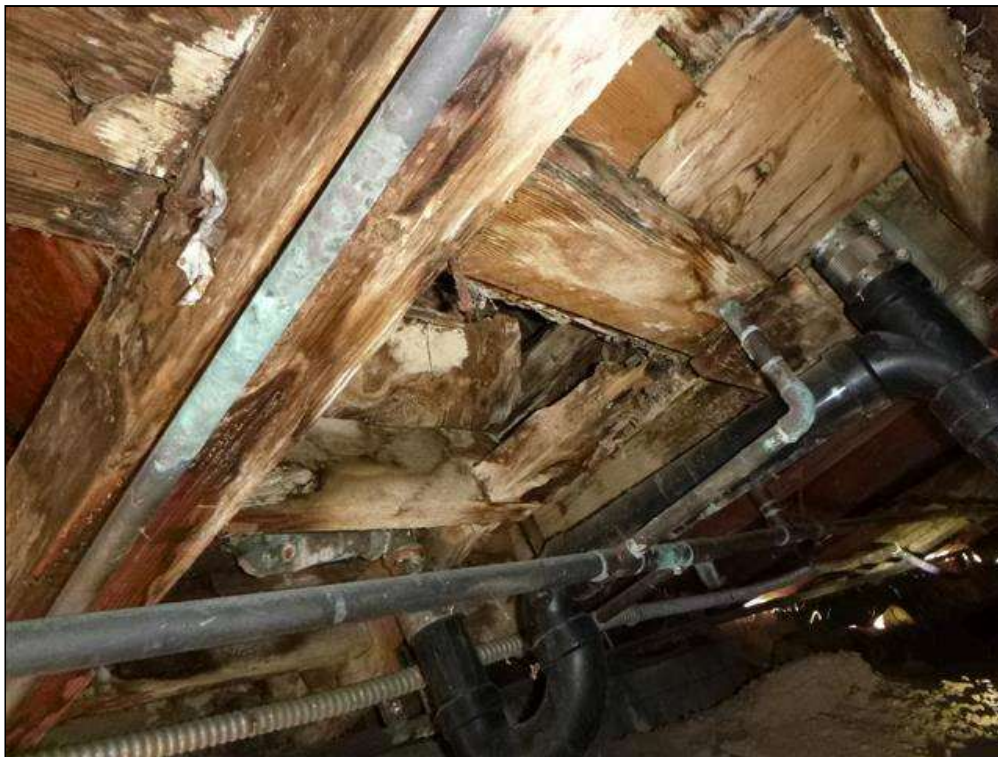
3.1 Item 1(Picture)

Excessive stains and deterioration noted at various flooring and supports from prior leaks. Suggest review with a termite company and/or a licensed contractor for any repair/replacement costs as needed.

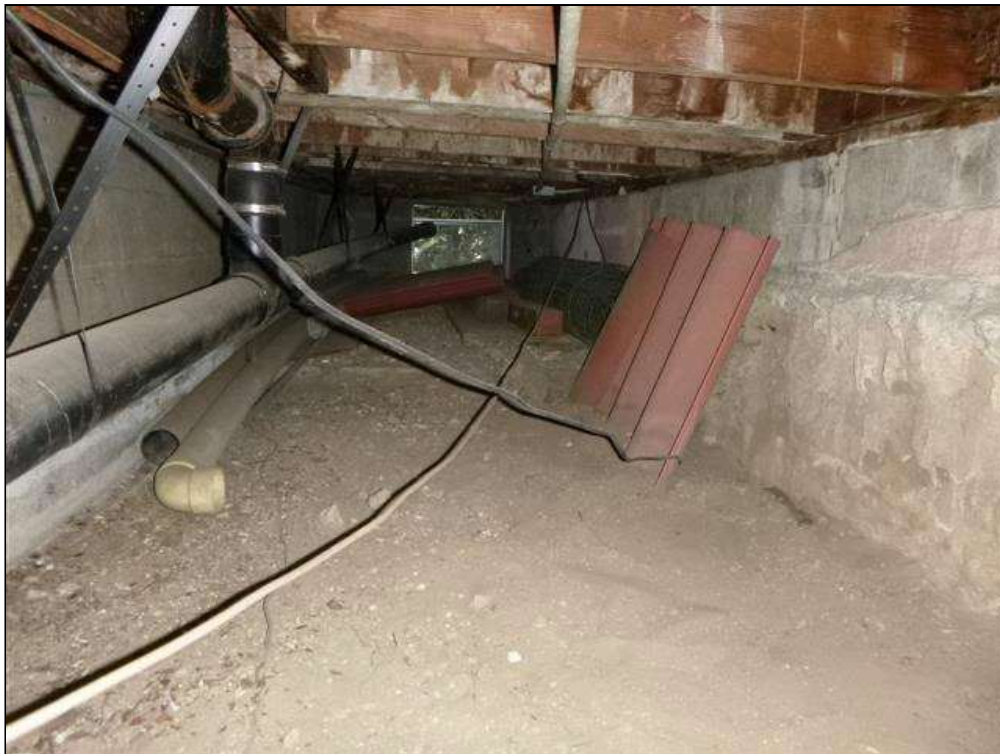
4.0 Item 1(Picture)

Suggest removal of debris and construction items from the crawl area.

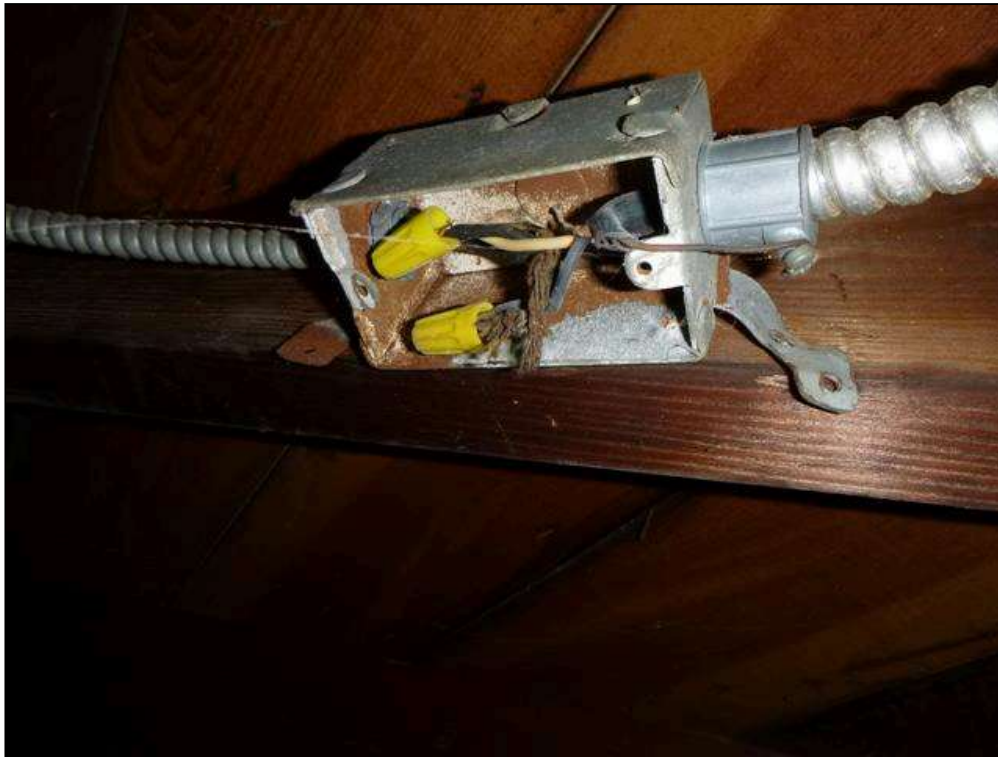
4.3 Item 2(Picture)

(1) Open junction boxes were noted. This is a safety concern. Whenever an electrical wire is cut and re-connected, the 'splice' should be encased in a covered junction box to prevent shocks and separation of the splice. Suggest review by a licensed electrician and repair as needed.

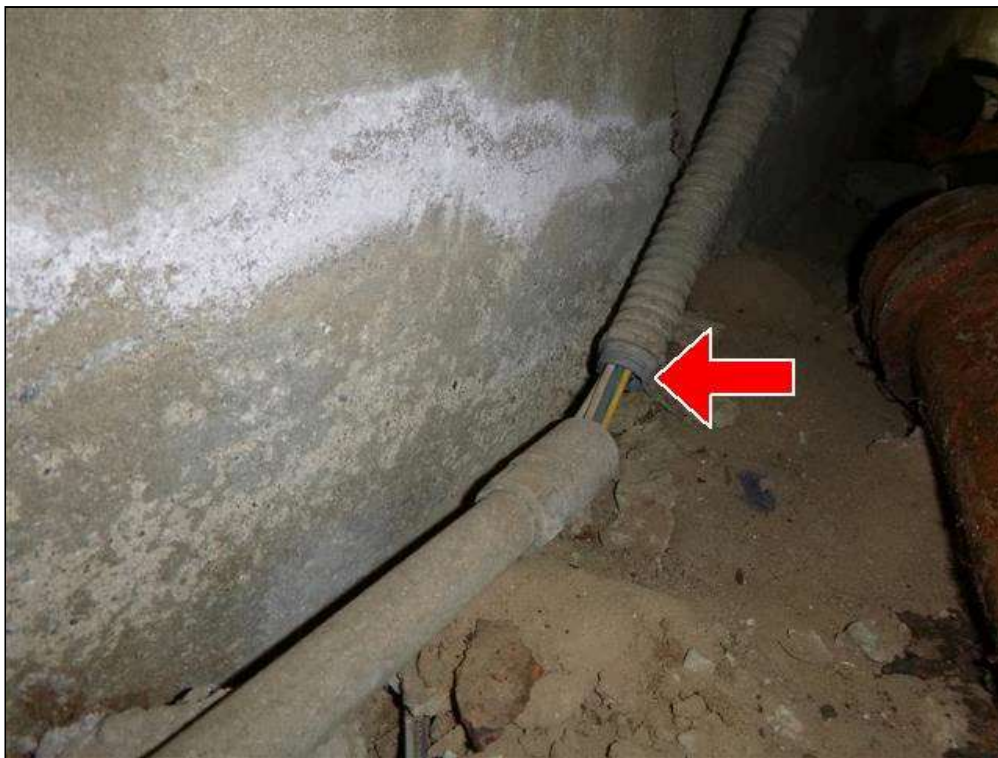
4.3 Item 3(Picture)

(2) The electrical wiring in the crawl area has been inadequately secured. The romex/conduit is in contact with the ground at various areas, suggest review with a licensed electrician to repair/secure as needed for safety and as required.

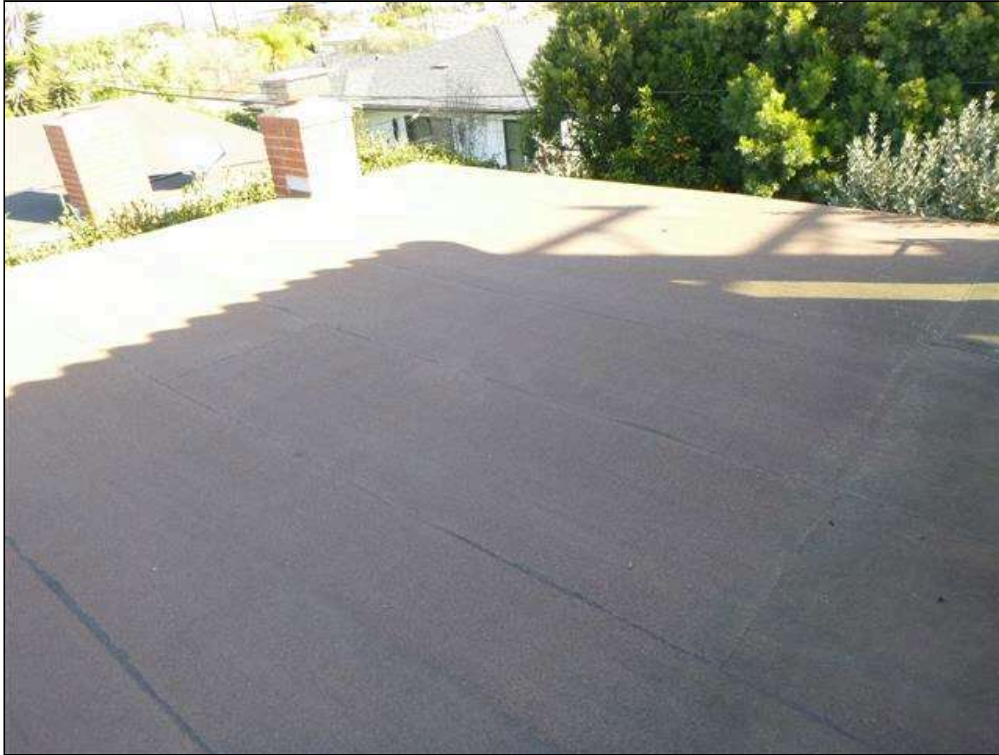
5.0 Item 7(Picture)

(2) Soft, uneven, wrinkling and worn areas of the sloped roof was noted. Suggest review with a licensed roofer for any repair/removal/replacement costs as needed.

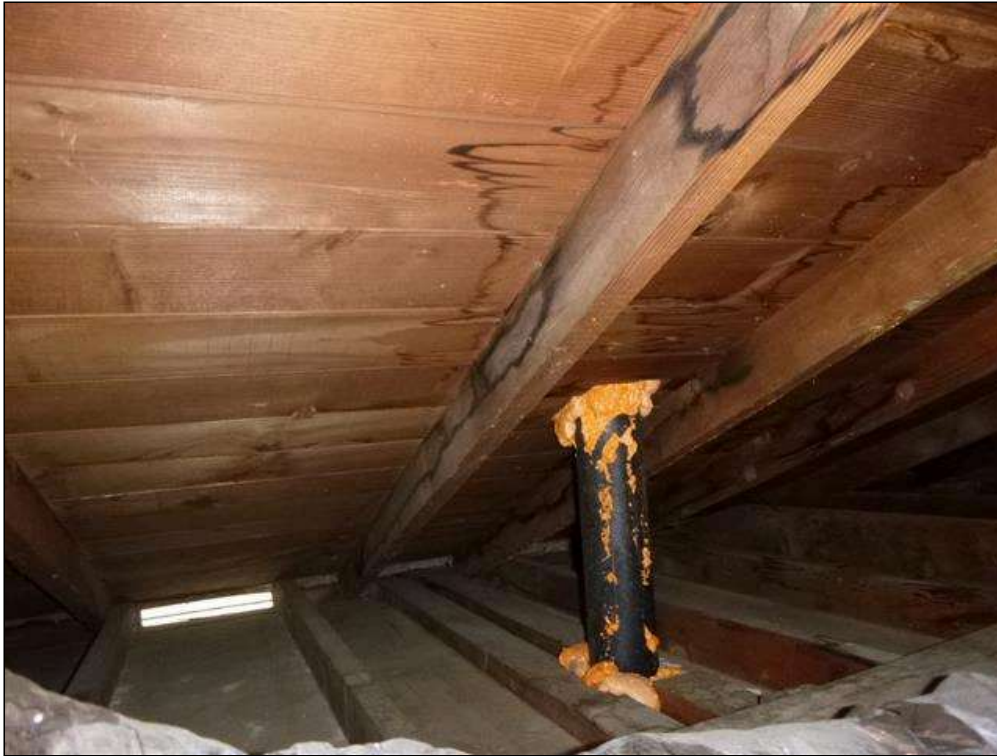
6.0 Item 1(Picture)

(1) Moisture stains noted at various areas of the attic sheathing/framing, see roof comments and repair as needed.

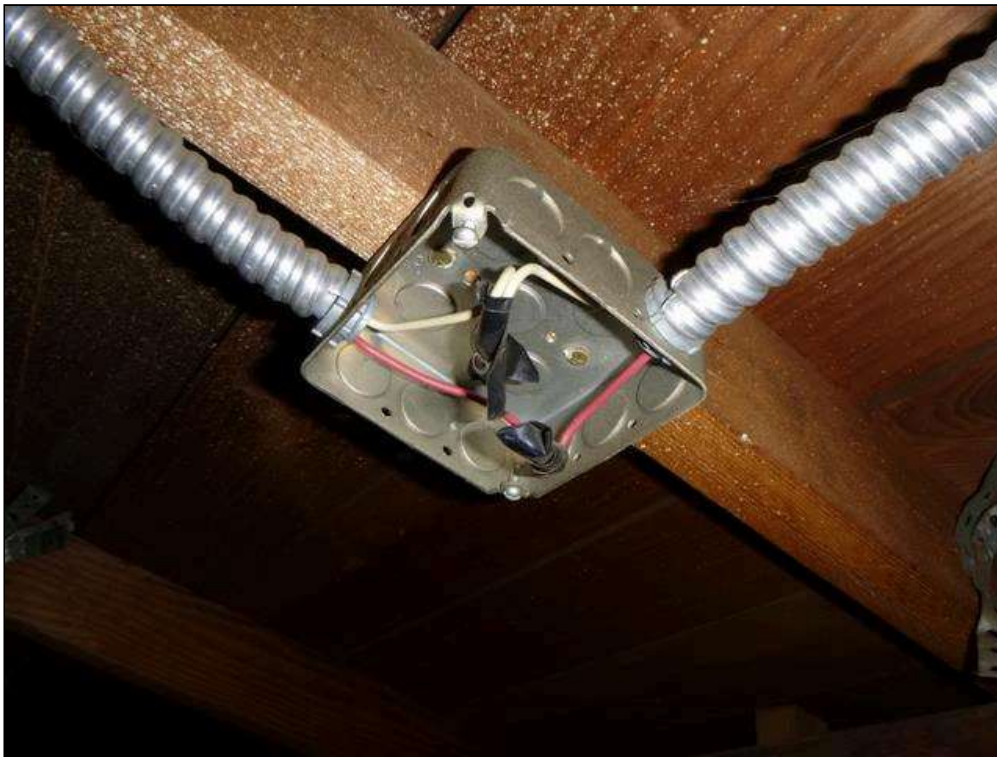
6.3 Item 1(Picture)

Open junction boxes were noted. This is a safety concern. Whenever an electrical wire is cut and re-connected, the 'splice' should be encased in a covered junction box to prevent shocks and separation of the splice. Suggest review by a licensed electrician and repair as needed.

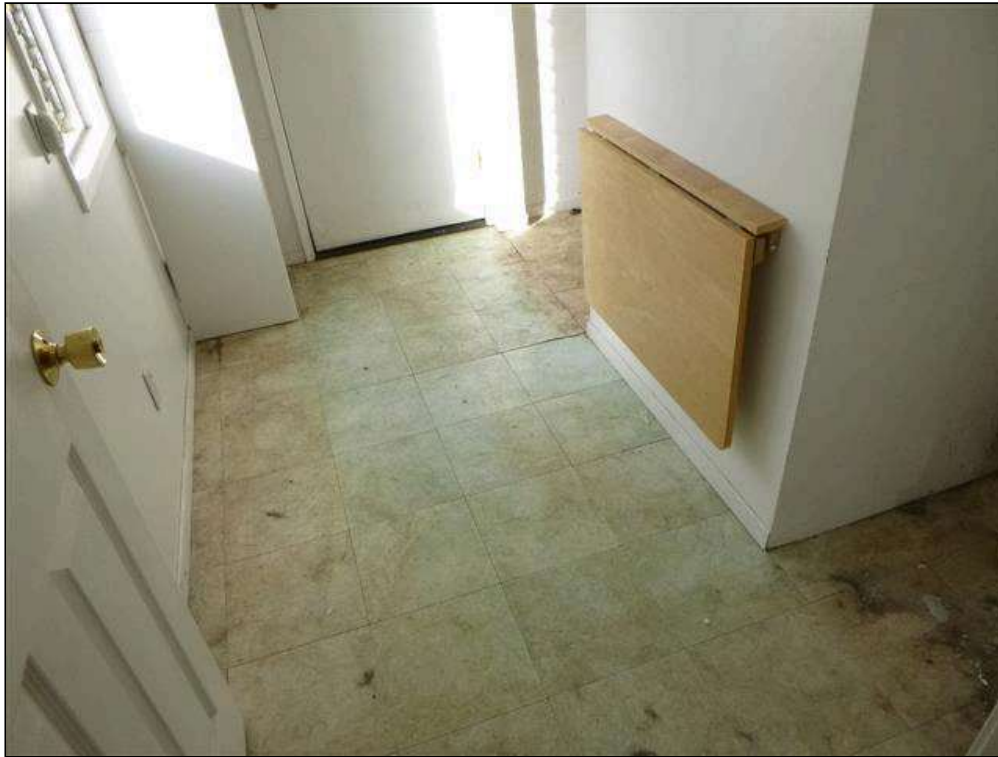
7.0 Item 1(Picture)

Deteriorated and loose sections noted at the laundry floor, suggest repair/replace as needed.

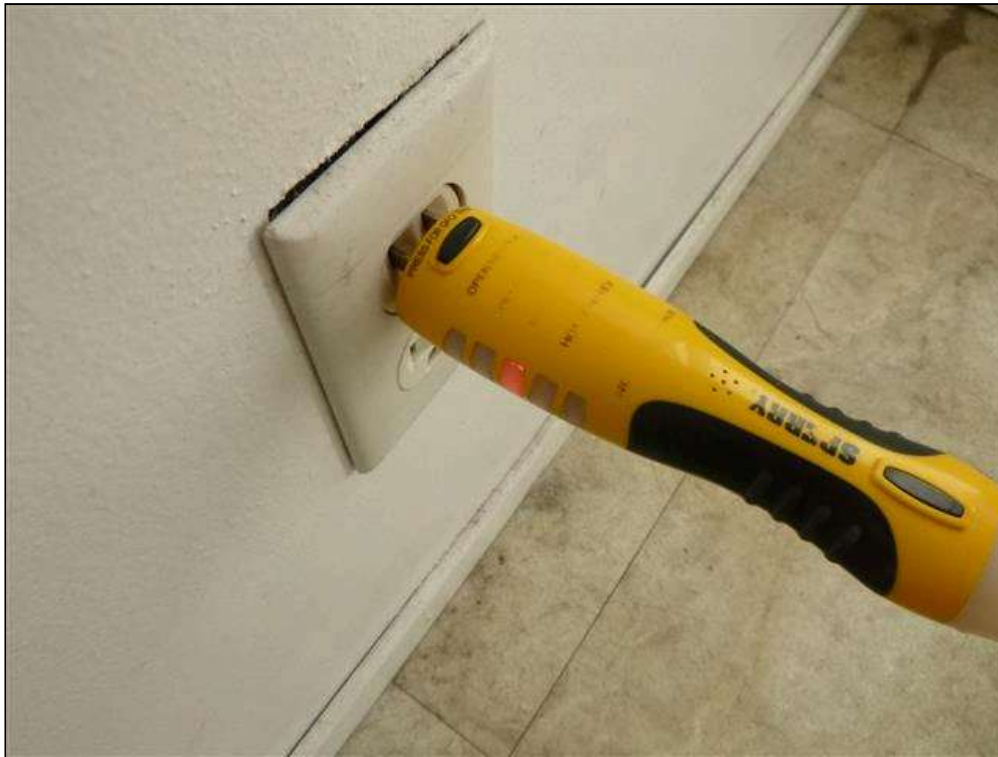
7.6 Item 1(Picture)

Reversed polarity noted at various outlets. Reversed polarity, hot and ground reversed and other terms used for electric outlets are usually easily corrected by minor wiring adjustments at the specified item. Suggest review with a licensed electrician for repair/replacement costs and confirm correct operation as needed.

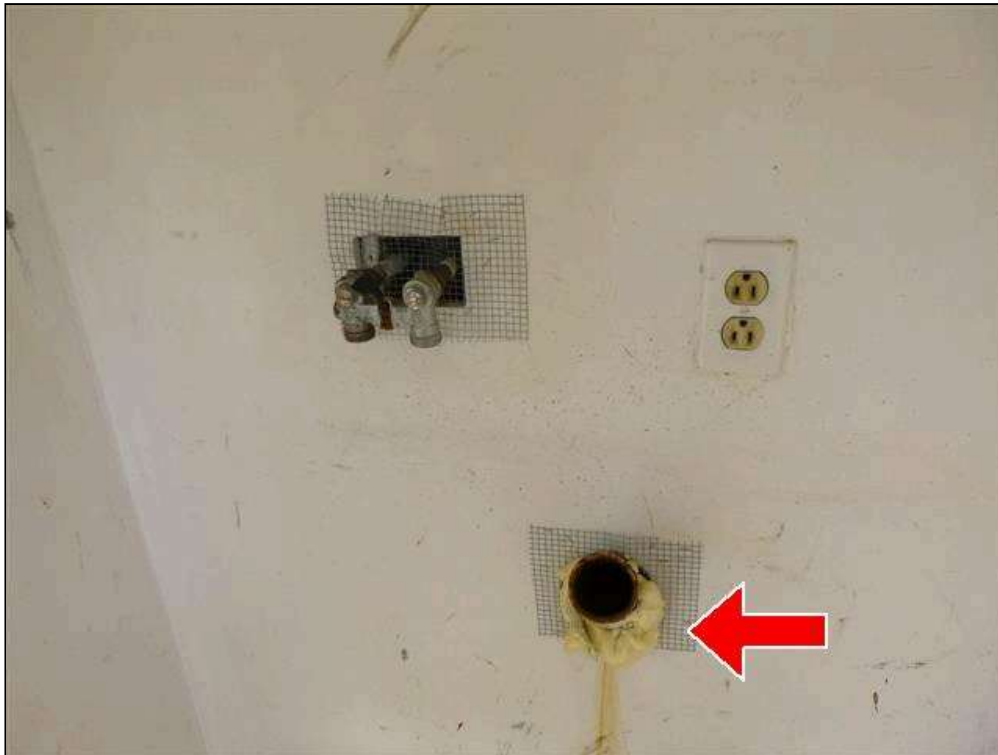
7.7 Item 4(Picture)

(2) Corrosion noted at the washing machine drain, no leaking noted at the time of the inspection. Suggest review with a licensed plumber and repair/replace as needed.

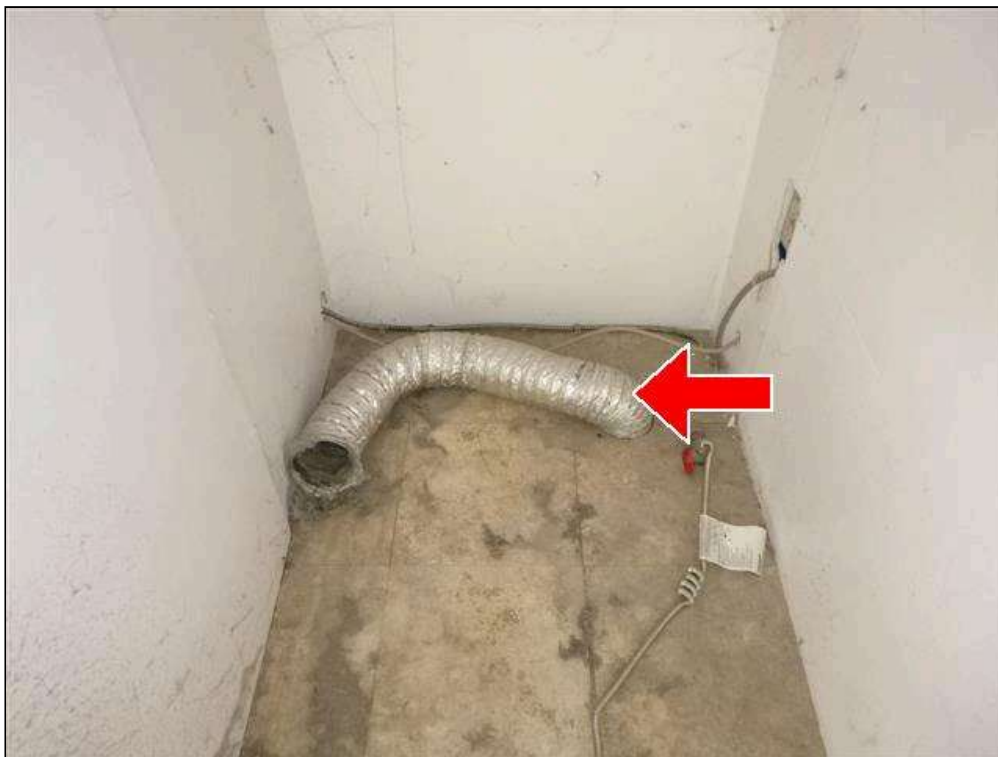
7.8 Item 1(Picture)

(1) Improper aluminum/vinyl flex vent installed to the exterior of the dwelling, this is a potential fire/safety hazard. Suggest remove the existing material and installation of a rigid metal vent pipe/duct and vent cap to the exterior as required.

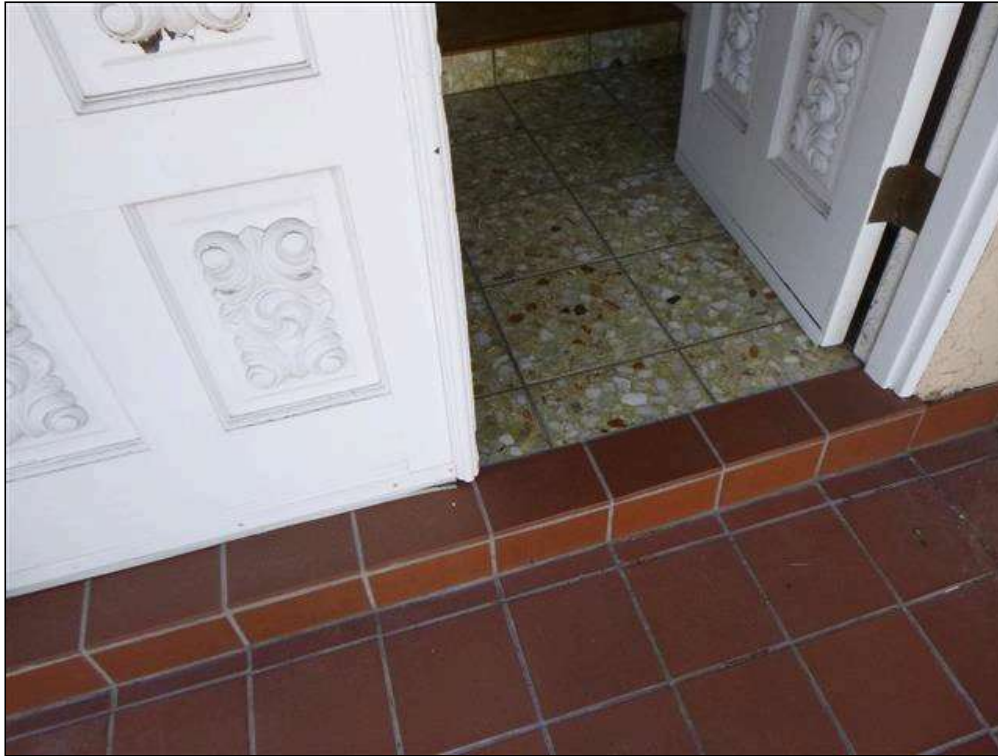
8.5 Item 1(Picture)

(1) The doors are weathered and deteriorated, suggest maintenance and repairs as needed.

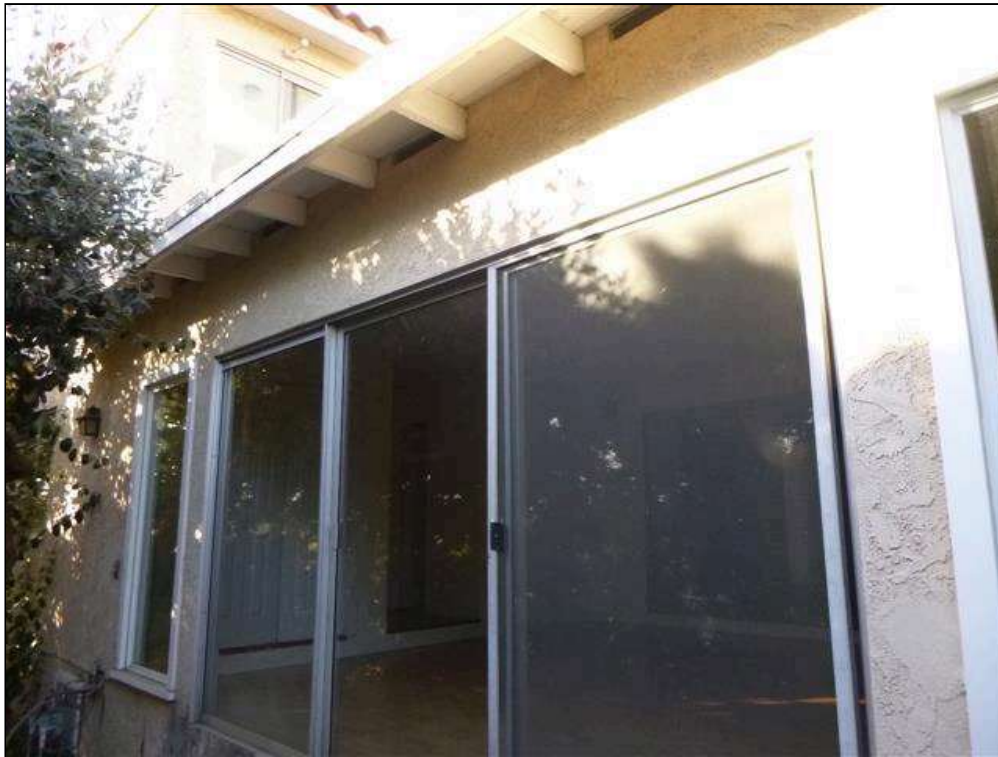
10.2 Item 1(Picture)

No light fixture installed at the door area, this is a possible safety hazard. Suggest review with a licensed electrician for costs to install a light fixture as required for safety.

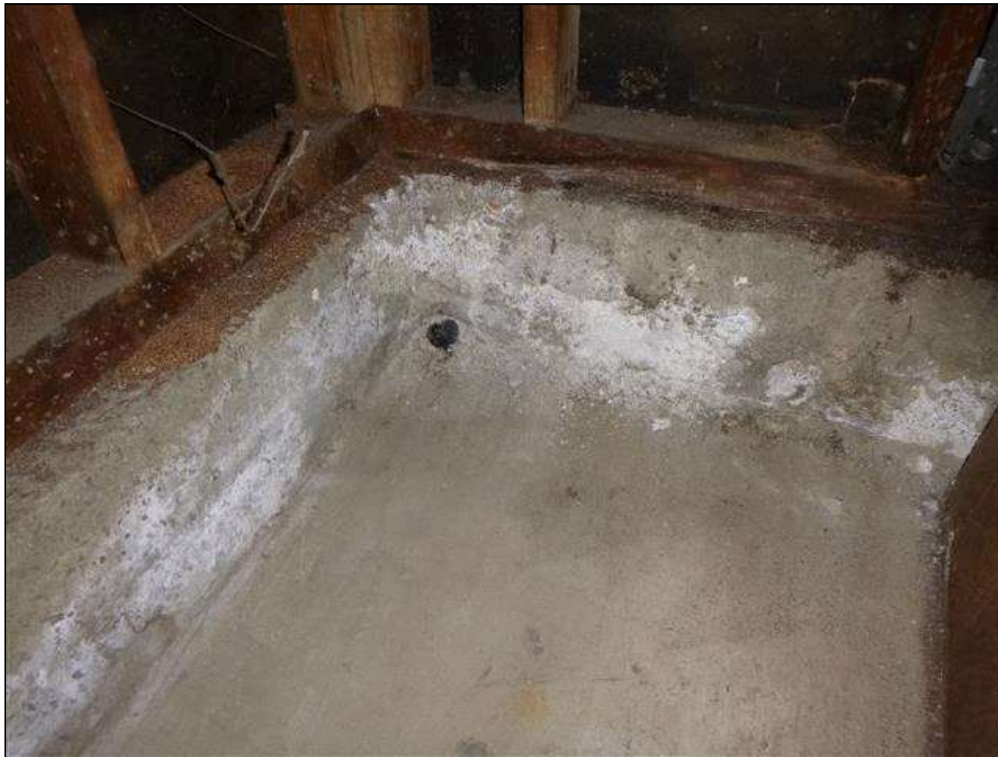
12.0 Item 1(Picture)

(2) White efflorescence (powder substance) on foundation footings indicates prior, and possibly ongoing, excessive moisture build up at the exterior of the foundation. Ongoing water intrusion at the foundations can, in some cases, cause the steel in the foundations to rust, called spawling, which can lead to horizontal cracking of the foundation (currently there are no major cracks visible at the foundation). Any future cracking/damaged can be an expensive repair as the foundation is now structurally weak and susceptible to horizontal movement. Suggest review of the Lot/Grade/ drainage and sewer drainage systems, including rain gutters, to reduce and prevent further and future water buildup at the exterior of the dwellings foundations.

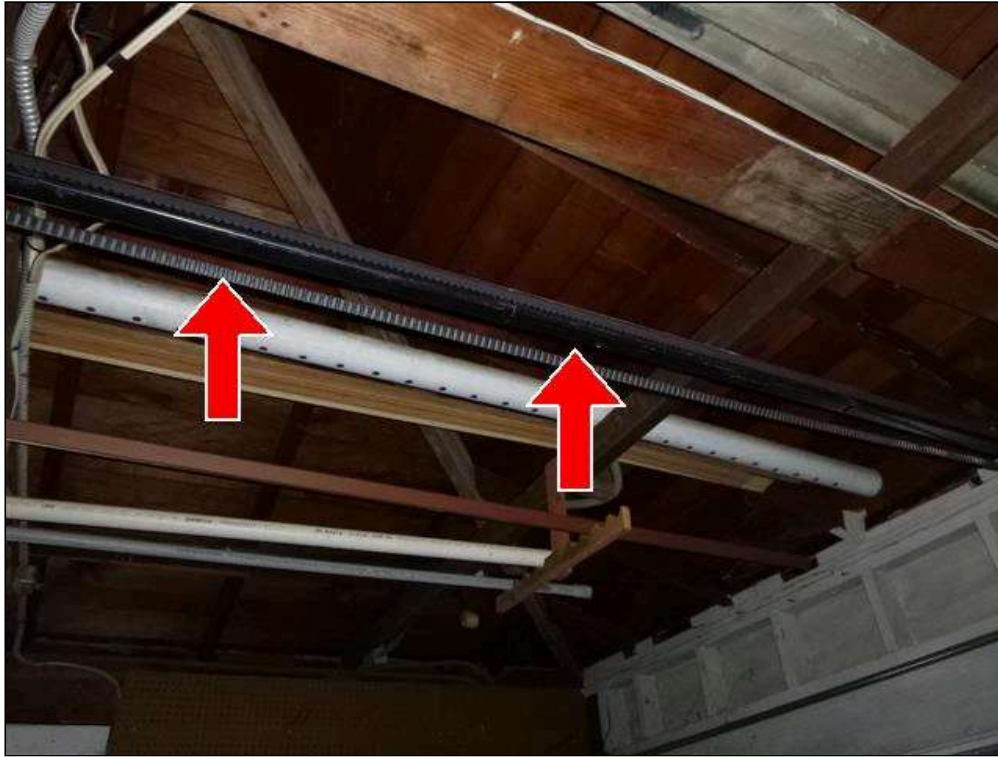
12.3 Item 1(Picture)

(2) The garage door opener(s) pull chain/rubber is excessively loose and periodically catches on the railing mount(s). Suggest review with a licensed contractor for costs to correctly tighten/tension the system as required and confirm correct operation as needed.

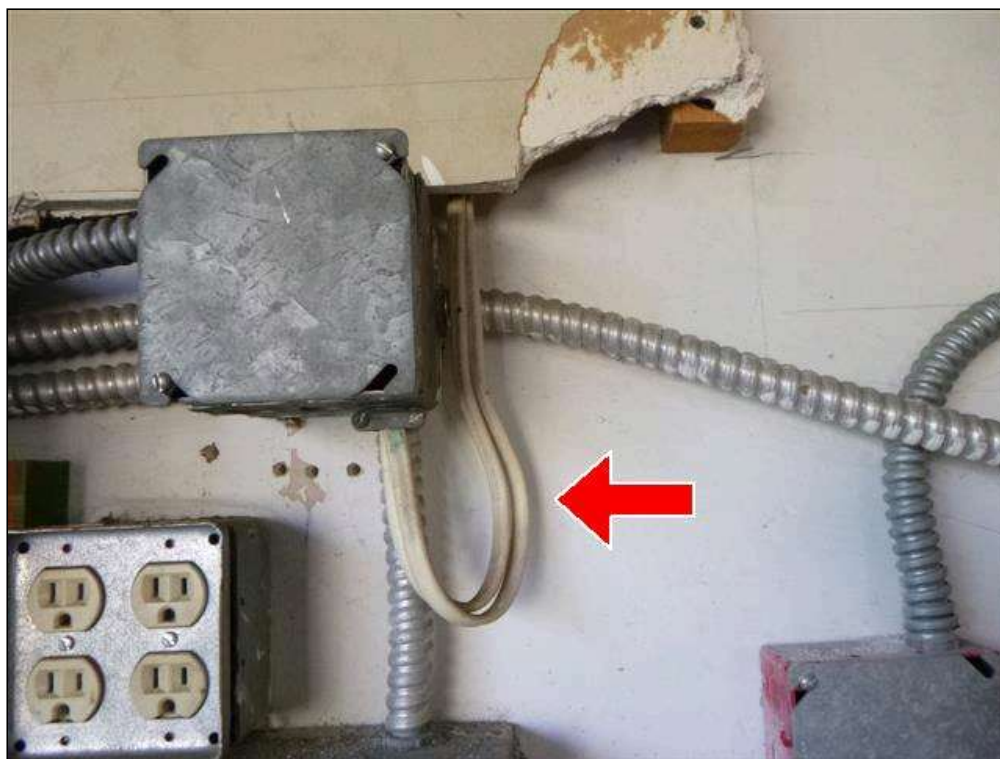
12.6 Item 2(Picture)

(3) Exposed romex wiring located in accessible areas. This is a safety concern as it could be subject to physical damage. Romex wiring is allowed in inaccessible areas such as attics, crawl spaces and within walls provided that all proper protective materials and required tie-downs are in place. Suggest review by a licensed electrician for repair/replacement costs as needed.

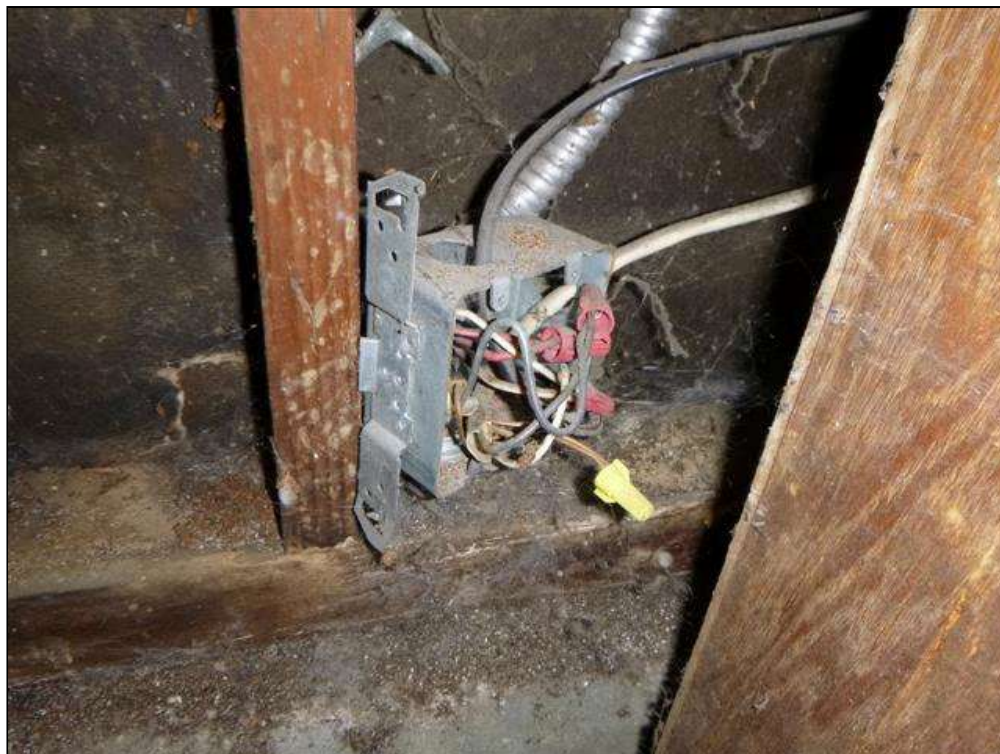
12.6 Item 3(Picture)

(4) Open junction boxes/conduit was noted, this is a potential safety hazard. Whenever an electrical wire is cut and re-connected, the 'splice' should be encased in a covered junction box to prevent shocks and separation of the splice. Suggest review by a licensed electrician for repair/replacement costs as needed.

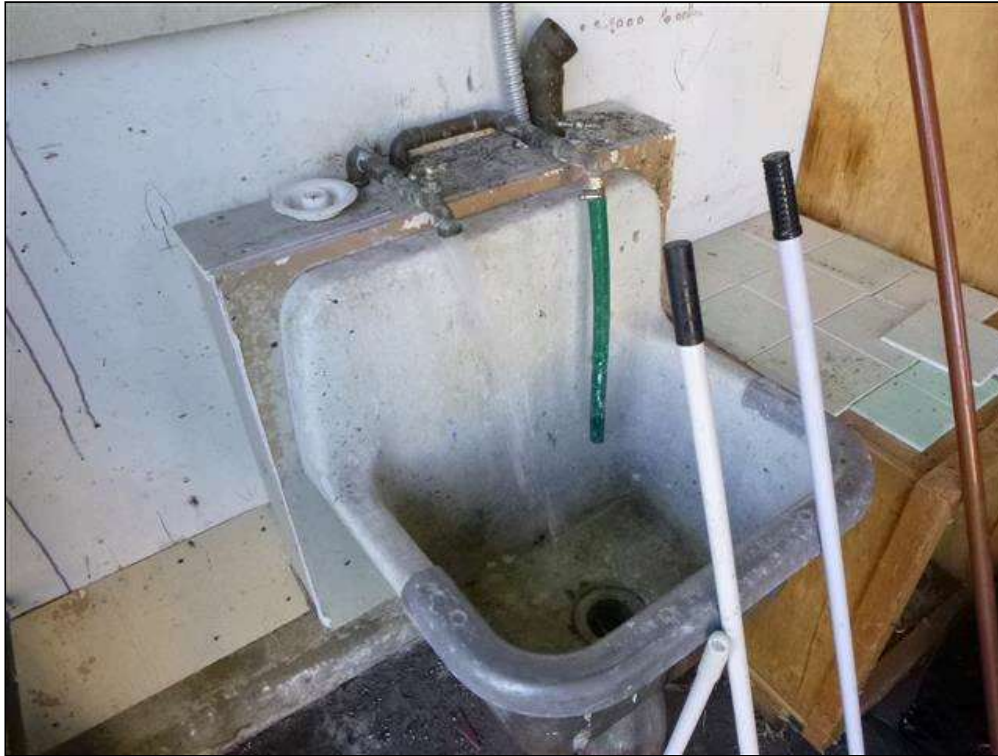
12.7 Item 1(Picture)

The existing sink faucet(s) are not low-flow systems as required. Suggest review with a licensed plumber for costs to replace the existing faucets with low flow faucets (2.2 gallons per minute) as required by the State of California as of January 1st, 2017. See the plumbing system comments for further details and a link to the State of California plumbing ordinance.

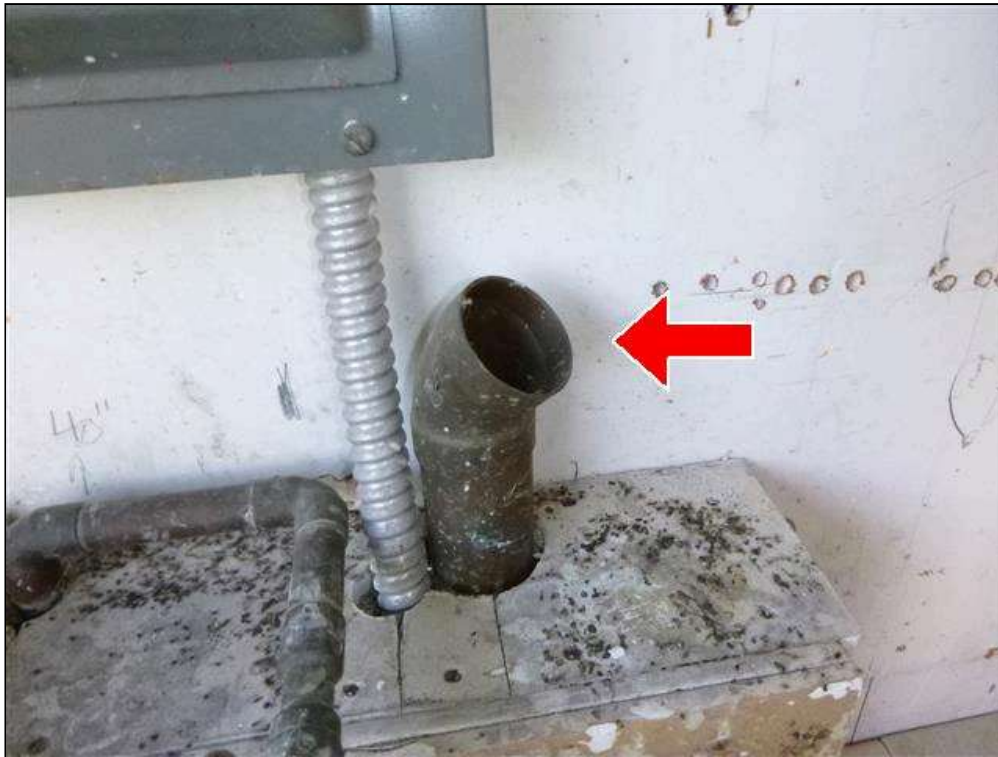
12.8 Item 1(Picture)

The sink drainage vent does not transfer through the roof as required, but terminates inside the garage area. Suggest review by a licensed plumber for costs to complete the installation as required for safety.

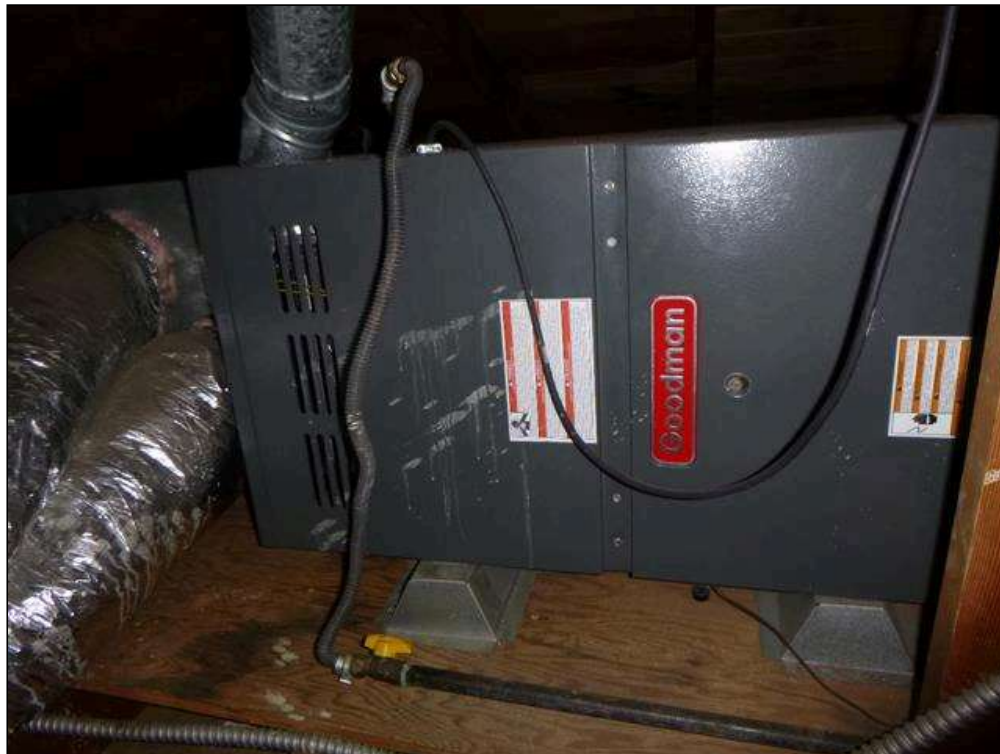
13.0 Item 1(Picture)

(1) The inspector was unable to test the heating system as the thermostat was inoperable at the time of the inspection. Suggest review by the Gas Company and/or a licensed heating company for review to determine if the unit is operational, any repair/replacement costs and confirm correct operation as needed.
