General Summary

Ferguson Home Inspections

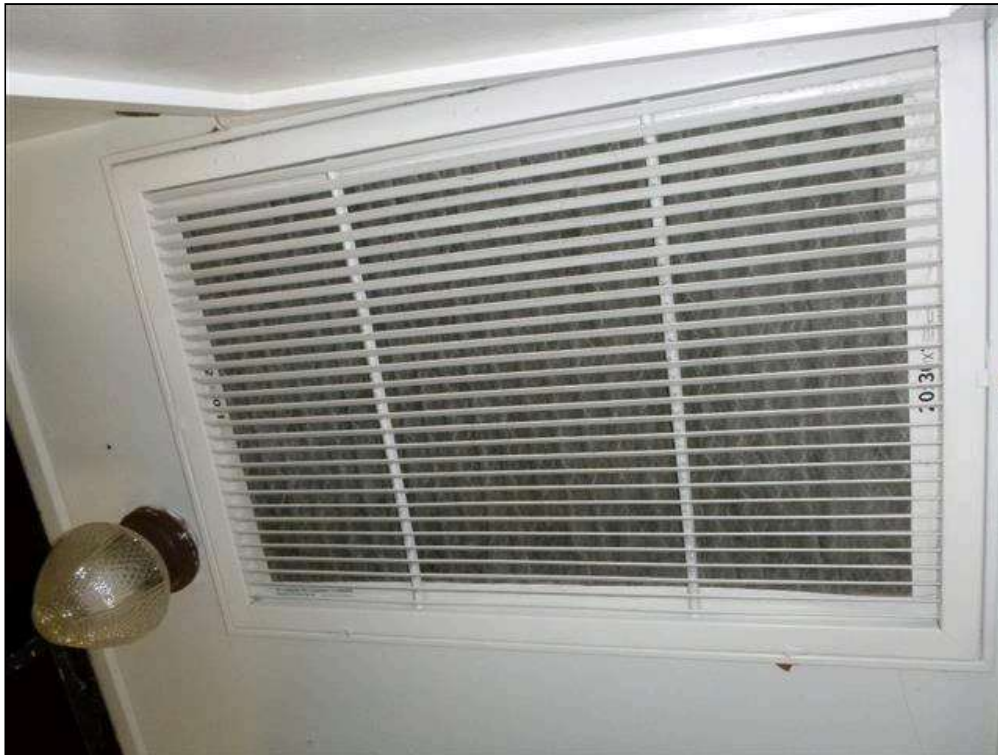
13.0 Item 3(Picture)

(2) Suggest replacing/cleaning the filter(s) as needed.

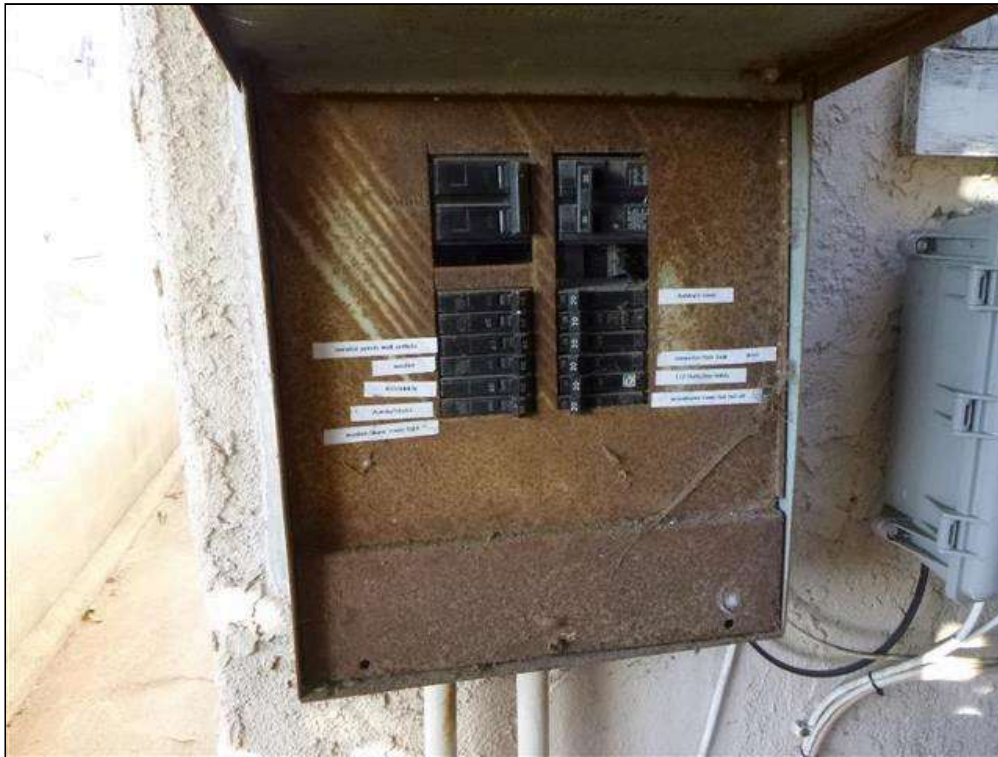
14.1 Item 1(Picture)

(1) Suggest adding correct/complete indexing/labelling to all breakers for identification of each circuit for safety.

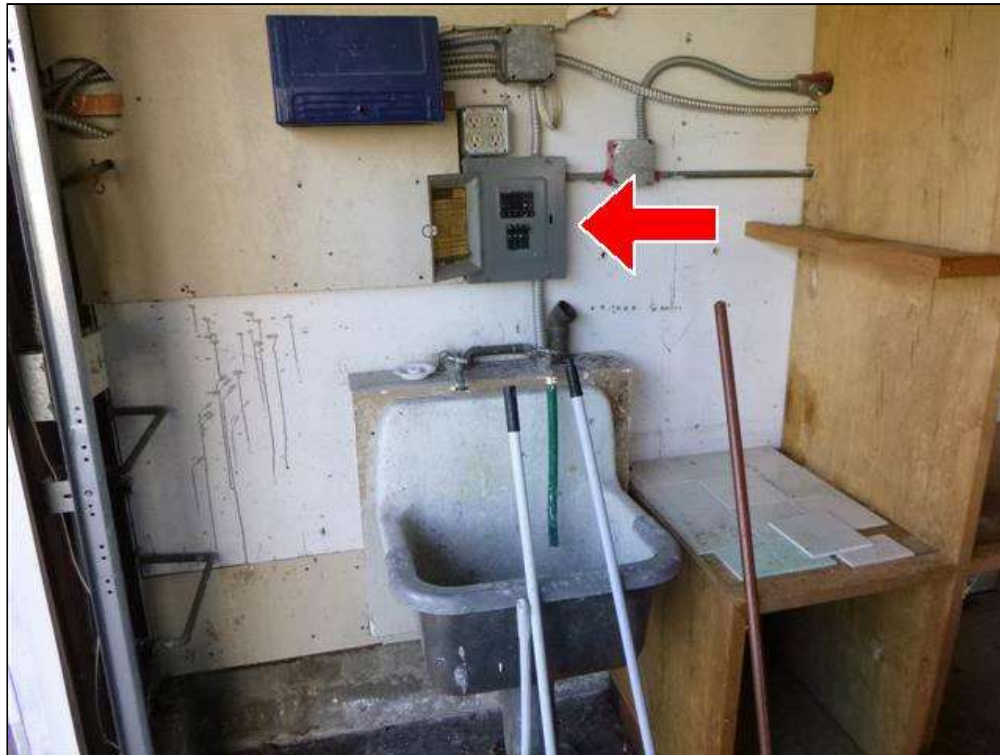
14.1 Item 3(Picture)

(2) Inadequate clearance to the front of the garage sub panel. A minimum of 36 inches of clear working space is required at the front side of the electrical panel. Suggest review with a licensed electrical contractor for repair/relocation costs as required.

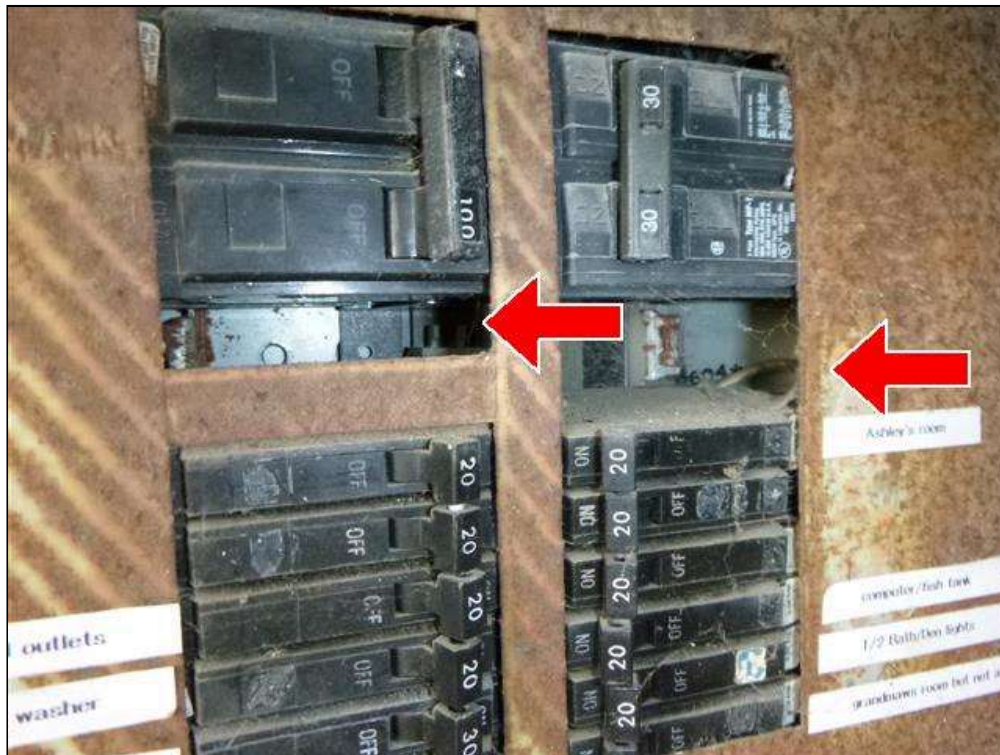
14.1 Item 4(Picture)

(3) Potential safety hazard due open areas of the electrical panel cover plate. Suggest installing future plugs in the cover plate where the blanks have been removed as required for safety.

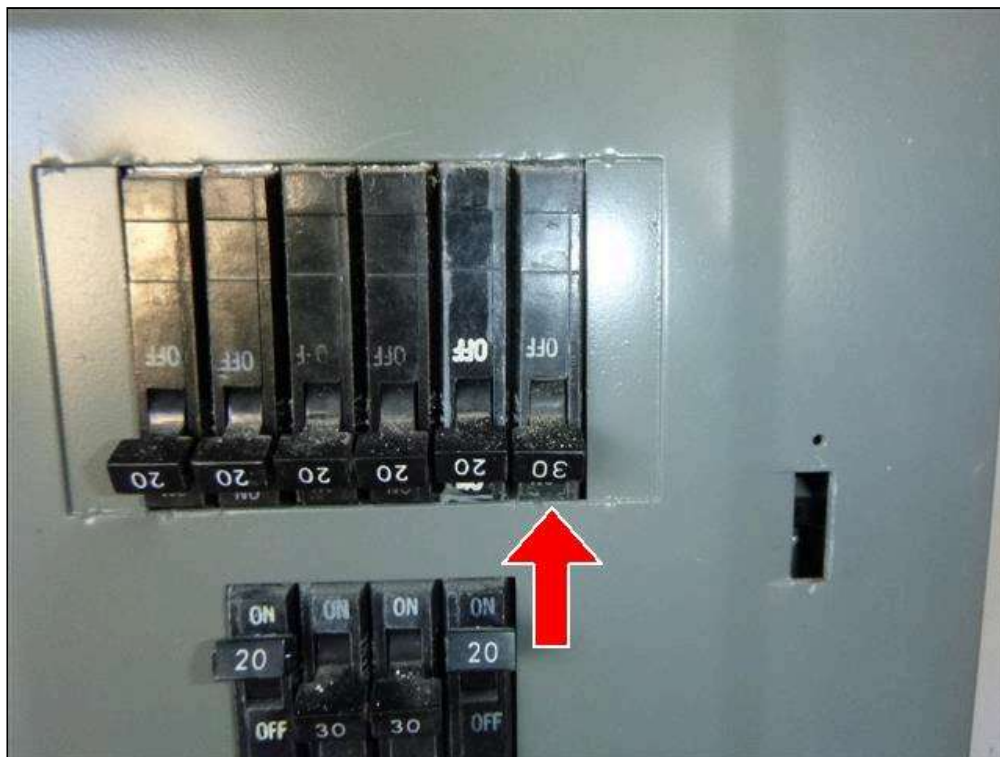
14.2 Item 1(Picture)

(1) Single 30 amp breakers are currently being used for a 110 volt circuits at the main and sub panels. This is a potential fire safety hazard. Suggest review with a licensed electrician for repair/replacement costs as needed for safety.

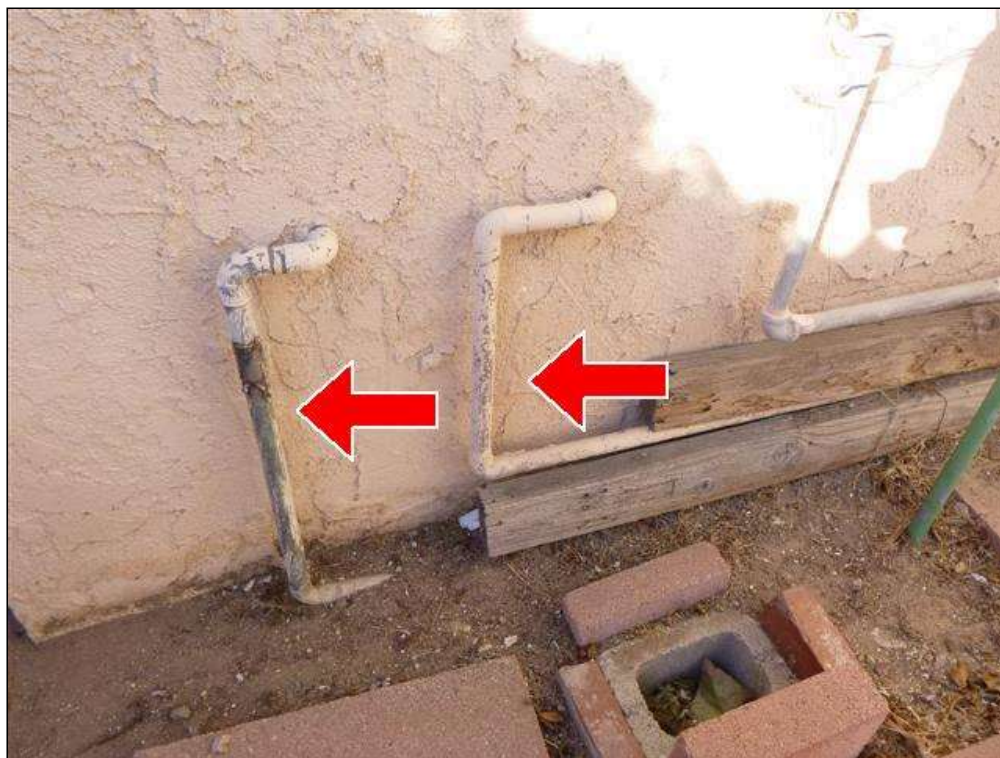
15.0 Item 1(Picture)

(1) Exposed and un-insulated surface mounted plumbing noted at the right side exterior of the dwelling. Suggest review with a licensed plumber for repair/replacement costs as needed.

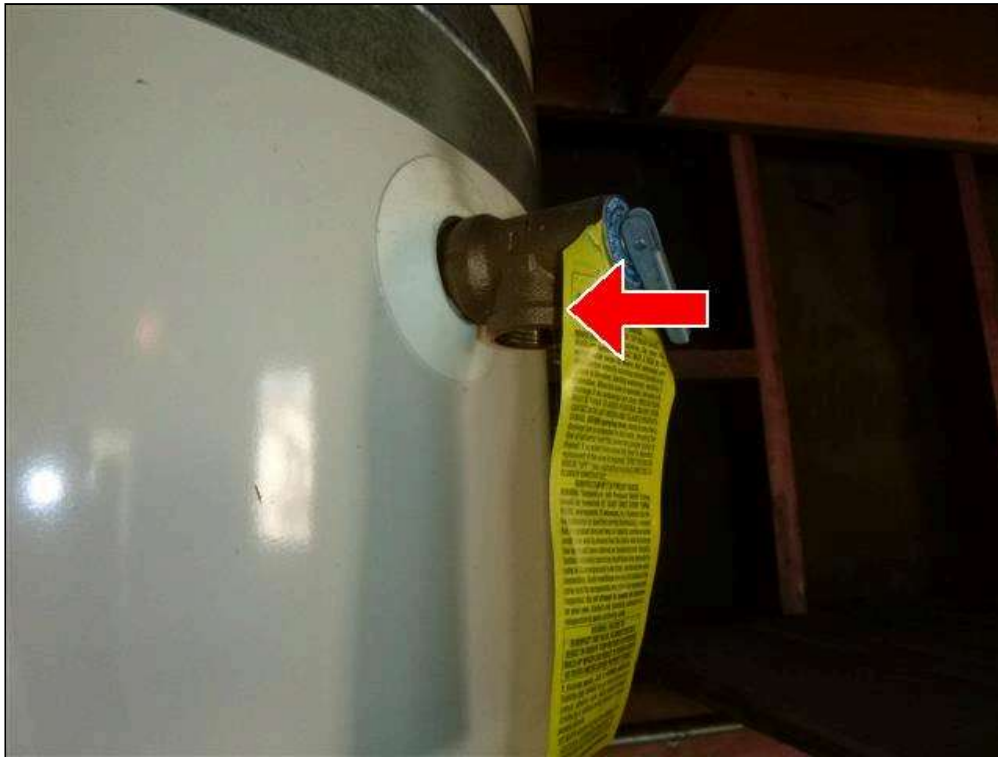
17.0 Item 2(Picture)

(3) No discharge pipe connected to the TP&R valve, this is a potential safety hazard. Suggest review by a licensed plumber for costs to install the TP discharge drain down to within 4-6 inches of the exterior grade/deck as required for safety.

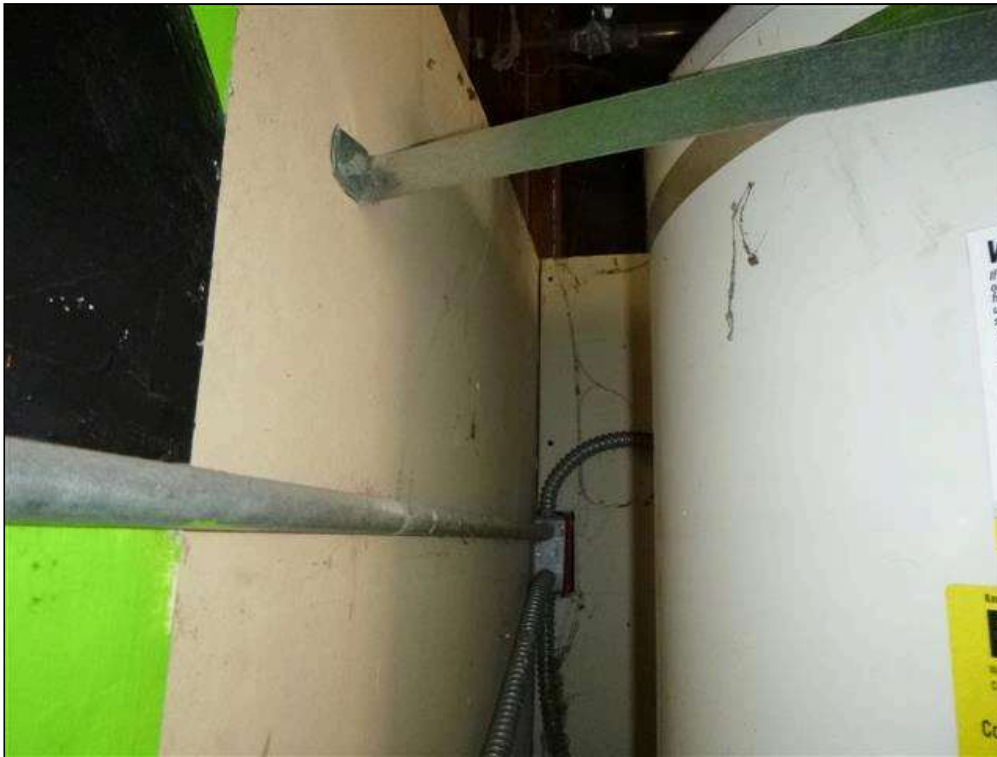
17.0 Item 4(Picture)

(5) The water heating strapping is missing the rear bracing at the time of the inspection, suggest review by licensed plumber for installation costs as required.

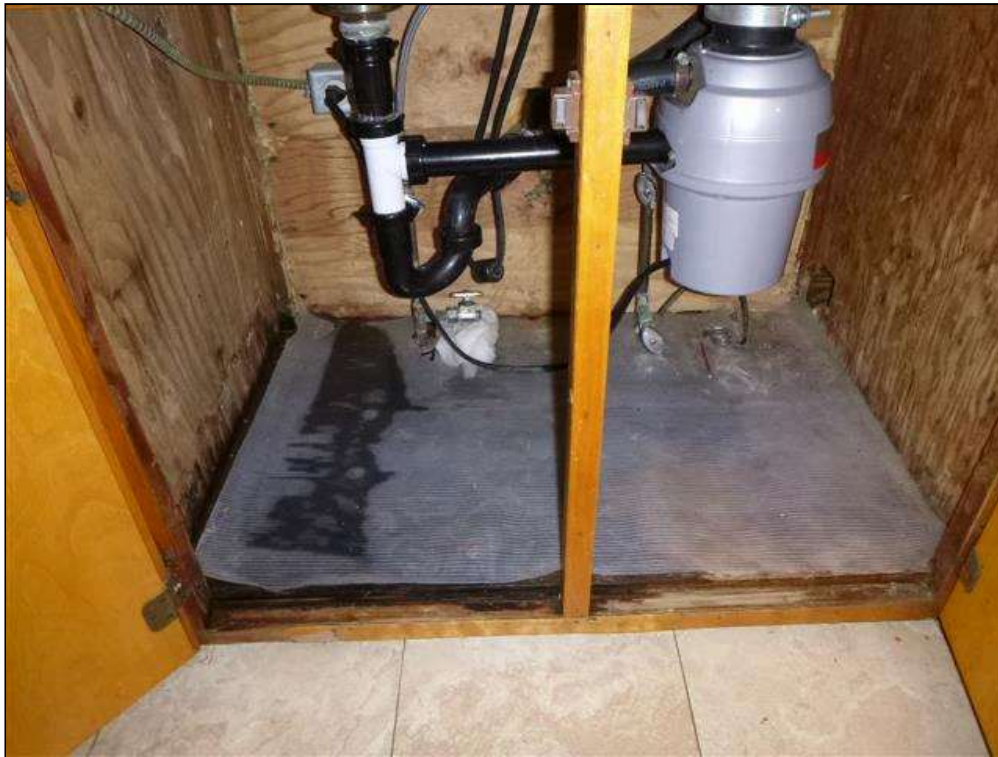
18.5 Item 1(Picture)

(1) The cabinet below the sink is wet, deteriorated and mold/mildew was noted. Suggest review by a licensed contractor and plumber for repair/replacement costs as needed.

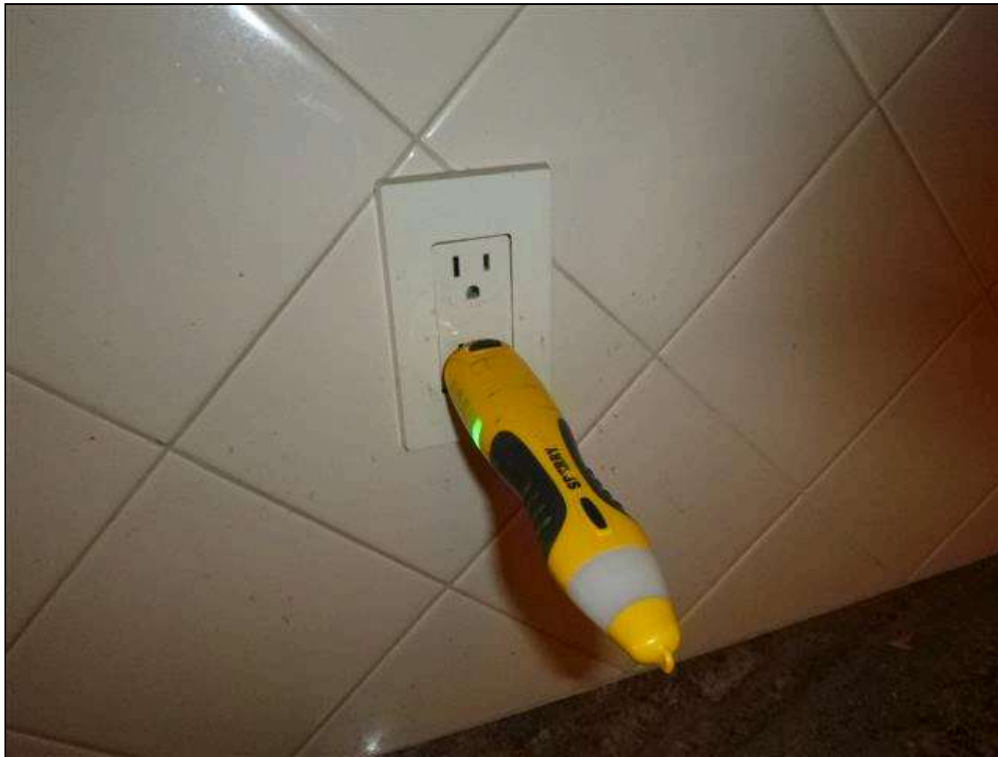
18.7 Item 1(Picture)

(1) Various countertop outlets are not GFCI protected as required. Countertop GFCI outlet(s)/protection has been required within six feet of the sink since 1987 and all countertop outlets since 1996. Suggest review by a licensed electrician for installation costs as required for safety.

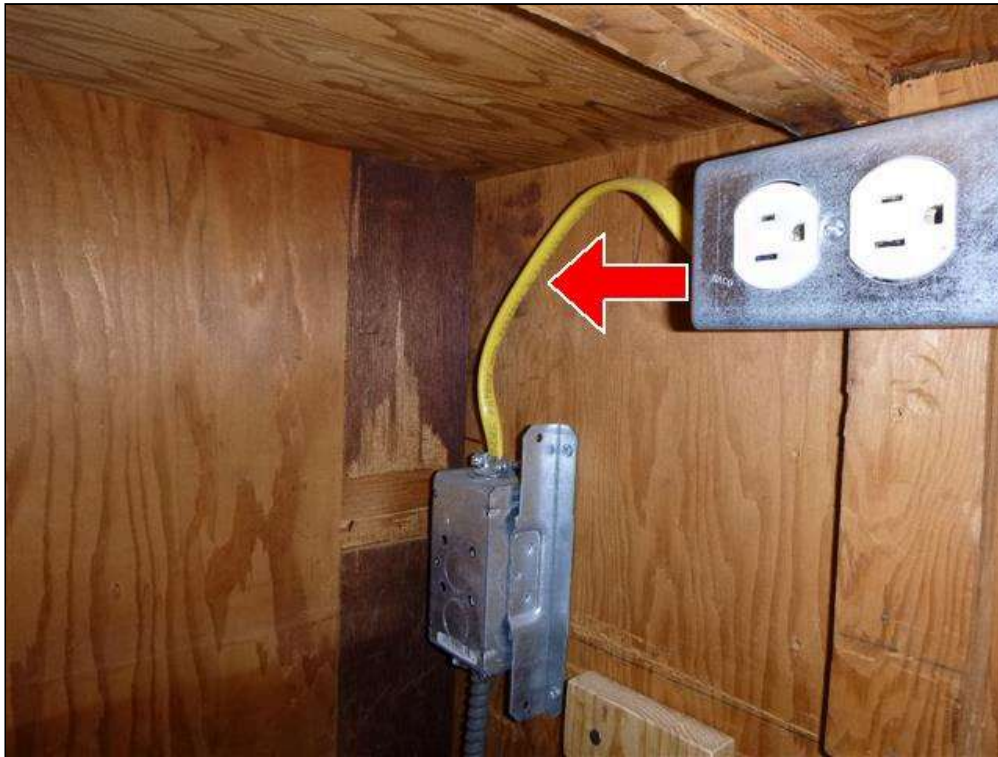
18.7 Item 6(Picture)

(3) Exposed romex wiring located in accessible areas. This is a safety concern as it could be subject to physical damage. Romex wiring is allowed in inaccessible areas such as attics, crawl spaces and within walls provided that all proper protective materials and required tie-downs are in place. Suggest review by a licensed electrician for repair/replacement costs as needed.

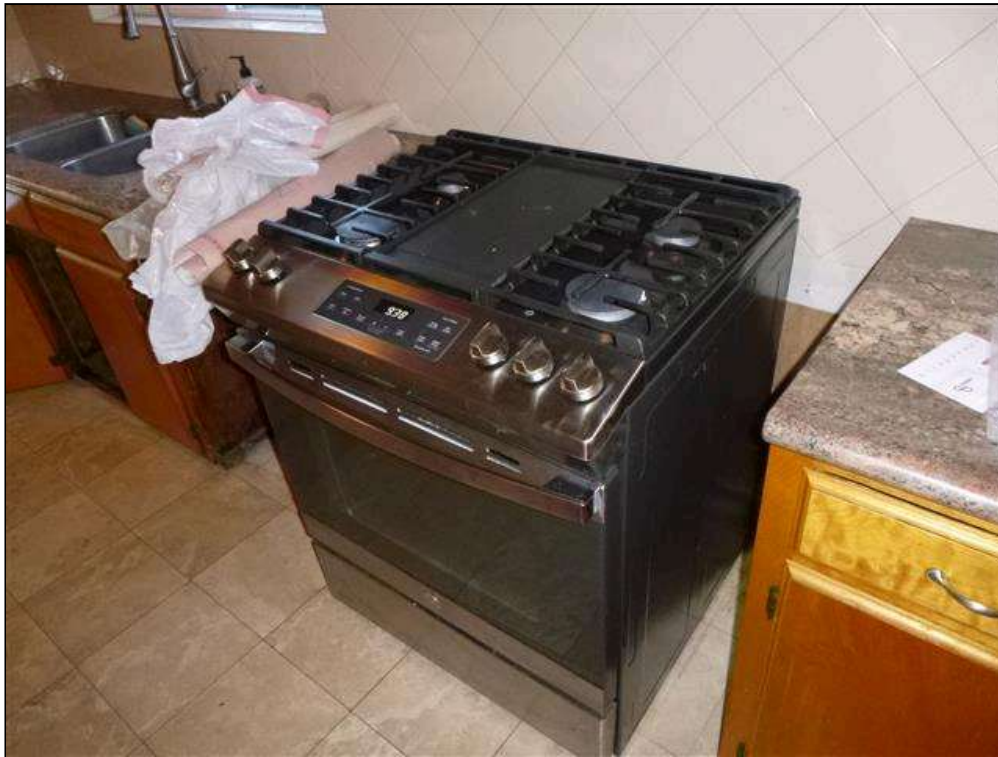
18.13 Item 1(Picture)

The anti-tip bracket is not currently installed correctly. An anti-tip bracket is usually installed on the floor and against the wall (towards the back of the stove) for one of the rear legs to slide into. Its purpose is to prevent the stove from tipping when a heavy load is placed on the door (possible child) or slide-out racks upsetting the center of gravity. Suggest review with a licensed contractor for costs to relocate/install the bracket correctly for safety as required since 1991.

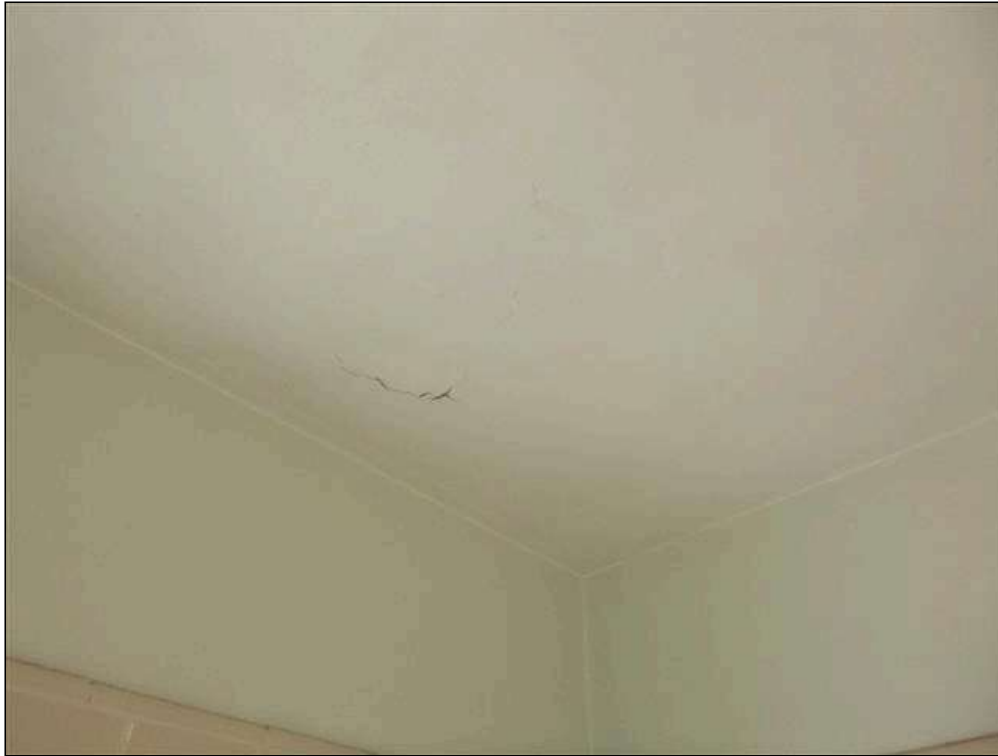
19.2 Item 1(Picture)

Blistering and minor deterioration noted at the ceiling due to inadequate ventilation. See the exhaust fan comment and repair/install as needed.

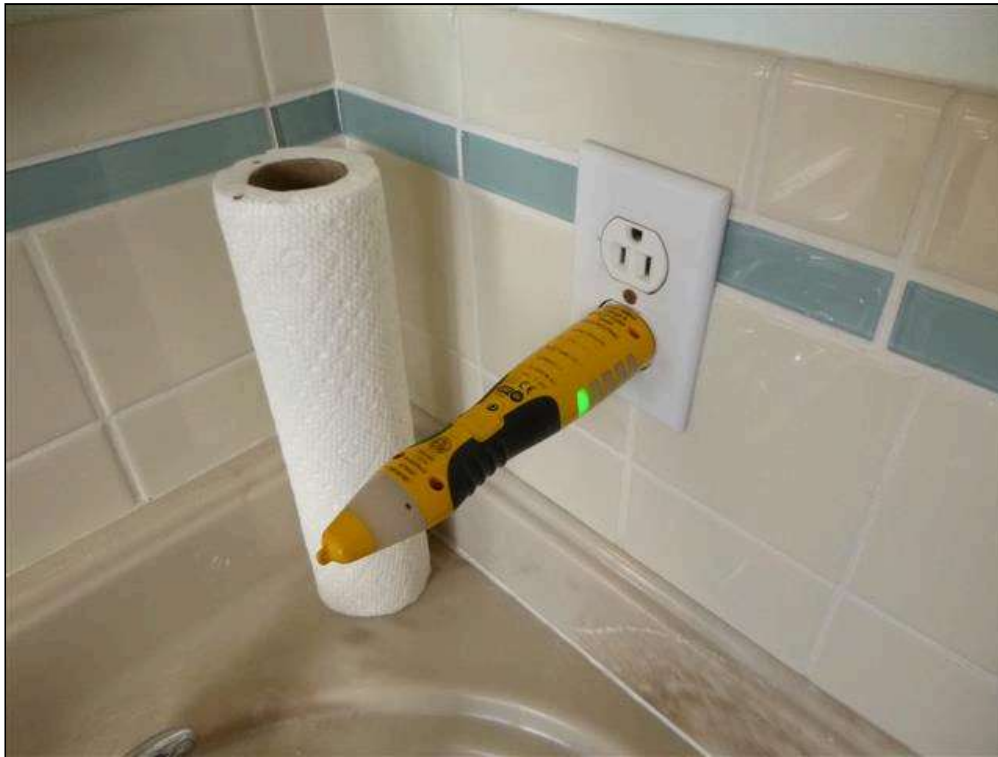
19.6 Item 1(Picture)

No GFCI outlet or protection installed in this bathroom. GFCI protection has been required in bathrooms since 1975, suggest review by a licensed electrician for installation as required for safety.

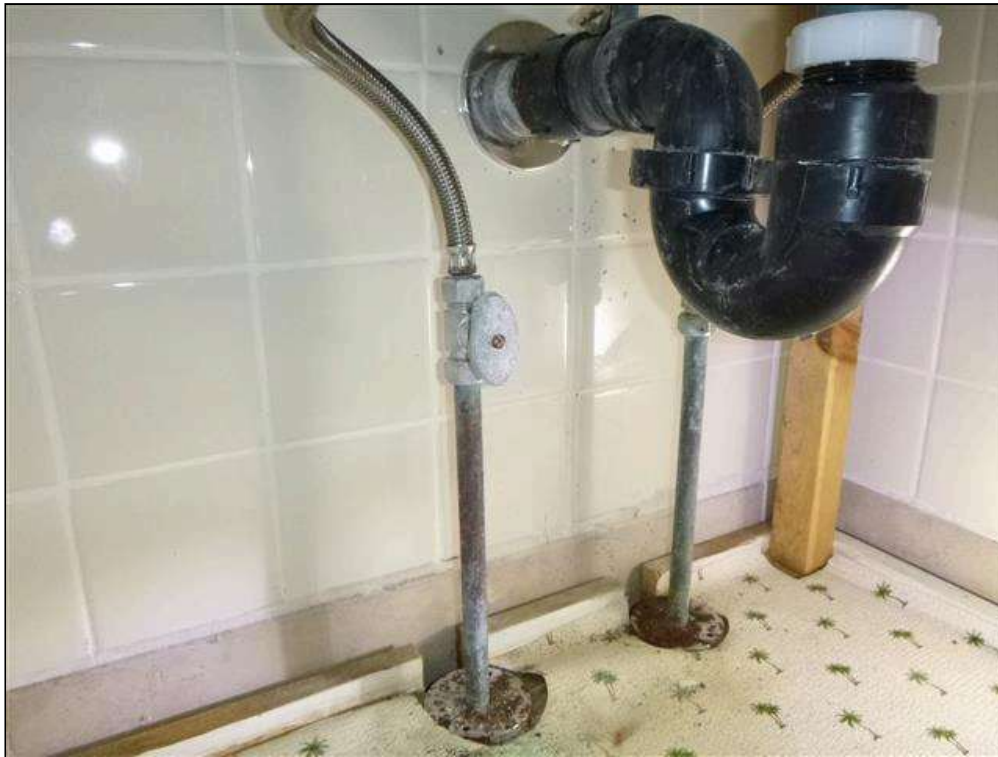
19.16 Item 1(Picture)

(1) Corrosion noted at the sink angle valve(s), no leaking noted at the time of the inspection. Suggest review by a licensed plumber for repair/replacement costs as needed.

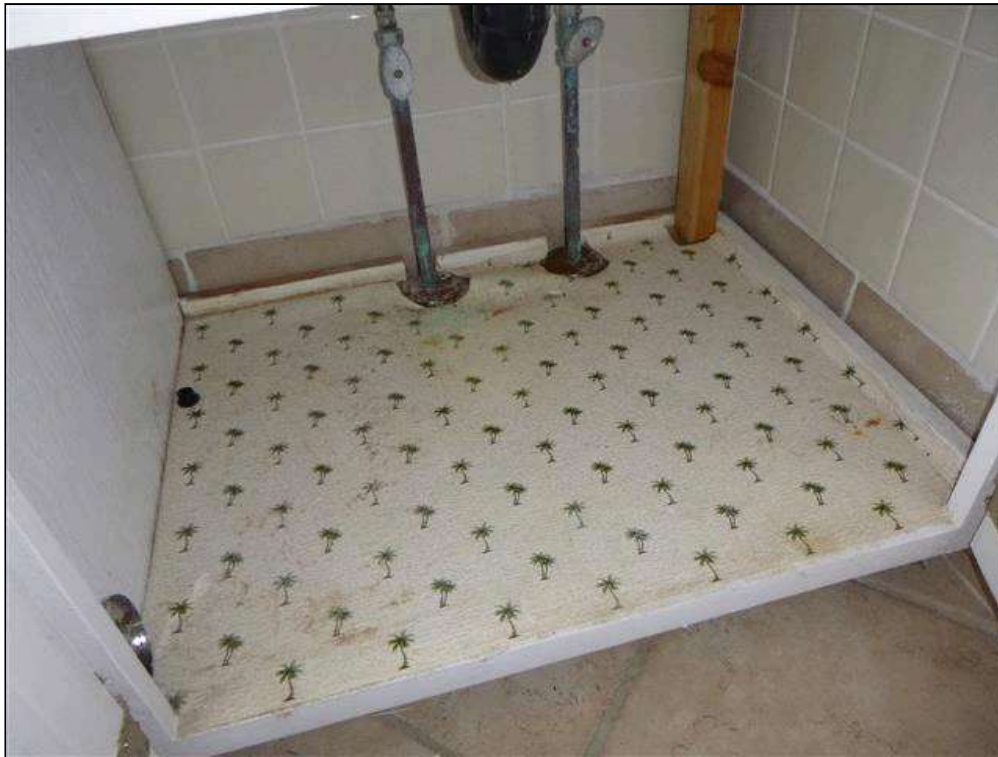
19.18 Item 1(Picture)

The base cabinet under the sink is deteriorated/stained from previous leaks, suggest repair/replace as needed.

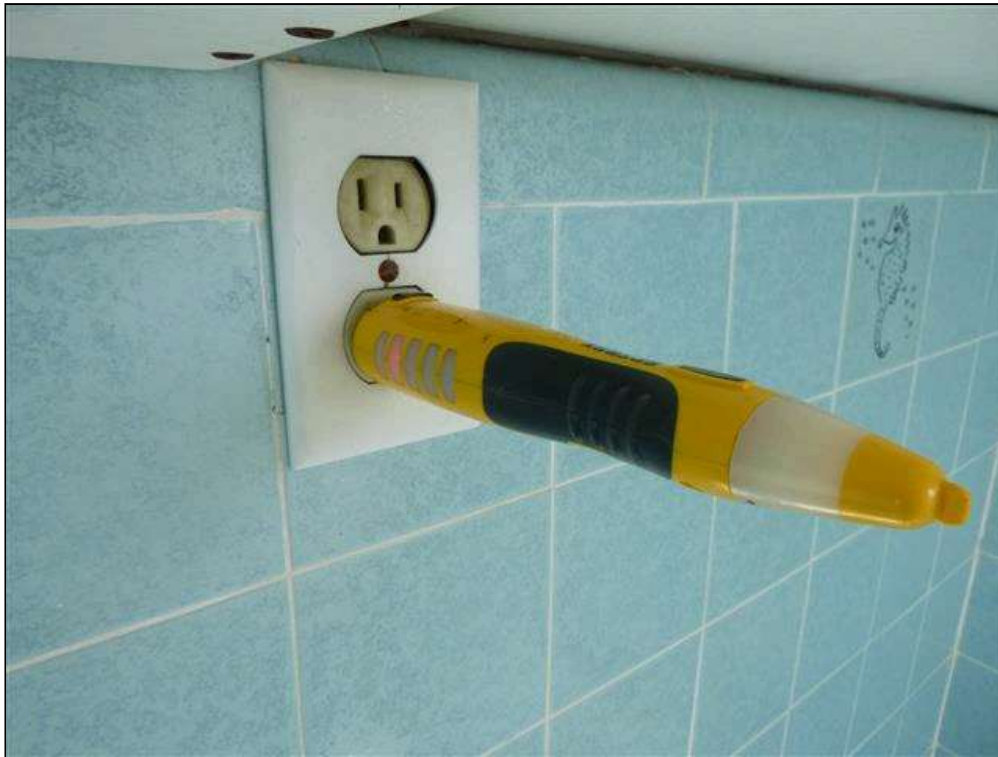
20.6 Item 1(Picture)

No GFCI outlet or protection installed in this bathroom. GFCI protection has been required in bathrooms since 1975, suggest review by a licensed electrician for installation as required for safety.

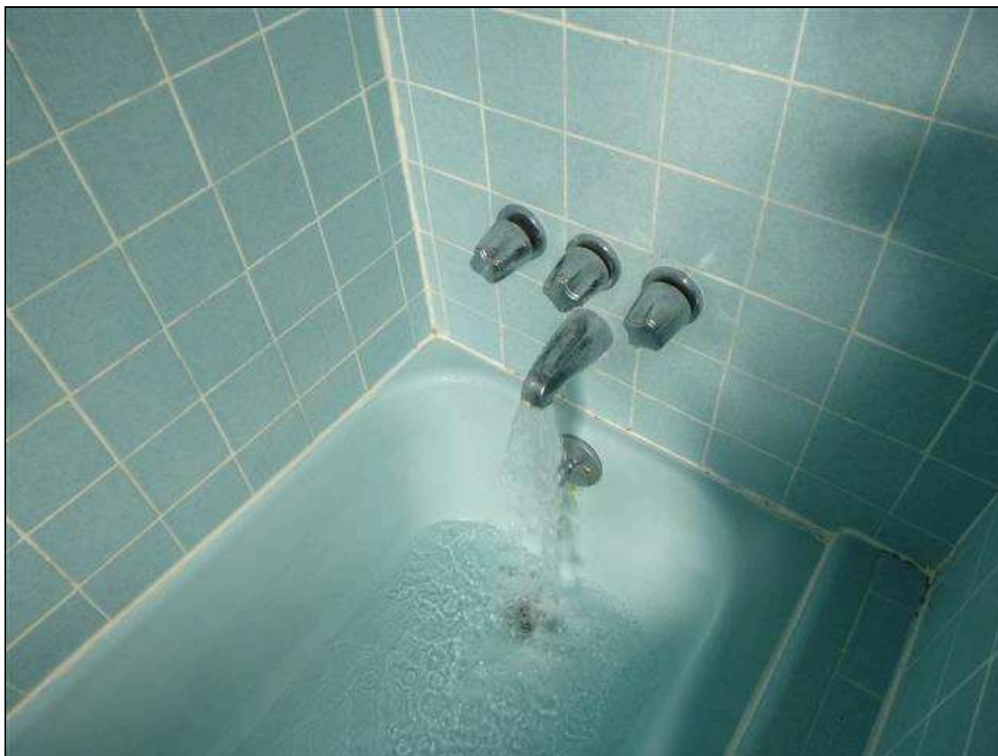
20.9 Item 1(Picture)

The existing tub faucet is not a low-flow system as required. Suggest review with a licensed plumber for costs to replace the existing tub faucet with a low flow faucet (2.2 gallons per minute) as required by the State of California as of January 1st, 2017. See the plumbing system comments for further details and a link to the State of California plumbing ordinance. Most retrofit companies/cities do not enforce the low flow tub faucet requirements due to it can take an excessive amount of time to fill the tub (you will use the same amount of water irrelevant of how long it takes to fill the tub).

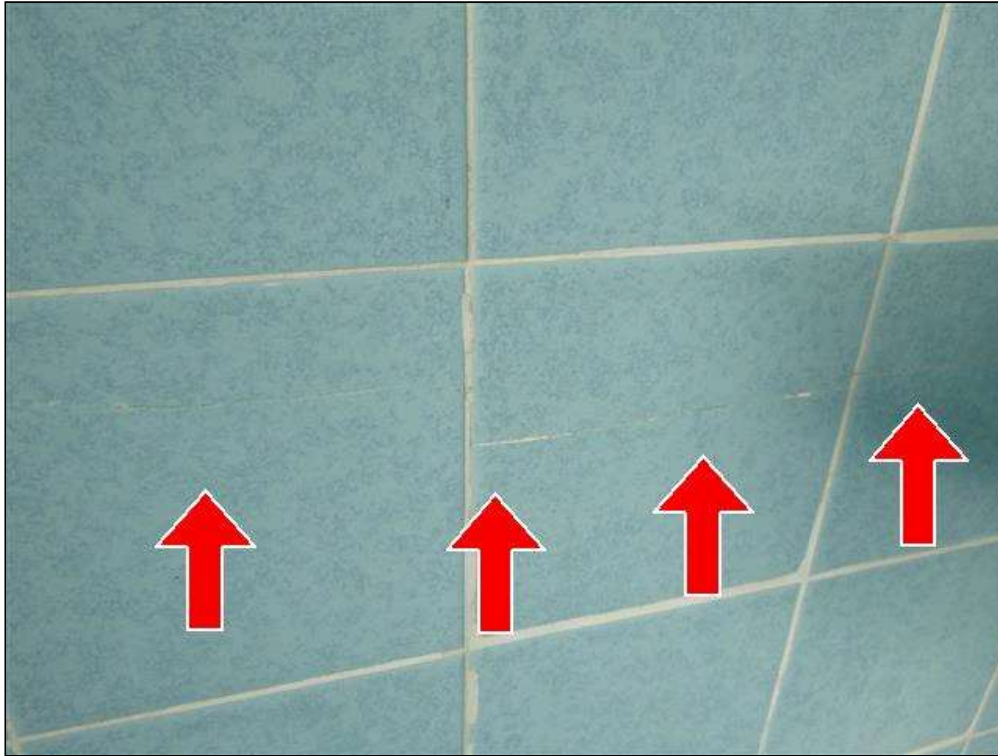
20.10 Item 1(Picture)

Hairline cracks noted at the tile areas, suggest repair/replace as needed.

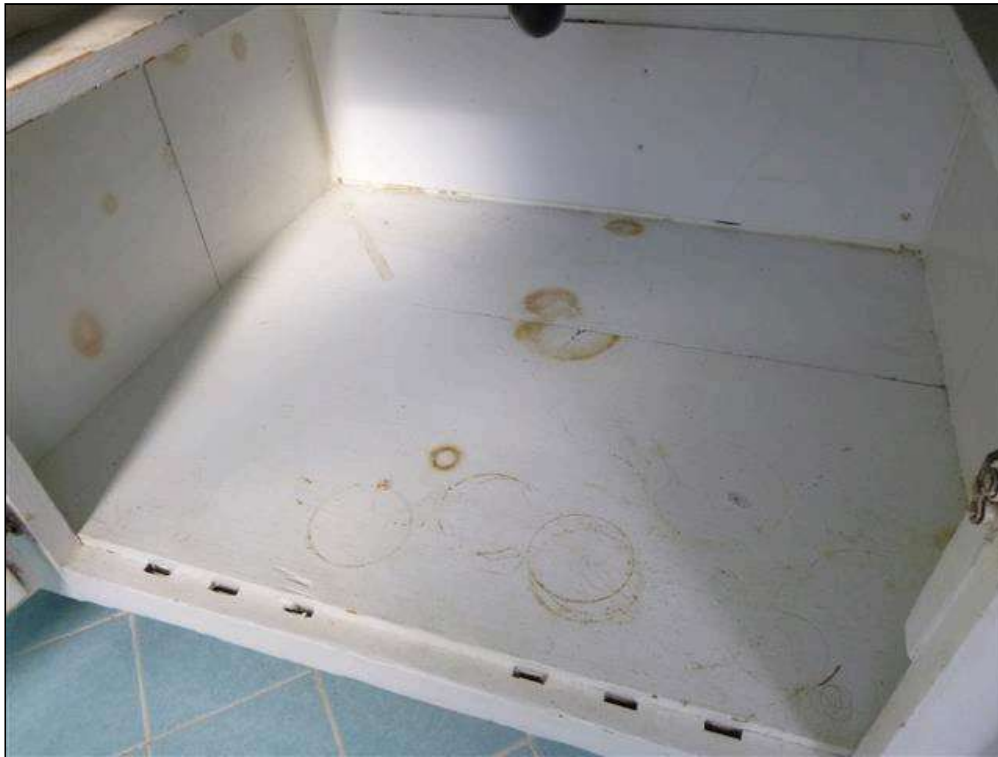
20.17 Item 1(Picture)

The base cabinet under the sink is deteriorated/stained from previous leaks, suggest repair/replace as needed.

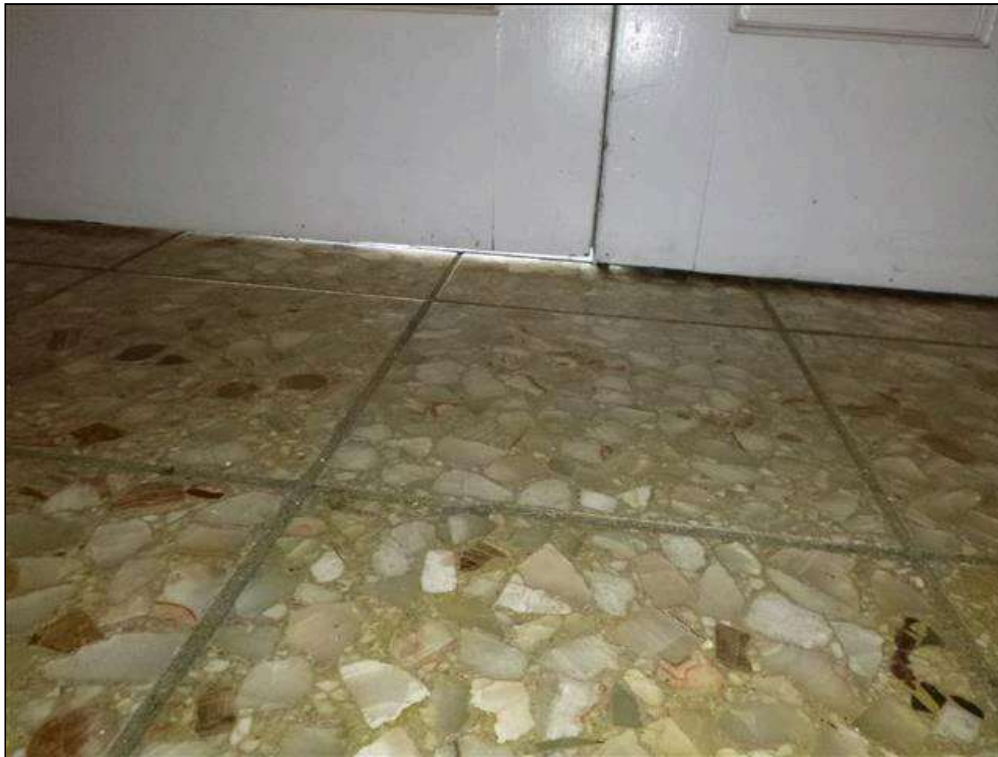
22.3 Item 1(Picture)

(2) Excessive gaps and light noted at the door(s) to the exterior when in the closed position. Suggest review with a licensed contractor for repair/replacement costs as needed to prevent future water, draft and insect/rodent intrusion at this area.

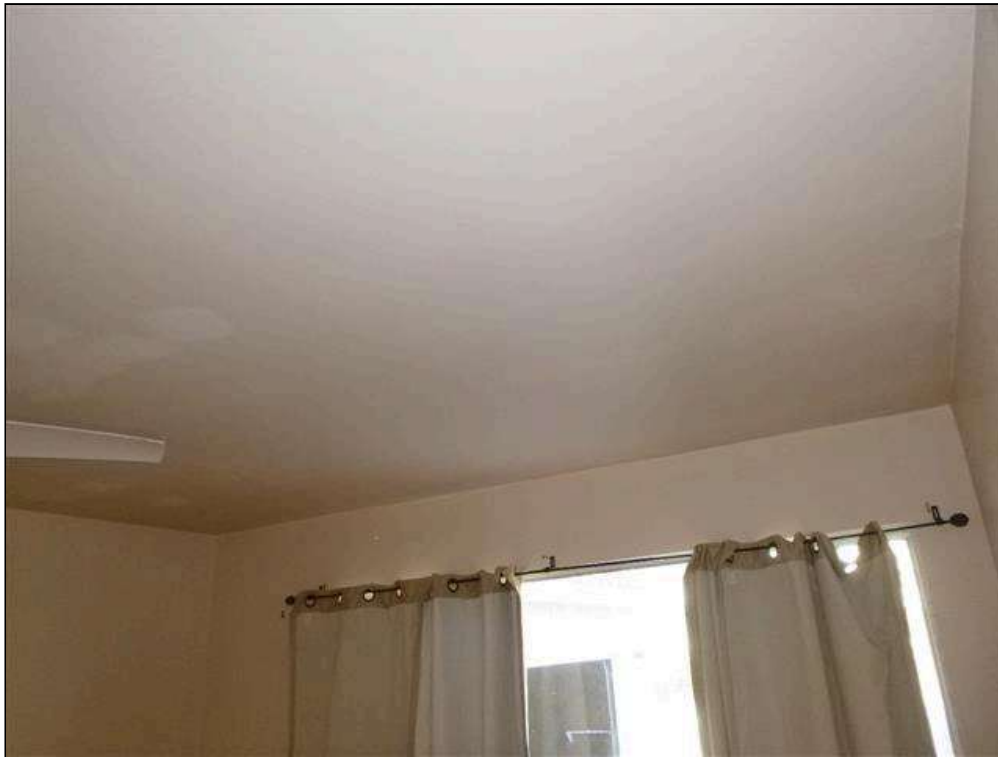
23.2 Item 1(Picture)

Patched and uneven areas of the ceiling was noted, suggest review with the seller on the cause and any repairs needed. Suggest review with a licensed contractor for any repair/removal/replacement costs as needed.

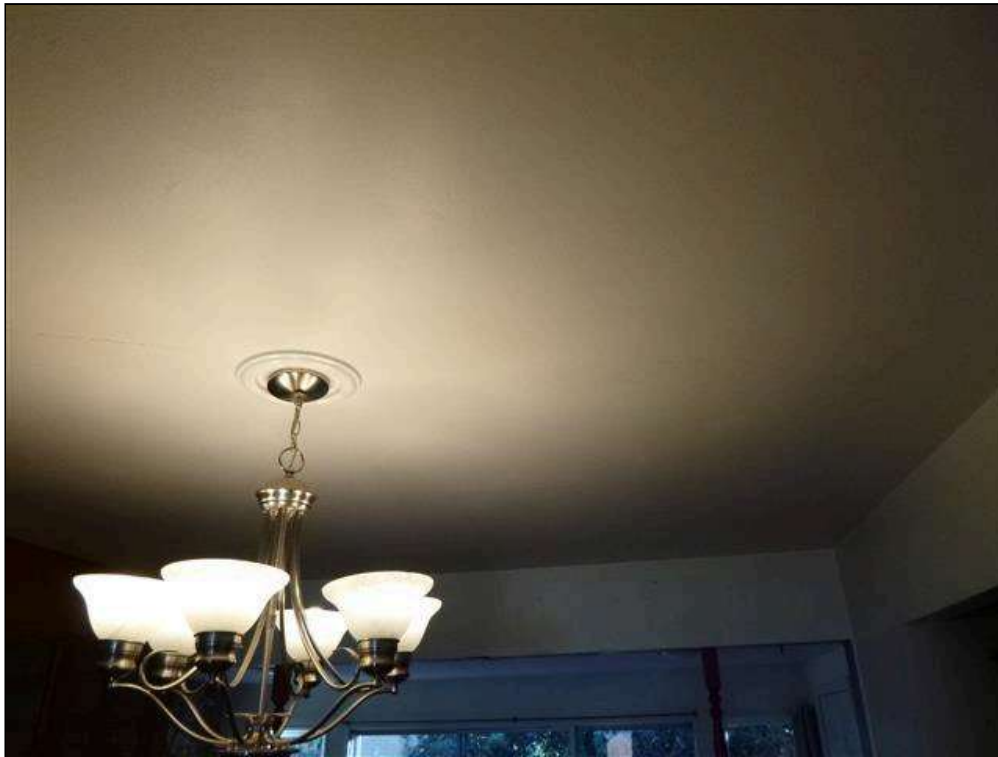
24.2 Item 1(Picture)

(1) Patched and uneven areas of the ceiling was noted, suggest review with the seller on the cause and any repairs needed. Suggest review with a licensed contractor for any repair/removal/replacement costs as needed.

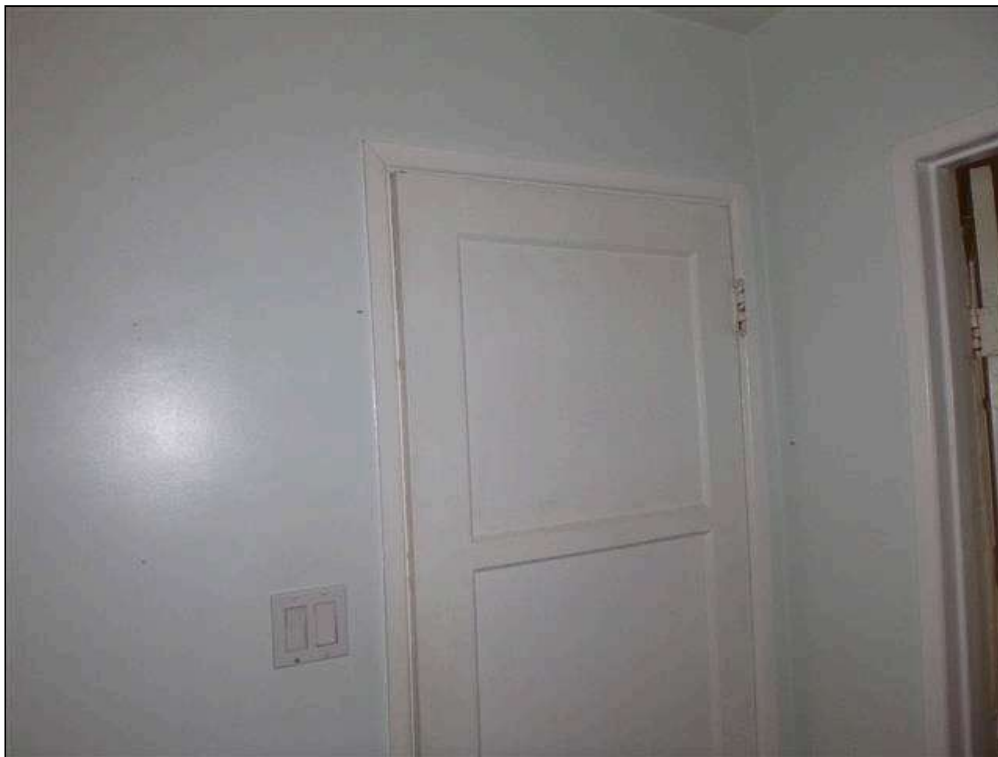
24.3 Item 1(Picture)

(2) The door sticks/impacts on the jamb when operating, suggest repair as needed.

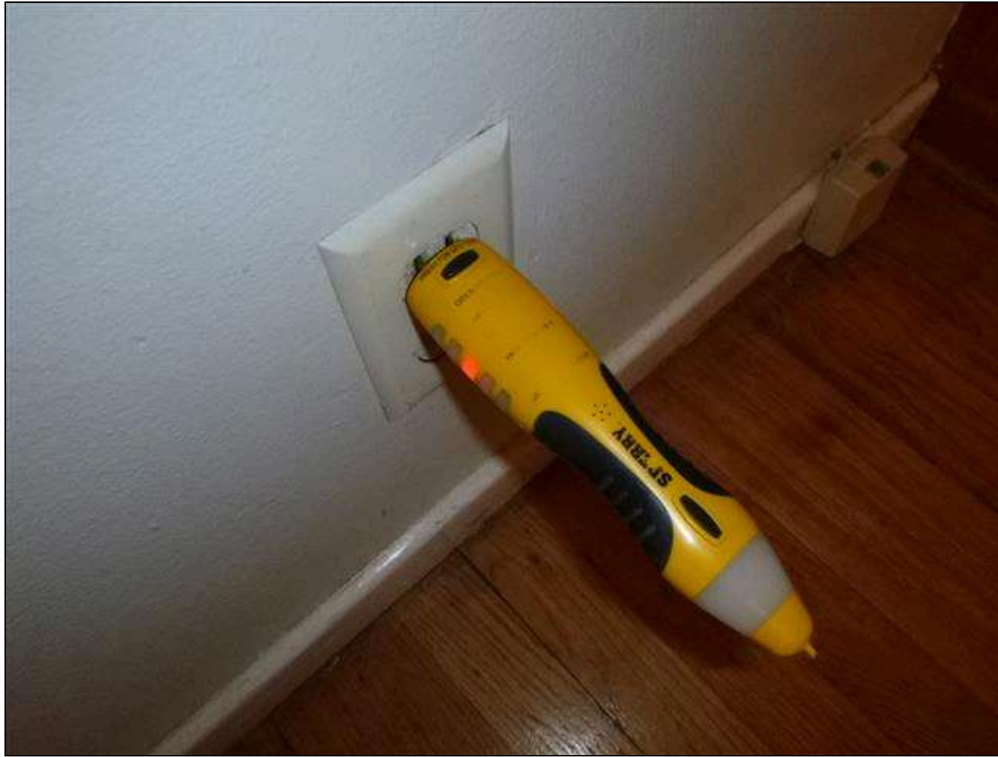
24.4 Item 1(Picture)

(2) Reversed polarity noted at various outlets. Reversed polarity, hot and ground reversed and other terms used for electric outlets are usually easily corrected by minor wiring adjustments at the specified item. Suggest review with a licensed electrician for repair/replacement costs and confirm correct operation as needed.

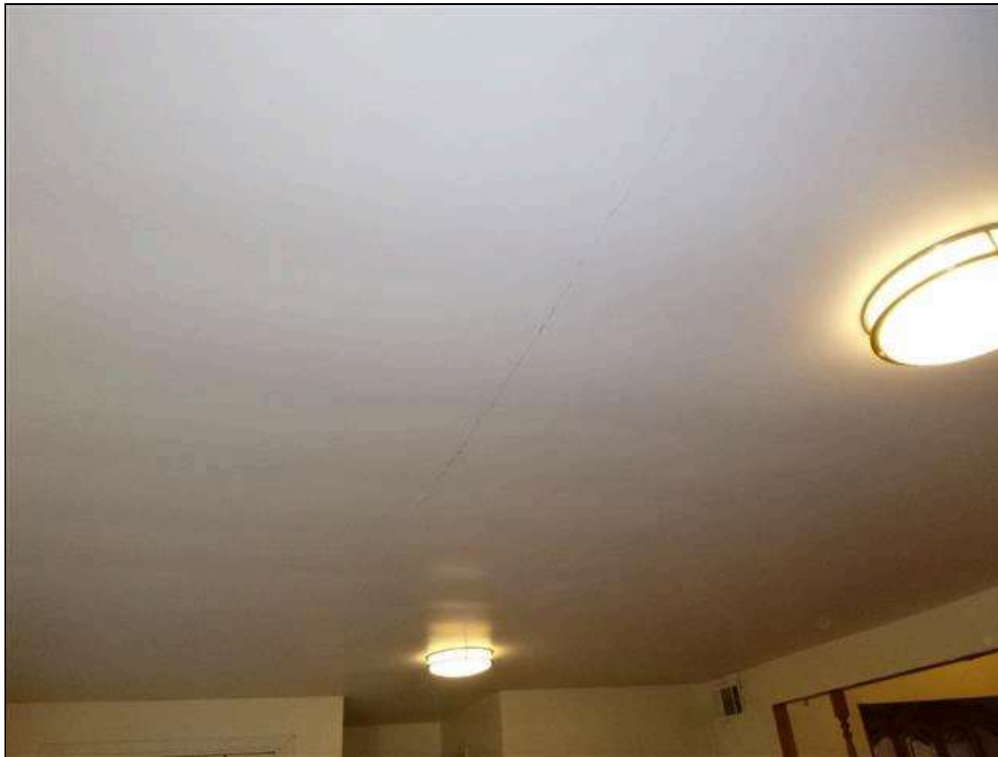
25.2 Item 1(Picture)

(1) Settling cracks and patching noted, suggest repair as needed.

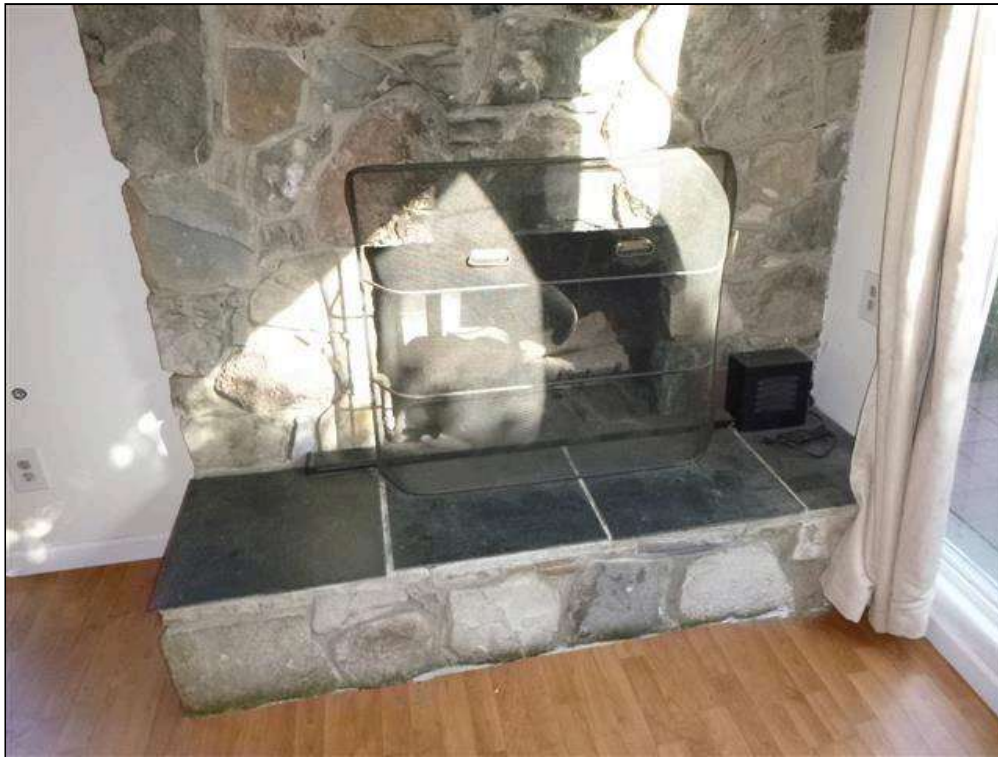
25.7 Item 1(Picture)

(1) The fireplace damper was operational at the time of the inspection. Suggest securing the damper to a fixed open position due to the gas installation per current requirements.

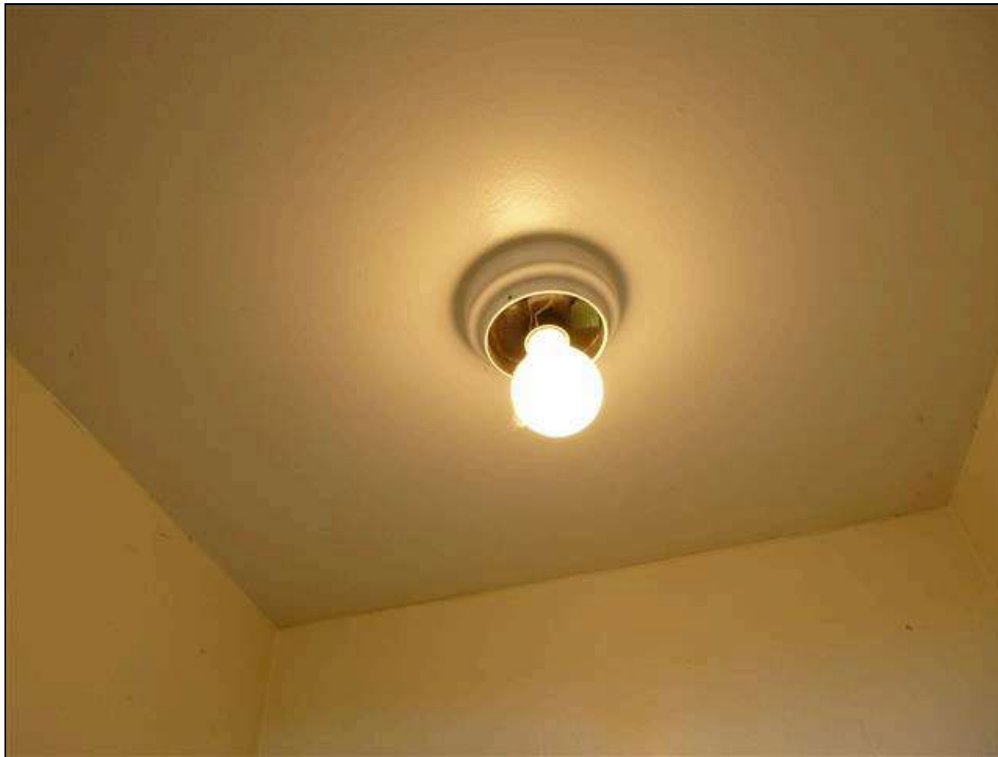
28.6 Item 1(Picture)

(2) The cover globe(s) are missing at light fixture(s) at the time of the inspection. Suggest replacing the missing cover globe(s) for safety.
