General Summary

Ferguson Home Inspections

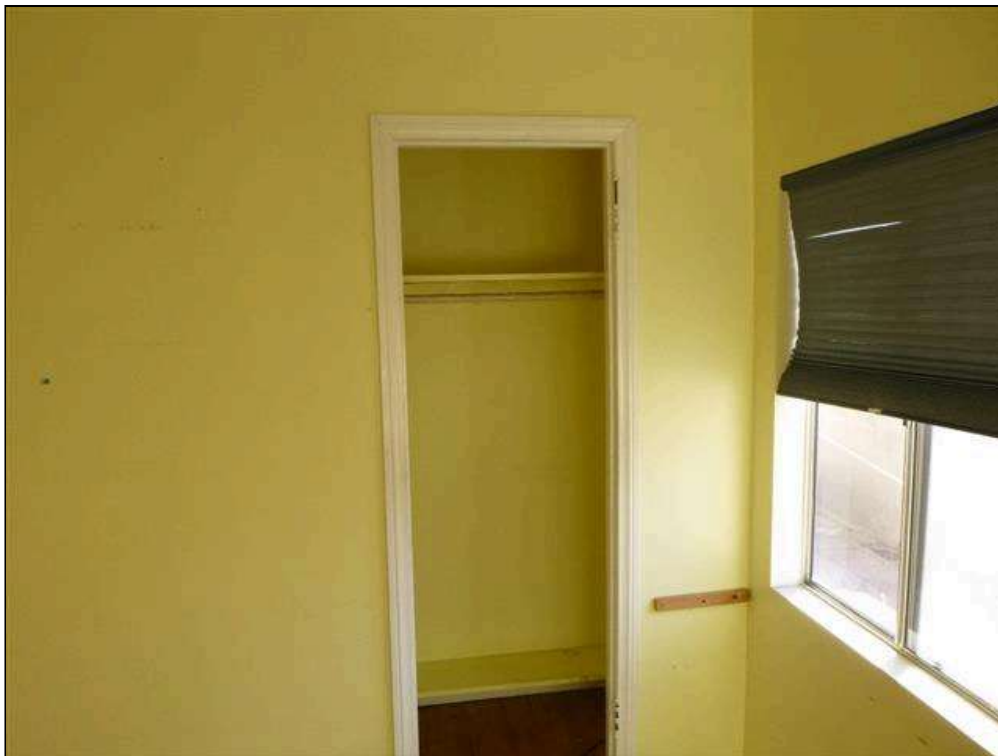
29.7 Item 1(Picture)

The closet door(s) were missing/not installed at the time of the inspection, suggest replacing/installing as needed.

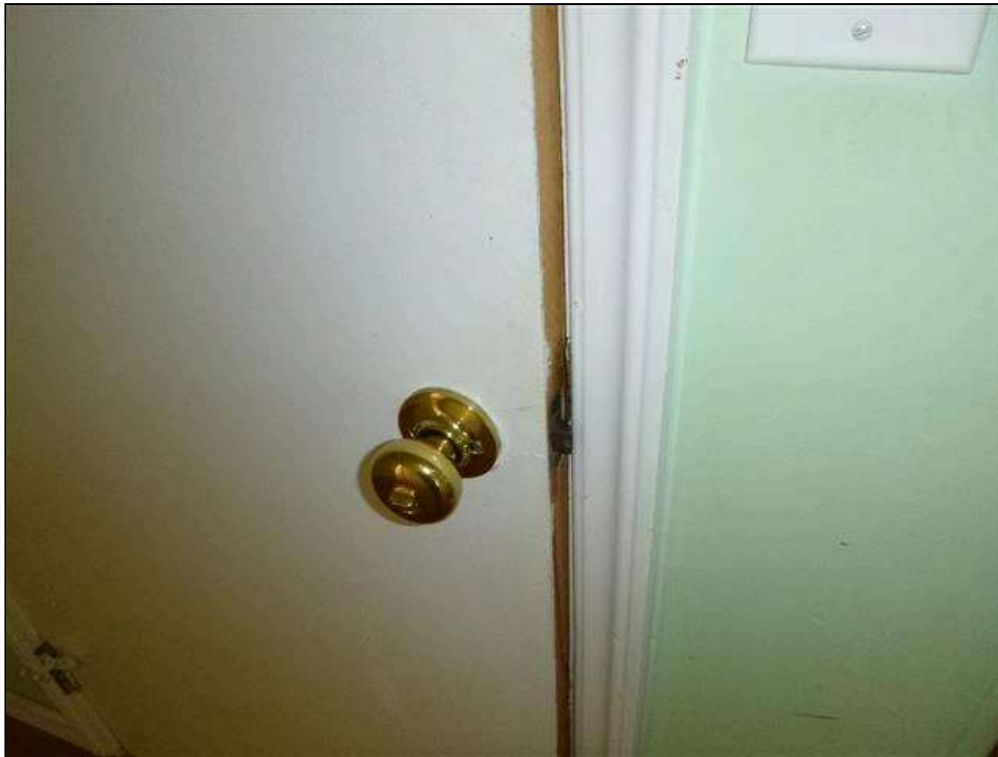
31.3 Item 1(Picture)

(1) The door will not close and latch correctly, suggest repair as needed.

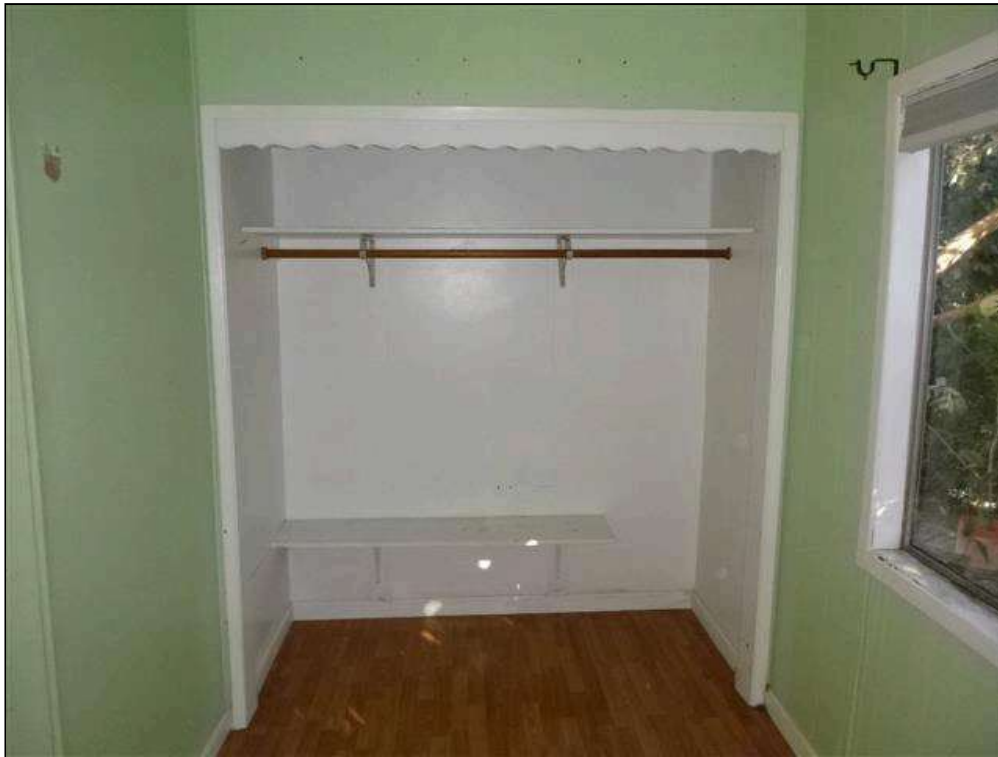
31.7 Item 1(Picture)

The closet door(s) were missing/not installed at the time of the inspection, suggest replacing/installing as needed.
