## SUMMARY

33525 Binnacle Dr, Dana Point CA  
92629  
David & Lesley Midkiff  
July 1, 2021

Randall Meadows  
InterNACHI CPI #19012717  
FOCUS Home Inspection Authority  
949-945-0111  
[focusinspectionauthority@gmail.com](mailto:focusinspectionauthority@gmail.com)

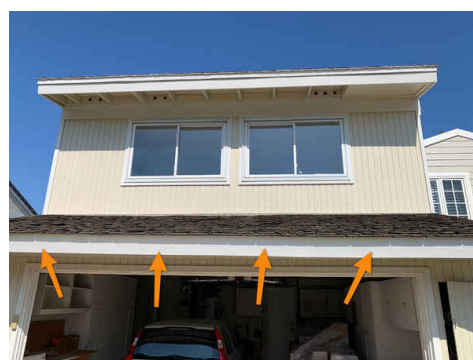
No Drip Edge

#### MISSING ROOF FLASHING

Flashings were missing in one or more areas at time of inspection. Flashings provide protection against moisture intrusion. Recommend a qualified roofing contractor evaluate and remedy.

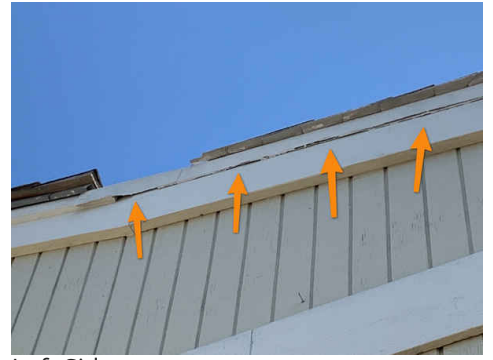
Left Side

**DAMAGED ROOF FLASHING**

Observed one or more damaged flashing at corner edge tile. Corner edge tile also appears damaged. This should be reported to your HOA for repair

Recommendation  
Contact a qualified professional.

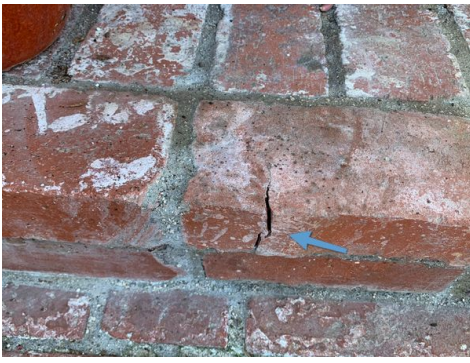
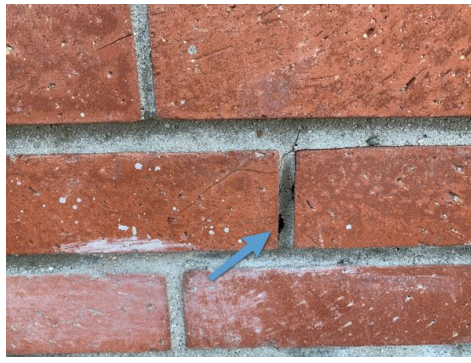
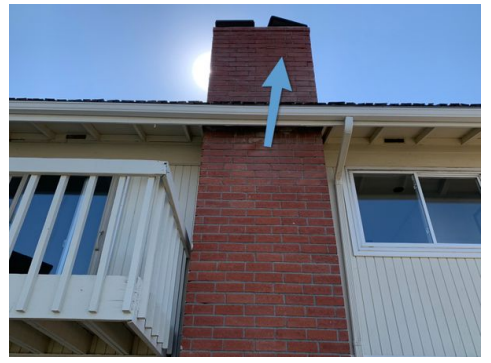
**CHIMNEY CRACK**

Observed horizontal chimney crack below crown. Should be further evaluated for repair.

Recommendation  
Contact a qualified professional.

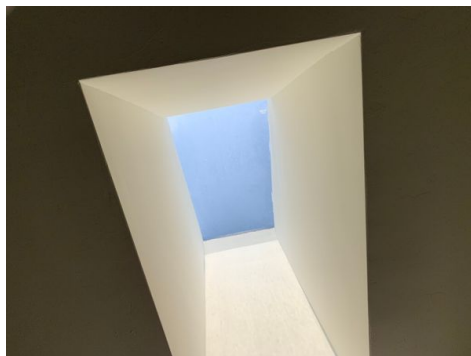
2.4.4 Skylights, Chimneys, Solar Panels & Other Roof Penetrations  
**SKYLIGHT CRAZING**

Small cracks or crazing were observed in one or more skylight features. Crazing is caused by weathering and UV exposure over time. Eventually the small cracks can widen due to sudden temperature change or slight impact. Hazing can also occur and the plastic can become brittle. Recommend monitoring and further evaluation for potential replacement needs by qualified professional.

Recommendation  
 Contact a qualified professional.

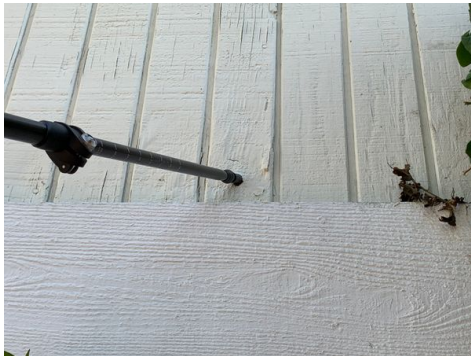
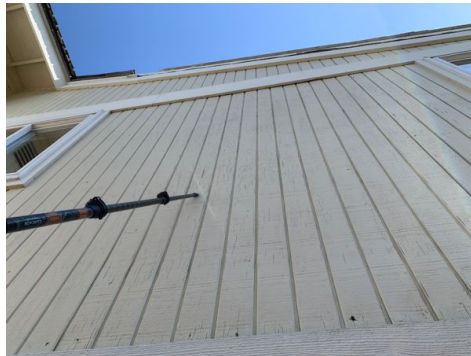
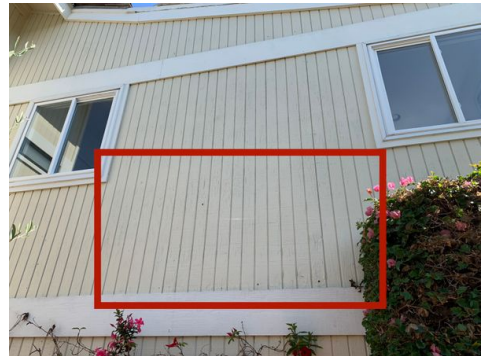
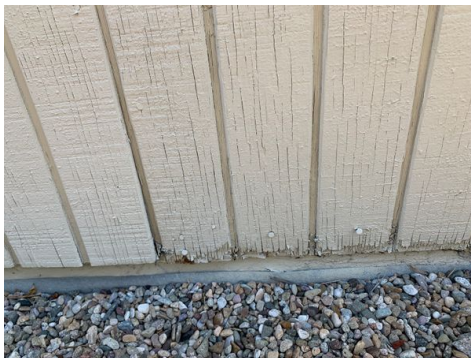
South Wall

**WOOD ROT/DETERIORATION OF SIDING**

Observe one or more areas of wood rot and/or deterioration and paint fade or flaking of siding. This should be evaluated further for repair or replacement of affected areas.

Contact a qualified professional.

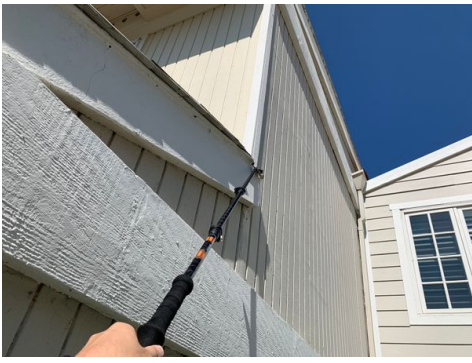
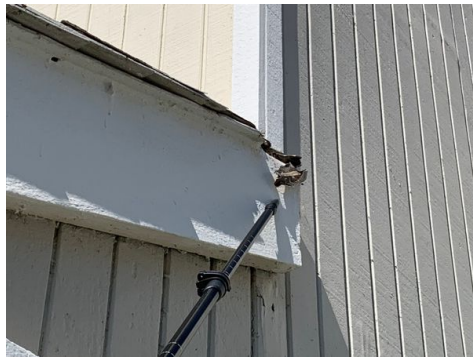
**WOOD ROT/DETERIORATION OF TRIM**

Observed wood rot and/or deterioration in one or more areas of trim, located at entry window sill, window seal fourth bedroom, and faux balcony railings second story elevation of third Bedroom.

Contact a qualified professional.

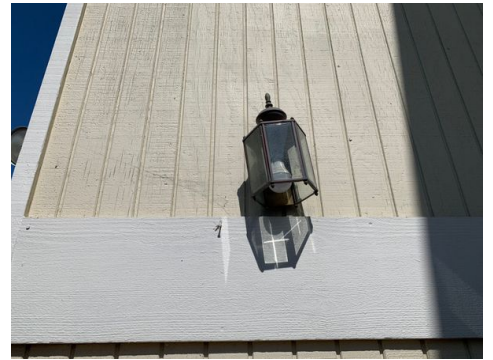
## EXTERIOR HOUSE/COACH LIGHTS LOOSE

Observed one or more exterior house/coach lights that were loose and should be re-secured.

Contact a handyman or DIY project

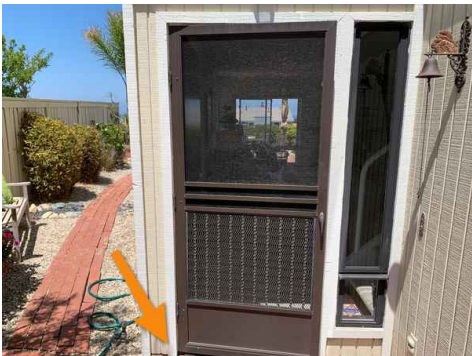
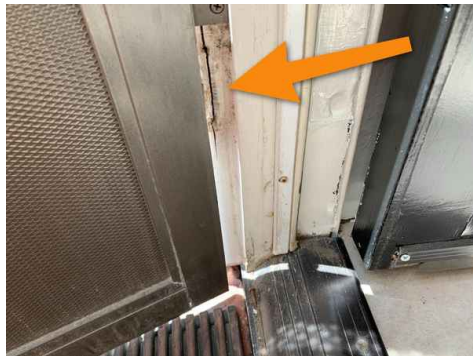
Front Door

## DOOR SILL/TRIM

Door sill and/or trim is loose, deteriorated or worn and repair or replacement should be considered.

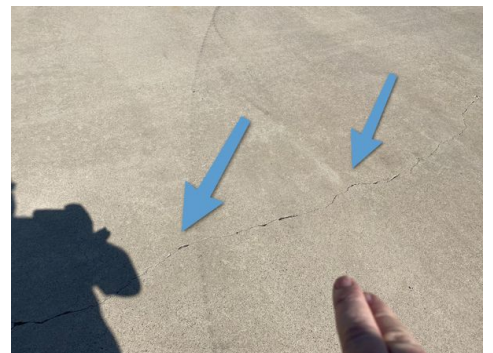
## CEMENT CRACKING - MINOR

Minor cosmetic cracks observed, less than 1/4" which may indicate movement in the soil. Recommend monitor and/or have concrete contractor patch/seal.

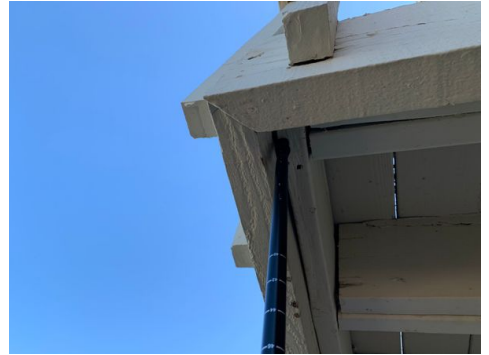
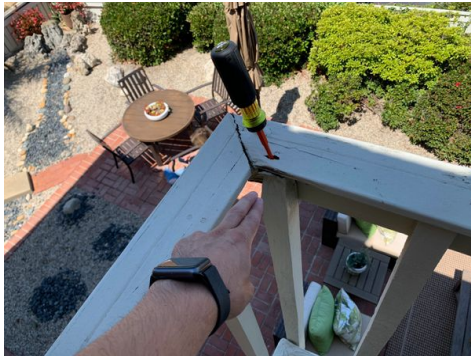
#### WOOD ROT OBSERVED STAIRS/DECKING/BALCONY

Wood rot was noted at the bottom ends and top rail of Balcony. Rot was also observed on one beam support under the decking. Recommend further evaluation for repair or replacement.

Contact a qualified professional.

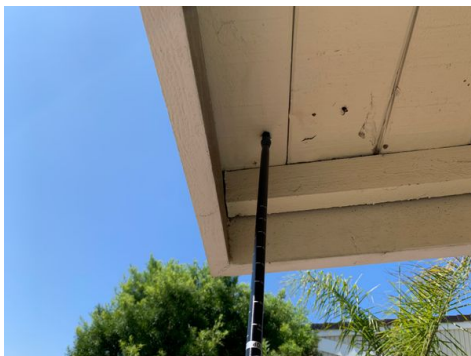
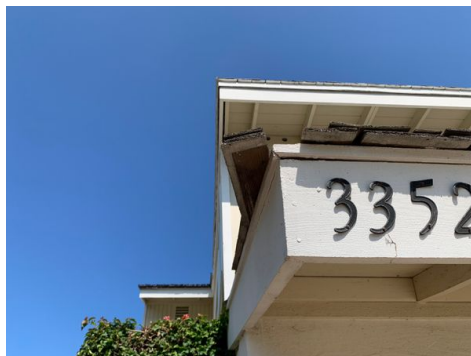
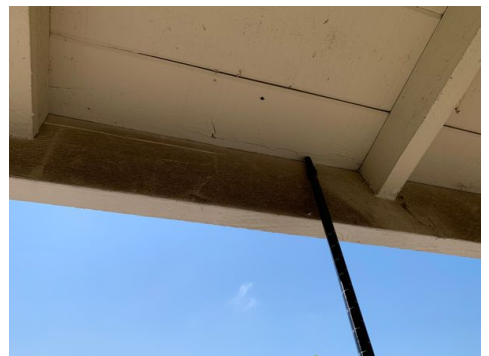
SE CORNER

#### FASCIA AND/OR EAVE ROTTED

One or more sections of the fascia are rotted. Recommend qualified roofer evaluate & repair.

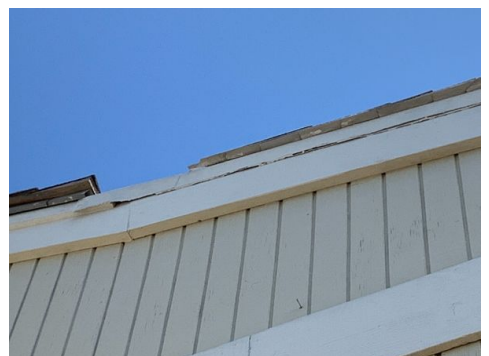
#### FASCIA DEFICIENCY - PAINT FADE/WEATHERED

Observed one or more areas of fascia in need of repainting. Fascia board should be repainted as a home maintenance every 5 to 6 years to prevent further weathering and deterioration.

Contact a qualified professional.

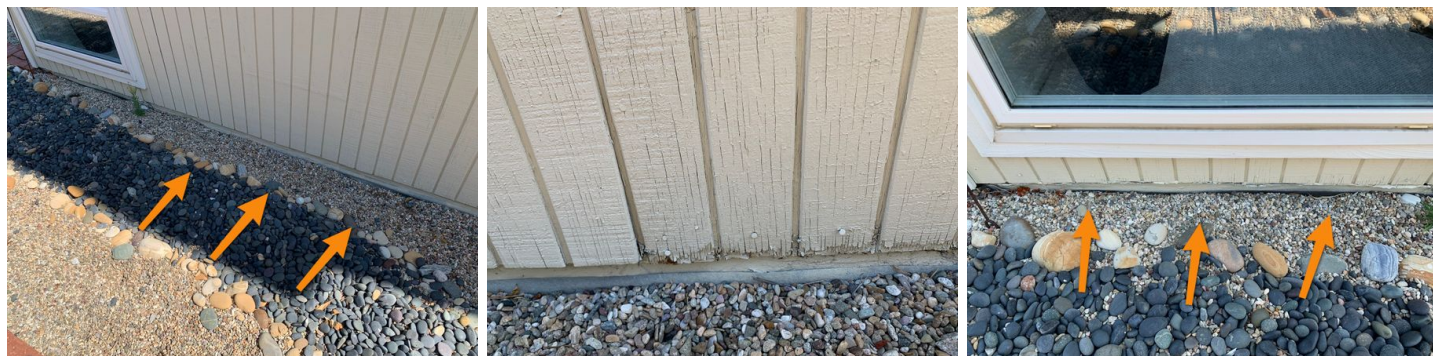
#### **NEGATIVE GRADING**

Grading is sloping towards the home in some areas. This could lead to water intrusion and foundation issues. Recommend qualified landscaper or foundation contractor regrade so water flows away from home. This may require installation of French drains or other adjustments.

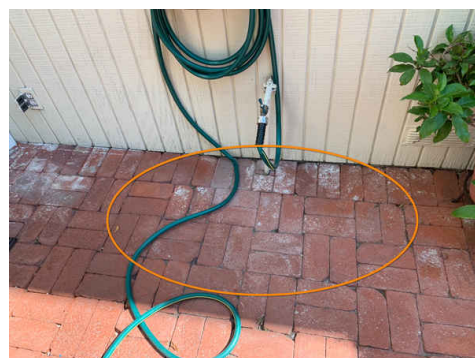
Evidence of standing water

#### **STANDING WATER**

Standing water observed, which could indicate poor drainage and/or grading. Recommend monitor and/or have landscaper correct.

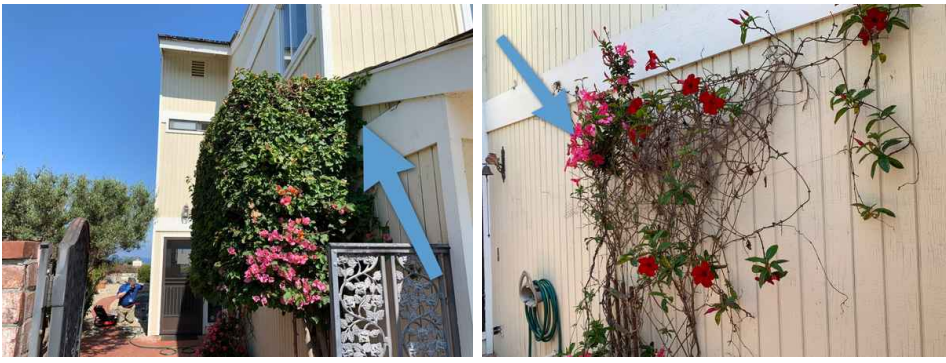
#### **OVERGROWTH OF TREES VEGETATION AGAINST SIDE OF STRUCTURE**

Observed trees/vegetation in need of trimming away from structure. Overgrowth against the structure may facilitate entry of moisture or vermin into the structure or deterioration of siding. Recommend the trimming of shrubs and trees away from the structure.

Contact a qualified professional.

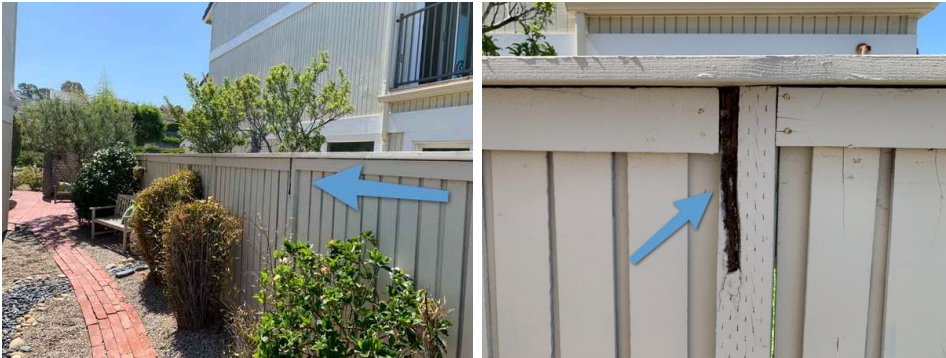
#### PRIVACY WALL CRACKS

Observe cracks along the border line of privacy wall of property. Recommend monitoring. If correction as needed, your HOA should be notified As this may be listed under common area walls depending on CC&Rs.

Recommendation  
Contact a qualified professional.

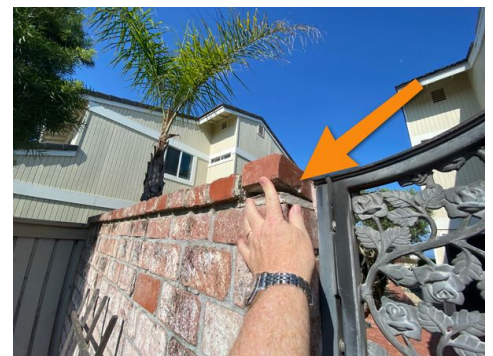
#### WALL CAP DEFICIENCY

Noted cap on brick wall was loose. Recommend re-securing.

Recommendation  
Contact a qualified professional.

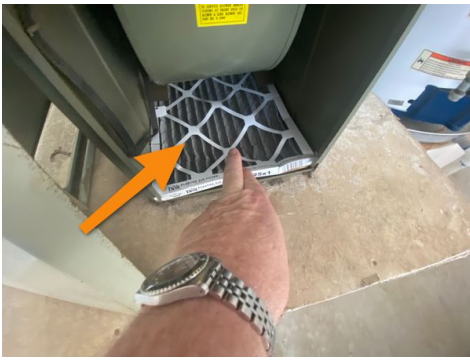
#### FILTER DIRTY

The furnace filter is dirty and needs to be replaced every 3- 6 months.

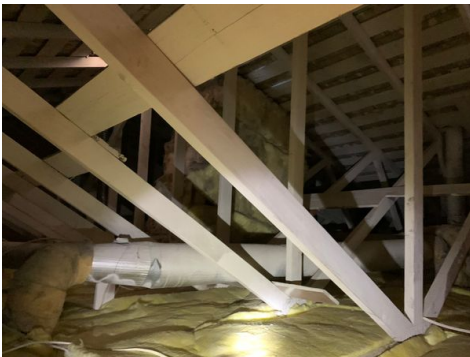
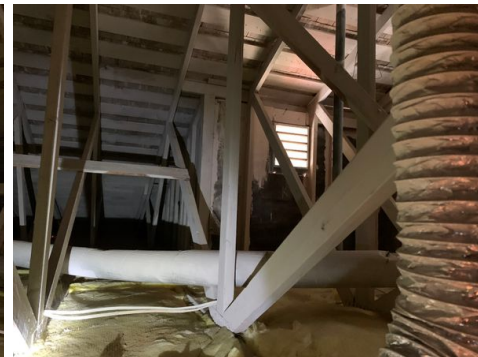
## TRANSITE TYPE VENT PIPE NOTED

Transite type vent pipe is not recommended material as it may contain asbestos. Suggest further review by qualified contractor if this component is being replaced upon upgrade.

Contact a qualified professional.

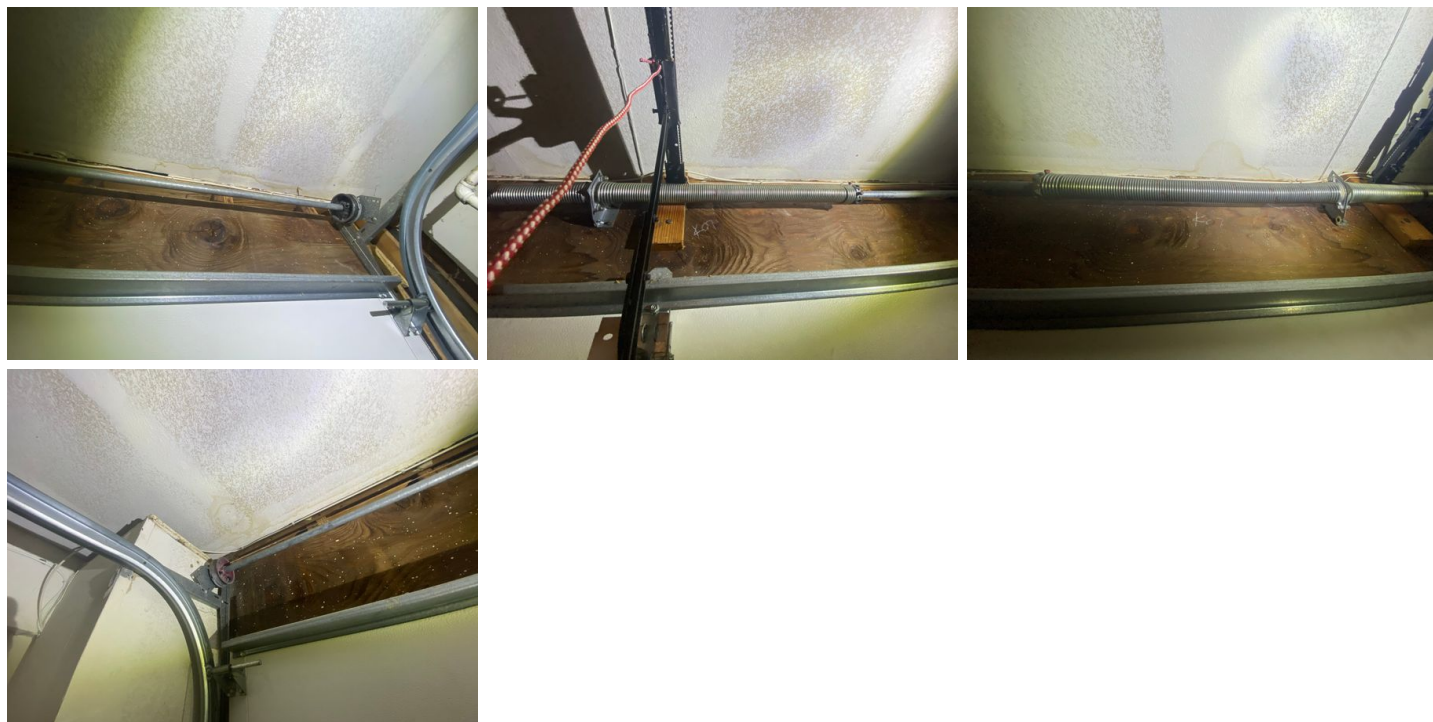
## MOISTURE INTRUSION

Garage ceiling shows signs of moisture intrusion. To prevent further damage or growth of mold, I recommend a qualified contractor evaluate the source of moisture intrusion.

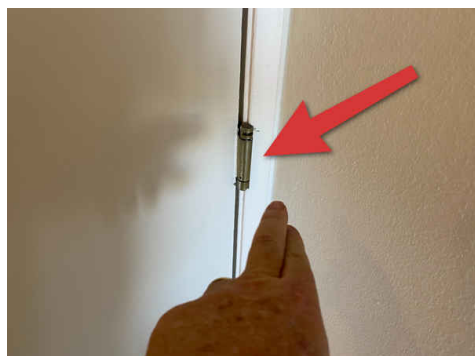
Tension Hinge Deficiency

Self Closing Tension Device is not set to close the door completely. Recommend adjusting tension hinges for proper closing.

Recommendation  
Contact a qualified professional.

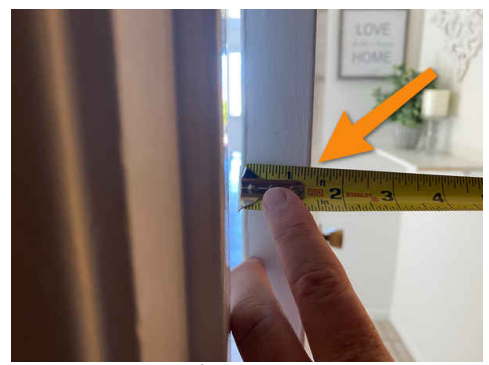
Not A Fire Rated Door

Note: Due to the age of this property and the likelihood that this door is original construction material, it is possible that the door is not fire rated.

Recommendation  
Contact a qualified professional.

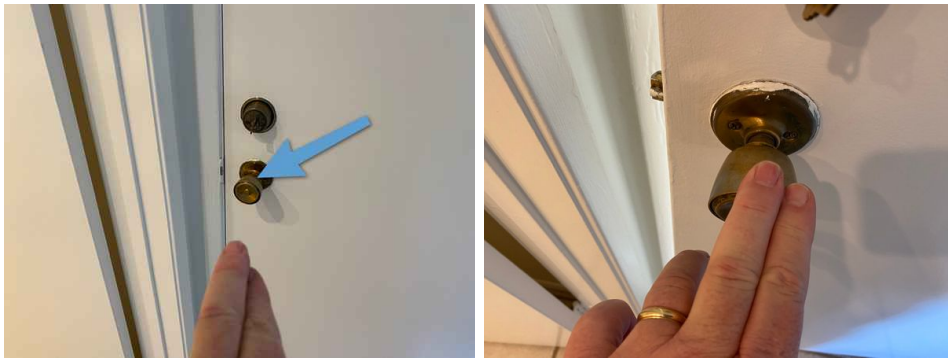
**FIRE DOOR HARDWARE LOOSE**

Door hardware on fire door was loose. Requires maintenance to adjust and tighten.

Recommendation  
Recommended DIY Project

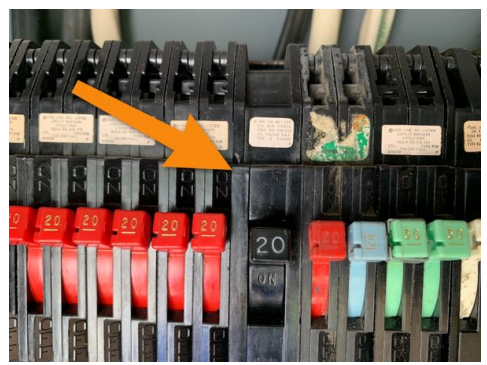
**AFTERMARKET CIRCUIT BREAKERS PRESENT**

ELECTRICAL PANEL: Be Advised Needs Attention: One or more circuit breakers do not appear to be the same brand as panel manufacturer, this is not a recommended electrical practice. Breakers should be same brand as panel manufacturer as some circuit breakers are not interchangeable. Recommend further evaluation by a qualified licensed electrician before the end of your inspection contingency period and the close of escrow.

Recommendation  
Contact a qualified electrical contractor.

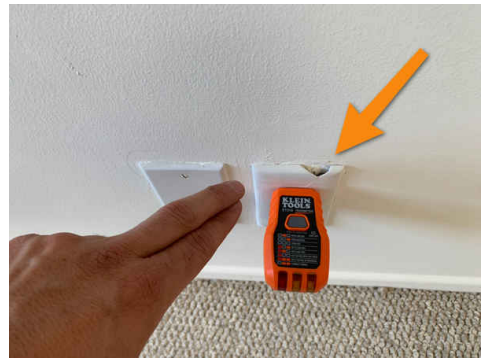
Primary Bedroom

**COVER PLATES DAMAGED**

One or more receptacles or light switches have a damaged cover plate. Recommend replacement.

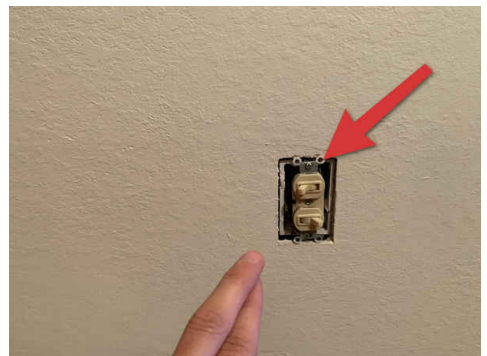
Primary Bath Closet

**COVER PLATES MISSING**

One or more receptacle cover plates are missing. This condition left energized electrical components exposed to touch, a shock/electrocution hazard. Recommend installation of cover plates.

Recommendation  
Contact a qualified professional.

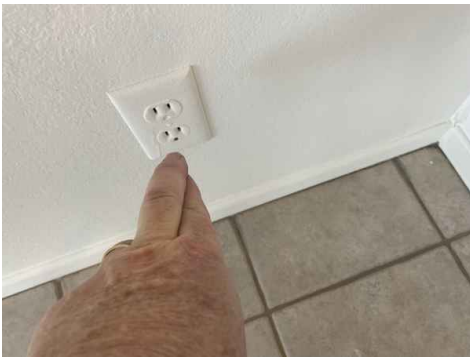
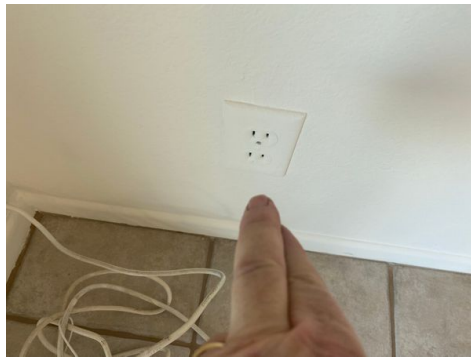
Dining Rom

**PAINTED RECEPTACLE**

Electrical receptacles in the home have been painted, making insertion of a plug difficult. Some receptacles will need to be replaced for this reason. All electrical work should be performed by a qualified electrical contractor.

Recommendation  
Contact a qualified electrical contractor.

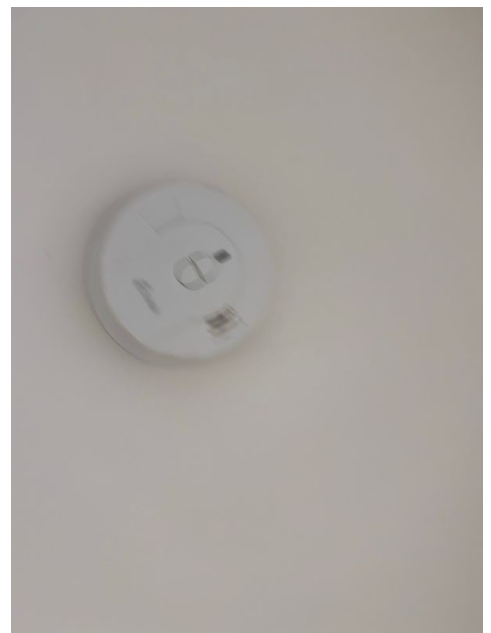
There are no smoke detectors located in any of the bedrooms or on first floor. This is recommended by the NFPA.

Contact a qualified professional.

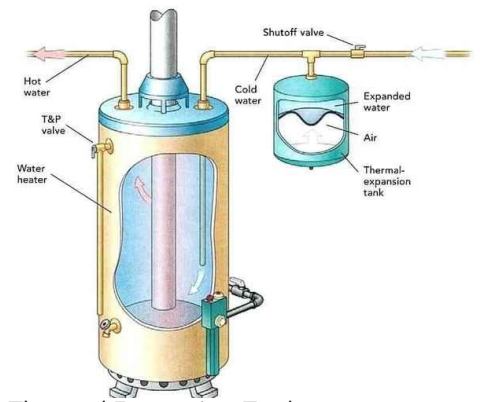
Thermal Expansion Tank

Needs Attention Be advised: One or more water heaters had no expansion tank(s) installed to allow for thermal expansion of water in the plumbing pipes. Expansion tanks are required in some city's or county's for new installations. Recommend consulting with a qualified plumbing contractor to determine if a expansion tank is necessary installation on this water heater system or upgrade on future installation.

Note: Some manufacturers may even void your water heater warranty if you have a closed plumbing system but don't have an expansion tank for your water heater. Expansion tanks work like shock absorbers on your car. They absorb excess water pressure, protecting your water heater from damage and early failure.

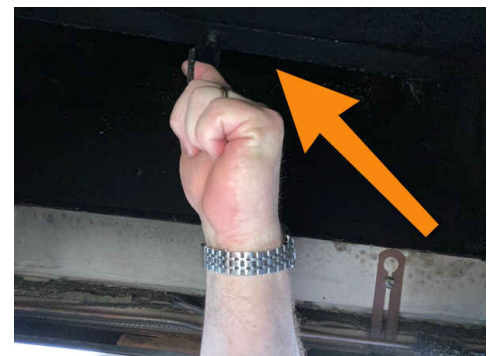
Living Room

Damper was inoperable, which could allow toxic fumes into the home. Recommend a qualified fireplace contractor evaluate and repair.

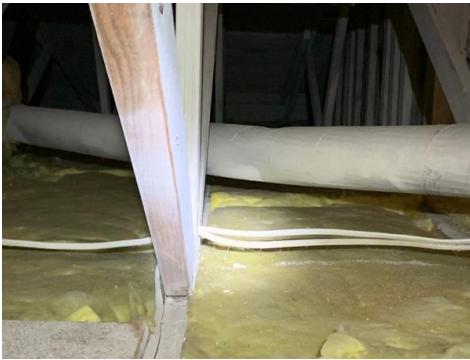
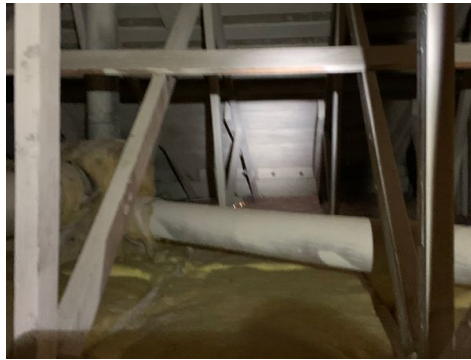
**TRANSITE TYPE VENT DUCTS NOTED**

Transite type vent pipe is not recommended material as it may contain asbestos. Suggest further review by qualified contractor if being replaced. We bring this to your attention for your information.

Contact a qualified professional.

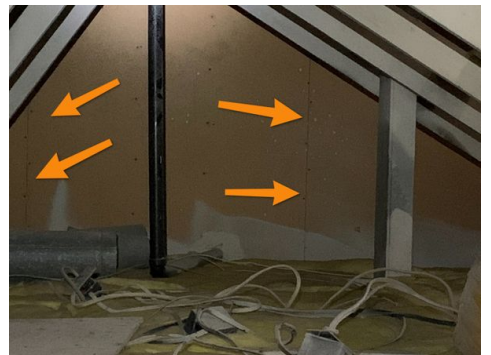
**FIREWALL DRYWALL NOT TAPED/SEALED**

Firewall taping along seams in attic or not complete. Drywall joints shall be taped or sealed. Joints shall be fitted so that the gap is no more than 1/20 inch with joint back by either solid wood or another layer of drywall such that the joints are staggered. Refer to a qualified contractor for corrective repair.

Contact a qualified professional.

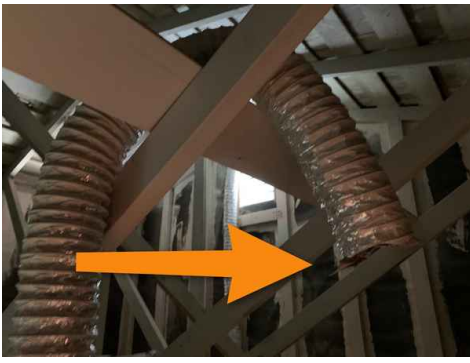
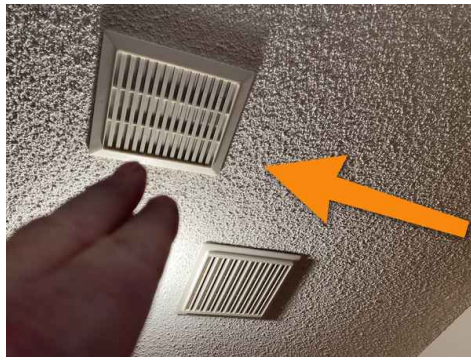
PRIMARY BATH CLOSET

**BATHROOM DUCT VENTS INTO ATTIC**

Bathroom fan duct vents into the attic, which can cause moisture and mold. Recommend a qualified attic contractor properly install or repair exhaust ducting to terminate to the exterior.

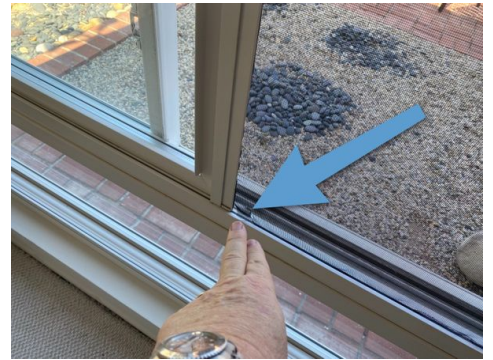
**MISSING OR DAMAGED SCREENS**

One or more windows have missing and/or damaged screens. Recommend replacement/repair.

Following Location: Master bedroom center window screen.

Recommendation  
Contact a qualified window repair/installation contractor.

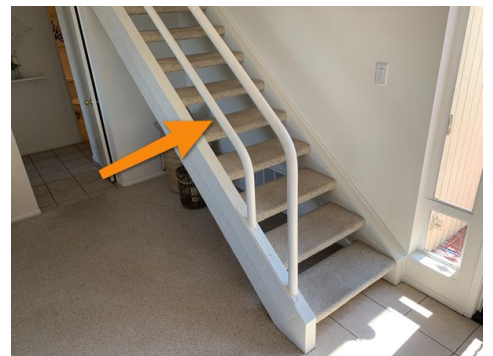
**BALUSTER SPACES TOO WIDE**

The baluster space is not up to modern safety standards. The space between balusters should not allow passage of a 4 3/8-inch sphere for child safety. Recommend a qualified handyman or original installer repair and bring up to code.

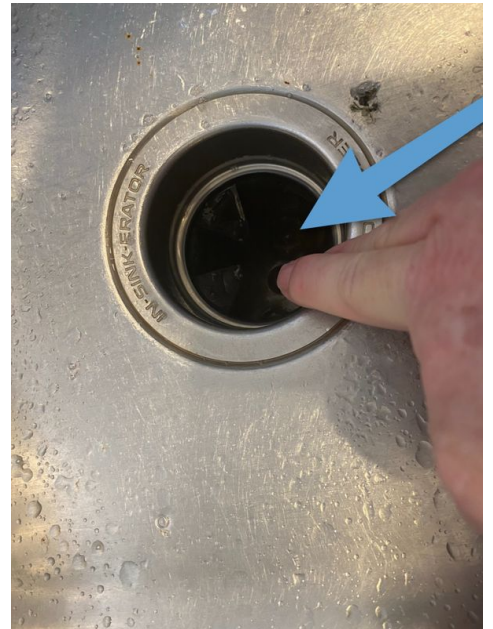
**DISPOSAL SPLASH GUARD DEFICIENCY**

Observed disposal splashguard damaged. Splashguard keeps garbage from splashing up above the sink. Recommend replacement. Maintenance item. Easy fix.

Recommendation  
Contact a qualified professional.

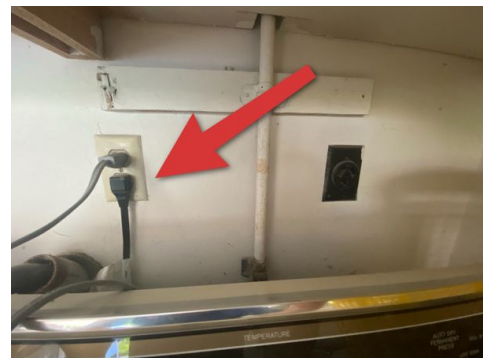
The laundry room did NOT have a GFCI outlet. The NEC requires GFCI protection for all standard receptacles serving laundry areas. Recommend GFCI be installed in the outlet located in the laundry area. Required since 2017. See electrical notation.

Recommendation  
Contact a qualified professional.

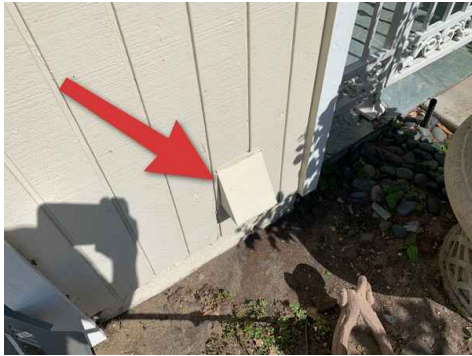
Ext Termination

## EXCESSIVE LINT BUILDUP AT DRYER VENT TERMINATION

Observed excessive lint build up at the termination of the dryer vent opening. This may indicate a blockage of the vent and/or duct which may cause a fire hazard. Recommend cleaning of dryer vent duct at earliest opportunity.

Contact a qualified professional.

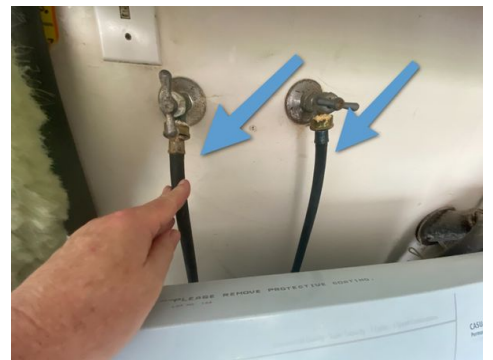
Recommend replacement of rubber type laundry supply hoses. Install stainless steel braided hoses. This is the simple advice that we usually give during home inspections. Stainless steel braided hoses are much more resistant to bursting, and they're fairly inexpensive. See link on this subject above under general comment.

Contact a handyman or DIY project

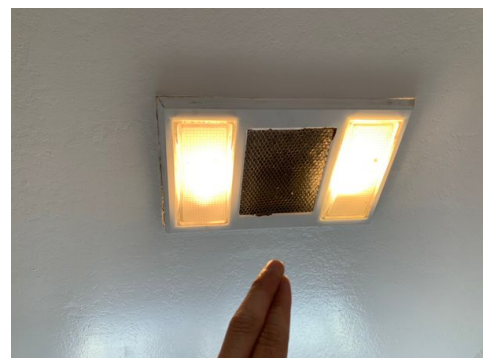
## TOILET FAN DEFICIENCY

Recommend a qualified contractor to evaluate further and correct.

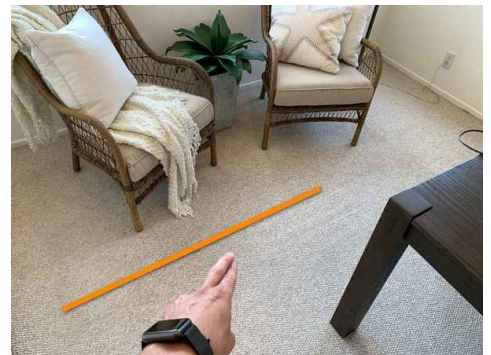
Slope

Observed Moderate creaking/squeaking and downward slope of subfloor in one or more areas. This is usually due to a lifting or loosening of subfloor screws or nails, connecting the subfloor plywood to the floor joice. Recommend further evaluation by a flooring contractor for re-securing and proper leveling as indicated.

Recommendation  
Contact a qualified professional.

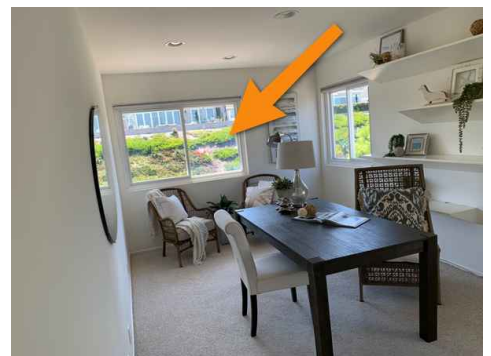
### 15.2.3 Bedroom Inspected **WINDOW SEAL DEFICIENCY**

Observed window deficiency in bedroom. Window is fogged indicating window seal failure. Recommend replacement of window glass.

Recommendation  
Contact a qualified professional.

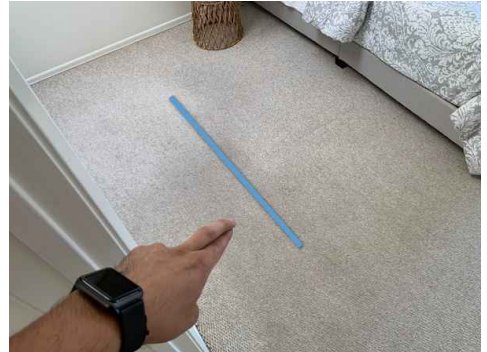
Observed creaking/squeaking of subfloor in one or more areas of the bedroom. This is usually due to a lifting or loosening of subfloor screws or nails, connecting the subfloor plywood to the floor joice. Recommend re-securing as a maintenance repair.

Recommendation  
Contact a qualified professional.

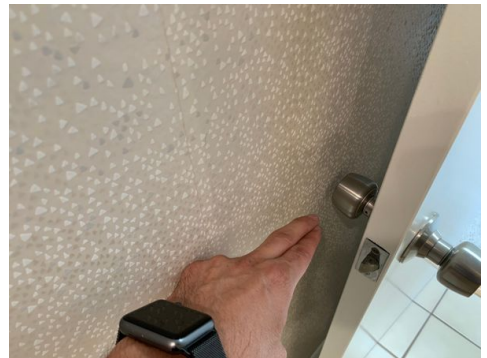
17.1.1 Bathroom Inspection  
**DOOR STOP OR STOP TIP MISSING**

Doorstop broken. This could damage the drywall if not replaced.

Recommendation  
Contact a handyman or DIY project

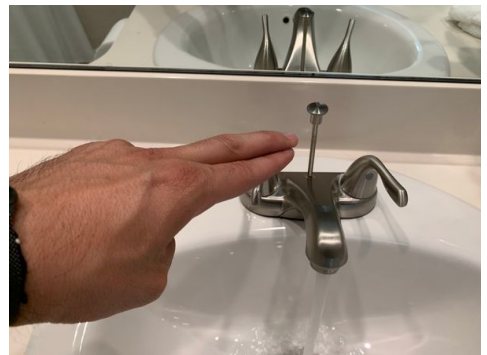
17.1.2 Bathroom Inspection  
**SINK STOPPER DEFICIENCY**

Observe sink stopper deficiency. Stopper is not functioning properly. It should be repaired.

Recommendation  
Contact a handyman or DIY project

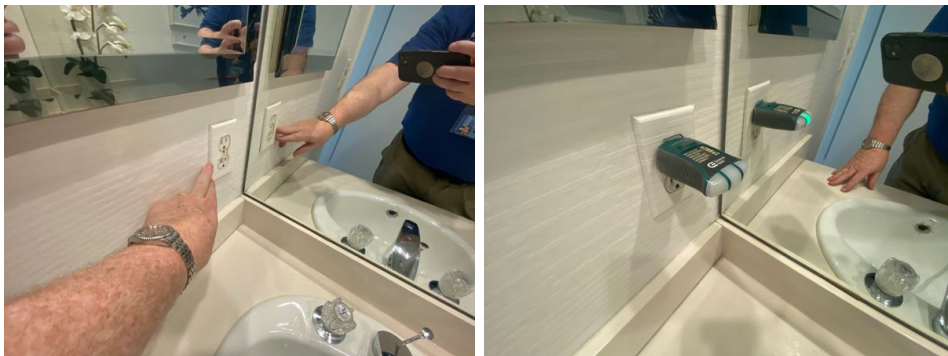
Outlet is not GFCI rated. Recommend replacement

Recommendation  
Contact a qualified professional.

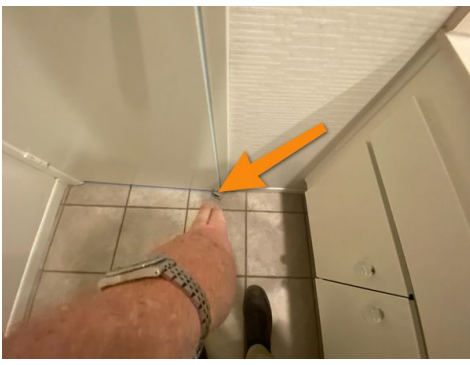
### DOOR STOP MISSING

Observed a doorstop was missing. A doorstop if I should be installed to avoid door hitting bathroom fixtures.

Recommendation  
Contact a handyman or DIY project

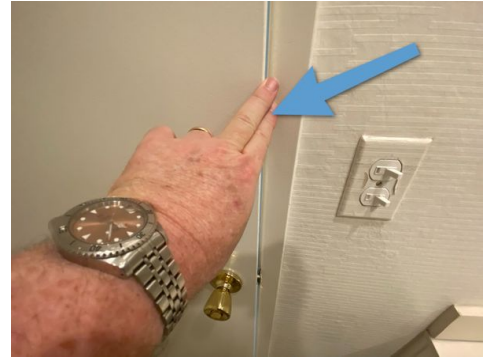
18.1.3 1/2 - 3/4 Bath Inspected  
**DOOR CLOSURE DEFICIENCY**

Door does not close smoothly. Binds at frame. Recommend maintenance repair and adjustment for proper closure.

Recommendation  
Contact a qualified professional.

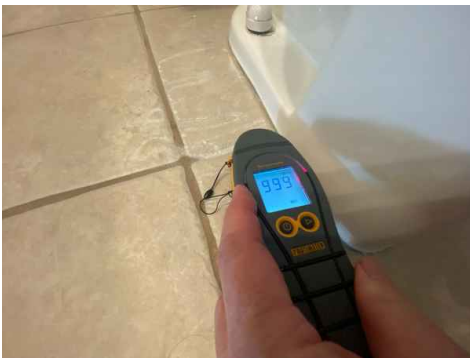
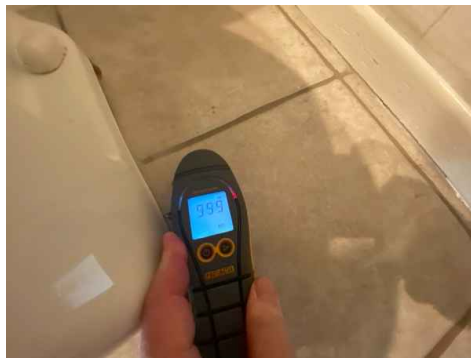
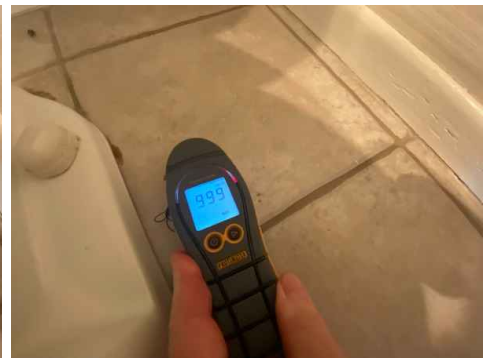
18.1.4 1/2 - 3/4 Bath Inspected  
**HIGH MOISTURE READING BASE OF TOILET**

Noted high moisture reading at base of toilet area. Recommend further evaluation by qualified contractor/qualified plumber, to determine cause of high reading. This may be due to wax seal breach from the toilet or other deficiency.

Recommendation  
Contact a qualified professional.
