Del Fine Home Inspections

Property Inspection Report

Property address: **6432 Via Canada
Rancho Palos Verdes, CA 90275**

Inspection date: **Friday, July 19, 2024**

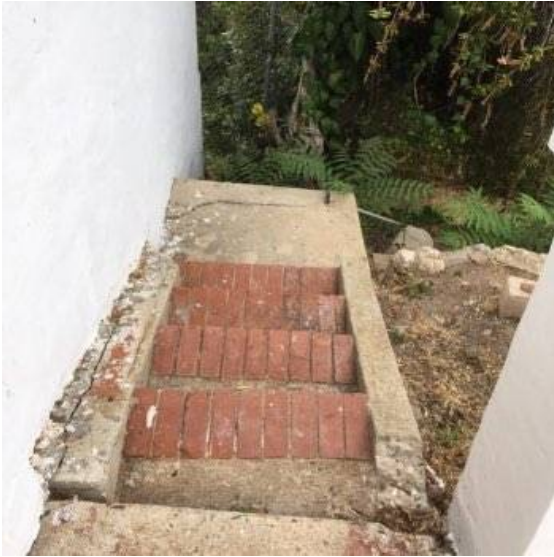
Photo 8-1

Handrails at one or more flights of stairs were missing. This is a potential fall hazard. Handrails should be installed at stairs with four or more risers or where stairs are greater than 30 inches high. Recommend that a qualified contractor install handrails where missing and per standard building practices.

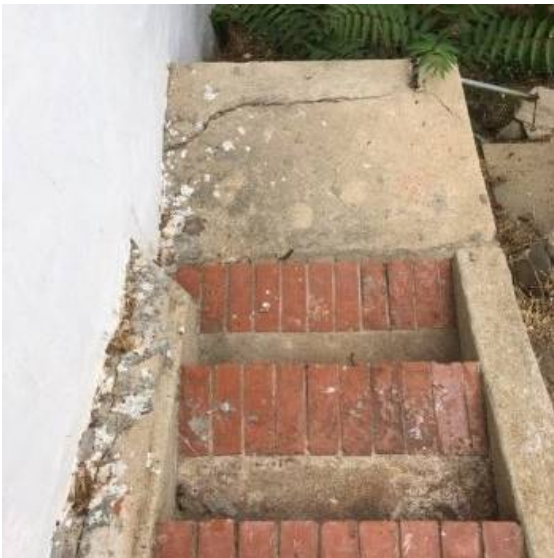
Photo 9-1

Guardrails at one or more locations with drop-offs higher than 30 inches were missing. This poses a fall hazard. At a minimum the client should be aware of this hazard. Consider having a qualified contractor install guardrails where walking surfaces are more than 30 inches above the surrounding grade or surfaces below, and per standard building practices.

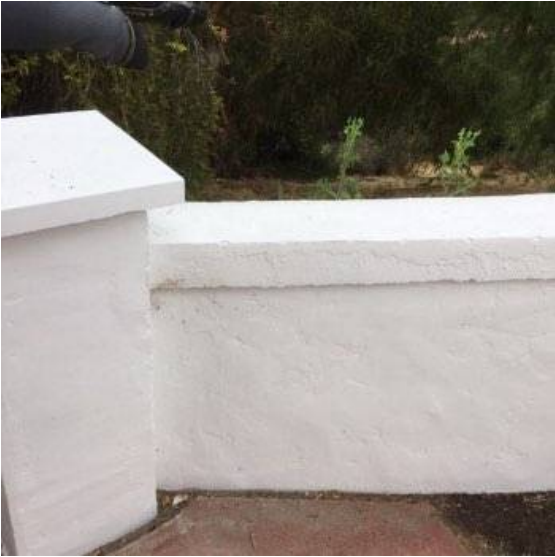
Photo 10-1

Guardrails at one or more locations with drop-offs higher than 30 inches were too low. This poses a fall hazard. Guardrails should be at least 36 inches in height. Recommend that a qualified contractor replace or repair guardrails per standard building practices.

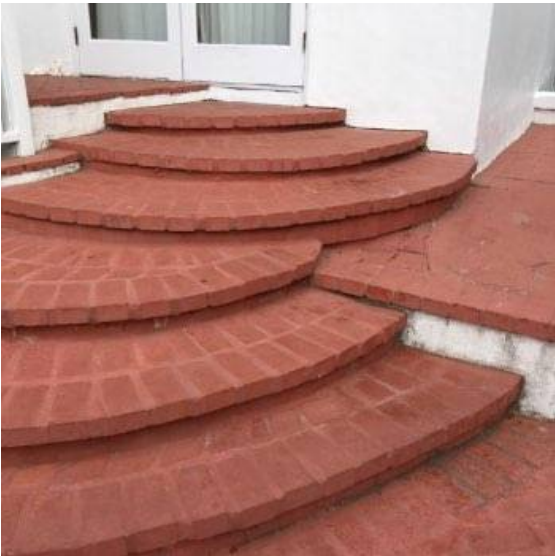
Photo 12-1

12) 🛠️ Handrails at one or more flights of stairs were missing. This is a potential fall hazard. Recommend that a qualified contractor install handrails where missing.

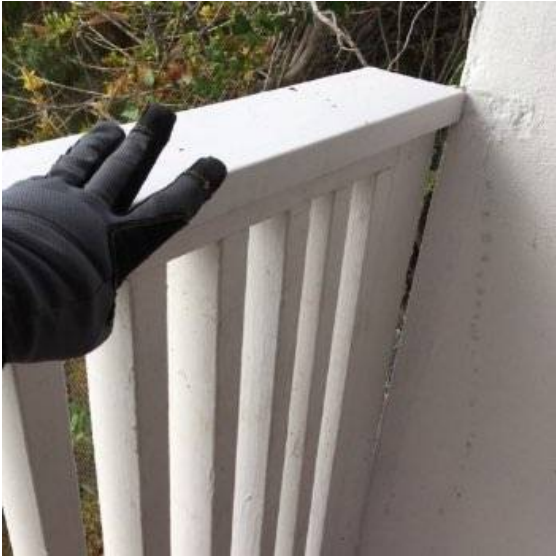
Photo 13-1

13) 🛠️ Guardrails at one or more locations with drop-offs higher than 30 inches were wobbly, and pose a fall hazard. Recommend that a qualified person repair guardrails as necessary.

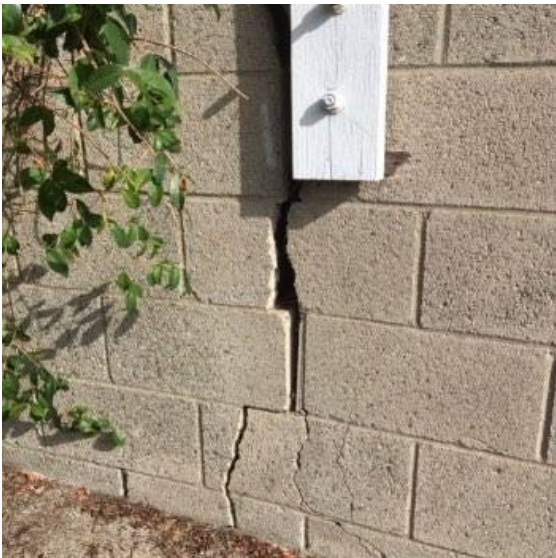
Photo 14-1

Cracks, deterioration, leaning and/or bowing were found in one or more retaining walls. Recommend that a qualified contractor evaluate and repair as necessary. Note that some retaining walls, based on their height or size, may require evaluation by a structural engineer.

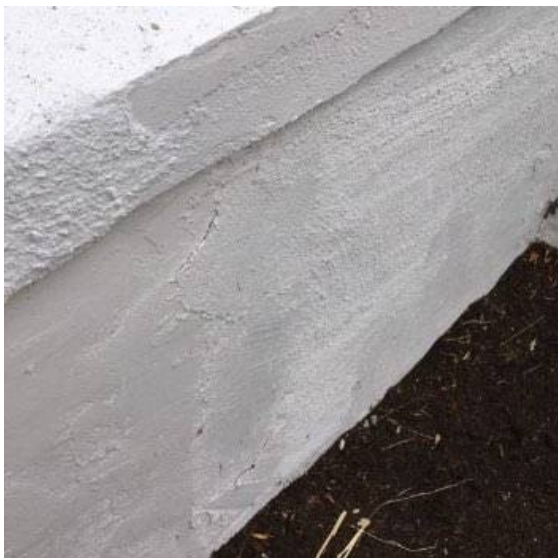
Photo 15-1

Cracks, deterioration, leaning and/or bowing were found in one or more walls. Recommend that a qualified contractor evaluate and repair as necessary.

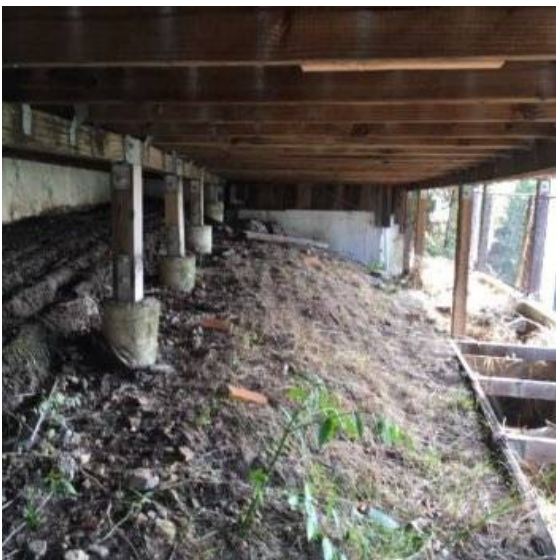
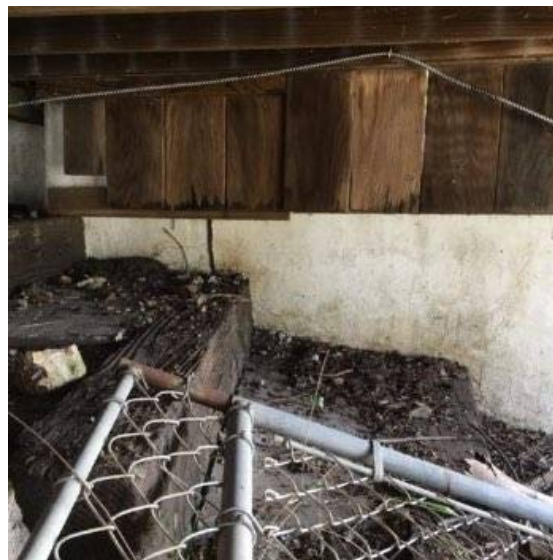
Photo 16-1

The wooden deck, porch or balcony was deteriorated, non-standard or substandard. Recommend having a qualified fully evaluate and repair as necessary.

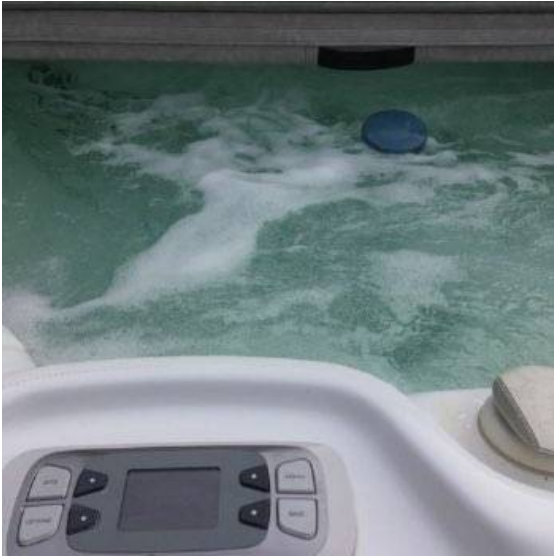
Photo 17-1

17) 🔧🔍 A hot tub was installed. Hot tubs, related equipment and supply hookups are specialty systems and are excluded from this inspection. Comments in this report related to this system are made as a courtesy only and are not meant to be a substitute for a full evaluation by a qualified specialist. Regular maintenance is required, and safety issues may exist. Recommend that a qualified specialist evaluate and, if needed, maintain or repair.

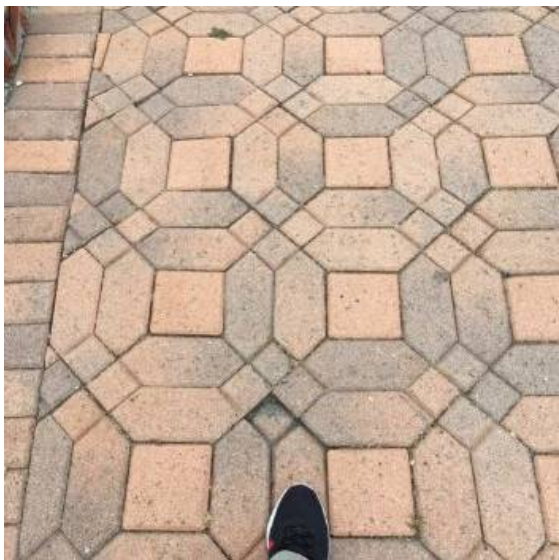
Photo 22-1

22) Cracks, holes, settlement, heaving and/or deterioration were found in the driveway. Recommend that qualified contractor repair as necessary.

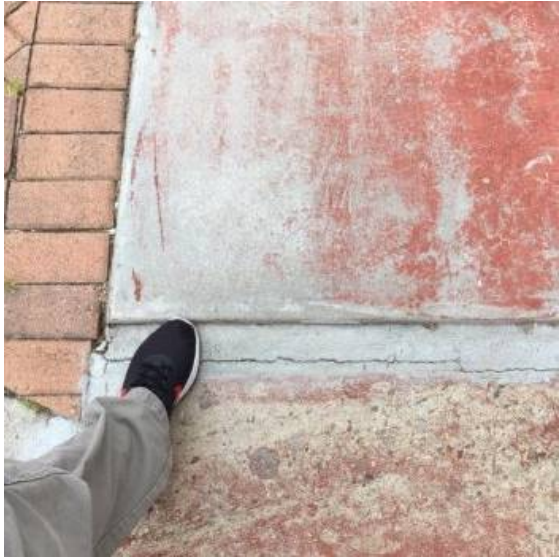
Photo 23-1

23) 🛠️ Cracks, holes, settlement, heaving and/or deterioration were found in sidewalks and/or patios. Recommend that qualified contractor repair as necessary.

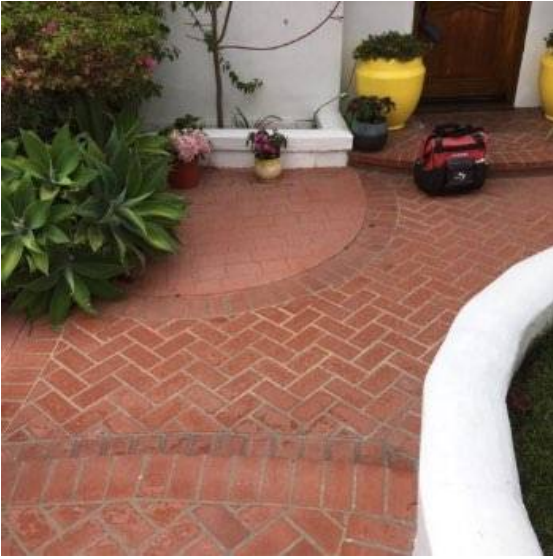
Photo 27-1

The soil or grading sloped down towards building perimeters in one or more areas. This can result in water accumulating around building foundations or underneath buildings. At a minimum, monitor these areas, and areas under the structure in the future for accumulated water. If water does accumulate, recommend grading soil so it slopes down and away from buildings with a slope of at least 1 inch per horizontal foot for at least 6 feet out from buildings.

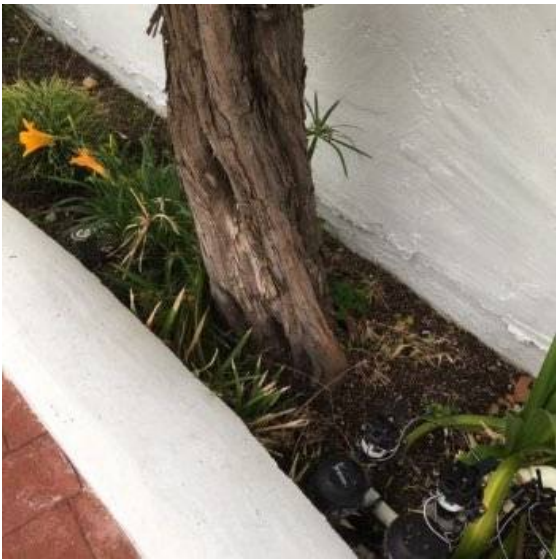
Photo 31-1

31) 🛠️ One or more large trees were very close to the foundation. Tree roots can cause significant structural damage to foundations. Recommend that a qualified tree service contractor or certified arborist remove trees as necessary to prevent damage to foundations.

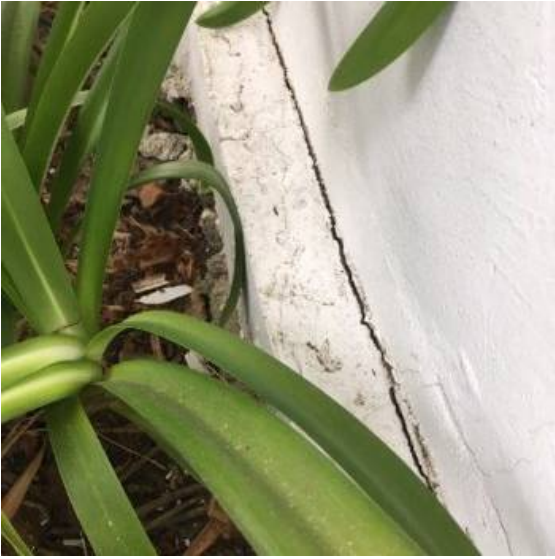
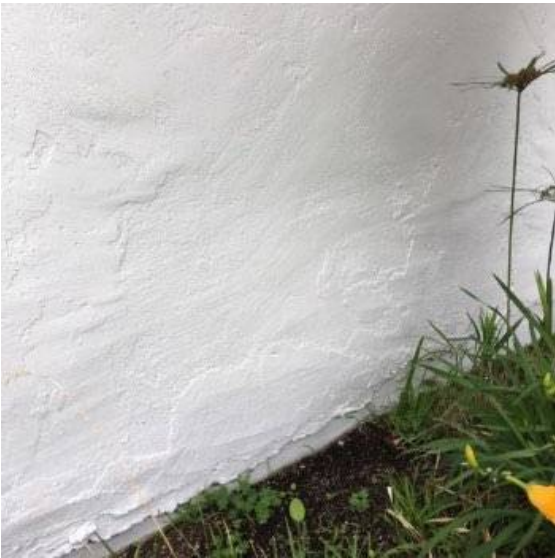
Photo 35-1

35) 🛠️ Cracks, deterioration and/or damage were found in one or more areas of the exterior stucco finish. In damp climates, moisture may enter cracks or damaged areas and further deteriorate the stucco. Also the wall behind the stucco may become damaged from moisture. Note that areas behind the stucco are inaccessible and excluded from this inspection. Recommend that a qualified contractor repair or replace stucco as necessary.

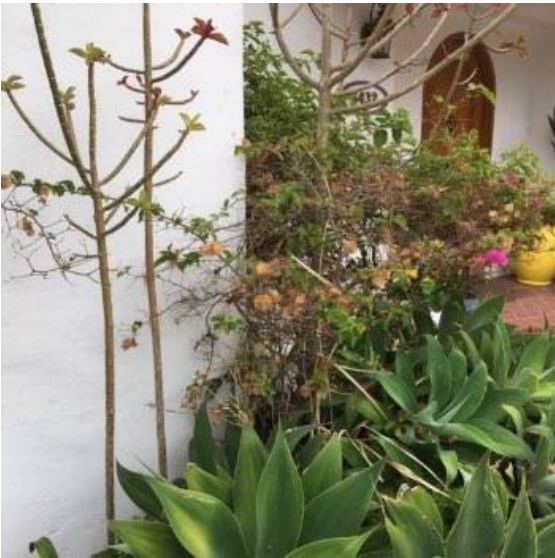
Photo 38-1

38) 🚧 Vegetation such as trees, shrubs and/or vines was in contact with or close to the building exterior. Vegetation can serve as a pathway for wood-destroying insects and can retain moisture against the exterior after it rains. This is a conducive condition for wood-destroying organisms. Recommend pruning, moving or removing vegetation as necessary to maintain at least 6 inches of space between it and the building exterior. A 1-foot clearance is better.

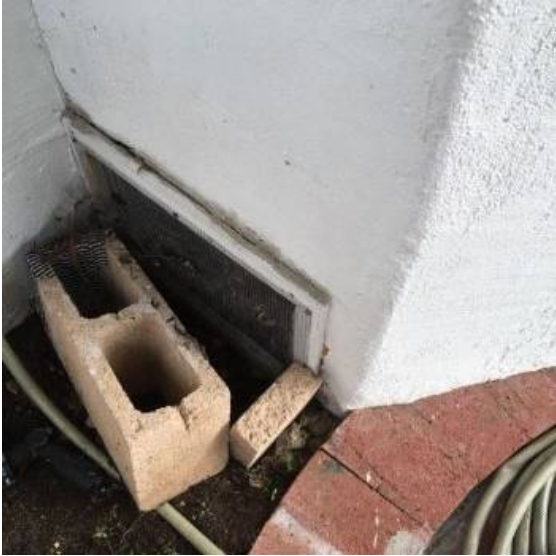
Photo 53-1

53) One or more crawl space access hatches or doors were too small to allow easy access. Such hatches through walls should be at least 16 x 24 inches in size, and hatches in the floor should be at least 18 x 24 inches in size. Recommend that a qualified person modify crawl space access points per standard building practices.

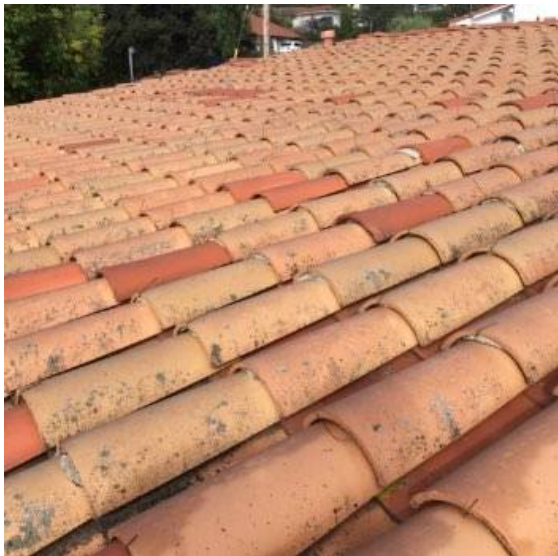
Photo 56-1

The roof was inspected and will require repair by a qualified roofer. The client may also wish to consider having a qualified contractor attempt to issue a "roof certificate" once all repairs have been made. No prediction of future performance or warranties can be offered.

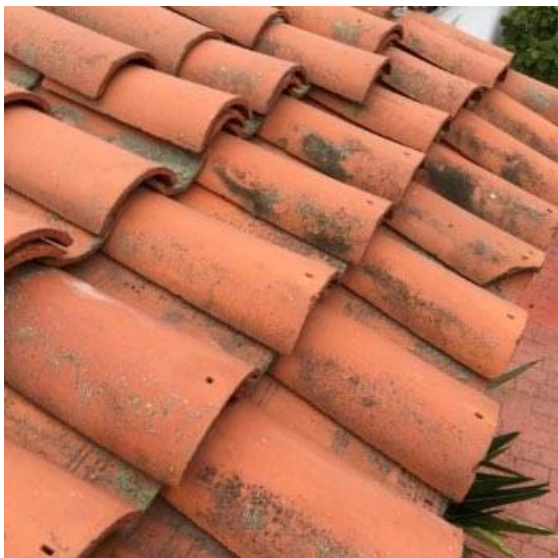
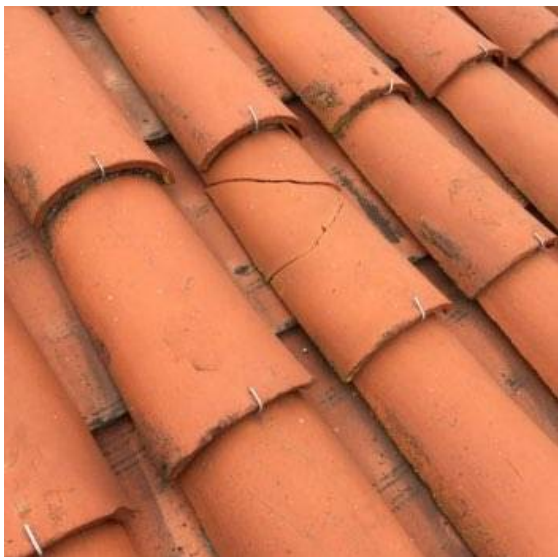
Photo 57-1

Some roof tiles were cracked, broken, loose and/or damaged. Leaks may occur as a result. This is a conducive condition for wood-destroying organisms. Recommend that a qualified person replace tiles or make repairs as necessary.

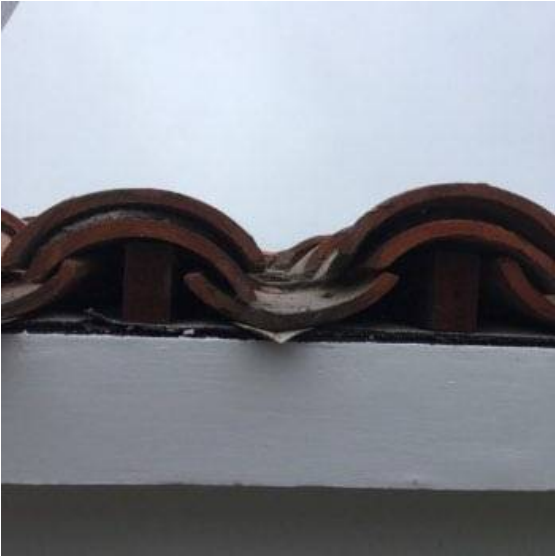
Photo 58-1

58) 🛠️ One or more (end caps) were missing. Recommend that a qualified person install or repair end caps where missing.

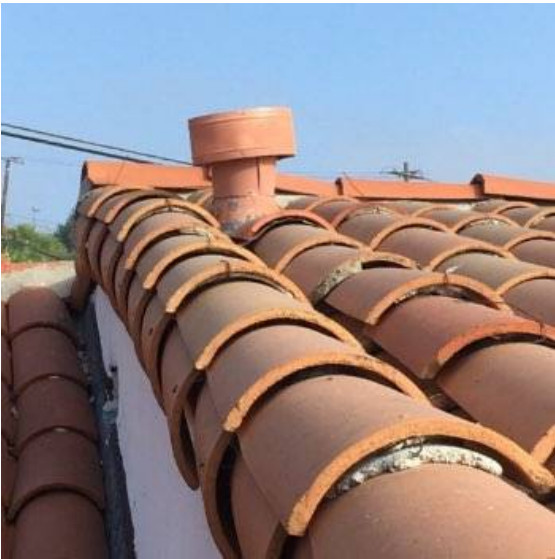
Photo 59-1

59) 🛠️ One or more roof flashings were lifting, substandard, missing and/or deteriorated. Leaks can occur as a result. This is a conducive condition for wood-destroying organisms. Recommend that a qualified person repair as necessary.

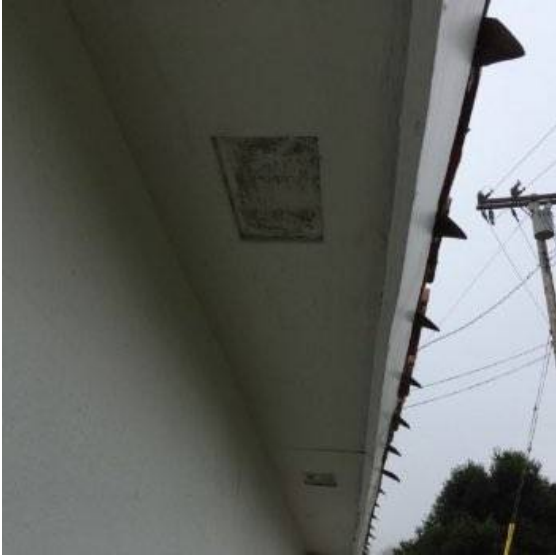
Photo 63-1

One or more attic or roof vent screens were clogged with paint. This can reduce air flow through the roof structure or attic and result in reduced service life for the roof surface materials because of high temperatures. Moisture from condensation is also likely to accumulate in the roof structure and/or attic. Recommend that a qualified person repair as necessary so air flows freely through all vents. For example, by cleaning screens or replacing screens with 1/8-inch to 1/4-inch wire mesh.

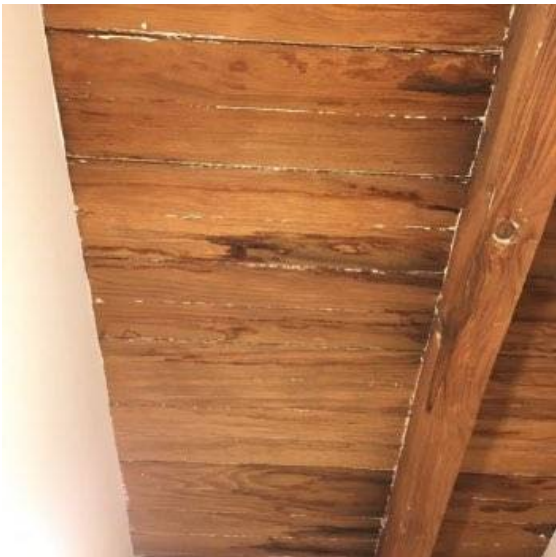
Photo 67-1

What appeared to be past water stains were visible on the roof structure at one or more locations. However, no elevated levels of moisture were found at these stains during the inspection. The stains may have been caused by a past leak. Recommend asking the property owner about past leaks. Monitor these areas in the future, especially after heavy rains to determine if active leaks exist. If leaks are found, recommend that a qualified contractor evaluate and repair as necessary.

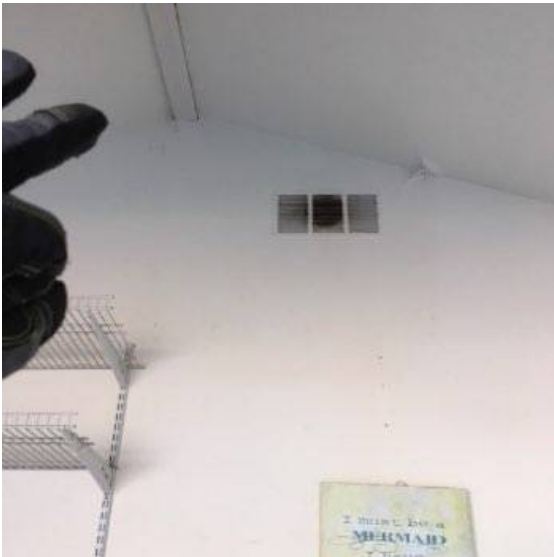
Photo 72-1

One or more gaps, holes and/or areas with missing or substandard surface materials were found in the attached garage walls or ceilings. Current standard building practices call for wooden-framed ceilings and walls that divide the house and garage to provide limited fire-resistance rating to prevent the spread of fire from the garage to the house. Recommend that a qualified person repair per standard building practices. For example, by patching openings or holes, firestopping holes or gaps with fire-resistant caulking, and/or installing fire-resistant wall covering (e.g. Type X drywall). For more information, visit: <https://www.reporhost.com/?AGFR>

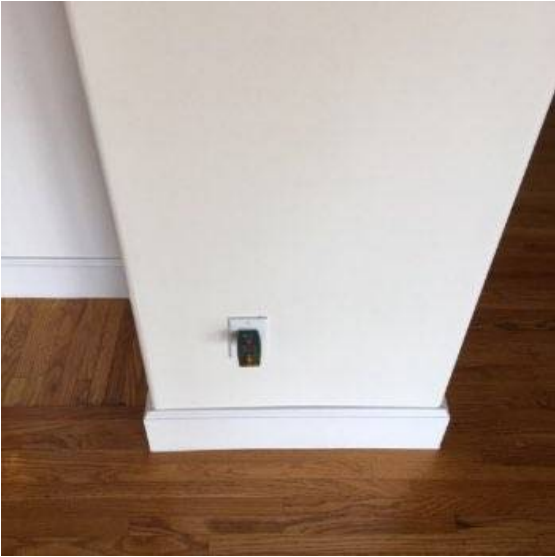
Photo 81-1

One or more modern, 3-slot electric receptacles were found with an open ground. This is a shock hazard when appliances that require a ground are used with these receptacles. Examples of such appliances include computers and related hardware, refrigerators, freezers, portable air conditioners, clothes washers, aquarium pumps, and electrically operated gardening tools. Recommend that a qualified electrician repair as necessary so all receptacles are grounded per standard building practices.

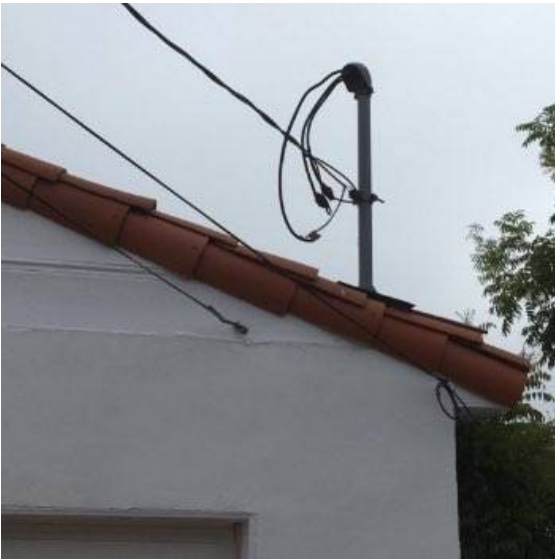
Photo 82-1

82) 🛠️⚡ The service drop wires were less than 18 inches above the roof surface. This is a potential shock hazard because wires are more likely to be damaged. Recommend that a qualified electrician or the utility company repair per standard building practices.

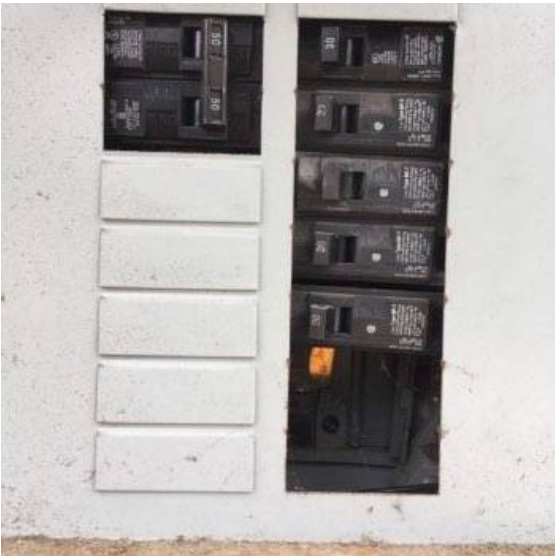
Photo 85-1

One or more slots where circuit breakers are normally installed were open in panel(s) #A. Energized equipment was exposed and is a shock hazard. Recommend that a qualified person install closure covers where missing.

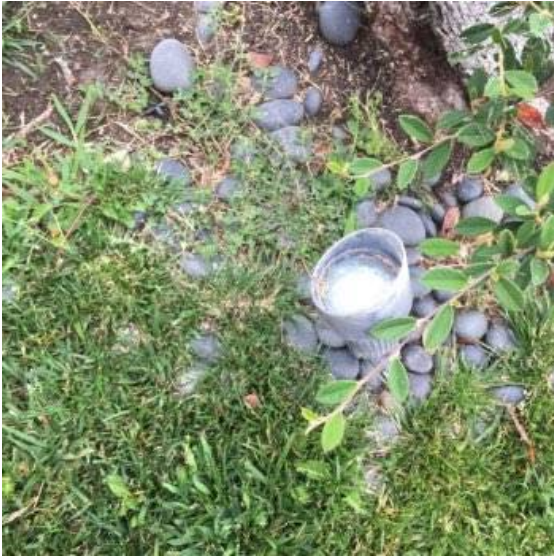
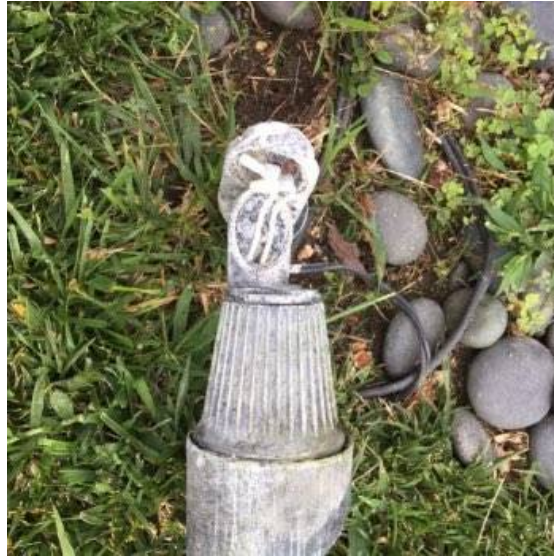
Photo 91-1

One or more light fixtures were damaged and/or deteriorated. Recommend that a qualified electrician repair or replace light fixtures as necessary.

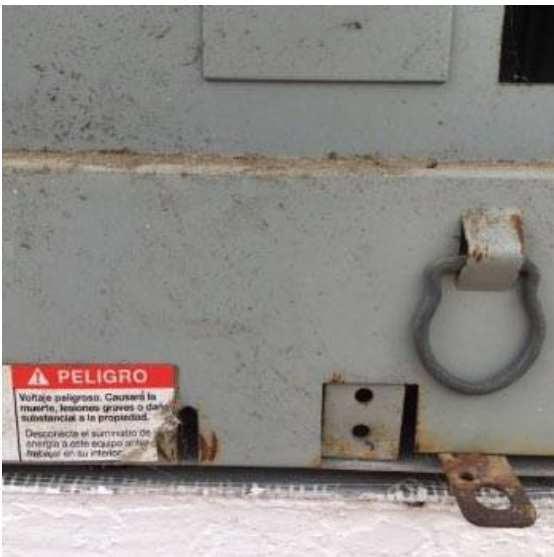
Photo 93-1

93) 🛠️ One or more screws that attach the cover or dead front to panel(s) #A were missing or not installed. Recommend installing screws where missing so the cover or dead front is secure. Only screws with blunt tips approved for this purpose should be installed, so wiring inside the panel is not damaged. Because energized wires may be located directly behind screw holes, the client should consider having a qualified electrician replace missing screws.

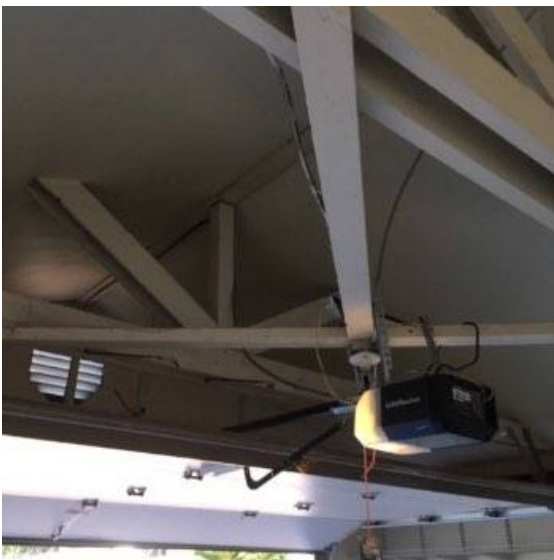
Photo 95-1

Bulbs in one or more light fixtures were missing or broken. These light fixtures couldn't be fully evaluated. If replacement bulbs are inoperable, then recommend that a qualified electrician evaluate and repair or replace light fixtures as necessary.

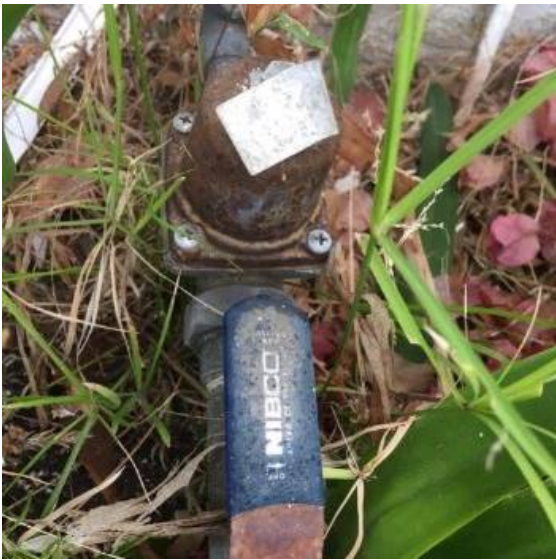
Photo 100-1

Significant corrosion was found at pressure regulator or fittings. Leaks can occur as a result. Recommend that a qualified plumber evaluate and replace components as necessary.

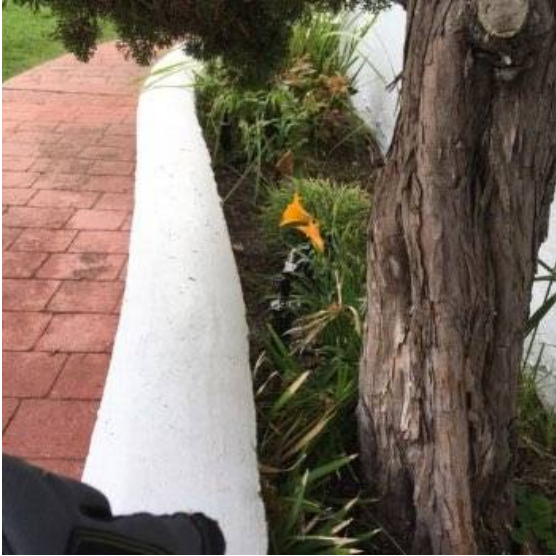
Photo 108-1 Sprinklers were located in planter boxes. Significant amount of water may stand in boxes and cause deterioration or damage. Recommend having a qualified person repair as necessary.

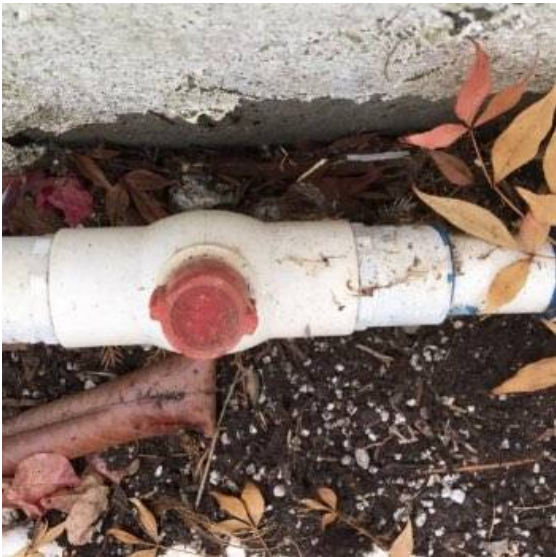
Photo 108-3 Handle was damaged at sprinkler plumbing line.

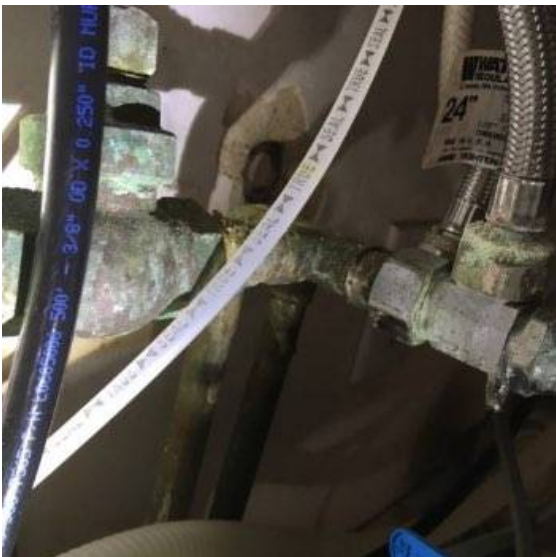
Photo 110-1

Corrosion or rust was found at one or more water supply valves. This can indicate past leaks, or that leaks are likely to occur in the future. Recommend that a qualified plumber repair as necessary. For example, by replacing valves or fittings.

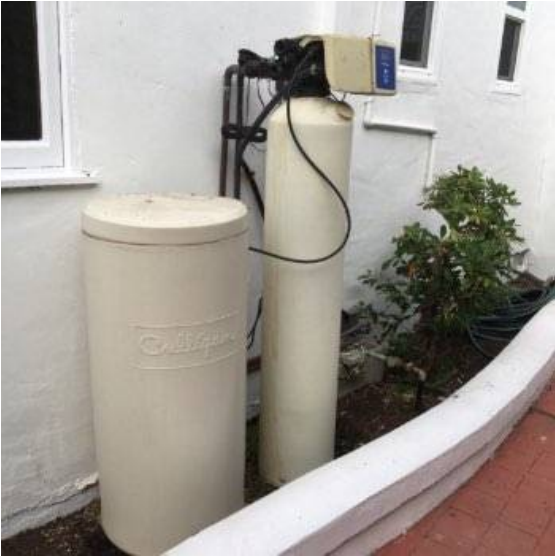
Photo 116-1 Loud noises could be heard near equipment. Recommend having a qualified person evaluate and repair as necessary.

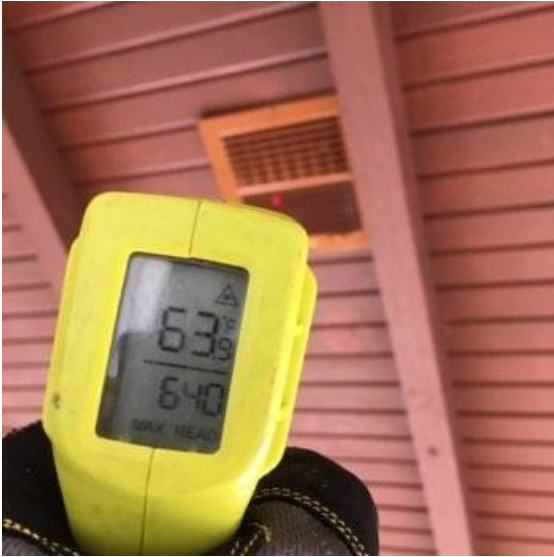
Photo 127-1

Supply air from the air conditioning or heat pump cooling system was not cool enough. Recommend that a qualified HVAC contractor repair as necessary.

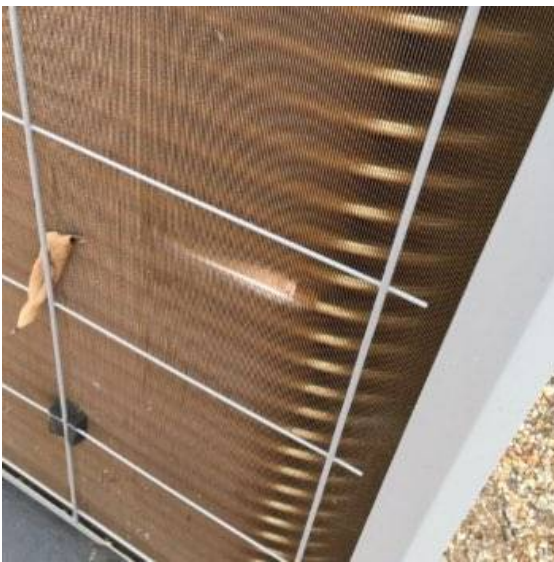
Photo 128-1

The cooling fins at the heat pump or air conditioning condensing unit were damaged. Energy efficiency can be reduced as a result. Recommend that a qualified person repair fins as necessary.

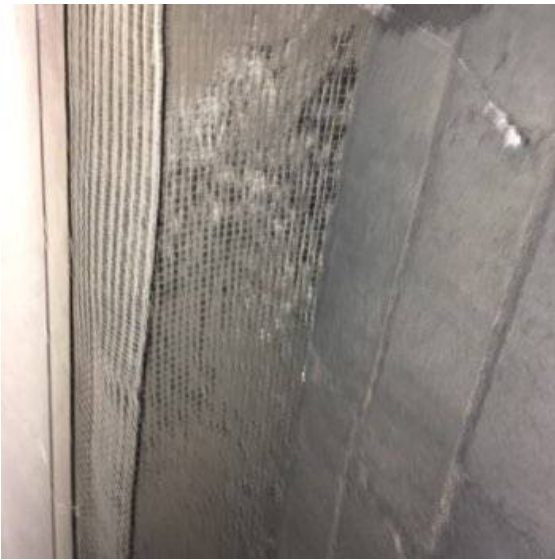
Photo 131-1

131) 🛠️ Screen was found at firebox which was clogged, dirty or filled with debris. This is a potential hazard. Recommend that a qualified person repair as necessary.

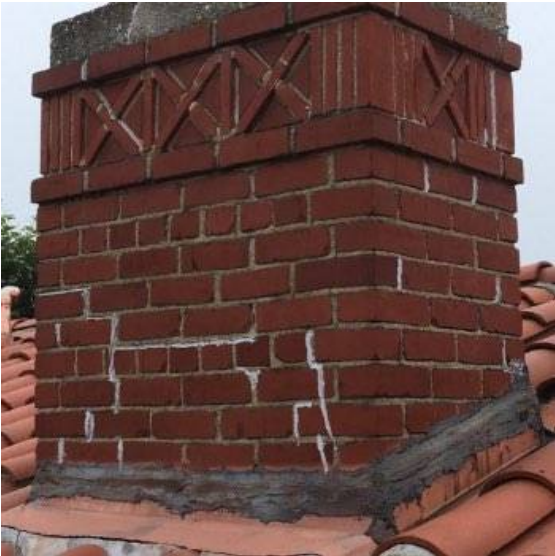
Photo 132-1

The brick chimney was deteriorated. For example, loose or missing mortar, cracked, broken, loose or spalled bricks. Loose bricks can pose a safety hazard, and deteriorated masonry can allow water to infiltrate the chimney structure and cause further damage. Recommend that a qualified contractor repair as necessary.

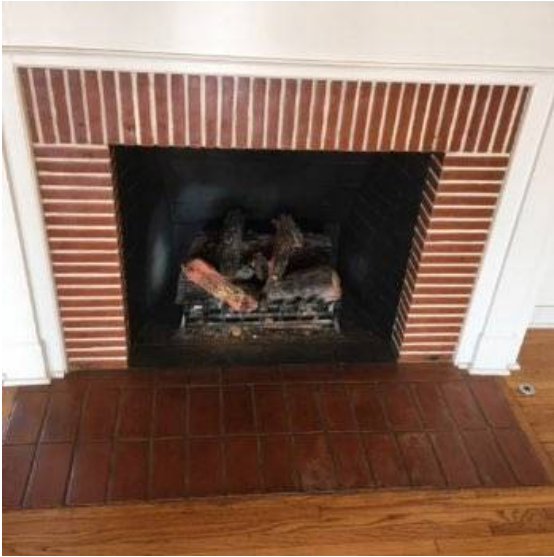
Photo 133-1

No glass doors were installed on the fireplace. For gas fireplaces, the fireplace damper should be modified so it is permanently open to prevent combustion gases from the pilot light and main burners accumulating in living spaces. Since the damper is always open, unconditioned air from outside can enter living spaces through the chimney, and conditioned air from inside can exit through the chimney. This can result in higher heating and cooling costs. Recommend that a qualified person install glass doors on the fireplace per standard building practices.

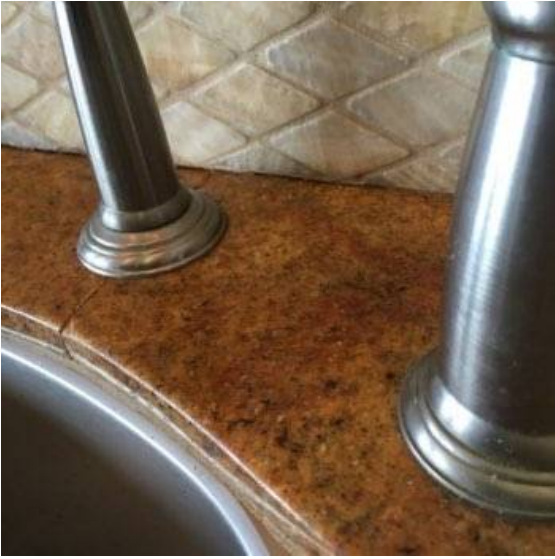
Photo 135-1

135) 🔧 Gaps, no caulk, or substandard caulking were found between countertops and backsplashes. Water may penetrate these areas and cause damage. Recommend that a qualified person repair as necessary. For example, by installing caulk.

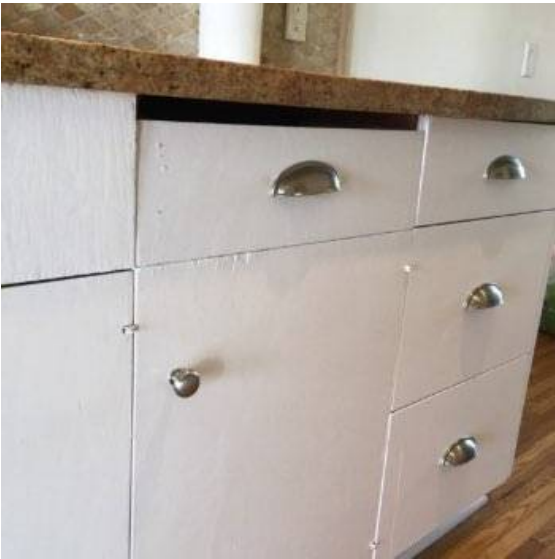
Photo 136-1

One or more cabinets, drawers and/or cabinet doors were deteriorated. Recommend that a qualified person repair or replace as necessary.

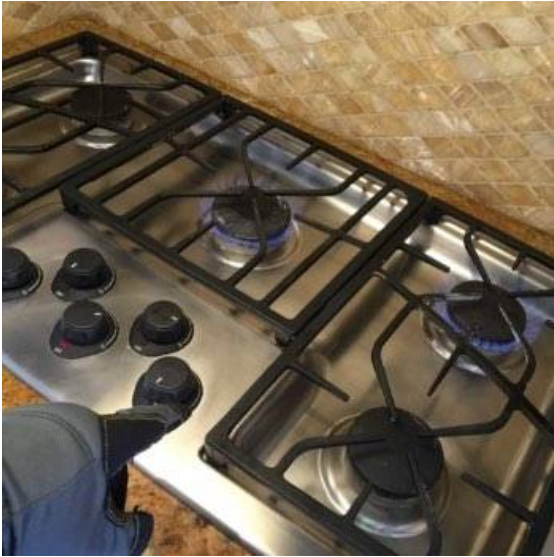
Photo 137-1

One or more cooktop burner(s) and/or element(s) were inoperable. Recommend that a qualified person repair as necessary.

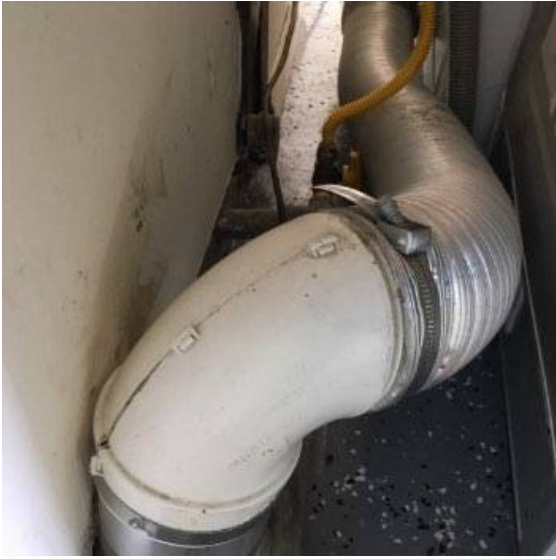
Photo 140-1

The clothes dryer was equipped with a vinyl or mylar,. The U.S. Consumer Product Safety Commission considers these types of ducts to be unsafe, and a fire hazard. Recommend that such ducts be replaced with a rigid or corrugated semi-rigid metal duct, and by a qualified contractor if necessary.

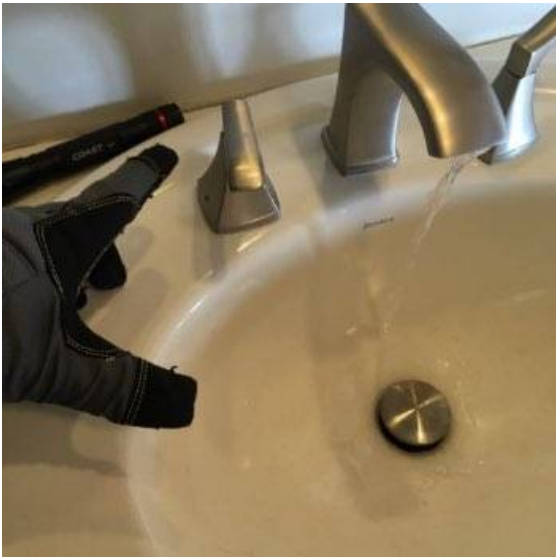
Photo 141-1

The hot and/or cold water supply flow for the sink at location(s) #B was low or inoperable. Recommend that a qualified plumber evaluate and repair as necessary.

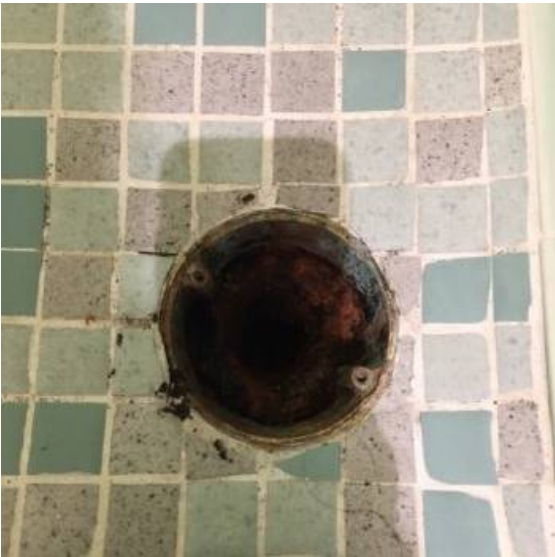
Photo 143-1

The shower grate at location(s) #B was missing. Recommend that a qualified person repair as necessary.
