# Worldwide ERC® Relocation Property Assessment

Transferee Property Address: 507 Sapphire Street

City/State/Postal Code: Redondo Beach, CA 90277

Date: 11/04/2022 Time: 9:00 AM Weather: Clear Temp: 52 Estimated Age of Main Dwelling (yrs.): 18

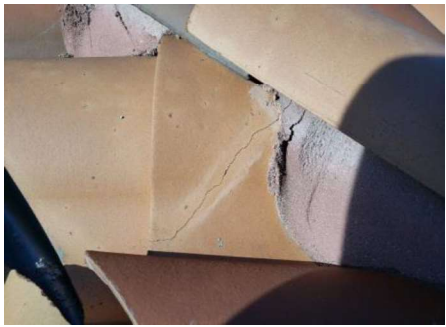
Cracked Tile at Roof

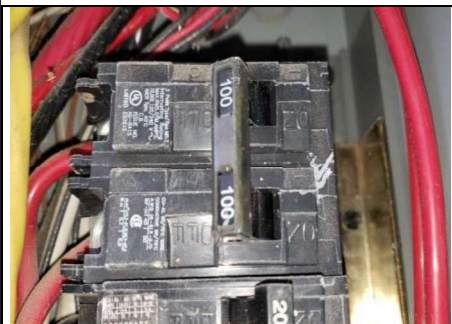
100 Amp Breaker in Off Position

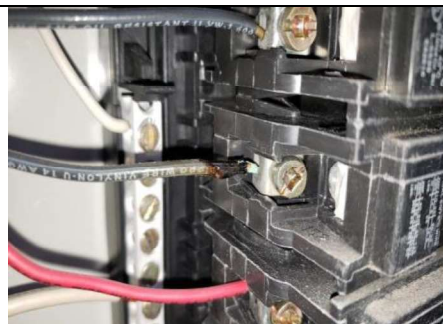
Scorched Wire in Main Panel

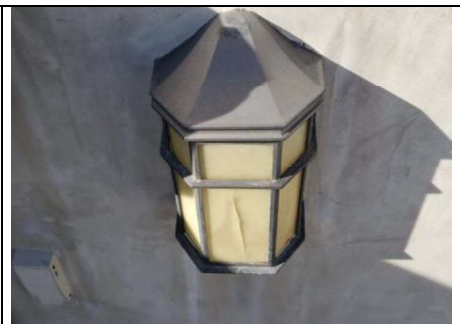
Cracked Light Cover at Rooftop

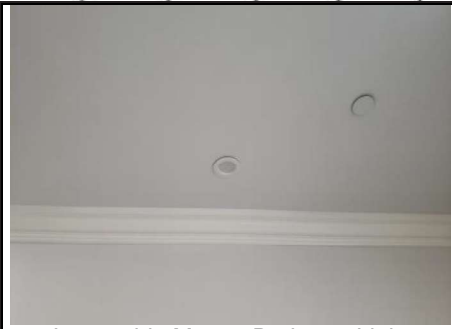
Inoperable Master Bedroom Light

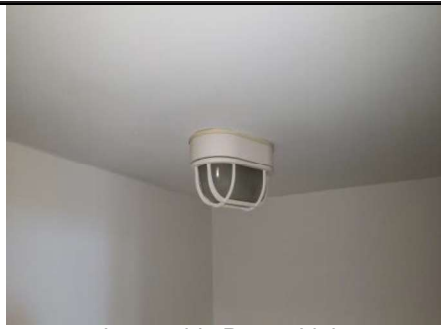
Inoperable Pantry Light

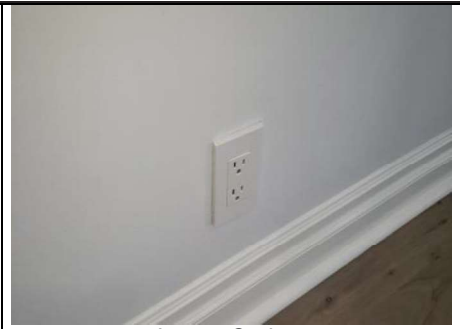
Loose Outlets

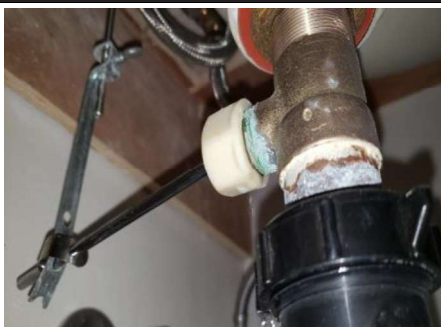
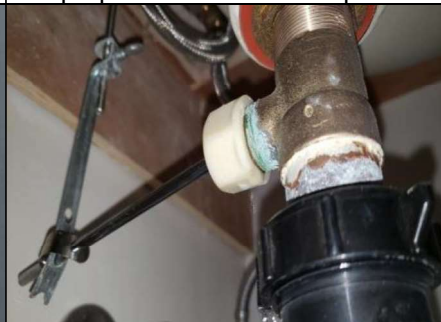
Leak at Bathroom Sink Drain

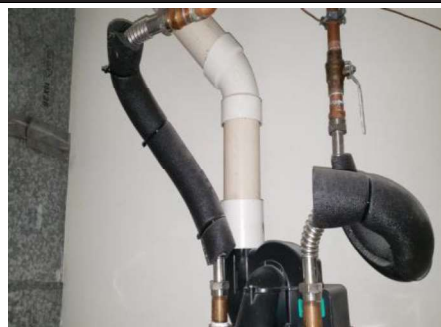
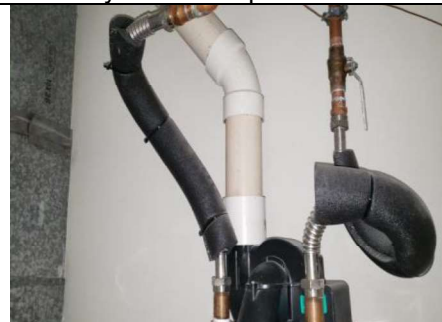
15	<input type="checkbox"/>	<input type="checkbox"/>	<input type="checkbox"/>	<input checked="" type="checkbox"/>	Exhaust System: The water heater has an improper PVC exhaust flue installed.	
16	<input checked="" type="checkbox"/>	<input type="checkbox"/>	<input type="checkbox"/>	<input type="checkbox"/>	Temperature/Pressure Relief Valve:

Improper PVC Flue at Water Heater

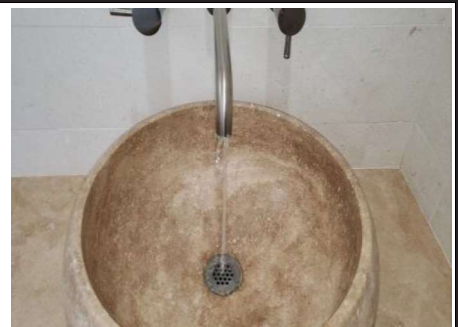
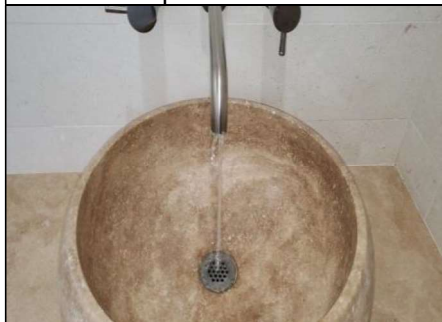
Low Water Flow at Bathroom Sink

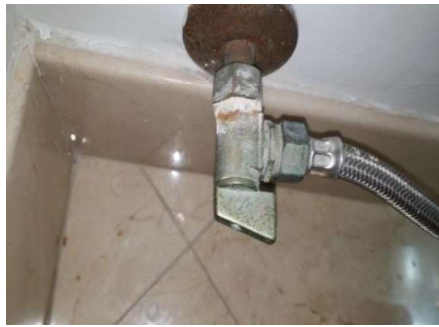
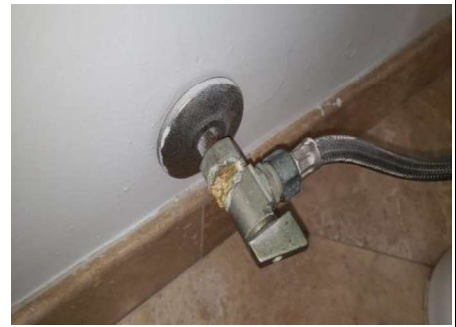
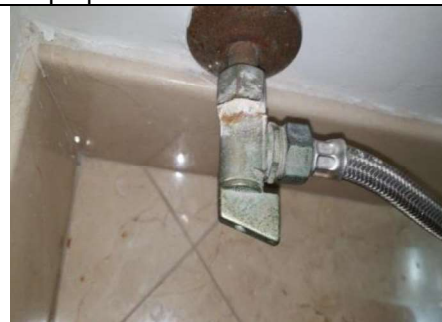
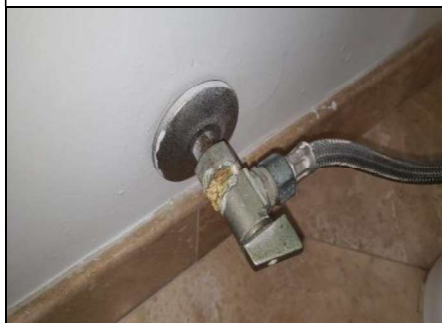
9	<input type="checkbox"/>	<input type="checkbox"/>	<input type="checkbox"/>	<input checked="" type="checkbox"/>	Toilet: Corrosion was observed at the water shut-off valves at the toilets throughout the house.	
10	<input checked="" type="checkbox"/>	<input type="checkbox"/>	<input type="checkbox"/>	<input type="checkbox"/>	Tub/Shower:	
11	<input checked="" type="checkbox"/>	<input type="checkbox"/>	<input type="checkbox"/>	<input type="checkbox"/>	Exhaust Fan:	
12	<input type="checkbox"/>	<input type="checkbox"/>	<input type="checkbox"/>	<input checked="" type="checkbox"/>	Sink: The drain line leaks under the second bedroom bathroom sink, low water flow was observed in the first bathroom sink, and corrosion was observed at the water shut-off valves at the sinks throughout the house.	
13	WATER HEATER: Approx Age (yrs): 5 Approx Design Life (yrs): 10					
14	<input type="checkbox"/>	<input type="checkbox"/>	<input type="checkbox"/>	<input checked="" type="checkbox"/>	Water Heater: Corrosion was observed at the water heater water supply lines and the fuel lines are missing a drip leg.

Corrosion at Water Shut Off Valves.

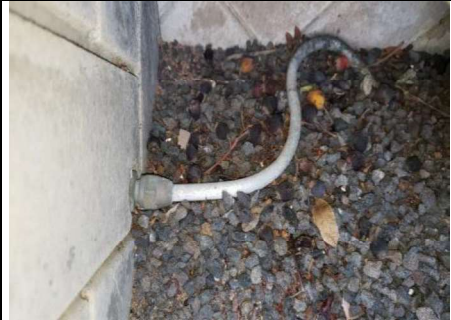
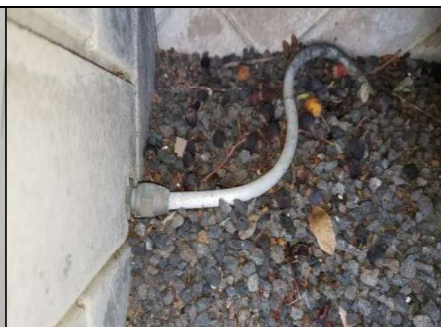
1	<input type="checkbox"/>	<input type="checkbox"/>	<input type="checkbox"/>	<input checked="" type="checkbox"/>	Fireplace: An improper semi rigid gas line was observed at the fireplace and the pilot is out at the fireplaces.
---	--------------------------	--------------------------	--------------------------	-------------------------------------	--

Improper Gas Line for Fireplaces

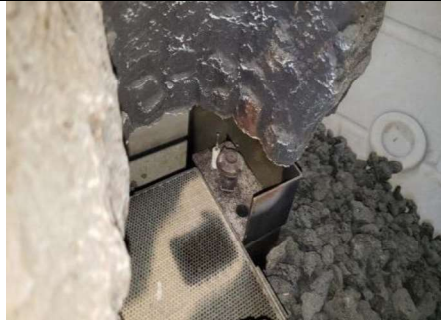
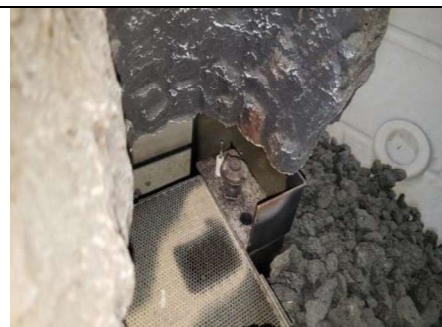
Family Room Fireplace Pilot Out

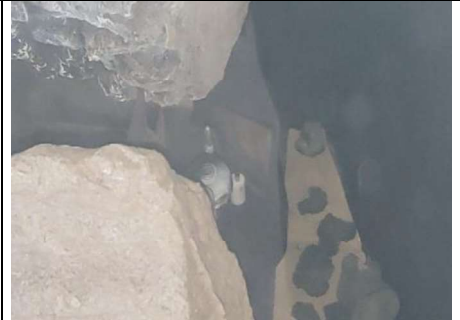
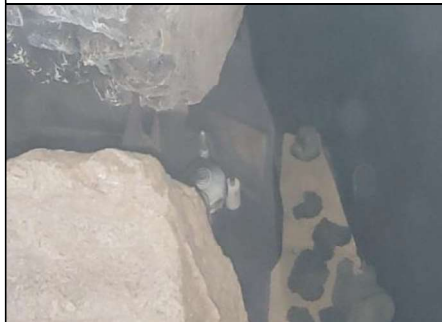
Fireplace Pilot Out
