T.I.N. ENGINEERING COMPANY

File No.: 250083

April 12, 2025

SUBJECT: Site Geologic Reconnaissance Report for Existing Residential Property at 32322 Conqueror Drive, Rancho Palos Verdes, California

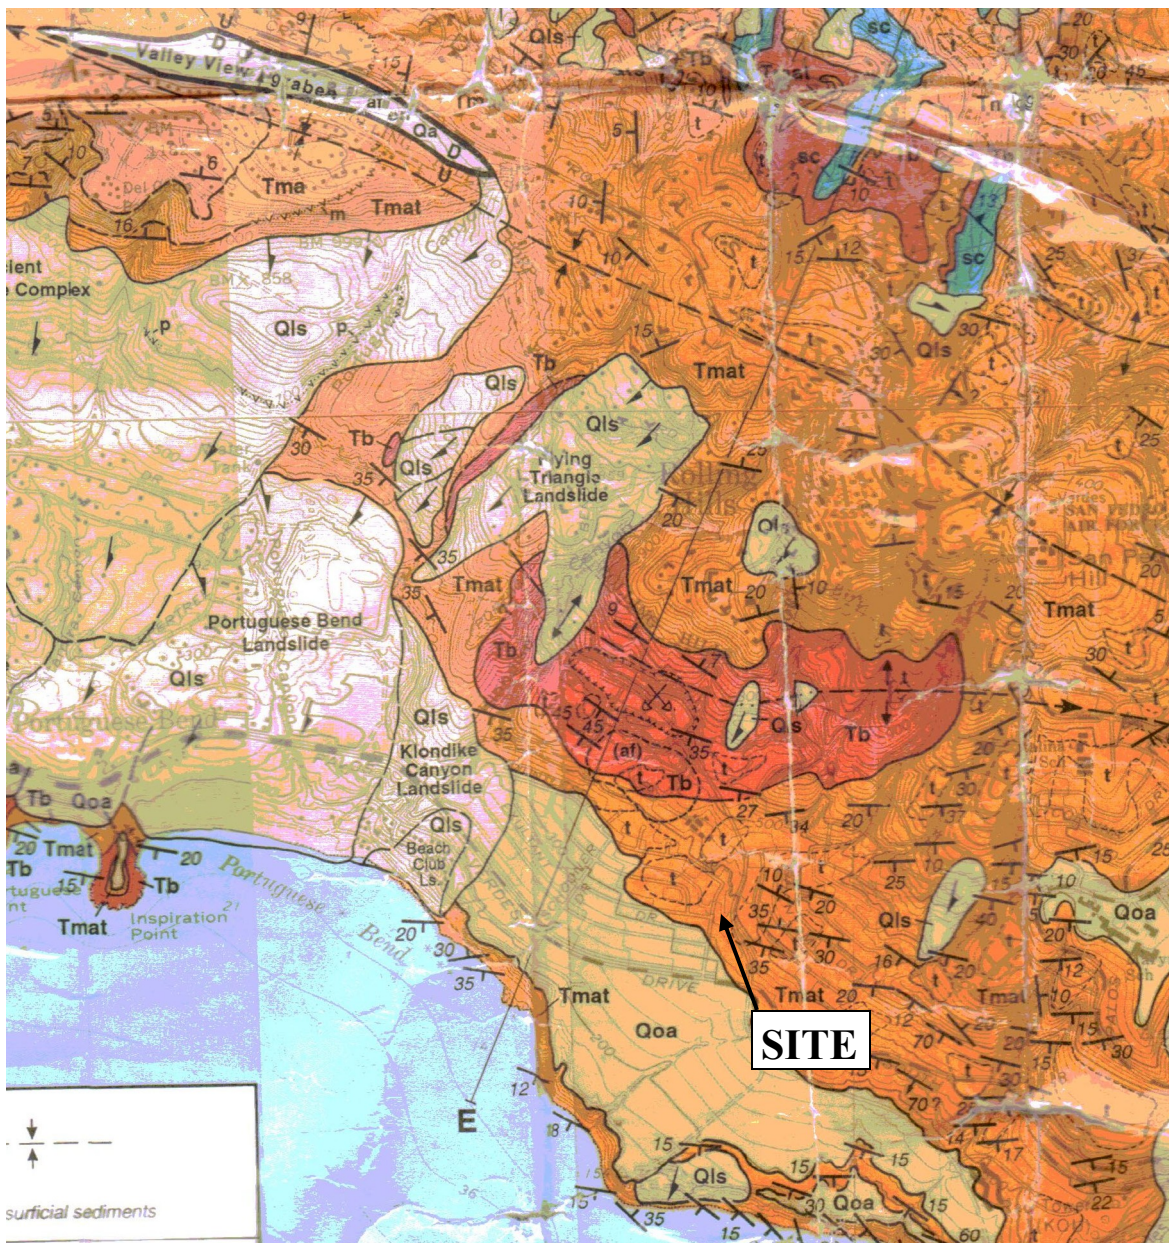
PLATE 1.1

6. No springs or seepage was observed on the site.
7. In review of the regional geologic map by Dibblee, Plate 1, there are no any landslides and/or slumps existed on-site slopes that could adversely affect the residence.

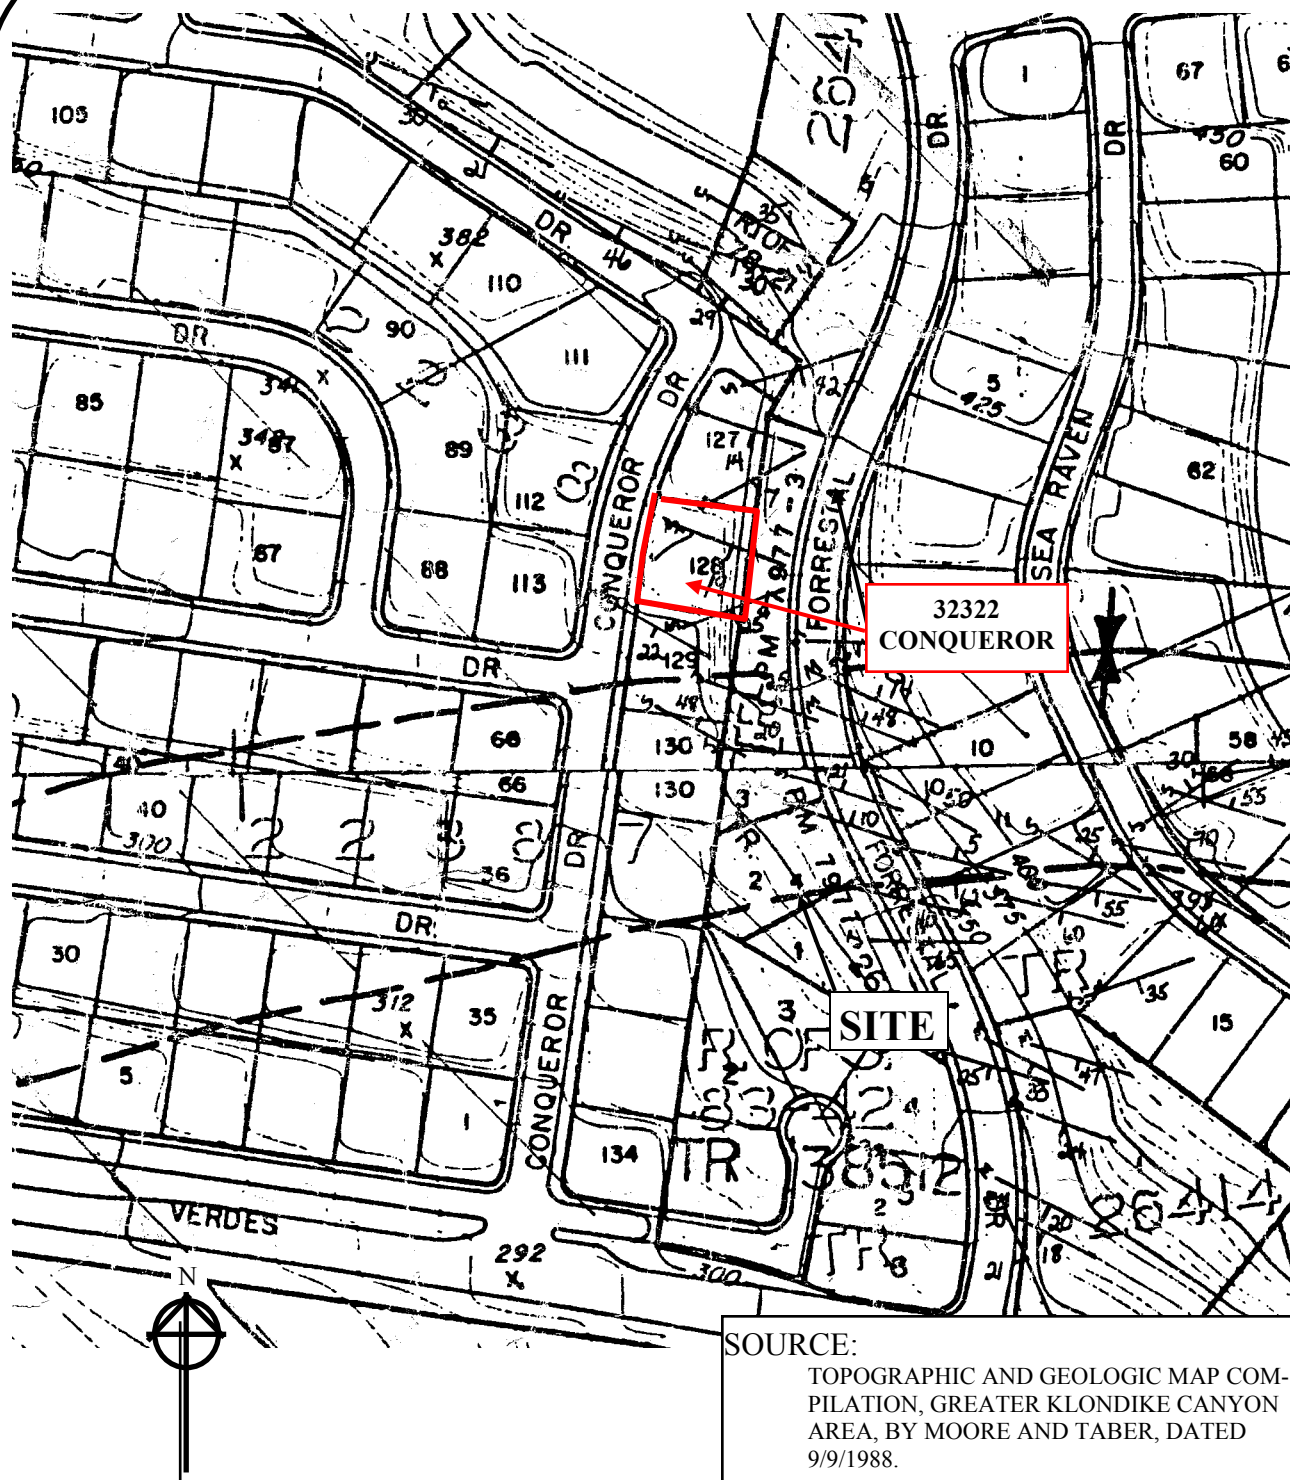
PLATE 1.2

Based upon the regional geologic map by Moore and Taber, Reference 2, the subject site is covered with shale bedrock. The bedrock bedding was dipping into Southeast. It appears that a

dip-in bedding condition was encountered which provides a favorable geologic condition at the subject site.

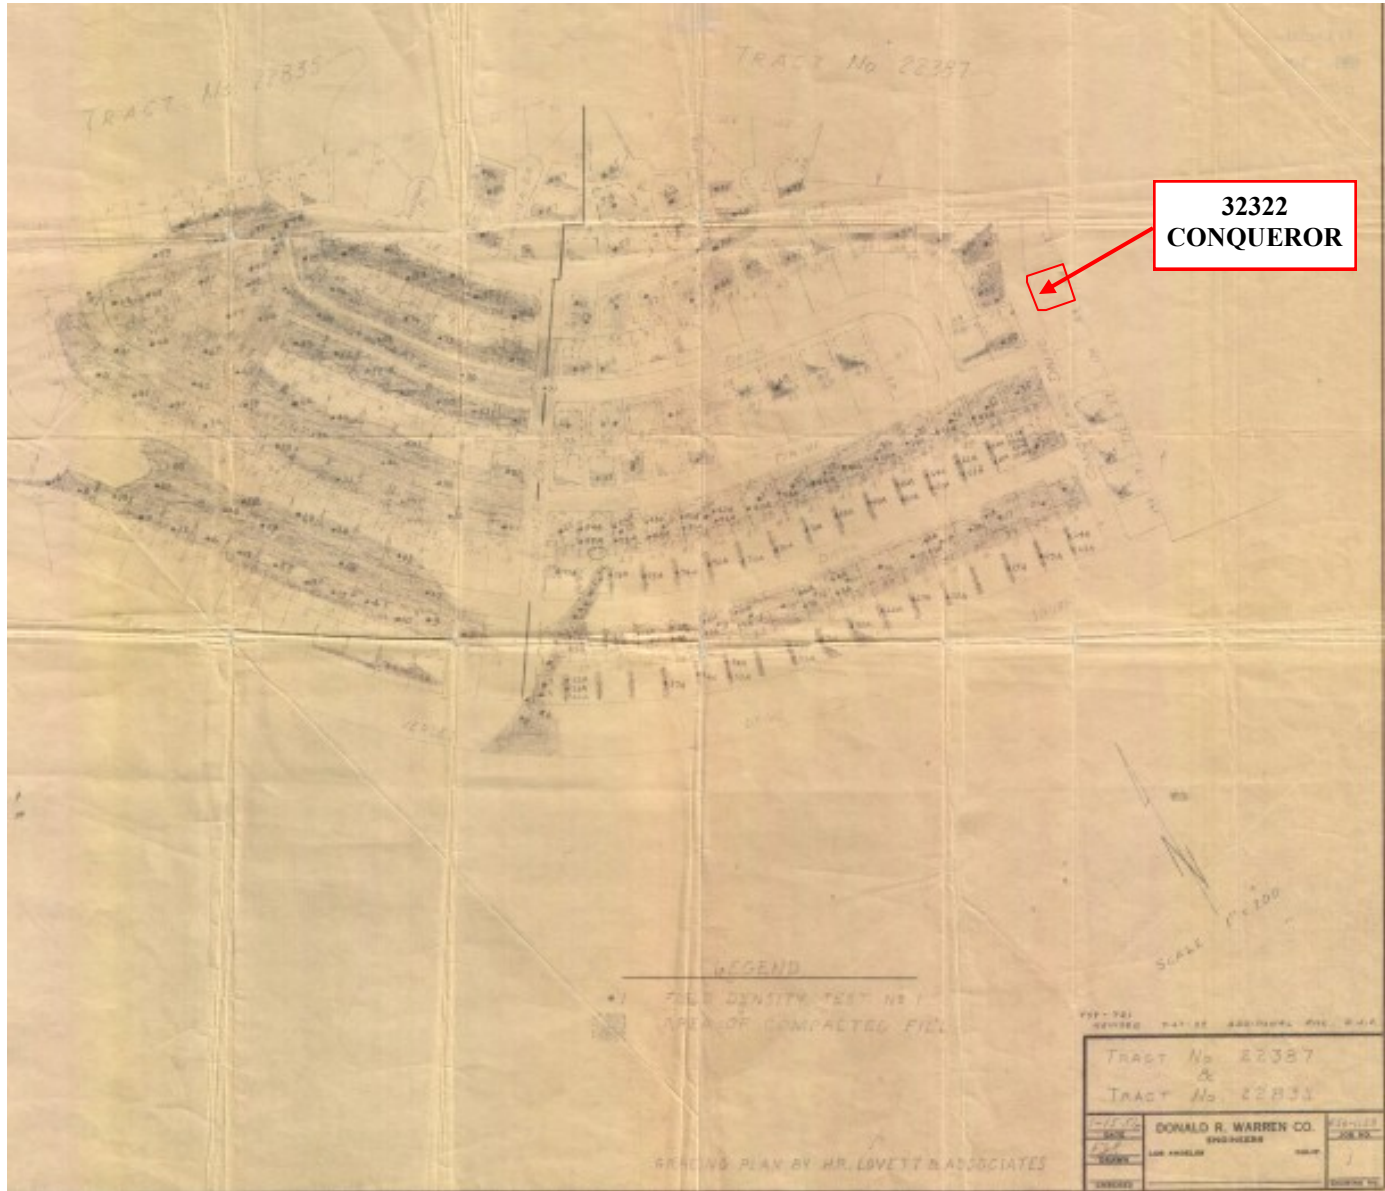
MS. LYNN JOHNSON 32322 CONQUEROR DRIVE RANCHO PALOS VERDES, CALIFORNIA		COMPACTED FILL MAP	
		NOT TO SCALE	PLATE 2
DATE: APRIL 12, 2025	T.I.N. ENGINEERING COMPANY		
JOB NO.: 250083

Based upon the compacted fill map by Donald Warren, Reference 3, no fill grading was performed at the subject. However, It appears that a minor fill grading was performed on the southwest side of the southern descending slope.

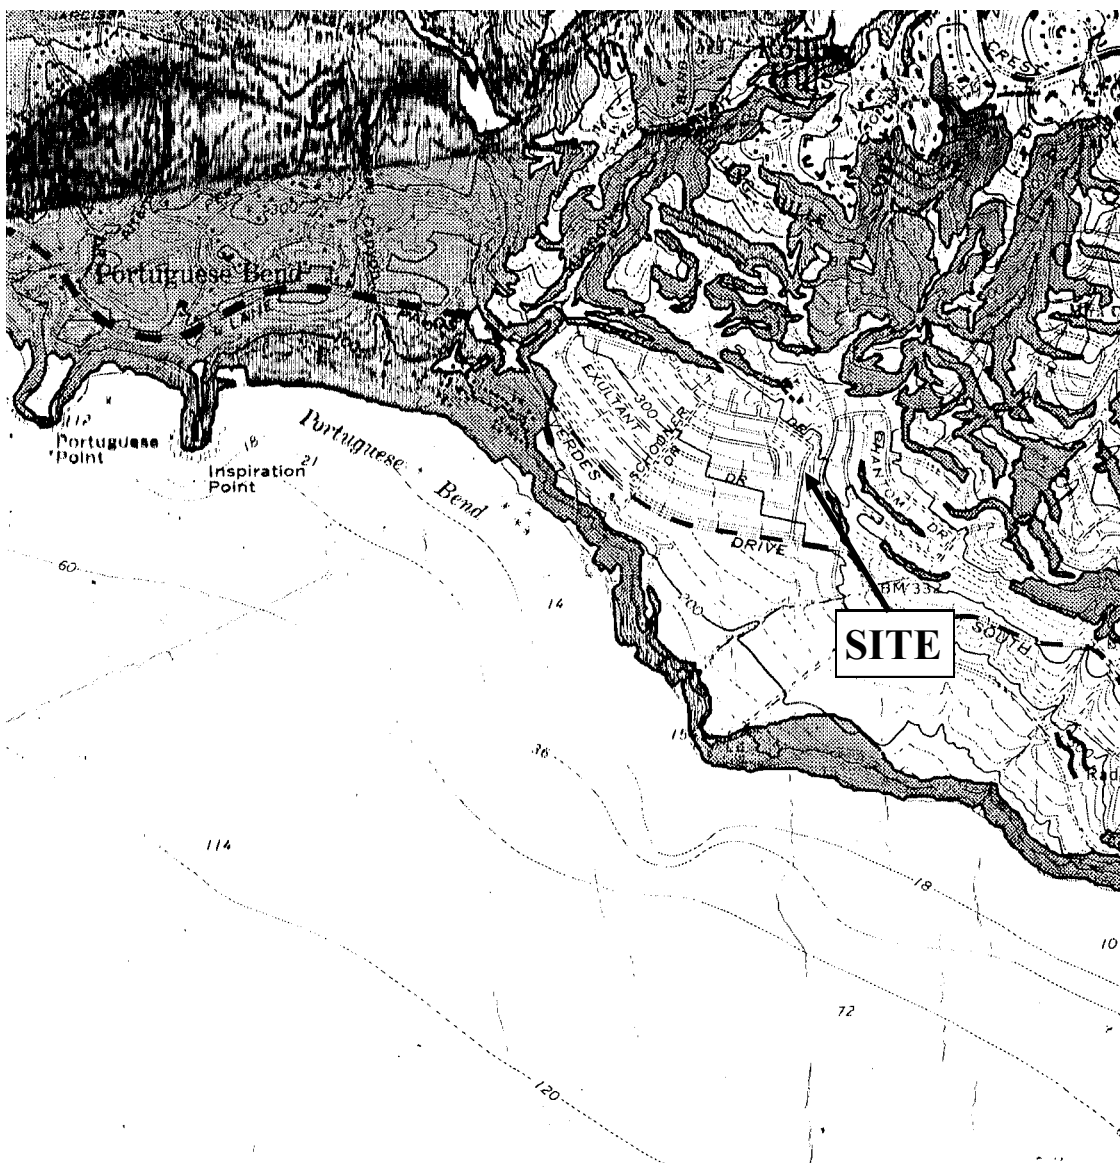
PLATE 3

9. The subject site is not located within the potential seismic hazard zones (liquefaction zones) mapped by the State as shown on Plate 3. The subject site is not located within a seismically-induced landslide hazard zone. The potential of the seismically-induced landslide at the subject site is to be minimal.
