**Address:** 3852 E 15th St, Long Beach

**Date of Inspection:** 2-29-24

## Main Sewer Line Inspection Report

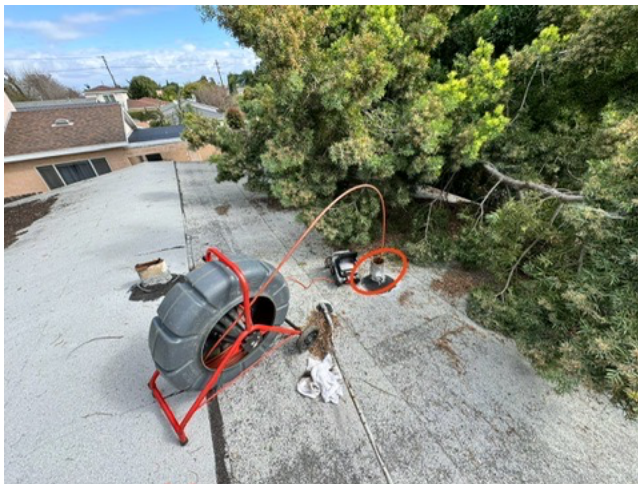
**Main Sewer Line Access Points:** In order to view the main sewer line for this property we used a 4" roof vent. This roof vent is insufficient access to perform routine maintenance and inspections on the main sewer line.

**4" roof vent used for inspection.**

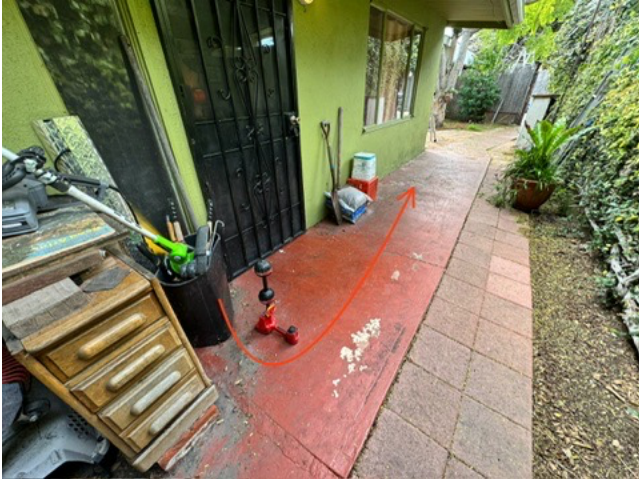
Path of sewer line. 2' deep under tool.

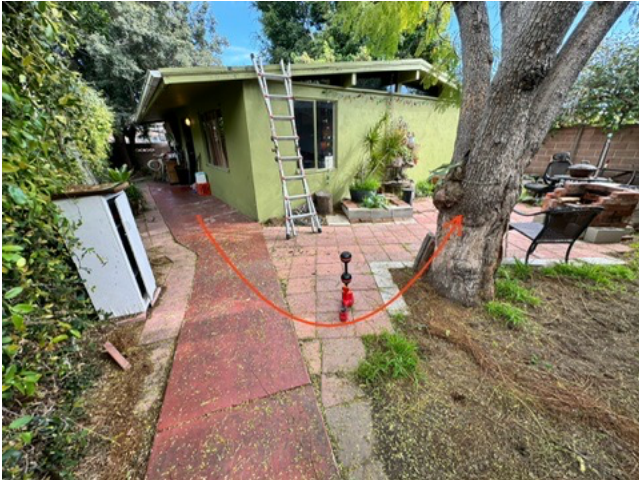
Continued path of sewer line. Good location for a cleanout to be installed under tool 3' deep.

**Areas Needing Attention:** A cleanout should be installed at this time in order to view the remainder of the sewer line up to the city sewer connection (see pictures for location). A cleanout is a pipe that comes out of the ground and allows cleaning tools and inspection cameras to be pushed towards the house and towards the city.

**Estimated Costs for Repairs:** To install a cleanout it might cost \$1,800 - \$2,000.

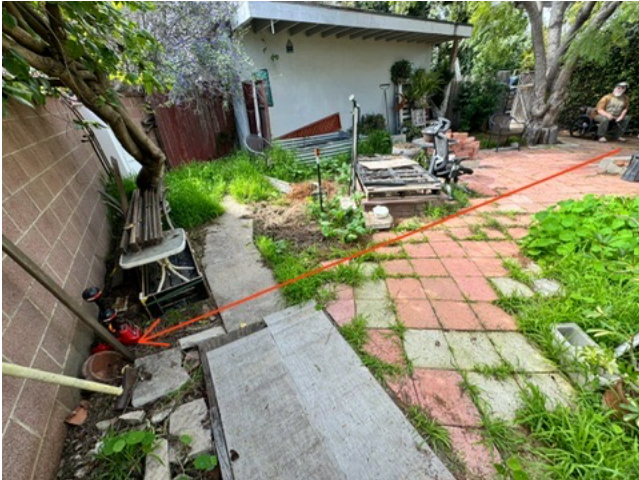
Continued path of sewer line.
