ASBESTOS SURVEY

May 31st, 2023

REF: 1303 Harkness Ln.,
Redondo Beach, CA 90278

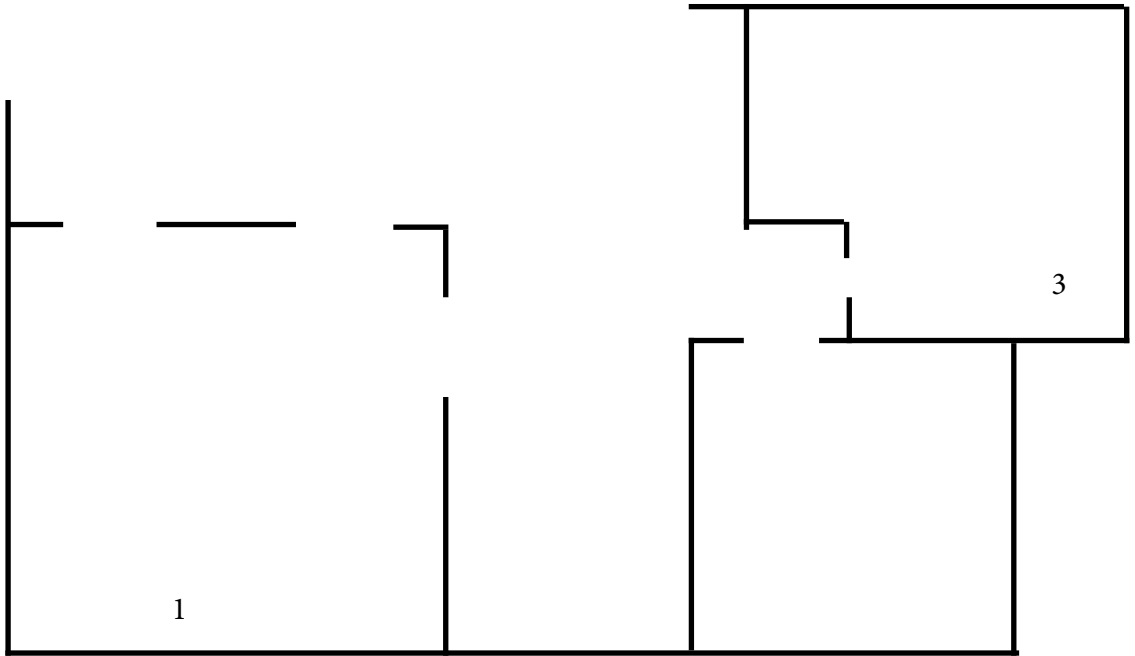
SAMPLE LOCATIONS

MATERIAL	SAMPLE #	LOCATION	QUANTITY	CONDITION
DWJC	1	Upstairs primary bedroom, under window	{<1,000 sq.ft.}	Good
DWJC	2	Dining room area, under window area		Good
DWJC	3	Upstairs back right bedroom, under window		Good
