# Report Table of Contents

## INSPECTION INFORMATION

**REPORT #:** 8560.  
**DATE:** August 5, 2025.  
**TIME:** 1:00 pm.  
**CLIENT NAME:** Tamara Sue Mann.  
**INSPECTION LOCATION:** 3656 Angeles Road, Santa Maria, Ca.  
**LISTING AGENT:** Megan Senter, exp Realty  
 Telephone #: 363-9762.

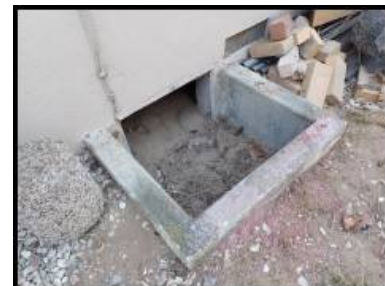
The crawl space was generally accessible during the inspection.

Recommend installing a proper cover to prevent access by unwanted rodents and critters.

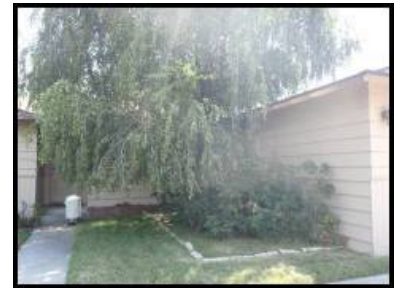
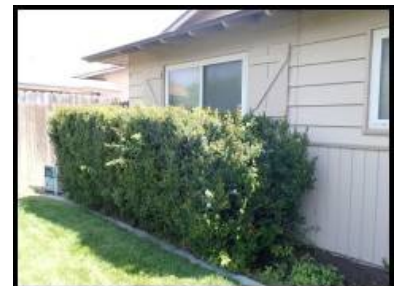
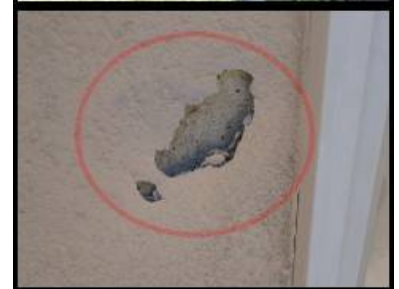
Loose/damaged stucco spot at the right rear corner of the house.

There was vegetation observed to be covering portions of the exterior siding and/or trim. This condition limits the inspection and is conducive to the deterioration of the building materials. Recommend the vegetation be trimmed away from the structure.

This structure was built in an era before weep screeds were installed at the bottom edge of the stucco siding. The stucco was extended into the soil. The stucco wicks water up out of the soil which causes the stucco to deteriorate from being moist for prolonged periods. Recommend minimizing moisture around the building to help protect the stucco and the foundation from moisture damage.

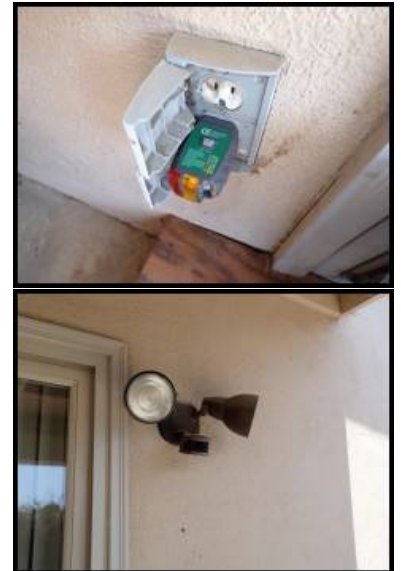
The exterior lights are in serviceable condition.  
The exterior lights that are sensor/motion controlled were not tested.  
Not all of the exterior outlets are GFCI protected.  
Recommend upgrading.

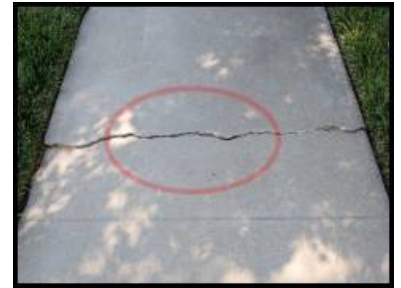
There is one crack at the front walkway that has an elevation difference at the gap/crack. Potential for tripping.

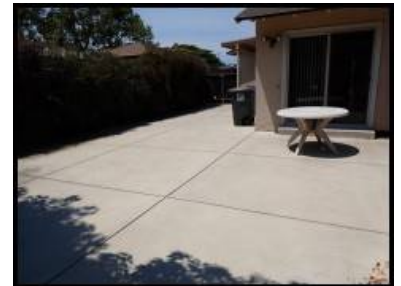
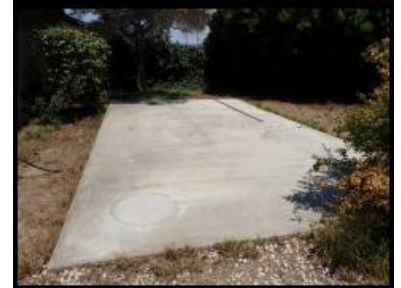
The patio deck appeared to be in serviceable condition with cracks and stains noted in the concrete.

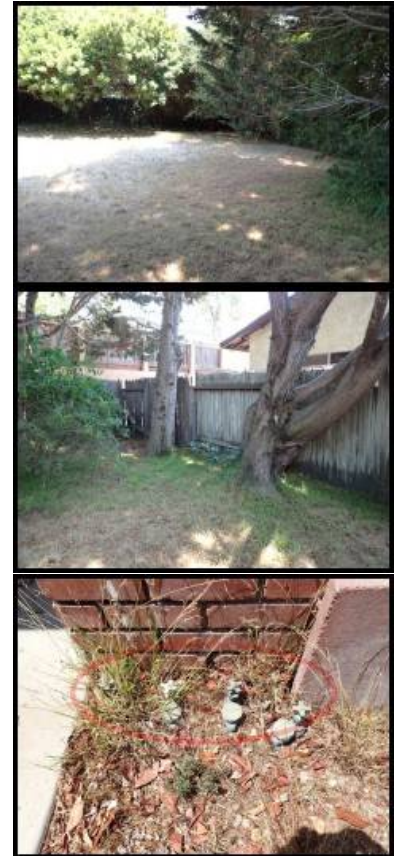
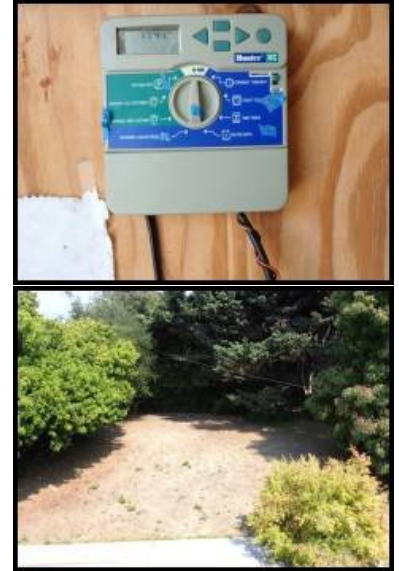
There are 4 manually operated valves at the rear of the house.

*Note: The rear yard has not been maintained.*

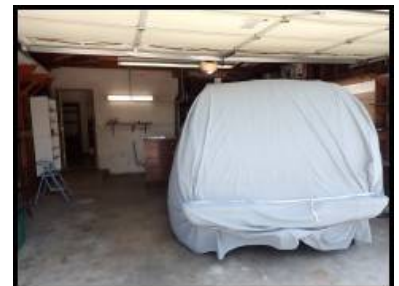
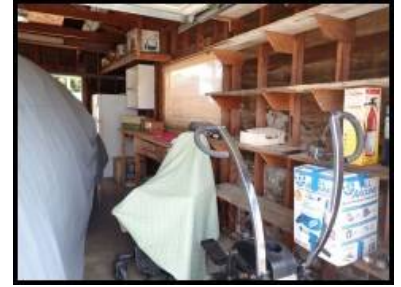
The visible portions of the concrete floor appeared serviceable with stains and common cracks noted. Areas of the floor and walls were not fully visible due to stored personal items and parked vehicle. Recommend checking these areas when the garage is free and clear of personal items.

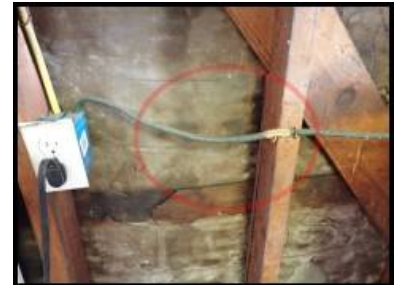
The lights and accessible outlets were in serviceable condition. The outlets were not GFCI protected.

Some of the outlets have open grounds.

Improper wiring on the surface of the wall.

Recommend upgrading to provide GFCI protection to all of the outlets in the garage.

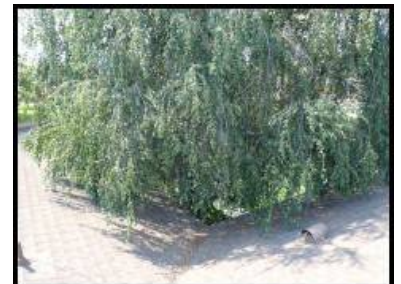
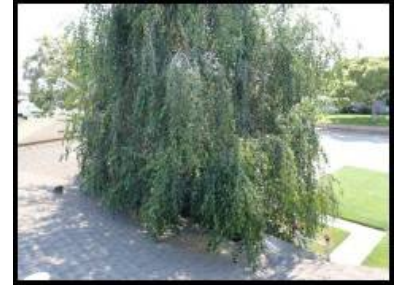
There were no provisions (rain gutters) for rooftop drainage. Gutters would be beneficial in collecting and directing the water runoff. Recommend installing rain gutters and downspouts on all down sloped roofs as an upgrade item.

Recommend trimming the front tree to prevent contact with the roofing surface.  
Recommend removing the tree debris at the front of the house/garage area.

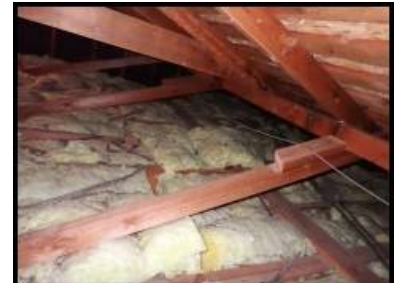
*Note: Insulation and general attic area is dirty from roof replacement.*

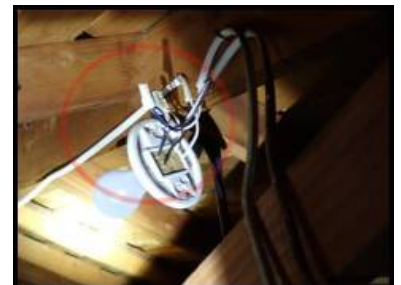
*Improper wiring to the add-on string of lights in the attic.*

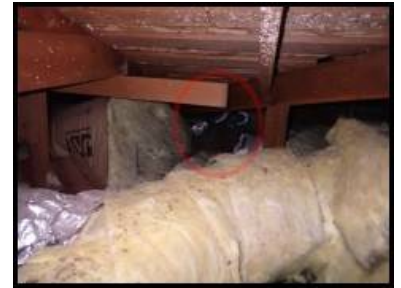
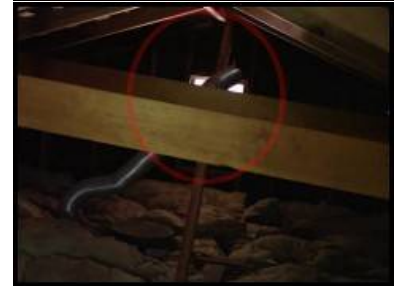
The bath vent fans are exhausting into the attic. This condition is conducive to a high moisture condition and possible wood deterioration. Additional ducting recommended to allow exhaust air to escape to the exterior.

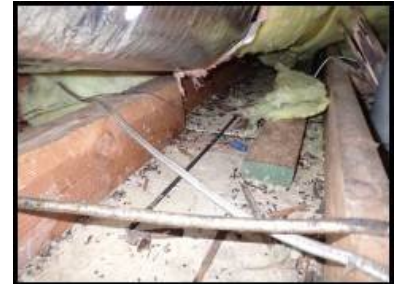
Evidence of rodent droppings were observed in the attic. Unknown if current rodent activity. Recommend further evaluation by a licensed general pest control operator.

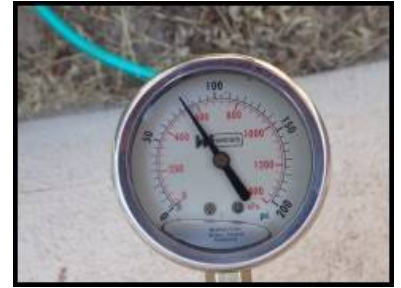
75-80 psi.

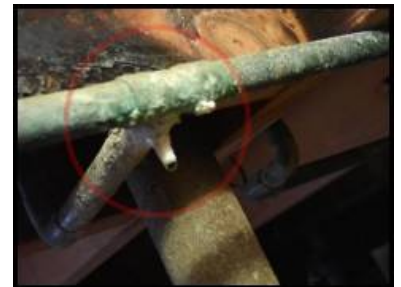
There is a slow drip below the master bathroom.

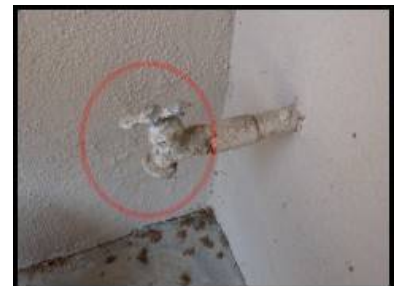
The faucets at the rear of the garage and left side of the house are damaged/handles are frozen/do not turn. Repairs needed to restore to operating condition.

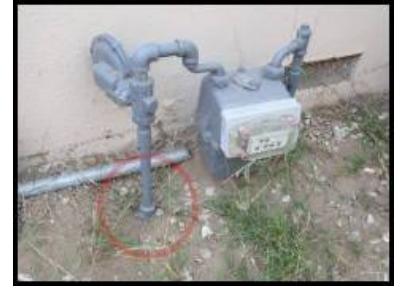
The gas shutoff valve is in contact with the soil/ground and not readily accessible. Proper clearance needed for safety.

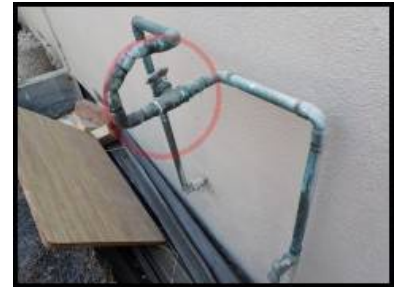
The valve is frozen/does not turn. Repairs needed.

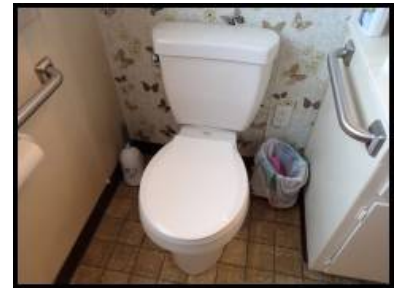
Damaged flooring and soft floor around the base of the toilet.

The toilet was loose on the floor. Repairs needed by a qualified plumbing contractor to restore to proper condition.

Recommend caulking around base of the toilet after repairs have been made.

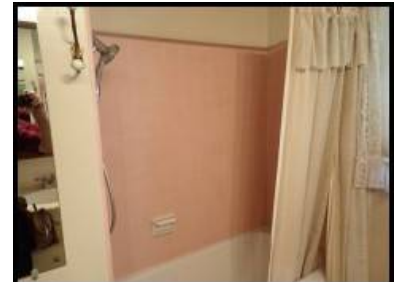
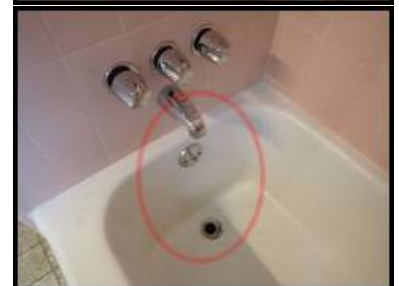
The tub/shower and control valves were in serviceable condition. The tiled shower surround appears to be in serviceable condition and the grout lines adequately sealed. The drain stopper mechanism was defective. Recommend repairing the mechanism to restore operation.

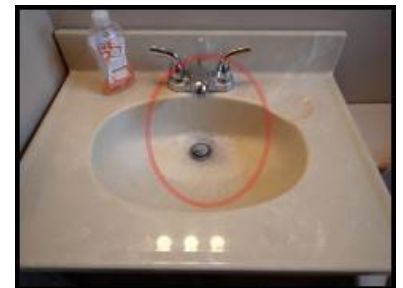
There is wear on the wood cabinet face and the cabinet is not secured to the wall. Movement noted.

The drain stopper mechanism was defective. Repairs needed to restore to proper operation.

Spider web cracking (surface cracks) were noted on sink surface.

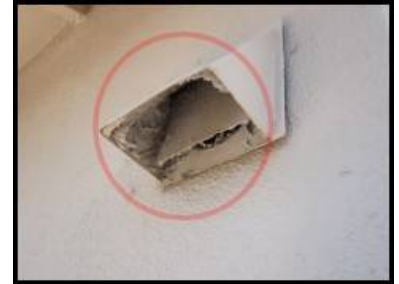
There is some lint build-up around the termination cover which prevents the damper/flapper from fully closing. Cleaning needed to restore to proper operation.

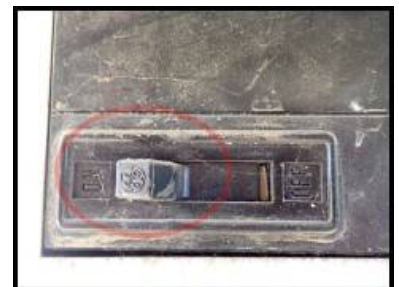
Appears to be 100 Amps. (hard to read)

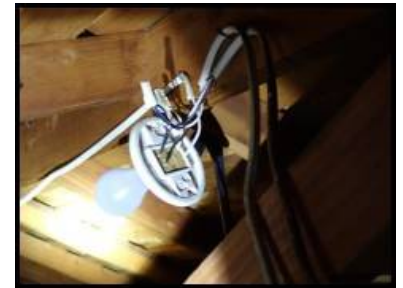
Improper Add-on string of light in the attic.  
 Older technology with ungrounded outlets.

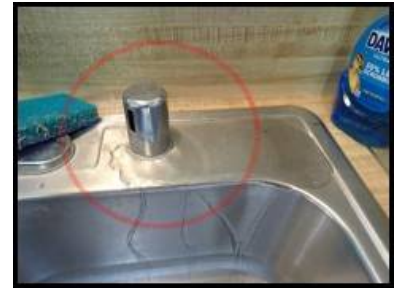
The dishwasher functioned through the "Normal Cycle" during the inspection. No visible leaks observed.  
 The air gap device installed on the sink was defective or restricted causing leakage into the sink. Repairs needed.

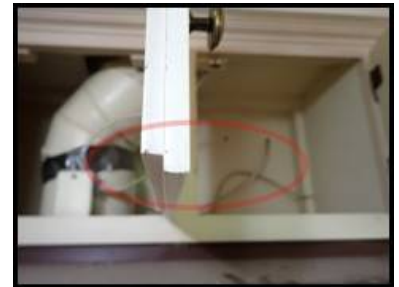
The lights and accessible outlets were in serviceable condition. The outlets were not GFCI protected. Recommend upgrading to the current standards and providing GFCI protection to all of the outlets in the kitchen.  
 There is exposed wiring in the cabinet above the exhaust hood.

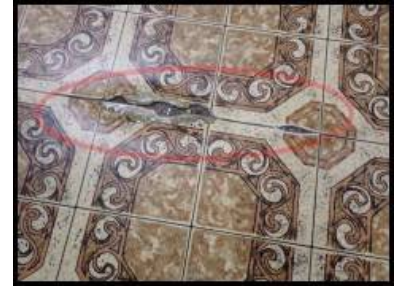
The visible portions of the vinyl floor were in serviceable condition, with common signs of aging and wear.  
There is a damaged seam.

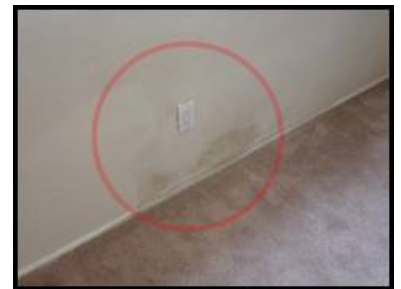
Materials: Drywall, Wallpaper  
The visible portions of the walls appeared to be in serviceable condition  
There are some marks and blemishes noted on the walls.  
There are stains in the master bedroom.

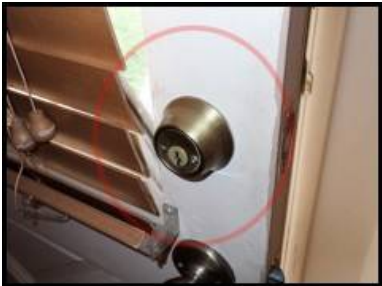
The doors were in serviceable condition.  
There are missing/damaged door stops.  
Missing lower plastic closet guides in all the bedrooms.

The door(s) were in serviceable condition.  
The dead bolt lock on the front entry door was key operated from both sides. All exterior doors should be able to be opened without the use of a key and/or special knowledge. Recommend replacing with thumb turn dead bolt for safety.

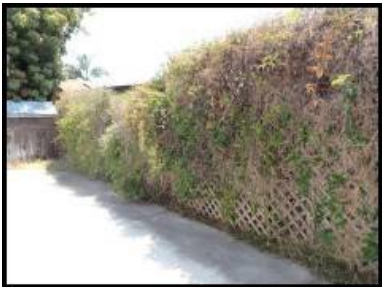
Older fencing  
Majority of the fencing is not visible due to shrubs and plant growth.  
There is extensive vegetation growth on the fence areas.
