Inspection Report

Property Address: 1 Palmera Rancho Santa Margarita CA 92688

Property Address Date of Inspection Report ID
1 Palmera 9/28/2022 092822-02

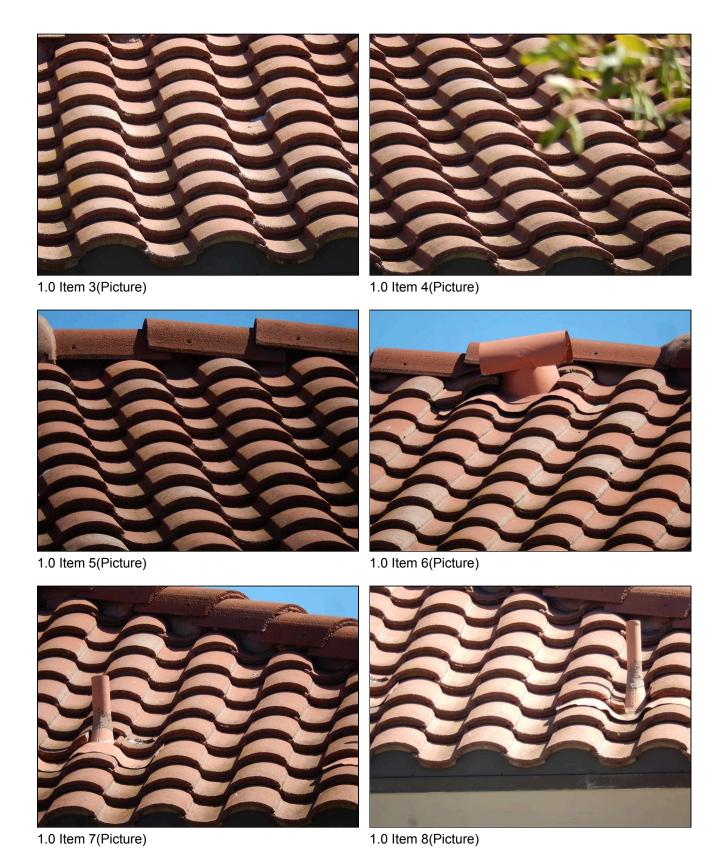
1.0 Roof is maintained by the Association.
