Property Inspection Report

Winkie Robb

Inspection Date:
04/12/2022

Prepared by:
Bona Fide Home Inspections
310-560-4394

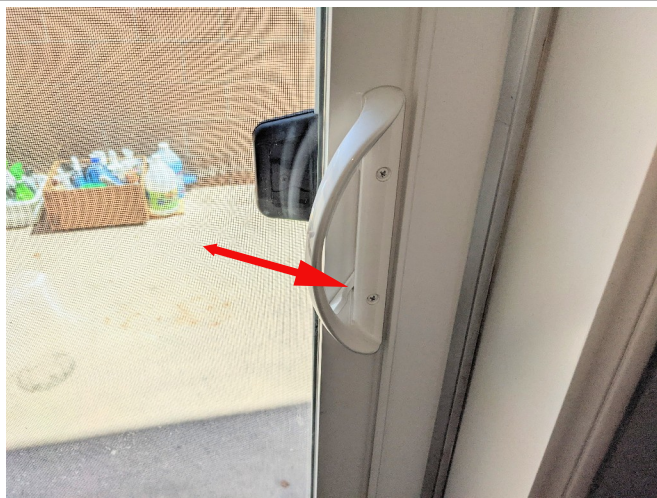
1. The sliding door locking hardware is defective, we recommend it be adjusted, repaired or replaced.

Sliding door does not lock

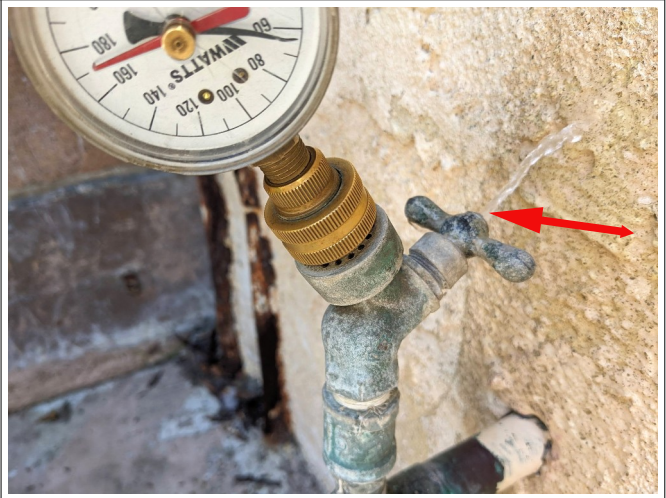
6. Leakage was observed at one or more hose bibs when turn on, we recommend tightening the packing nut or replacement of the hose bib.

Hose bib leaking

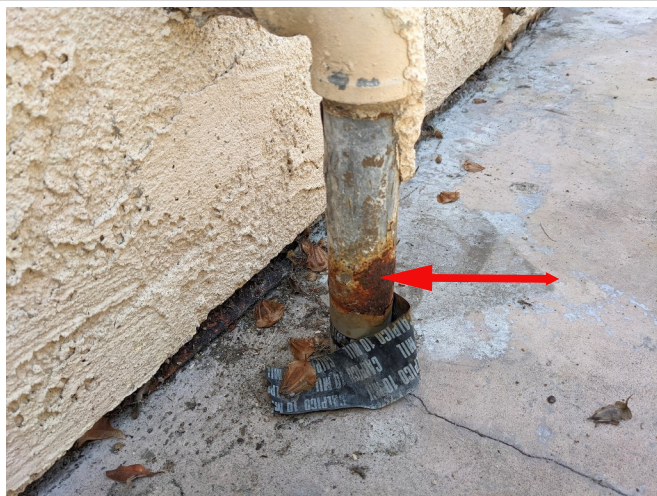
5. Portion of the gas piping do not have the proper protection where it is exposed and/or where buried. We recommend that an approved coating or wrapping be installed.

Rust at gas piping

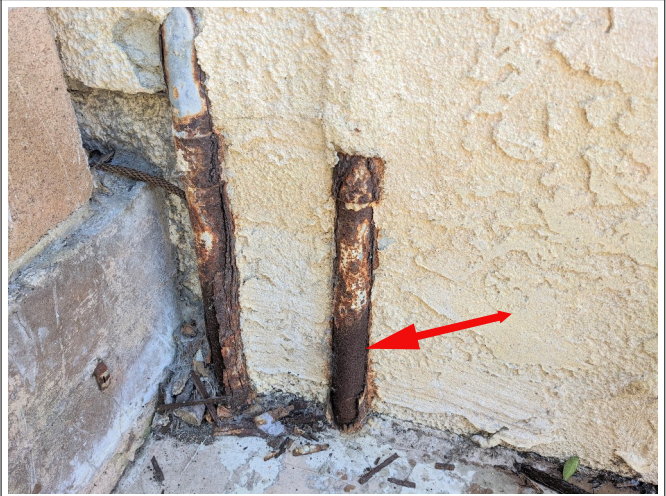
Rust at electrical conduit

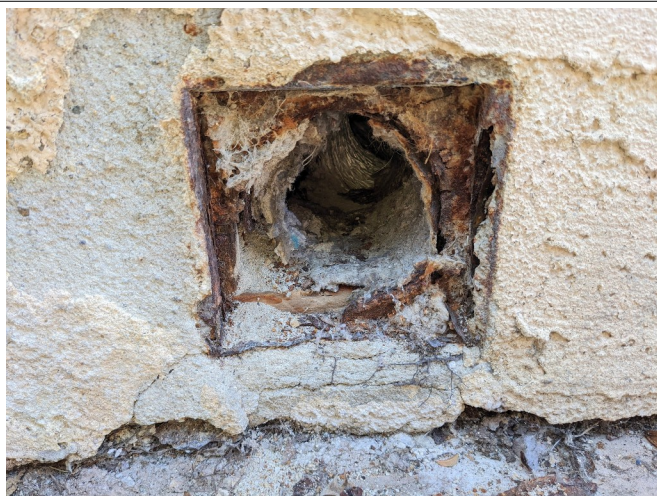
14. The dryer vent termination cover is damaged/missing, we recommend it be replaced.

Missing dryer vent termination

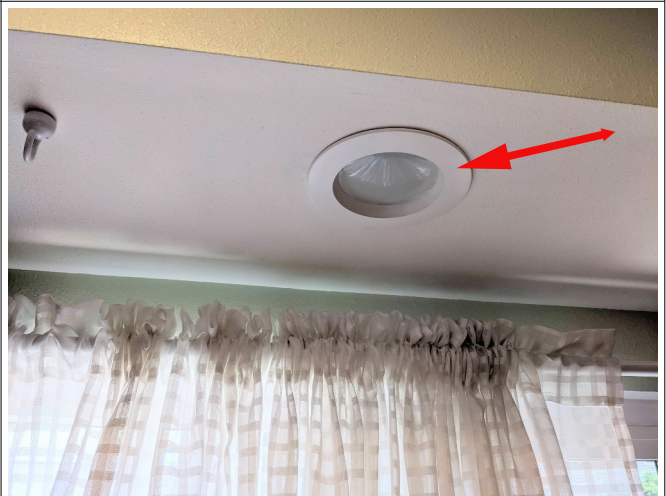
13. Some lights are inoperative (bad bulbs?) We recommend they be replaced and operation tested before close of escrow.

Kitchen light inoperable

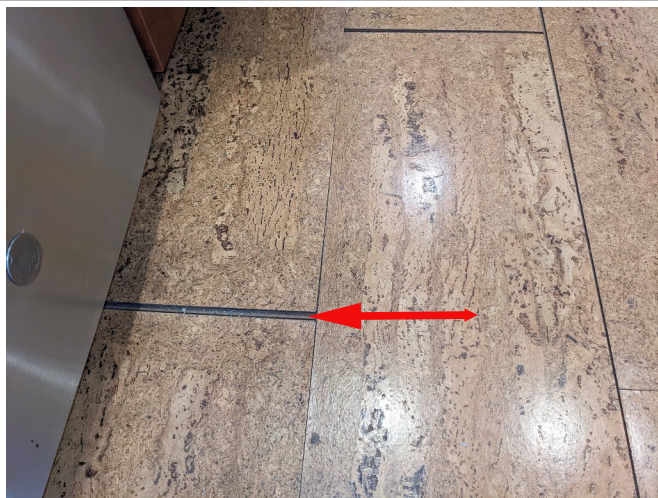
12. The flooring material is wood/cork, which has joints that have separated, we recommend it be repaired or replaced.

Kitchen flooring joint separations

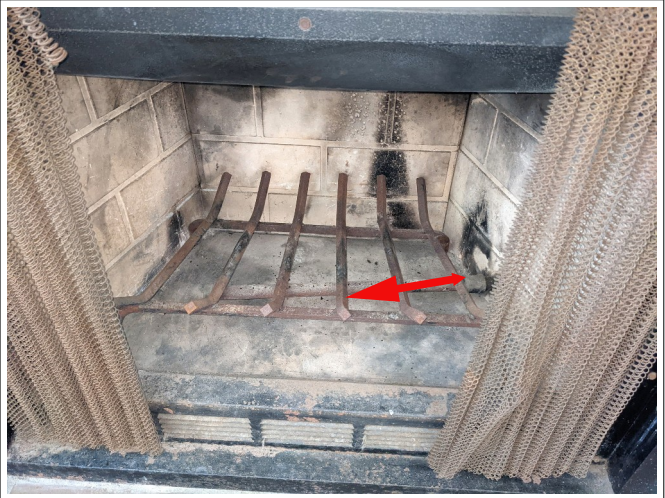
11. The firebox metal grate appears the incorrect size, we recommend contacting the manufacturer for replacement with the correct type.

The chimney flue damper does not open fully, we recommend repair

Fireplace, improper size grate, damper not opening fully

The gas log lighter or log set responded to operation of the valve. We recommend the damper be blocked from closing fully to prevent possible of exhaust fumes entering the room.

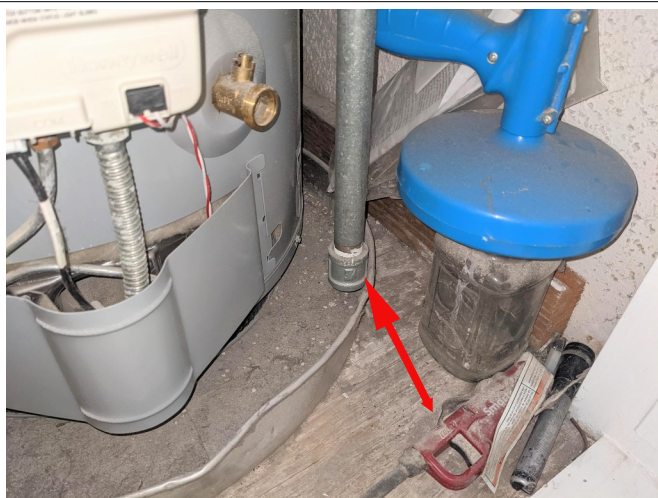
2. A temperature/pressure relief valve and drain line is installed as required, it was not tested and it should not be altered or blocked off . The threaded end of pipe not permitted, we recommend correction.

Water heater TPR drain pipe end cannot be threaded

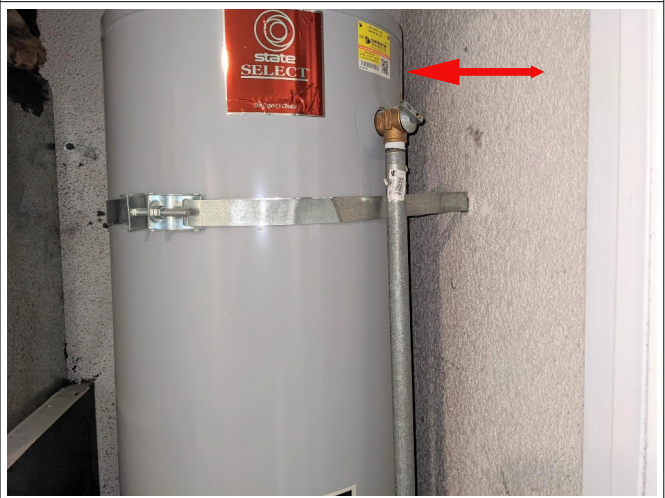
3. The water heater is double strapped as required but there should have been wood blocking added behind it as required to prevent movement.

Water heater lacks wood blocking to wall

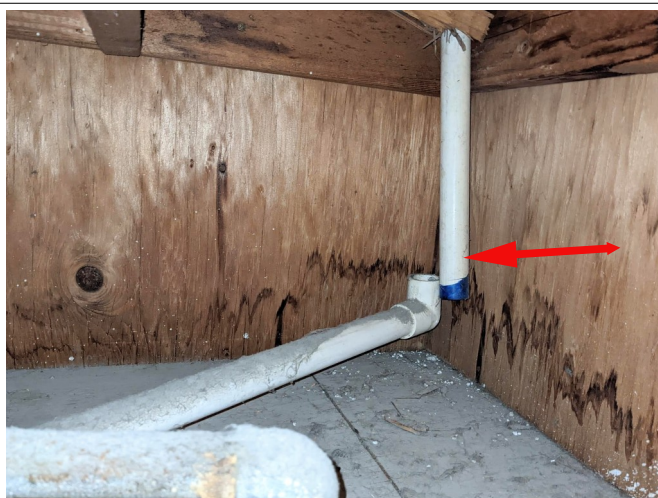
4. The water heater drain pan overflow piping is not connected under the water heater, we recommend repair.

Water heater overflow drain pipe not connected

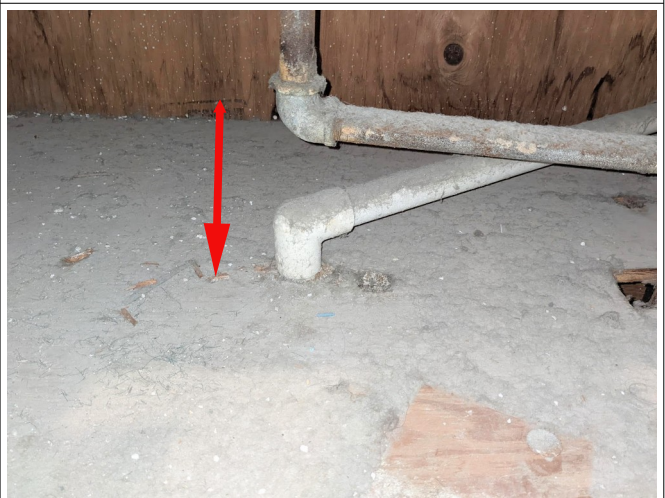
Dust/debris build up under furnace

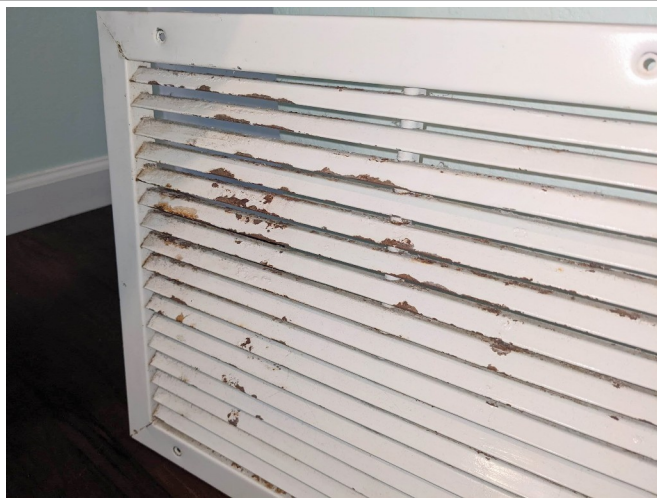
The return air grill is rusting, we recommend new paint or replacement

Furnace air intake grill rusting

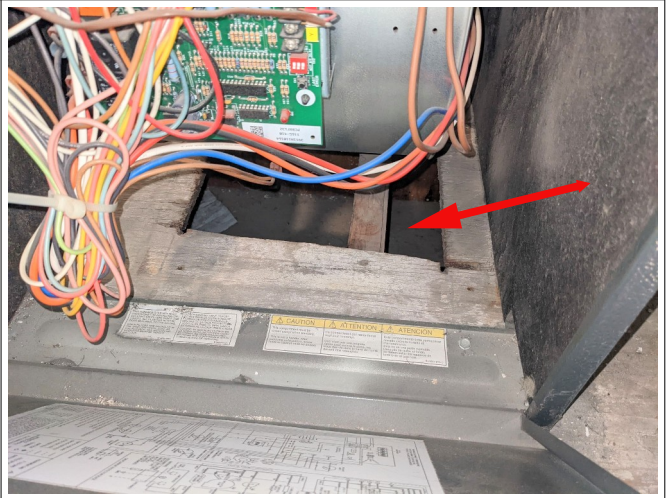
10. There is no air filter for this heating unit. We recommend a filter be installed for proper operation. The entire fan and area below the furnace needs to be thoughty cleaned out also.

No filter installed for furnace

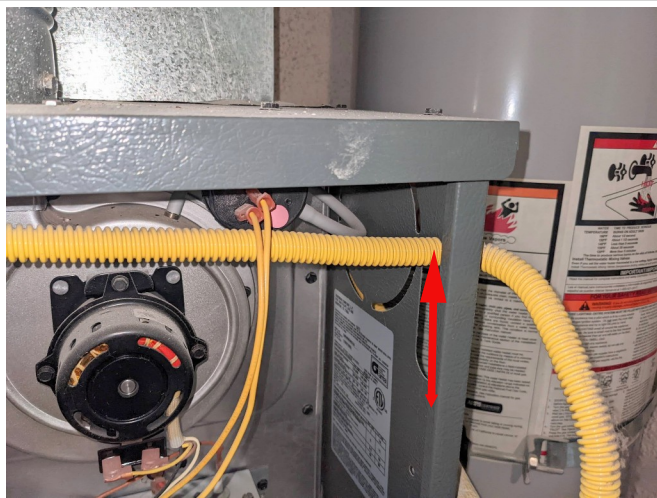
9. Natural Gas. The gas valve is installed but not tested. An approved flexible gas connected is installed but this goes through the side of the furnace and is subject to damage in an earthquake. Newer installations require a rigid steel pipe be used to pass through the side of furnace, correction is recommended.

Gas piping incorrect to furnace

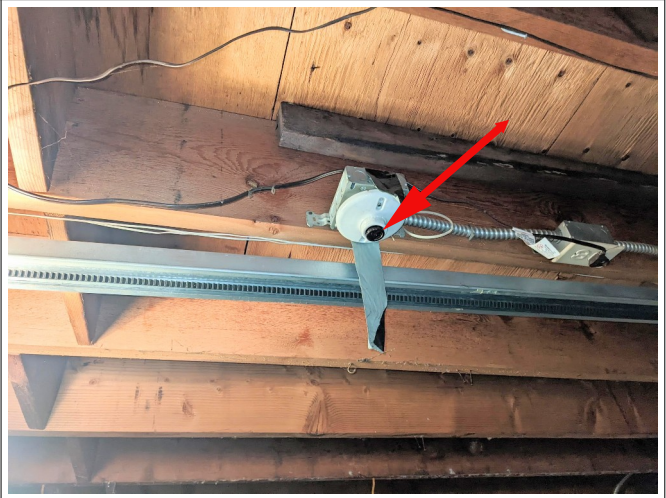
8. There is no active switched lighting installed in the garage, we recommend new lighting fixtures be installed as necessary.

No lighting installed in garage

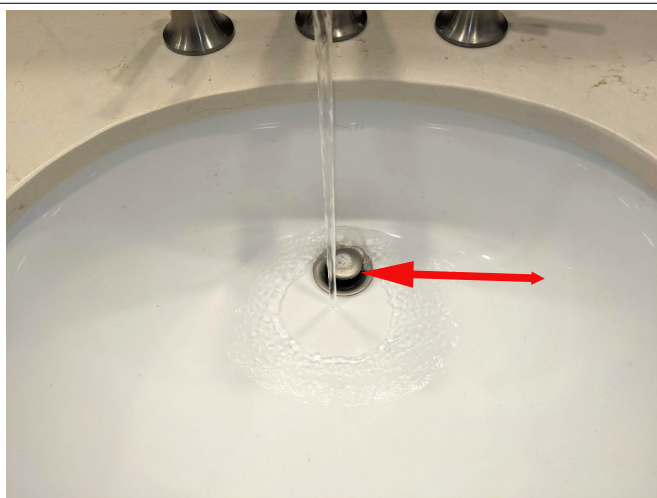
15. The sink stopper did not operate properly, we recommend it be repaired or replaced.

Master sink drain stopper inoperable

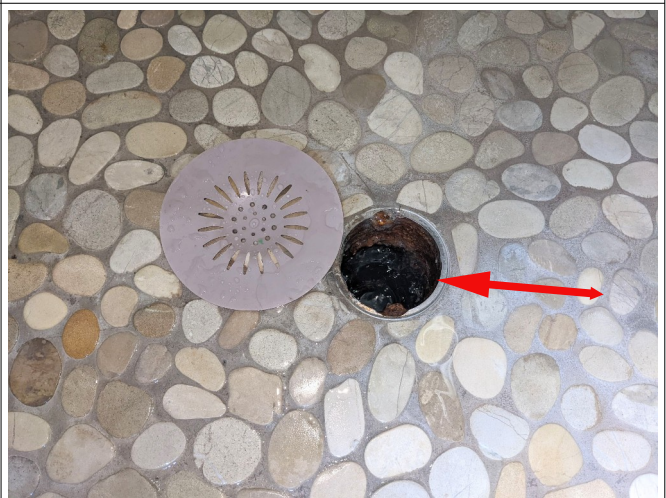
16. The shower drain screen cover is missing, recommend it be repaired or replaced.

Master shower missing metal drain cover
