# **Cornerstone Inspections**

## **Property Inspection Report**

**276 Miramar Ln, Pismo Beach, CA 93449**  
**Inspection prepared for: David Skinner**  
**Real Estate Agent: David Skinner - Central Coast Realty Group**

**Date of Inspection: 4/26/2018 Time: 9:00 AM Size: 1753**  
**Order ID: 3422**

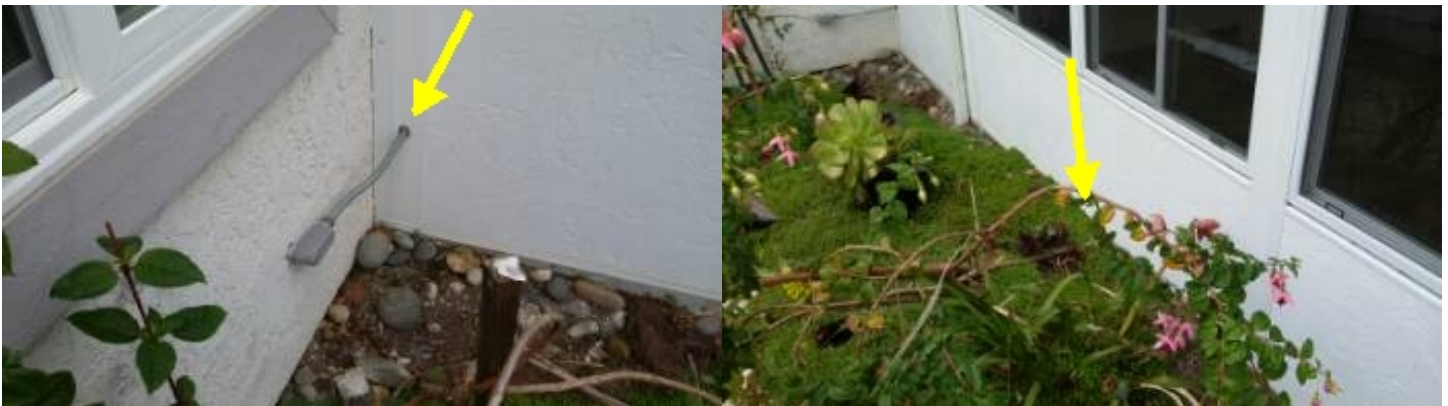
There are separations, gaps, cracks or openings on the siding that need to be serviced/sealed. This includes hose bibs, electrical or cable wires that enter the home, or cracks around the windows or doors.

The soil is too high against the home at various areas around the home which should be serviced.

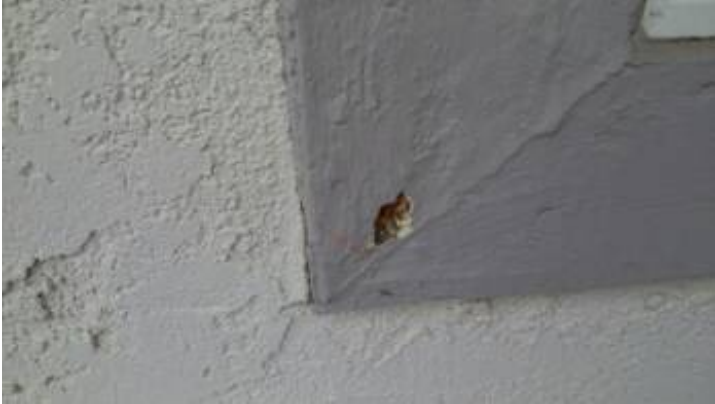
There is damage to the wood trim that should be evaluated by a termite inspector.

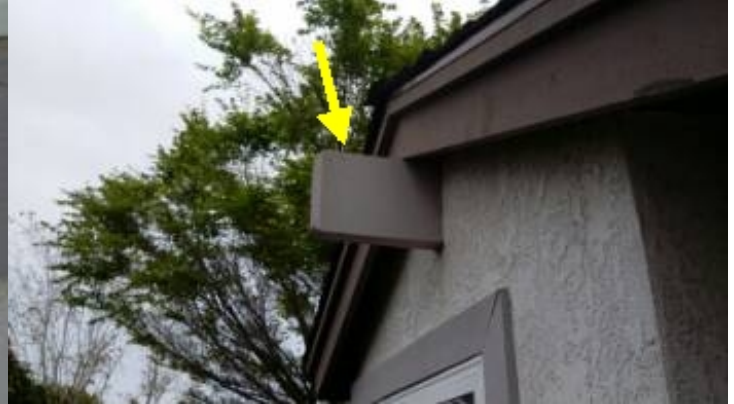
There is moisture damage or dry rot to the wood trim and or fascia on the upper roof area, which is typically not inspected by the pest inspector. The pest control company should be alerted so as to inspect and include these repairs in their estimate.

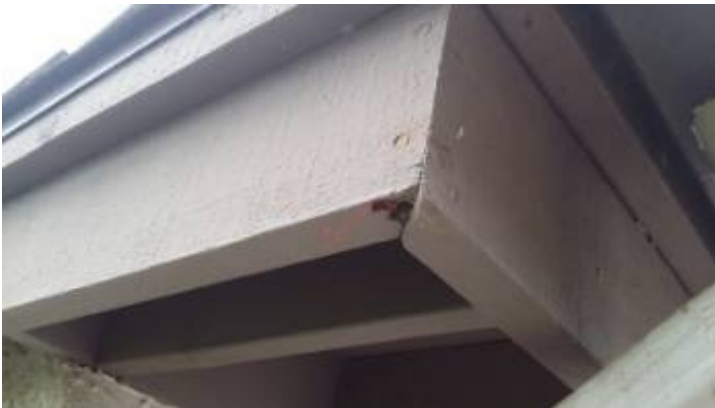
There is damage to the wood trim that should be evaluated by a termite inspector.

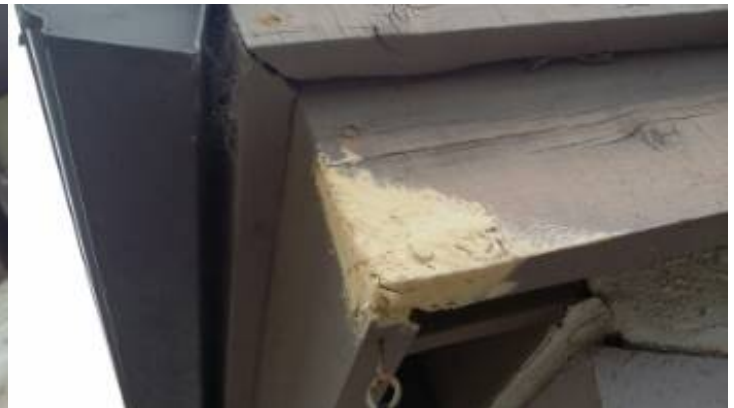
The termite report should confirm moisture, dry rot or insect damage to the fascia board and or eaves of the roof.

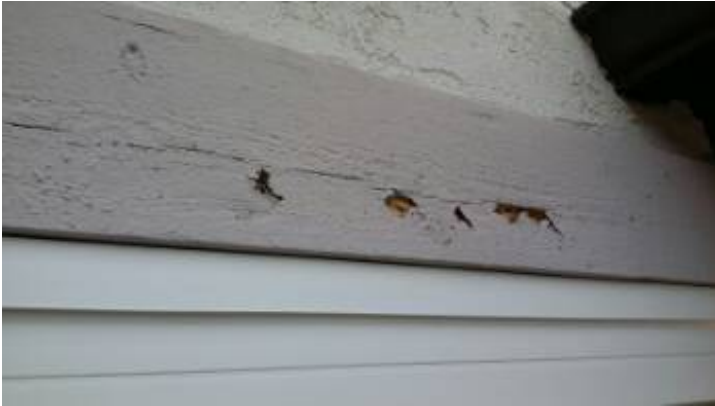
The termite report should confirm moisture, dry rot or insect damage to the fascia board and or eaves of the roof.

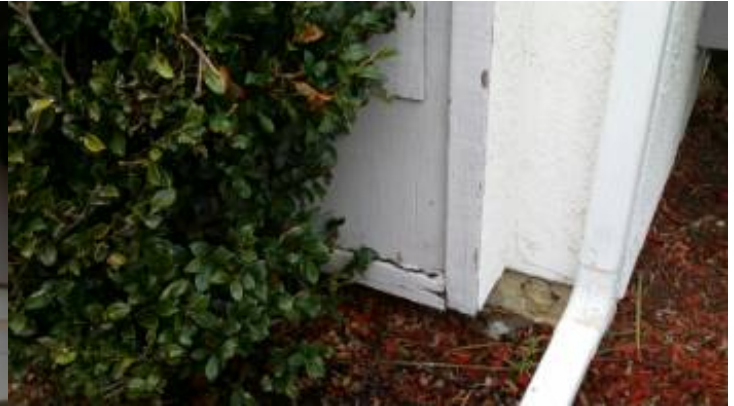
There is damage to the wood trim that should be evaluated by a termite inspector.

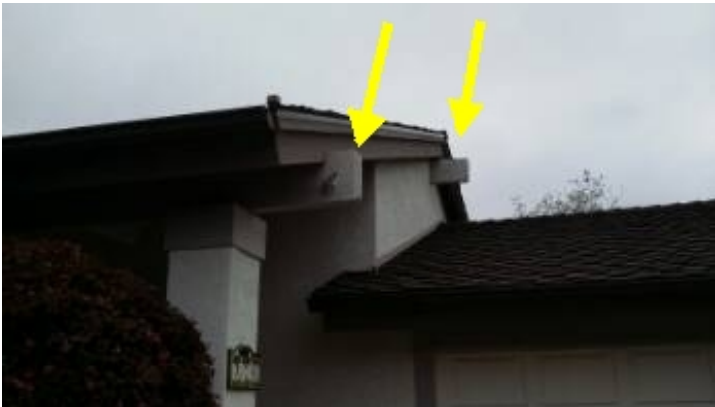
There is moisture damage or dry rot to the wood trim and or fascia on the upper roof area, which is typically not inspected by the pest inspector. The pest control company should be alerted so as to inspect and include these repairs in their estimate.

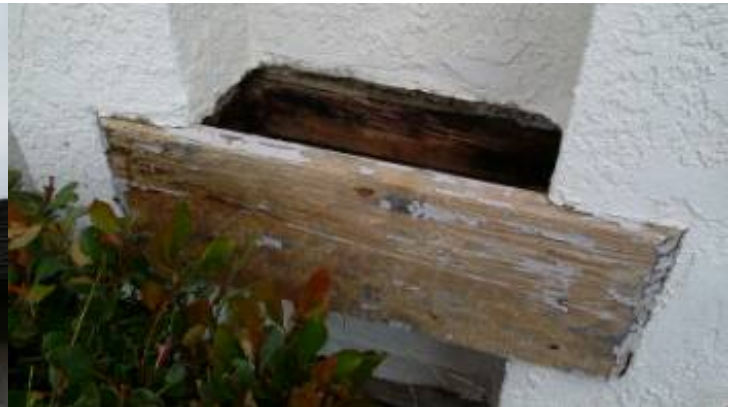
There is damage to the wood trim that should be evaluated by a termite inspector.

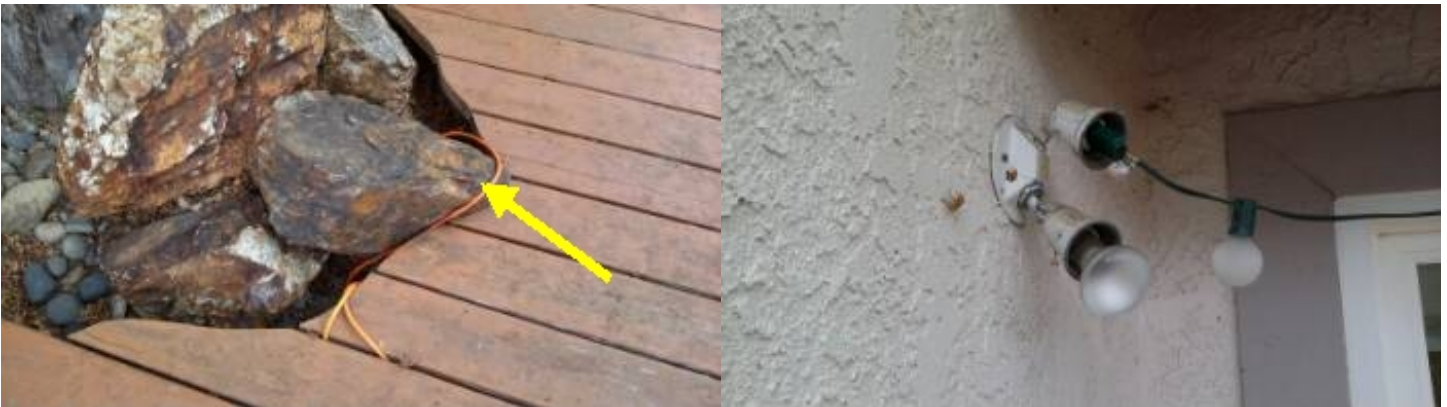
We have noted that an extension cord is being used for permanent wiring which is not allowed in most jurisdictions.

We were not able to activate some of the exterior lights which may be operated on a timer, sensors, or a light bulb that is burned out. Nonetheless, they should be demonstrated as functional by the seller.

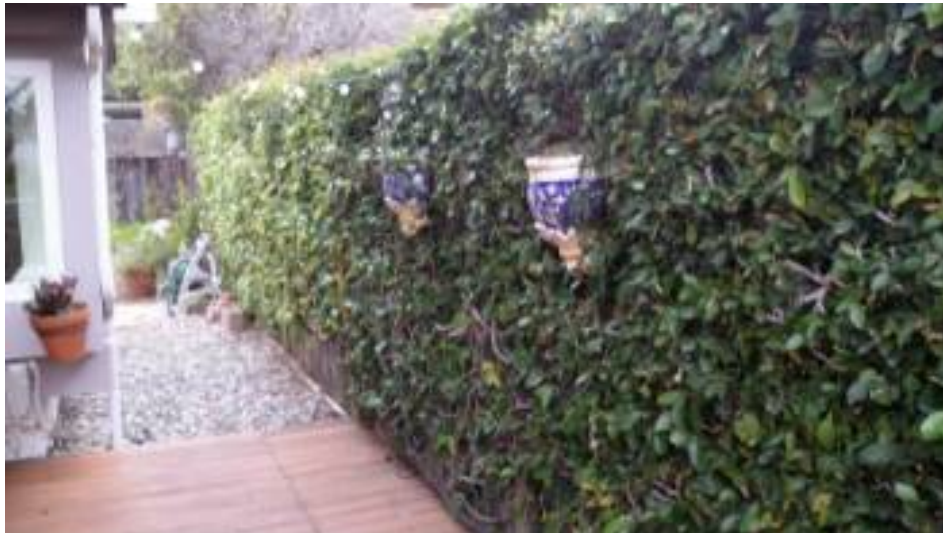
Portions of the fences are obscured by foliage or other material, which prevents a thorough inspection.

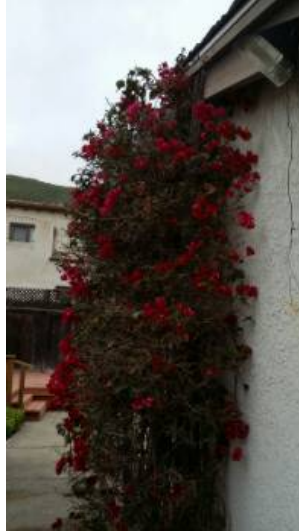
Vegetation is encroaching on the structure, and should be kept a minimum of twelve inches away for the general welfare of the walls and foundation.

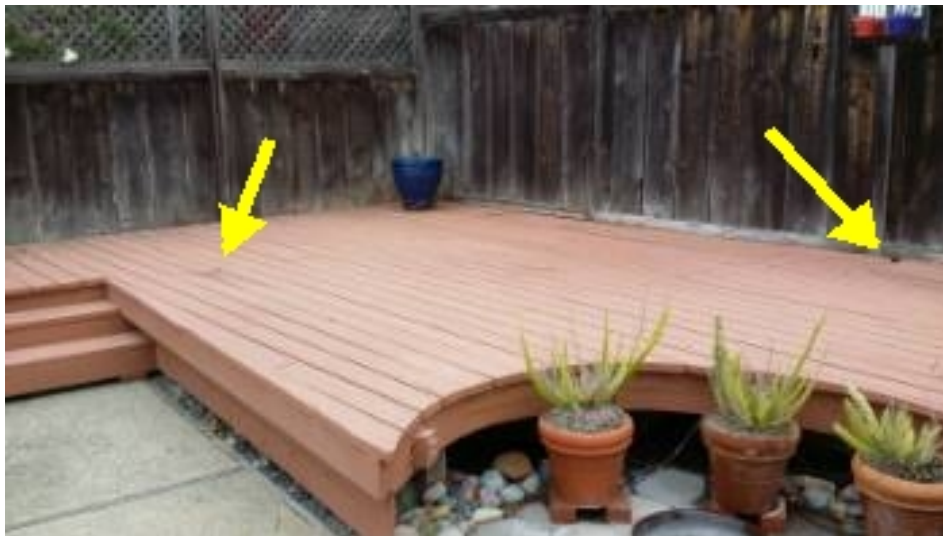
There is damage to the deck that should be evaluated by the termite inspector.

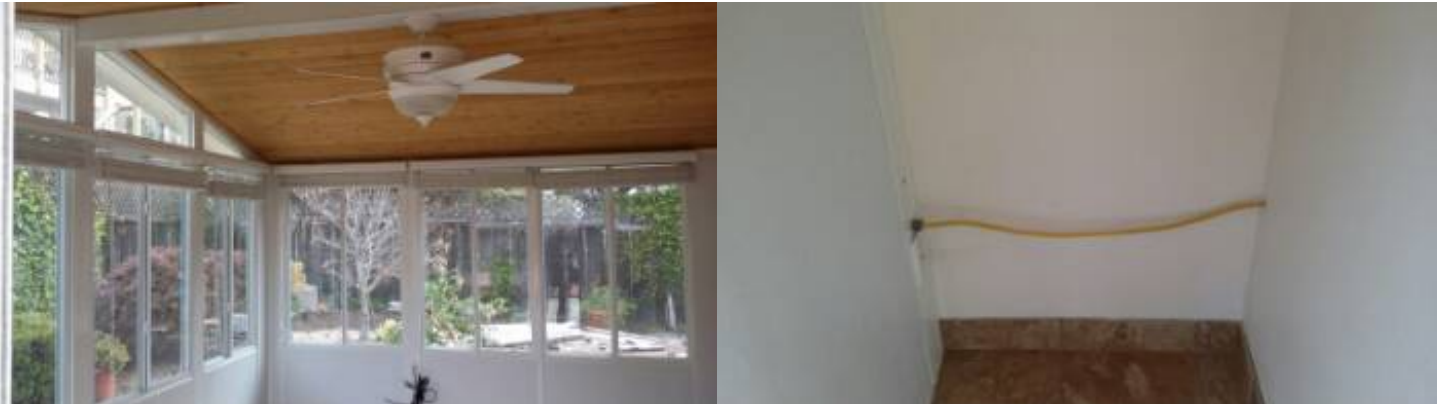
The Patio room is located adjacent to the bedroom 2. There is exposed romex that should be protected by installing the romex inside the wall cavity, or properly wired into conduit.

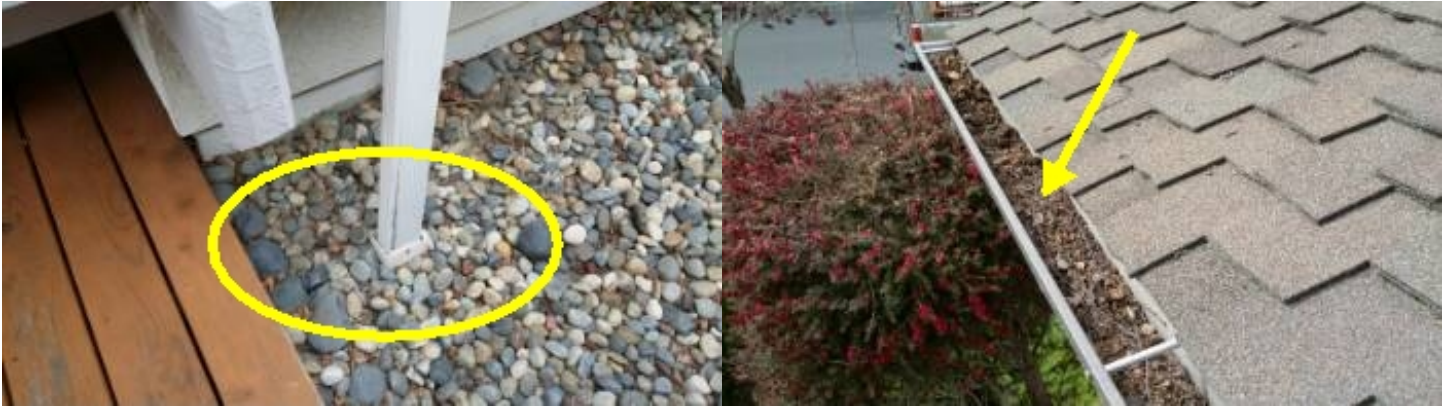
We have noted that the downspouts enter into underground drains, but we cannot confirm their termination points. It should be verified that they are clear, and the termination points be verified.

The gutters need to be cleaned to drain properly.

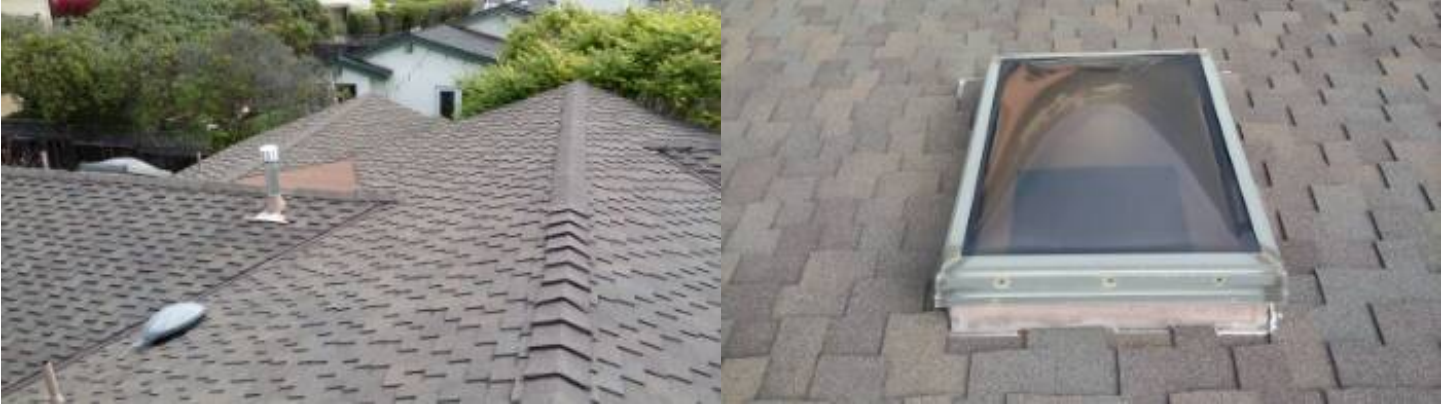
The roof includes one or more skylights, which are notoriously problematic and a common point of leaks. There are different methods of installing them and, although opinions will vary, some methods are better than others. Therefore, it will be important to keep the area around them clean and to monitor them for evidence of leaks.

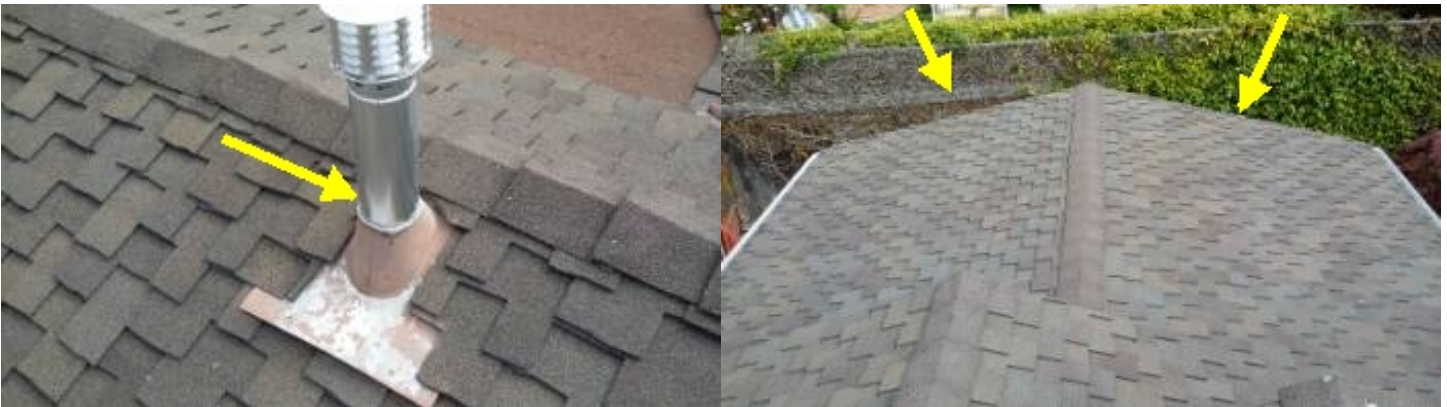
A rain-collar is missing on a heat vent and should be installed.

A portion of the composition shingle roof was installed on a roof with less than a three-twelve pitch, which is typically the minimum pitch recommended by the manufacturers of composition shingles. Therefore, you should request the installation permit from the sellers, which will not only reveal the exact age of the roof and any warranty or guarantee that might be applicable but will confirm a professional installation, or you may wish to have a roofing contractor comment on this issue.

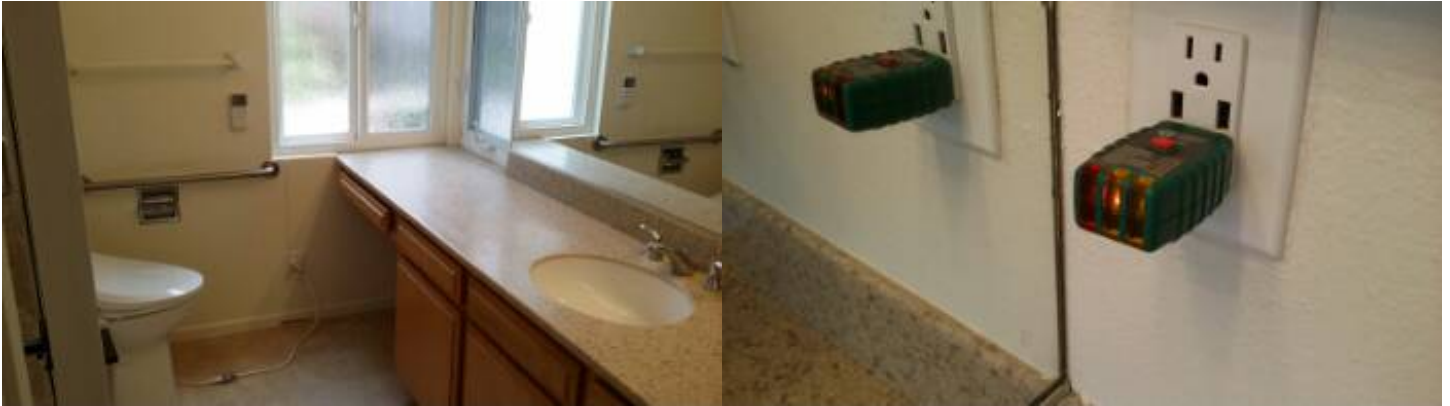
Page 31 Item: 1	Master Bathroom Observations	1.12. The bathroom sink outlet has a has an open-ground, and should be evaluated and serviced by a licensed electrical contractor.
Page 33 Item: 2	Hallway Bathroom	2.13. The outlets are functional, but should be upgraded to have ground-fault protection.

The bathroom sink outlet has a has an open-ground, and should be evaluated and serviced by a licensed electrical contractor.

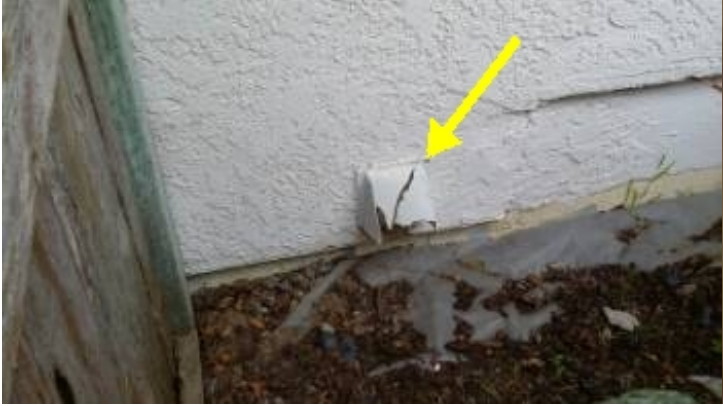
Damaged dryer vent

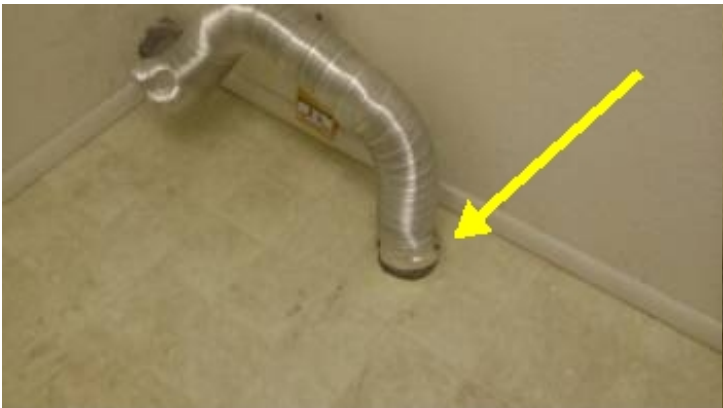
The dryer vent is routed through an inaccessible substructure and should be serviced.

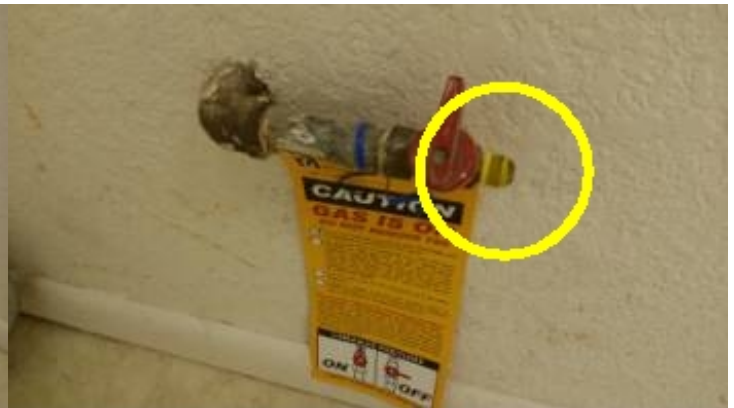
Page 34 Item: 1	Laundry Room	1.7. A gas supply valve is installed but needs an approved connector to connect gas to the dryer, which is not required and you should have one already installed if you have a gas dryer. Gas valve is required to be capped when not in use.
-----------------	--------------	--

A gas supply valve is installed but needs an approved connector to connect gas to the dryer, which is not required and you should have one already installed if you have a gas dryer. Gas valve is required to be capped when not in use.

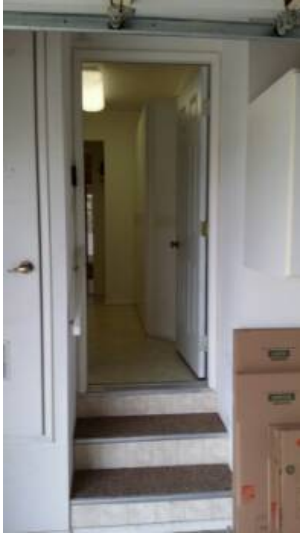
The house entry door is not self-closing and should be serviced.

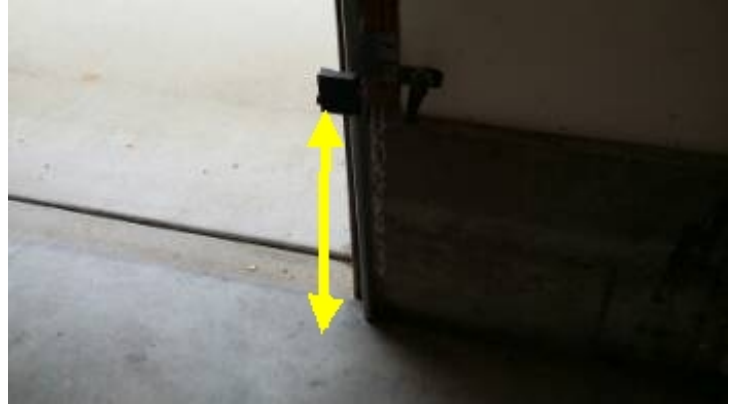
The infra red auto-reversing sensor mechanisms are functional but located higher than the recommend six inches above grade.
