ELEVATE INSPECTIONS

GENERAL RESIDENTIAL INSPECTION

15506 Seaforth Ave Norwalk, CA 90650

Chase Wybenga & Pat Groeneveld AUGUST 23, 2024

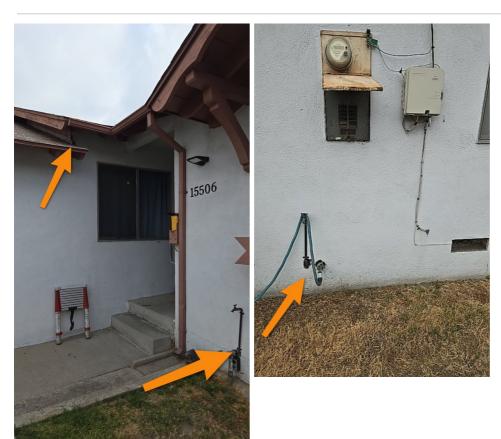
Excessive gaps observed at the wall penetrations. Recommend repair/sealing to prevent water intrusion and pest.

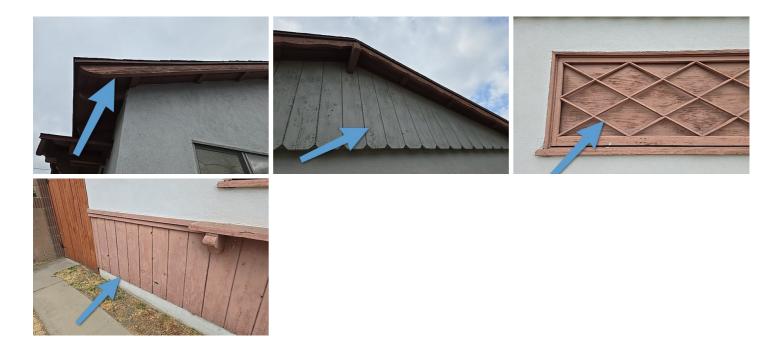
6.3.5 WALL CLADINGS, TRIM & EAVESWEATHERED WOODWeathered wood observed. Suggest maintenance.

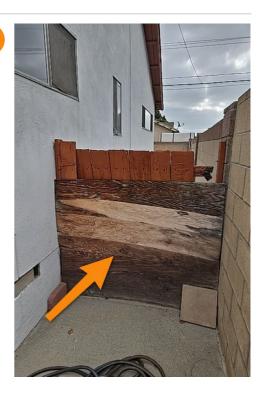
RIGHT

FENCING DETERIORATED

Deteriorated fencing observed. Recommend repair/replacement or maintenance.

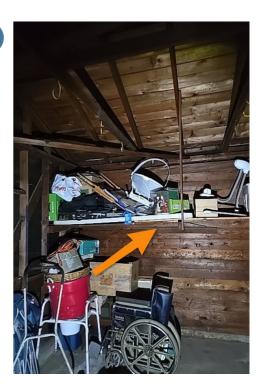
Storage racks/platform are hung from the roof framing. Suggest removal to prevent sagging.

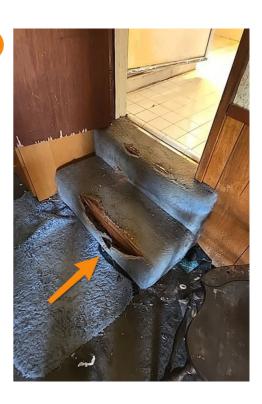
Torn step observed. Recommend securing or replacement.

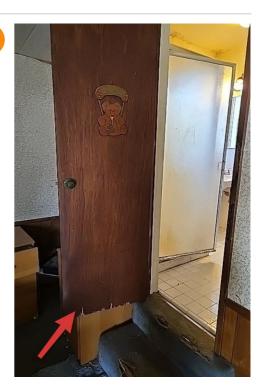
FIRE DOOR - NOT RATED

Fire resistant rated door is not installed. Recommend replacement with the appropriate rated door.

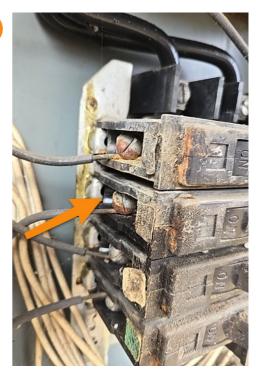
BREAKERS - RUST/CORROSION

Rust/corrosion observed breaker connections. Recommend replacement of the rusted breakers.

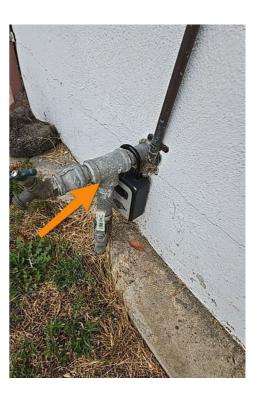
Galvanized distribution piping is in use from the water meter and in areas throughout the home. This type of water distribution is beyond its intended service life. Suggest verifying overall condition and remaining service life with a qualified plumber.

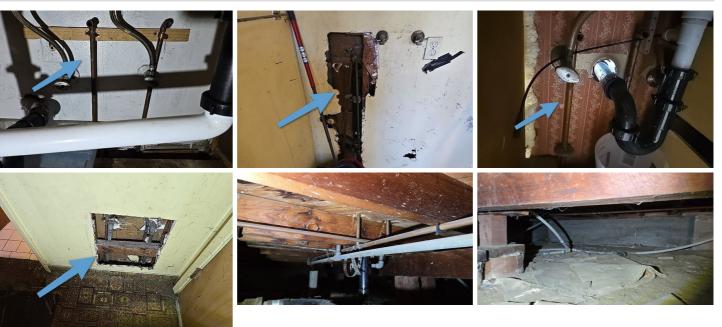
PARTIAL REPIPE

Copper water lines and temporary PEX supply lines were overserved. It appears the house is in the process of being repiped with copper material. Holes and missing sections of walls were observed within the interior spaces. We recommend completing the repipe or verify current condition with a qualified plumber to finish the repipe.

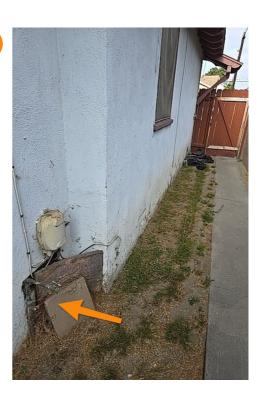
FRONT, REAR, LEFT

Faucet did not respond to test; appears that these fixtures are currently in the process of being connected/repiped. Recommend correcting.

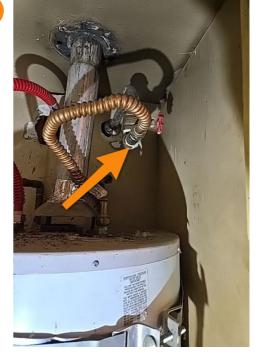
SUPPLY - CORROSION/GATE VALVE COMBO

Corrosion observed at supply piping and a gate type valve is installed. Recommend correcting and upgrading to a ball valve type.

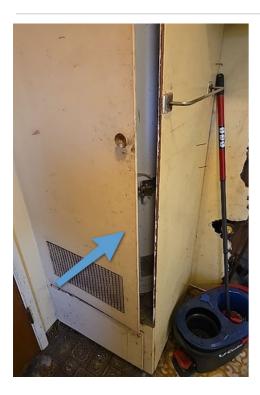
Door to cabinetry is poorly fitted; gaps observed. Suggest replacement.

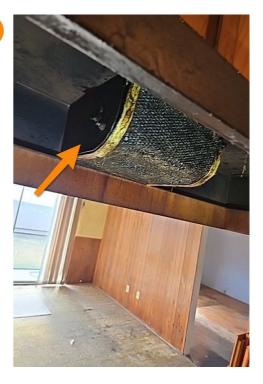
FAN/HOOD APPLIANCE - INOPERABLE

The *APPLIANCES* did not respond to test. Recommend repair/replacement.

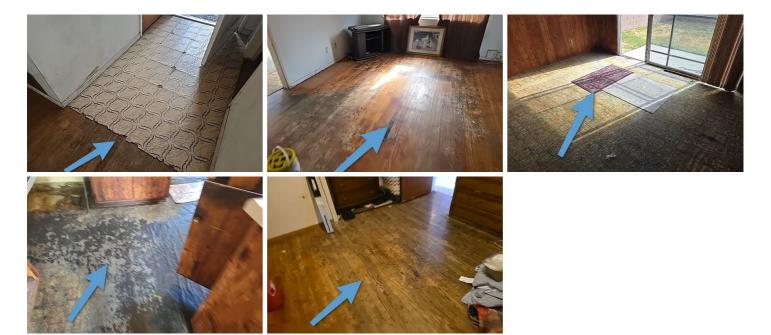
HOLES/PHYSICAL DAMAGE

Hole(s)/physical damage observed. Suggest repair.

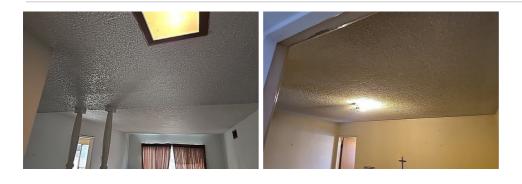
ACOUSTIC/POPCORN TEXTURED

Acoustic textured walls/ceiling observed. Due to the age of the property, we suggest testing, remediation or removal.

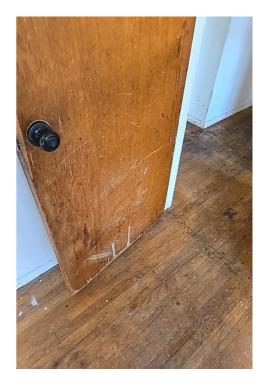
NUMBER OF AREAS

13.2.1 INTERIOR DOORS DELAMINATING/SEPERATING DOOR

Door is separating/delaminating. Suggest repair/replacement.

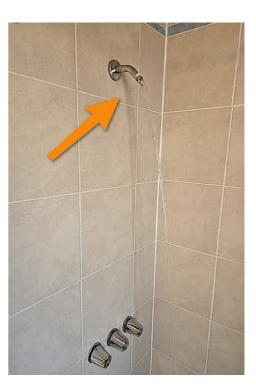
HALLWAY BATHROOM

MISSING SHOWERHEAD

Missing showerhead observed. Recommend replacement.
