WOOD DESTROYING PESTS AND ORGANISMS INSPECTION REPORT

Building No. 201	Street E Platt St. Long Beach CA 90805	City Long Beach CA 90805	Zip 90805	Date of Inspection 06/06/24	Number of Pages 8
----------------------------	--	------------------------------------	---------------------	---------------------------------------	-----------------------------

REPORT# ja8633

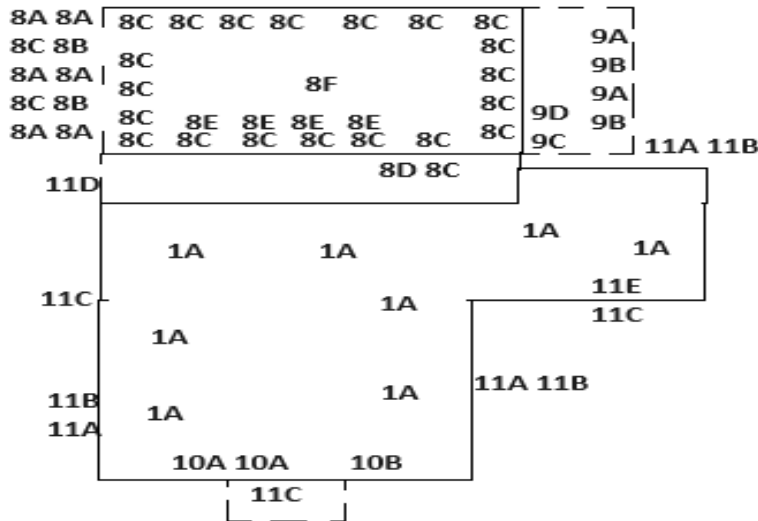
FOUNDATION DIAGRAM (Diagram not to scale)

- Finding: 8A DRY ROT NOTED AT DOOR JAMB, STUCCO MOULDING AS INDICATED ON THE DIAGRAM.
Recommendation: 8A **REPLACE/REPAIR AS NECESSARY TO CORRECT.**
- Finding: 8B EVIDENCE OF DRYWOOD TERMITE DAMAGE NOTED AT 1X4 DOOR TRIM, STUCCO MOULDING AS INDICATED ON THE DIAGRAM.
Recommendation: 8B **REPLACE/REPAIR AS NECESSARY TO CORRECT.**

- Finding: 8C EVIDENCE OF DRYWOOD TERMITES NOTED AT DOOR TRIM AS INDICATED ON THE DIAGRAM.
Recommendation: 8C **THIS IS A PRIMARY RECOMMENDATION-VACATE PREMISES AND SEAL THE STRUCTURE. FUMIGATE WITH A LETHAL GAS-OVERNIGHT.REMOVE THE SEALS AND AIR BUILDING READY FOR OCCUPANCY.REMOVE OR COVER ACCESSIBLE EVIDENCE OF INFESTATION.**

- Finding: 8D EVIDENCE OF DRYWOOD TERMITE DAMAGE NOTED AT 1X4 DOOR TRIM AS INDICATED ON THE DIAGRAM.
Recommendation: 8D **REPLACE/REPAIR AS NECESSARY TO CORRECT.**

- Finding: 8E EVIDENCE OF SUBTERRANEAN TERMITES NOTED AT GARAGE AS INDICATED ON THE DIAGRAM.
Recommendation: 8E **DRILL THROUGH CONCRETE SLAB AND PRESSURE TREAT WITH REG. CHEMICAL FOR THE CONTROL OF SUBTERRANEAN TERMITES. REMOVE ALL ACCESSIBLE TERMITE TUBING. SEAL HOLES WITH CEMENT PLUG.**

- Finding: 9A EVIDENCE OF DRYWOOD TERMITE DAMAGE NOTED AT 1X6 POST TRIM AS INDICATED ON THE DIAGRAM.
Recommendation: 9A **REPLACE/REPAIR AS NECESSARY TO CORRECT.**

- Finding: 9B EVIDENCE OF DRYWOOD TERMITES NOTED AT POST JOIST AS INDICATED ON THE DIAGRAM.
Recommendation: 9B **THIS IS A PRIMARY RECOMMENDATION-VACATE PREMISES AND SEAL THE STRUCTURE. FUMIGATE WITH A LETHAL GAS-OVERNIGHT.REMOVE THE SEALS AND AIR BUILDING READY FOR OCCUPANCY.REMOVE OR COVER ACCESSIBLE EVIDENCE OF INFESTATION.**

- Finding: 9C DRY ROT NOTED AT 2X4 RIM JOIST AS INDICATED ON THE DIAGRAM.
Recommendation: 9C **REPLACE/REPAIR AS NECESSARY TO CORRECT.**
- Finding: 9D FUNGUS NOTED AT RIM JOIST AS INDICATED ON THE DIAGRAM.
Recommendation: 9D **WIRE BRUSH AND REMOVE ALL VISIBLE AND ACCESSIBLE SURFACE FUNGUS. TREAT THE INFECTED AND ADJACENT WOOD MEMBERS WITH TIMBOR (ACTIVE INGREDIENT, SODIUM OCOBORATE) TO CONTROL THE WOOD DECAY FUNGI.**

- Finding: 10A EVIDENCE OF DRYWOOD TERMITES NOTED AT LIVING ROOM WALL AS INDICATED ON THE DIAGRAM.
Recommendation: 10A **THIS IS A PRIMARY RECOMMENDATION-VACATE PREMISES AND SEAL THE STRUCTURE. FUMIGATE WITH A LETHAL GAS-OVERNIGHT.REMOVE THE SEALS AND AIR BUILDING READY FOR OCCUPANCY.REMOVE OR COVER ACCESSIBLE EVIDENCE OF INFESTATION.**

Finding: 11A EVIDENCE OF DRYWOOD TERMITE DAMAGE NOTED AT FRAMING ACCESS AS INDICATED ON THE DIAGRAM.

Finding: 11B EVIDENCE OF DRYWOOD TERMITES NOTED AT FRAMING ACCESS AS INDICATED ON THE DIAGRAM.

Finding: 11C DRY ROT NOTED AT DOOR SILL AS INDICATED ON THE DIAGRAM.

Finding: 11D DRY ROT NOTED AT CUSTOM FENCE AS INDICATED ON THE DIAGRAM.

Finding: 11E EVIDENCE OF DRYWOOD TERMITE DAMAGE NOTED AT 1 3/8X36X76 CUSTOM FRONT DOOR AS INDICATED ON THE DIAGRAM.

Finding: 1A FAULTY GRADE WAS FOUND AT SUBAREA AS INDICATED ON THE DIAGRAM

Finding: 8F CRACKS NOTED IN FOUNDATION AS INDICATED ON THE DIAGRAM

Finding: 10B WATER DAMAGE NOTED AT BEDROOM WALL AS INDICATED ON THE DIAGRAM.

Recommendation: 11A REPLACE/REPAIR AS NECESSARY TO CORRECT.

Recommendation: 11B THIS IS A PRIMARY RECOMMENDATION-VACATE PREMISES AND SEAL THE STRUCTURE. FUMIGATE WITH A LETHAL GAS-OVERNIGHT.REMOVE THE SEALS AND AIR BUILDING READY FOR OCCUPANCY.REMOVE OR COVER ACCESSIBLE EVIDENCE OF INFESTATION.

Recommendation: 11C REPLACE/REPAIR AS NECESSARY TO CORRECT.

Recommendation: 11D OWNER TO CONTACT PROPER TRADESMEN TO MAKE ANY NECESSARY REPAIRS.

Recommendation: 11E REPLACE/REPAIR AS NECESSARY TO CORRECT. AN EXACT MATCH OF MATERIALS IS NOT GUARANTEED. WARRANTY DOES NOT APPLY TO DAMAGES CAUSED BY WEATHER.

Recommendation: 1A LOWER SOIL TO PROPER GRADE LEVEL(S).

Recommendation: 8F OWNER TO CONTACT PROPER TRADESMEN TO MAKE ANY NECESSARY REPAIRS.

Recommendation: 10B OWNER TO CONTACT PROPER TRADESMEN TO MAKE ANY NECESSARY REPAIRS.
