The Chimney Guy, Inc.

Inspection Report

██████████
3417 Palos Verdes Dr. N.
Palos Verdes Estates, CA 90274
310.499.8065
██████████

Living room 1-story Masonry Fireplace

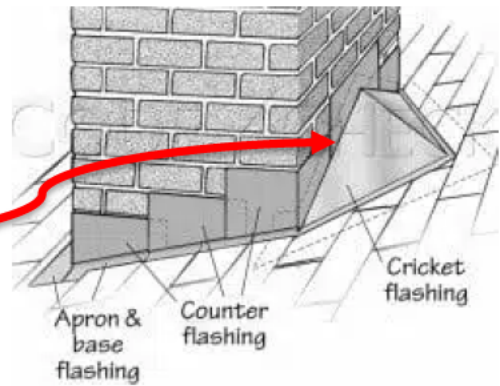
Chimney Cricket

The flashing behind the chimney is flat and can allow water to pool. For a chimney 30” or wider, there should be a chimney cricket installed behind the chimney. A cricket is a ridge structure designed to divert water on a roof around the high side of a chimney. It is recommended to have a roofer install a cricket behind the chimney. This is a maintenance issue.
