CROSSWIND SEWER INSPECTION

4338 Carfax Ave
Lakewood, CA 90713

03/05/2024

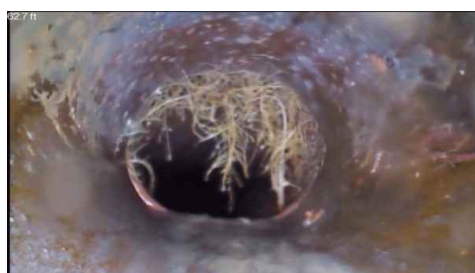
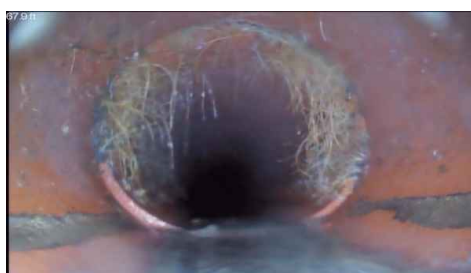
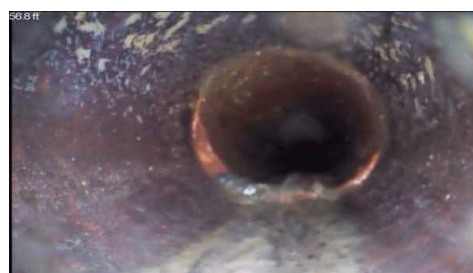
4.1.1 Drain System

4.1.1 Qualitative Survey of Main Sewer Line - Drain System: Root Growth
 -

ROOT GROWTH

There is root growth present which is commonly a result of a damaged drain line or entry at joint. We recommend Contacting a plumbing company to clear the roots and further evaluate the line for damage related to the root penetration.

Contact a qualified professional.

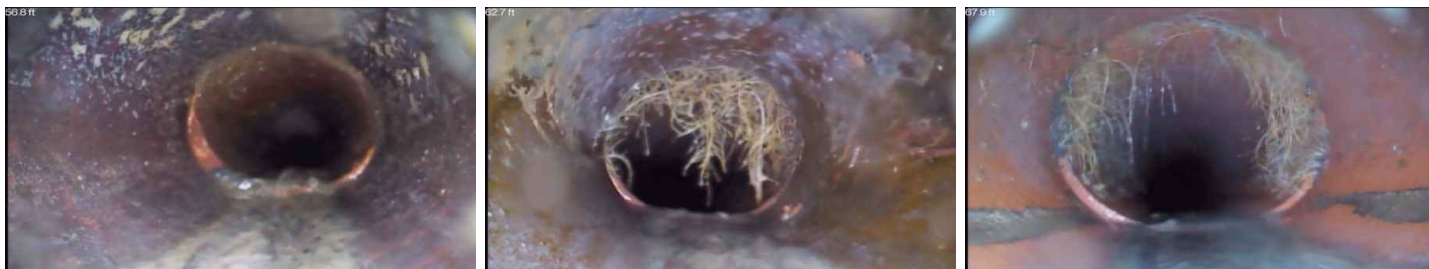
4.1.2 Drain System

RECOMMEND HYDRO-JETTING

Hydro-jetting offers a comprehensive cleaning of your plumbing. The system uses, on average, 4000 psi. That level of pressure and the amount of water is sure to tackle even the smallest of dust particles. It clears out any obstructions, clogs, or build up, allowing the water to run smoothly after. We always recommend consulting a professional for any work that gets done.

Contact a qualified plumbing contractor.

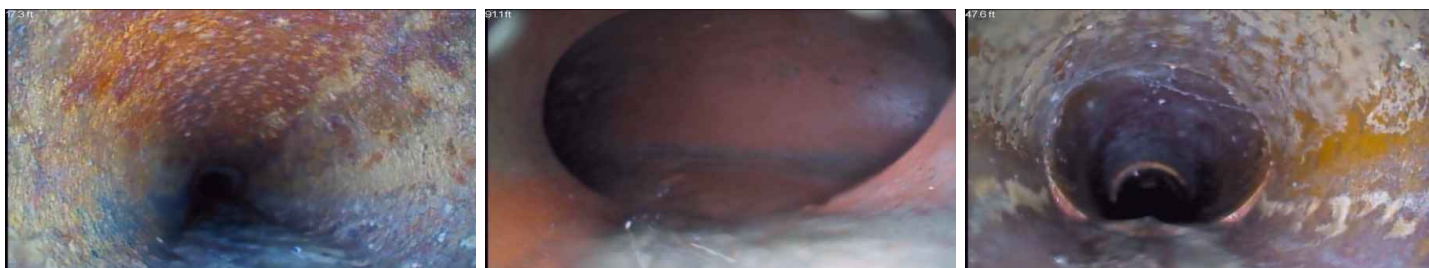
4.1.3 Drain System

RECOMMEND A GROUND LEVEL 4" CLEAN OUT

We would recommend adding a ground level 4" clean out for plumbing access to maintain drain system.

Contact a qualified professional.
