Sewer Inspection Report

**323 South Francisca
Redondo Beach, California 90277**

Thursday, November 11, 2021 at 8:33 AM

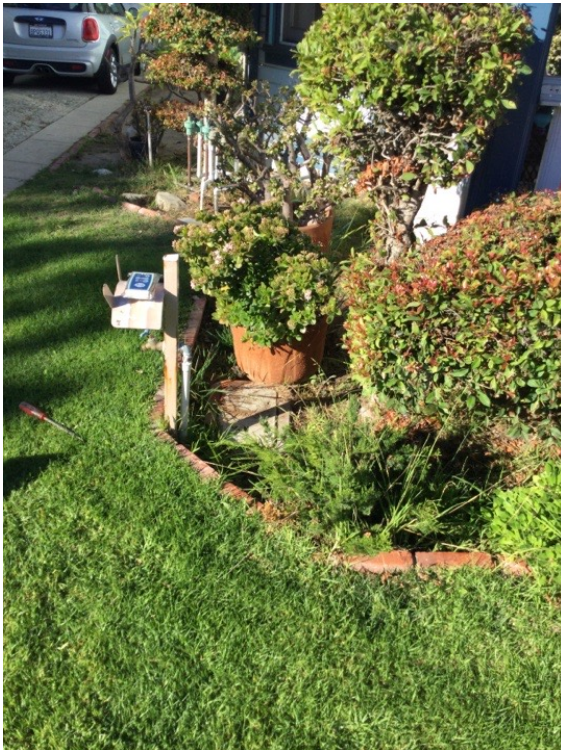
Four inch abs plastic clean out.
