## Confidential Inspection Report

LOCATED AT:  
579 Crane Blvd  
Los Angeles, California 90065

INSPECTED ON:  
Thursday, April 24, 2025

Inspector, Jerry Holt  
Brooke and Sons Inspections

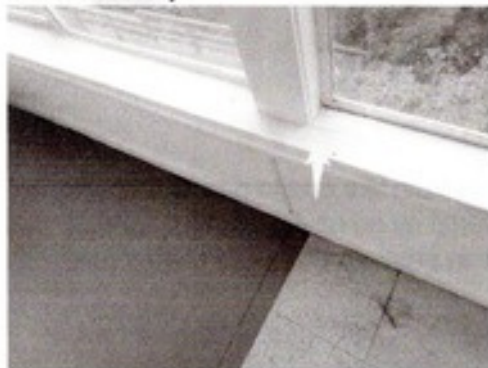
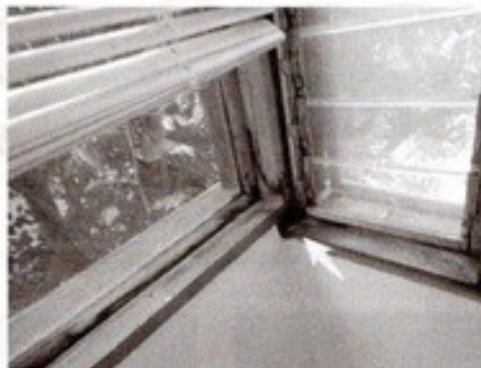
**s-42:** Attention needed: There is evidence of leakage. There is wet trim noted from the interior of the wall cavity.

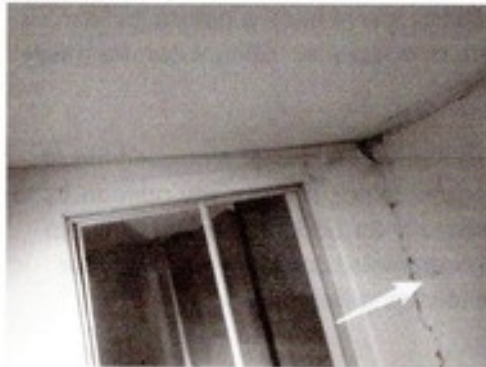
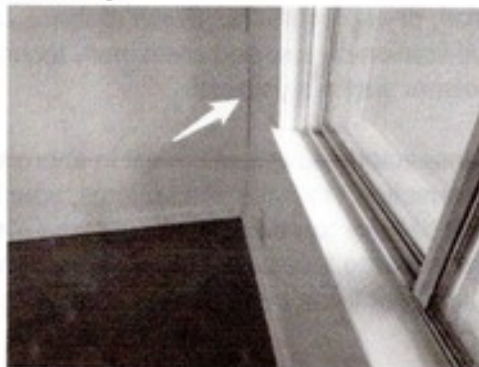
**s-48:** Attention needed: Stress or settlement cracks are seen throughout. This does indicate evidence of prior structural movement. Suggest further evaluation by qualified professional such as structural engineer to determine cause and remedy.

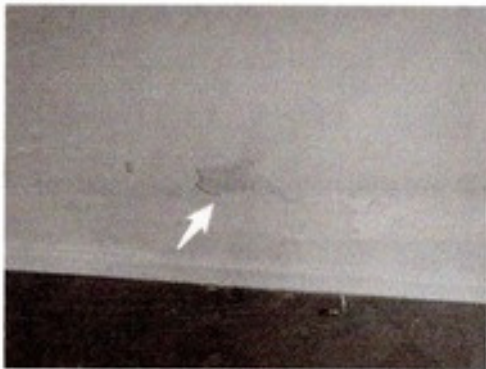
**s-49:** Peeling paint is seen at some locations. Recommend testing for presence of lead prior to any work

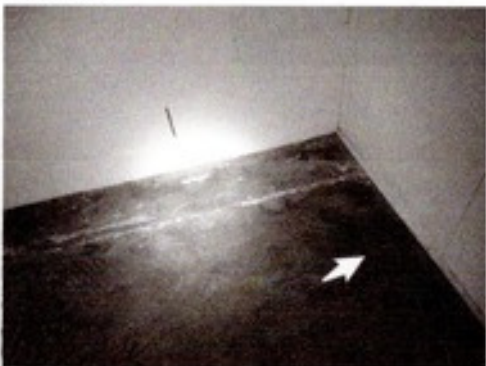
**s-50:** General water stains seen in various areas that are more than like due to previous roof leak issues. Some of the darker stains should be evaluated and tested by an environmental agency. This would determine on whether or not any special remediation procedures would need to be followed.

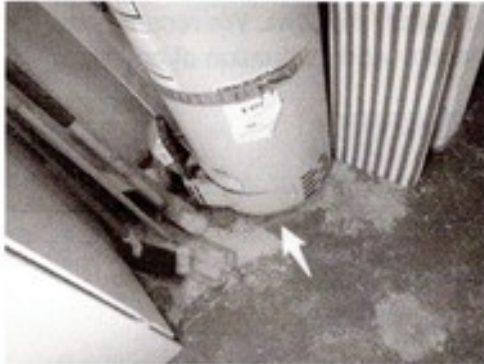
**s-67:** Tank lacks a sheet metal pan. Ideally a sheet metal pan would have been installed under this tank with a drain to prevent potential water damage to structure in the event of leak.

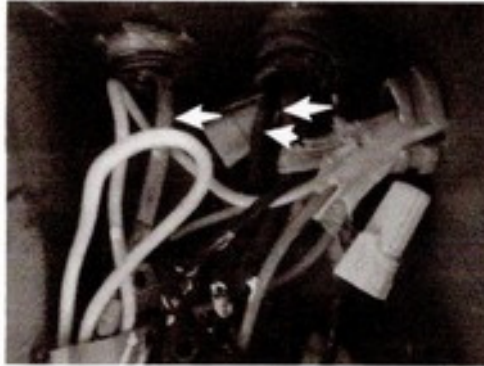
**s-98:** Attention needed: It looks as though that some of the wiring is of the older cloth insulation. This type of insulation wears and breaks off with age. Most electricians in the industry will recommend upgrades to newer plastic insulated conductors for safety reasons. We recommend that a qualified licensed and insured contractor do further inspection and evaluation of any cloth covered wiring.

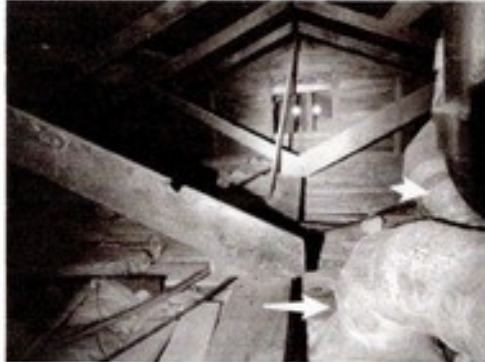
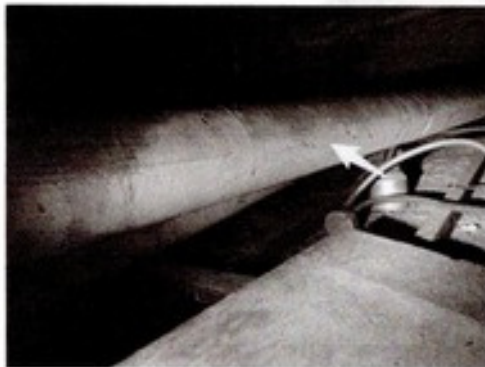
**s-128:** The original duct work that appears to be of asbestos product that is compromised and or in poor condition . Further testing and removal needed.

You need to be aware that some buyers are concerned about asbestos materials in relation to health considerations as well as cost to remove the materials should conditions of the materials or remodeling call for it. Further information can be obtained by environmental agency.

Contact a qualified asbestos abatement agency for further evaluation

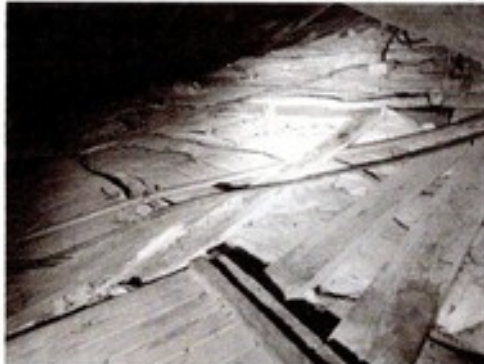
**s-143:** The attic insulation appears not to be correctly installed or needs attention.

**s-144:** Attention Needed - The attic insulation appears not to be correctly installed or needs attention. Paper exposed on insulation is not to industry standards. Manufactures Installation instructions requires paper to be covered by a non combustible material such as sheetrock or using insulation with non flammable backing..

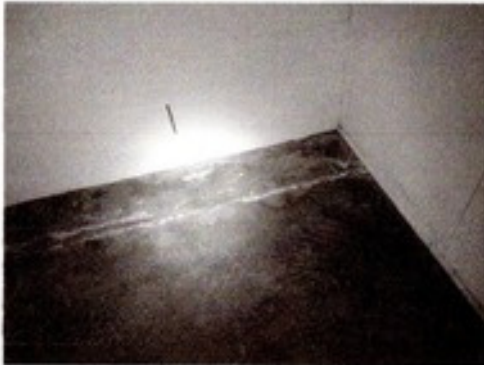
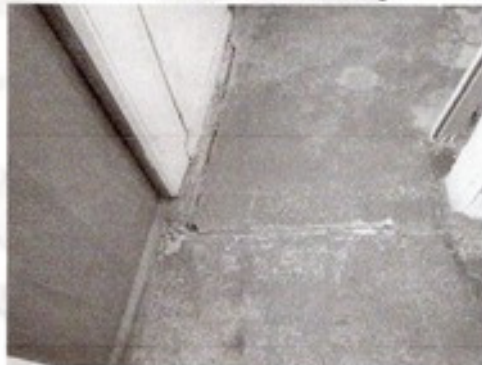
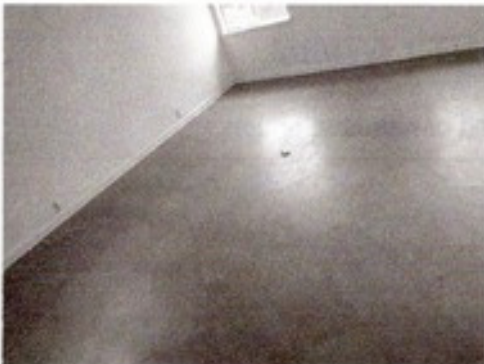
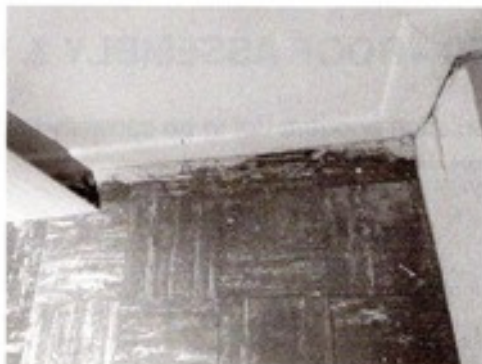
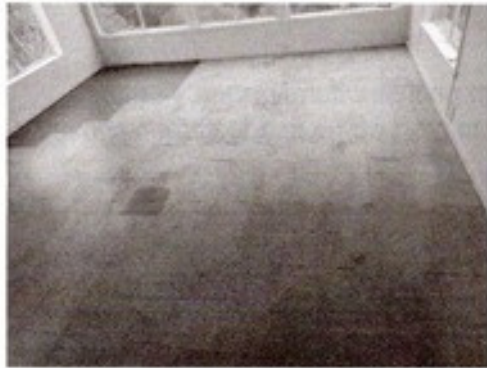
**s-157:** Unsatisfactory- Flooring is deteriorated throughout. Extensive repairs will be needed. Contact a licensed contractor for further evaluation as to extent of damage as well as cost.

**s-158:** Issues noted are as such: Excessive sloping to the degree that foundation problems are present. Further evaluation as to cause is needed. Contact licensed and insured foundation specialist or licensed qualified engineer.

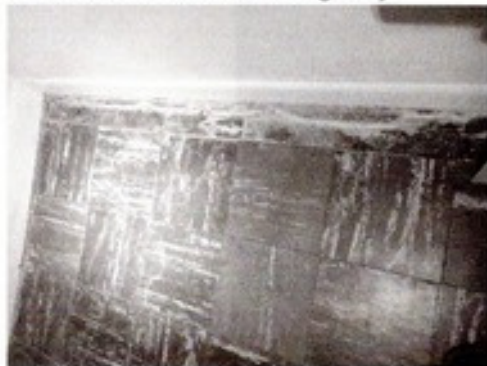
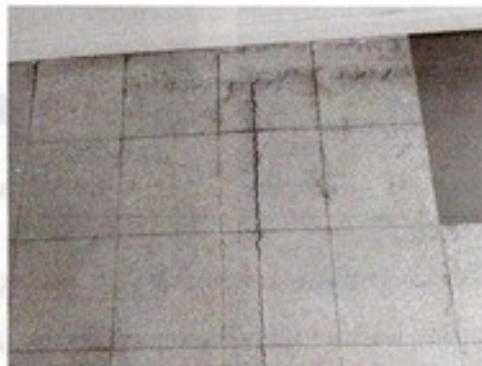
**s-159:** Attention needed: Possible Vinyl asbestos tiles noted in areas. Further evaluation by licensed environmental agency.

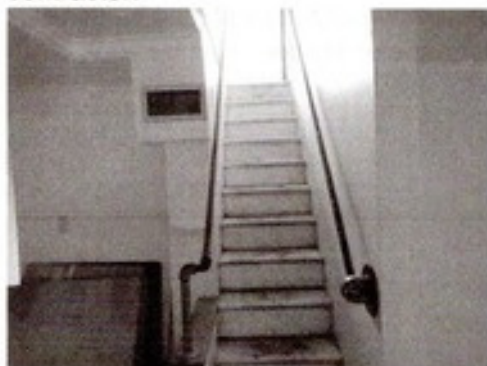
**s-160:** Attention: Stairway width not to today's standards. Further evaluation by licensed general contractor.

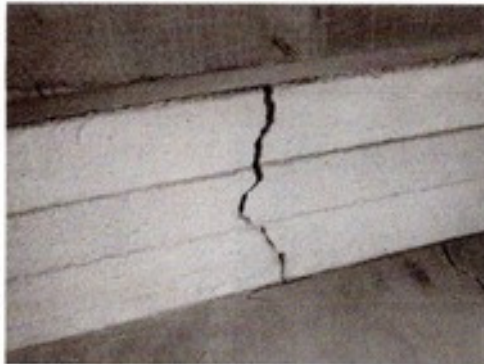
**s-189:** Horizontal cracks were noted in at least one exterior wall.

**s-191:** These conditions warrant further investigation by a Professional Engineer or qualified licensed foundation contractor. Seek bids to remedy the condition from at least three (3) Licensed Professional Foundation Contractors.

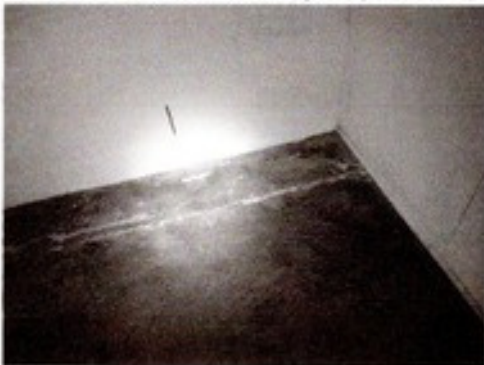
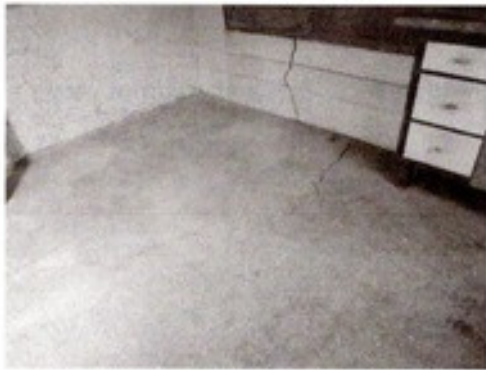
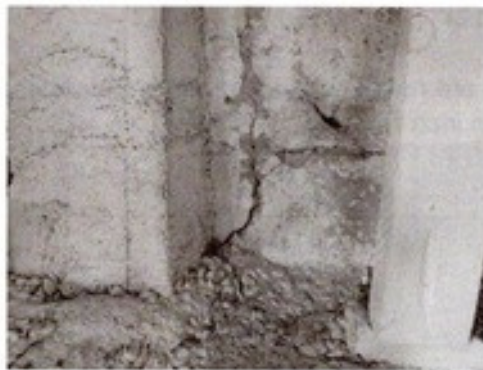
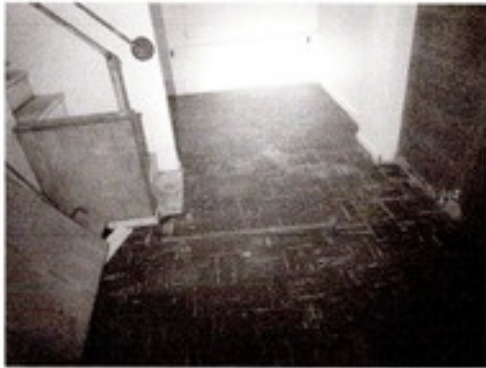
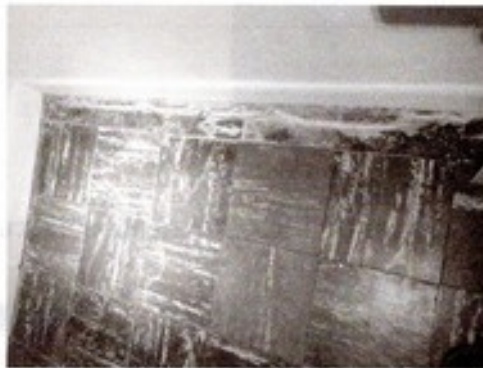
**s-192:** Uneven areas of sub floor noted. These uneven areas warrant further investigation by a licensed foundation contractor. Make arrangements with seller or pertinent party to have floor covering removed exposing sub slab for further viewing. All further investigations should be done during inspection contingency period prior to close of escrow or transfer of title.

**s-193:** Significant cracks were noted that warrant further inspection by a licensed foundation expert or licensed structural engineer.

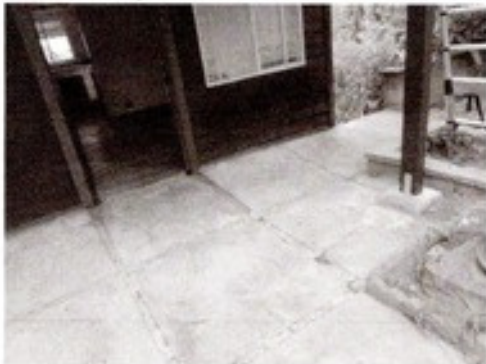
**s-196:** The walkways need action. Repair or replacement is indicated.

**s-197:** The walkway slope is such that water either does not run off or run-off is directed towards the house. This run-off may interfere with the foundation. The driveway should slope to allow water to run away from the structure and foundation.

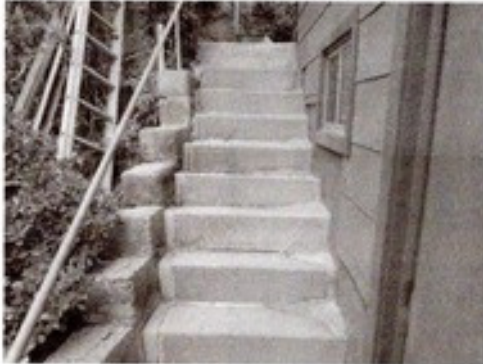
**s-199:** Step risers are not of even increments and a potential trip hazard. Steps should not vary more than 3/8 of an inch from step to step

**s-200:** Steps are in poor repair. Further evaluation by licensed general contractor.

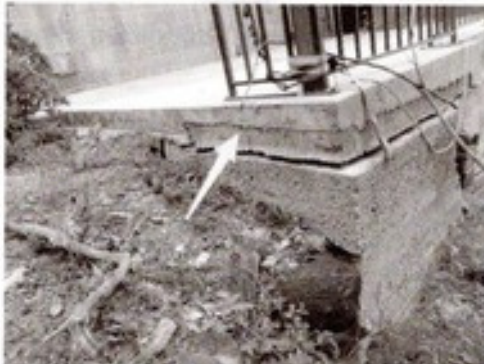
**s-202:** The slab is in such a condition that repair or replacement is necessary.

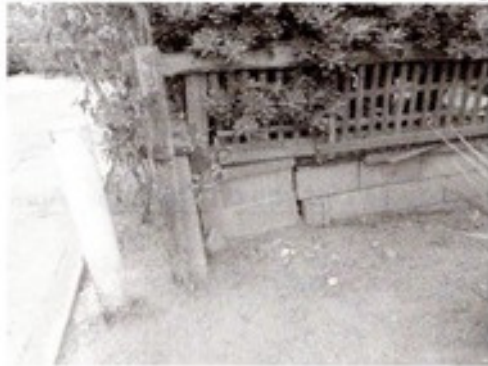
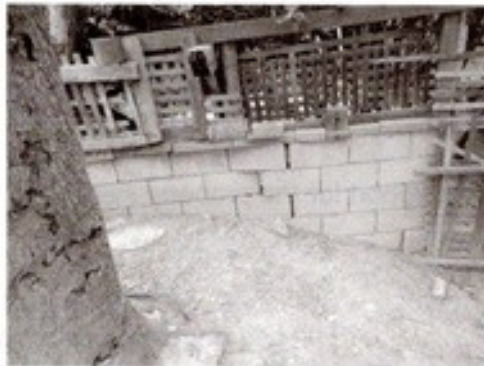
**s-204:** Attention Needed - The fencing needs to be repaired.

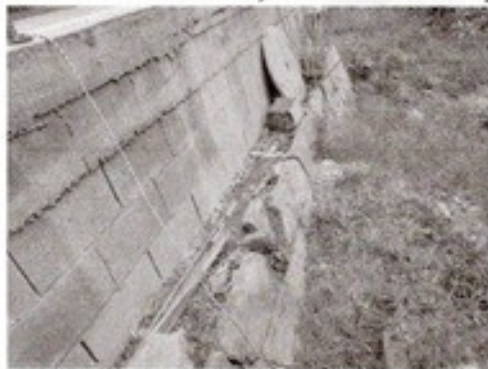
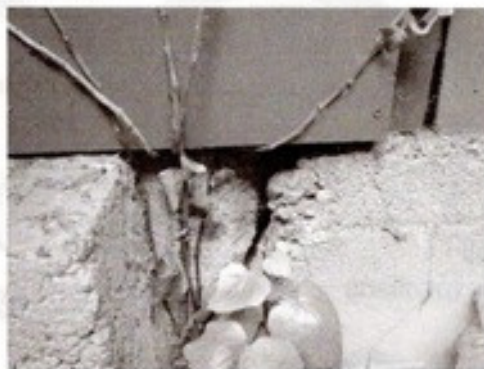
**s-207:** Attention needed: The retaining wall requires some repair or replacement which is due either to movement or deteriorated materials.

Further evaluation by licensed masonry contractor.

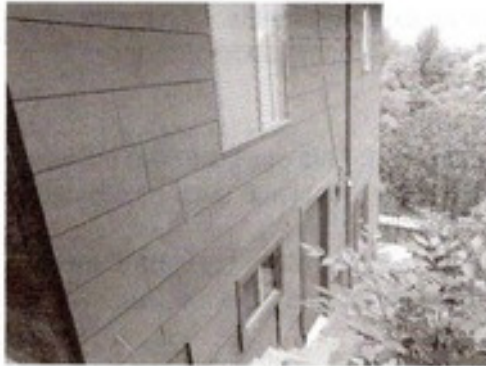
38: Asbestos Cement Shingles.

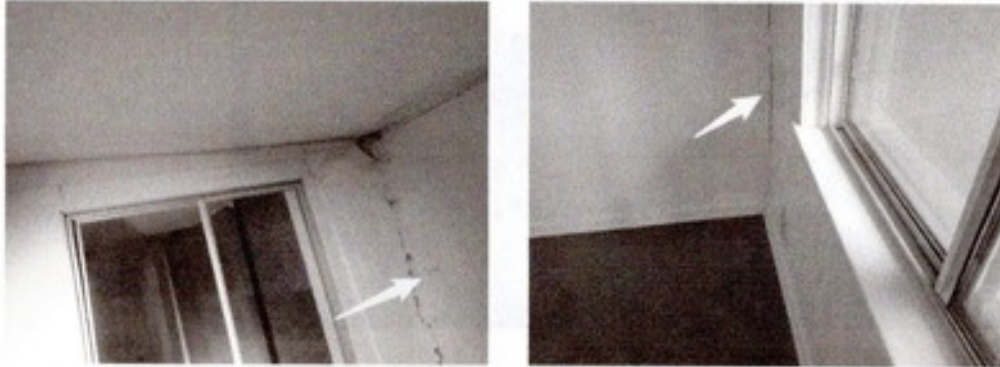
**48:** Attention needed: Stress or settlement cracks are seen throughout. This does indicate evidence of prior structural movement. Suggest further evaluation by qualified professional such as structural engineer to determine cause and remedy.

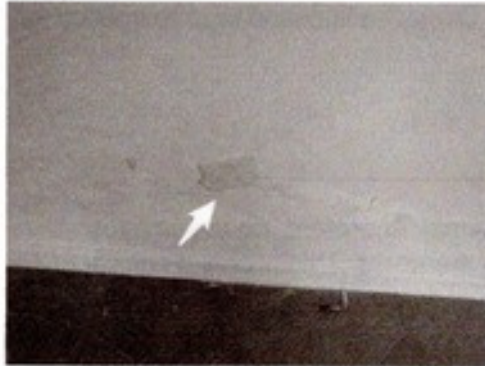
**49:** Peeling paint is seen at some locations. Recommend testing for presence of lead prior to any work

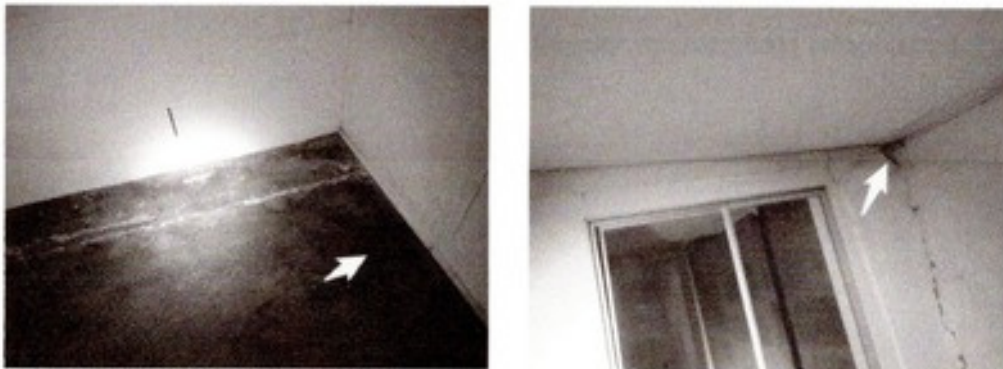
**50:** General water stains seen in various areas that are more than likely due to previous roof leak issues. Some of the darker stains should be evaluated and tested by an environmental agency. This would determine on whether or not any special remediation procedures would need to be followed.

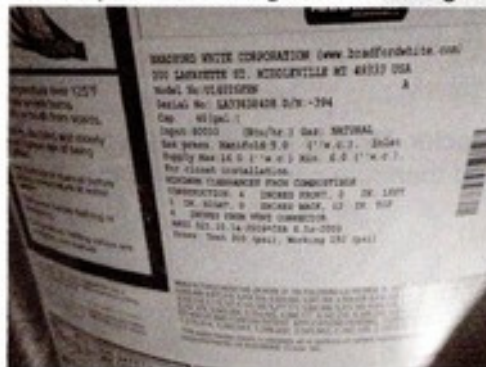
65: 11 years old, 40 gallon natural gas fired. Average life span of a water heater is 12 to 15 years.

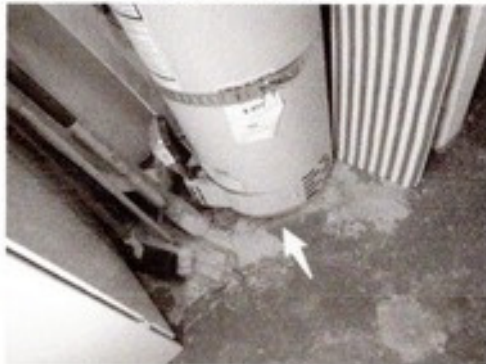
67: Tank lacks a sheet metal pan. Ideally a sheet metal pan would have been installed under this tank with a drain to prevent potential water damage to structure in the event of leak.

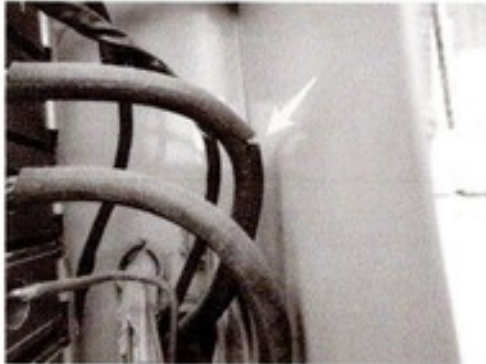
**90:** Action Necessary - Electrical circuitry wiring in the power panel shows some condition that calls for the immediate action of a qualified licensed electrician.

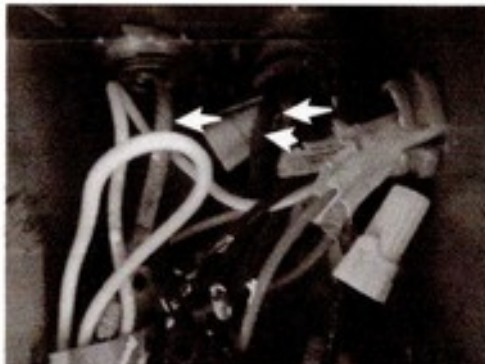
**98:** Attention needed: It looks as though that some of the wiring is of the older cloth insulation. This type of insulation wears and breaks off with age. Most electricians in the industry will recommend upgrades to newer plastic insulated conductors for safety reasons. We recommend that a qualified licensed and insured contractor do further inspection and evaluation of any cloth covered wiring.

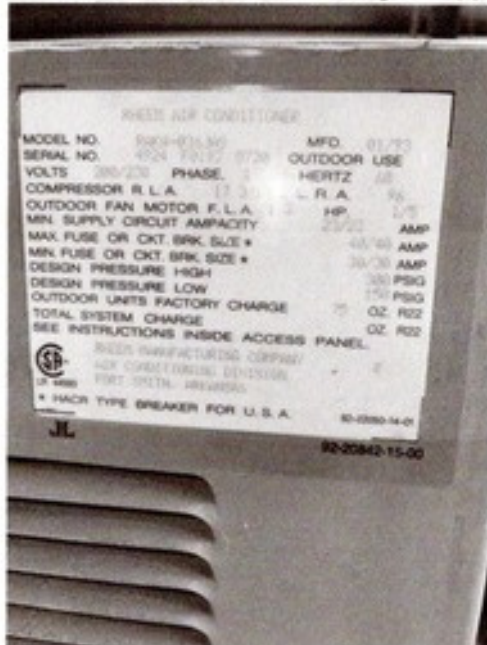
121: 32 years old, 3 ton. The typical service life for an AC unit is 12 - 15 years.  
Each ton provides conditioning for approximately 500-600 square feet of area.

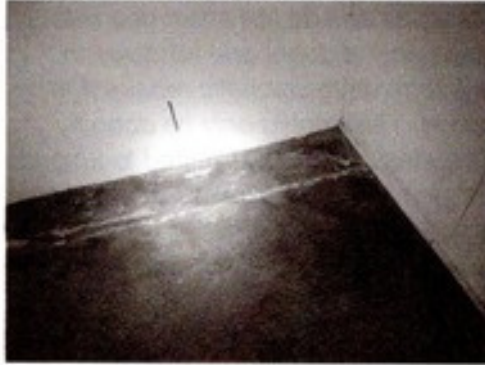
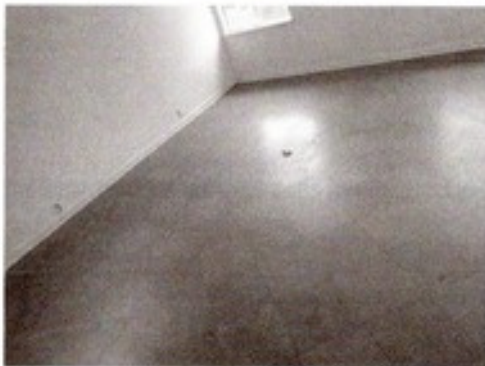
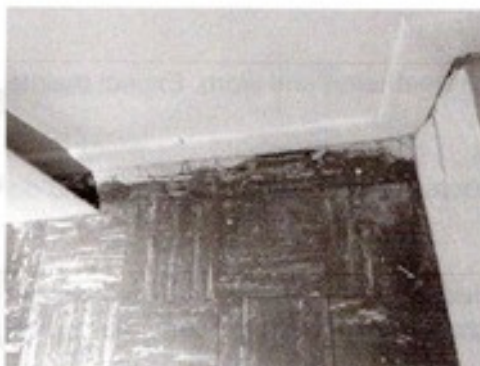
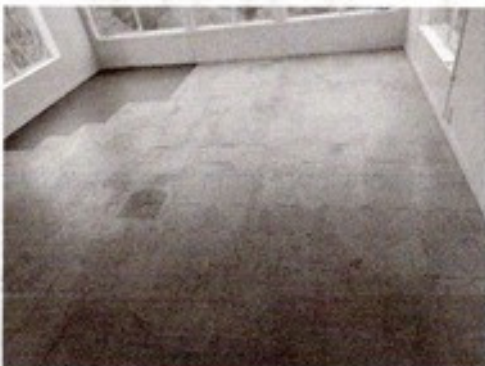
**157:** Unsatisfactory- Flooring is deteriorated throughout. Extensive repairs will be needed. Contact a licensed contractor for further evaluation as to extent of damage as well as cost.

**158:** Issues noted are as such: Excessive sloping to the degree that foundation problems are present. Further evaluation as to cause is needed. Contact licensed and insured foundation specialist or licensed qualified engineer.

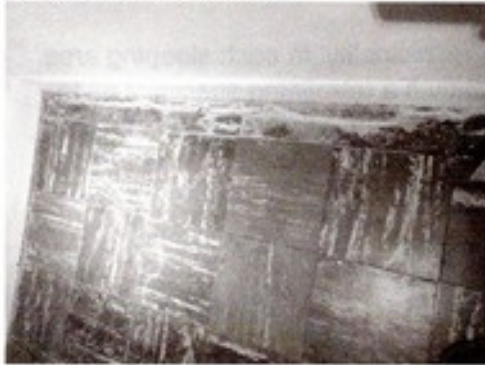
**159:** Attention needed: Possible Vinyl asbestos tiles noted in areas. Further evaluation by licensed environmental agency.

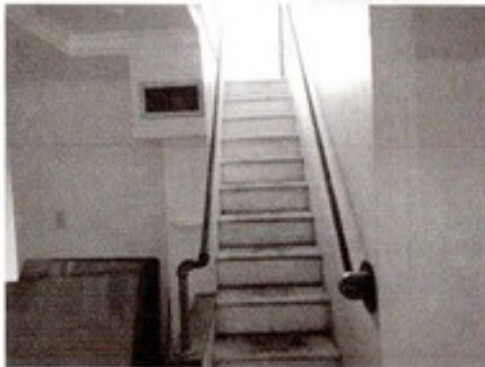
**160:** Attention: Stairway width not to today's standards. Further evaluation by licensed general contractor.

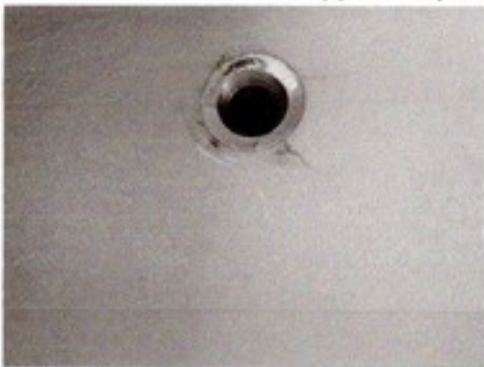
181: Attention: Sink is chipped. Replacement is expected

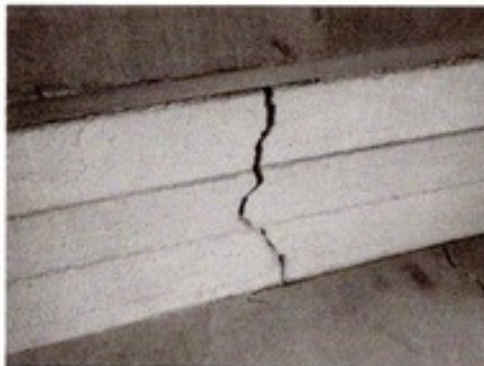
**189:** Horizontal cracks were noted in at least one exterior wall.

**190:** Attention needed: Cracking in the vertical foundation walls was noted. Cracks of 1/4" and wider were noted in the foundation walls. This condition warrants further investigation and analysis by a professional structural engineer and/or a licensed qualified foundation contractor to determine the cause and course of action

**191:** These conditions warrant further investigation by a Professional Engineer or qualified licensed foundation contractor. Seek bids to remedy the condition from at least three (3) Licensed Professional Foundation Contractors.

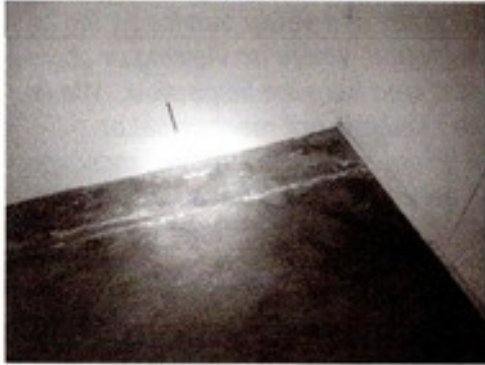
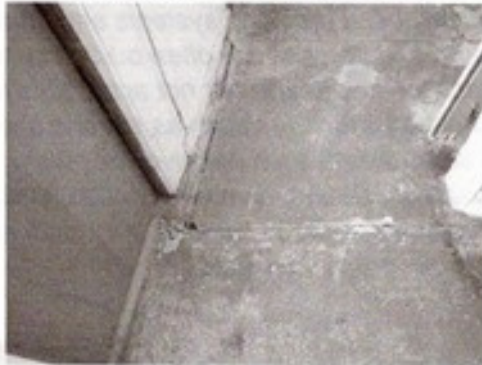
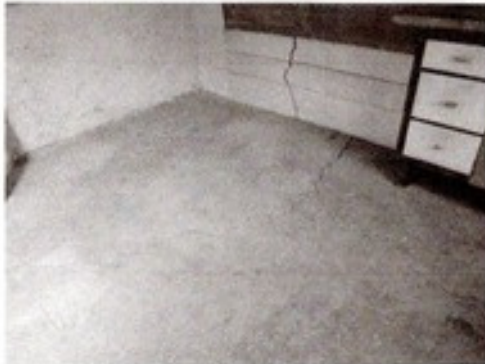
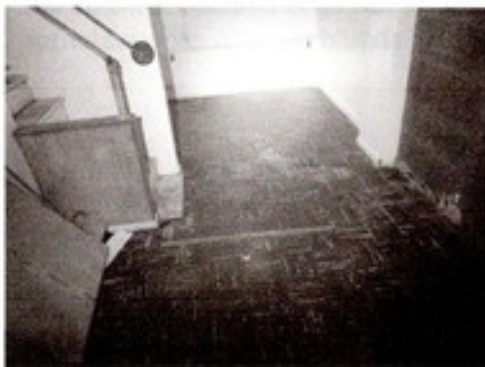
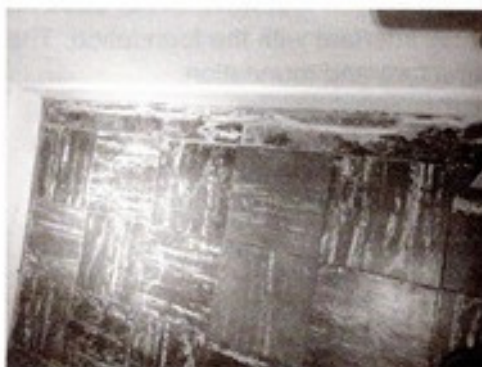
**192:** Uneven areas of sub floor noted. These uneven areas warrant further investigation by a licensed foundation contractor. Make arrangements with seller or pertinent party to have floor covering removed exposing sub slab for further viewing. All further investigations should be done during inspection contingency period prior to close of escrow or transfer of title.

**193:** Significant cracks were noted that warrant further inspection by a licensed foundation expert or licensed structural engineer.

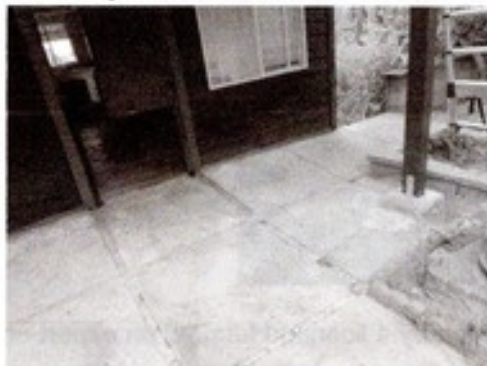
**197:** The walkway slope is such that water either does not run off or run-off is directed towards the house. This run-off may interfere with the foundation. The driveway should slope to allow water to run away from the structure and foundation.

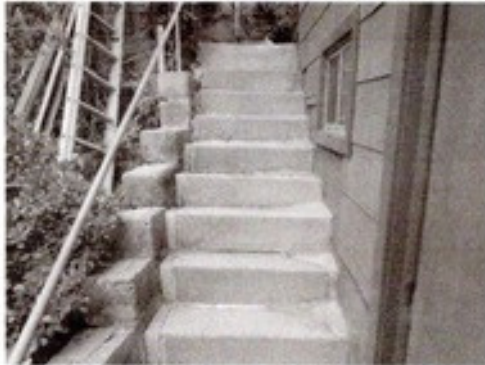
199: Step risers are not of even increments and a potential trip hazard. Steps should not vary more than 3/8 of an inch from step to step

200: Steps are in poor repair. Further evaluation by licensed general contractor.

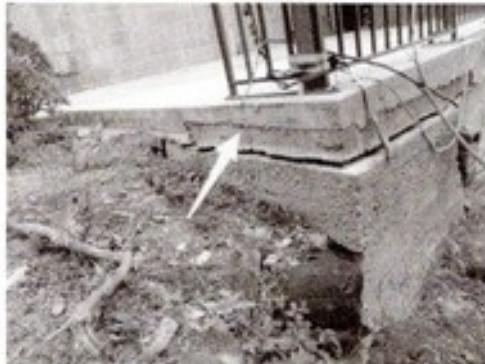
202: The slab is in such a condition that repair or replacement is necessary.

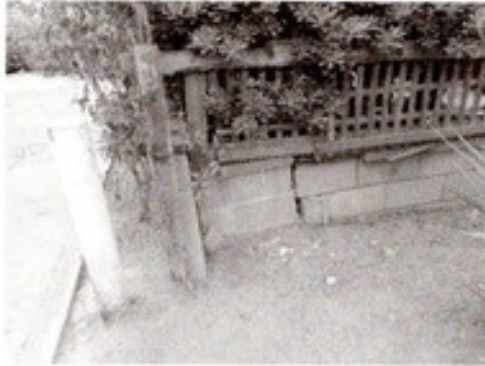
**204:** Attention Needed - The fencing needs to be repaired.
