HENRY
HOME
INSPECTIONS LLC

Inspection Report

4924 Shelby Lane, Clearlake, California 95422

AP-381-001786

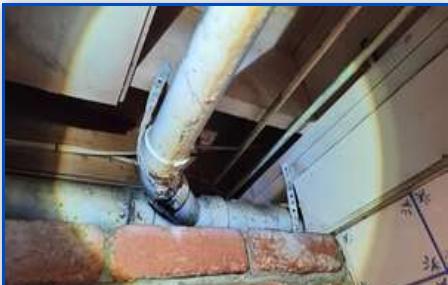
Location: KITCHEN

4.9.1 Leaking drain connections

The drain above the cooktop area was leaking. We recommend that the leaks be repaired by a plumbing contractor.

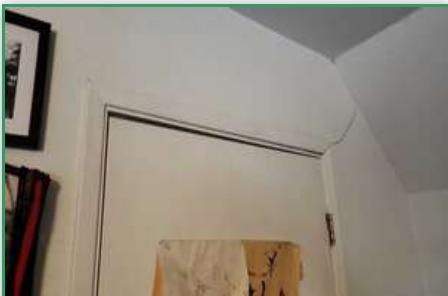
Location: UPSTAIRS SOUTH BEDROOM

One or more interior doors were out of square. Out of square doors can be an indication of poor installation or structural movement. This area should be evaluated and repaired by a professional contractor as needed.

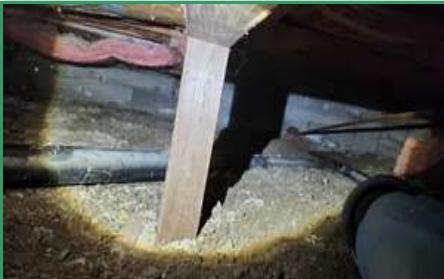
11.2.1 Column not plumb

One or more columns were found to not be plumb. Evaluation and repairs are recommended by a professional contractor.

1.1 3/8 inch not plumb

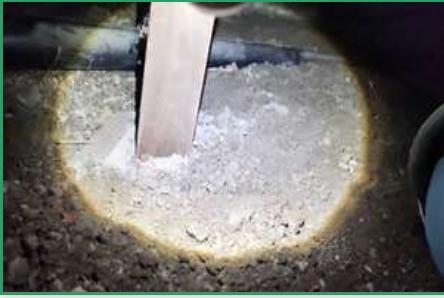
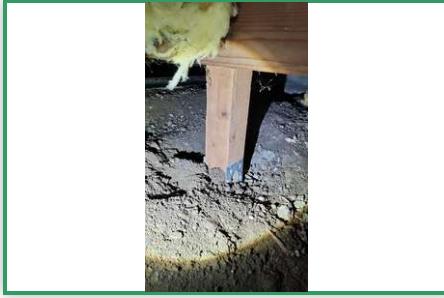
11.2.2 Wood in Contact with Soil

There were one or more wood support posts or other wooden members that had dirt in contact with the wood. We recommend that repairs be made to reduce the risk of wood rot and wood destroying organisms. All work should be performed by a professional contractor.

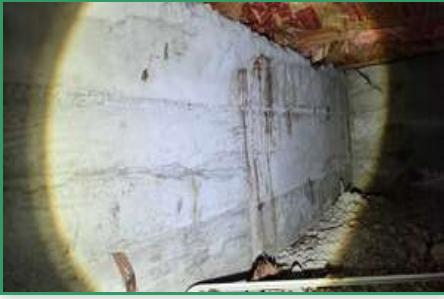
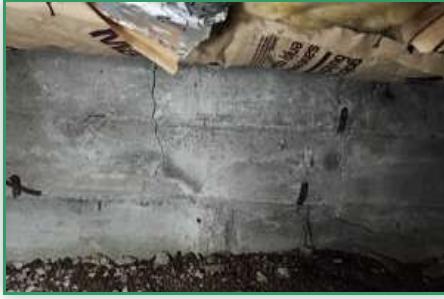
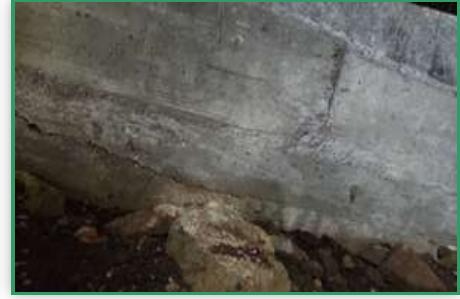
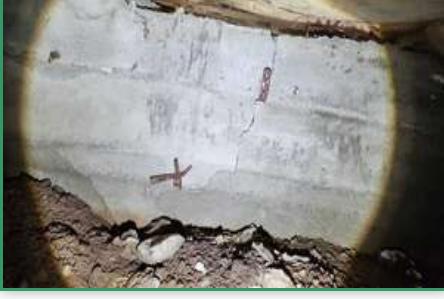
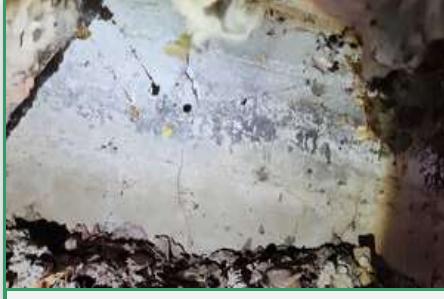
Location: DINING ROOM ADDITION

11.5.1 Excessive Foundation Cracks

Excessive foundation cracks were observed, and many of them were horizontal cracks roughly 1/8 inch in width. Evaluation and repair as needed by a concrete contractor is recommended.

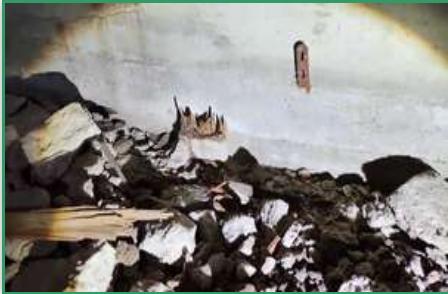
These are form boards and/or wooden stakes that were not removed after the concrete was poured. Wood in contact with soil promotes rot and pests and it's recommended for this wood to be removed.

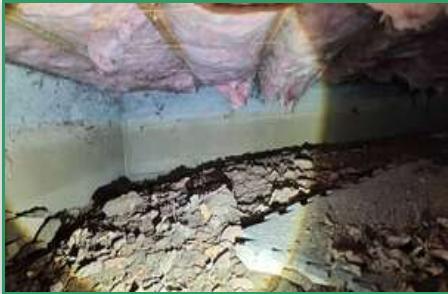
Location: DINING ROOM ADDITION

11.9.1 Water marks

Water marks were observed on the ground and/or on the foundation wall. This indicates excess moisture pooling and/or streaming in the crawlspace at some point in time. Being as conditions were dry or not streaming/pooling at time of the inspection it is difficult to determine if this is a current issue. It is recommended to ask the owners about any knowledge of the situation. If no repairs have been made then the area should be evaluated and improved as needed by a contractor. This may include improving grading, drainage, installing a sump pump, etc...

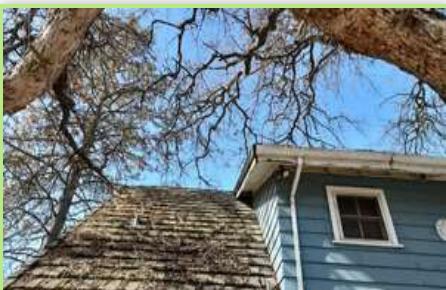
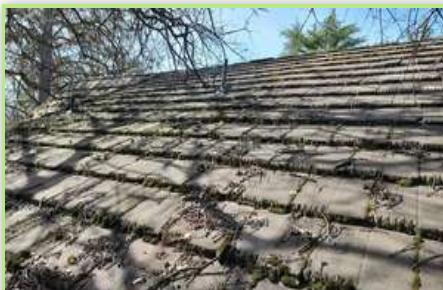
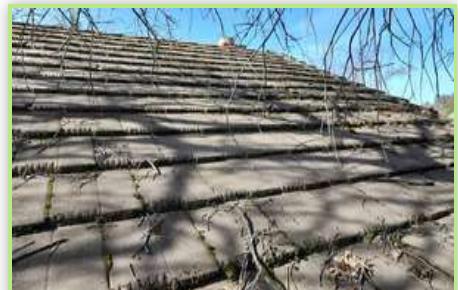
1.6.1 Vegetation Findings(Multiple Defects)

Trees near the house have limbs that overhang the home. These have a potential to damage homes during storms or high wind situations. We recommend that the tree limbs in question be trimmed by a professional removal company.

Excessive debris from leaves or other materials was found on the roof. This will allow for more rapid deterioration of the roofing material and eventually leaks. Regular maintenance is recommended as needed.

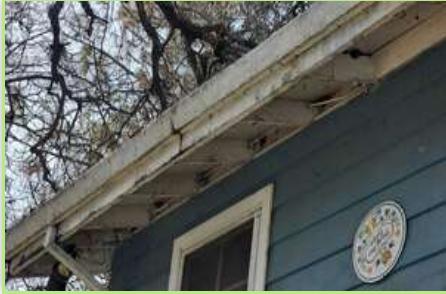
2.6.2 Evidence of Leak

There was evidence of water leaks on the gutters/downspouts such as water stains/corrosion. Conditions were dry at time of the inspection. It is recommended to have the gutter/downspouts sealed or replaced as needed. Consult with owners to see if any repairs have been made already.

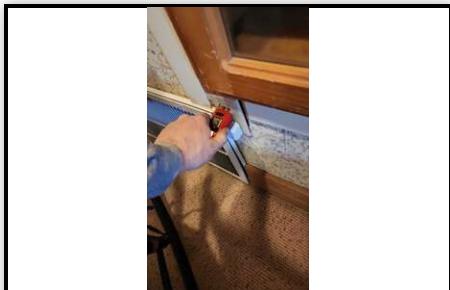
Location: LIVING ROOM

3.9.1 Loose plug/box

There were one or more loose electrical outlets in the residence at the time of the inspections. The affected outlets should be replaced as needed by a professional electrical contractor.

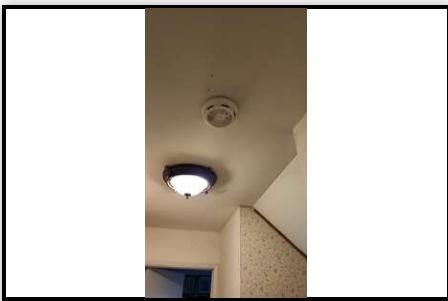
Location: UPSTAIRS HALLWAY

3.10.2 Smoke Detector Inoperable

Smoke alarms were inoperable, loose or damaged in one or more locations. Smoke alarms should be replaced as necessary and installed per standard building practices (e.g. in hallways leading to bedrooms, in each bedroom, on each floor). We recommend installing photoelectric type smoke detectors / alarms. Note: Homes built prior to 1992 were not required to have smoke detectors installed in each bedroom, only hallways. Regardless, calfire.ca.gov recommends installing smoke detectors in each bedroom for increased safety.

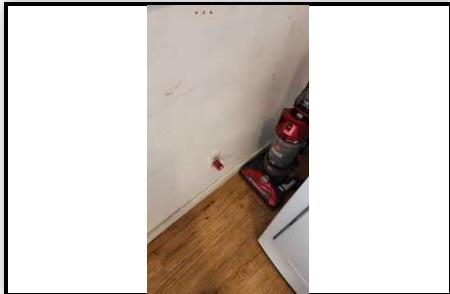
An electrical outlet in the laundry room had hot and neutral wires reversed. The Inspector recommends that it be evaluated and repaired as needed by a professional electrical contractor.

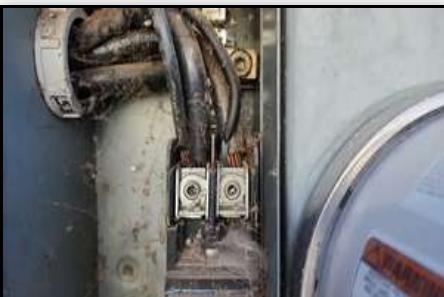
Location: FRONT EXTERIOR

Two or more wires were installed in a lug, which is called "double tapped". A lug is meant to secure one wire and the other can be loose, which poses a safety concern. This is going to the sub panel, which does not have overcurrent protection. The inspector recommends a professional electrician evaluate and correct as needed.

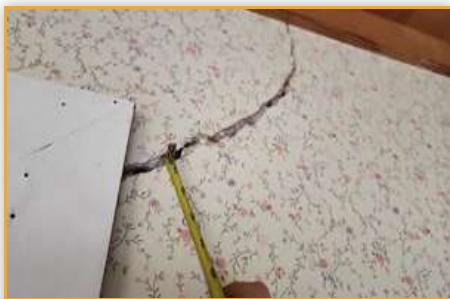
Location: DINING ROOM

3.2.2 Drywall Cracks (ground movement)

Drywall cracks were observed which appear to be a result of ground movement. This should be confirmed with a Geotechnical Engineer. The cracks can be repaired as desired.

2.1 3/8 inch

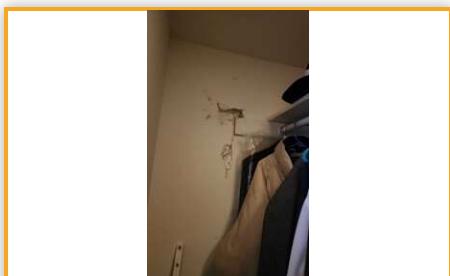
Location: UPSTAIRS NORTH BEDROOM CLOSET

3.2.3 Wall Damaged

One or more walls were damaged. Recommend repairs as needed by a professional contractor

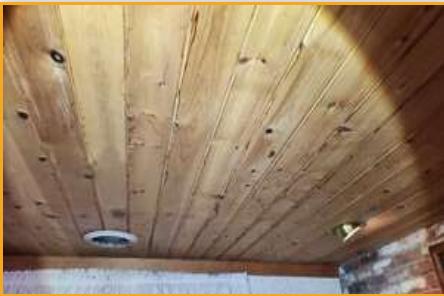
Location: LIVING ROOM

3.3.1 Water Stains Active (roof)

Water stains were observed and an increased level of moisture was present. Repairs will be needed by a professional roofer to fix the leak. After that a contractor or remediation team may make interior repairs as needed.

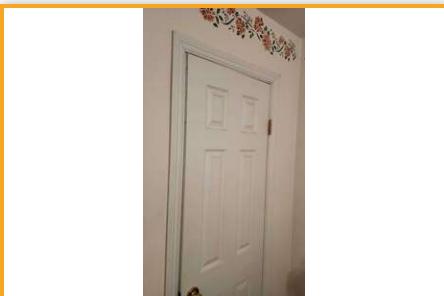
Location: UPSTAIRS NORTH BEDROOM CLOSET

One or more interior doors were binding in the jamb. This can be a result of long term settlement, poor installation or a buildup of paint. Recommend evaluation and repairs as needed by a professional contractor.

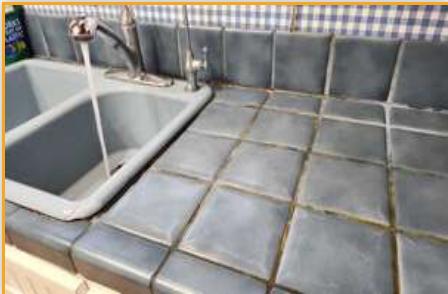
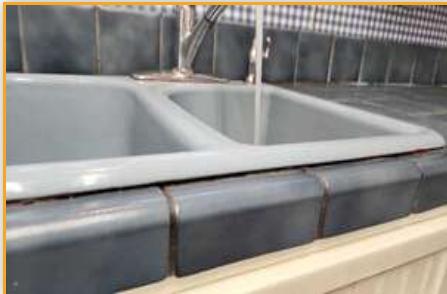
4.3.1 Grout lines damaged

The kitchen countertops grout lines were damaged in one or more areas. It appears the counter has sunk around the kitchen sink, possibly due to poor support. Recommended repair by a professional contractor.

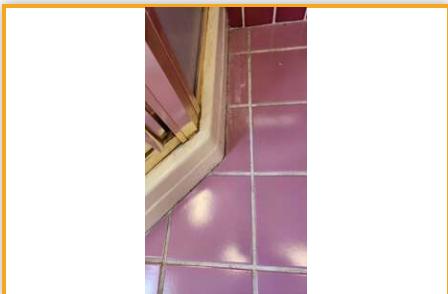
5.8.1 Shower Caulk/Grout Damage

The caulking and/or grout used to seal the shower surround was deteriorated or cracked. Recommend that a qualified contractor repair as necessary.

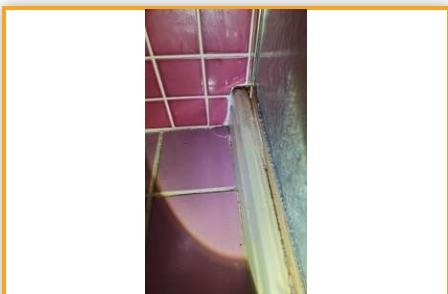
Location: DOWNSTAIRS BATHROOM

5.8.2 Leaking shower door/wall

The shower door or wall was leaking in areas at the time of the inspection. We recommend that all of the affected areas be repaired as needed by a professional contractor.

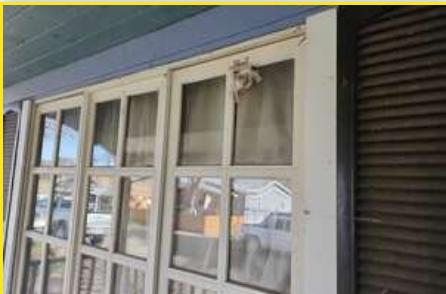
Location: FRONT EXTERIOR

2.1.1 One or more cracked/broken exterior windows

One or more exterior windows had broken window panes. The Inspector recommends that the affected area(s) be evaluated, replaced or repaired, as needed, by a professional contractor.

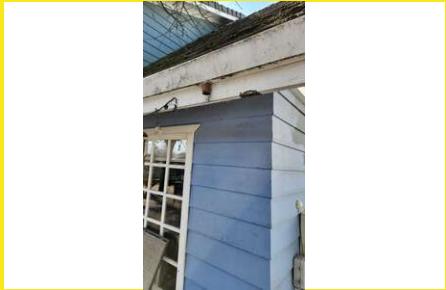
2.6.1 Downspout (Damaged/Missing)

There were downspouts that were damaged or missing leaving the water drainage to close to the foundation of the home. We recommend that the missing downspouts be installed as needed running at least six feet from the foundation. All work should be done by a professional gutter installation company.

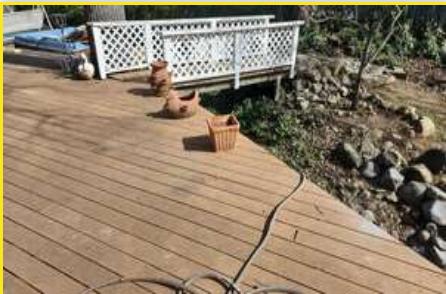
2.8.1 Guardrail Missing

Guardrails at one or more locations where the height off of the ground was higher than 30 inches were missing. This can be a safety concern. The inspector recommend that a qualified contractor install guardrails where they are missing to industry standard.

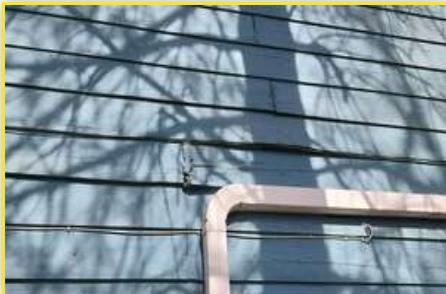
2.11.1 Damaged Siding or Trim

Siding or trim in one or more areas was damaged and/or poorly repaired. This may allow for moisture intrusion. Recommend professional repairs.

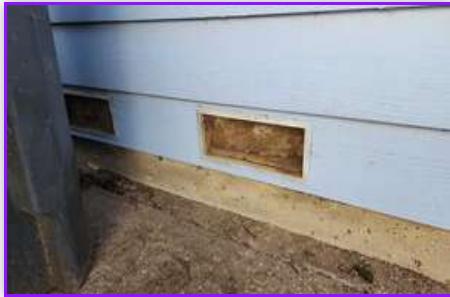
One or more crawlspace vents were blocked. This will limit ventilation and promote wood destroying organisms. Recommend to clear the vents.

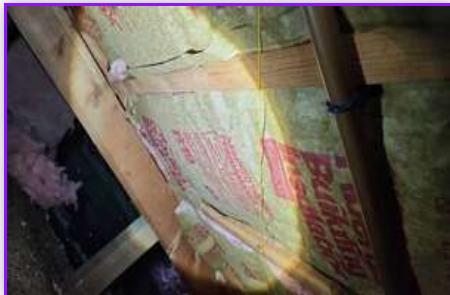
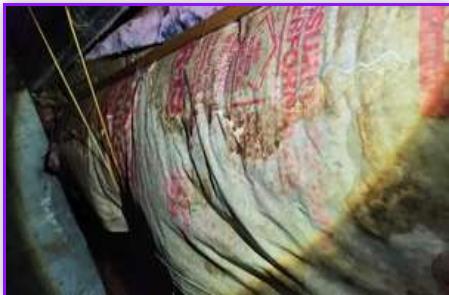
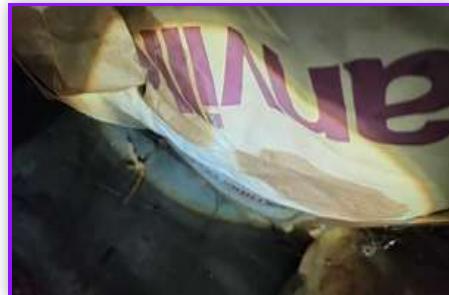
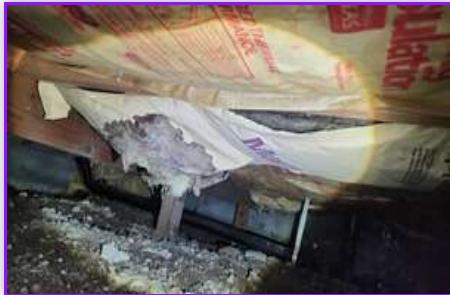
11.3.1 Insulation backwards, discoloration

Insulation in the crawl space/basement was installed backward (upside down) as the paper side should be installed towards the living area. This may allow moisture to be trapped in the insulation. Some of the areas were damaged and discolored. We recommend that all of the affected insulation be replaced.

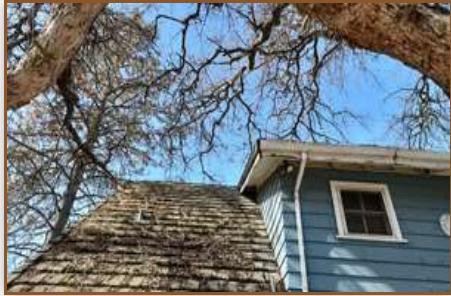
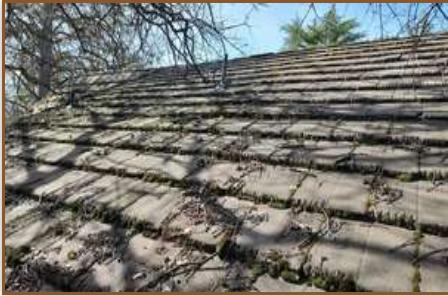
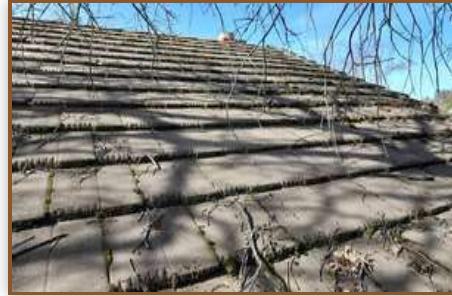
1.6.1 Vegetation Findings(Multiple Defects)

Trees near the house have limbs that overhang the home. These have a potential to damage homes during storms or high wind situations. We recommend that the tree limbs in question be trimmed by a professional removal company.

Excessive debris from leaves or other materials was found on the roof. This will allow for more rapid deterioration of the roofing material and eventually leaks. Regular maintenance is recommended as needed.

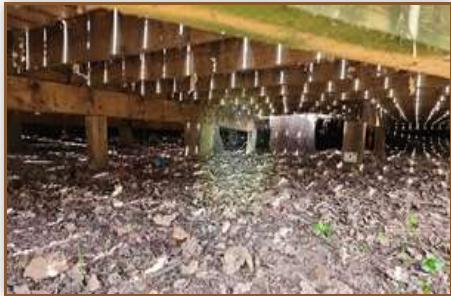
2.7.1 Deck Framing not Level/Plumb

Deck framing was observed as not being level and/or plumb. This may be due to poor installation, ground movement, or for other reasons. Evaluation and repair by a decking contractor is recommended.

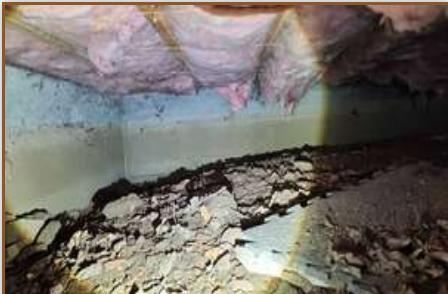
Location: DINING ROOM ADDITION

Water marks were observed on the ground and/or on the foundation wall. This indicates excess moisture pooling and/or streaming in the crawlspace at some point in time. Being as conditions were dry or not streaming/pooling at time of the inspection it is difficult to determine if this is a current issue. It is recommended to ask the owners about any knowledge of the situation. If no repairs have been made then the area should be evaluated and improved as needed by a contractor. This may include improving grading, drainage, installing a sump pump, etc...

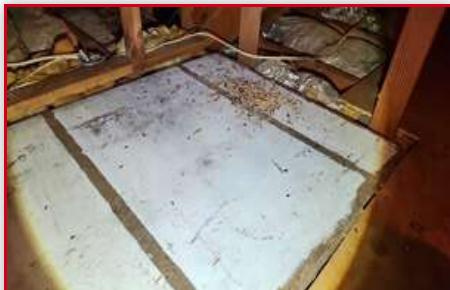
Location: ATTIC

12.1.1 Rodent feces found

One or more areas had rodent feces visible. We recommend that a pest control company be called out to evaluate the area to see if the nesting is recent. If it is then they will need to exterminate the rodents and clean the affected areas.

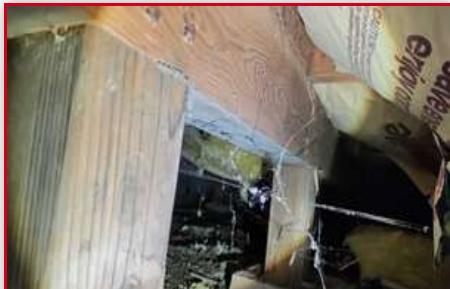
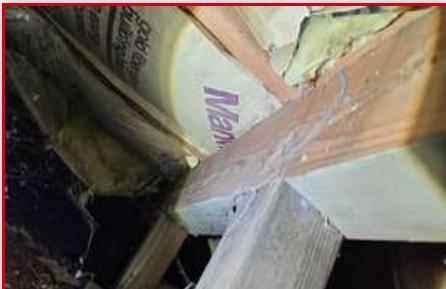
Location: CRAWLSPACE, ROUGHLY UNDER LIVING ROOM

Tubes visible in one or more areas indicated termite infestation. The Inspector recommends that a inspection be performed by a professional pest control contractor.
