WOOD DESTROYING PESTS AND ORGANISMS INSPECTION REPORT

Building Address: 6125 Yearling St., Lakewood, CA 90713		Date of Inspection 10/29/2024	Number of Pages 7
<h1 style="margin: 0;">BUGMASTERS</h1> <p style="margin: 0;">Termite Control Services since 1974!</p>		350 E. Orangethorpe #8 Placentia, CA 92870 Office: 800-982-2131 www.bugmasters.com	
		Report # W54515	
		Lic. Registration # PR 0894	
Escrow #			
Ordered by: First Team Real Estate Terrie Whittaker 12501 Seal Beach Blvd. #100 Seal Beach, CA 90740	Property Owner and/or Party of Interest: First Team Real Estate Terrie Whittaker 12501 Seal Beach Blvd. #100 Seal Beach, CA 90740	Report Sent to: First Team Real Estate Terrie Whittaker 12501 Seal Beach Blvd. #100 Seal Beach, CA 90740	
COMPLETE REPORT <input checked="" type="checkbox"/> LIMITED REPORT <input type="checkbox"/> SUPPLEMENTAL REPORT <input type="checkbox"/> REINSPECTION REPORT <input type="checkbox"/>			
General Description: Single story stucco single family residence with detached garage		Inspection Tag Posted: Sub Area

Address 6125 Yearling St., Lakewood, CA 90713

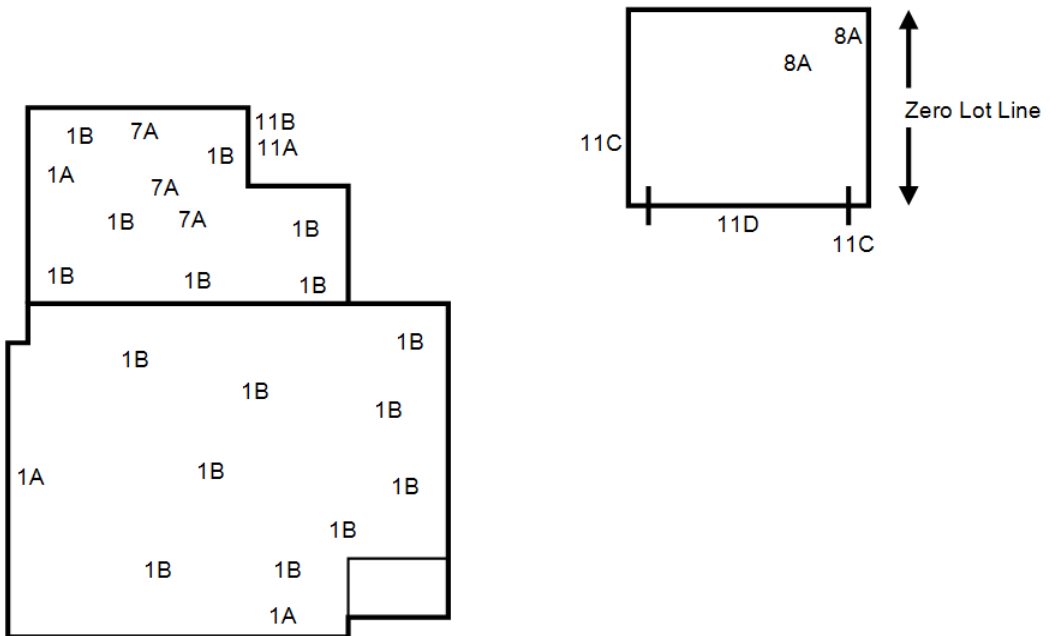
This Diagram is not to scale

1A PRICE: \$1,787.00 (Section I)
FINDINGS: Evidence of drywood termite infestation noted at time of inspection.
RECOMMENDATION: Vacate the premises and seal the structure for fumigation. Remove or cover accessible evidence of infestation. Fumigation awareness notice must be signed prior to fumigation. See fumigation notice for terms and liabilities. Fumigation warranty three years.

1B PRICE: Unknown (Section II)
FINDINGS: Cellulose debris noted at time of inspection in sub area.
RECOMMENDATION: Contact proper tradesman to clean-out cellulose debris and remove from premises.

7A PRICE: See 1A (Section I)
FINDINGS: Evidence of drywood termite infestation noted at time of inspection.
RECOMMENDATION: Vacate the premises and seal the structure for fumigation. Remove or cover accessible evidence of infestation. Fumigation awareness notice must be signed prior to fumigation. See fumigation notice for terms and liabilities. Fumigation warranty three years.

8A PRICE: See 1A (Section I)
FINDINGS: Evidence of drywood termite infestation noted at time of inspection.
RECOMMENDATION: Vacate the premises and seal the structure for fumigation. Remove or cover accessible evidence of infestation. Fumigation awareness notice must be signed prior to fumigation. See fumigation notice for terms and liabilities. Fumigation warranty three years.

- 11A PRICE: See 1A (Section I)
FINDINGS: Evidence of drywood termite infestation noted at time of inspection.
RECOMMENDATION: Vacate the premises and seal the structure for fumigation. Remove or cover accessible evidence of infestation. Fumigation awareness notice must be signed prior to fumigation. See fumigation notice for terms and liabilities. Fumigation warranty three years.
- 11B PRICE: \$430.00 (Section I)
FINDINGS: Evidence of termite damaged wood members noted at time of inspection.
RECOMMENDATION: Repair or replace termite damaged wood members as required. Bugmasters is not responsible for any damage to roofing materials that may occur during repairs made to roof members.
- 11C PRICE: \$70.00 (Section I)
FINDINGS: Wood Fungus condition visible noted at time of inspection.

RECOMMENDATION: Scrape and remove fungus condition, chemically treat with wood preservative, and fill with a hard wood filler
- 11D PRICE: See 11B (Section I)
FINDINGS: Dry-rot wood members found at time of inspection.
RECOMMENDATION: Replace dry-rot damaged wood members, as necessary. Bugmasters is not responsible for any damage to roofing materials that may occur during repairs made to roof eve members. If additional adverse conditions are uncovered during repairs, further inspection will be recommended, and a supplemental report will be issued indicating any additional costs.
