PROPERTY INSPECTION REPORT 15475 Rochlen St, Hacienda Heights, CA 91745, 01/17/2025

OC World Inspection, Inc.

Inspector: Harry Xing and Leo Wang Certified Master Inspector Certified:#ICA00029875

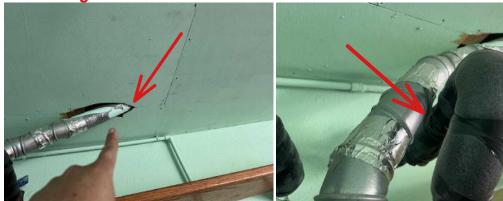
11. Garage Water Heater Flue Pipe: Double wall - Metal vents that are too close to wood or combustionable materials may cause the wood to burst into flames. Single wall vents should have a minimum of 6 inches of clearance and double wall, sometimes called a vent, should have 1 inch minimum clearance. A qualified air conditioning contractor is recommended to evaluate and estimate repairs.

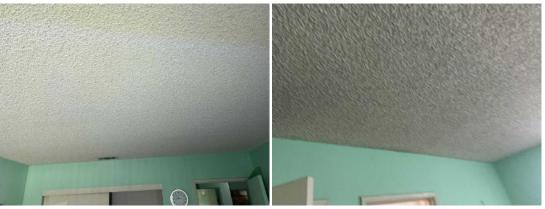
14. All rooms Bedroom Ceiling: Paint - Popcorn ceiling in the living space. Popcorn roofs may contain asbestos, a harmful substance that can cause serious health problems if inhaled. Service as needed.

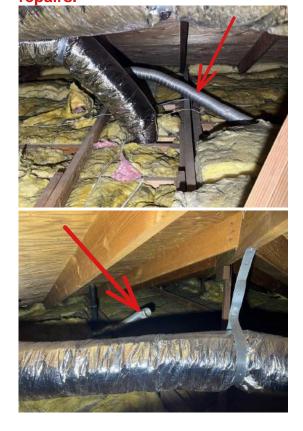
10. DBathroom Fan Venting: Electric fan - Bathroom improperly vents into attic and may cause moisture damage to the insulation. The services of a qualified contractor is recommended to evaluate and estimate repairs.
