Inspection Report

Provided by: Inspector Nuz'zo Home Inspections

Property Address

638 N. Grass Valley Road Lake Arrowhead, CA. 92352

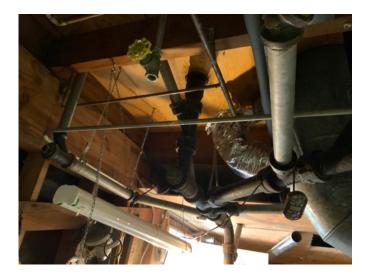
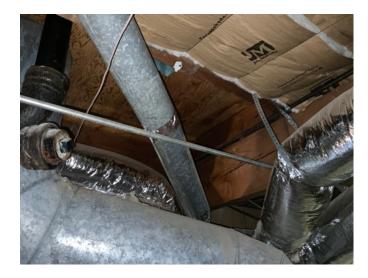
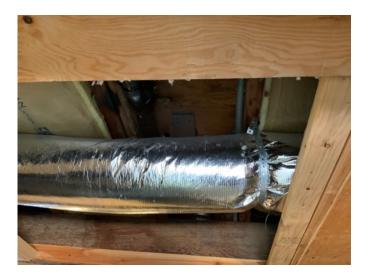
1.3) Floor Insulation Condition

The floors are partially insulated. Recommend insulating for better thermal quality inside the home.

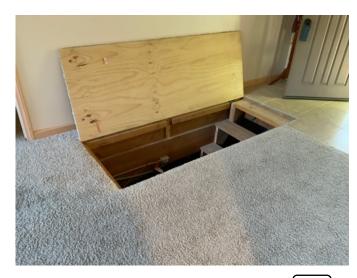
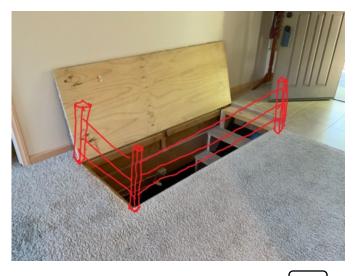
1.4) Access Condition

S

Railings needed to avoid fall hazard. It is suggested that a "Licensed General Contractor" be contacted for further evaluation and repair.

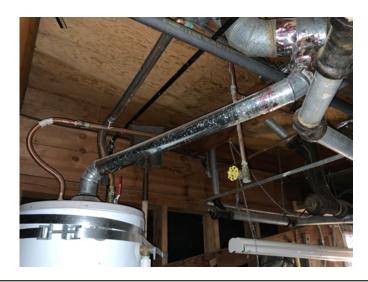
1.8) Pipe Insulation Condition

No insulation. Pipe insulation is recommended to control condensation and protecting pipes from freezing conditions.

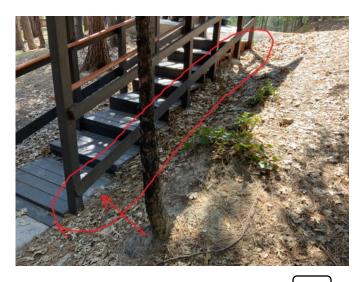
2.4) Steps Condition R

The steps have earth to wood contact in multiple locations. Stair framing should have at least 6 inches of distance between earth and wood. Recommend removing earth to wood contact to reduce termite infestation and to increase the life of the staircase and the safety of the people that use it.

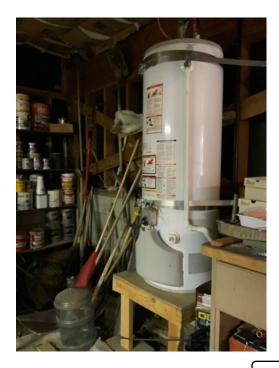
4.3) Water Heater Conditions NI

Water heater off. No hot water at time of the inspection. All utilities and appliances should be up and running for the inspection. Recommend seller disclosure regarding the condition of the water heater prior to closing or a licensed plumbing contractor.

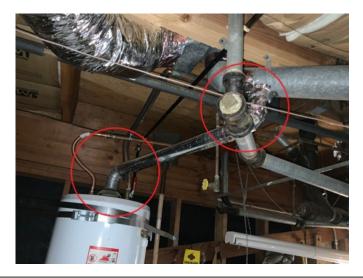
4.5) Venting Condition

The draft style water heater vent is designed to go above roof line so wind pulls exhaust out of the vent pipe. This vent was tapped into the heater exhaust. It is suggested that a "Licensed Plumbing Contractor" be contacted for further evaluation and repair.

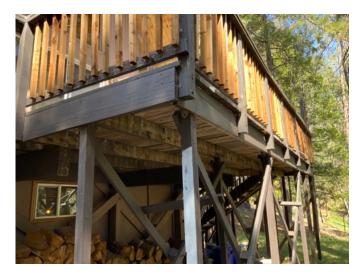
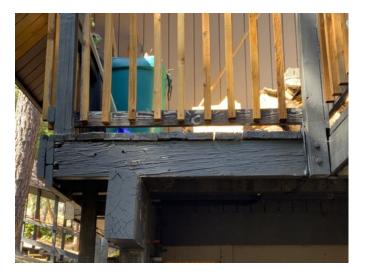
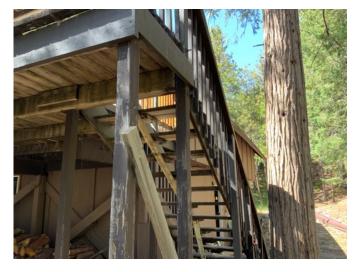
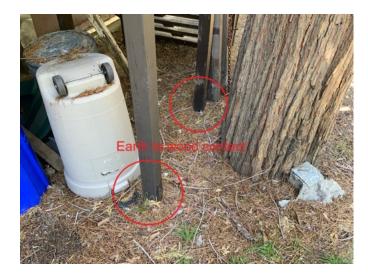
5.3) Deck Condition

Deck framing weathered in some locations. Recommend repairs as needed to protect wood. Deck framing wood damage. Recommend replacing damaged wood.

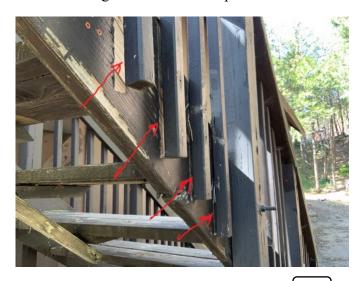
5.4) Railings Condition

S

Loose railing balusters in multiple locations. Recommend re-securing for safety.

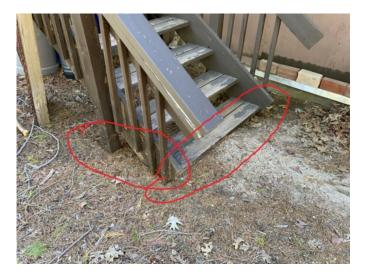
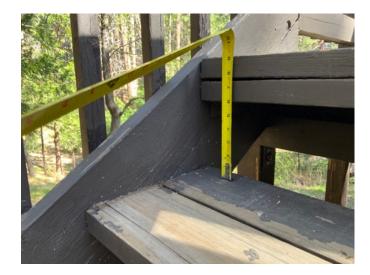
5.5) Stairs Condition

R

- * Earth to wood contact at stairs. Recommend adding a concrete slab and sit steps on the concrete to remove the earth to wood contact.
- * Uneven risers at top of deck stairs may cause tripping hazard. Maximum stair height is 7 3/4". These steps a 7" with the top riser is 9".
- * Surfaces weathered. Recommend repairs as needed.

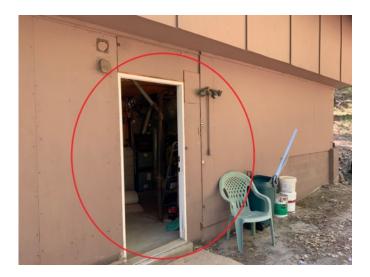
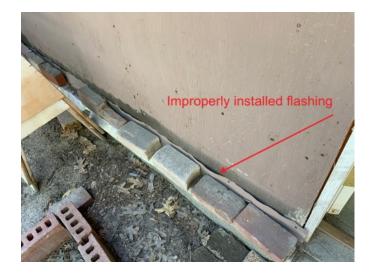
5.6) Exterior Wall Conditions

R

The siding / wall covering on the lower section of the structure was unprofessionally installed and incomplete. Recommend further evaluation by a qualified siding contractor.

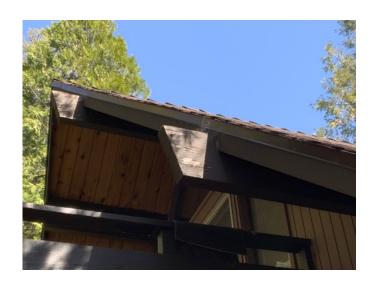
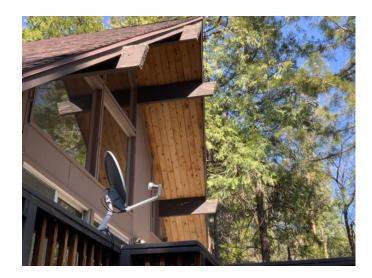
5.7) Exterior Trim and Eave Condition

MA

The finish has minor weathering in some locations in the trim, fascia and eaves. Recommend sanding, priming and painting/stain for the protection of the wood.

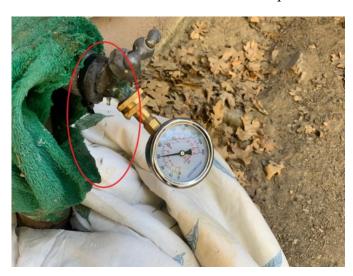
5.10) Faucet Conditions

The hose faucets had an active leak / drip.

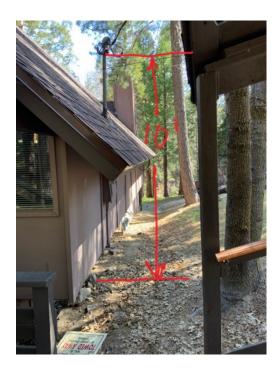
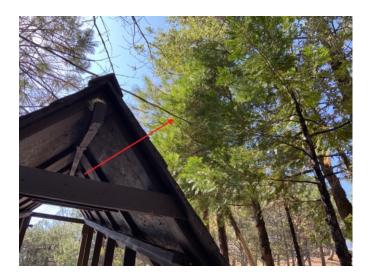
6.1) Electrical Service Conditions

- * Considering today's standards, the main service wires appeared to be too low to the ground. Recommend further evaluation by a licensed electrical contractor or utility contractor prior to close.
- * The main service drop wires from the pole to the house were in contact with tree limbs. Local utility company should be contacted for trimming.

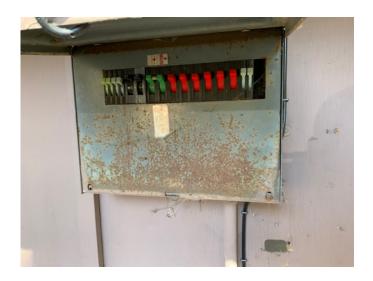
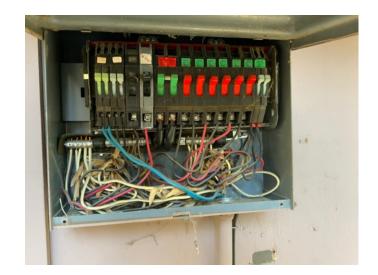
6.3) Electrical Panel Conditions

The panel manufacturer is Federal Pacific (Sylvania/Zinsco). The company is no longer in business. Thousands of these panels were installed from about the 60's to the early 80's. In some cases, problems have been associated with breakers not tripping when needed. Client is advised to consult a licensed electrician for further information.

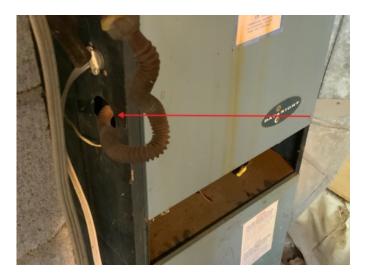
7.1) Unit Conditions

Gas flex runs through metal cabinet, this condition can allow the flex line to rub against the metal cabinet causing a rupture very close to an open flame.

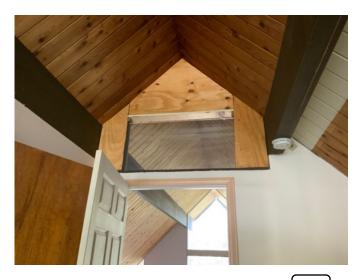
8.1) Wall Conditions

Incomplete wall repairs at upper bedroom. Recommend repairs as needed.

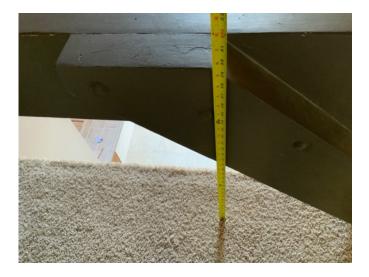
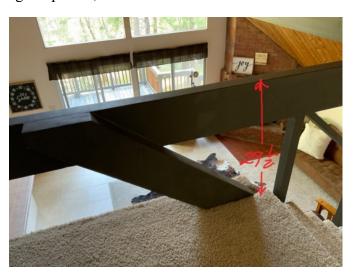
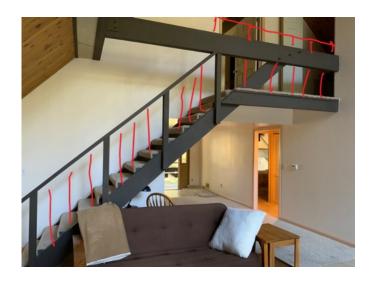
8.4) Railing Condition

- * Upper railing is too low. Code calls for 38" to 42".
- * Stair railing needs balusters with a max. spacing of 4" or glass pallets, etc.

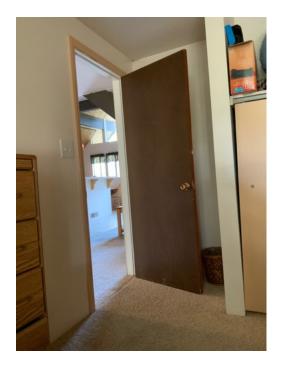
8.6) Interior Door Conditions

The door rubs at the floors or carpeting at main level bedroom. Repairs and / or adjustments are recommended.

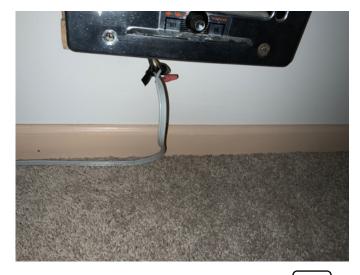
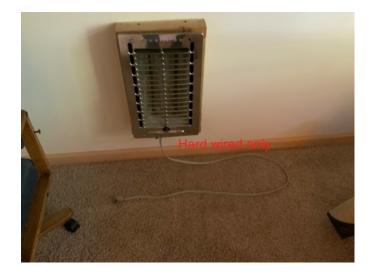
8.7) Electrical Conditions

S

Upper bedroom wall heater wiring is not to code.

It is suggested that a "Licensed Electrical Contractor" be contacted for further evaluation and repair.

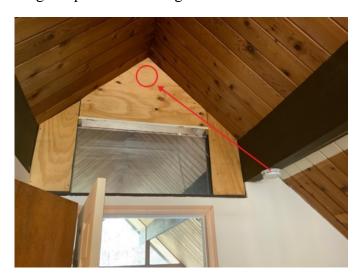
8.9) Smoke Detector Conditions

Relocate smoke detector in upper bedroom. Smoke detectors are supposed to be within 12 inches of the highest point of a ceiling.

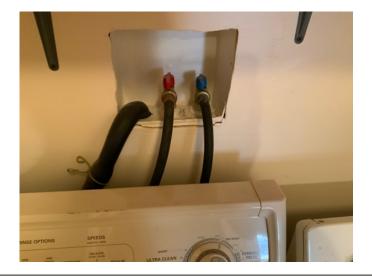
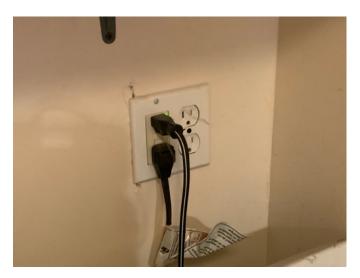
9.1) Laundry Room Conditions

- * Although acceptable, rubber supply line hoses have the tendency to burst causing interior water damage. Recommend replacing rubber hoses with braided stainless steel hoses.
- * A GFCI receptacle was installed at laundry. These receptacles have the tendency to trip due to the motor surges from the washing machine. It is recommended to install a conventional receptacle in this location to avoid unnecessary nuisance tripping of the GFCI receptacle.

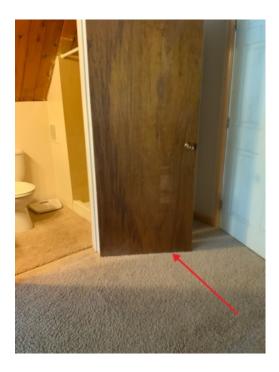
10.1) Bathroom Door Conditions

R

Door rubs carpeting. Recommend repairs as needed for privacy.

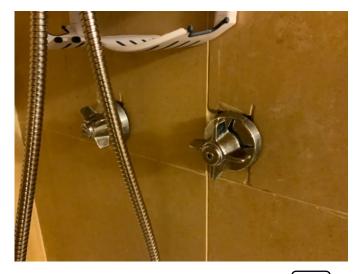
10.7) Shower - Tub Conditions

There are openings in the tile tub surround behind the shower valves. Recommend sealing so the water does not go behind the wall.

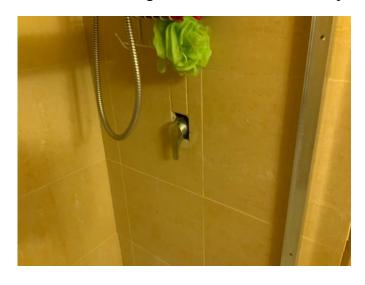
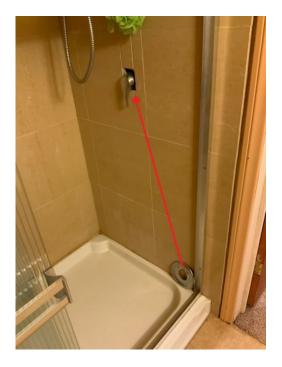
11.7) Shower - Tub Conditions

Escutcheon missing or removed. Recommend replacing to avoid water behind the wall.

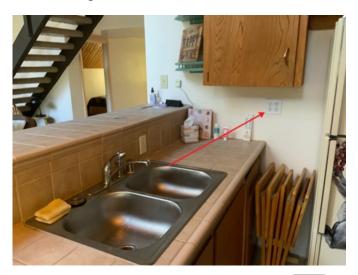
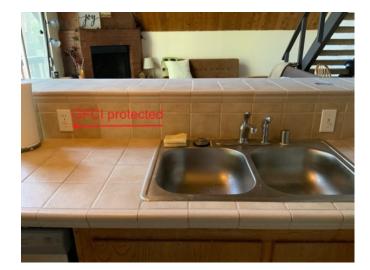
12.1) Electrical Outlet Conditions

GFCI receptacles needed within 6' of water sources.
