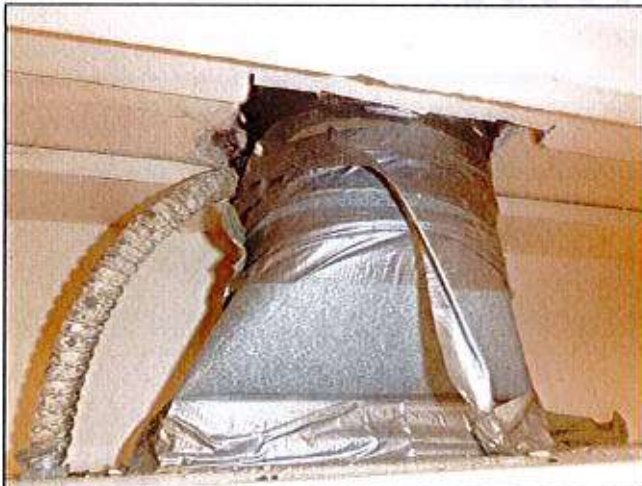
17.15 Item 1 (Picture)

(1) Regular duct tape has been used at the vent connections and various connections are not currently sealed, this is a potential fire hazard. Suggest review with a licensed contractor for costs to replace the tape with approved fire rated tape as required.

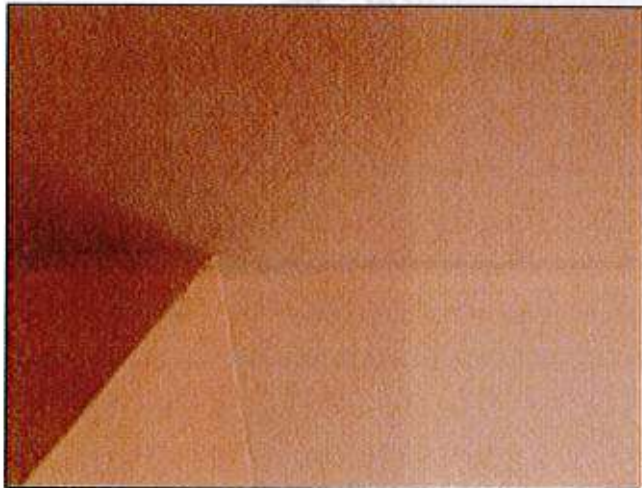
18.2 Item 1 (Picture)

(1) Common cracks, flaking and deterioration noted. Suggest maintenance and repairs as needed.

(2) Settling cracks and patching noted, suggest repair as needed.

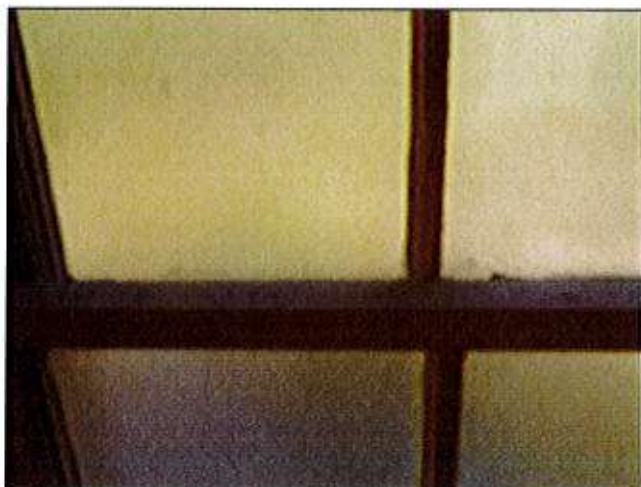
18.4 Item 1 (Picture)

The lock latch(s) are missing/damaged at the window(s), suggest replacing as needed for security.

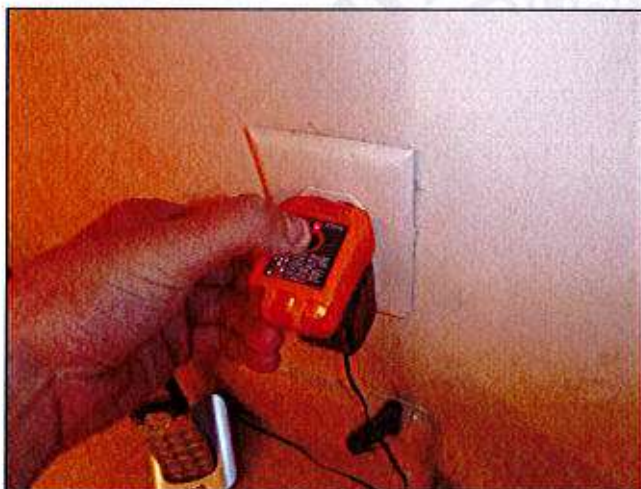
18.6 Item 1 (Picture)

(1) No GFCI outlet or protection installed in this bathroom. GFCI protection has been required in bathrooms since 1975, suggest review by a licensed electrician for installation as required for safety.

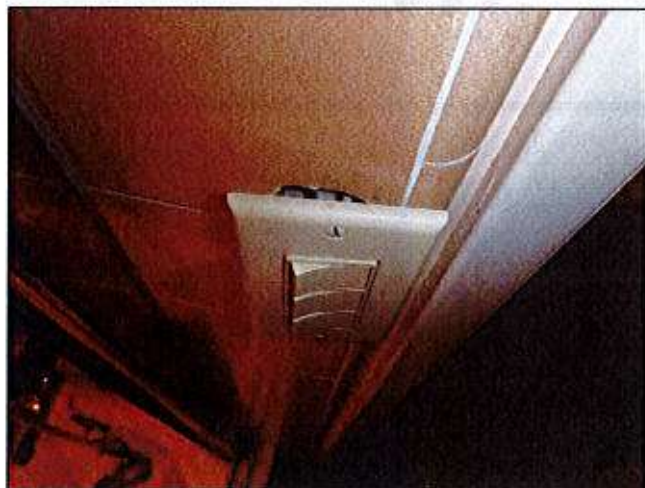
18.6 Item 2 (Picture)

(2) The light switch is loose at the wall mount, suggest repairs as needed.

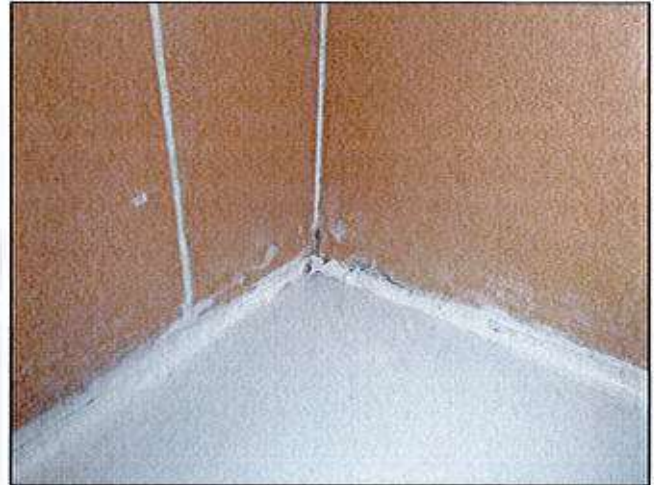
18.9 Item 2 (Picture)

Suggest caulking or re-grout as needed. The edges of the tub walls should be caulked to prevent moisture penetration. Failure to keep walls sealed can cause deterioration and extensive moisture damage to the interior walls, which is not always visible.

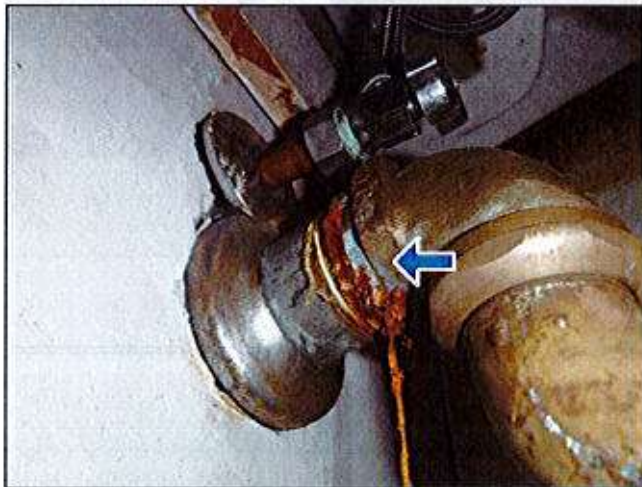
18.15 Item 1 (Picture)

(1) Corrosion noted at the sink drain(s), no leaking noted at the time of the inspection. Suggest review with a licensed plumber and repair/replace as needed.

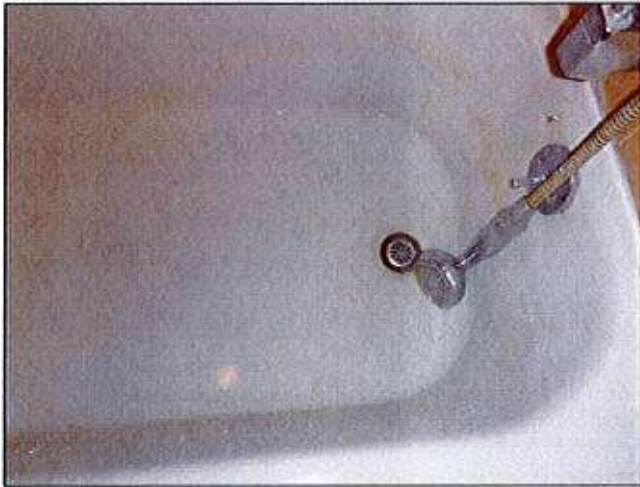
18.15 Item 2 (Picture)

(2) The tub drains slowly, suggest review with a licensed plumber for costs to clear the trap or drain as needed and confirm correct drainage as needed.

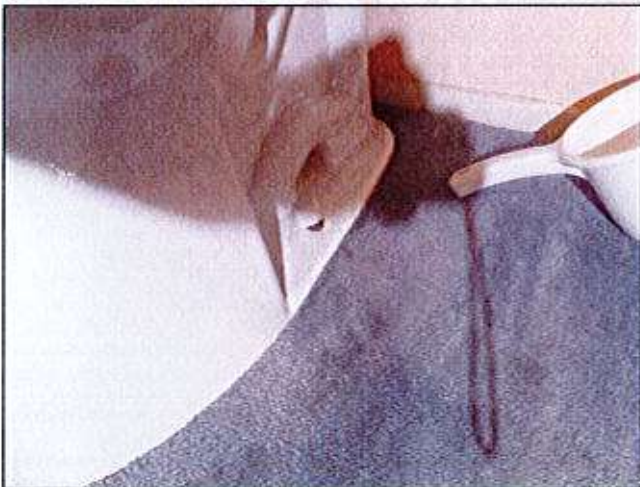
18.16 Item 1 (Picture)

The toilet bowl is loose at floor anchor bolts. The wax ring inside the unit must have a snug, secure fit in order to keep it from leaking. Suggest review with a licensed plumber for repair/replacement costs as needed to seal and re-secure this unit to prevent leakage and damage to the surrounding area.

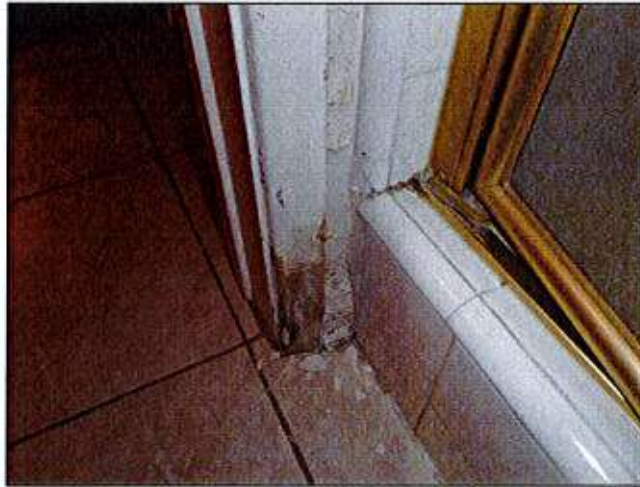
19.1 Item 1 (Picture)

(1) Wet and deteriorated wall & trim around the shower door/screen area. This area tested positive for moisture at time of the inspection. Unable to determine the cause of the moisture, suggest review by a licensed contractor to determine the cause of the moisture and for removal/repair/replacement costs as needed.

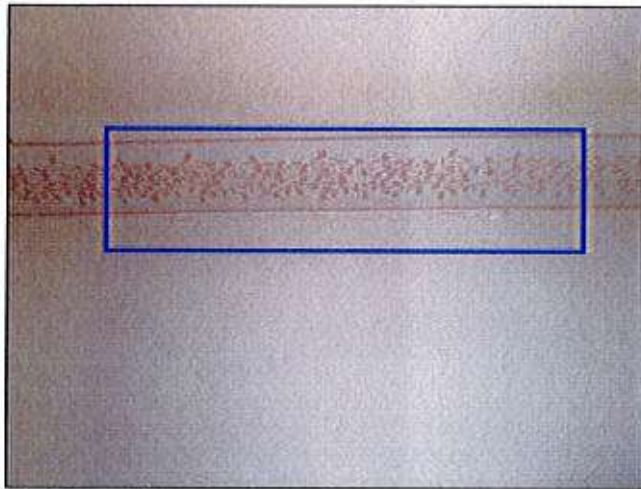
19.2 Item 1 (Picture)

Water damage/deterioration was noted at this area. Unable to determine the cause of the staining/deterioration. Suggest review with a licensed contractor to determine the cause of the staining/deterioration and for removal/repair/replacement costs as needed.

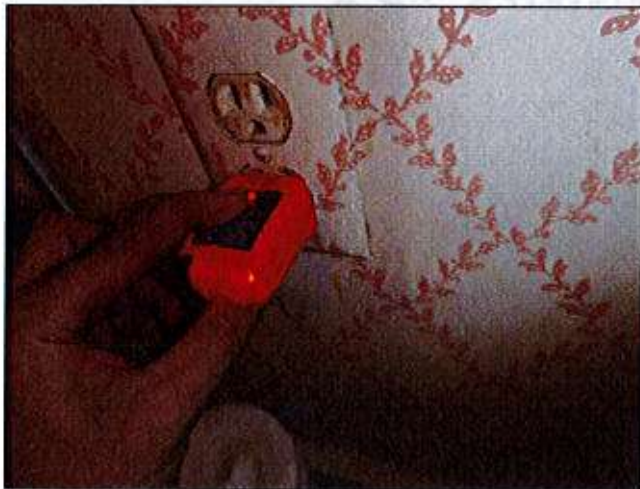
19.4 Item 1 (Picture)

No GFCI outlet or protection installed in this bathroom. GFCI protection has been required in bathrooms since 1975, suggest review by a licensed electrician for installation as required for safety.

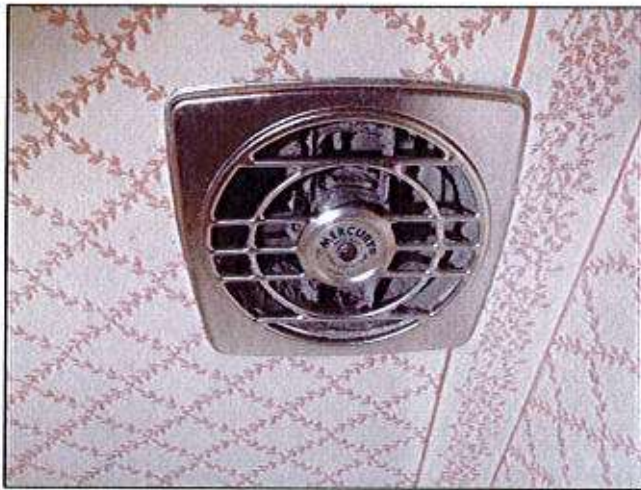
19.5 Item 1 (Picture)

The exhaust fan is old/original, suggest review with a licensed contractor for repair/replacement costs as needed.

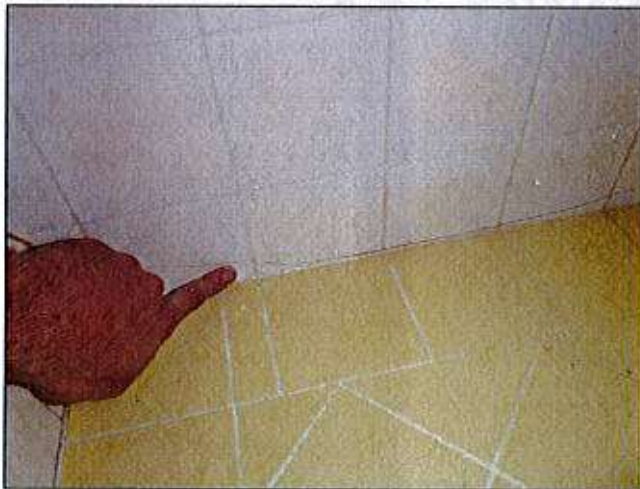
19.6 Item 1 (Picture)

Cracked tiles noted at the shower area, suggest review with a licensed contractor for repair/replacement costs as needed.

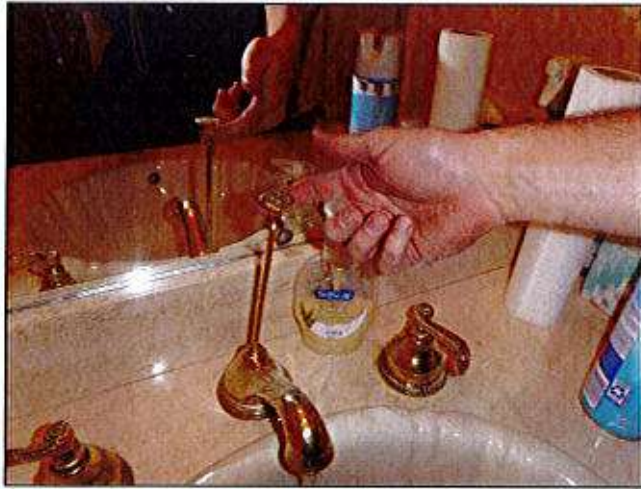
19.8 Item 1 (Picture)

The sink stopper is faulty/inoperable, suggest repair/replace as needed.

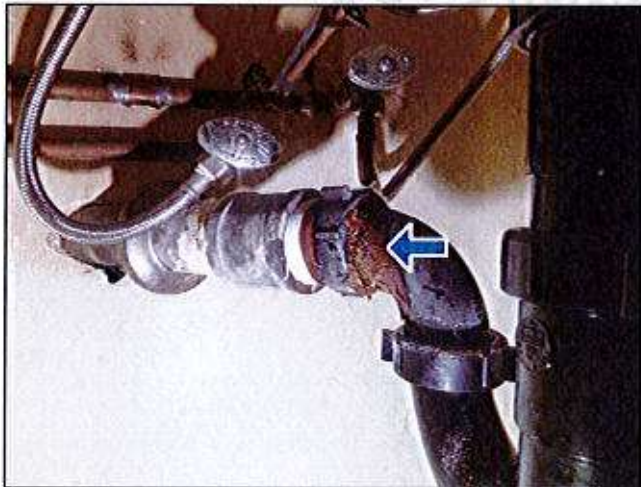
19.10 Item 1 (Picture)

Excessive corrosion noted at the sink drain, see the main sewer/waste system comments and review with a licensed plumber and repair/replace as needed.

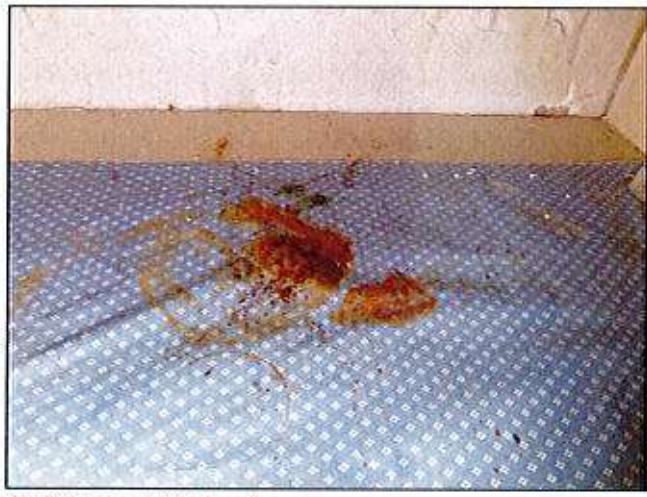
19.12 Item 1 (Picture)

The base cabinet under the sink is deteriorated/stained from leaks, suggest repair/replace as needed.

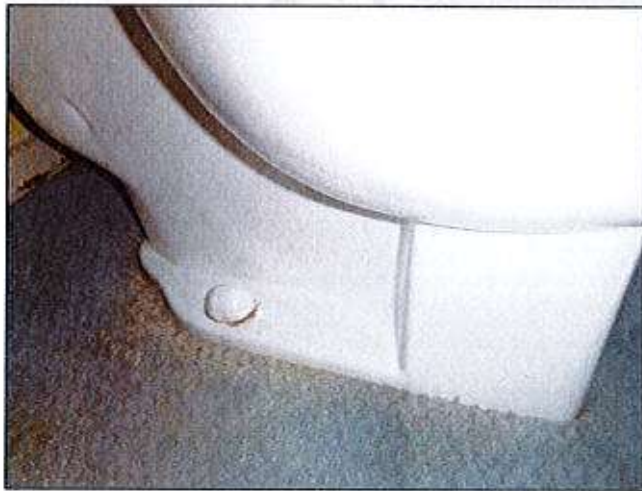
20.0 Item 1 (Picture)

Soft areas of the flooring were noted, suggest review with a licensed contractor for removal/repair/replacement costs as needed.

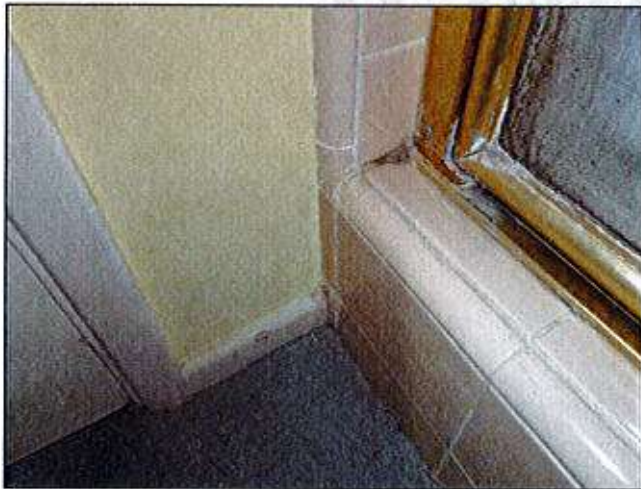
20.1 Item 1 (Picture)

(1) Deteriorated wall & trim around the shower door/screen area, this is probably due to water splashing/leaking from shower area. This area tested dry at the time of the inspection. Suggest repair/replace as needed.

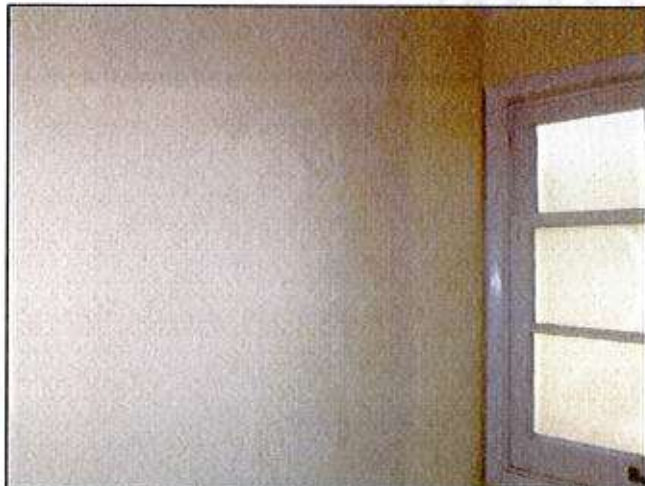
20.1 Item 2 (Picture)

(2) Patched areas of the walls was noted, suggest review with the seller for the cause and any repairs needed. Suggest repair as needed.

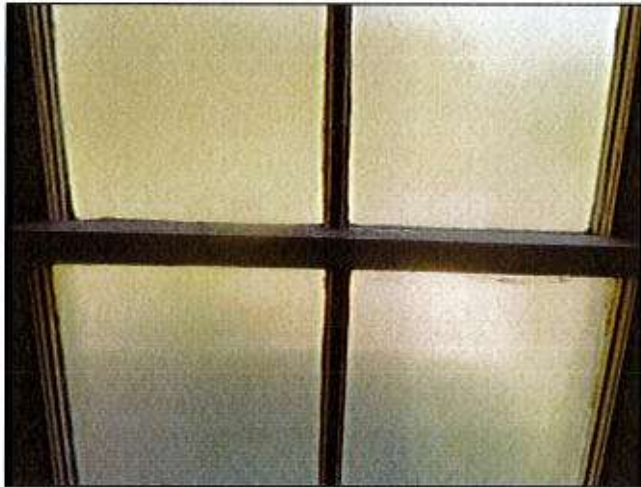
20.4 Item 1 (Picture)

The lock latch(s) are missing/damaged at the window(s), suggest replacing as needed for security.

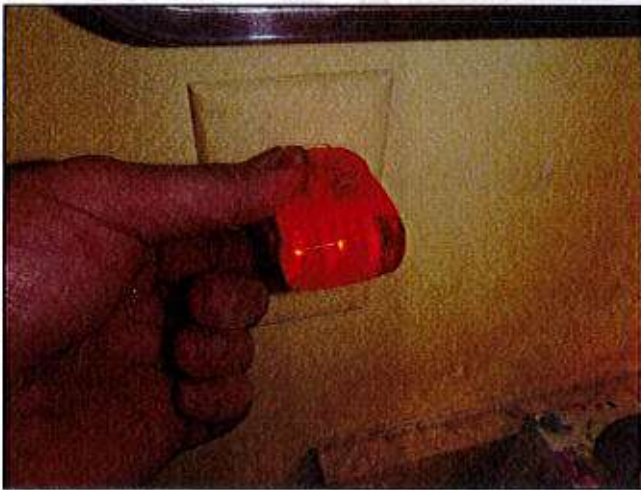
20.5 Item 1 (Picture)

No GFCI outlet or protection installed in this bathroom. GFCI protection has been required in bathrooms since 1975, suggest review by a licensed electrician for installation as required for safety.

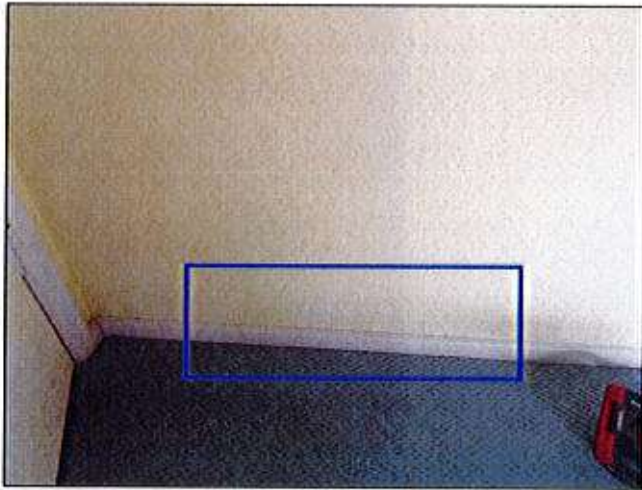
20.8 Item 5 (Picture)

(3) Staining and deterioration with noted in the master bedroom adjacent/opposite to the shower pan indicating that the shower pan may be leaking into the master bedroom. Suggest review with the licensed contractor for removal/repair/replacement cost as needed.

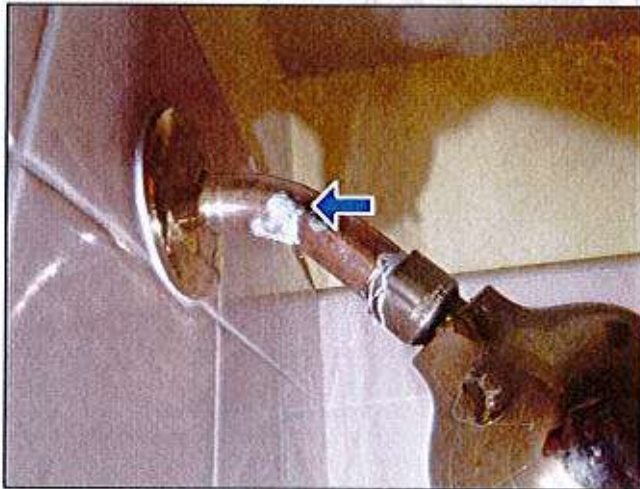
20.9 Item 1 (Picture)

The shower head is deteriorated, suggest repair/replace as needed.

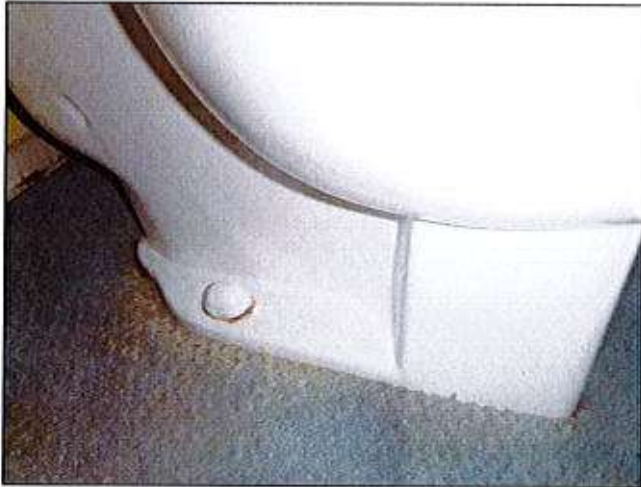
20.13 Item 1 (Picture)

(1) The existing toilet is not a low-flow system as required. Suggest review with a licensed plumber for costs to replace the existing toilet with a low flow toilet (1.6 GPF Maximum) as required by the State of California as of January 1st, 2017.

(2) The toilet bowl is loose at floor anchor bolts. The wax ring inside the unit must have a snug, secure fit in order to keep it from leaking. Suggest review with a licensed plumber for repair/replacement costs as needed to seal and re-secure this unit to prevent leakage and damage to the surrounding area.

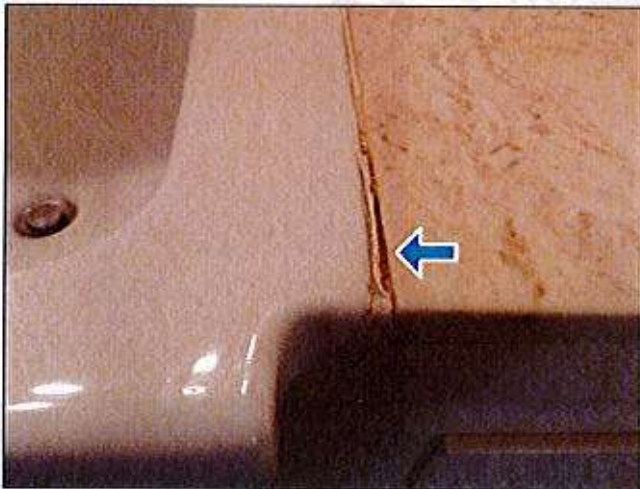
20.14 Item 1 (Picture)

- (1) The base cabinet under the sink is deteriorated/stained from previous leaks, suggest repair/replace as needed.
- (2) Suggest caulking/grouting at the sink to prevent any future water intrusion.

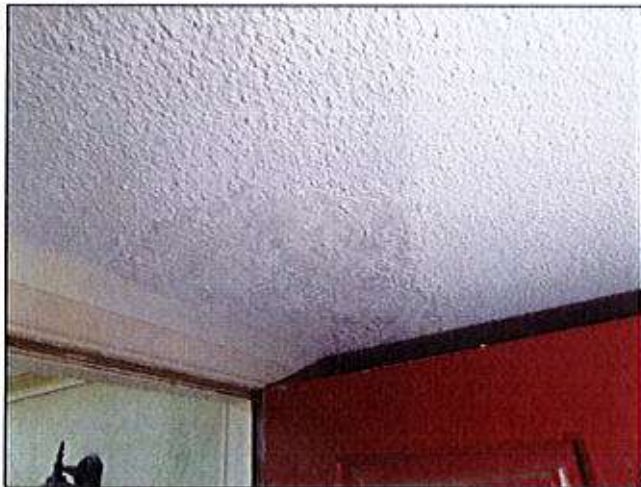
21.2 Item 1 (Picture)

Excessively patched and uneven areas of the ceiling noted, suggest review with the seller on the cause and any repairs needed. Suggest repair as needed.

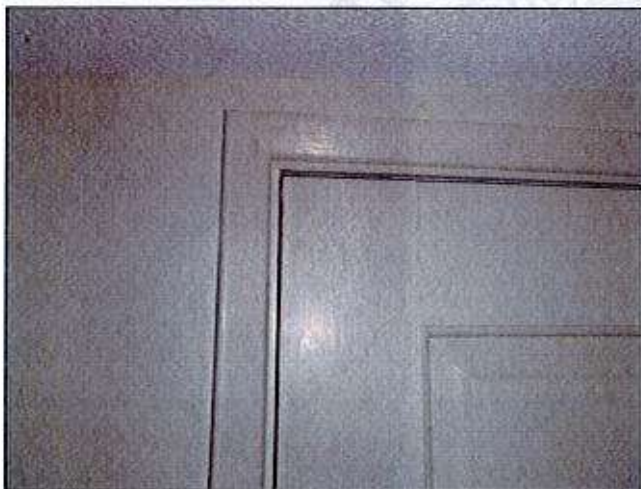
21.3 Item 1 (Picture)

- (1) The door is weathered and deteriorated, suggest maintenance and repairs as needed.
- (2) The door will not close correctly as the door impacts/strikes the frame, suggest repair/replace as needed.

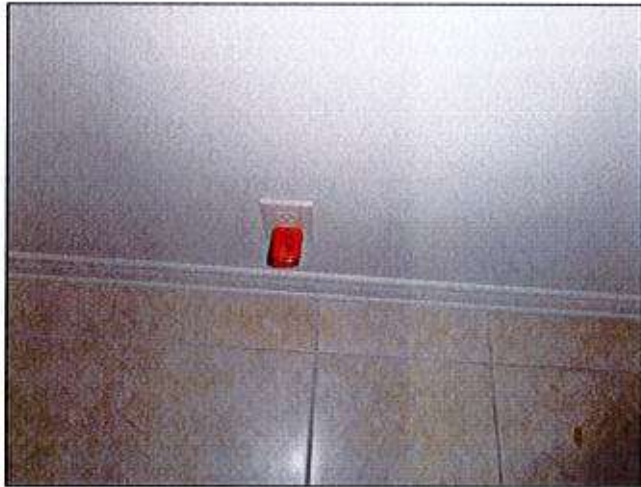
21.4 Item 1 (Picture)

No power to the left side wall outlet(s) at the time of the inspection. Suggest review with a licensed electrician for repair/replacement costs as needed and confirm correct operation as needed.

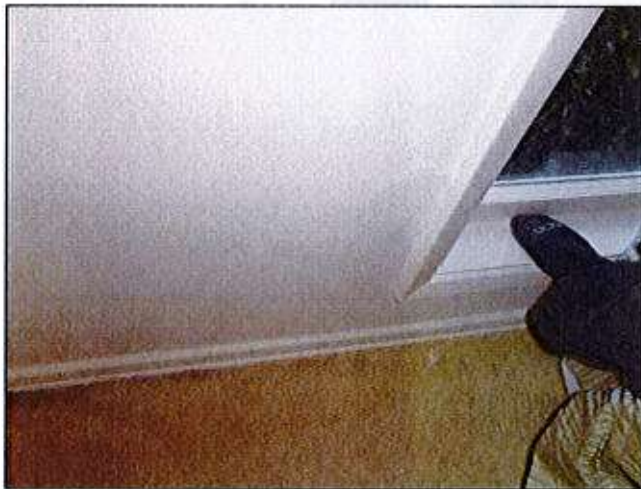
22.1 Item 1 (Picture)

Settling cracks and patching was noted, suggest repair as needed.

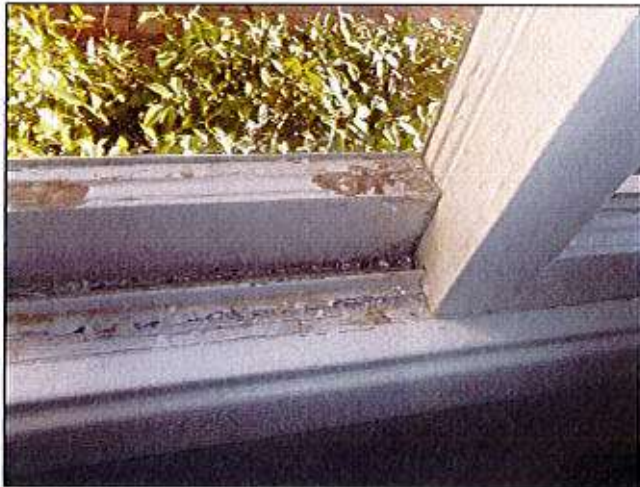
22.3 Item 1 (Picture)

The wood trim/frames are peeling paint at various windows, further deterioration may occur if not repaired. Suggest review by a licensed contractor and repair/replace as needed.

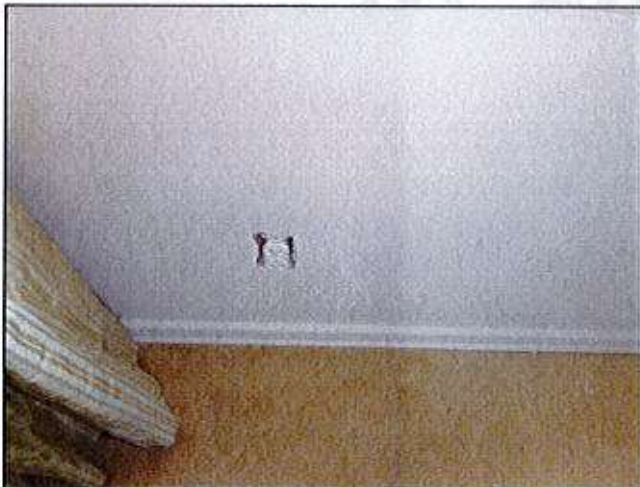
22.5 Item 1 (Picture)

Various outlet cover(s) are missing, suggest installation for safety.

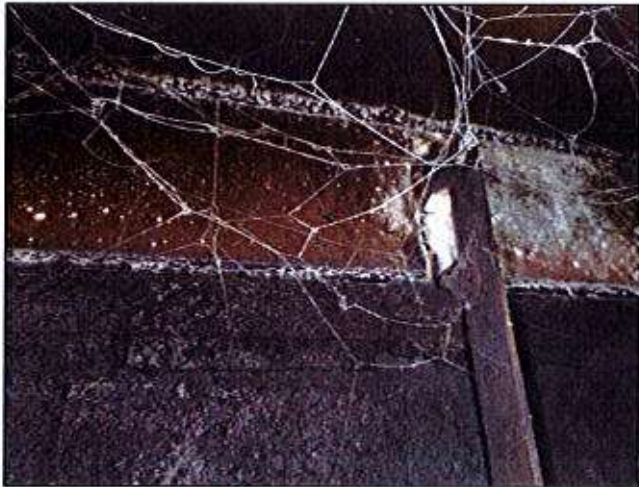
22.6 Item 1 (Picture)

(1) The fireplace damper was operational at the time of the inspection. Suggest securing the damper to a fixed open position due to the gas installation per current requirements.

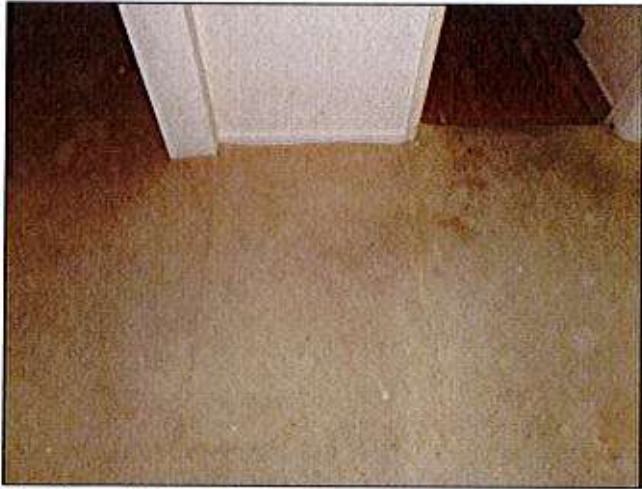
23.0 Item 1 (Picture)

Damaged/cut areas of the carpet were noted, suggest repairs as needed.

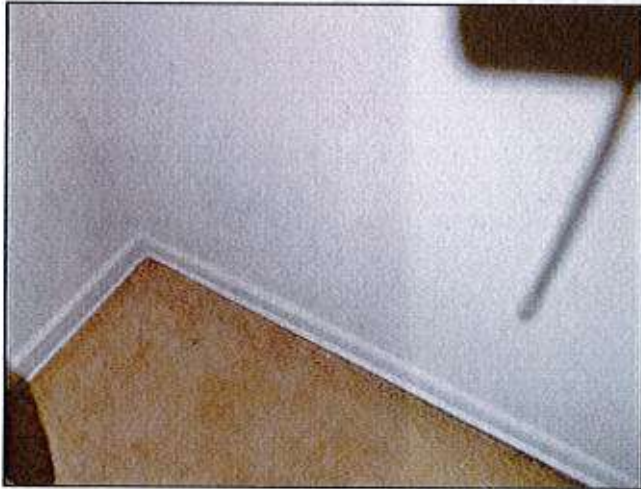
23.1 Item 1 (Picture)

Patched areas of the walls was noted, suggest review with the seller for the cause and any repairs needed. Suggest repair as needed.

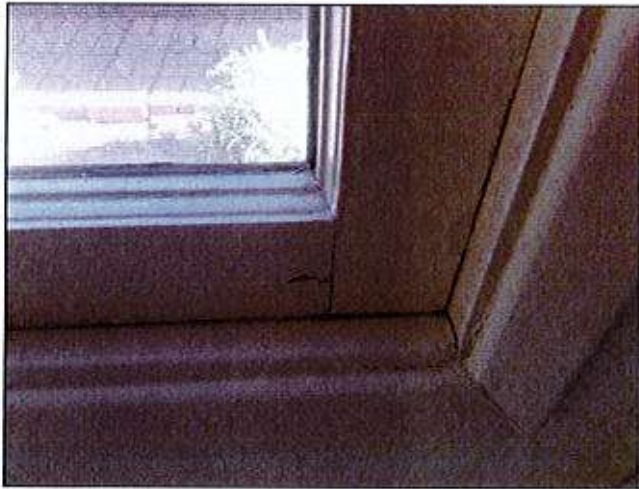
23.3 Item 1 (Picture)

The wood trim/frames are peeling paint at various windows, further deterioration may occur if not repaired. Suggest review by a licensed contractor and repair/replace as needed.

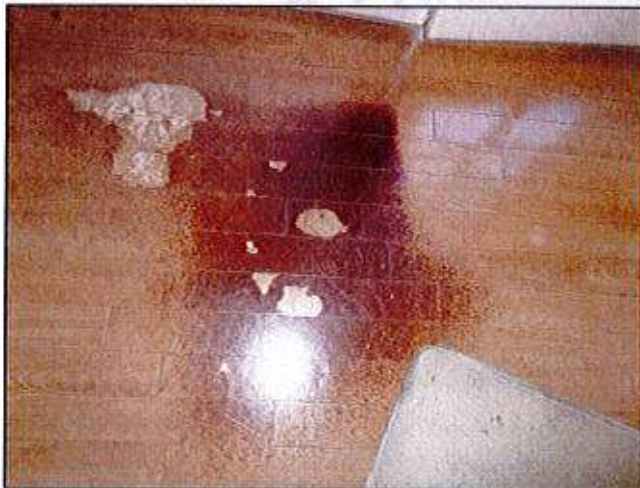
24.0 Item 1 (Picture)

(1) Stains and deterioration noted at the floor, suggest repair as needed.

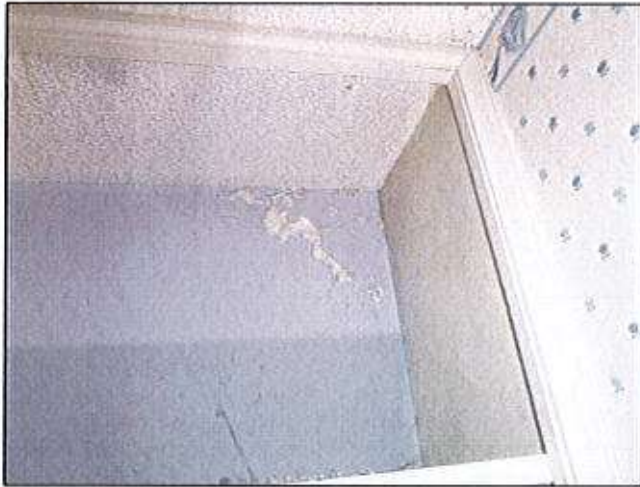
24.1 Item 1 (Picture)

Water damage/deterioration was noted at this area. Unable to determine the cause of the staining/deterioration. Suggest review with a licensed contractor to determine the cause of the staining/deterioration and for removal/repair/replacement costs as needed.

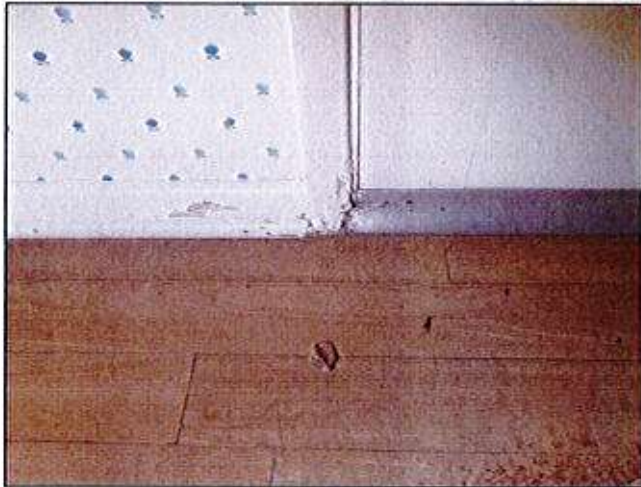
24.3 Item 1 (Picture)

(1) Evidence of previous and possible on-going water intrusion was noted at the door(s) to the exterior. Suggest review with a licensed contractor for repair/replacement costs as needed.

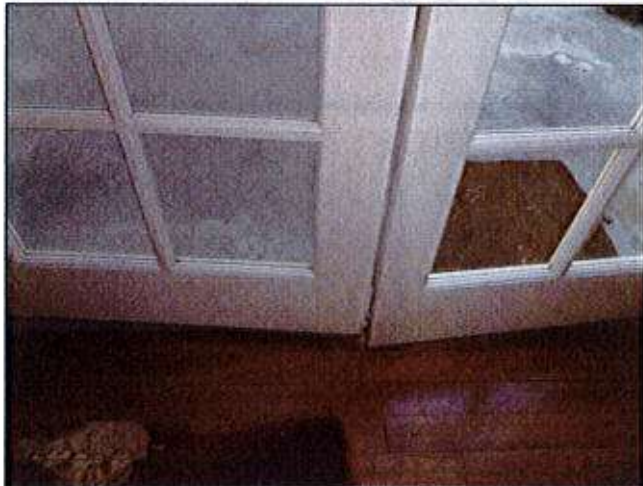
24.3 Item 2 (Picture)

(2) The doors will not close easily as they impact onto each other, suggest repair/replace as needed.

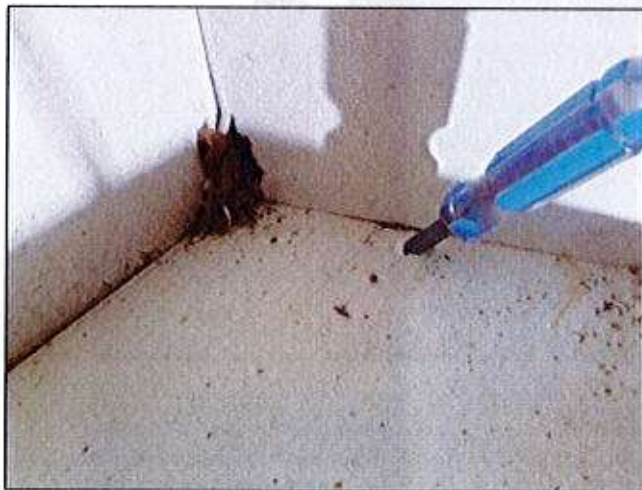
24.7 Item 1 (Picture)

Excessive wood deterioration was noted at the wood cabinetry, suggest review with a licensed termite contractor as needed.

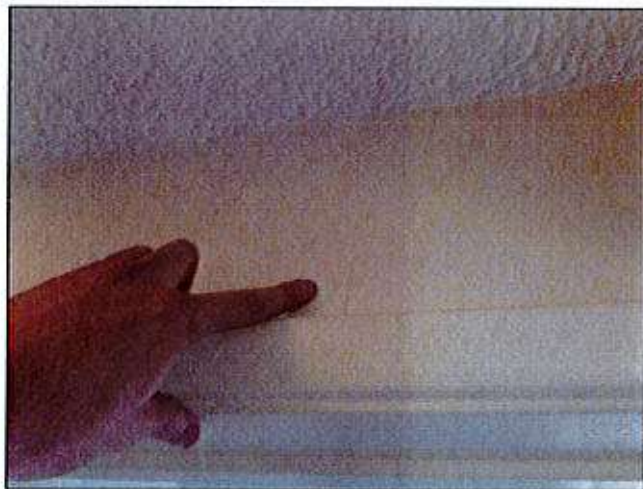
25.1 Item 1 (Picture)

(1) Settling cracks and patching was noted, suggest repair as needed.

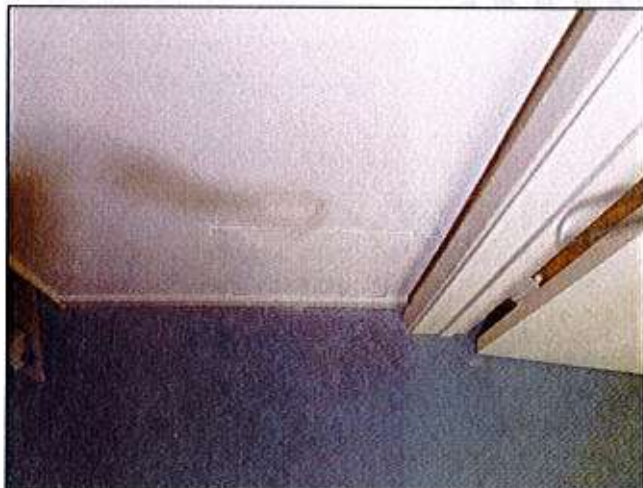
25.1 Item 2 (Picture)

(2) Patched areas of the walls was noted, suggest review with the seller for the cause and any repairs needed. Suggest repair as needed.

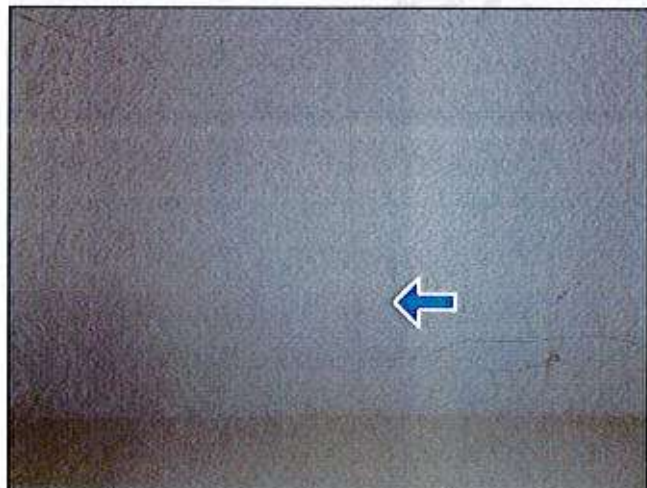
25.2 Item 1 (Picture)

Settling cracks and patching noted, suggest repair as needed.

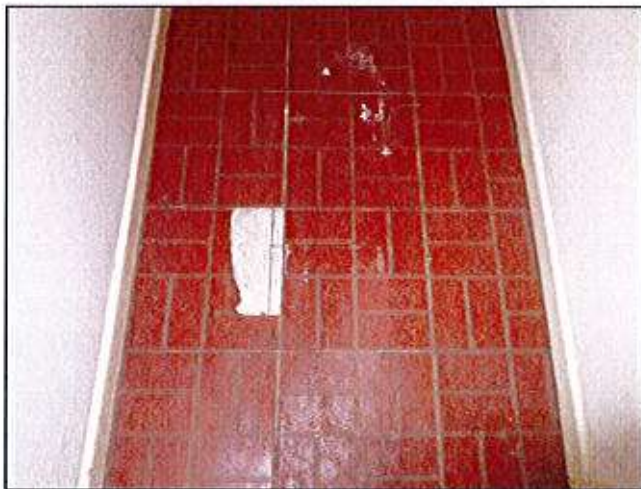
26.0 Item 1 (Picture)

Deteriorated and loose sections noted at the flooring in the closet, suggest repair/replace as needed.

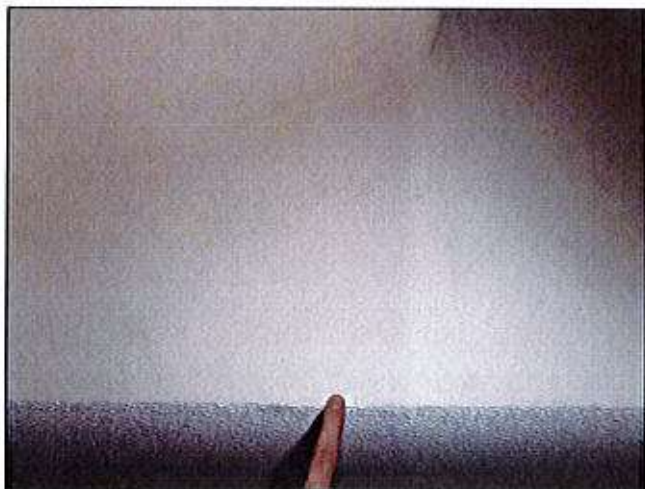
27.1 Item 1 (Picture)

Settling cracks and patching was noted, suggest repair as needed.

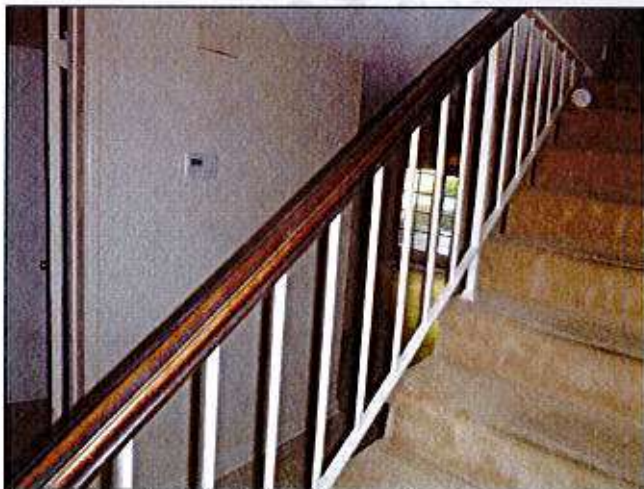
27.4 Item 1 (Picture)

The spacing between the guardrails/newel posts are larger than current requirements, this is a potential safety hazard for a young/small child or animal. Suggest review with a licensed contractor for costs to reduce the spacing at the railings/newel post to enhance safety and as per current requirements as an upgrade (currently a 4" inch spacing).

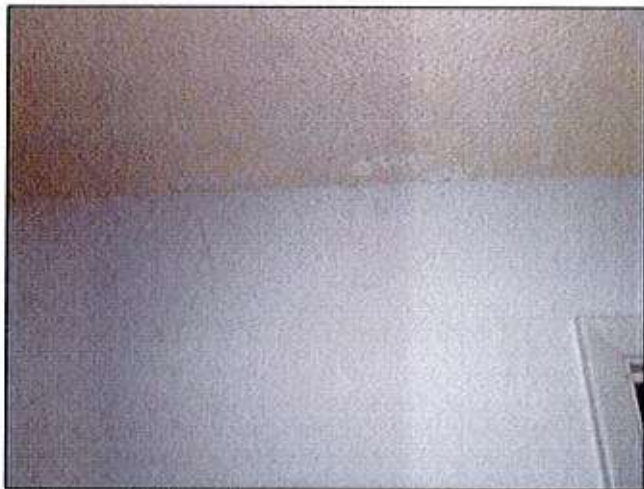
28.1 Item 1 (Picture)

(1) Water damage/deterioration was noted at this area. Unable to determine the cause of the staining/deterioration. Suggest review with a licensed contractor to determine the cause of the staining/deterioration and for removal/repair/replacement costs as needed.

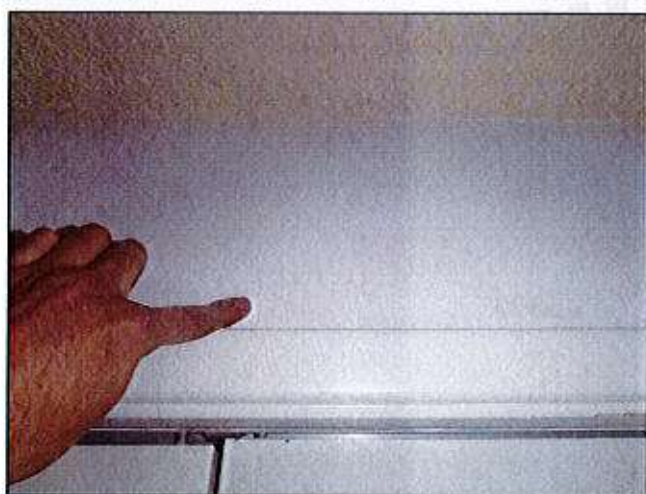
28.1 Item 3 (Picture)

(2) Settling cracks and patching was noted, suggest repair as needed.

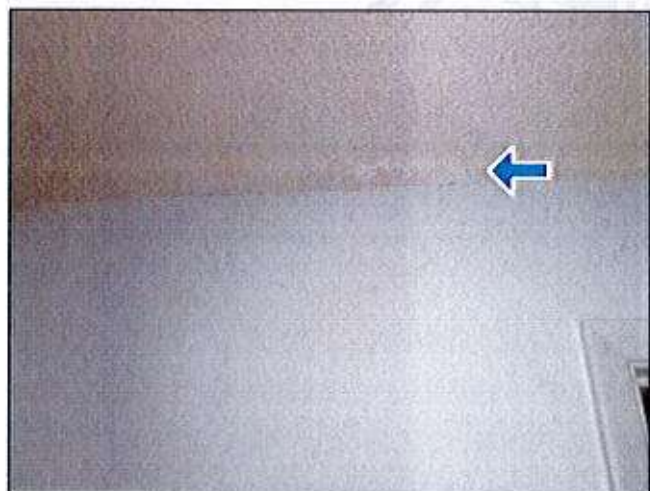
28.2 Item 1 (Picture)

Water stains and deterioration noted at the ceiling, suggest review with a licensed contractor for repairs as needed.

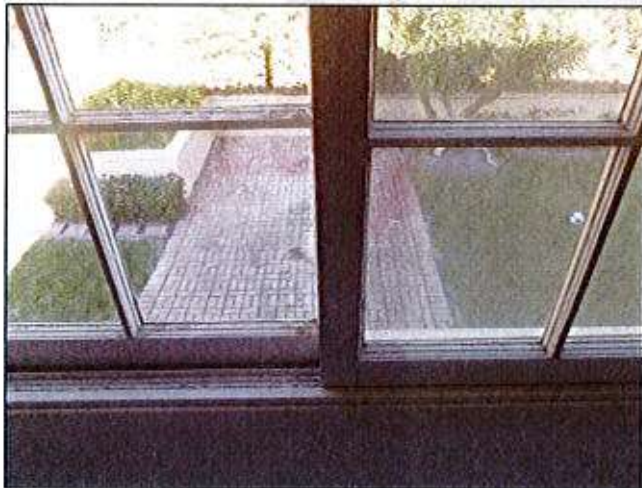
28.4 Item 1 (Picture)

The wood trim/frames are peeling paint at various windows, further deterioration may occur if not repaired. Suggest review by a licensed contractor and repair/replace as needed.

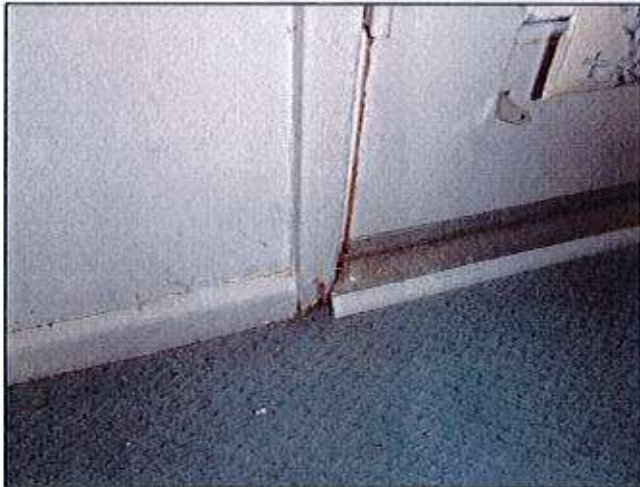
29.3 Item 1 (Picture)

- (1) Evidence of previous and possible on-going water intrusion was noted at the door(s) and walls to the exterior. Suggest review with a licensed contractor for repair/replacement costs as needed.

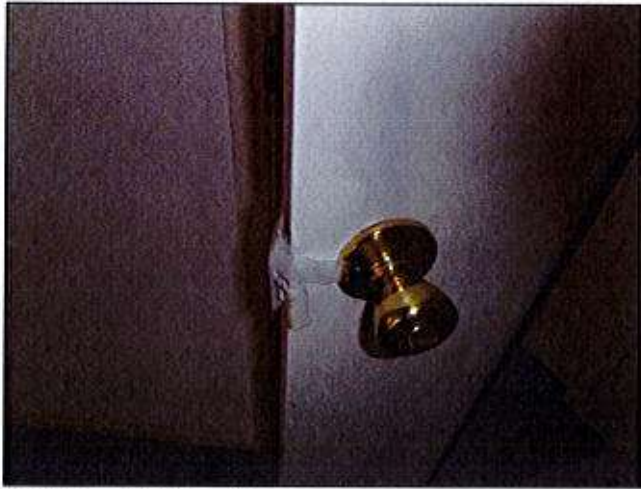
29.3 Item 2 (Picture)

- (2) The wood doors are weathered and deteriorated, suggest repair/replace as needed.
- (3) Unable to determine if tempered glass is installed at the window/door glass at this area (no labelling/etching is visible). Windows and doors with glass 18 inches off the floor area or windows within doors should have safety glass. Suggest review of these areas for possible costs to upgrade for safety.
- (4) The door won't close and latch correctly due to the latch being taped, suggest repair as needed.

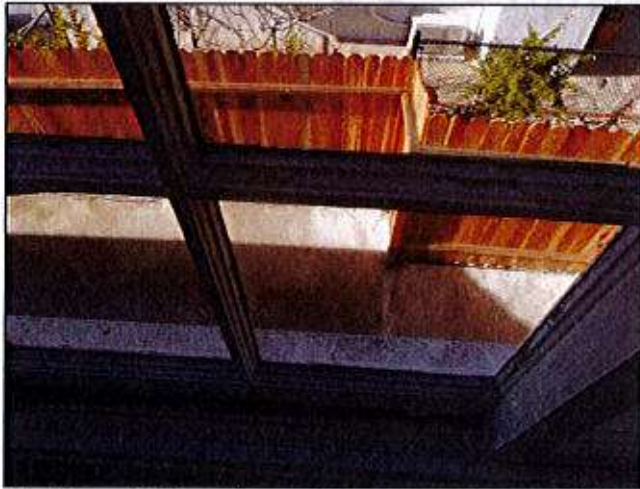
29.4 Item 1 (Picture)

The wood trim/frames are peeling paint at various windows, further deterioration may occur if not repaired. Suggest review by a licensed contractor and repair/replace as needed.

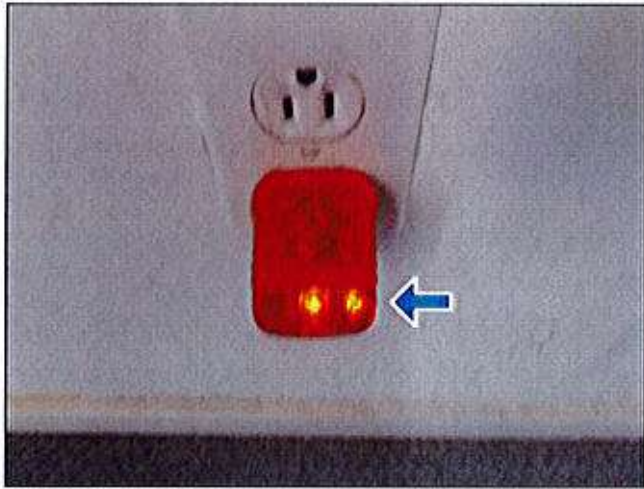
29.6 Item 1 (Picture)

(2) Reversed polarity noted at various outlets. Reversed polarity, hot and neutral are reversed, is usually easily corrected by minor wiring adjustments at the specified item. Suggest review with a licensed electrician for repair/ replacement costs and confirm correct operation as needed.

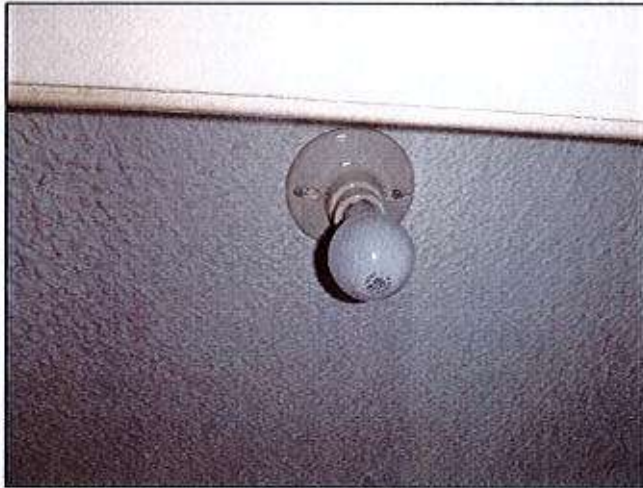
29.6 Item 2 (Picture)

(3) The cover globe(s) are missing at light fixture(s) in the closet at the time of the inspection. Suggest replacing the missing cover globe(s) for safety.

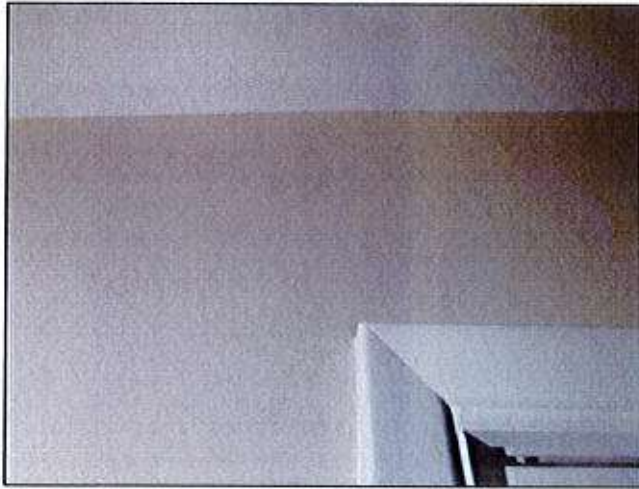
30.1 Item 1 (Picture)

Settling cracks and patching was noted, suggest repair as needed.

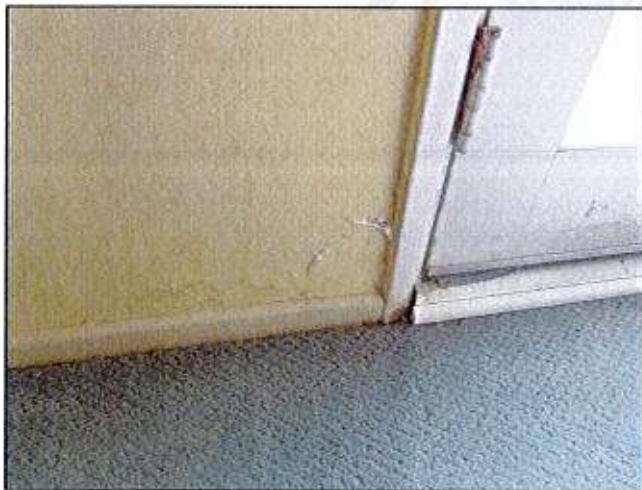
31.1 Item 1 (Picture)

(1) Excessive stains, deterioration and water damage noted at various walls/areas. Suggest review with the seller and/or a licensed contractor to determine/verify the source of the leaks and any repairs needed. Suggest review with a licensed contractor for repair/removal/replacement costs as needed.

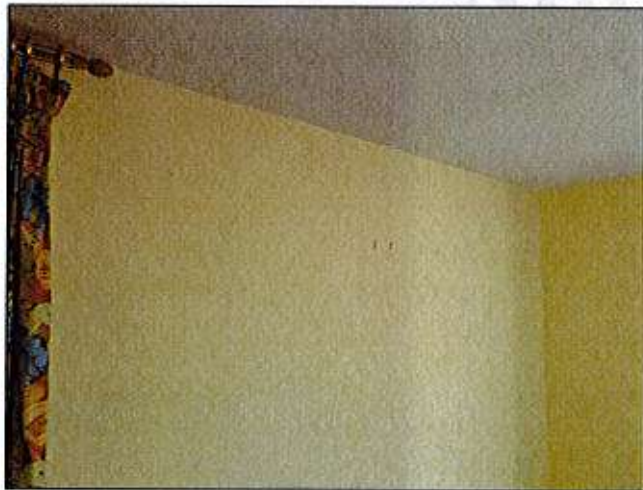
31.1 Item 4 (Picture)

(2) Excessive settling cracks noted, see the foundation and Lot/Drainage comments. Suggest review with a licensed contractor for repair/replacement costs as needed.

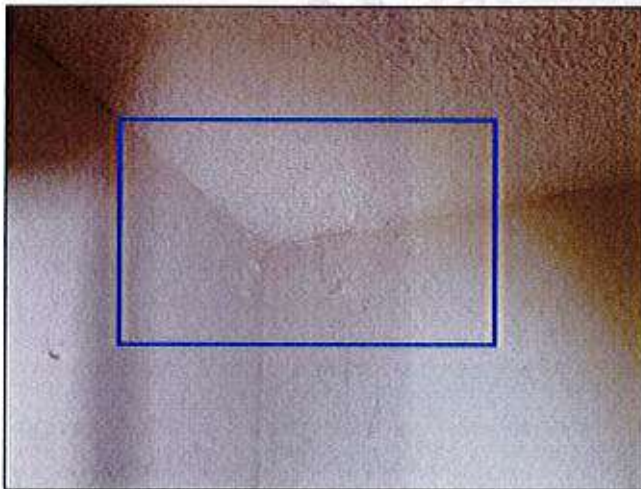
31.2 Item 1 (Picture)

(1) Water stains and deterioration noted at the ceiling, suggest review with the sellers on the cause and any repairs needed. This area tested dry at the time of the inspection. Suggest review with a licensed contractor for repair costs as needed.

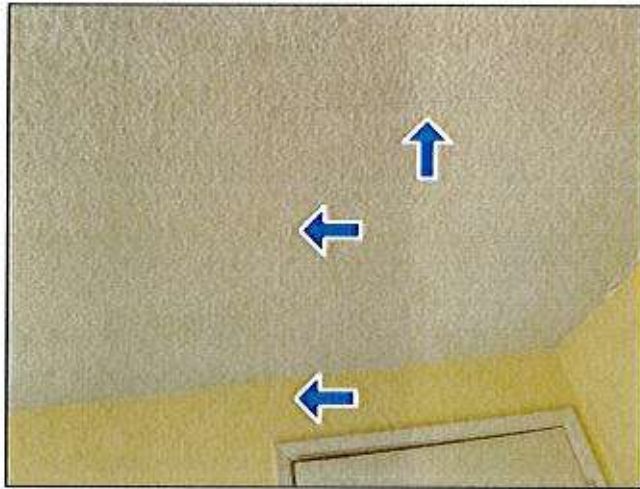
31.2 Item 2 (Picture)

(2) Excessive settling cracks noted, see the foundation and Lot/Drainage comments. Suggest review with a licensed contractor for repair/replacement costs as needed.

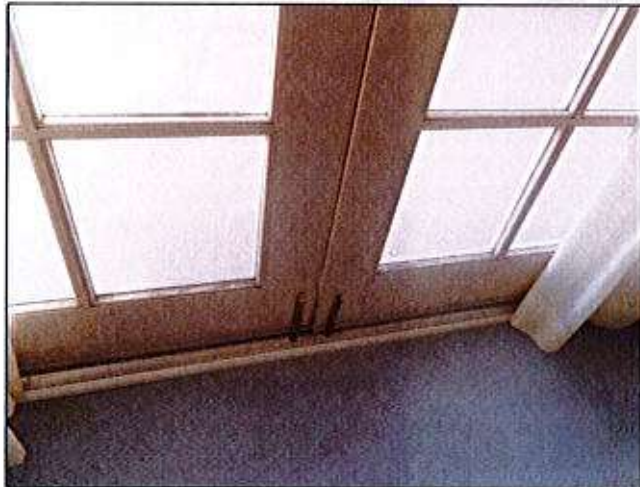
31.3 Item 1 (Picture)

(1) The doors will not open/close easily, suggest repair as needed.
