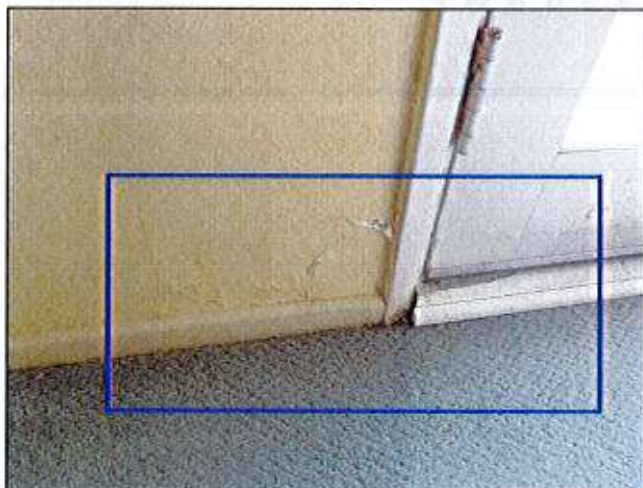
31.3 Item 2 (Picture)

(2) Evidence of previous and ongoing water intrusion noted at the door(s) to the interior. Black staining/growth was noted at the door panels. Suggest review with a licensed contractor/licensed mold contractor for removal/repair/replacement costs as needed and to prevent further and future water intrusion at this area.

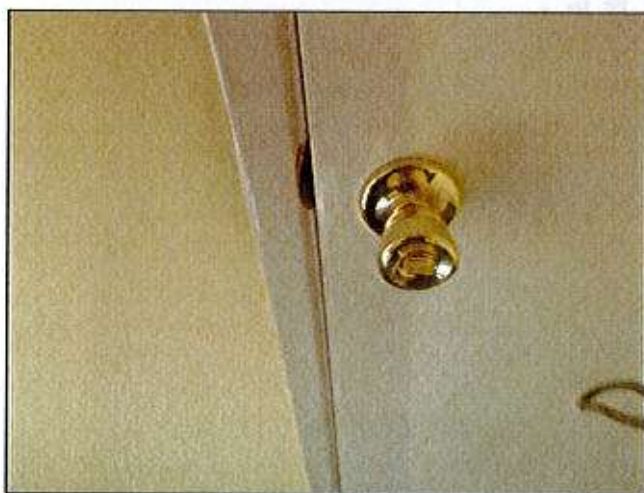
31.3 Item 5 (Picture)

(3) The door will not close and latch correctly, suggest repair as needed.

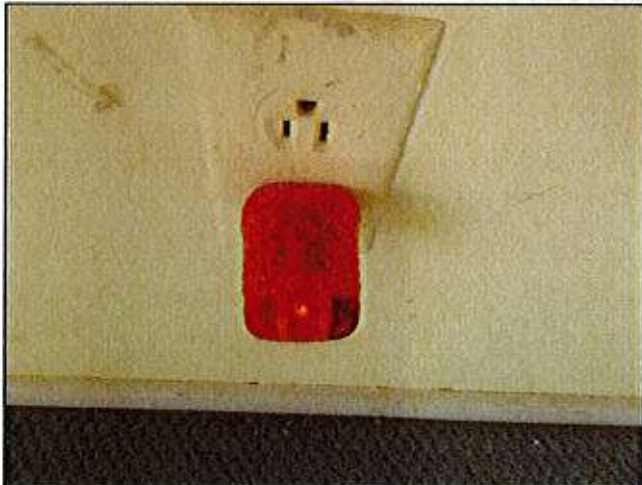
31.6 Item 1 (Picture)

(1) Ungrounded three prong outlets noted at this area. Suggest review with a licensed electrician for costs to ground the outlets as needed as an upgrade and/or protect the outlet(s) on a GFCI circuit where recommended.

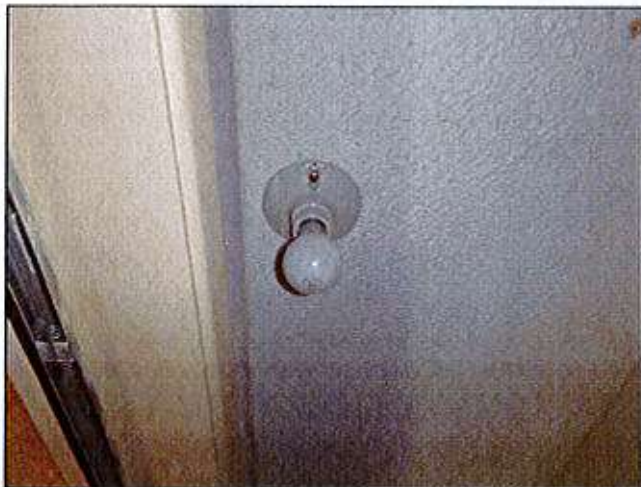
31.6 Item 3 (Picture)

(4) The light fixture(s) in the closet area are missing the diffuser covers and are loose on the mount(s). Suggest installing the missing diffuser cover(s) and re-securing for safety.
